MICHIGAN
DEPARTMENT OF STATE HIGHWAYS

Subject: Report on Witcogard Rustproofer for Guard Rails.
Research Project 63 NM-90; Research Report No. R-644

Witcogard Rustproofer for guard rails, a coating system consisting of a proprietary bituminous binder overcoated with colored stone granules, has been under test evaluation on about 115 ft of weathered, galvanized guard rail since September 1963. Details covering the application were presented in Research Report No. R-440, dated October 7, 1963.

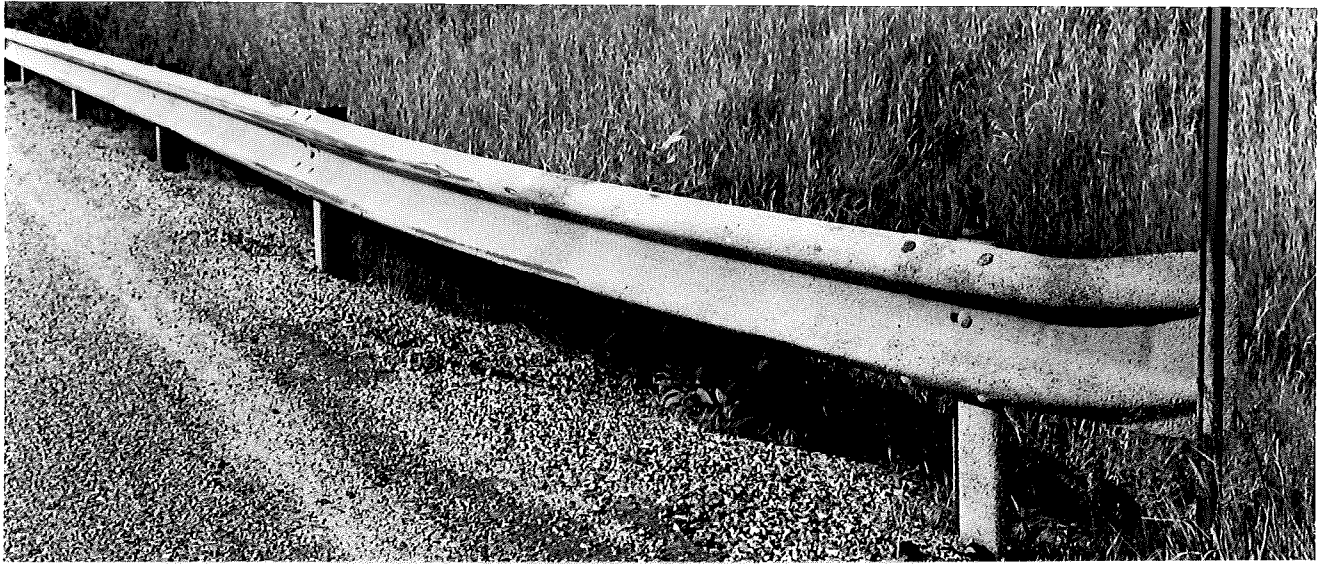
1. The coating was scraped from the outward ridge of rail corrugations by vehicles, presumably snow plows, to give the poor appearance shown in Figures 1 and 2. The scrapings varied from complete to partial removal of the composite Witcogard coating.
2. There was some minor loss of granules on the top face at Knapp Street where black binder was becoming visible.
3. There were only two small areas, about 1-in. diameter, where the coating had flaked off as shown in Figure 3. Otherwise, adhesion was adequate.
4. The Witcogard coating, except as noted, gave good protection to the galvanizing during the test period.

Figure 1. (top) Scraping damage on 50 ft of test guard rail at Knapp St. after four years of service. Gray granules overcoated the black binder.

the galvanized coating. During four years of service testing, the guard rails presented unsightly appearance due to removal of granules and coating, and some exposure of black binder. The damage can easily be repaired, according to the producer, but the maintenance operation is probably undesirable.

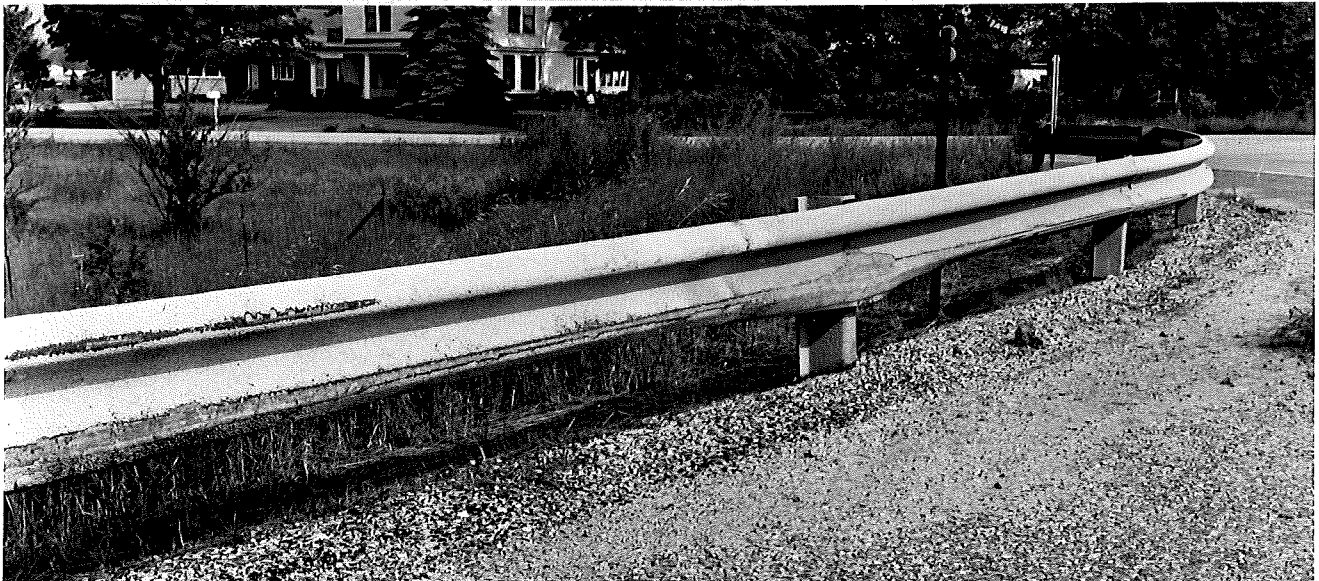
Figure 2. (center) Scraping damage occurring on 65 ft of test guard rail at the Leonard St. ramp, after four years of service.

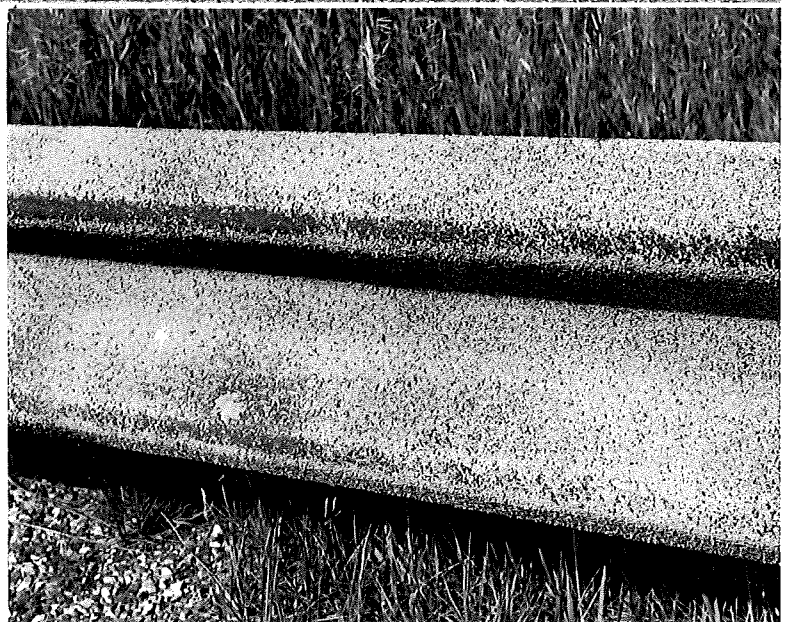
Figure 3. (right) The Witcogard coating had good adhesion since only two small round areas showed flaking. This was at Knapp St. Photo also shows scraping damage. (Photographed 6-23-67)
