1. Report No. RC-1389B		2. Government Accession No.		3. Recipient's Catalog No.	
4. Title and Subtitle Michigan Deck Evaluation Guide			5. Report Date November 2000

# MICHIGAN DECK EVALUATION GUIDE

**Report submitted to  
The Michigan Department of Transportation**

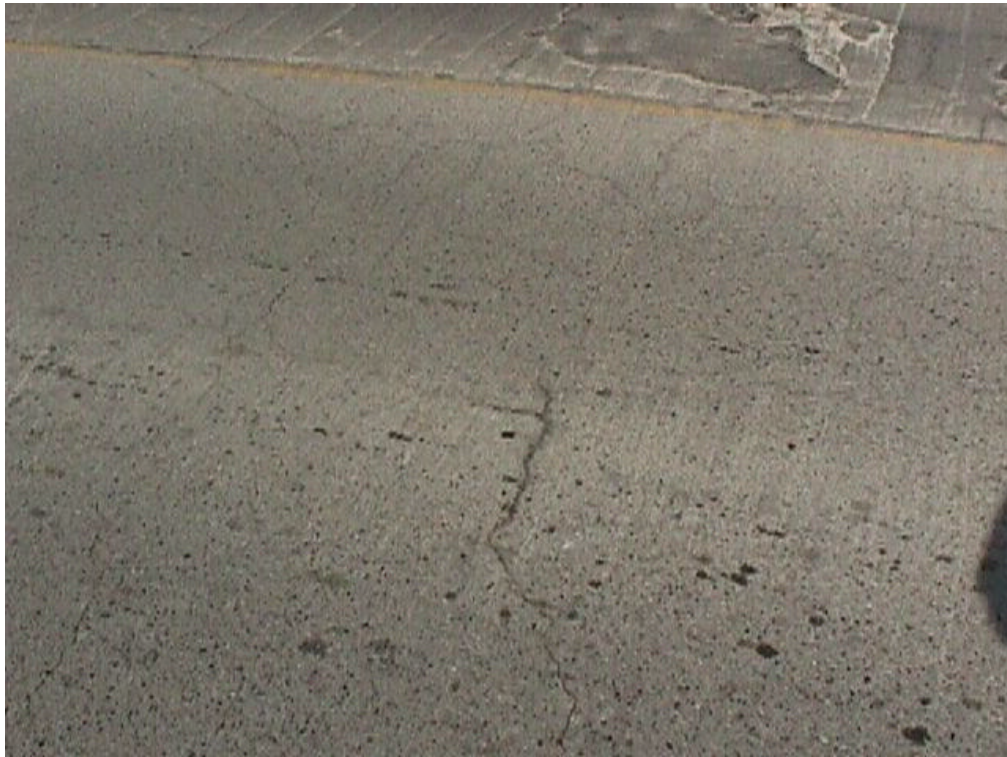
Figure 3-1. Craze cracks (top of the deck)

*Craze cracks* – Fine random cracks or fissures in the surface of mortar or concrete, Figures 3-1, 3-2.

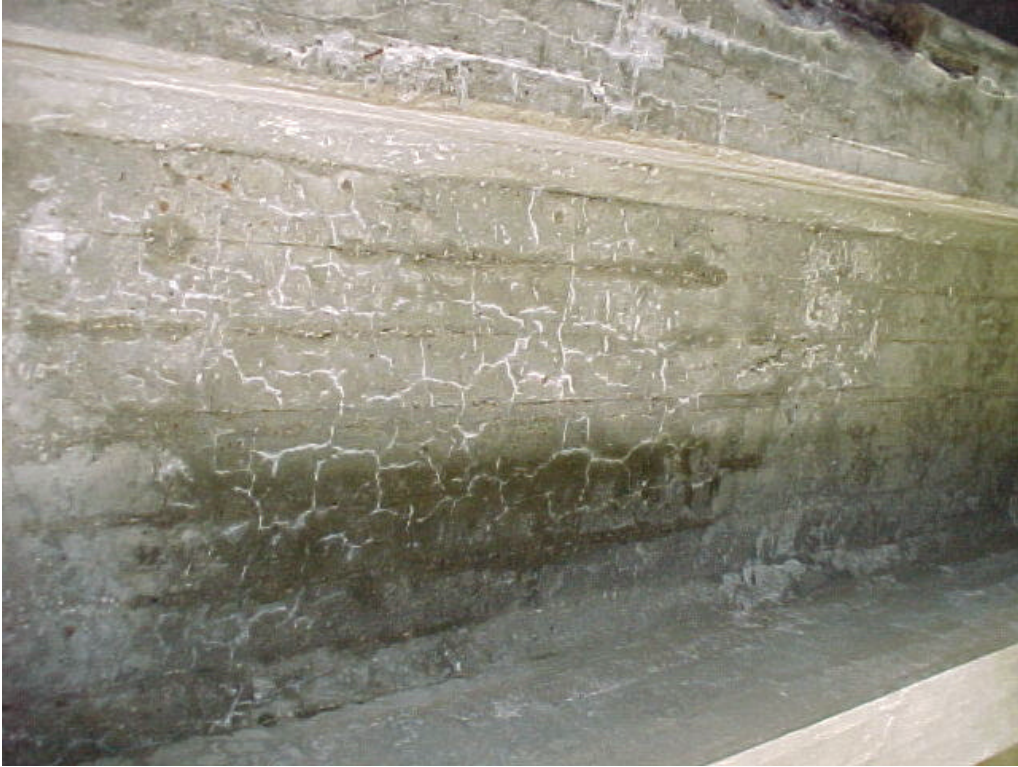
Figure 3-2. Pattern cracks (bottom of the deck)

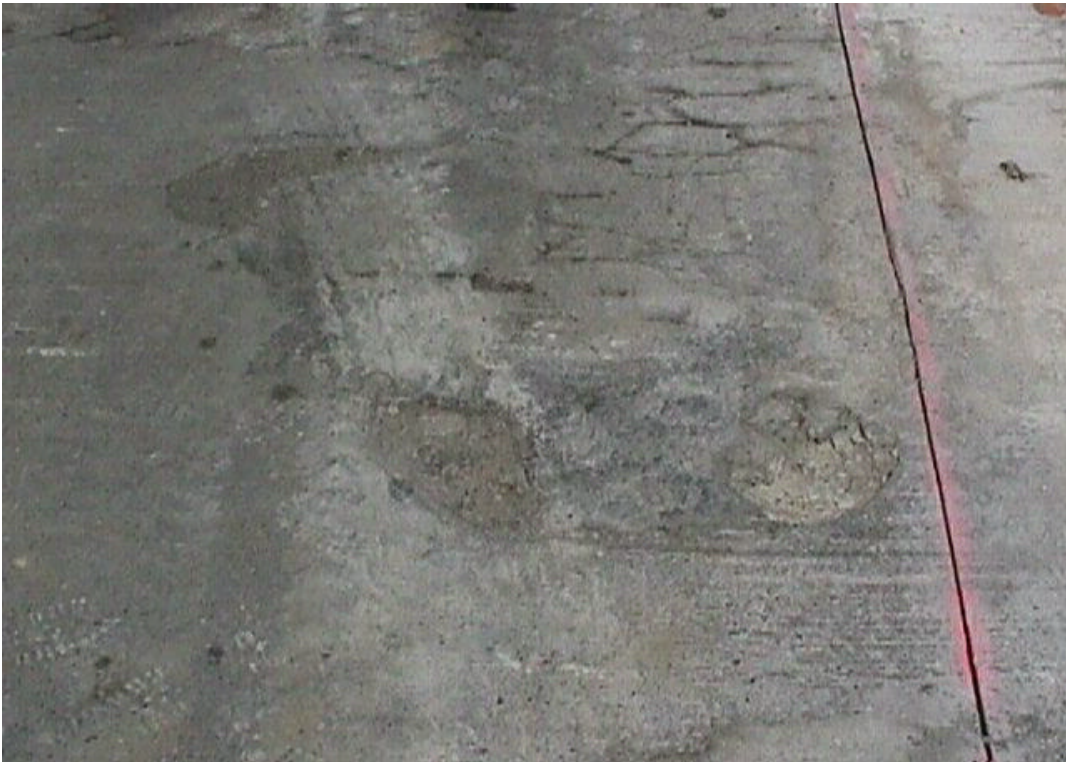
Figure 3-3. Pattern cracks (large)

*Pattern cracking (Map cracking)* – Cracking in the concrete in the form of a pattern; resulting from a decrease in volume of the material near the surface; increase in volume of the material below the surface, or both, Figures 3-3, 3-4.

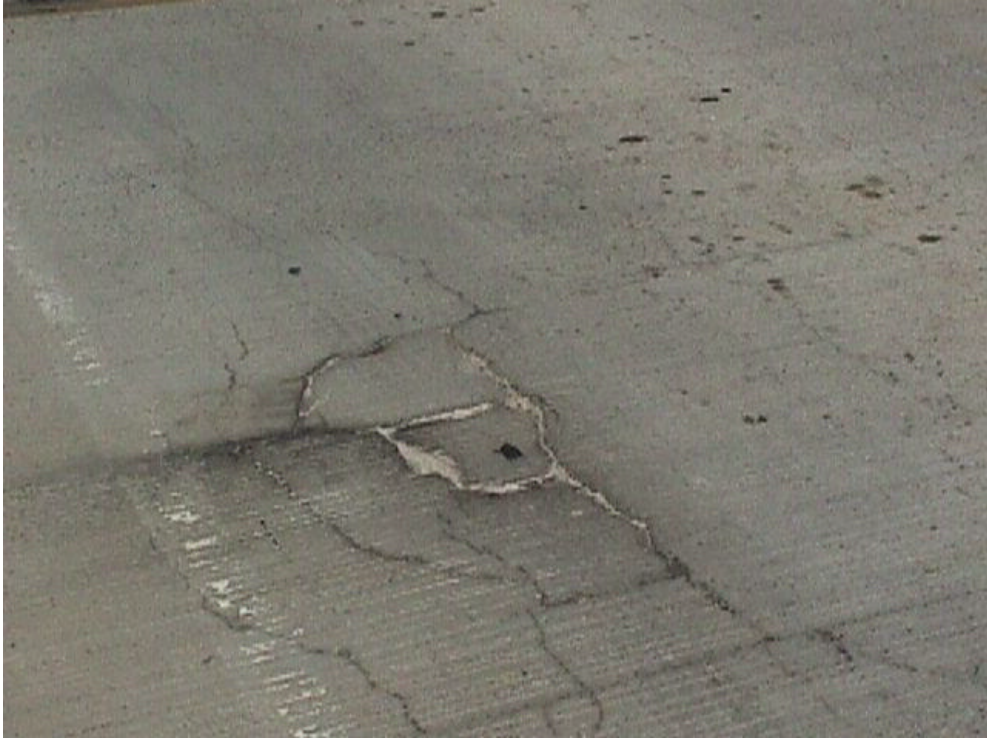
Figure 3-4. Pattern cracking (large)

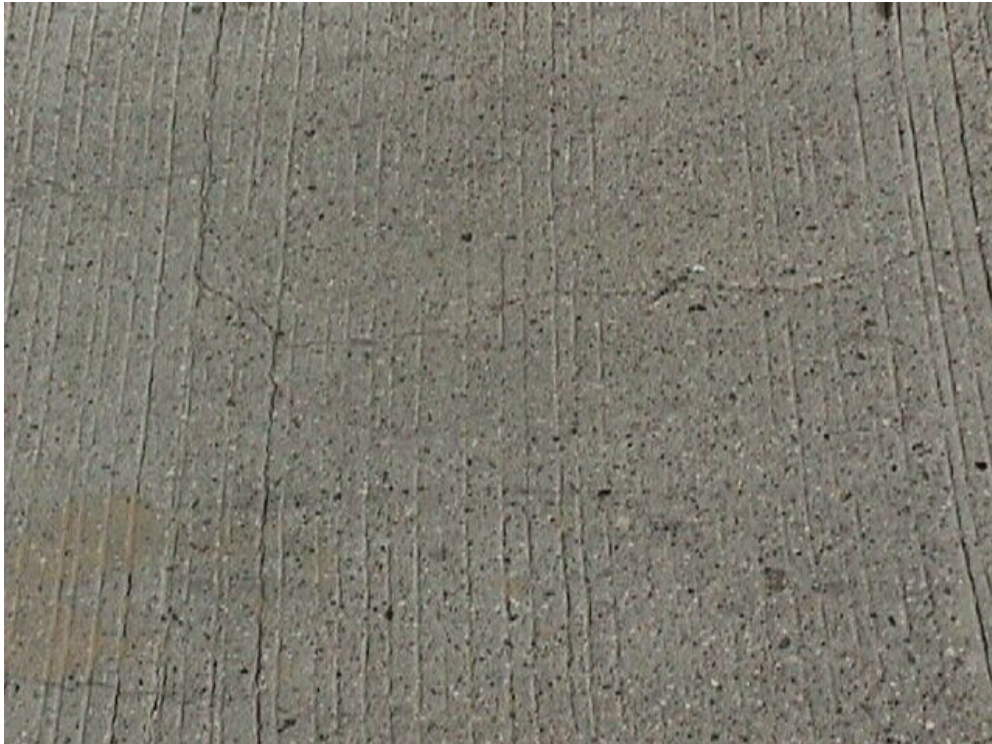
Figure 3-5. Shrinkage cracks

*Shrinkage cracking* – Cracking of a structure or member due to failure in tension caused by external or internal restraints as reduction in moisture content develops, or as carbonation occurs, or both, Figure 3-5. Plastic shrinkage cracks occur when the rate of evaporation exceeds the rate of concrete bleeding in fresh concrete (which has not started to harden).

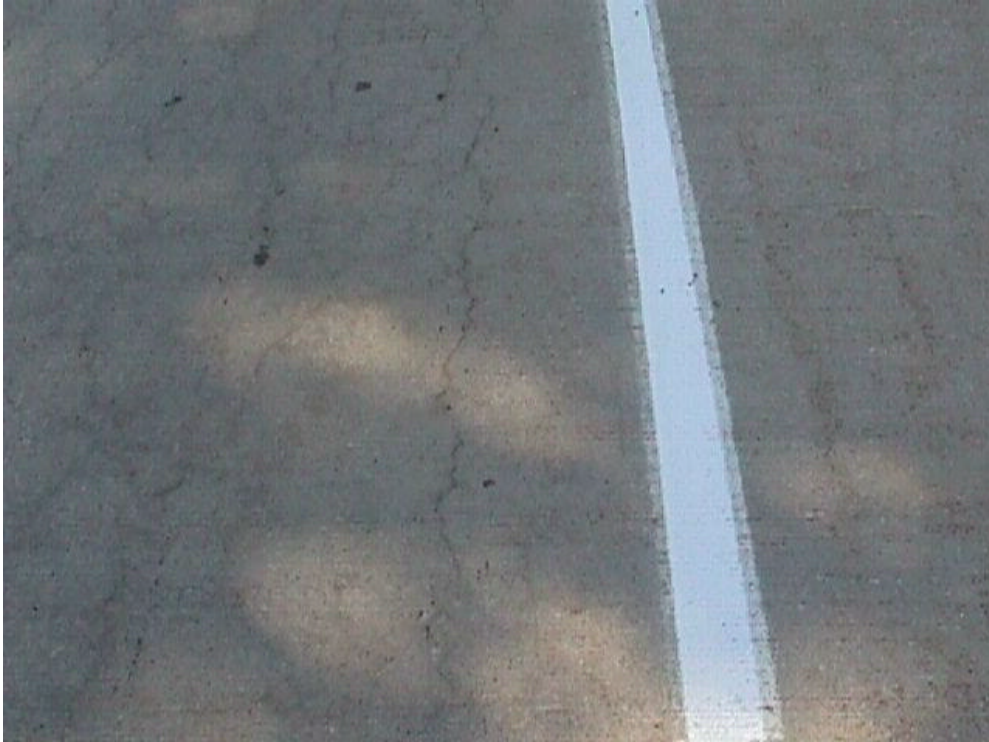
Figure 3-6. Longitudinal cracks (top of the deck)

*Longitudinal cracks* – Cracks that develop parallel to the long direction of a member, Figures 3-6, 3-7, 3-8.

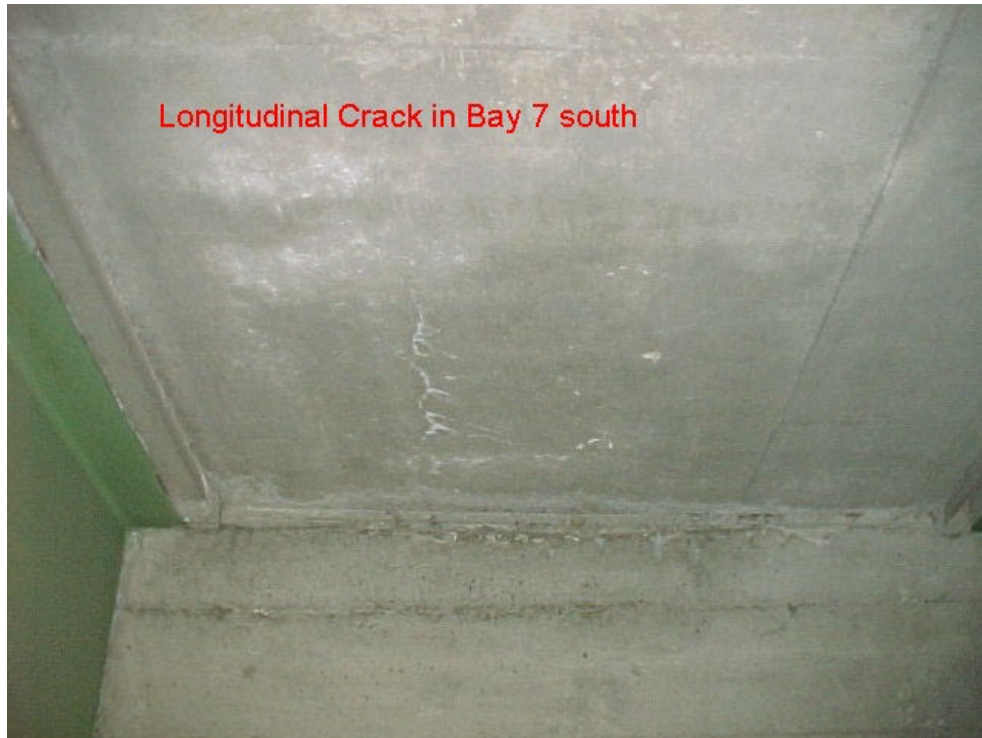
Figure 3-7. Longitudinal crack (bottom of the deck)

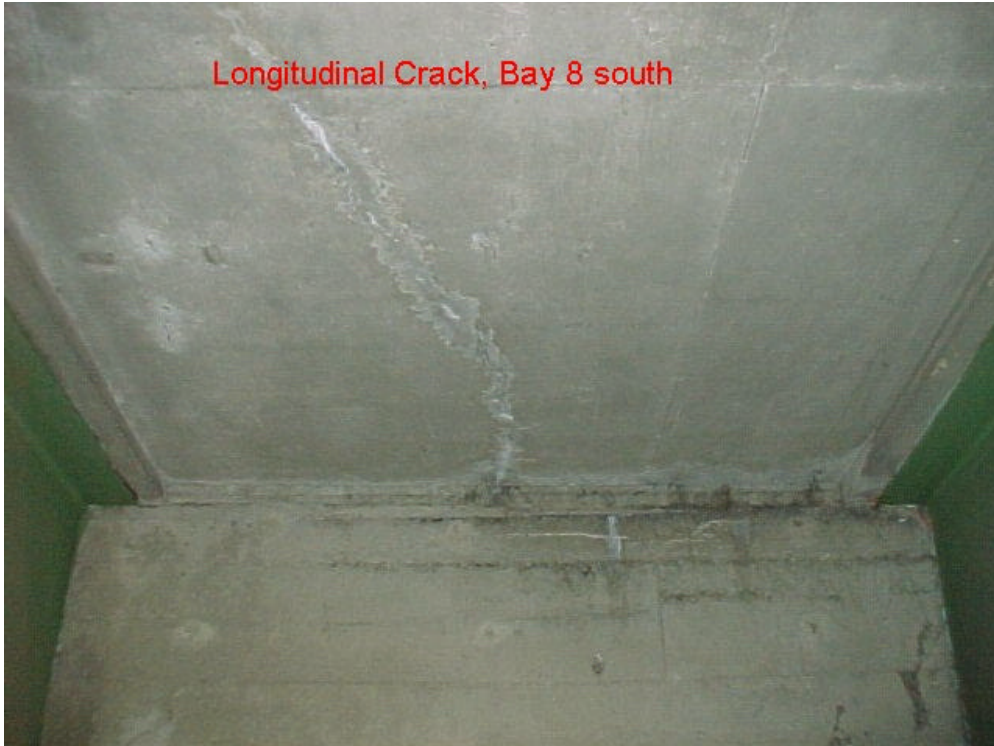
Figure 3-8. Longitudinal crack (bottom of the deck)

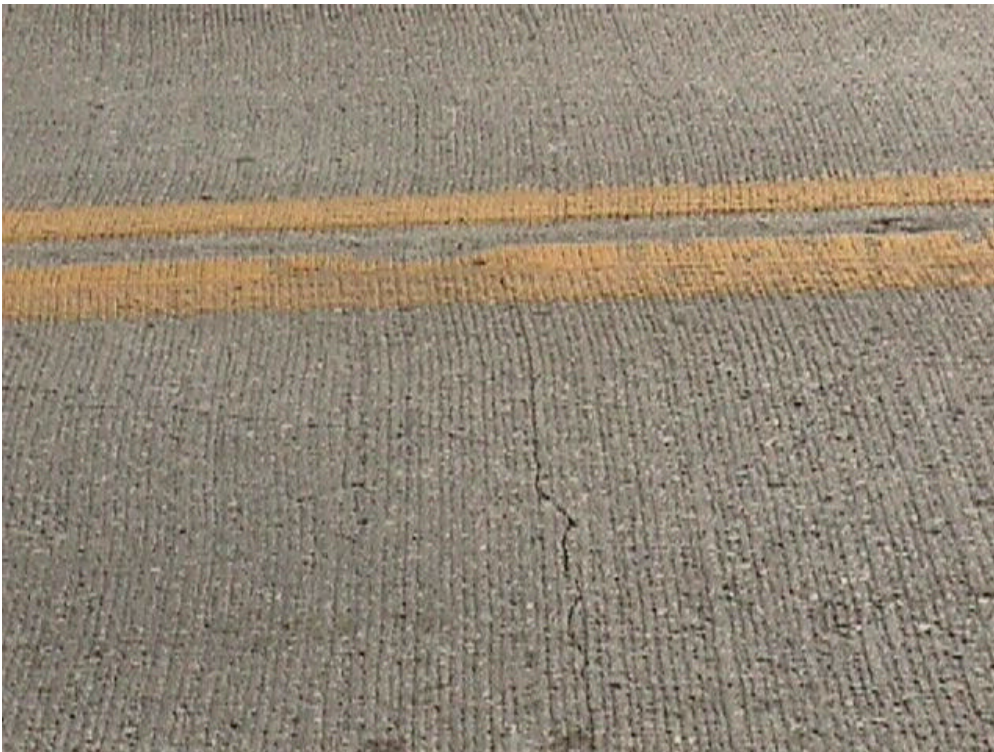
Figure 3-9. Transversal cracks

*Transverse cracks* – Cracks that develop at right angles to the long direction of a member, Figures 3-9, 3-10, 3-11.

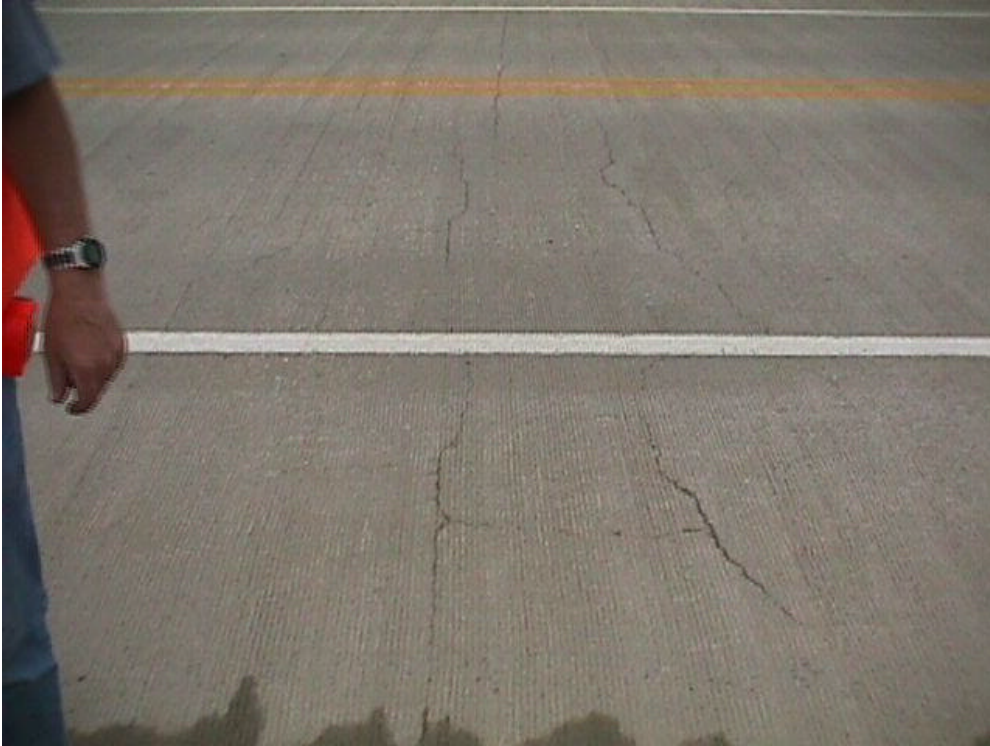
Figure 3-10. Transverse cracks, caused by restraint shrinkage

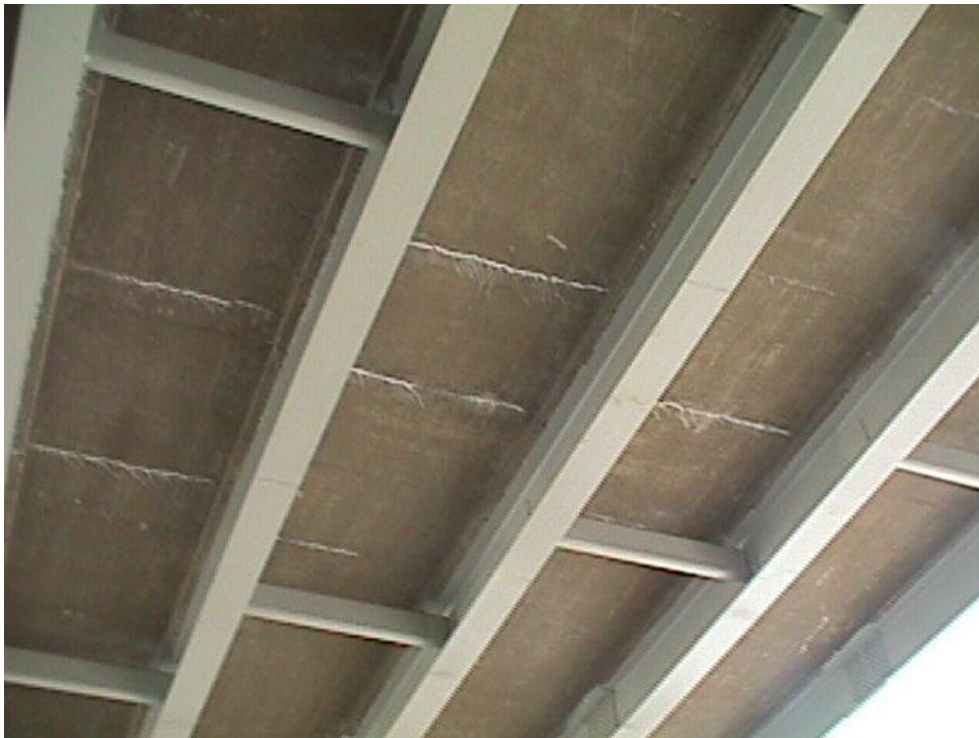
Figure 3-11. Transverse cracks (bottom of the deck), caused by restraint shrinkage

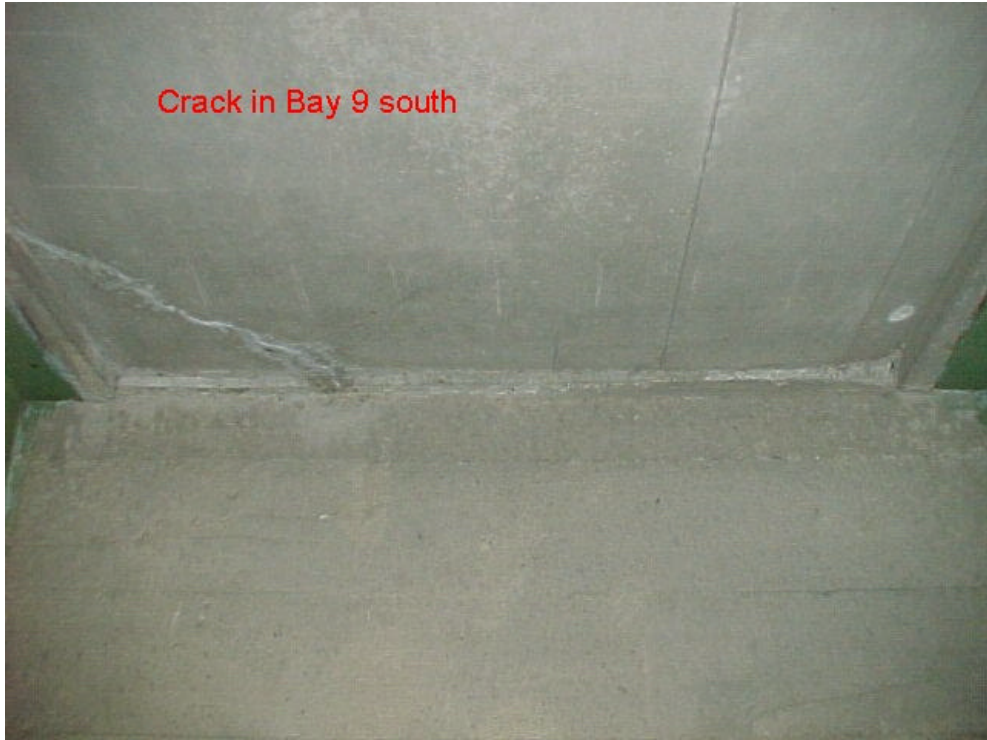
Figure 3-12. Diagonal crack close to support (bottom of the deck)

*Diagonal crack* – In a flexural member, an inclined crack caused by shear stress, usually inclined at about 45 degrees to the vertical axis; or a crack in a slab, not parallel to either the lateral or longitudinal directions, Figures 3-12, 3-13, 3-14..

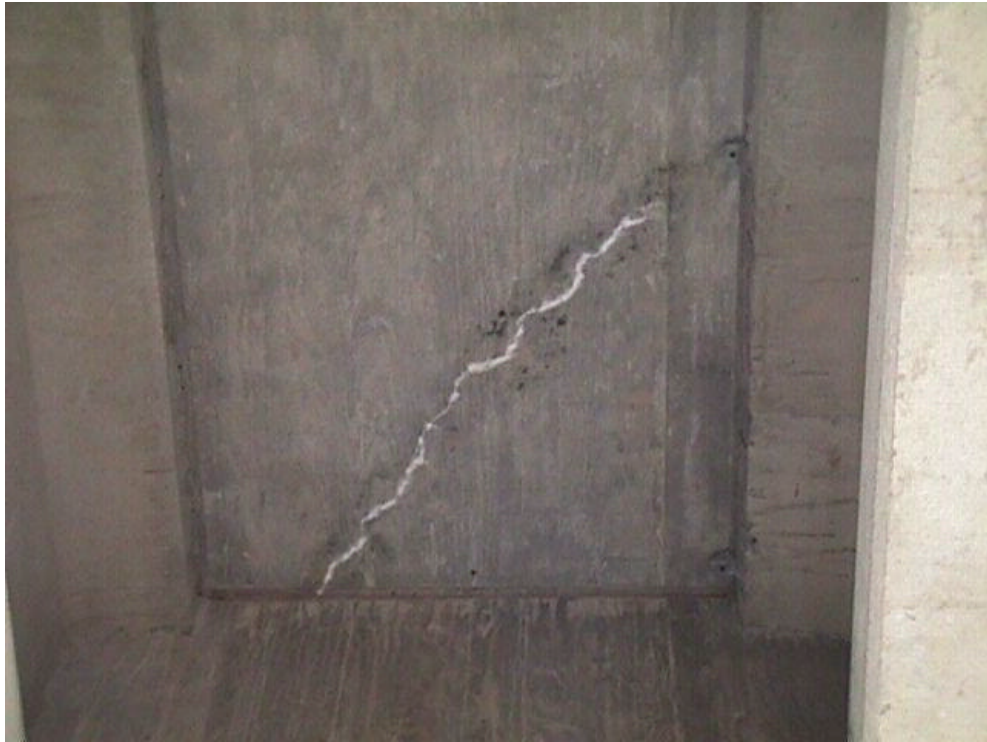
Figure 3-13. Diagonal crack close to support (bottom of the deck)

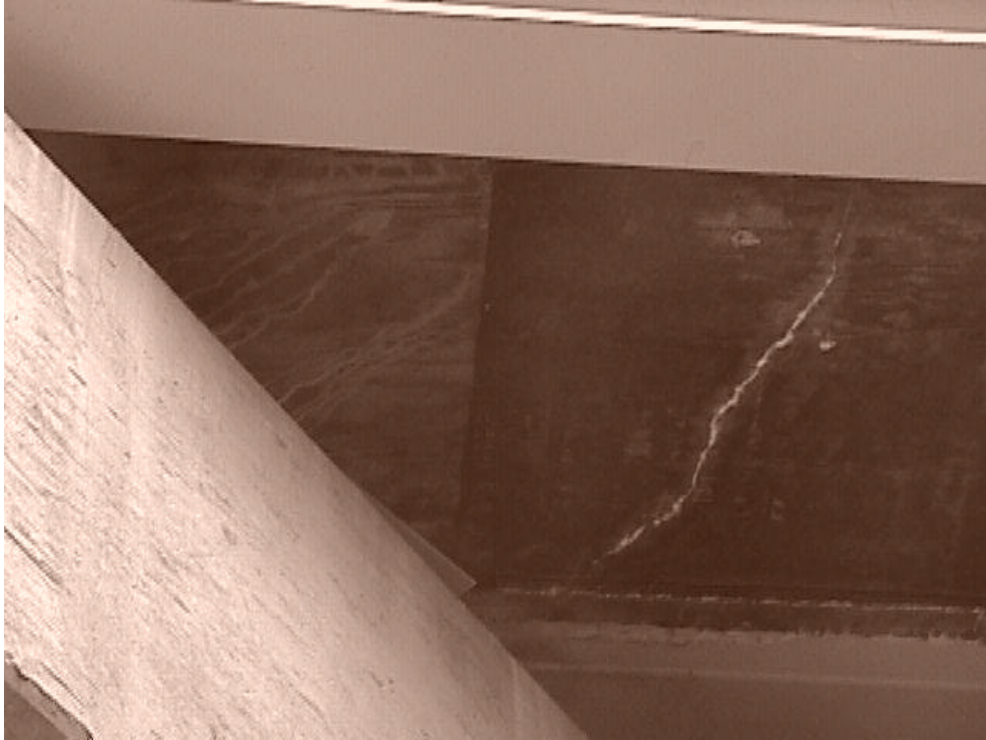
Figure 3-14. Diagonal crack close to joint (bottom of the deck)

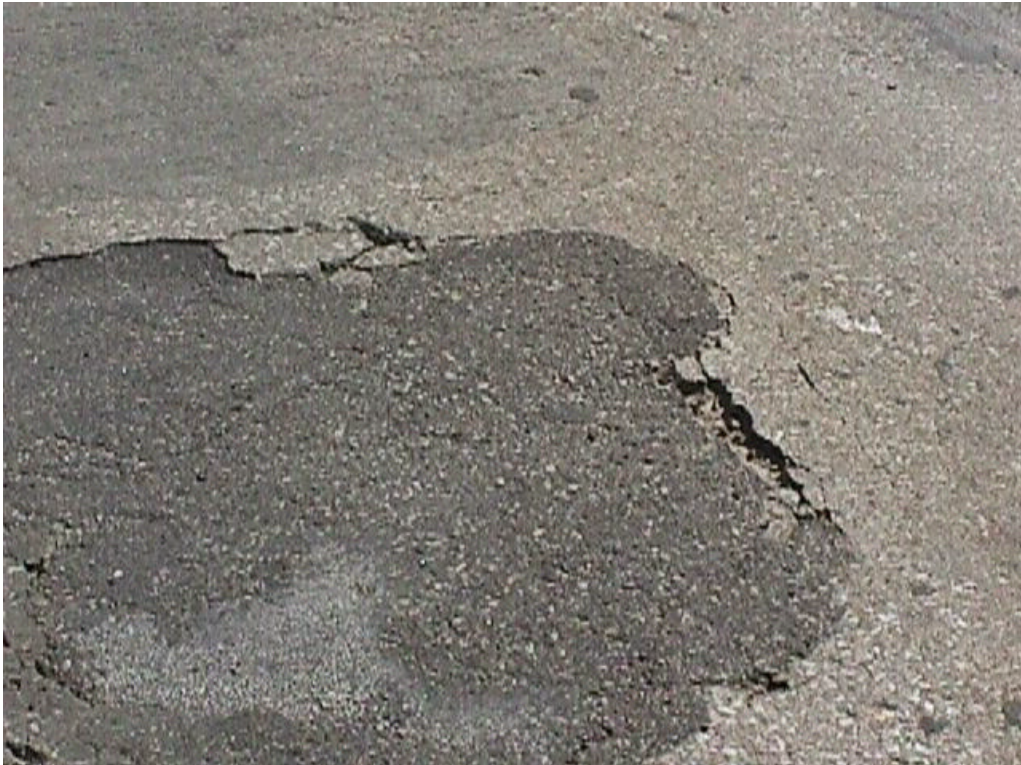
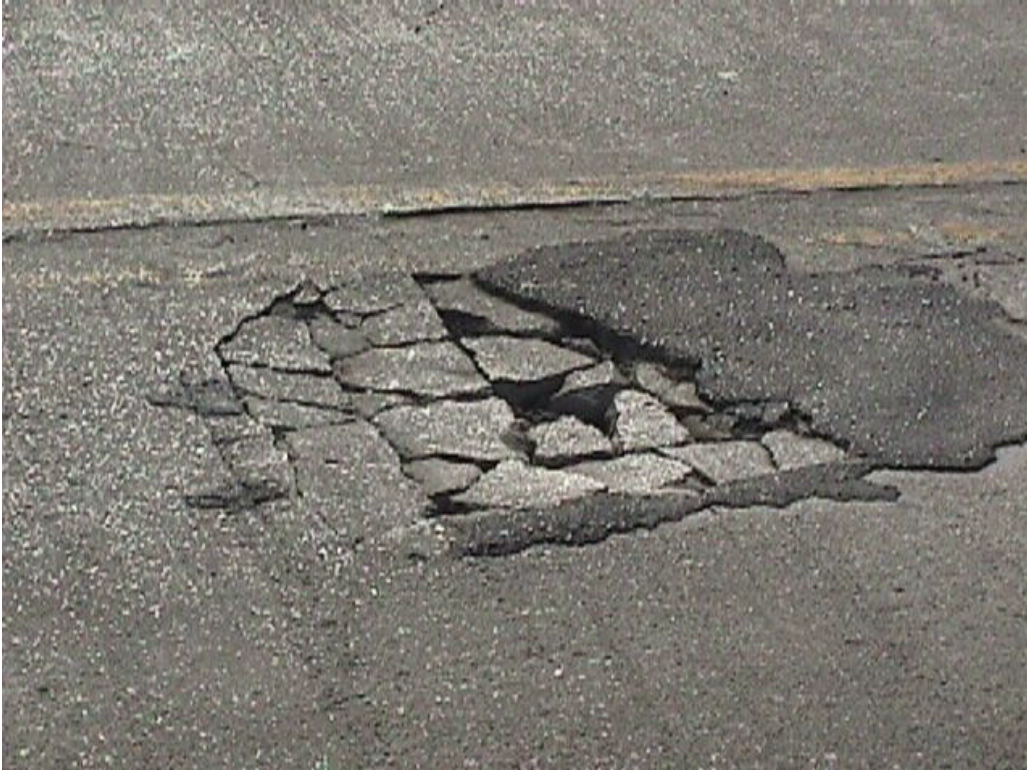
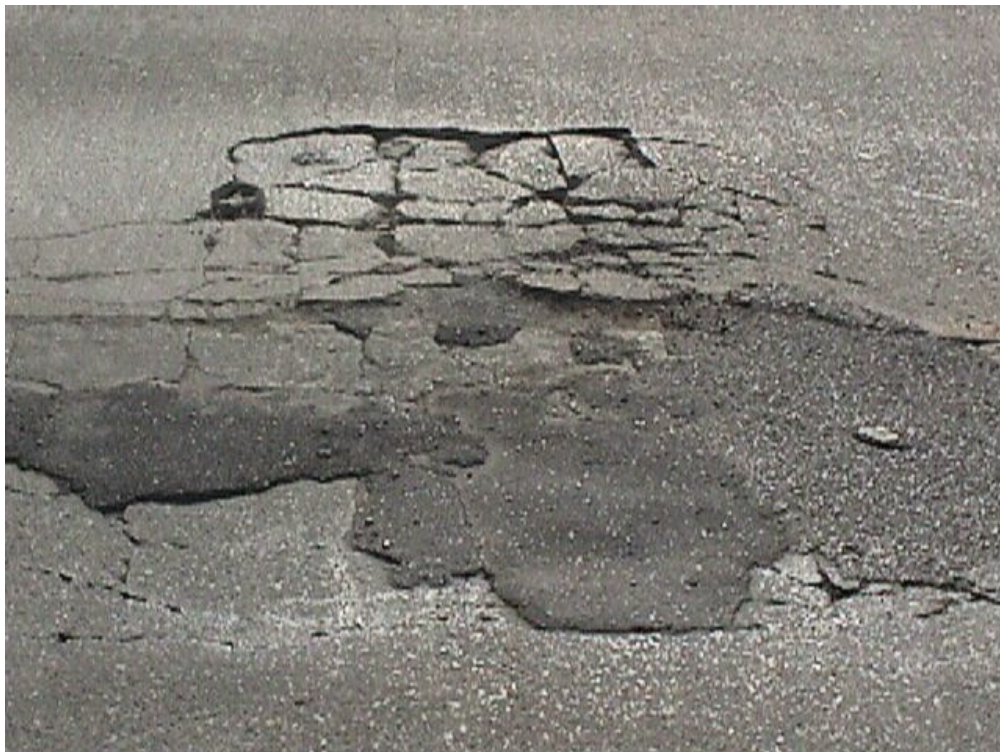
Figure 3-15. Delamination

Figure 3-16. Delamination

Figure 3-17. Delamination

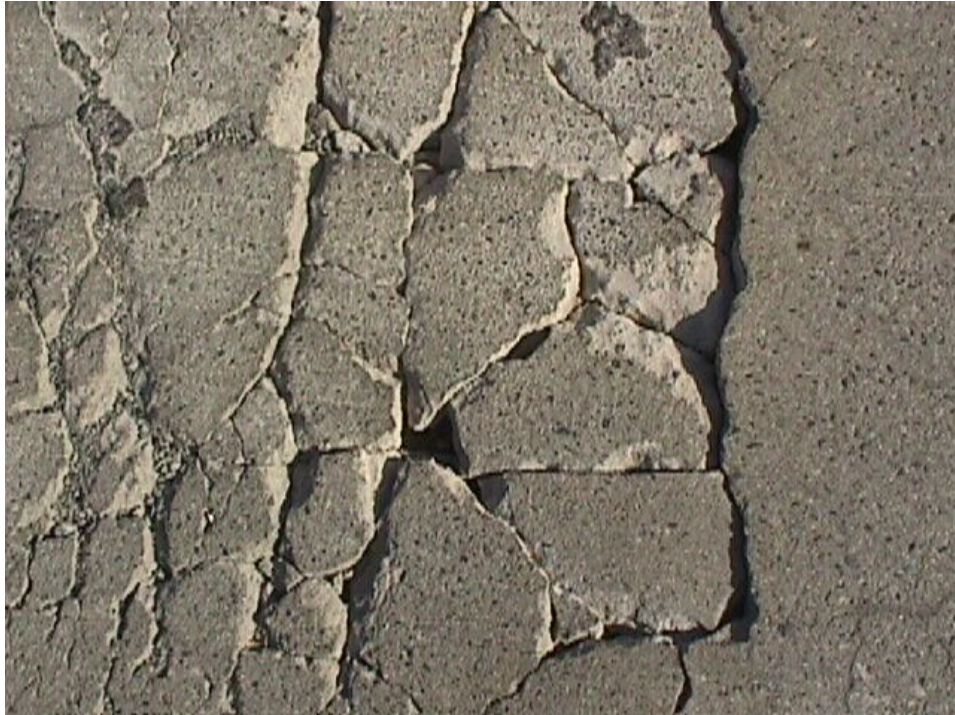
Figure 3-18. Disintegration

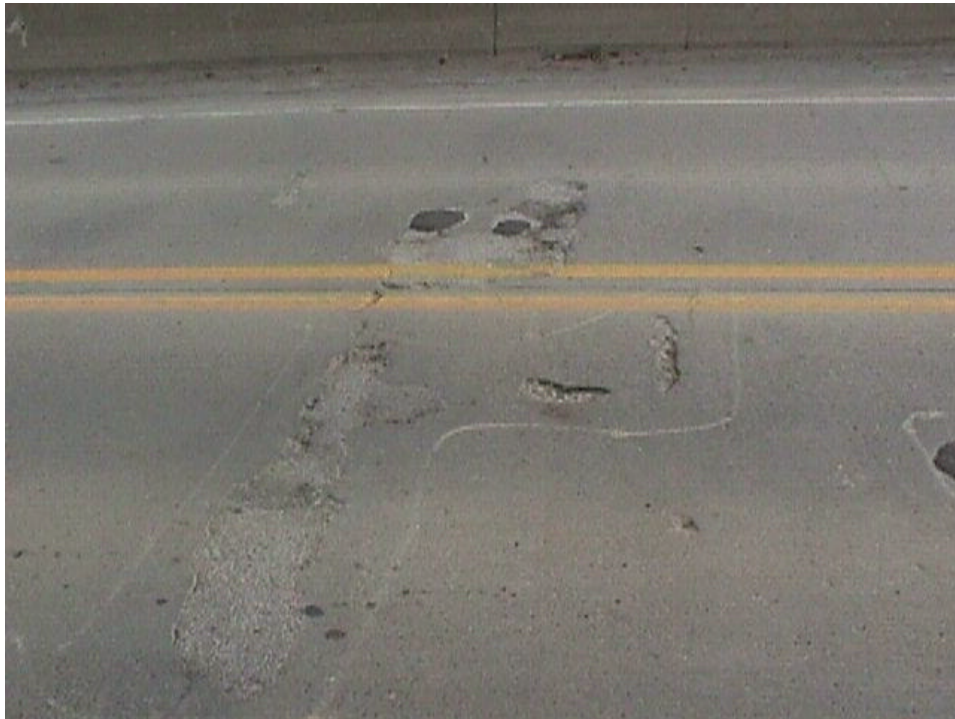
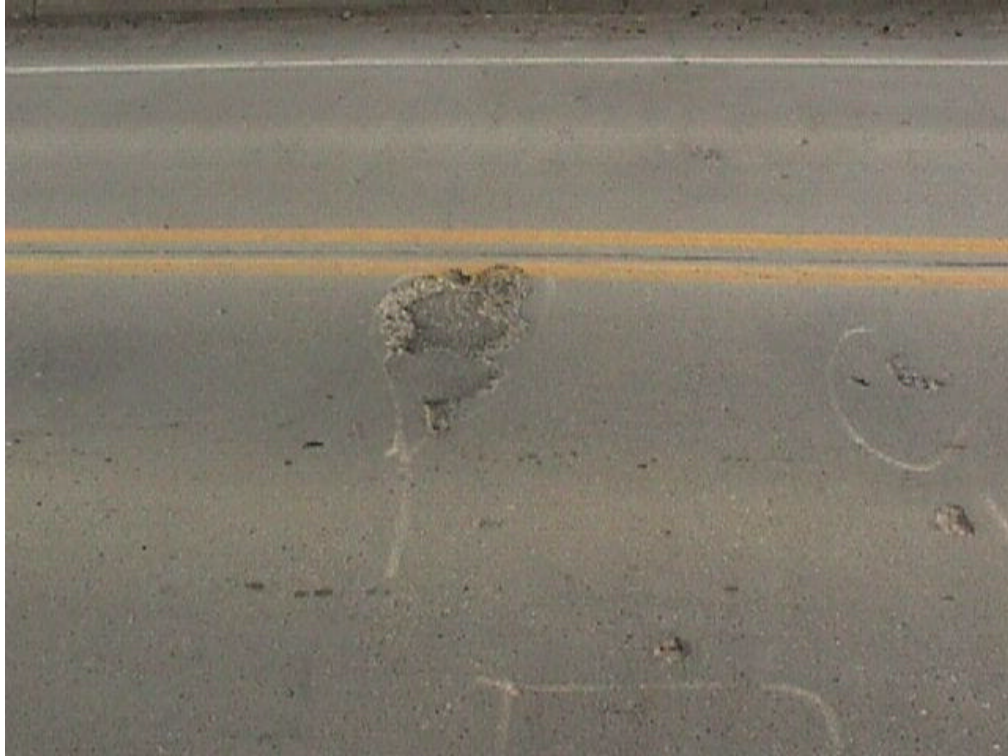
Figure 3-19. Blistering

Figure 3-20. Blistering

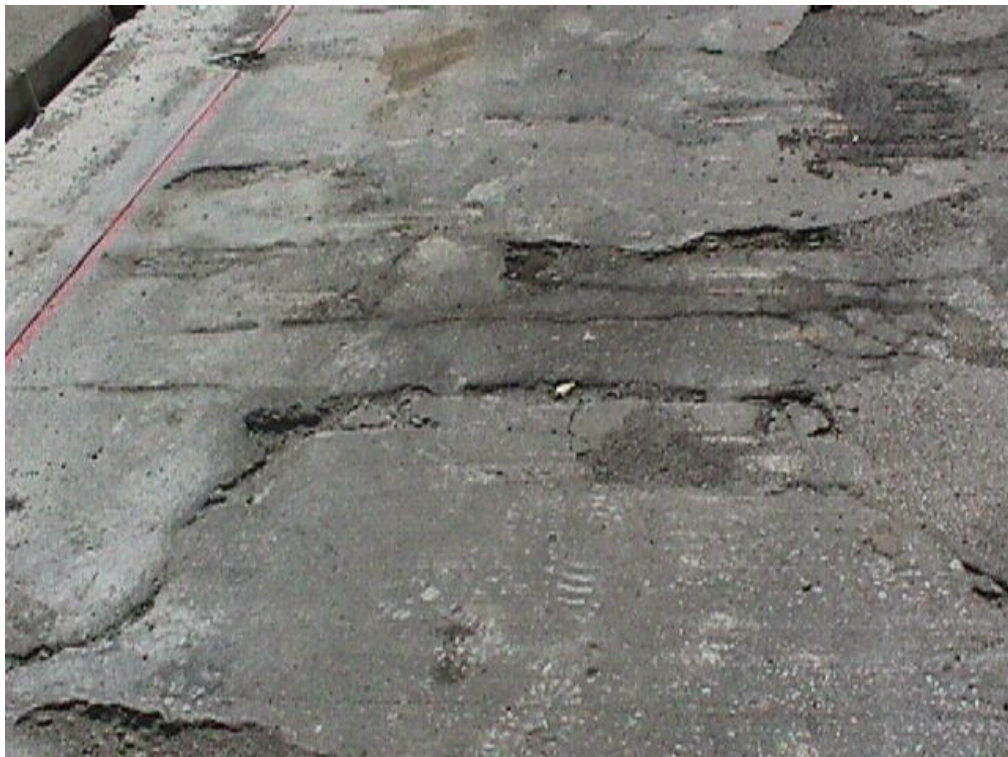
Figure 3-21. Potholes with local erosion of material, located on the line of bigger crack

Other potholes may start with blistering and be caused by local erosion of material. Often they are located on the line of a bigger crack, Figure 3-21. Prior to hole formation, the top reinforcement cover is cracked and disintegrated in many places by a complex influence of weather, corrosion and fatigue load cycles. Then, this highly cracked part of the material is easily crushed by truck wheels. These holes are irregular in shape, different in depth, and in some cases the top reinforcement is exposed through the hole.

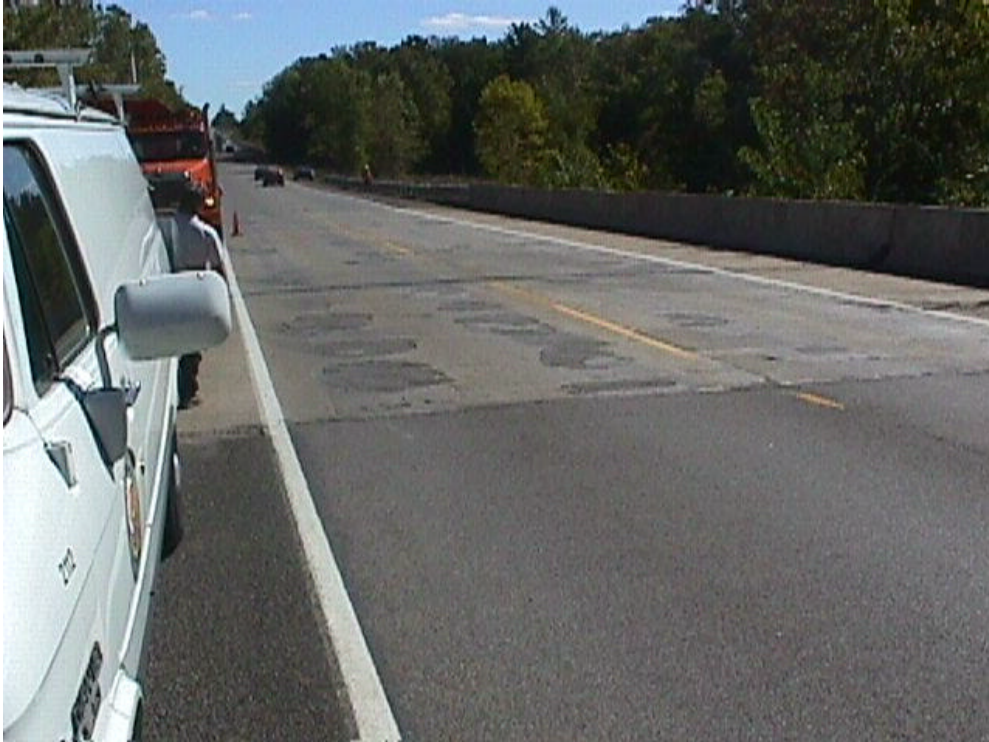
Figure 3-22. Potholes following pattern of wheels

Generally, the occurrence of potholes appears to be random, but it is possible to find some regularity. They are typically located in lanes which are most exposed to traffic, and quite often in the path of trucks wheels, Figure 3-22. This location indicates the

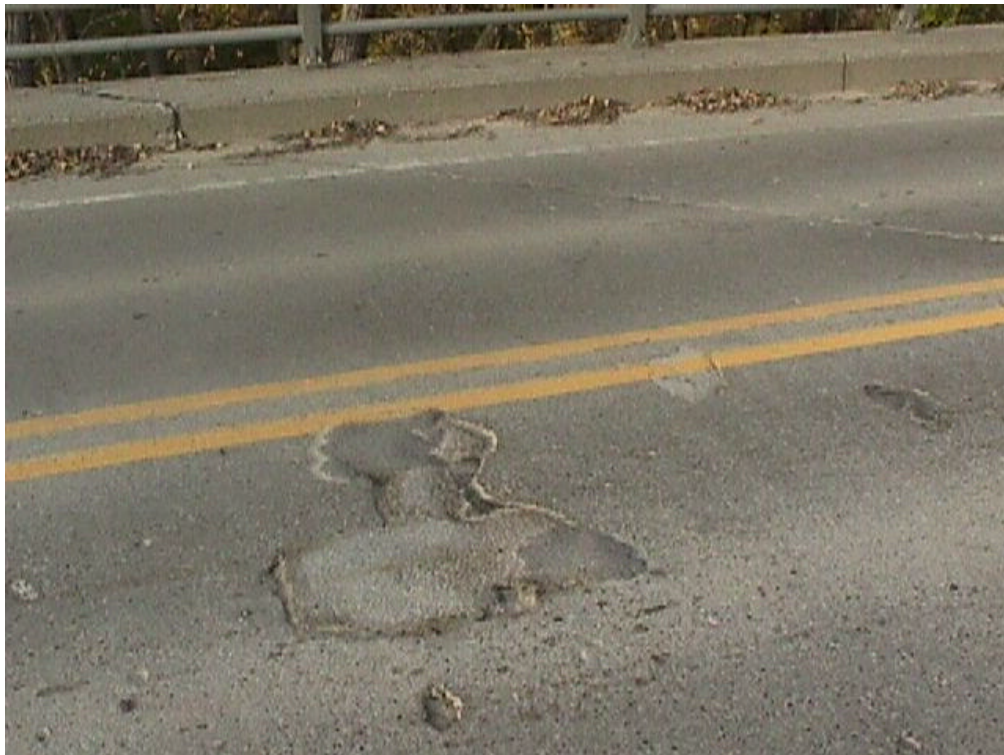
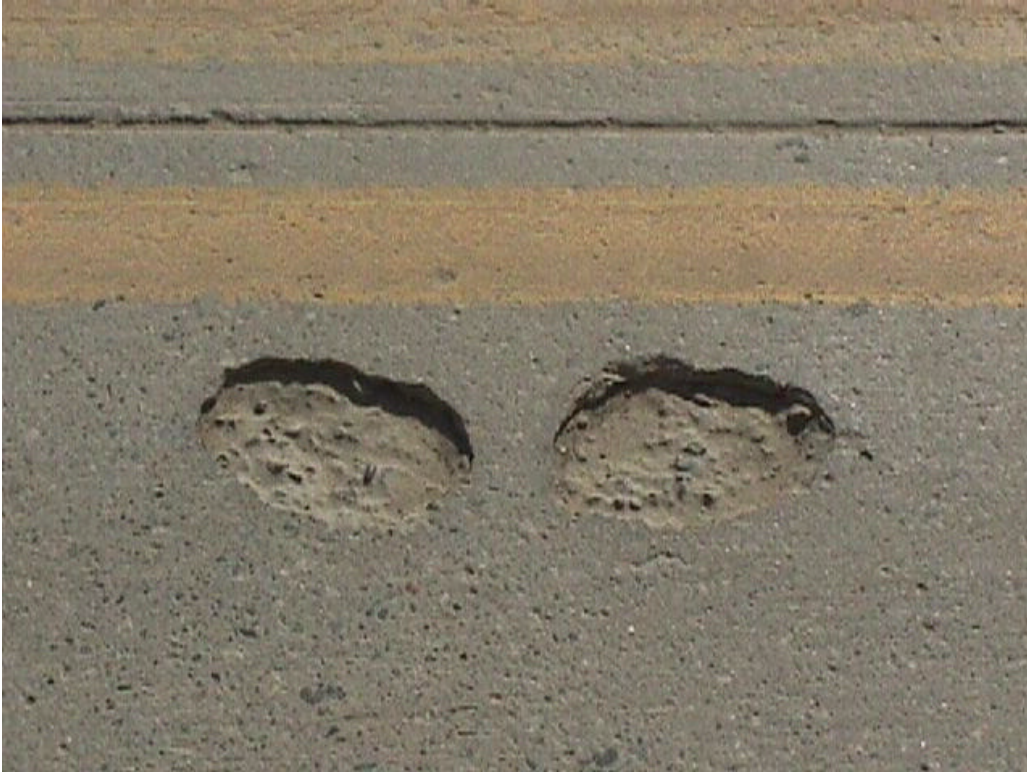
Figure 3-23. Potholes in latex overlay

Figure 3-24. Potholes in latex overlay

There are several different types of potholes. They can be located in decks of relatively good condition, where there are no cracks and the surface quality is good. Potholes are also often observed on decks with a latex layer on top, Figures 3-23, 3-24. Because of likely delamination between the concrete slab and latex, the locally cracked upper part of the deck can be disconnected from the bottom slab and crushed by truck wheels. Such potholes usually have sharp edges perpendicular to the hole bottom.

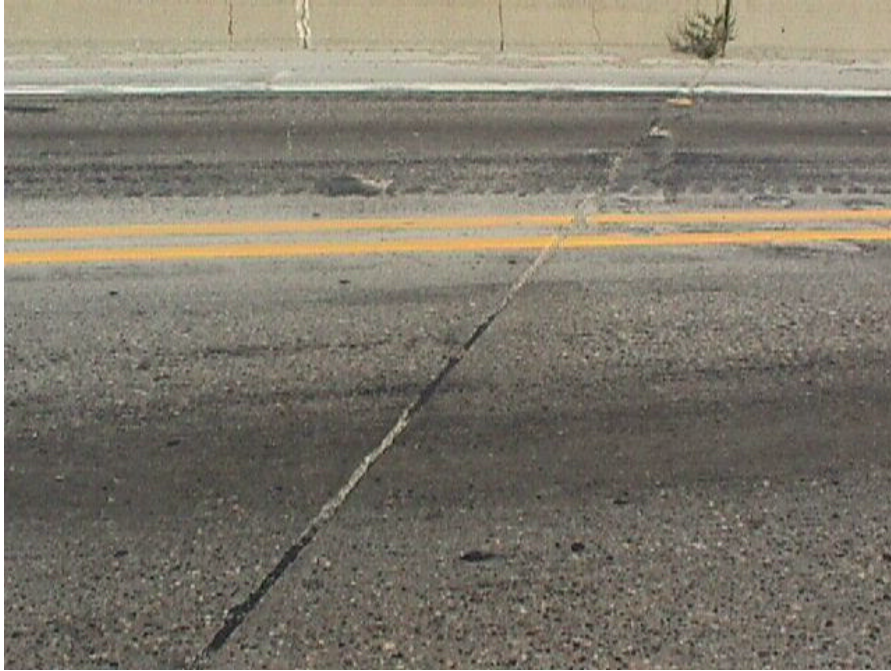
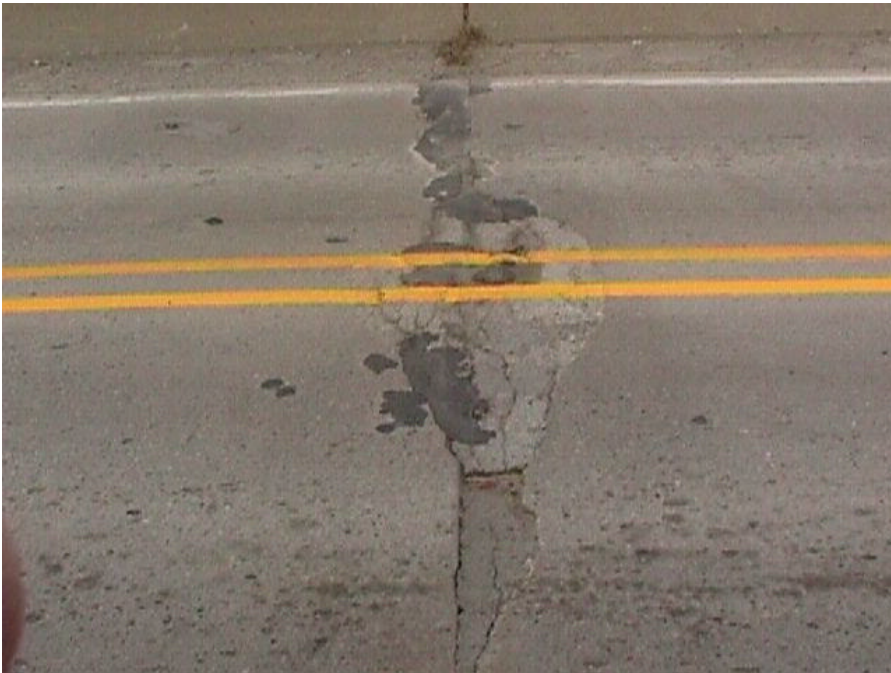
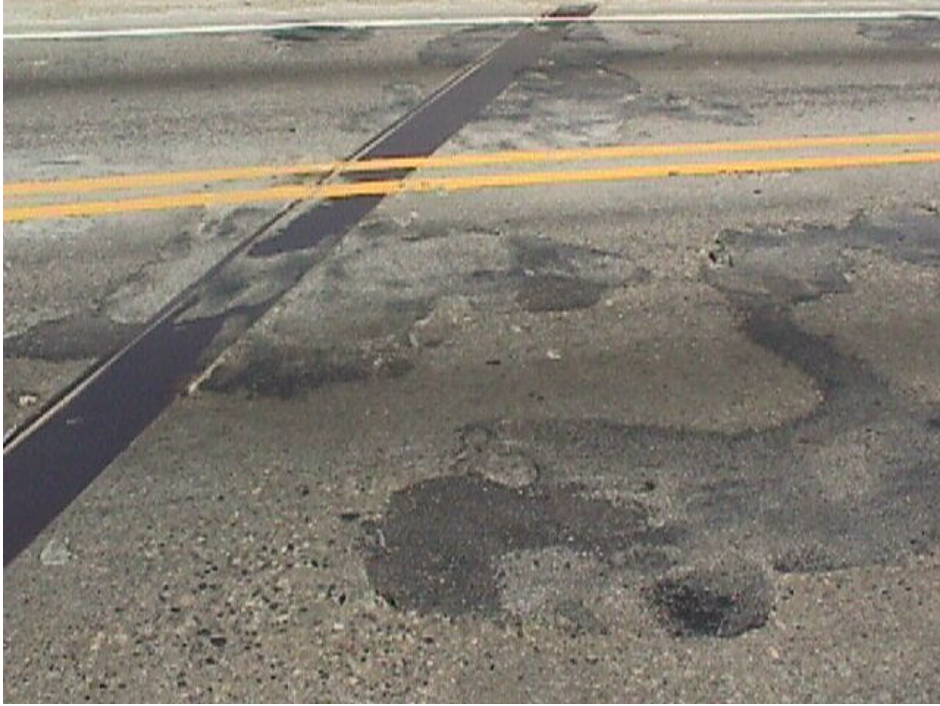
Figure 3-25. Destruction of joint

Figure 3-26. Destruction close to joint

Figure 3-27. Destruction close to joint

Examples of destruction close to deck joint are presented in Figures 3-25, 3-26 and 3-27.

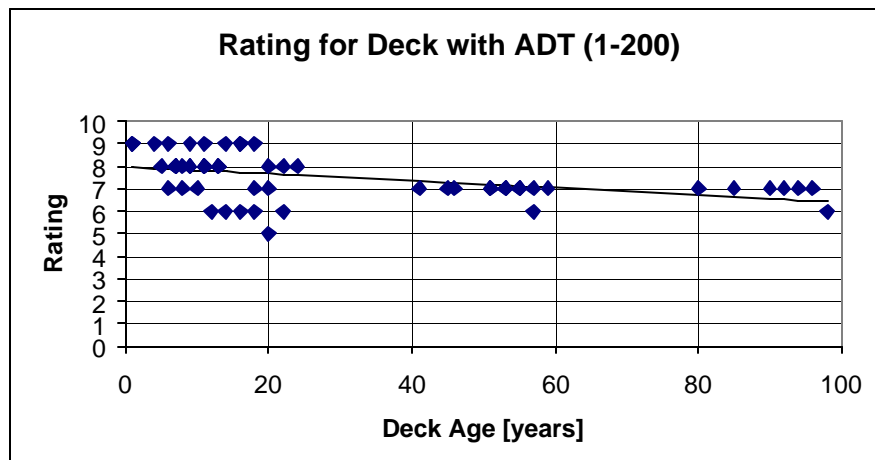
Figure 4-1. Rating for decks based on MBID (Michigan Bridge Inventory Data) (ADT 1-200).

It is clear that rating decreases with years of service and the decrease is faster for larger ADT. To further analyze this trend, a linear regression line was fitted for each graph for four categories of ADT. The slope of the regression line increases with increasing ADT. This confirms the detrimental effect of truck load on bridge decks. Deck ratings versus years of service for different categories of ADT are shown in Figures 4-1, 4-2, 4-3, and 4-4. Linear regression lines for deck rating versus years of service are shown in Figure 4-5. A polynomial (4<sup>th</sup> degree) was also fitted to model the data. For all ADT categories the results are shown in Figures 4-6, 4-7, 4-8, and 4-9 (with all data points). The curve confirms various stages of deck deterioration. The steep slope for the first 20 years corresponds to initial shrinkage cracking followed by freeze/thaw cycles. The plateau, and even slight increase of the rating corresponds to ongoing maintenance and repair of the deck slabs. A sharp decline after 60 years corresponds to the final stage of deck slab life, with extensive damage caused by trucks combined with freeze/thaw cycles.

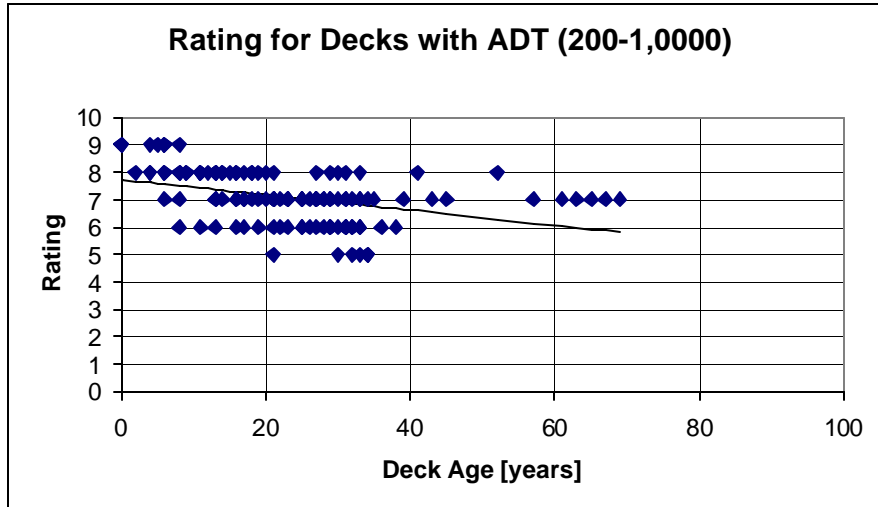
Figure 4-2. Rating for decks based on MBID (ADT 200-1,000).

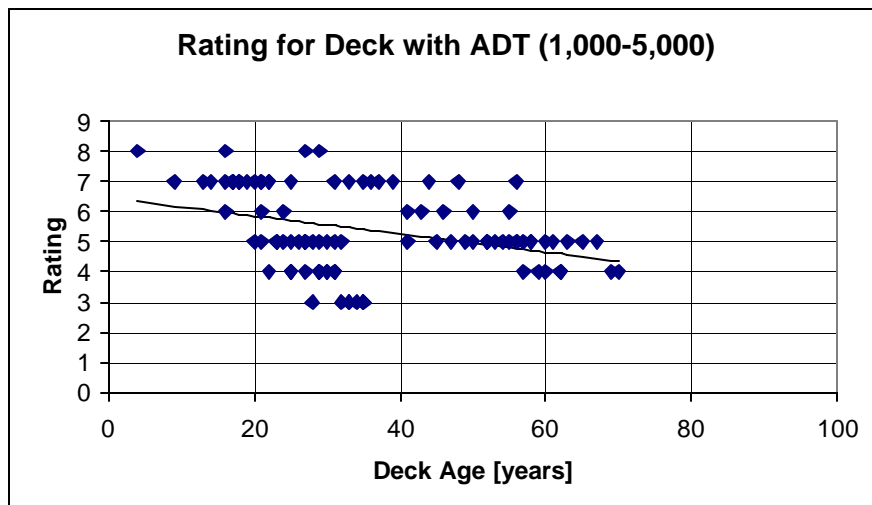
Figure 4-3. Rating for decks based on MBID (ADT 1,000-5,000).
