1. Report No. RC-1389B		2. Government Accession No.		3. Recipient's Catalog No.	
4. Title and Subtitle Michigan Deck Evaluation Guide			5. Report Date November 2000

# MICHIGAN DECK EVALUATION GUIDE

**Report submitted to  
The Michigan Department of Transportation**

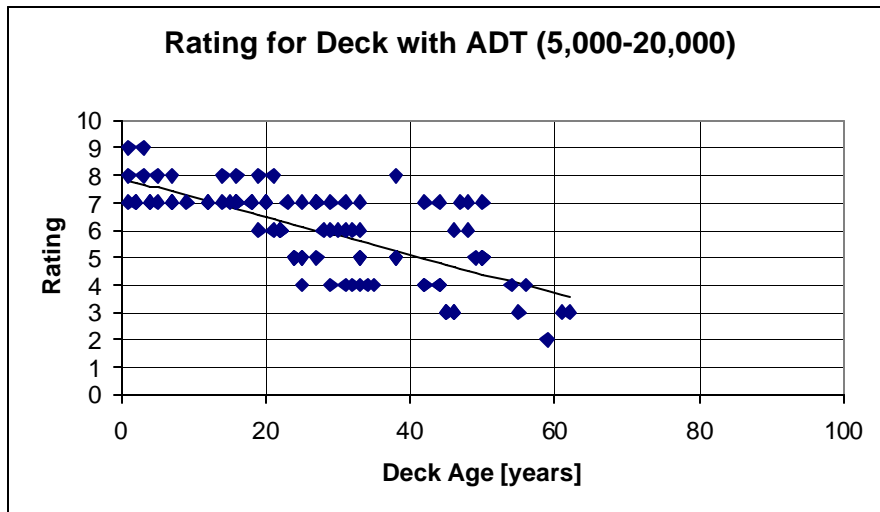
Figure 4-4. Rating for decks based on MBID (ADT 5,000-20,000).

It is clear that rating decreases with years of service and the decrease is faster for larger ADT. To further analyze this trend, a linear regression line was fitted for each graph for four categories of ADT. The slope of the regression line increases with increasing ADT. This confirms the detrimental effect of truck load on bridge decks. Deck ratings versus years of service for different categories of ADT are shown in Figures 4-1, 4-2, 4-3, and 4-4. Linear regression lines for deck rating versus years of service are shown in Figure 4-5. A polynomial (4<sup>th</sup> degree) was also fitted to model the data. For all ADT categories the results are shown in Figures 4-6, 4-7, 4-8, and 4-9 (with all data points). The curve confirms various stages of deck deterioration. The steep slope for the first 20 years corresponds to initial shrinkage cracking followed by freeze/thaw cycles. The plateau, and even slight increase of the rating corresponds to ongoing maintenance and repair of the deck slabs. A sharp decline after 60 years corresponds to the final stage of deck slab life, with extensive damage caused by trucks combined with freeze/thaw cycles.

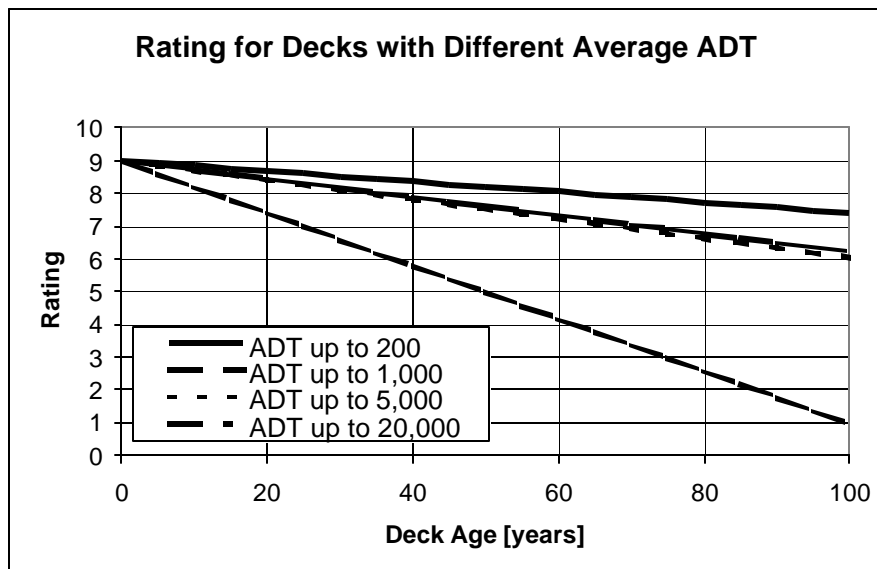
Figure 4-5. Linear regression lines for deck rating versus years of service.

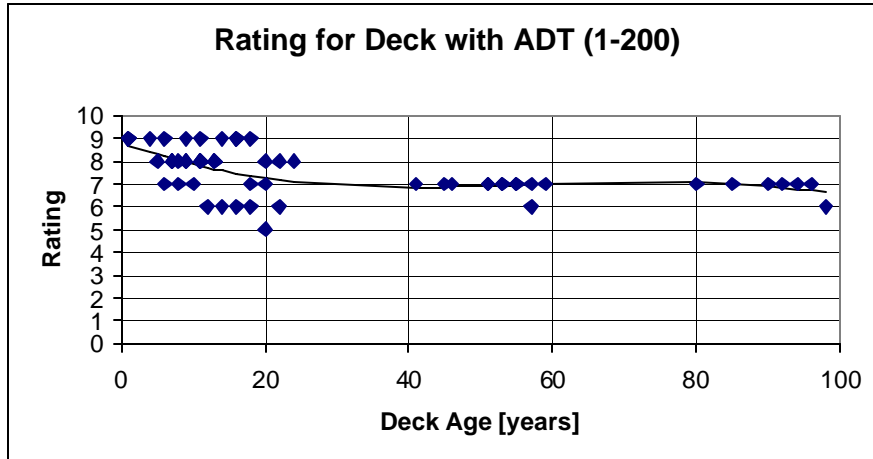
Figure 4-6. Nonlinear Regression curve for deck rating versus years of service (ADT 1-200).

The curves presented above can be used as an aid to estimate the remaining life of the deck under known loading condition (ADT) and years of service.

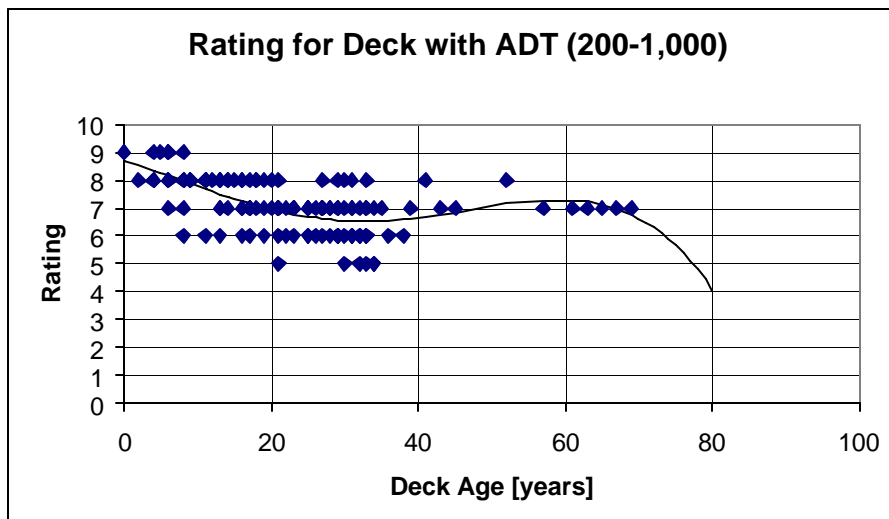
Figure 4-7. Nonlinear Regression curve for deck rating versus years of service (ADT 200-1,000).

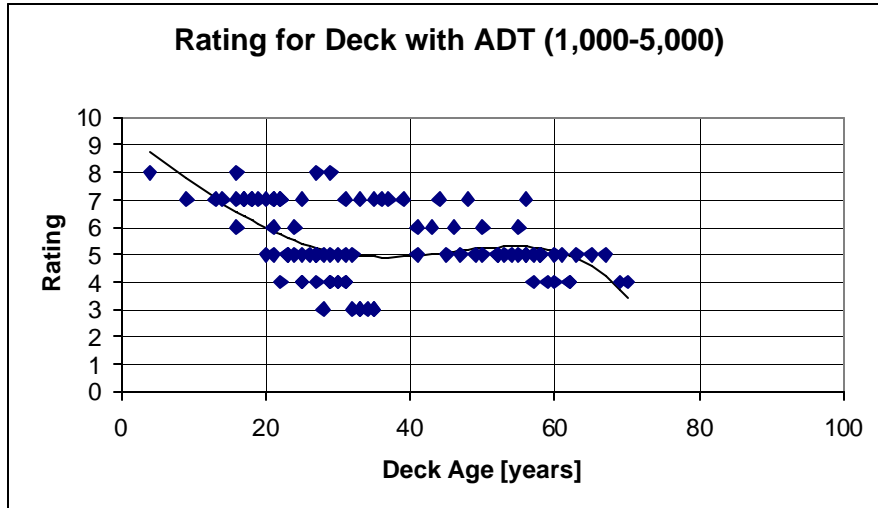
Figure 4-8. Nonlinear Regression curve for deck rating versus years of service (ADT 1,000-5,000).

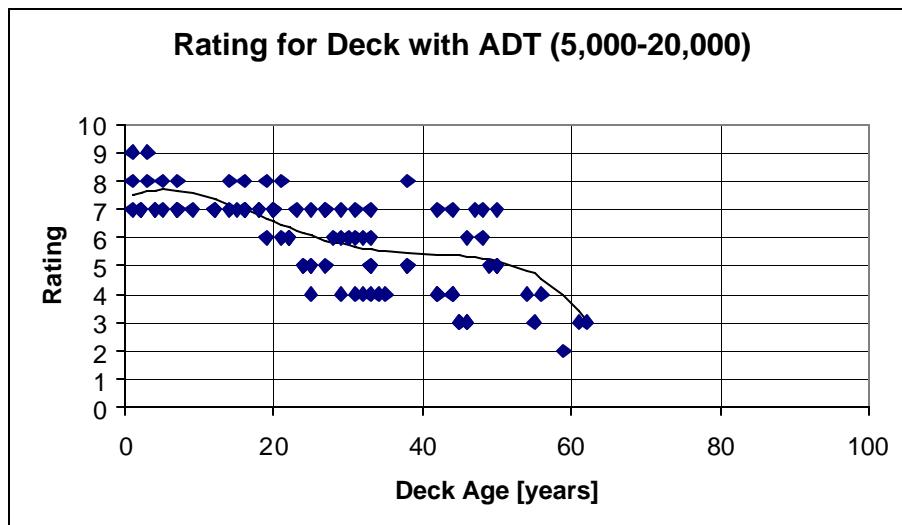
Figure 4-9. Nonlinear Regression curve for deck rating versus years of service (ADT 5,000-20,000).
