MDOT Research Report RC-1445

# **Causes and Cures for Cracking of Concrete Barriers**

## **Final Report**

**April 2004**

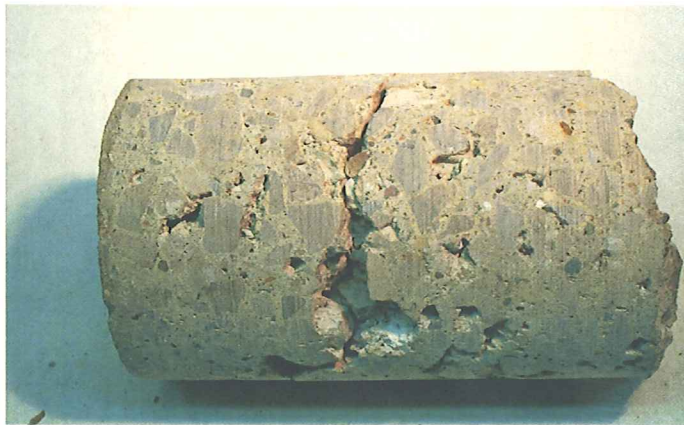
Figure 7. Honeycombing in core G2.

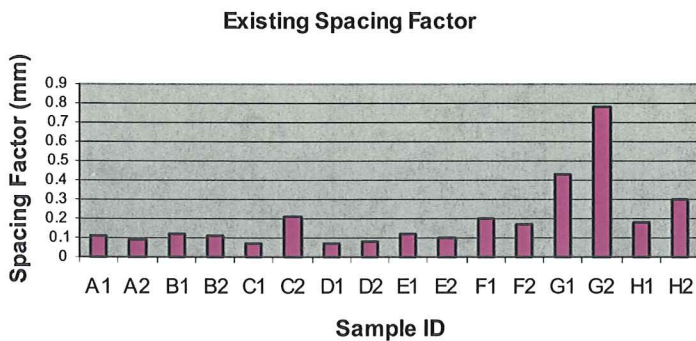
As can be seen in table 2 (the highlighting is used to identify samples exceeding recommended limits) and figures 8 and 9, the samples from locations A, B, D, E, all have an adequate spacing factor ( $< 0.200$  mm) and specific surface ( $> 25\text{mm}^2/\text{mm}^3$ ), and no or little filling of the air void system. Samples from location A and B have an air content slightly under the limit normally specified for concrete with 0.75 in maximum size aggregate (6 percent); however, since the other air-void parameters are within safe limits, the protection against freeze-thaw damage should be adequate. For location A, the low air content is due to the very small size of the air voids, while for location B it results from a lower paste content. Figure 10 shows the air-void systems of A2 and D1. Both samples have similar spacing factors, but the air content of A2 is lower because the air-voids are much smaller than in D1.

Figure 9. Spacing factor of cores evaluated.

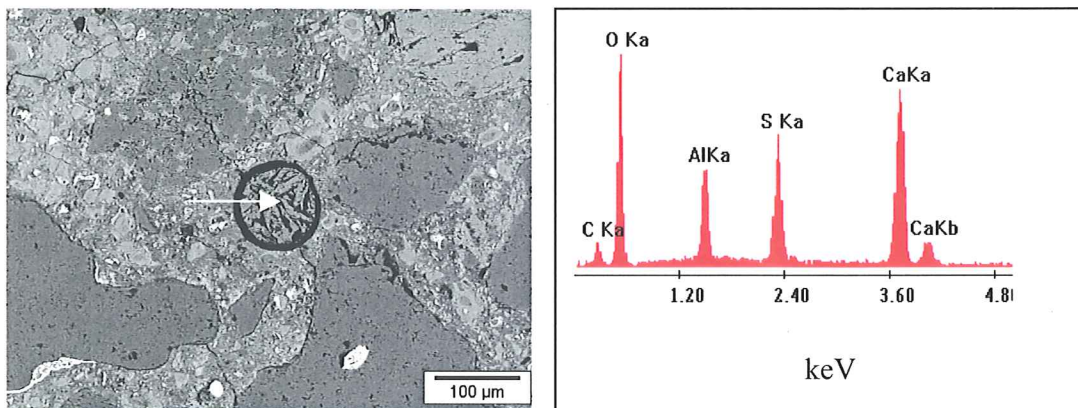
Figure 20. SEM image and x-ray spectra of ettringite infilling air void in G2.

image of a filled air void in G2 with the corresponding x-ray spectrum, confirming the presence of ettringite (calcium sulfoaluminate).

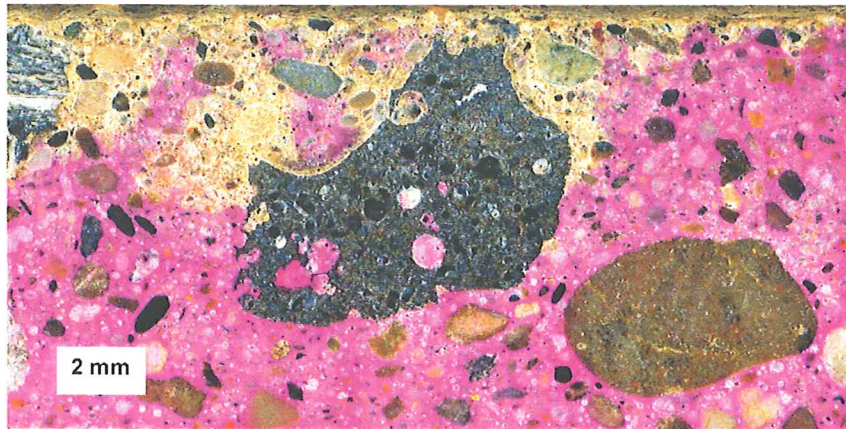
Figure 21. Part of phenolphthalein stained polished slab from F1, showing variation of carbonation along the surface.
