INVESTIGATIONAL CONCRETE PAVEMENT IN MICHIGAN  
DESIGN PROJECT - MICHIGAN TEST ROAD

10 Year Progress Report

Research Laboratory  
Testing and Research Division  
Report No. 156  
December 15, 1950

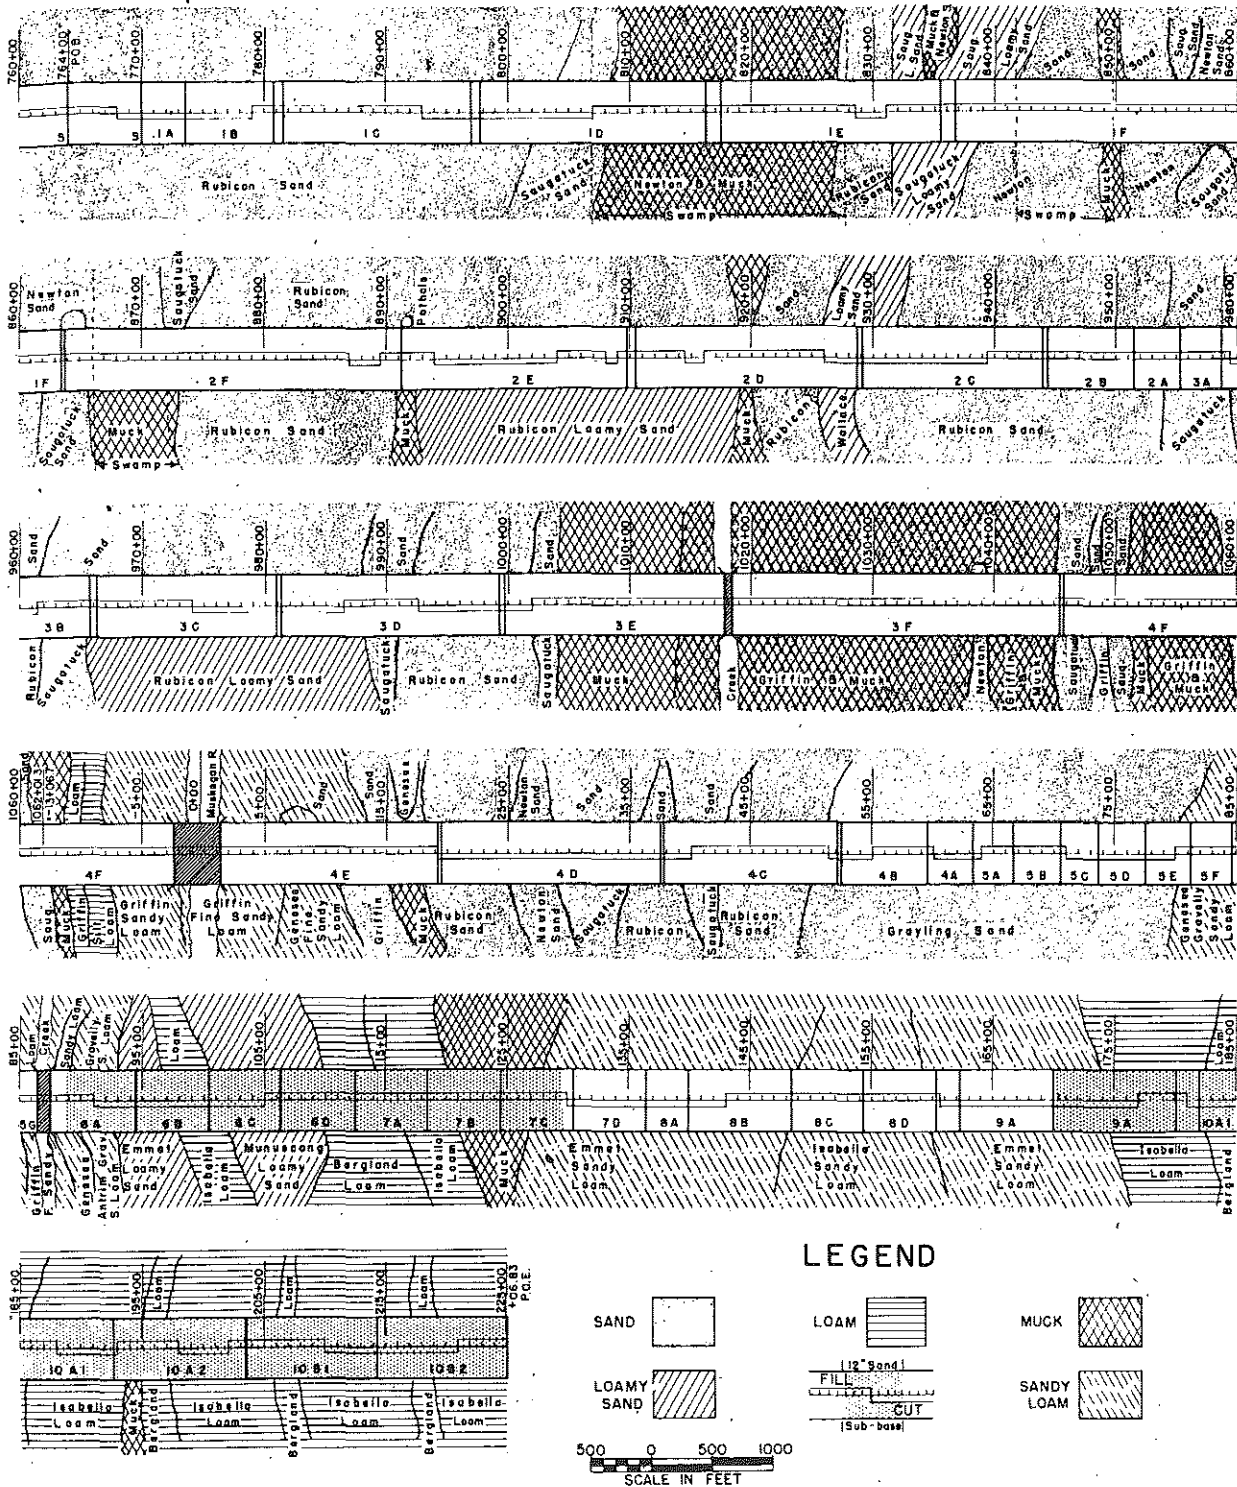
SOIL TYPES AND  
EARTHWORK OPERATIONS

A review of Figure 1 will show that Series 8 lies entirely on an excellent granular subgrade soil whereas all of Series 6 and 7, with the exception of Section 7D, were placed on a subbase over a questionable subgrade material. This is no doubt the reason why Series 8 has performed so well over the past years. A complete crack and spill summary will be found in Table VIII. For comparative purposes the crack information in Table VIII, for Series 6, has been tabulated both for the entire series and also just for those slabs outside of frost heave areas previously described.

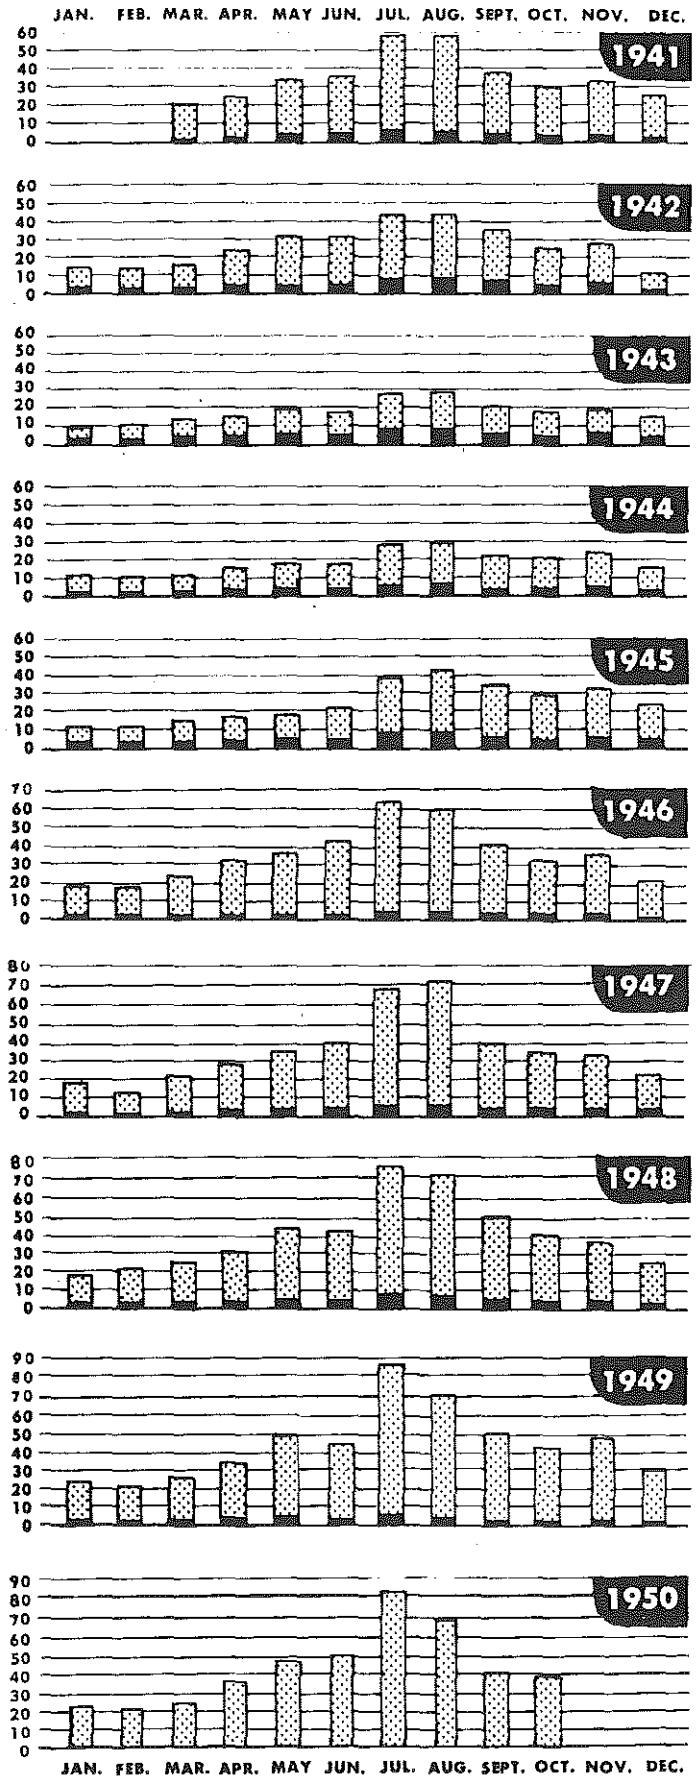
Figure 2

**MONTHLY TRAFFIC  
RECORD**

Normal monthly traffic flow on the Test Road is presented graphically in Figure 2. Values representing the percentages of different types of vehicles traveling the Test Road based on an average annual day for the years 1941 to 1949 inclusive are given in Table IV. Annual average wheel load distribution values by direction of travel are presented in Table V. Figure 3 presents a graphic comparison of axle load frequencies on the Test Road with that of a normal heavy primary route.

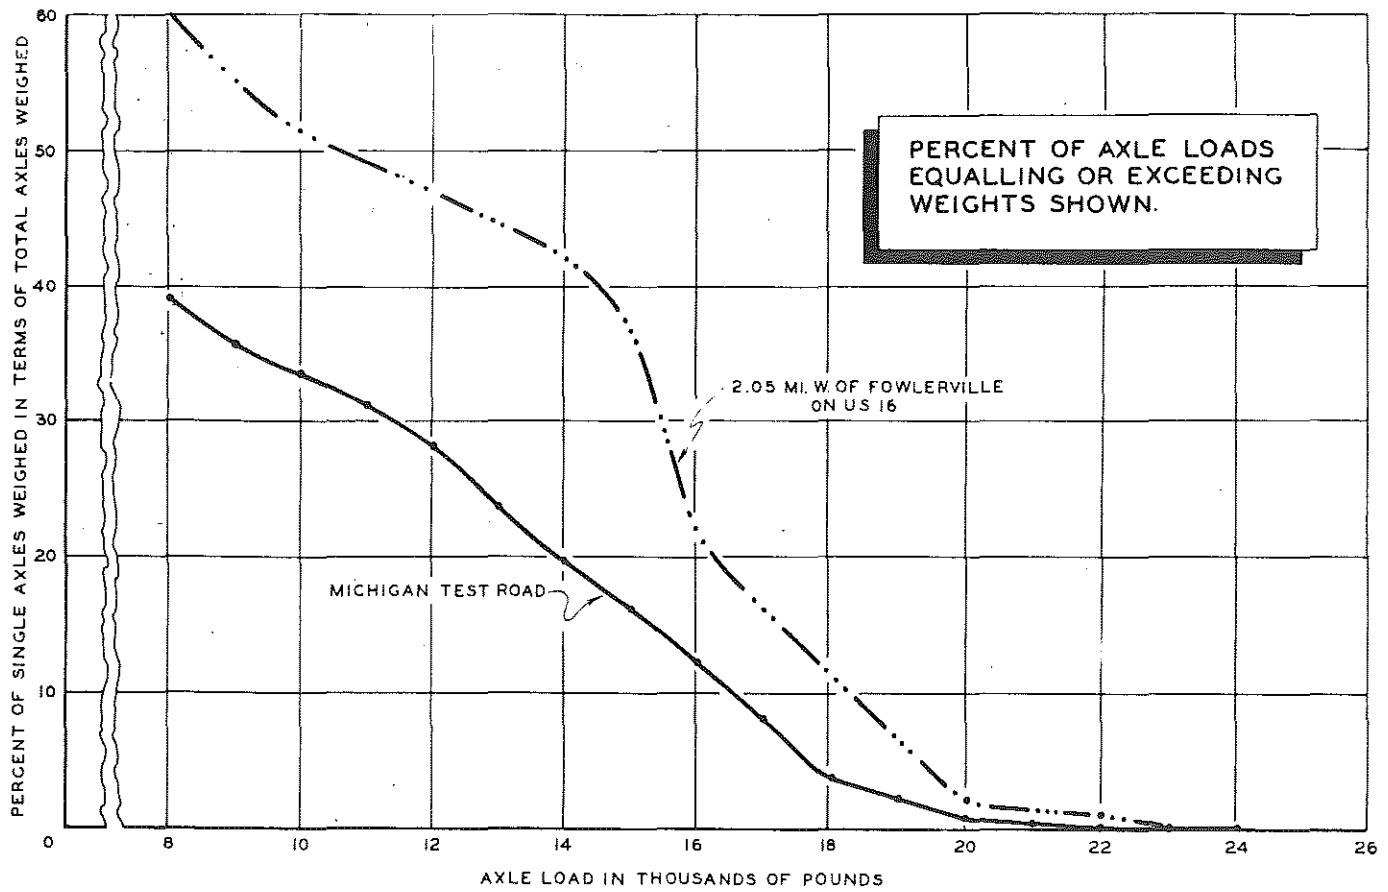
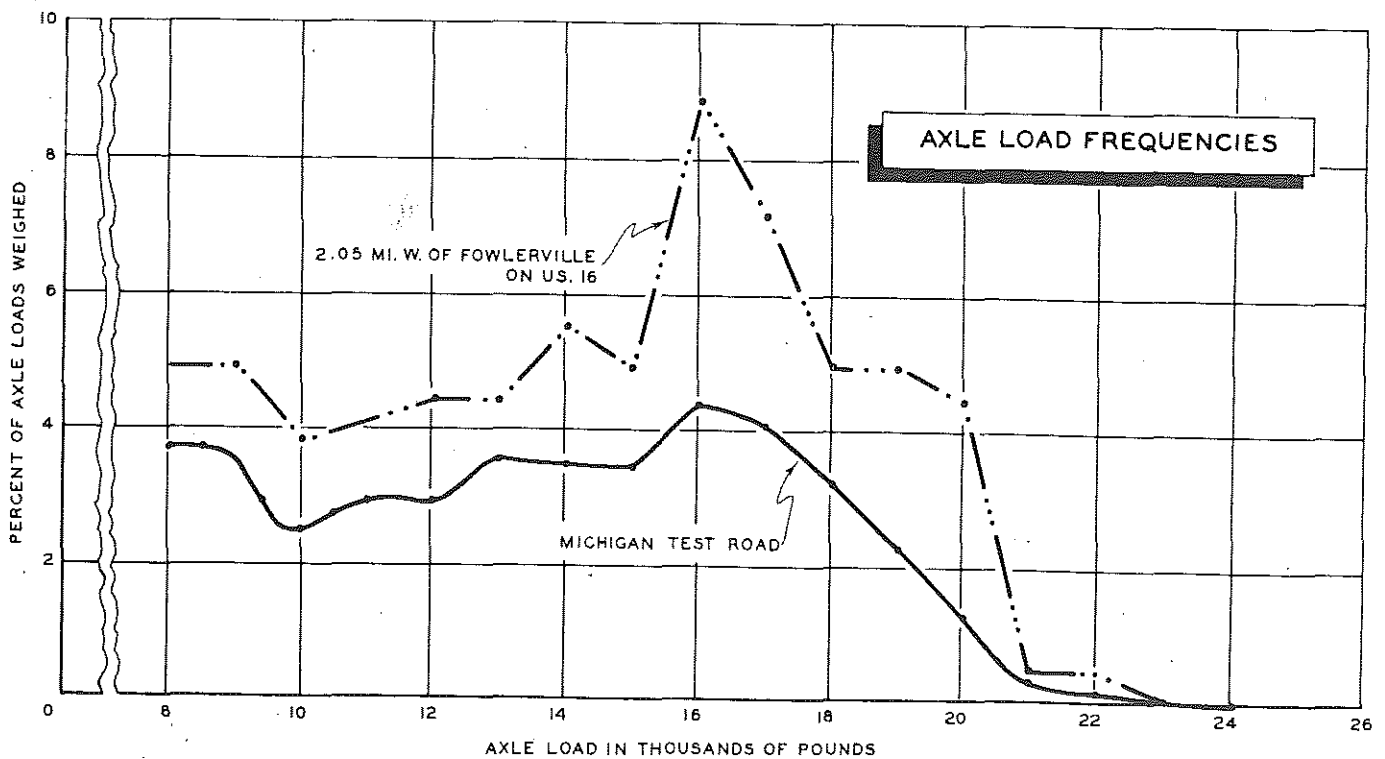
**Figure 3**

**COMPARISON OF AXLE LOADS ON TEST ROAD WITH PRIMARY ROUTE US 16**

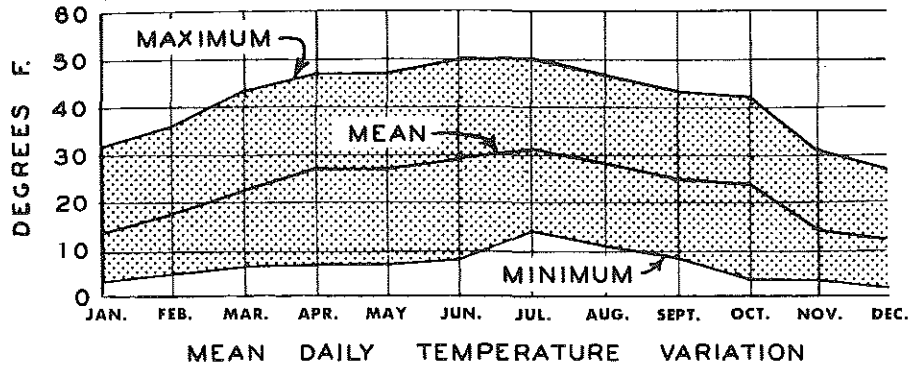
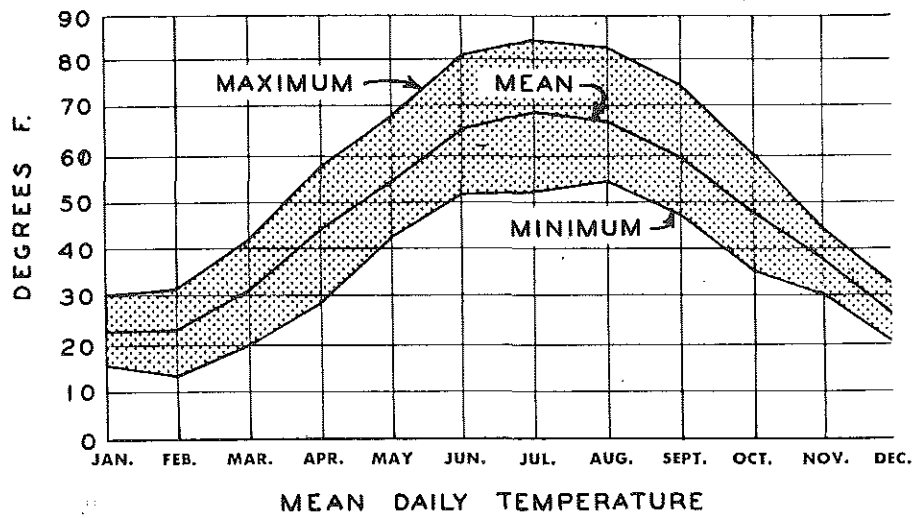
TEMPERATURE RECORD

The graph in Figure 4 shows that the average temperature in winter is approximately 25°F. while in summer it is 70°F., making an average temperature difference of about 45°F. It may be observed also that daily temperature fluctuations in winter are about 18°F. less than those occurring during the summer.

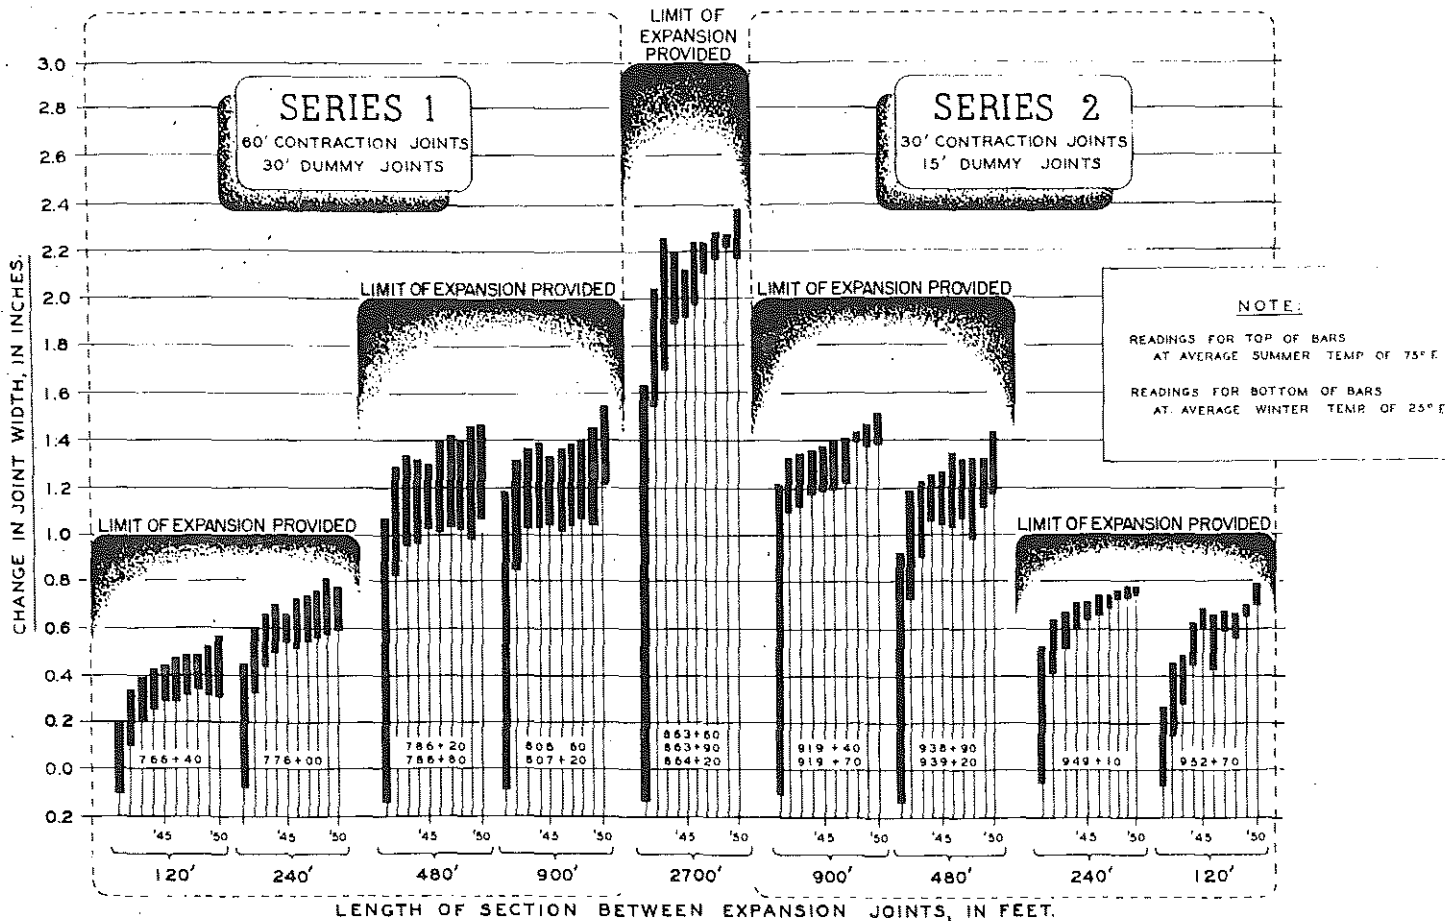
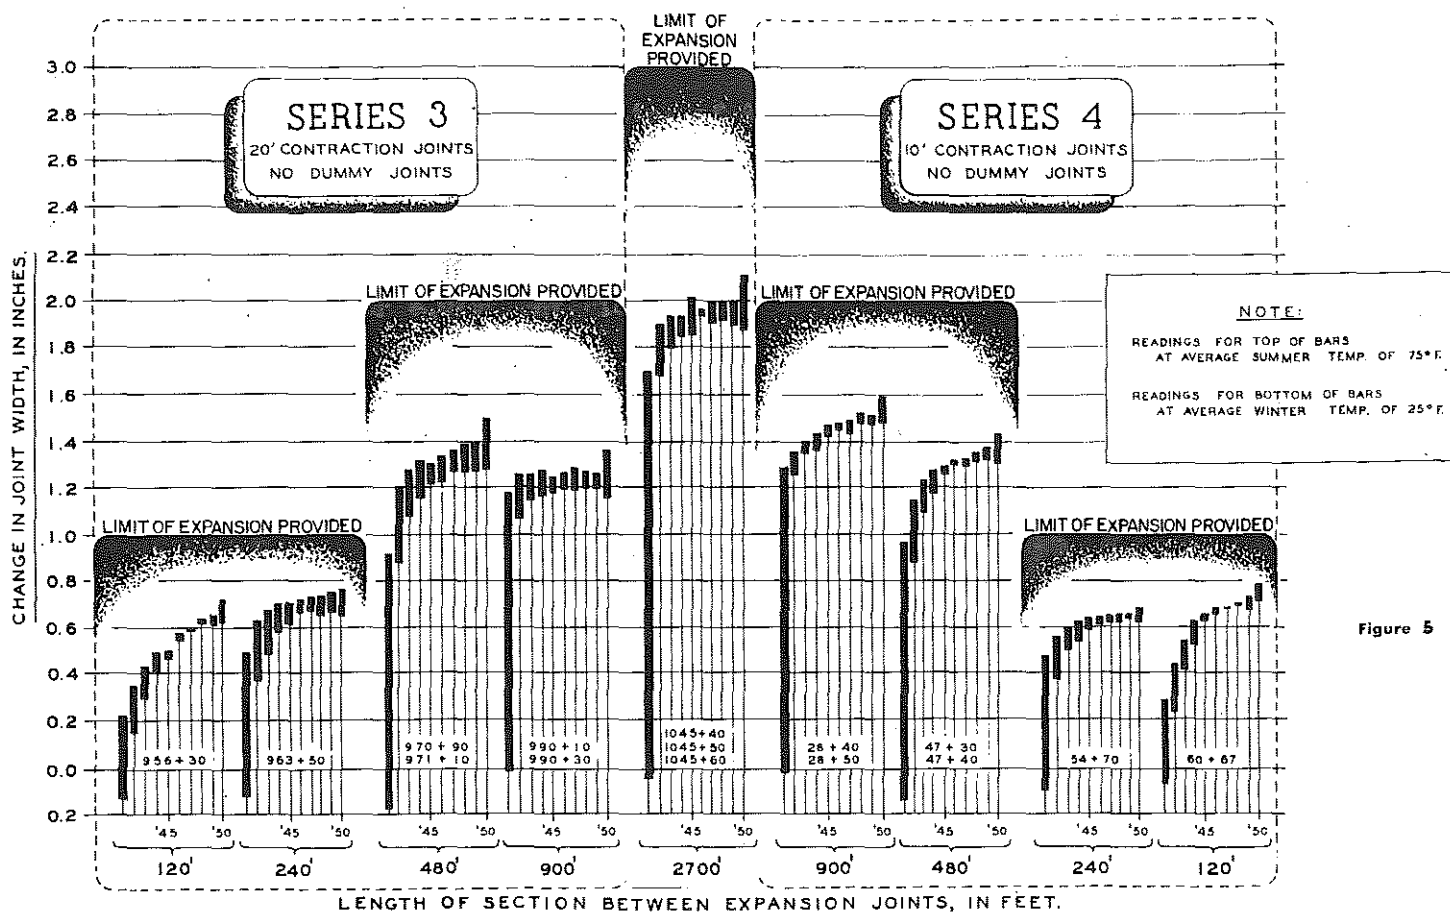
ANNUAL AND PROGRESSIVE CHANGES IN EXPANSION JOINT WIDTH

Figure 5 presents the joint width movement of certain expansion joints in relation to length of section after the joint width readings had been adjusted to an average summer temperature of 75°F. and an average winter temperature of 25°F., using coefficients derived from daily movements.

Several significant facts are revealed by the graphs in Figure 5. First, in most cases the sections contracted sufficiently during the first winter season to cause a slight widening of the expansion joints in

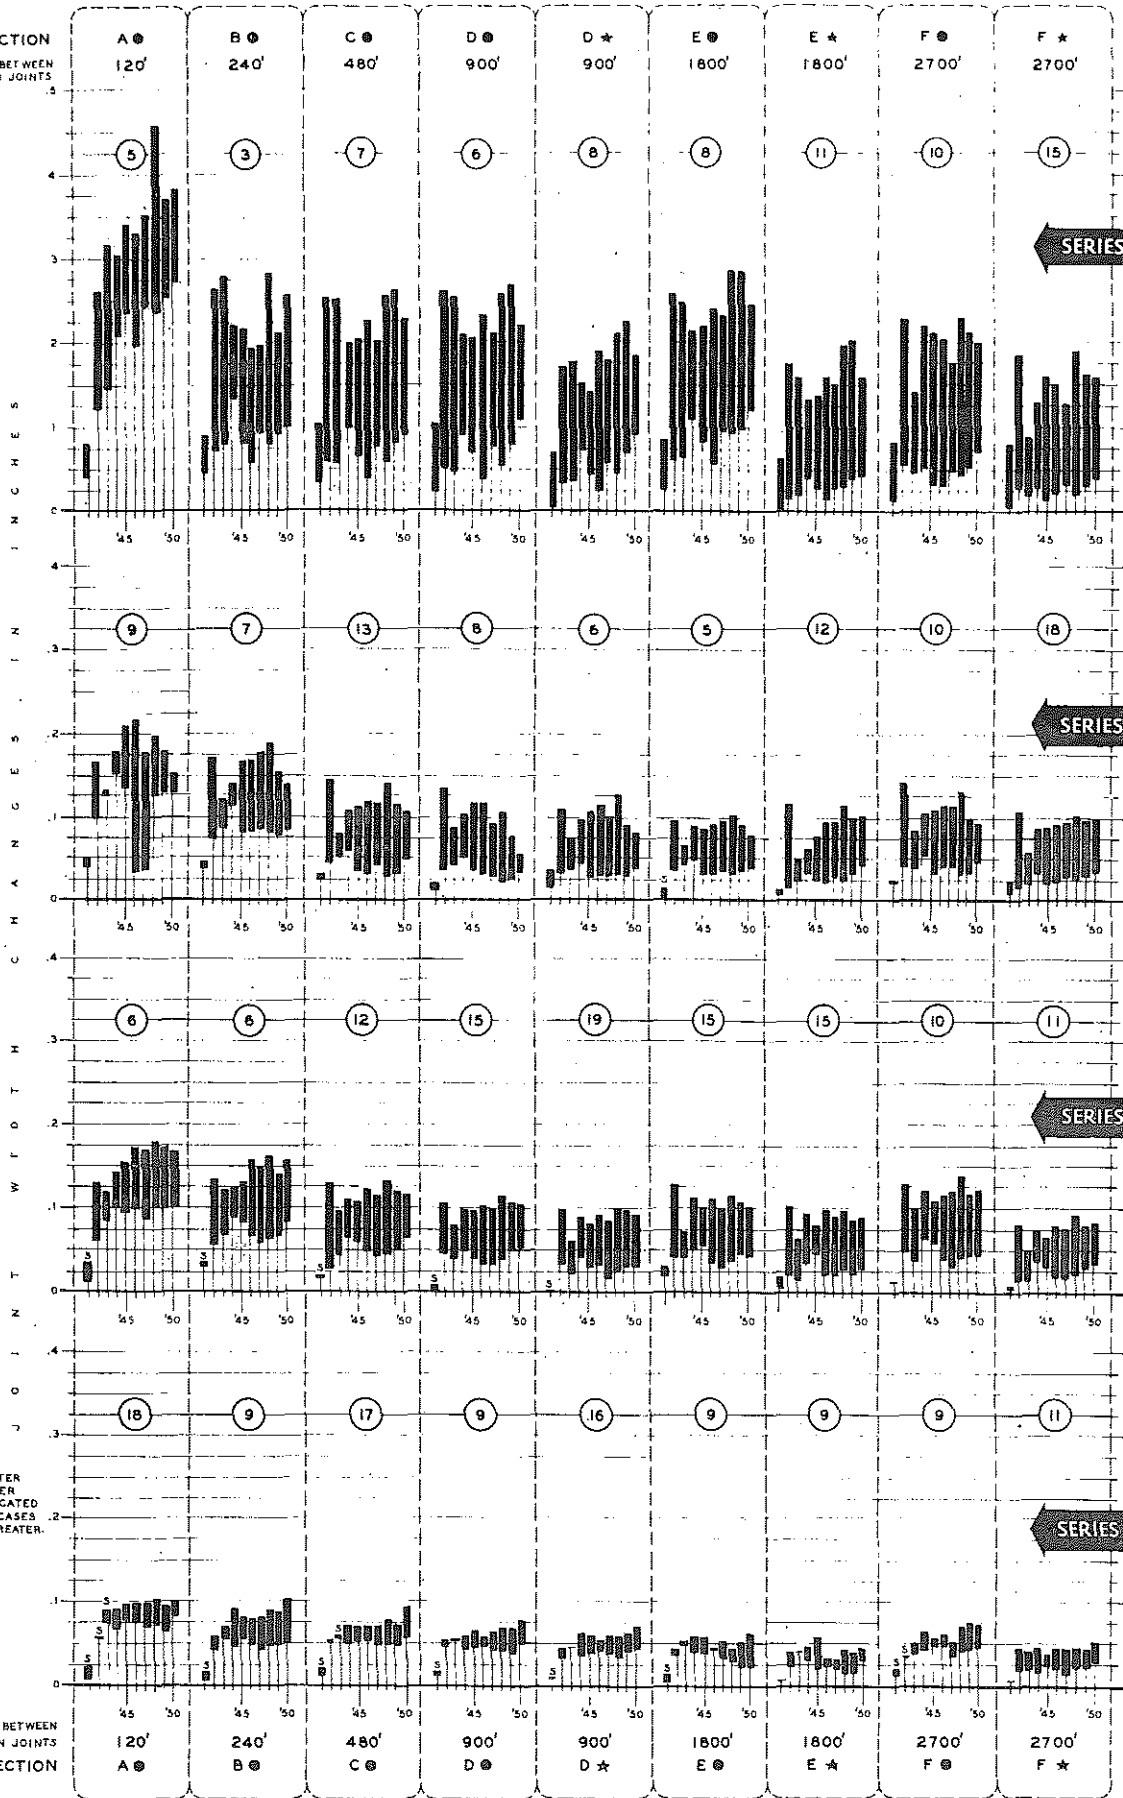
Figure 6

SECTION  
DISTANCE BETWEEN  
EXPANSION JOINTS

TOPS OF BARS REPRESENT WINTER  
READINGS AND BOTTOMS SUMMER  
READINGS EXCEPT WHERE INDICATED  
BY THE LETTER S, IN WHICH CASES  
THE SUMMER READINGS ARE GREATER.

Contraction Joints: The actual changes in contraction joint widths for different seasons of the year and for the variable expansion and contraction joint spacings included in Series 1-2-3 and 4 are shown graphically in Figure 6. The graphs show the average joint width movements for summer and winter seasons.

The following significant facts are disclosed by the graphs in Figures 6 and 7: first, that under similar conditions of expansion joint spacing the movement of the 60-foot contraction joints is at least four times as great as those spaced at 10 feet; second, the changes in width of contraction joints vary with the section length, the shorter the section length the greater the contraction joint movement; third, in the long sections the movement of the contraction joints near the expansion joints is slightly greater than that of the joints near the center of the section; fourth, the contraction joints show an annual amplitude of joint width change which apparently decreases with time, the amplitude being greater in the longer slabs and diminishing with decrease in slab length; and

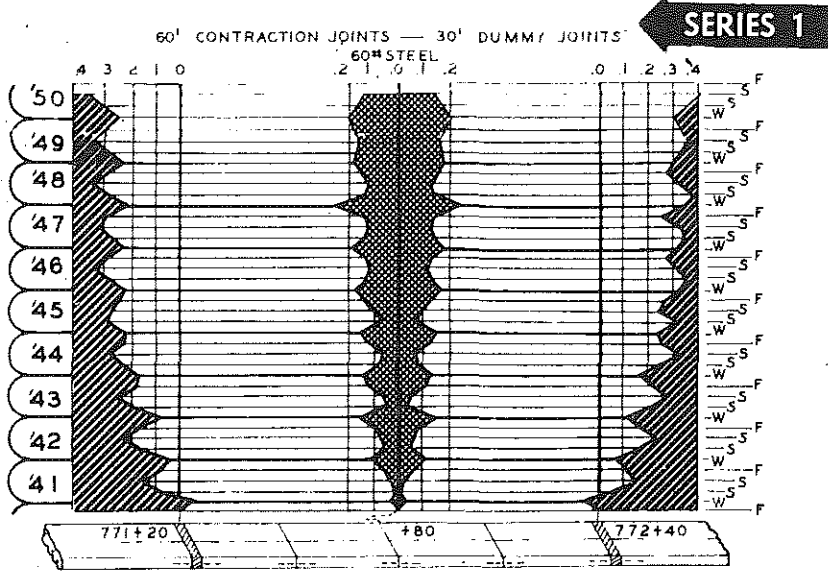
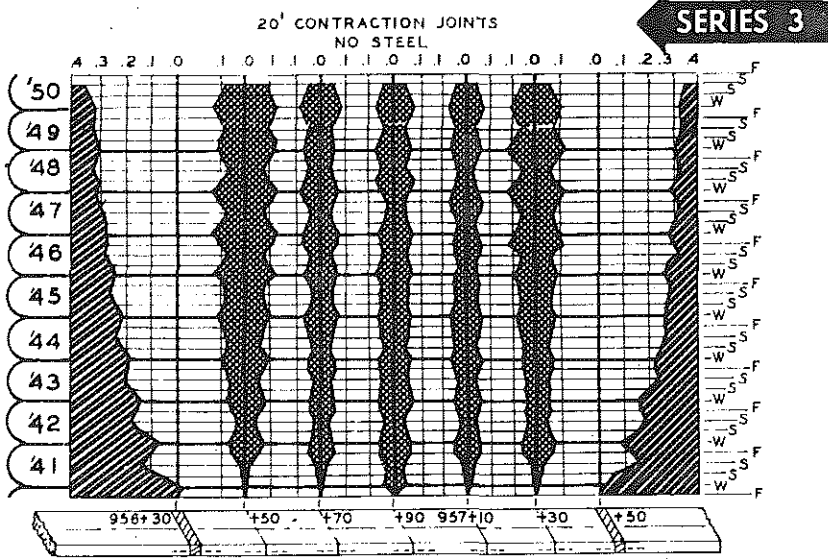
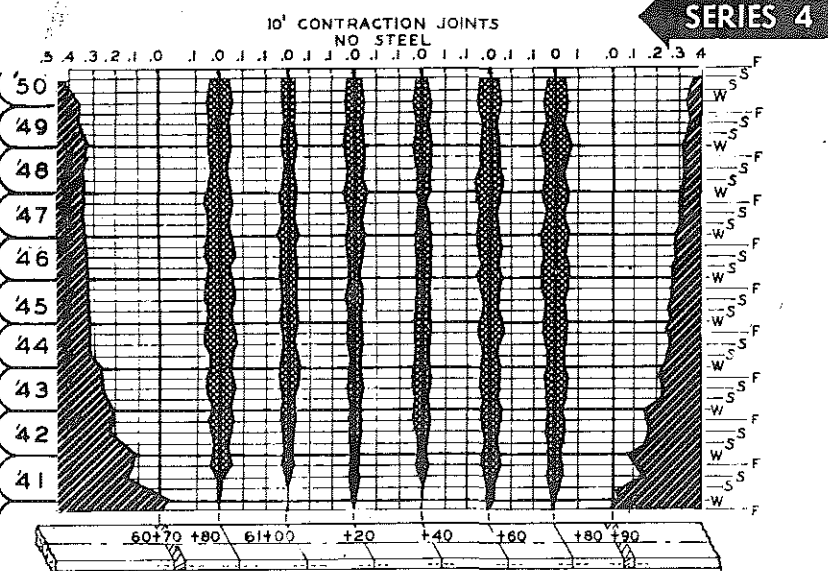
Figure 7

JOINT WIDTH CHANGE IN INCHES

The relative change in contraction joint width for three particular joint spacings--60, 20, and 10 feet-- are graphically presented in Figure 7. In addition to showing the effect of joint spacing upon joint width changes, these graphs show the residual opening of the joints with time and that the joints closest to the expansion joints open more than the joints near the center portion of the section. This same phenomenon may be observed on all of the test sections.

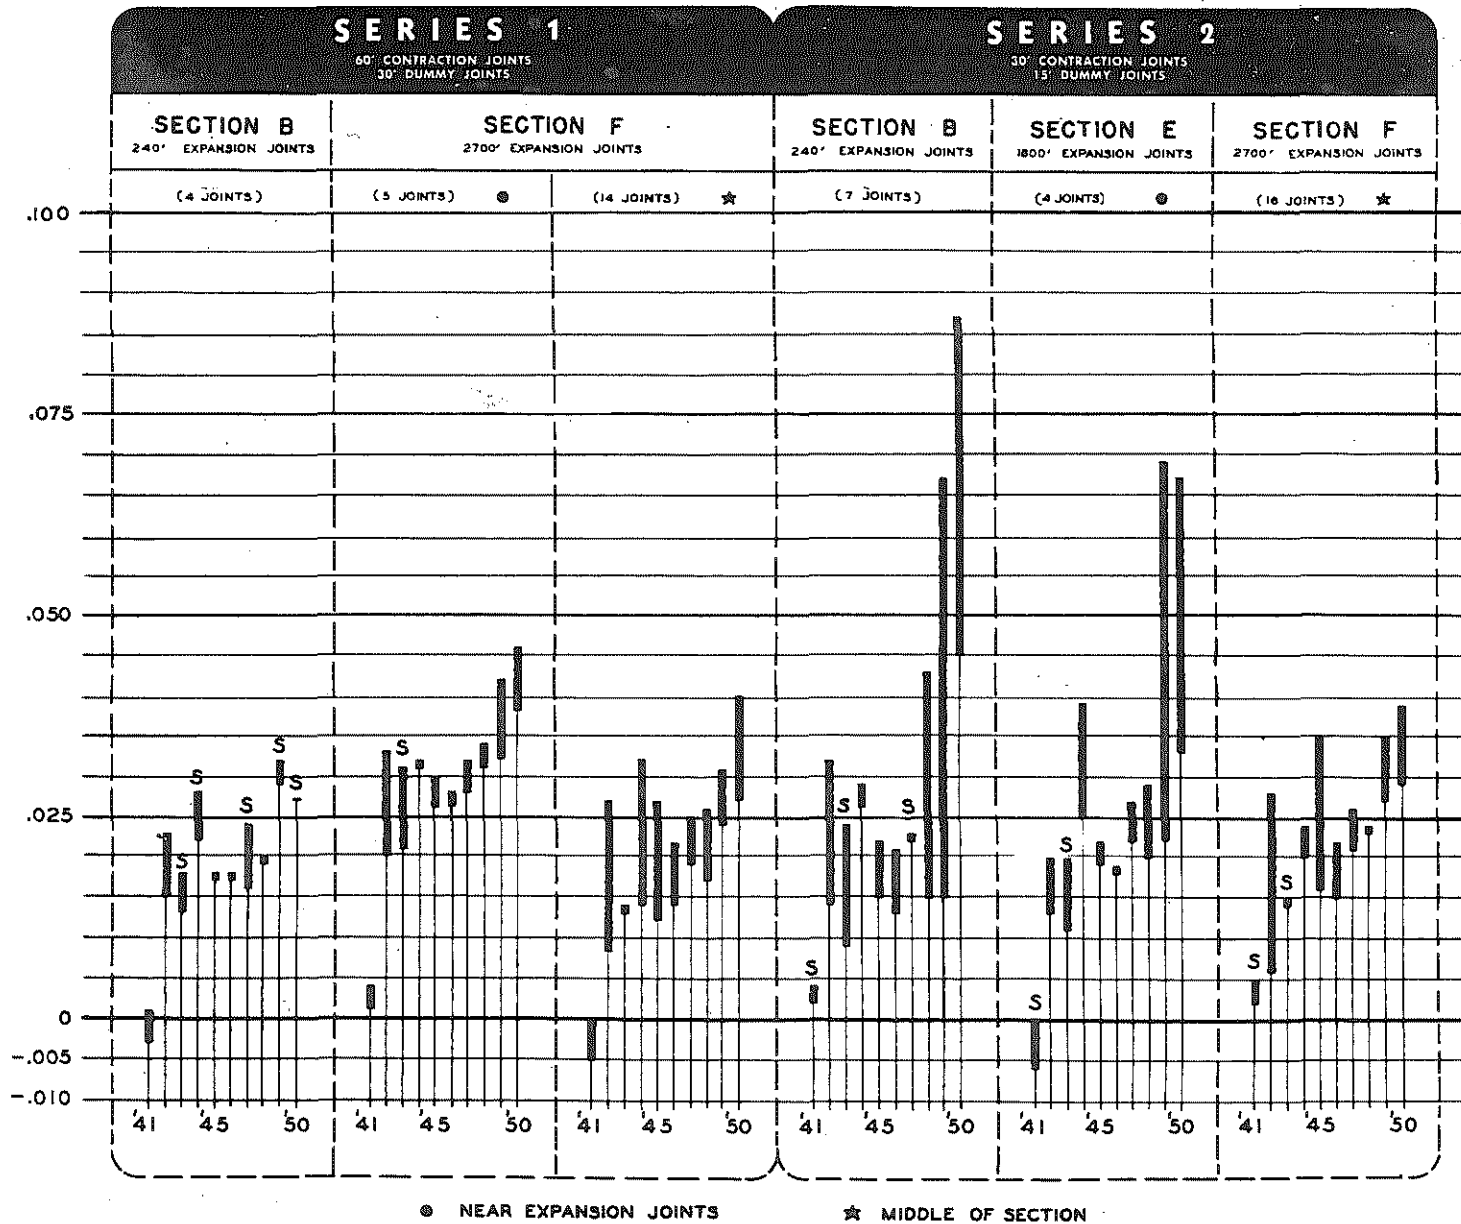
Figure 8

TOPS OF BARS REPRESENT WINTER READINGS AND BOTTOMS SUMMER READINGS EXCEPT WHERE INDICATED BY THE LETTER S, IN WHICH CASES THE SUMMER READINGS ARE GREATER

Dummy Joints: In Series 1 and 2, 60-pound and 37-pound per 100 square feet mesh reinforcement, respectively, was laid continuously through the dummy joints. Measurements have been taken at several joint locations throughout Series 1 and 2 to study the effect of the reinforcement upon joint behavior. Average seasonal changes in joint width are shown by graphs in Figure 8.

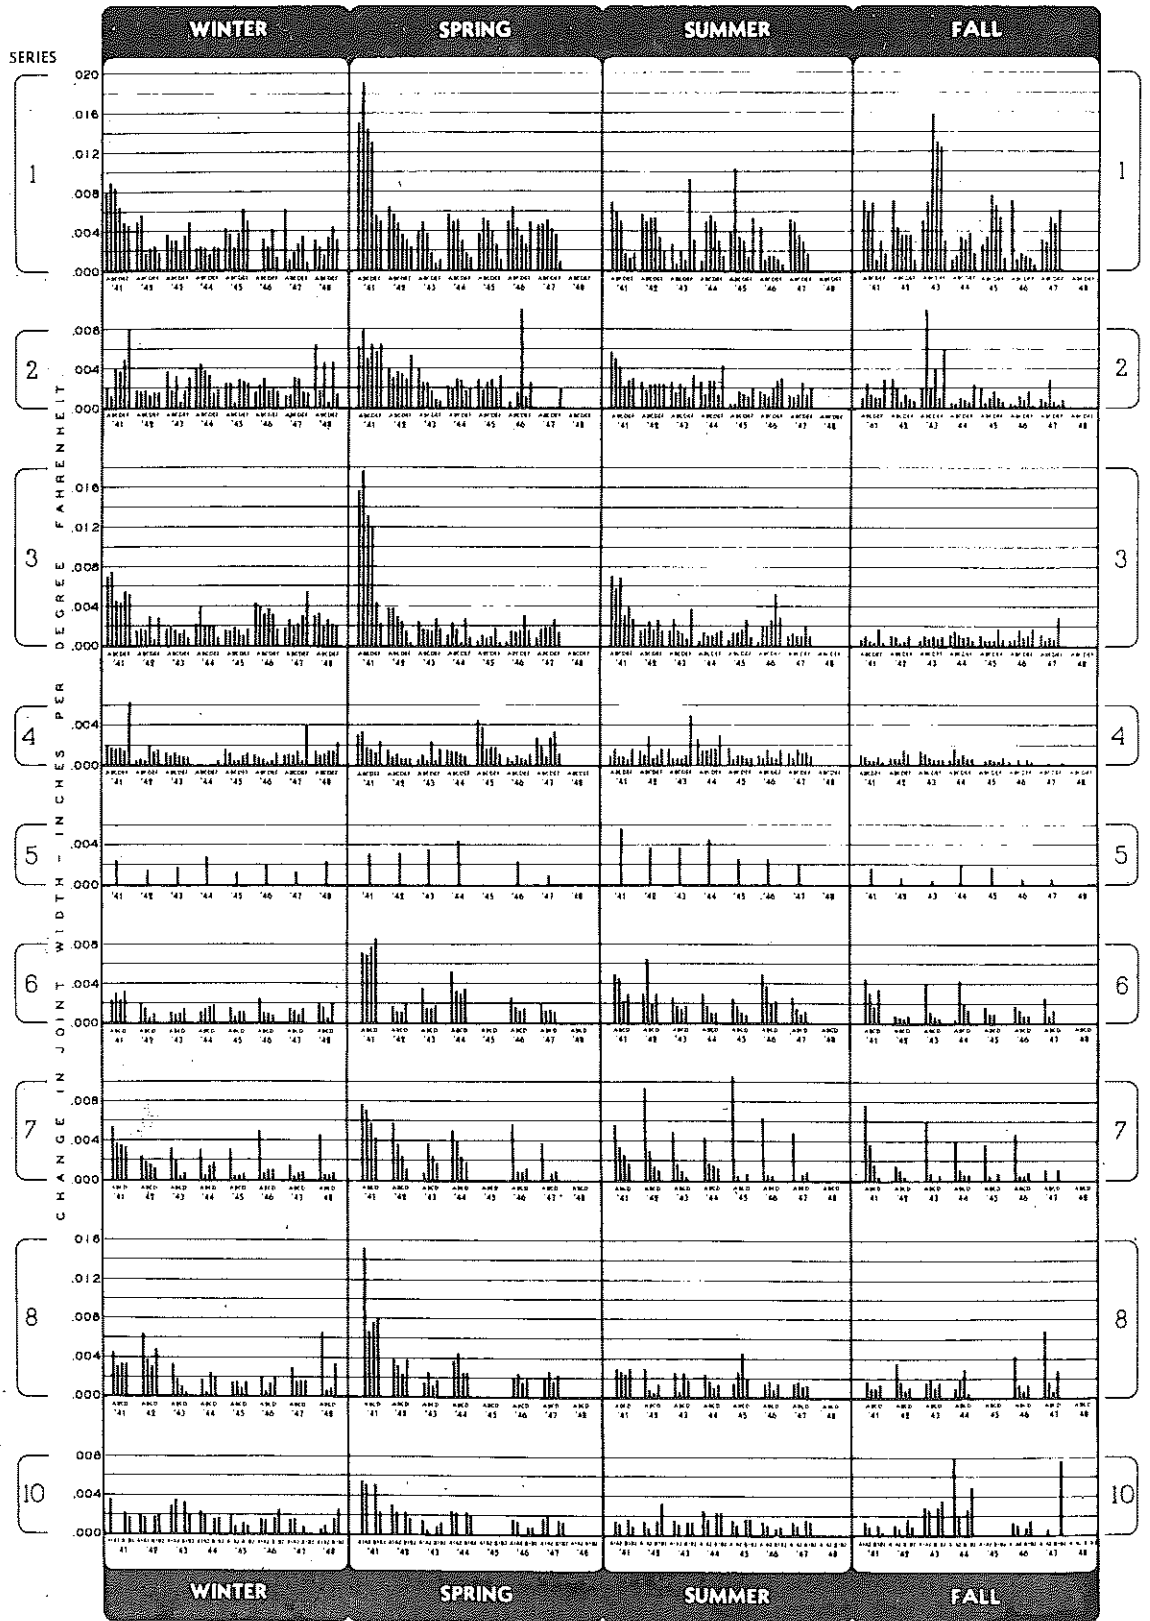
Figure 9

DAILY MOVEMENT OF EXPANSION JOINTS

Expansion Joints: The average daily changes in expansion joint widths by years and seasons are represented by bar graphs in Figure 9. Included in the graphs are measurements from selected joints in all ten sections of the Design Project. In general, the data disclose several significant facts. First, daily joint width movement is influenced to a certain extent by the degree of pavement restraint which normally increase with age due to depletion of expansion space and residual volume changes in the concrete. Second, intermediate contraction joint spacing has a decided effect upon daily joint width movement as may be observed by comparing graphs of Series 1 with those of Series 4. Third, in general, the movement is greatest during the spring and least in the fall seasons, while summer and winter seasonal readings are about comparable. It is believed that this greater movement in the spring than in the fall may be due to the relatively greater freedom of the slab resulting from winter opening of the joints combined with a wider temperature range induced by the radiant heat of the sun, which is maximum at the summer solstice (June 21). Fourth, no definite relationship is discernible between daily joint width movement and certain construction features such as weight of reinforcement, cross section, thickness, or joint design.

It is believed that the exceptionally high daily movements for all series in section lengths greater than 240 feet are due to the fact that

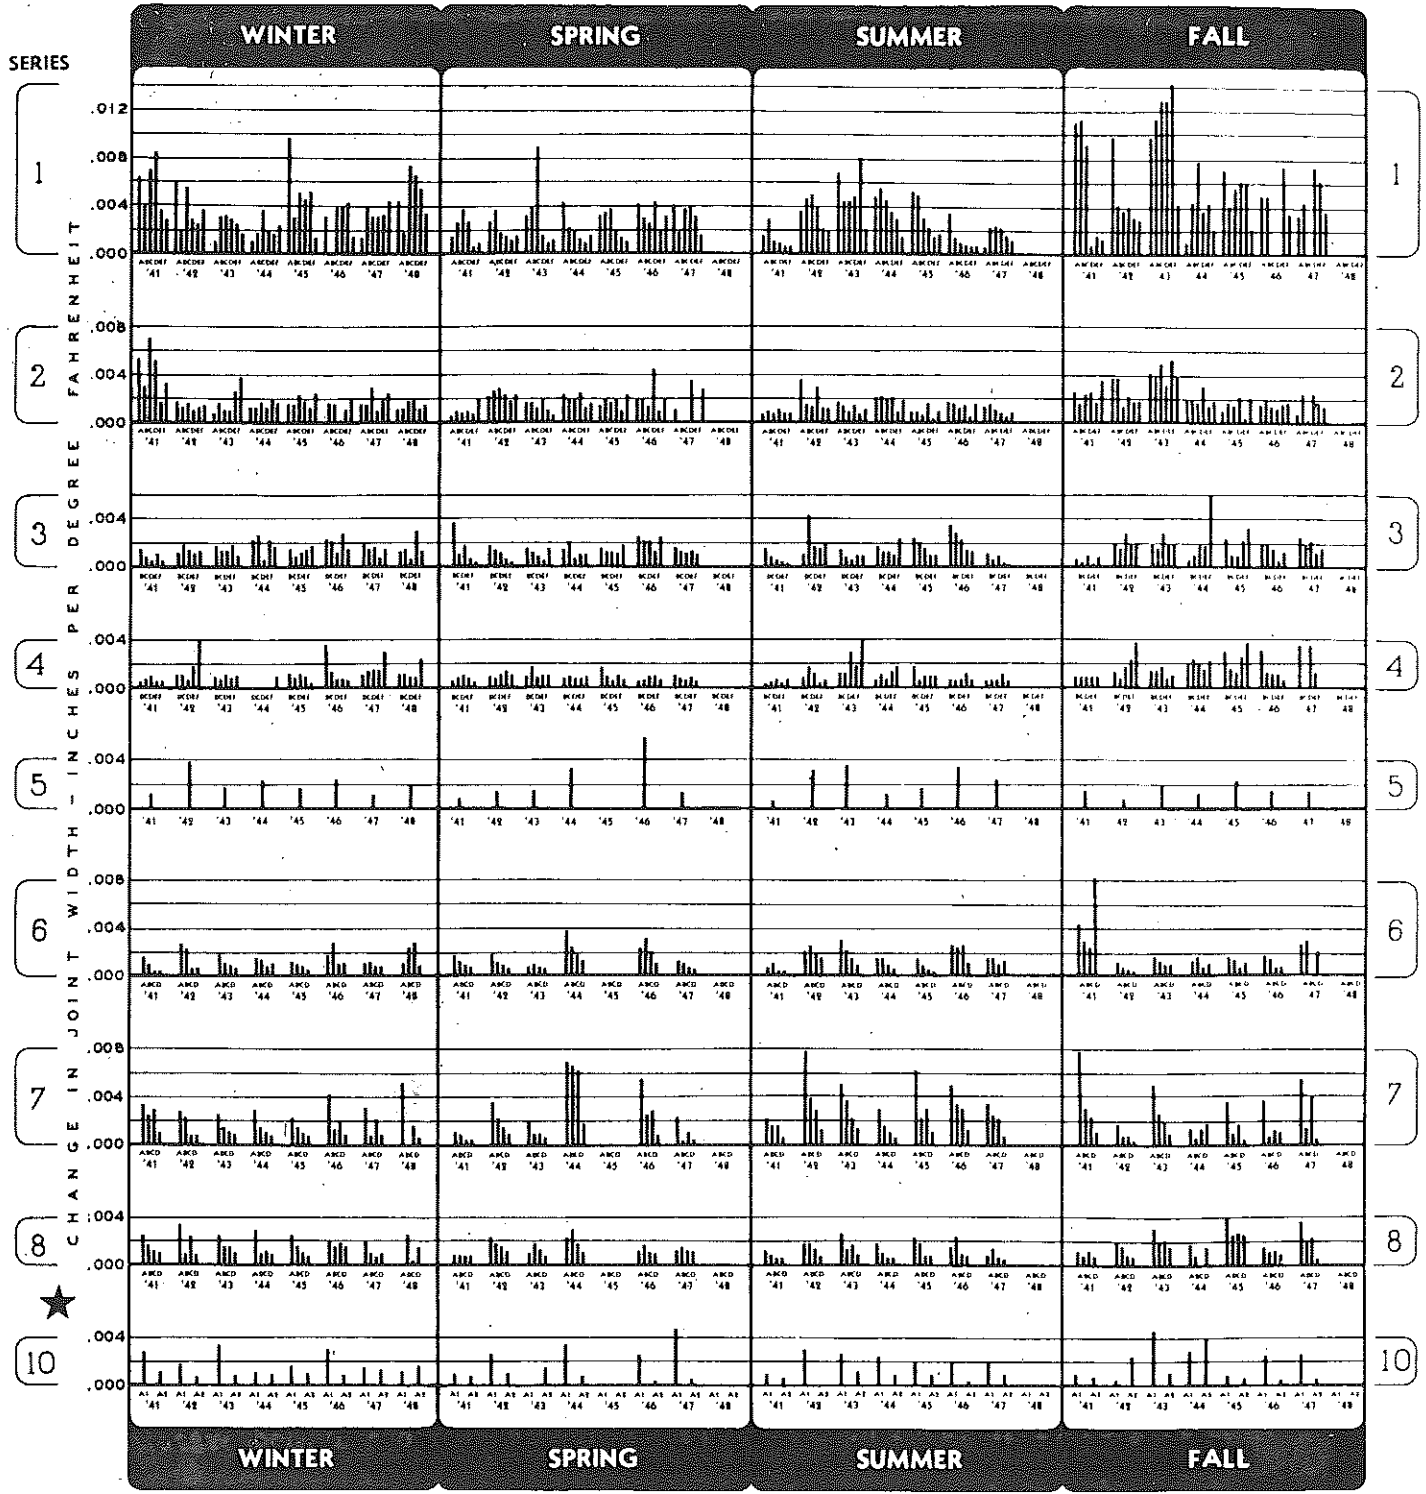
Figure 10

DAILY MOVEMENT OF CONTRACTION JOINTS

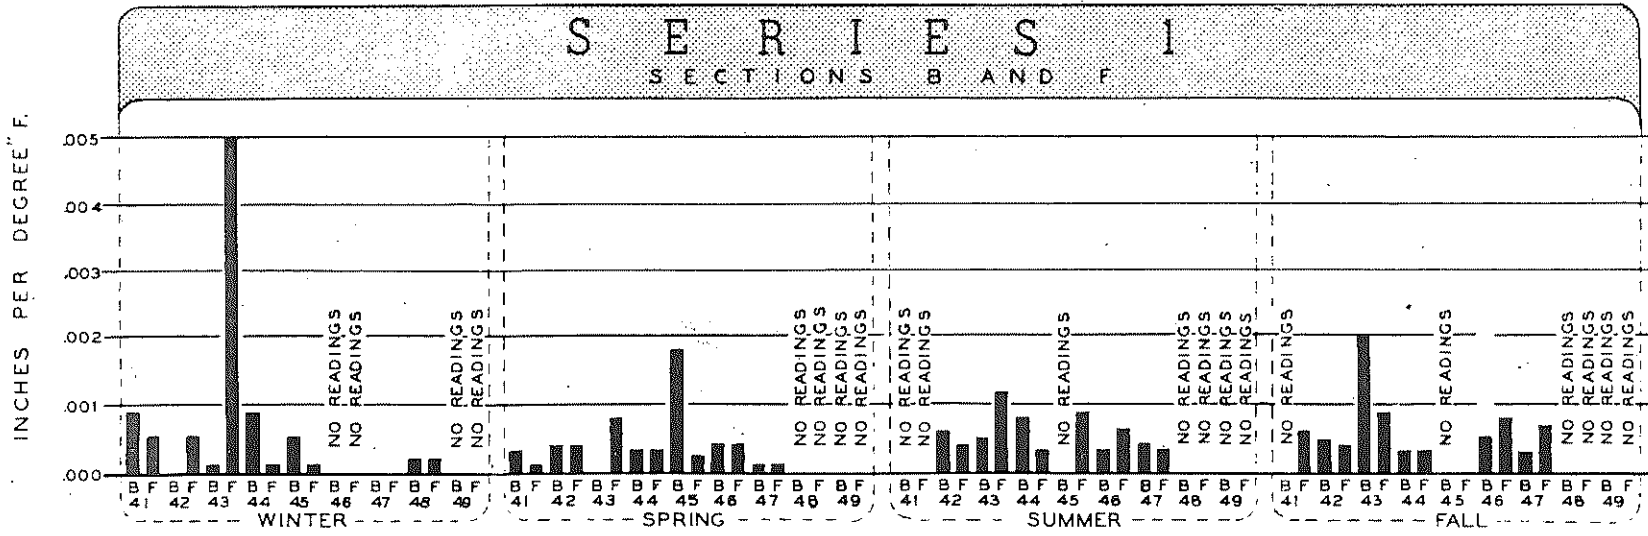
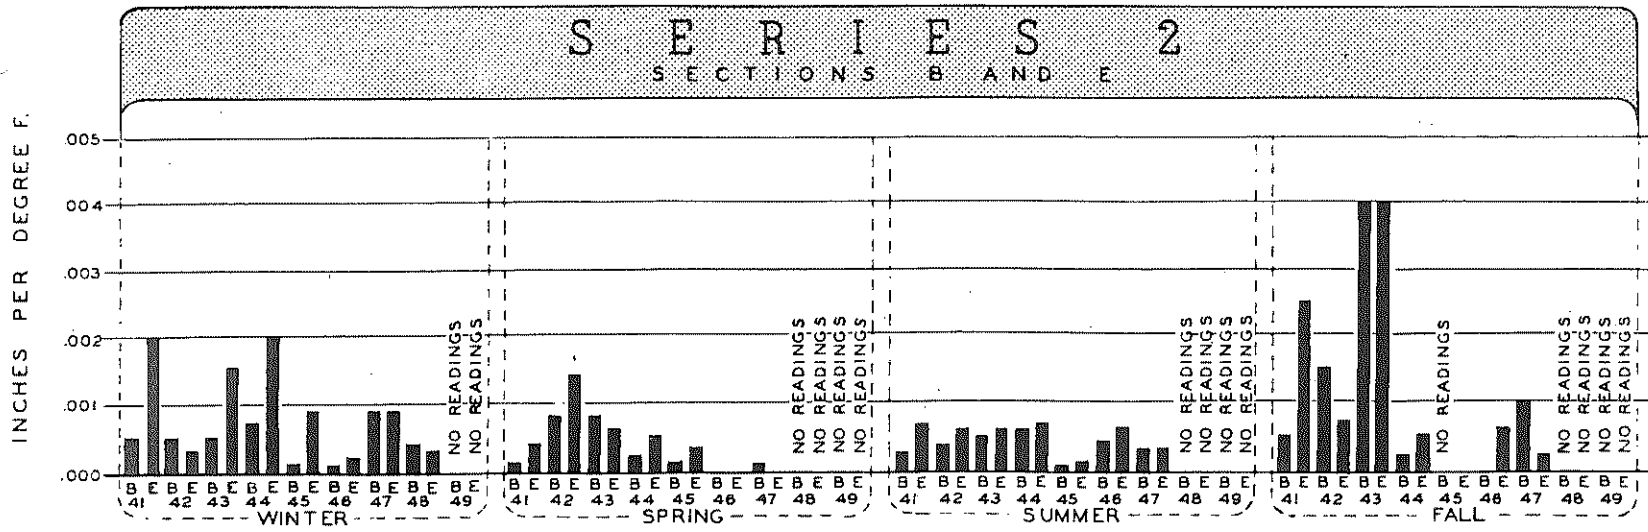
Figure 11

DAILY MOVEMENT OF DUMMY JOINTS
