INVESTIGATIONAL CONCRETE PAVEMENT IN MICHIGAN  
DESIGN PROJECT - MICHIGAN TEST ROAD

10 Year Progress Report

Research Laboratory  
Testing and Research Division  
Report No. 156  
December 15, 1950

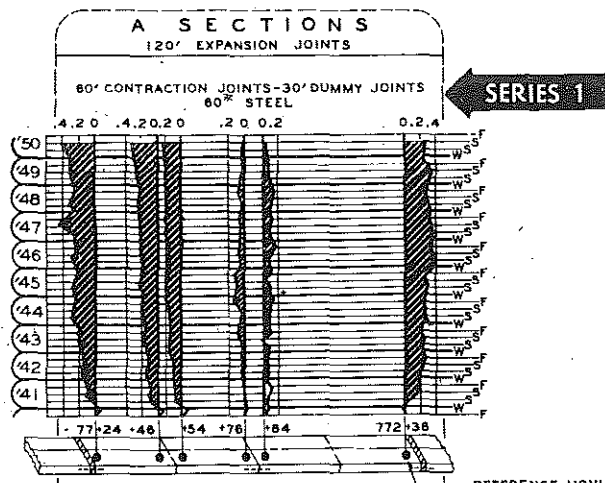
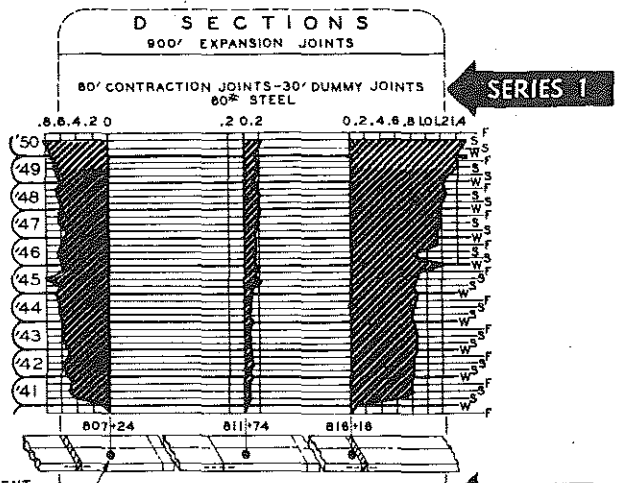
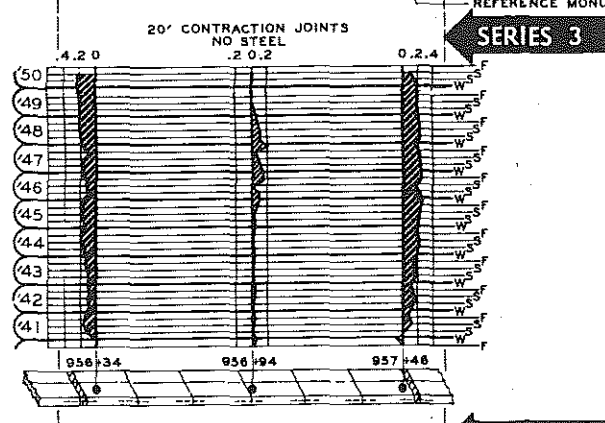
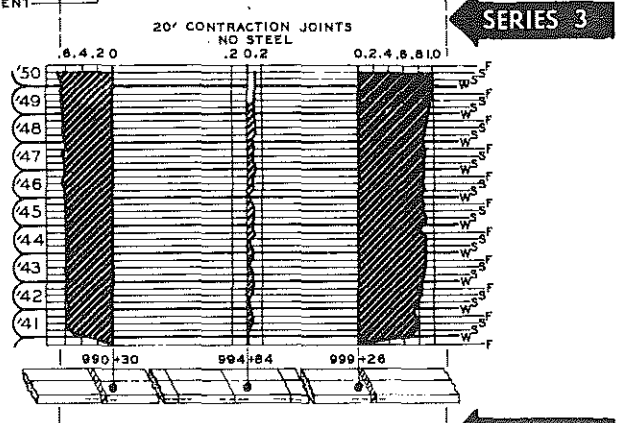
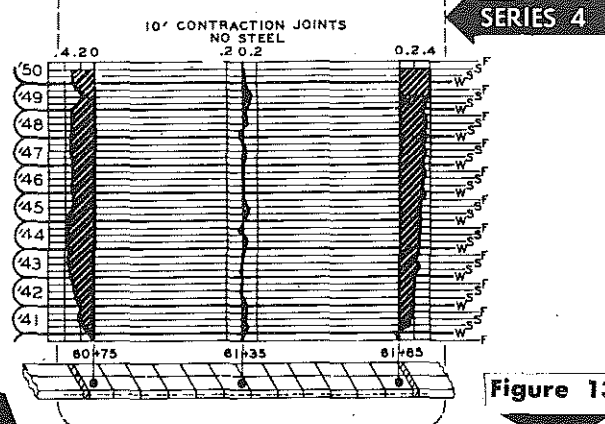
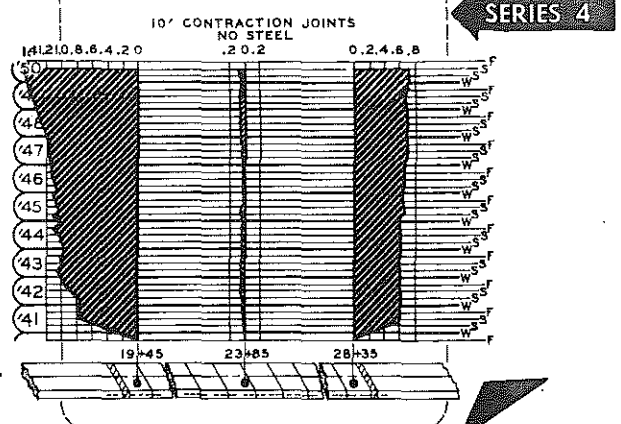
Figure 11

DAILY MOVEMENT OF DUMMY JOINTS

Dummy Joints: Daily observations have been made on certain dummy joints in Series 1 and 2. Data from these observations are presented graphically in Figure 11. The graphs serve to show that the joints function in the manner of other joints but to a lesser degree, and that the magnitude of the daily movement is in general under 0.001 of an inch per degree F.

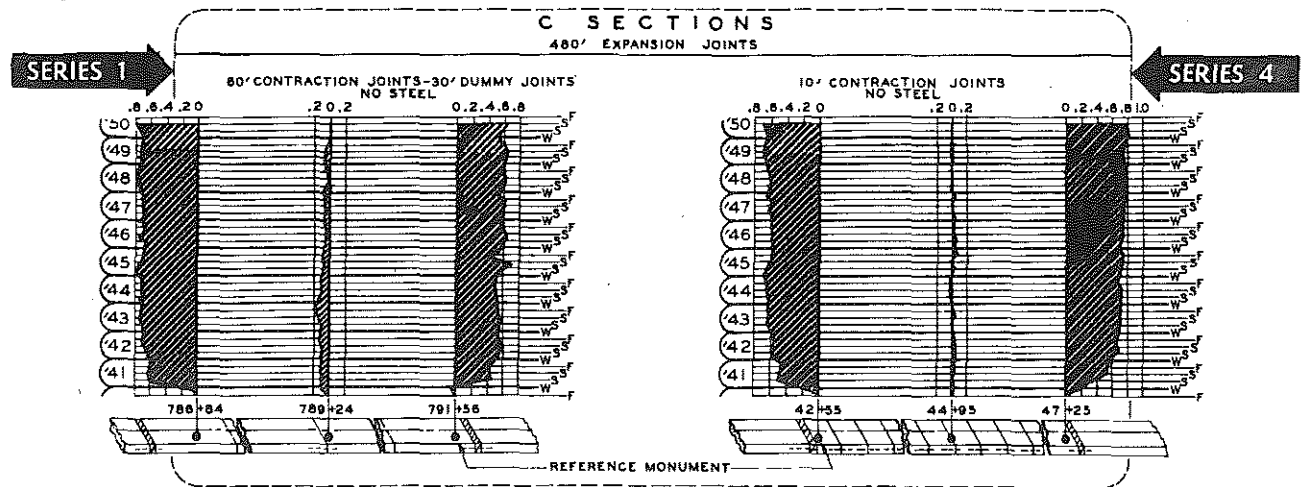
Figure 14

SEASONAL CHANGES IN SECTION LENGTH

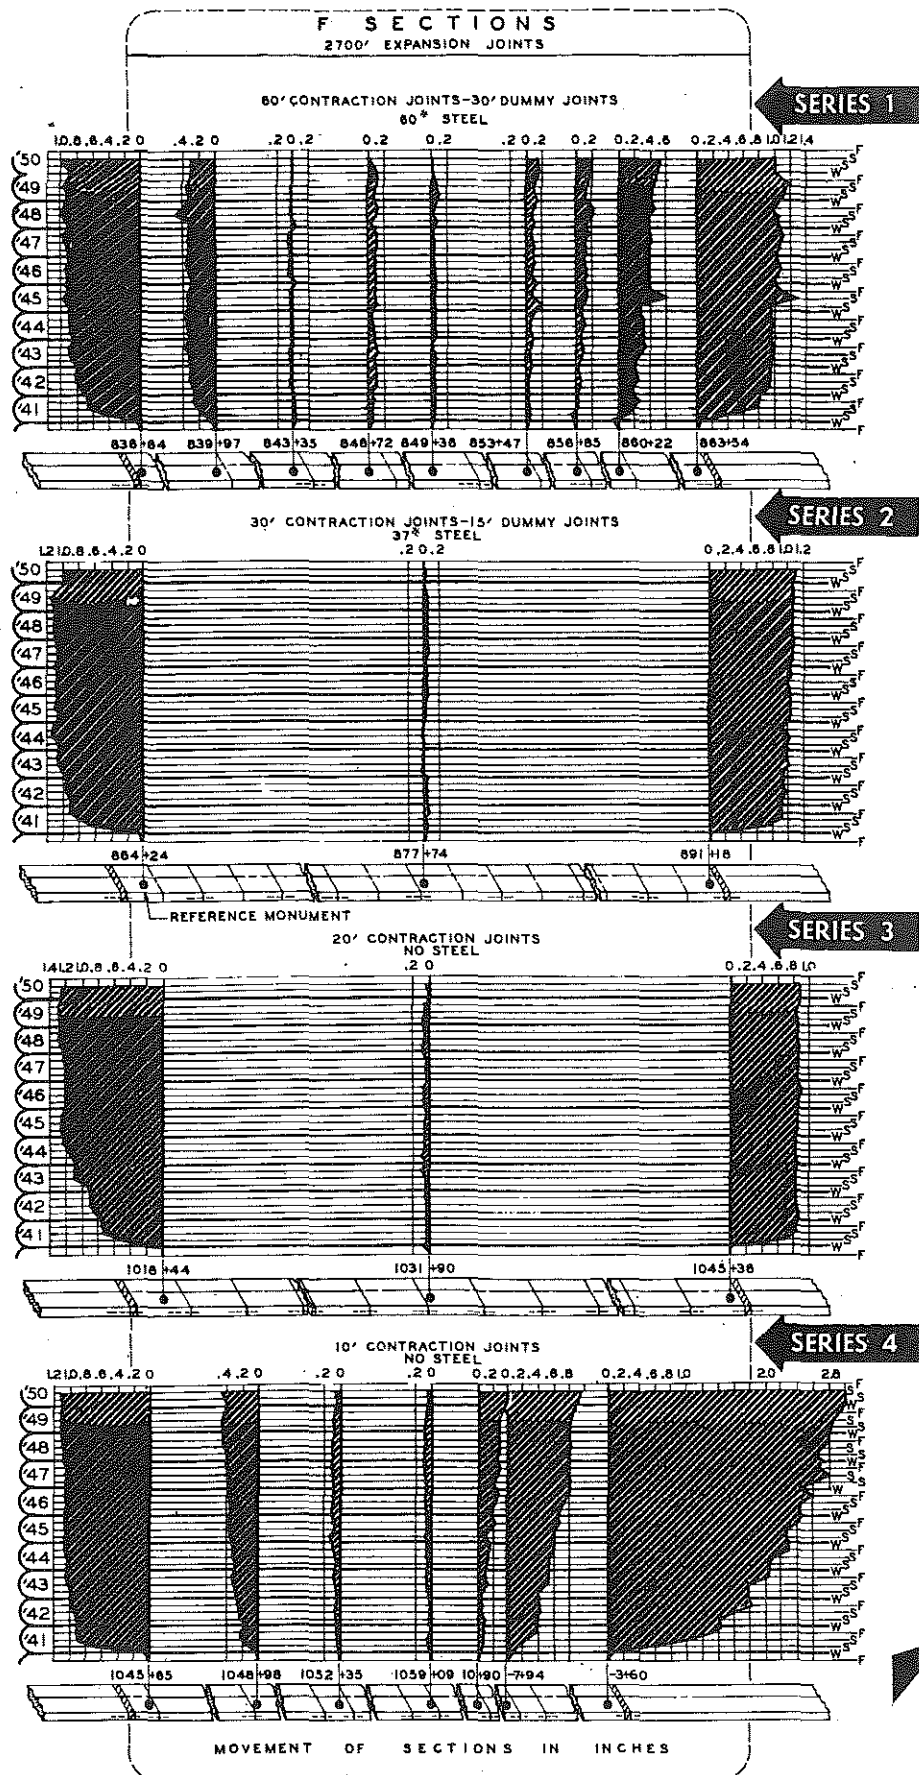
Figure 15

SEASONAL CHANGES IN SECTION LENGTH

The data indicate that for long sections of pavement the greatest movement is at the ends and rapidly diminishes until a point is reached at which practically no longitudinal movement takes place. This is clearly shown by graphs presented in Figure 16. For the two 2700-ft. sections -- Series 1 and Series 4 -- the point of zero longitudinal movement was, in 1941, approximately 700 to 800 ft. from the ends of the sections but in 1950 the same point had retreated slightly to 1000 and 1100 ft. from the ends. It is also noted in Figure 16 that the two sections have acquired a considerable increase in residual displacement during the 10-year interim. The substantially greater movement of the north end of Section 4F is due to the presence of five 1-in. expansion joints at the relief end instead of the usual three expansion joints because of the abutting Muskegon River bridge. Thus, there exists in the central part of the 2700-ft. sections in Series 1, 2, 3, and 4, portions of pavement more than 500 ft. along which at elevated temperatures are under restraint similar to that of a continuous slab without expansion joints. Therefore, in the case of sections whose lengths are less than about 1800 ft., it may be expected that every point in each half of the section will display some movement with respect to the center of the section. For short sections such as illustrated by the graph at the top of Figure 16, (Series 1A), the movement of any point in either half of the section is approximately proportional to its distance from the center of the section.

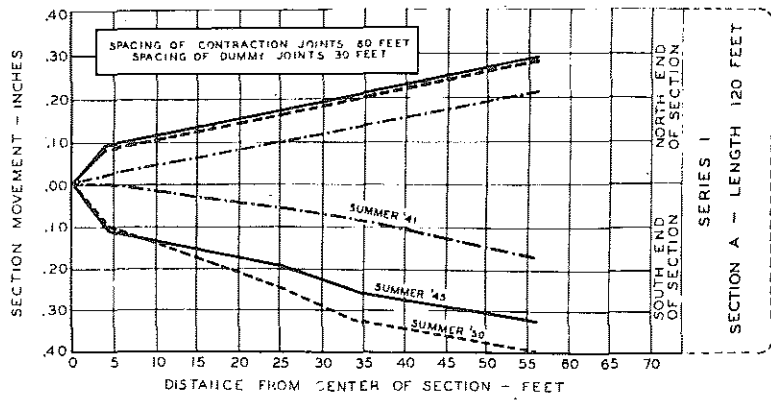
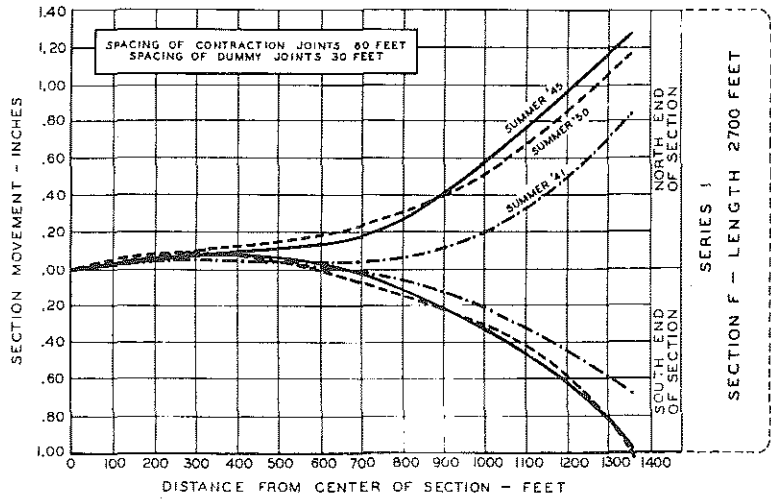
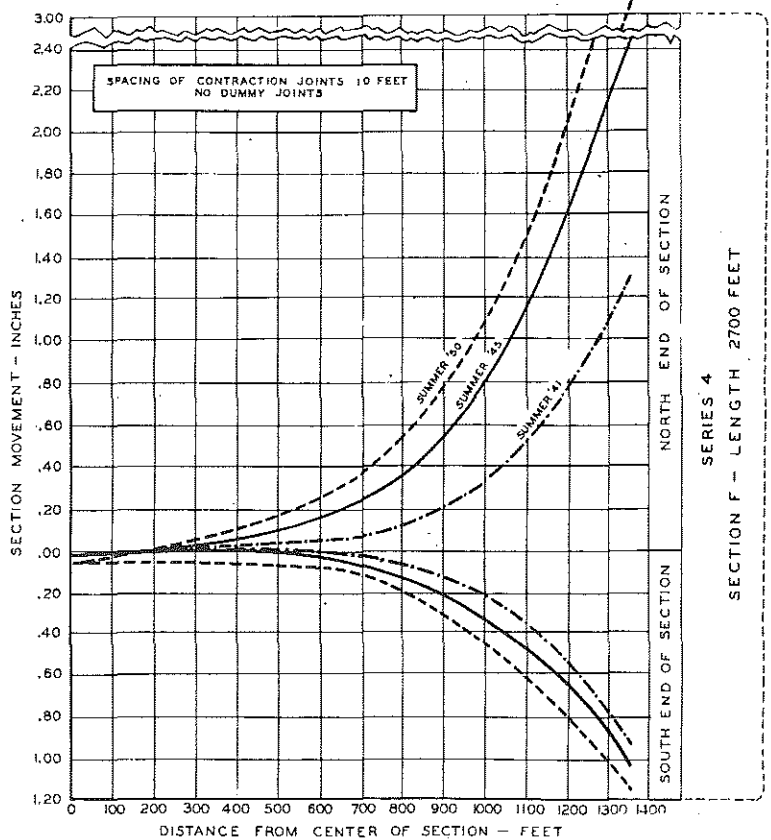
**RELATION BETWEEN  
SECTION MOVEMENT  
AND DISTANCE FROM  
CENTER OF SECTION**

of the entire section, resulting in a general displacement of the whole section toward the right or left causing the point of zero movement to occur on either side of the geometric center of the section. It is also indicated in Figure 16 that the sections experienced their greatest movement during the first 5 years after construction.

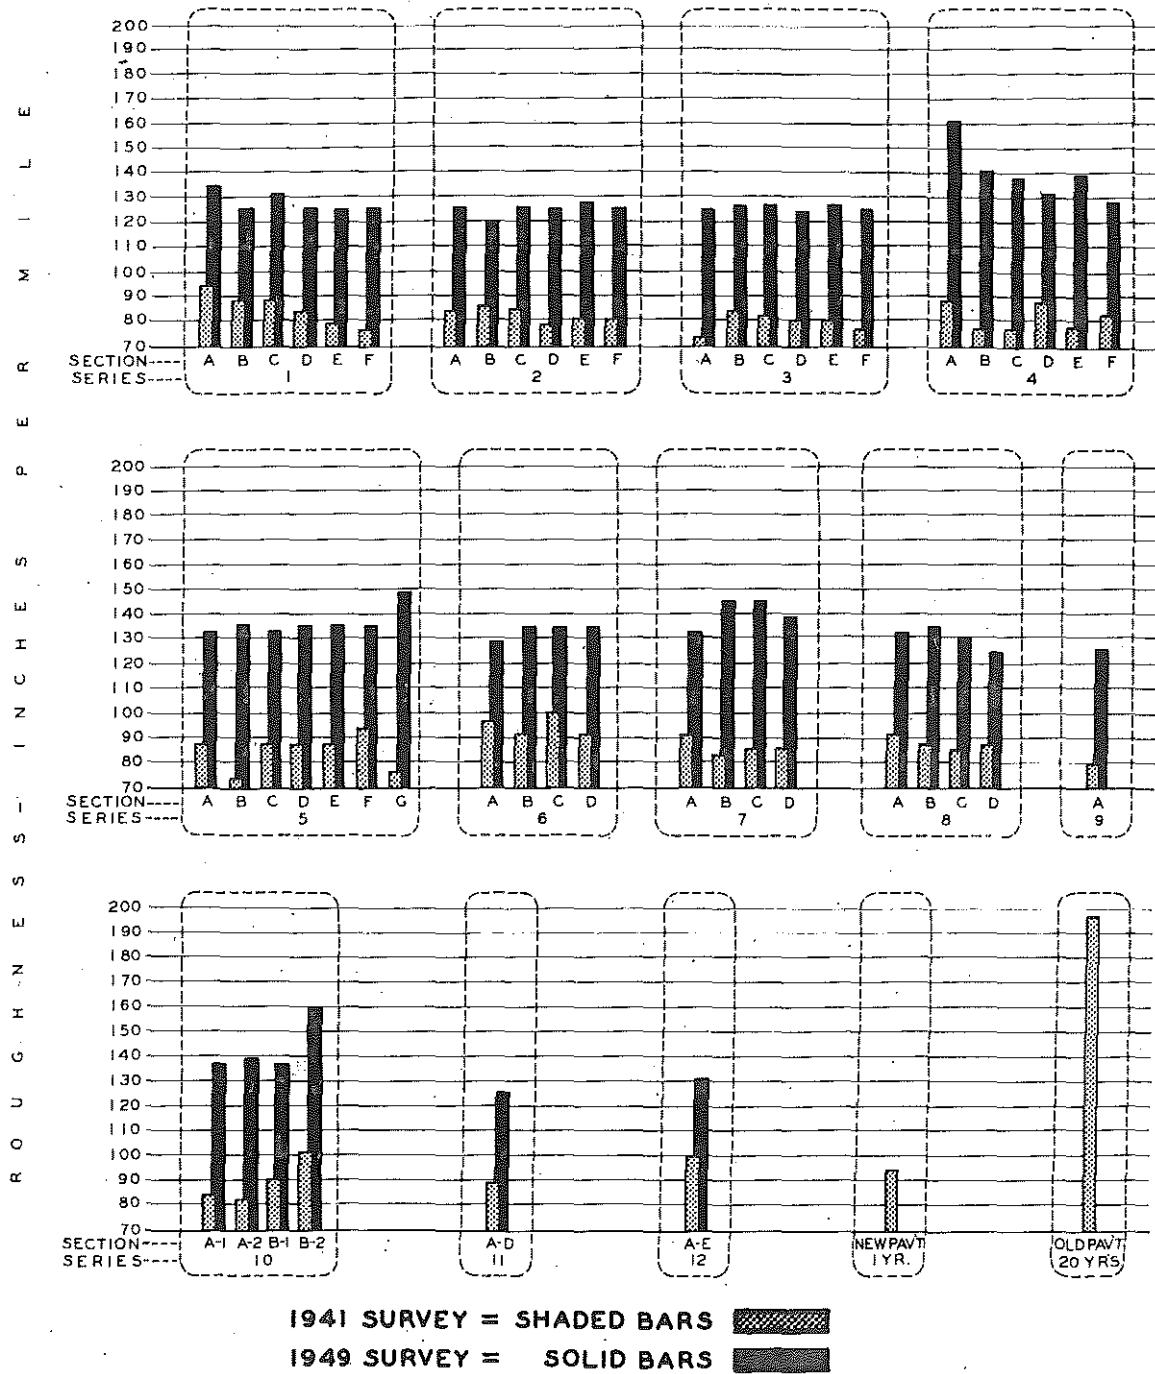
Figure 17

ROAD ROUGHNESS DATA

With reference to Figure 17, it may be seen that the riding qualities of Series 6, 7, and 8 are approximately the same with Series 7 being probably slightly rougher. All three series have increased approximately the same amount with age.

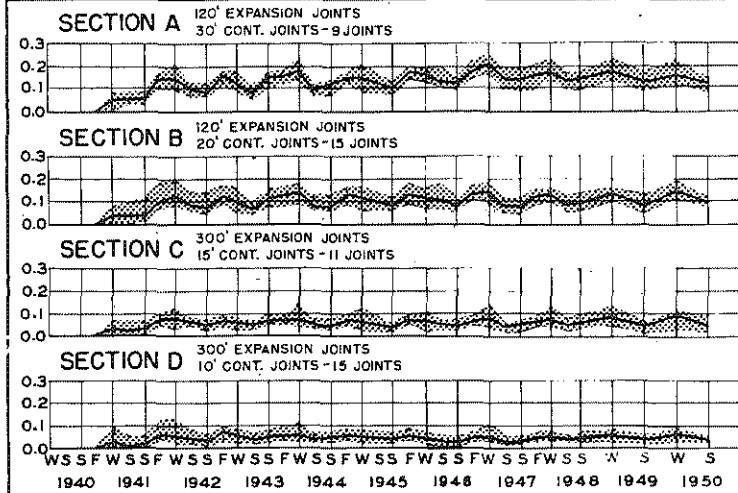
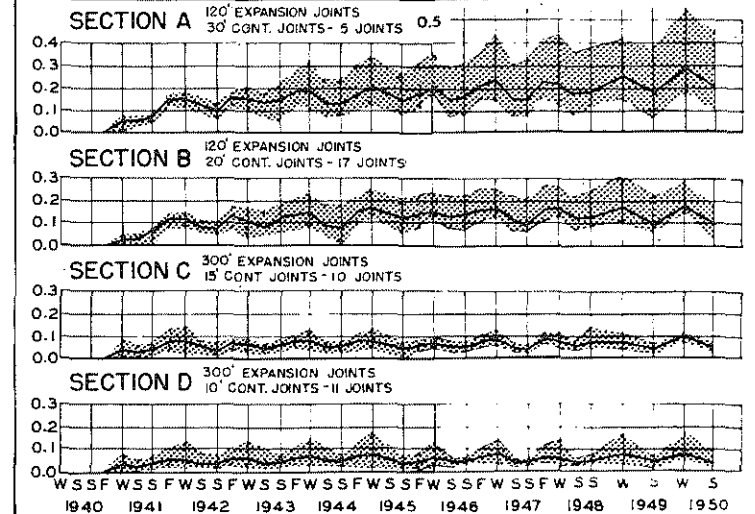
Figure 19

8" UNIFORM - NO STEEL

7" UNIFORM - NO STEEL

SOLID CURVES INDICATE AVERAGE VALUES  
SHADED BANDS INDICATE MAXIMUM AND  
MINIMUM VALUES

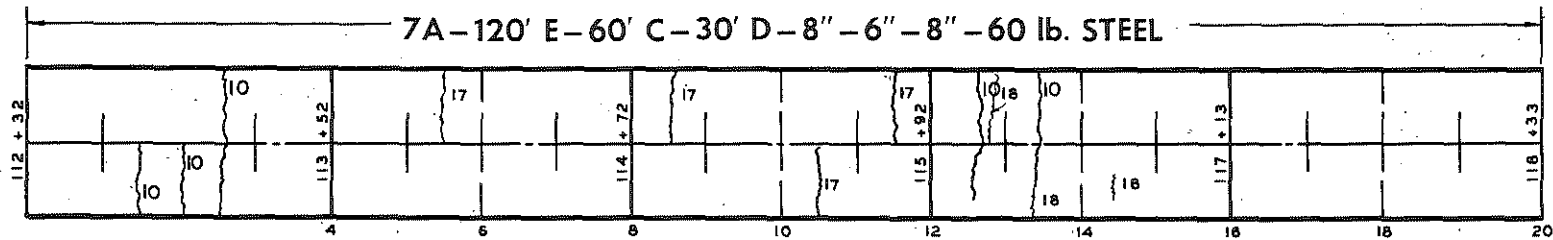
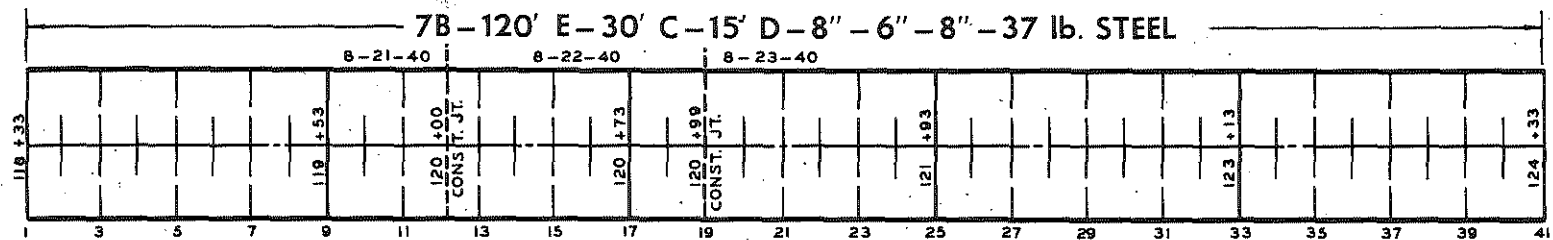
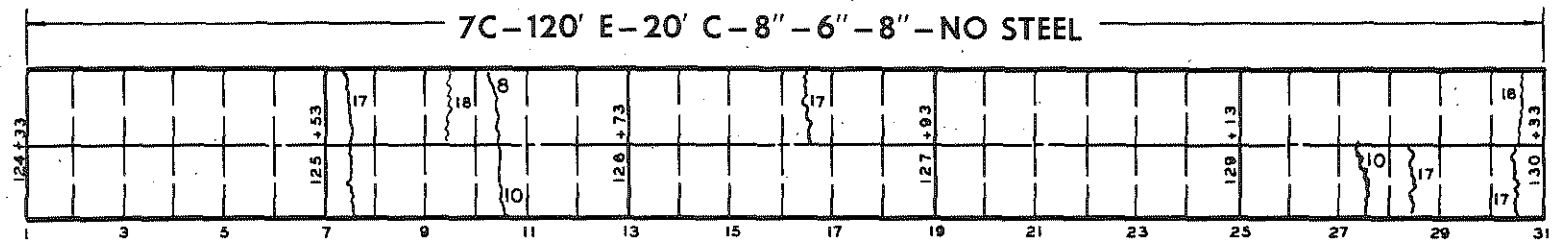
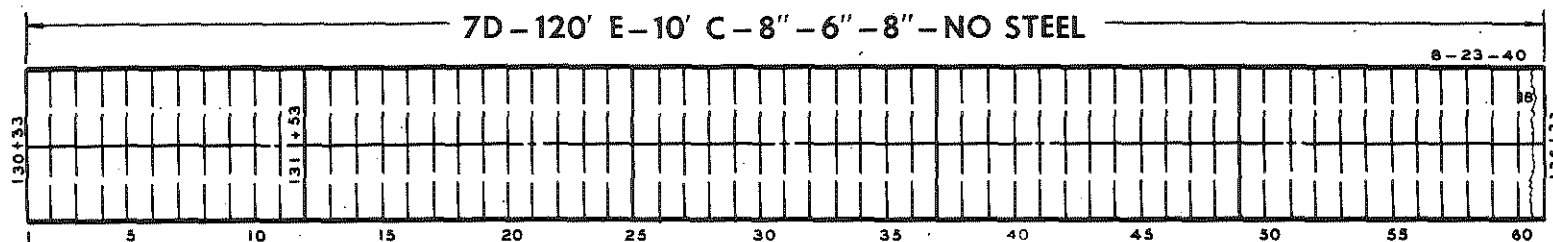
Figure 21

TIME OF SURVEY: 8-DEC. 1944 18-OCT. 1950  
 10-SEPT. 1945  
 17-MAY 1949

CONDITION OF  
 PAVEMENT IN  
 SERIES 7

In Series 7, with 8-6- 8-in. cross section, the first transverse crack was noted in December, 1944 and, since that time, several more have developed as may be seen in Figure 21. \*

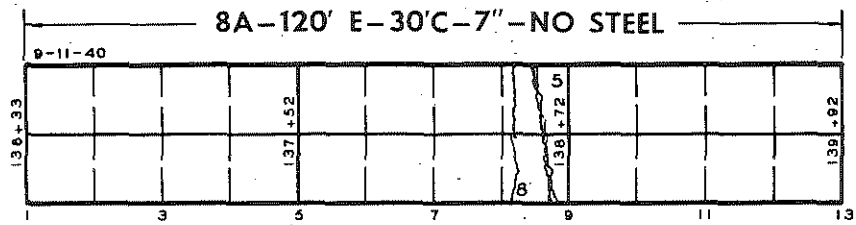
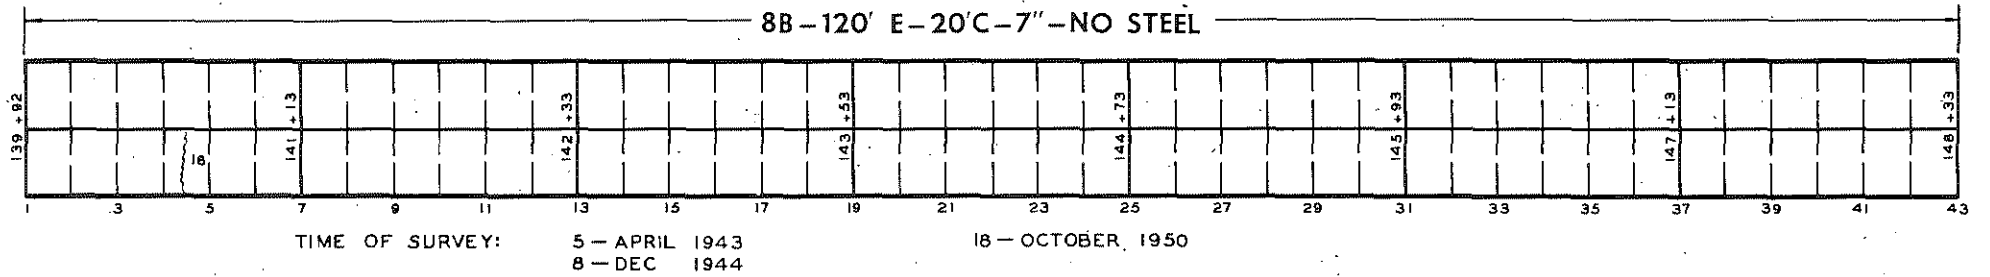
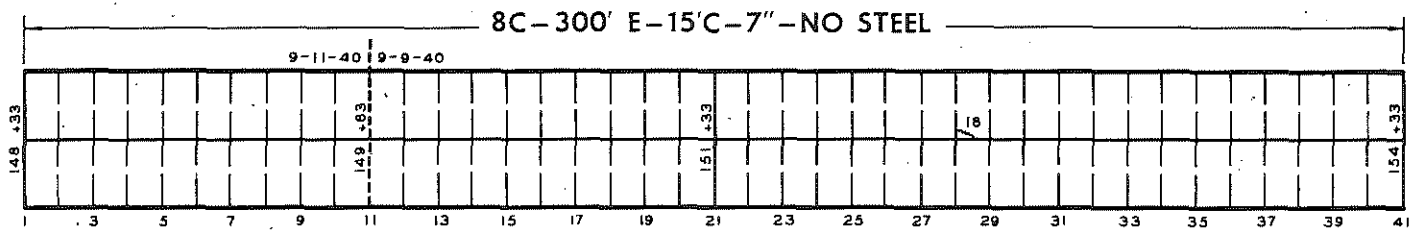
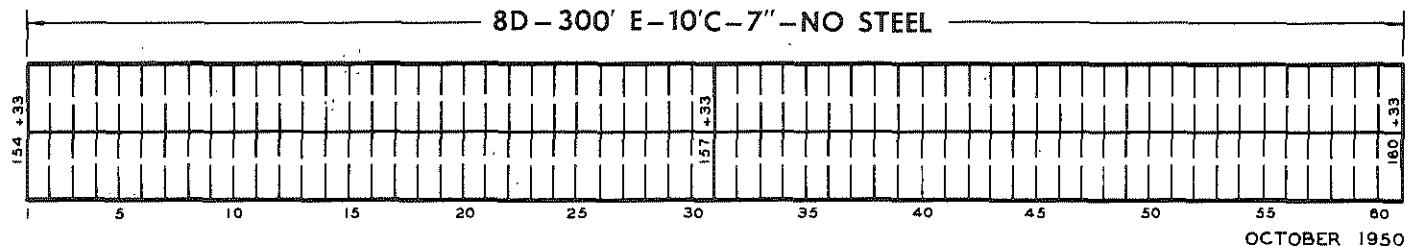
Figure 22

CONDITION OF  
PAVEMENT IN  
SERIES 8

Only two transverse cracks have developed in Series 8 with 7-in. slab thickness. The first was observed in April, 1943 and the last in December, 1944. See Figure 22.

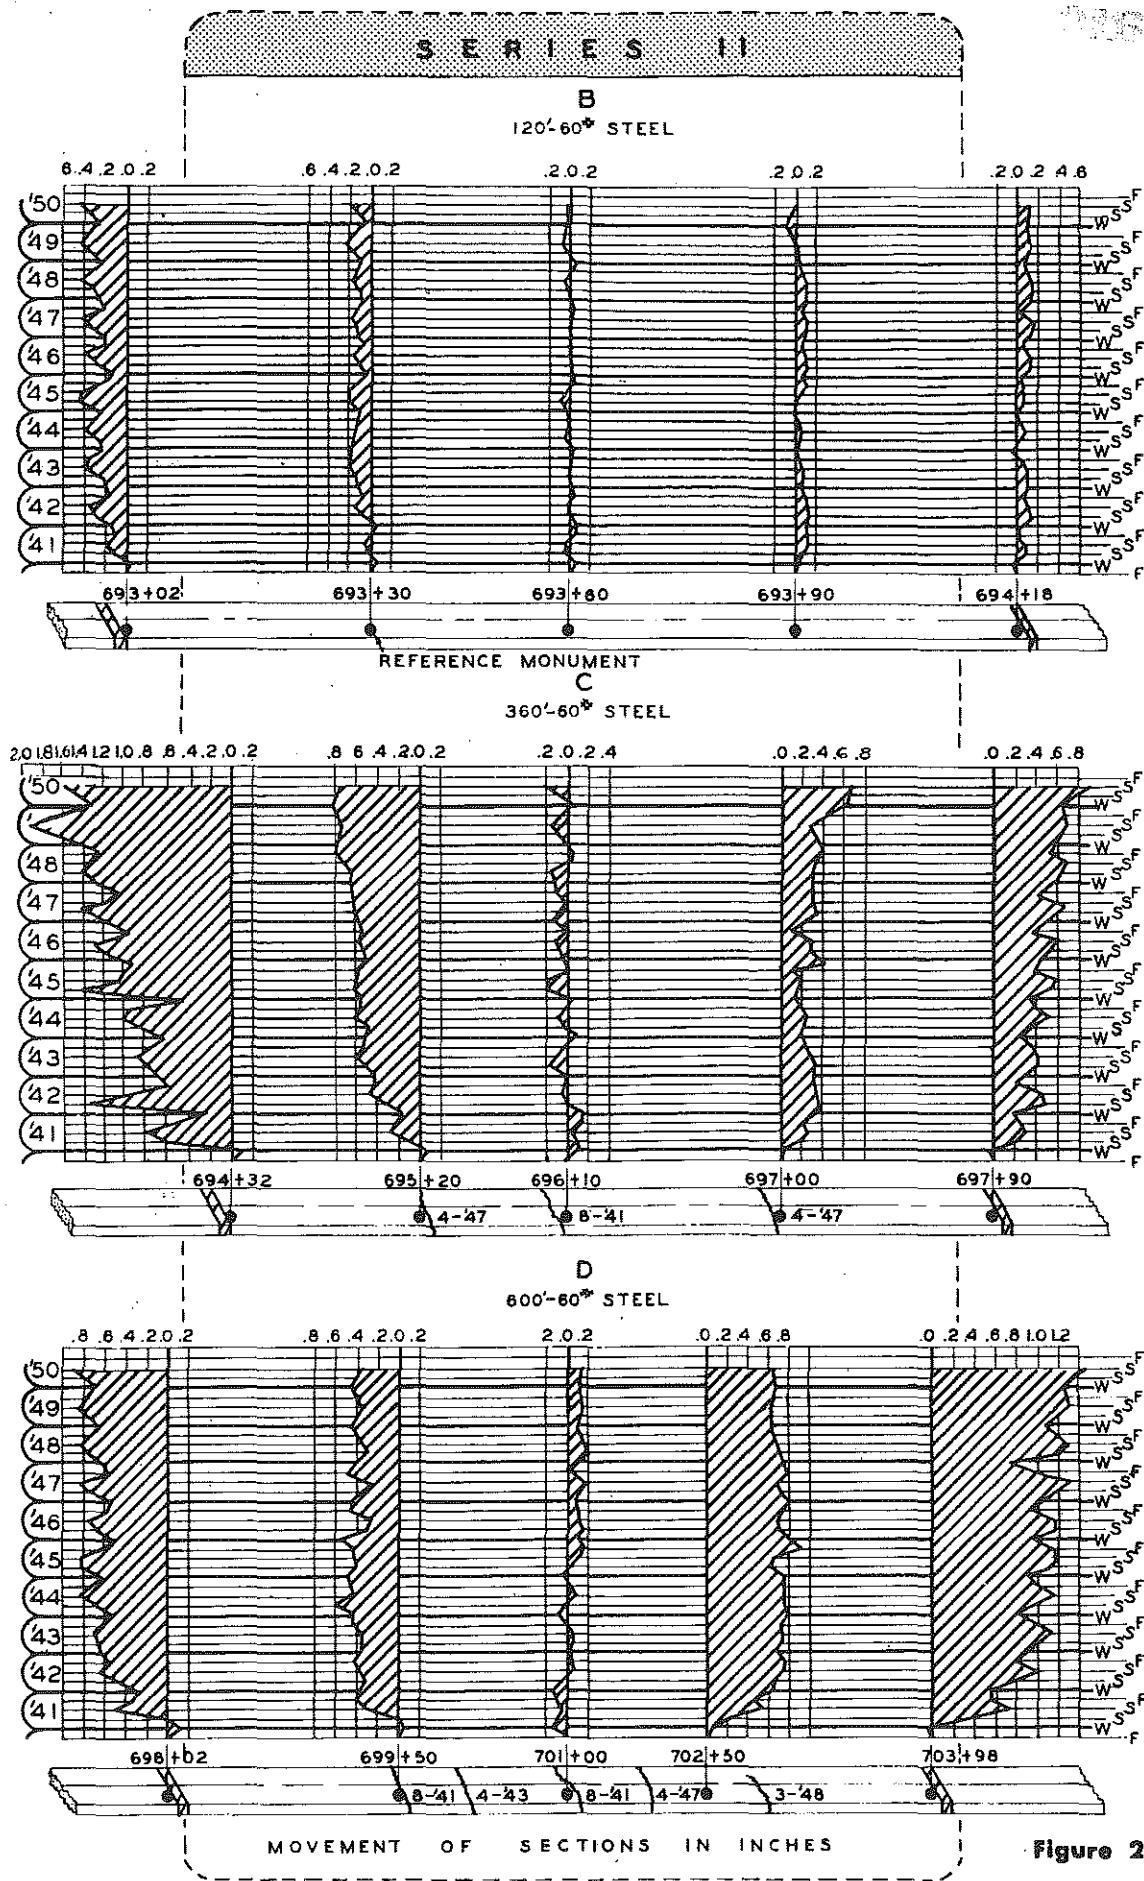
Figure 23

SEASONAL CHANGES IN SECTION LENGTH

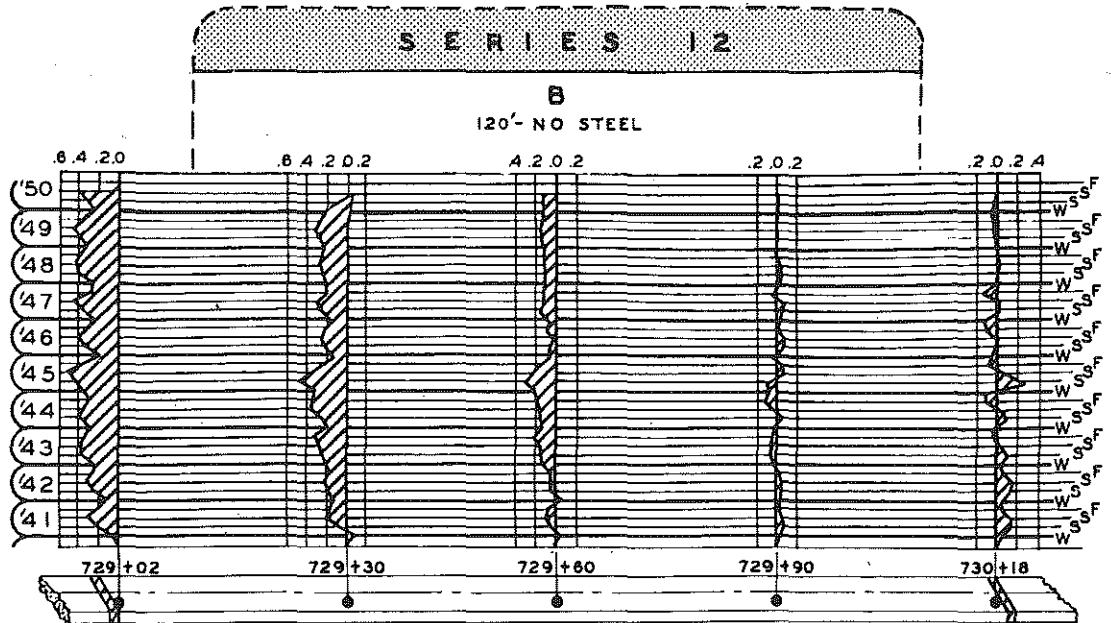
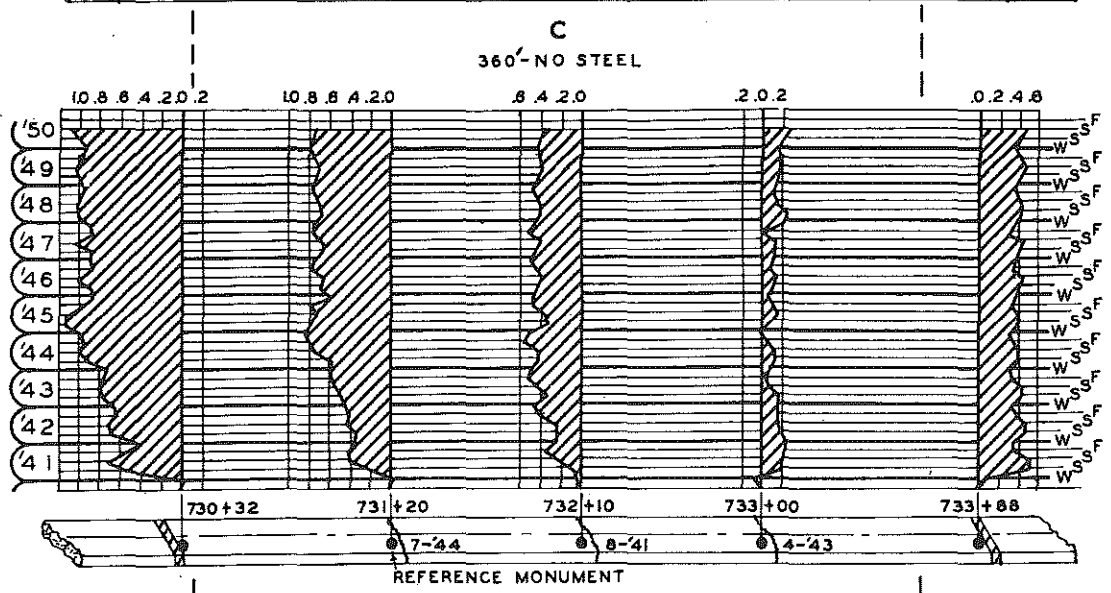
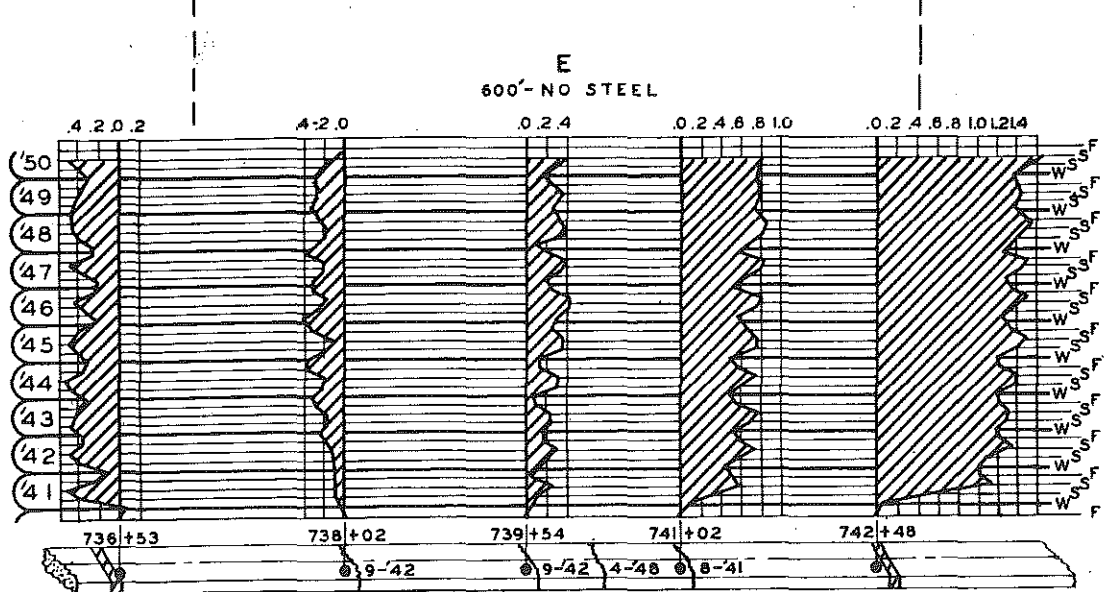
Figure 24

**SEASONAL CHANGES IN SECTION LENGTH**

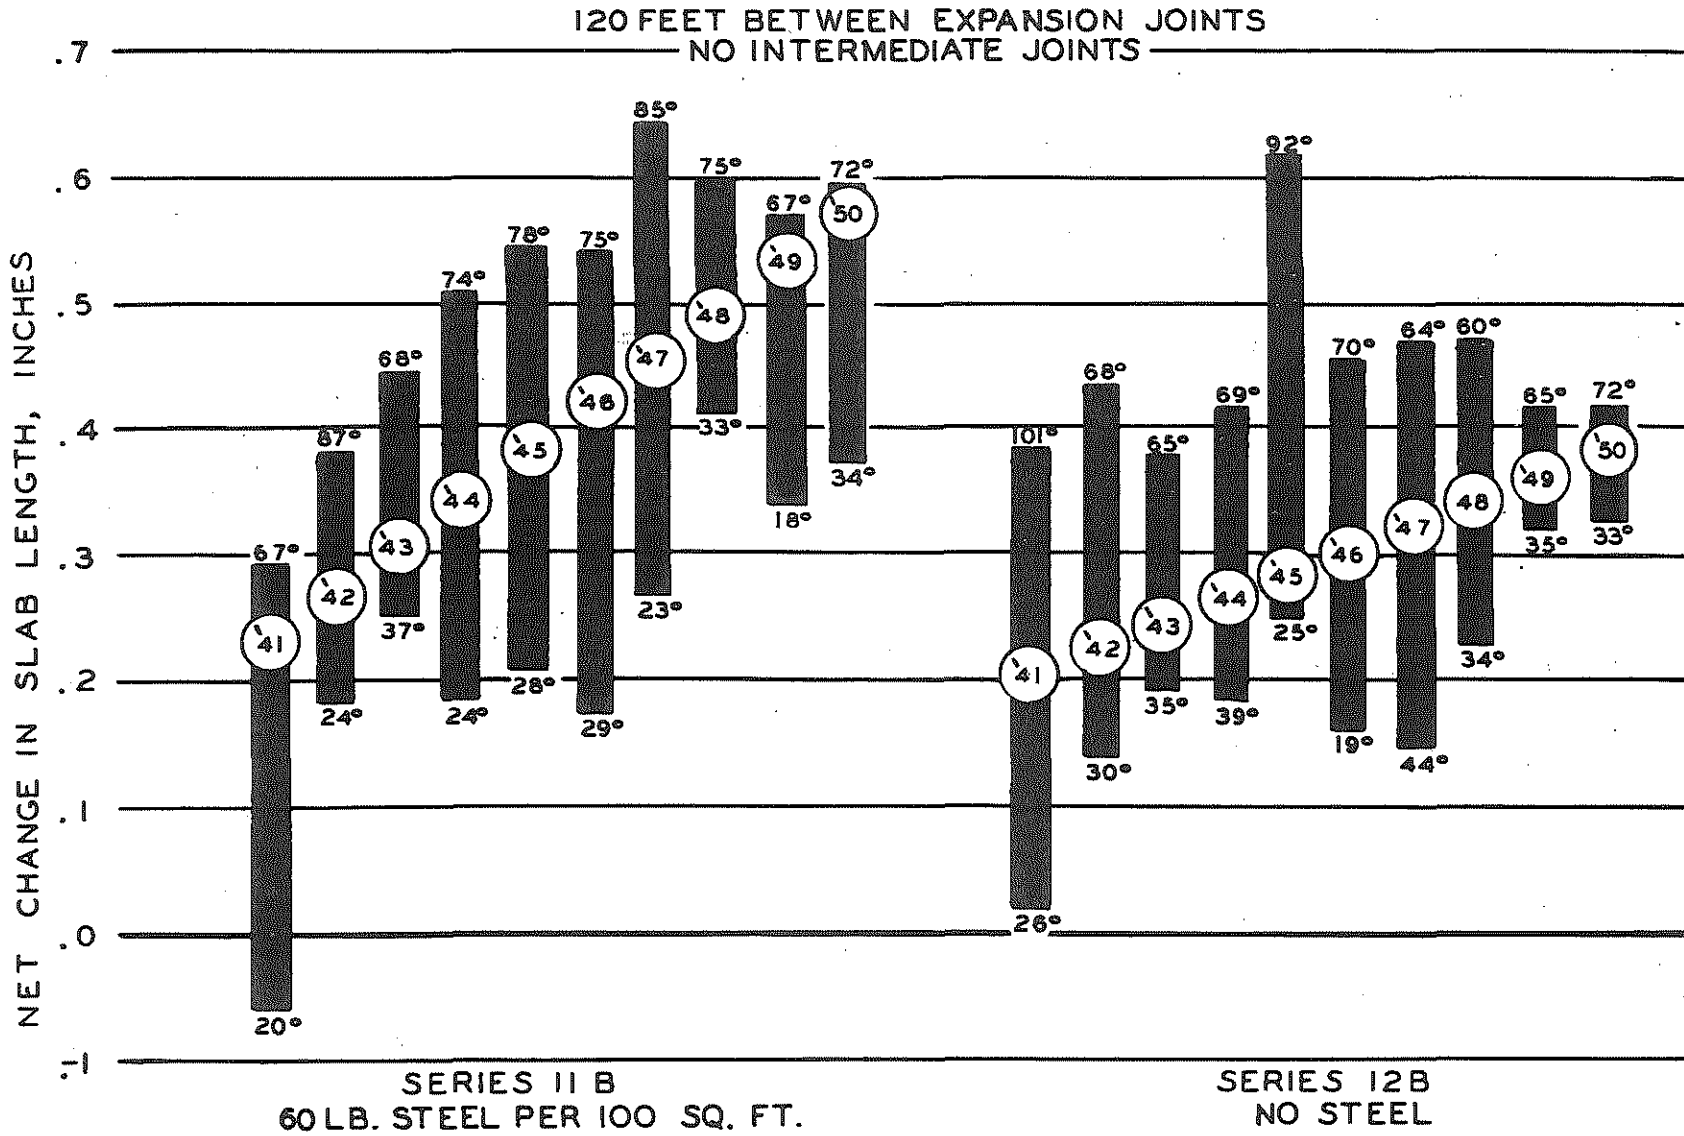
Figure 25

ANNUAL AND PROGRESSIVE CHANGES IN SLAB LENGTH

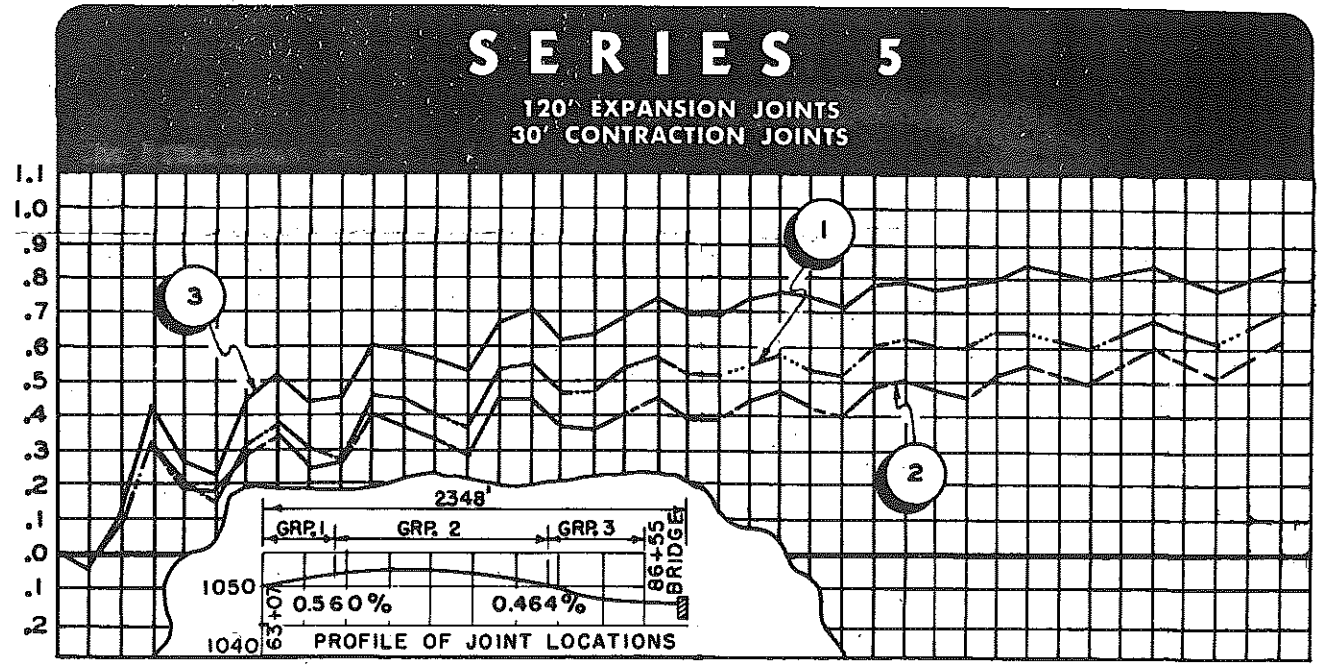
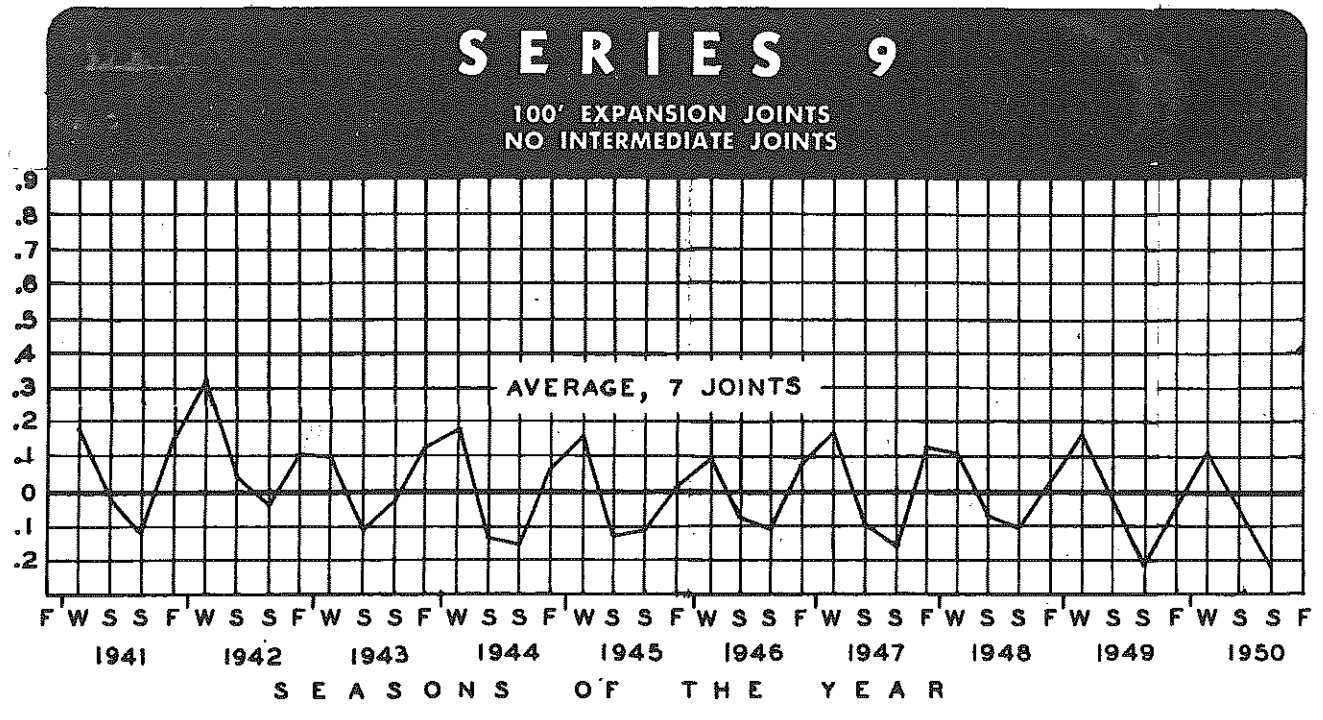
Figure 27

### SEASONAL CHANGES IN EXPANSION JOINT WIDTH

Type DB 1 (3) Series 5: Seasonal joint width changes for the two types of air-chamber expansion joints are presented graphically in Figure 27. In general, the joints in Series 5 have developed a slightly greater permanent closure than joints in other series constructed with premolded fiber. This is to be expected since these joints offer no restraint to the adjacent slabs. In the case of Type DB 1 (3) joints, this movement has caused excessive extrusion of the bituminous seal onto the pavement surface. In two cases in Section 5G the metal inserts employed to retain the bituminous seal in place have been pushed partially out of the joint. The abnormal movement encountered in Series 5, Sections F and G may be due to two constructional factors associated with this particular test section: first, the two end sections F and G lie at the foot of a downgrade of 0.464 percent; second, these two sections abut against a bridge structure which cannot shift laterally.

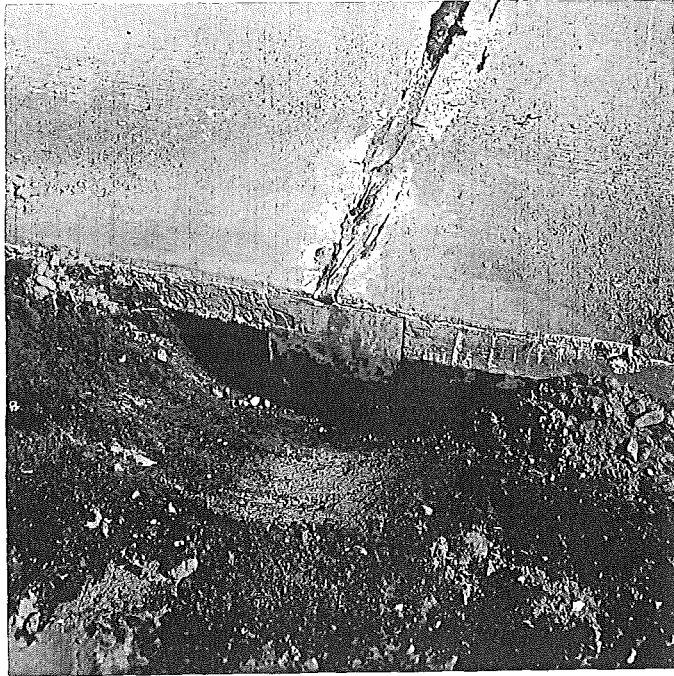
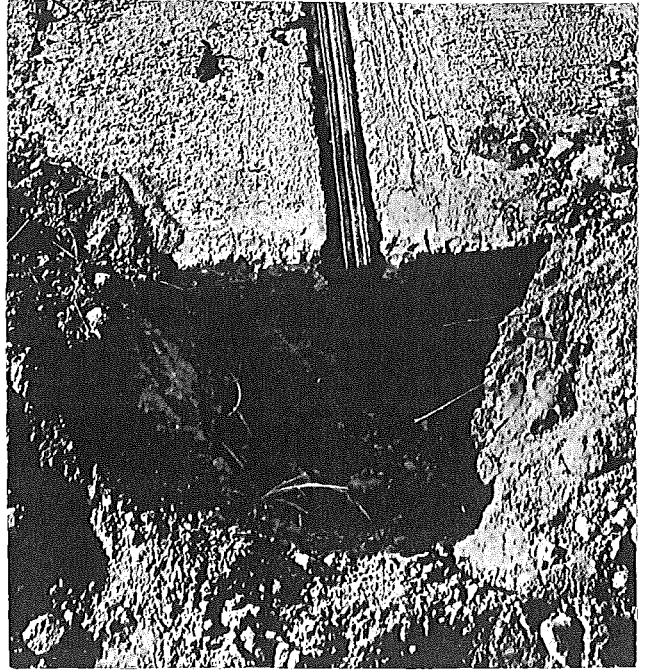
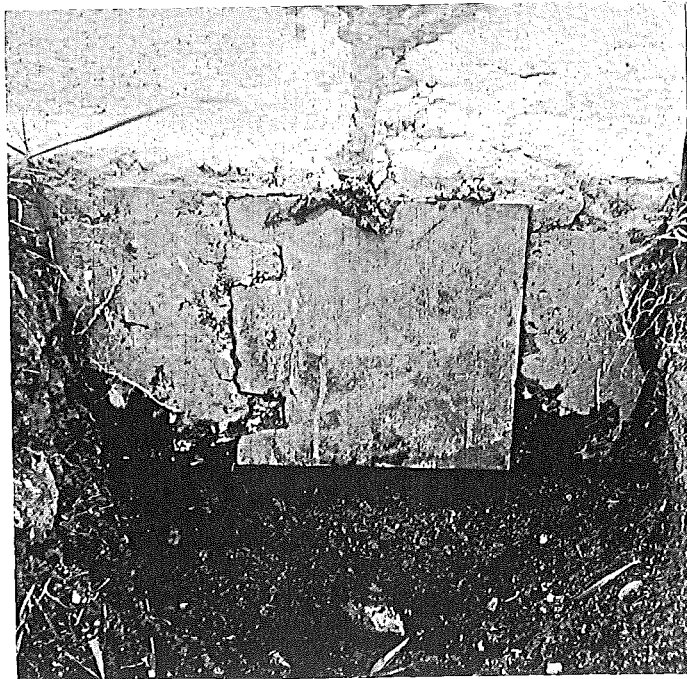
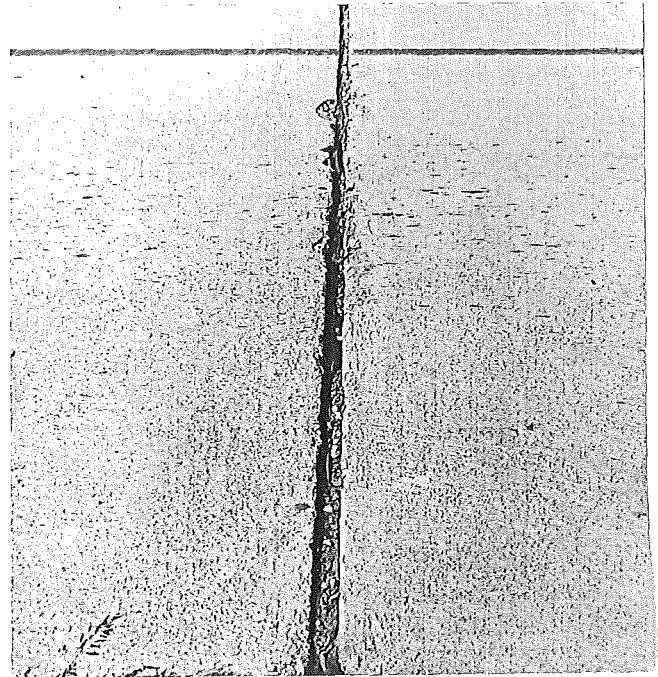
At Time of Construction  
1940

10 Years Later - 1950

Same Joint 2 Years Later (1942)  
when Joint had to be repaired.

Figure 28. Air Chamber Expansion Joint,  
Type DB-1 (3) Series 5, Station 74+30

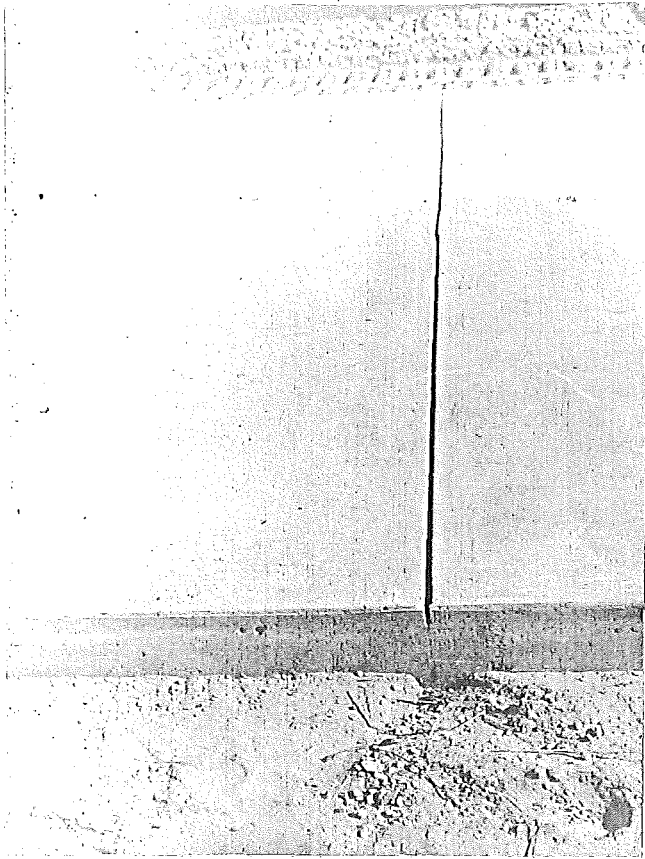
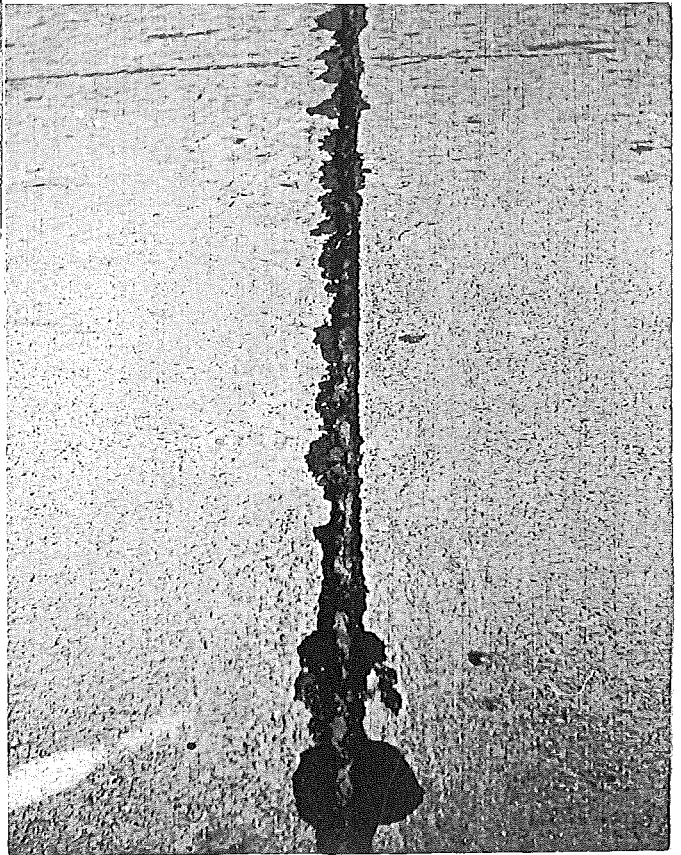
Joint When Installed - 1940

Same Joint - 1950

Figure 30. Type 1B Contraction Joint with Groove,  
Station 64+90

Spalling at Transverse Edges: In Series 5 the majority of the contraction joints were constructed with a groove which was subsequently filled with a bituminous-latex sealing compound. At the present time the joints are in excellent condition except for weathering of the seal as may be seen in Figure 30. The joint edges have remained intact and no spalling of the concrete has been noted. Some scaling has appeared at joint edges. In the case of contraction joints constructed with premolded fiber strip several kinds of failure have been encountered, the most undesirable of which is spalling of the concrete along the joint edge. For comparable data on joint spalling see Table XII, also, Tables VII and VIII. Perhaps the spalling is a direct outcome of installation practice since it is usually associated with tipping of the fiber strip during installation or placing the strip too far below the surface of the pavement. Typical examples of this kind of spalling may be noted in
