INVESTIGATIONAL CONCRETE PAVEMENT IN MICHIGAN  
DESIGN PROJECT - MICHIGAN TEST ROAD

10 Year Progress Report

Research Laboratory  
Testing and Research Division  
Report No. 156  
December 15, 1950

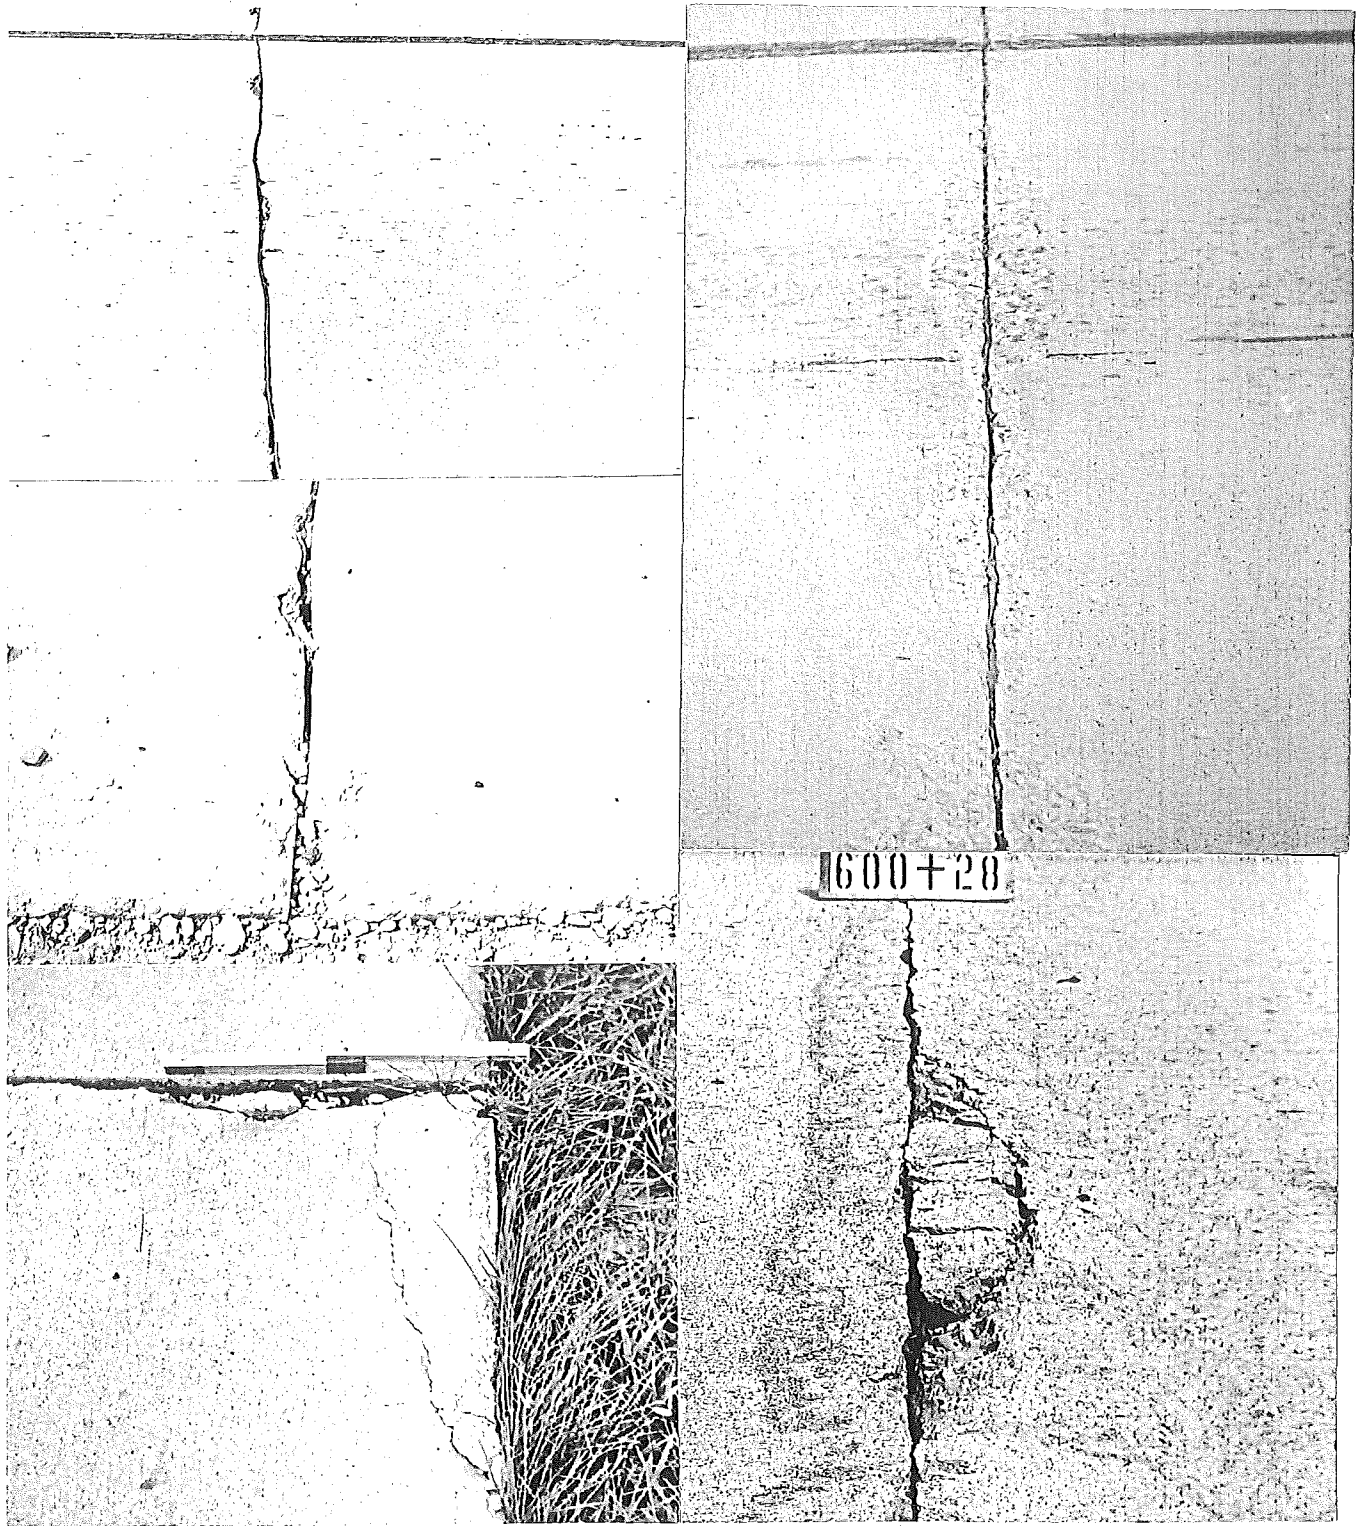
Figure 31. Typical Failures Common to Contraction Joints Constructed with Premolded Fiber Strips.

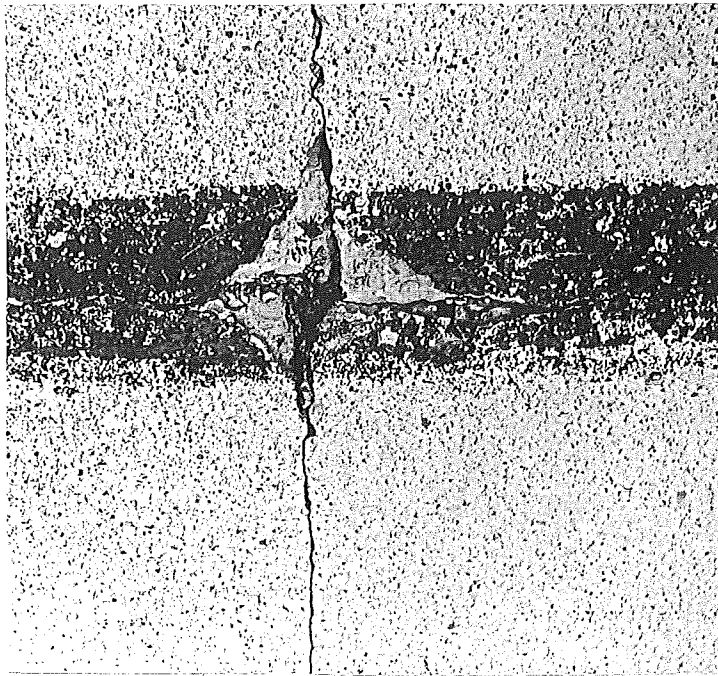
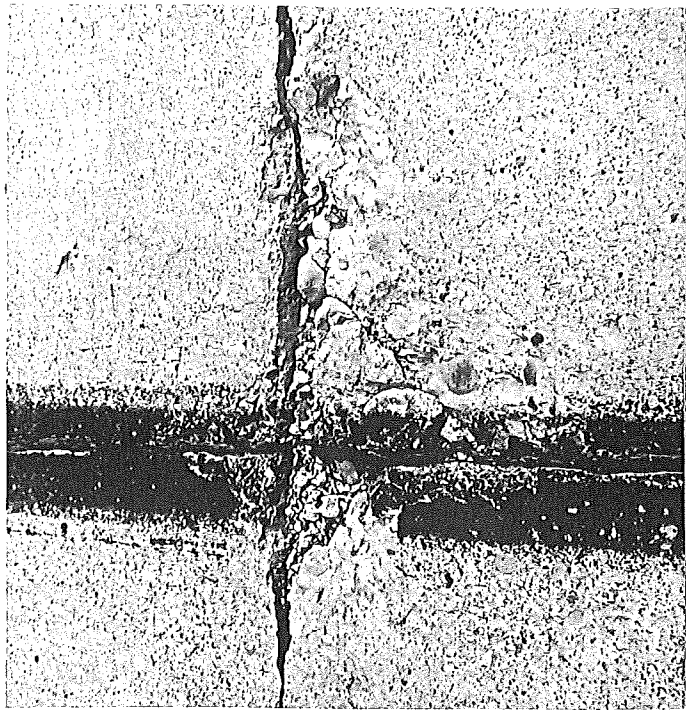
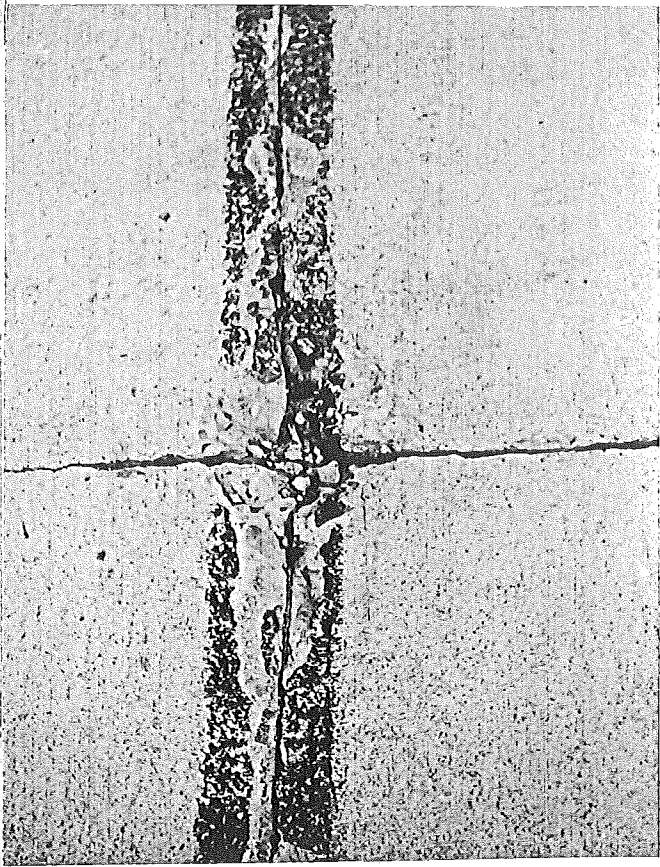
Deep Corner Spalls  
Series 3E, No Load Transfer

Progressive Spalling Along  
Longitudinal Joint

Spalled and Shattered  
Concrete, Series 4 with  
Load Transfer

Figure 32. Spalling at Junction of Contraction and Longitudinal  
Joints Formed with Premolded Fiber Strips.

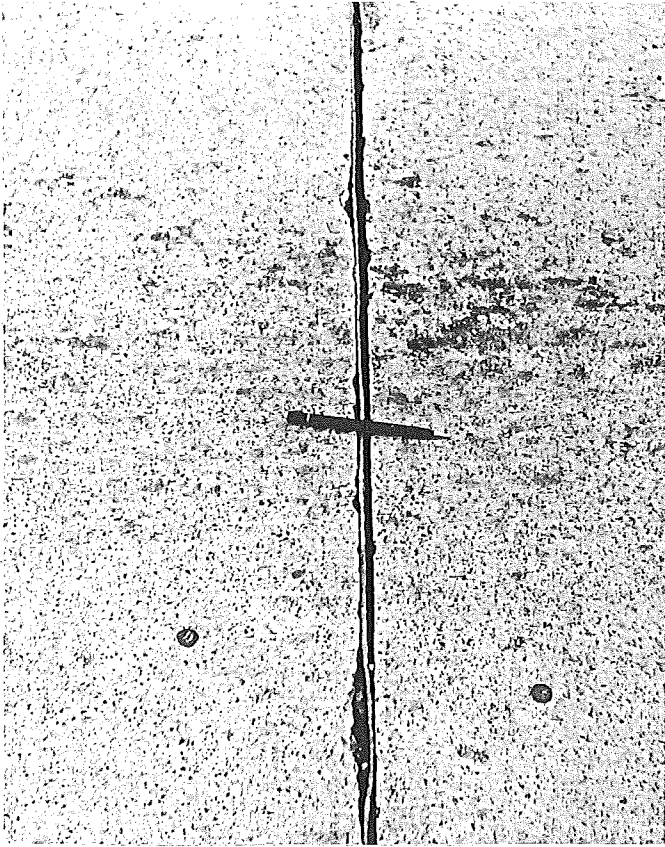
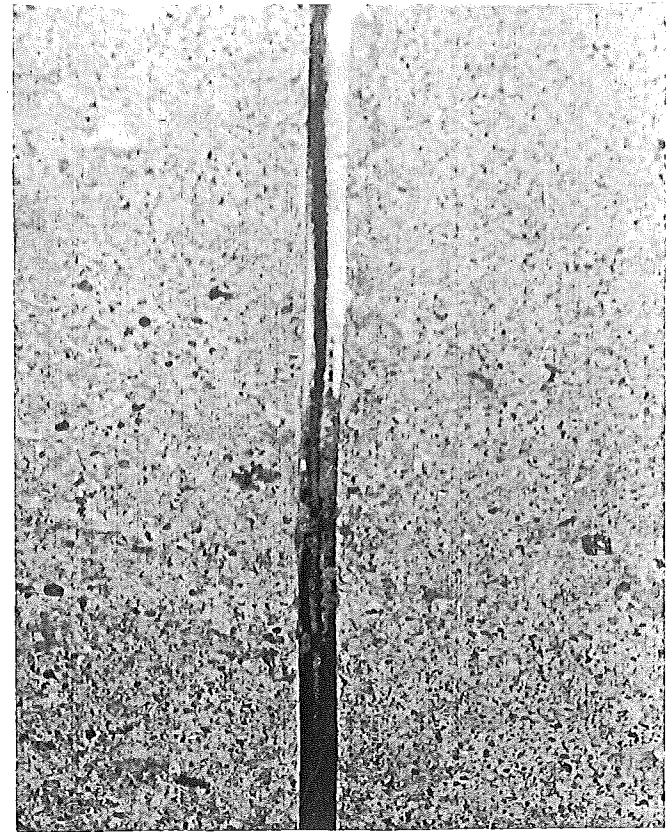
Open to Permit Intrusion of Inert material

Snow and Ice Forms in Joint

Figure 33. Typical Condition of Contraction Joints in Winter with Bituminous Premolded Fiber strip, Series 1A, 60-ft. Contraction Joint Spacing. Winter 1944-45.

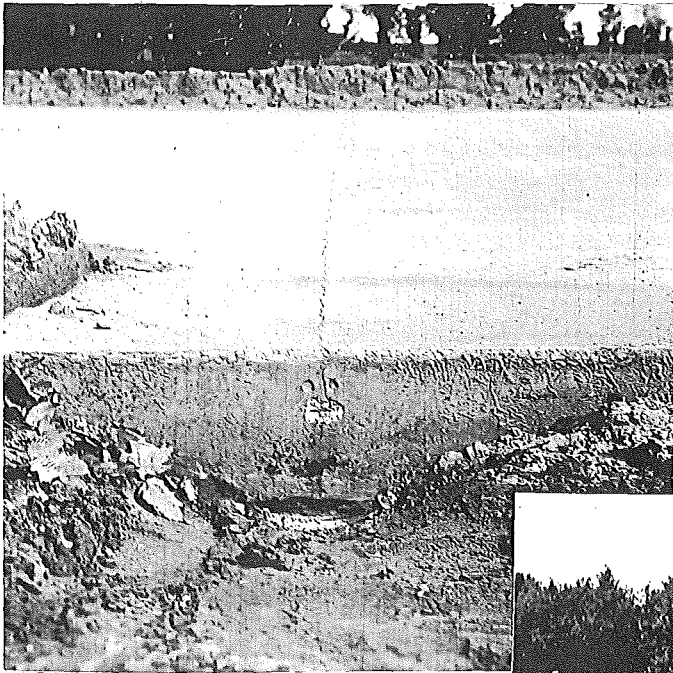
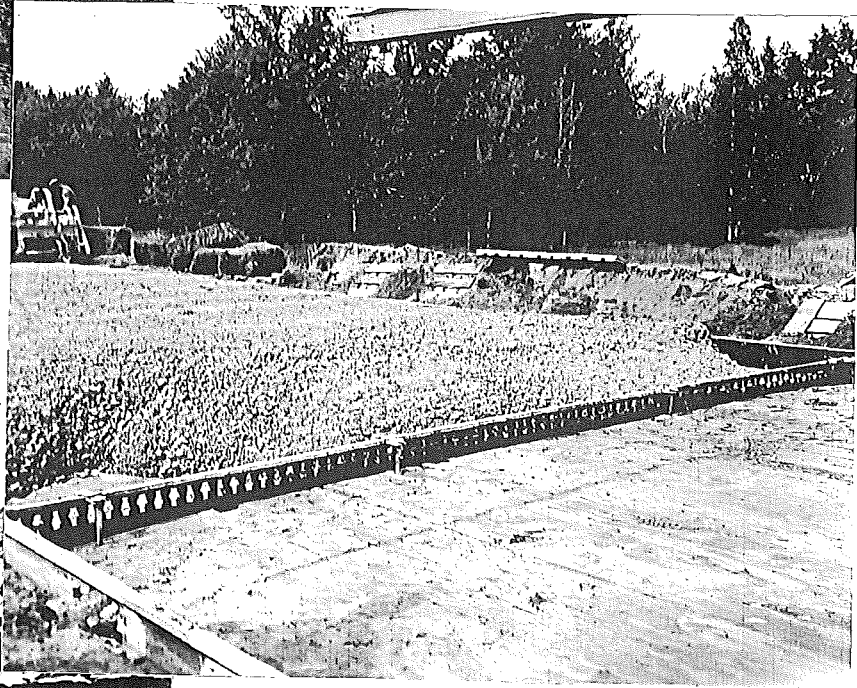
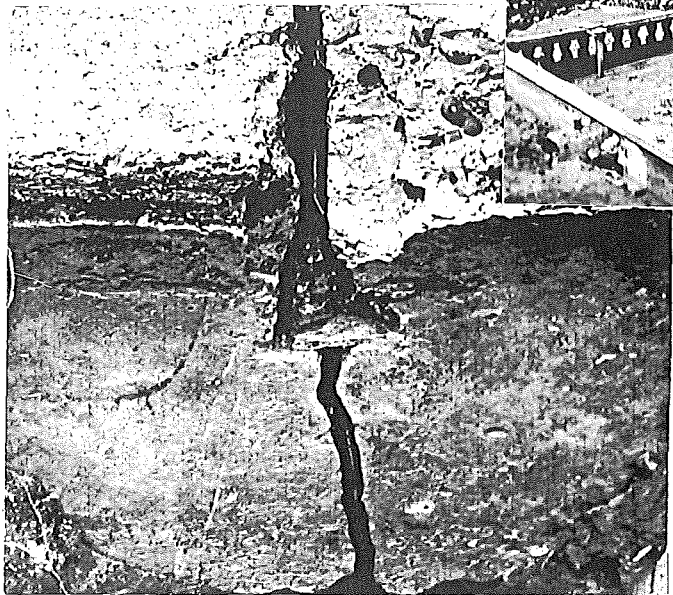
Typical Condition at Time of Construction, 1940, Station 181+60

General View of Joint Assembly

Typical Condition of All Similar Joints after 10 Years, Station 181+60

Figure 34. Type 5, Kijode Contraction Joint Assembly. In Series 9TS.

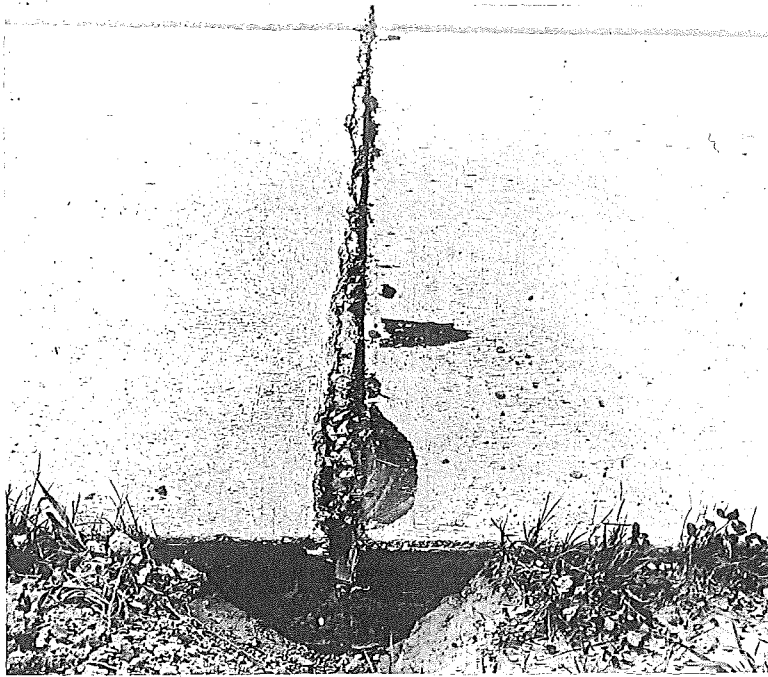
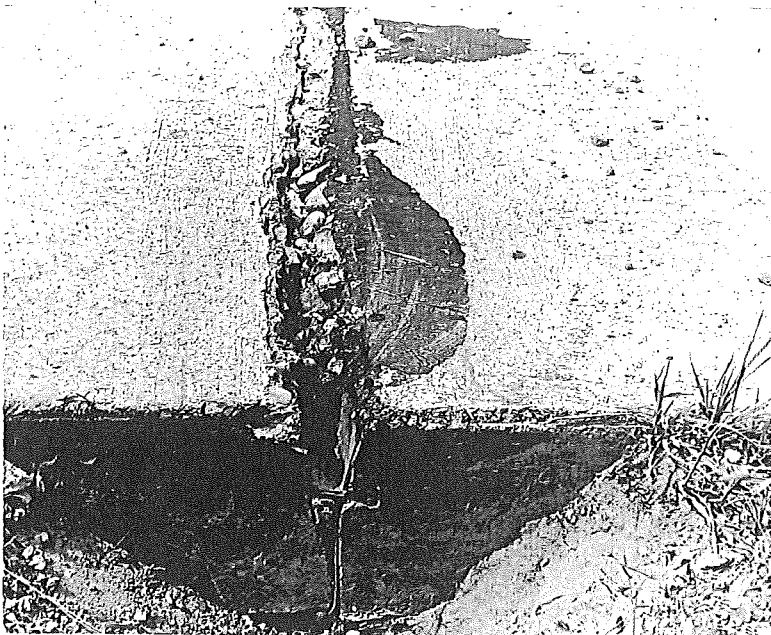
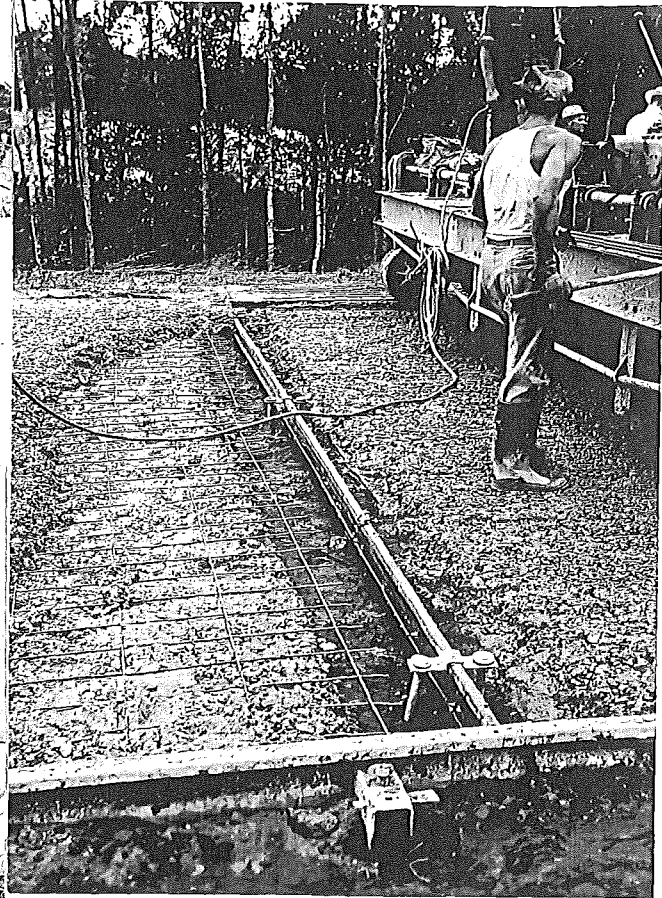
Typical Spalling at Joint Edge.  
(1946). Station 85+20.

General View of Joint Assembly

Condition of Joint at End, 1946.

Figure 35 - Type 4. Continuous Plate Dowel Contraction Joint Assembly in Series 5.

The continuous plate dowel, Type 4 located in Series 5, has an inherent design weakness which causes spalling along the joint edge. Examples of the type of spalling may be seen in Figure 35. An examination of the joint revealed that the plates invariably were frozen in place due to rust and consequently the joints were not functioning as designed.

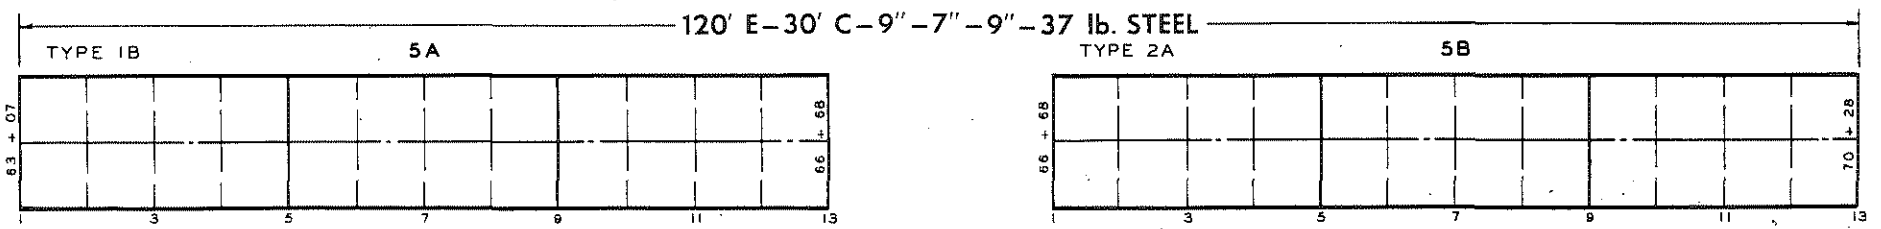
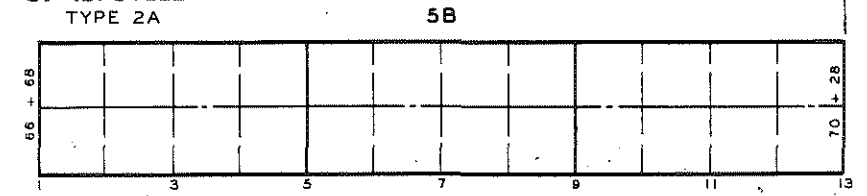
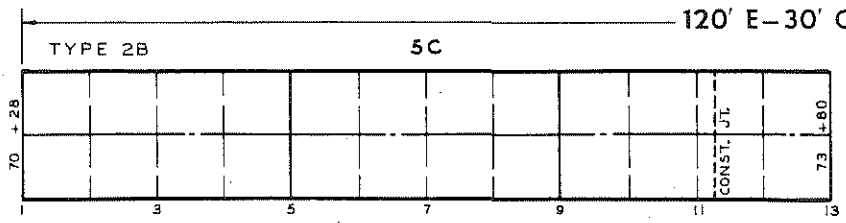
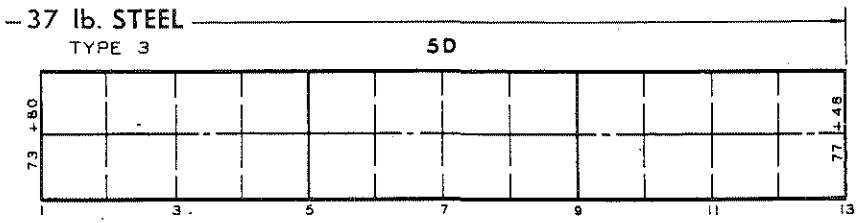
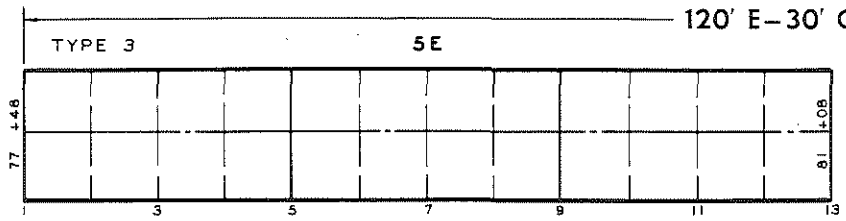
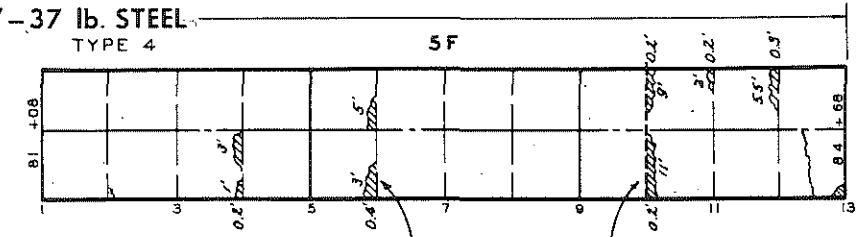
FOR CONTRACTION JOINT TYPES SEE TABLE I

CONDITION OF PAVEMENT  
IN SERIES 5

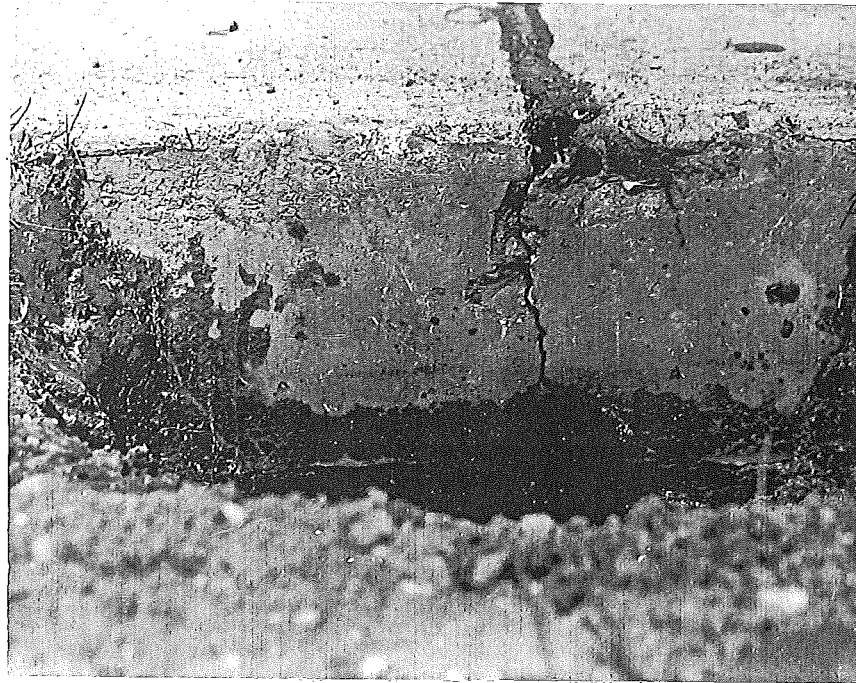
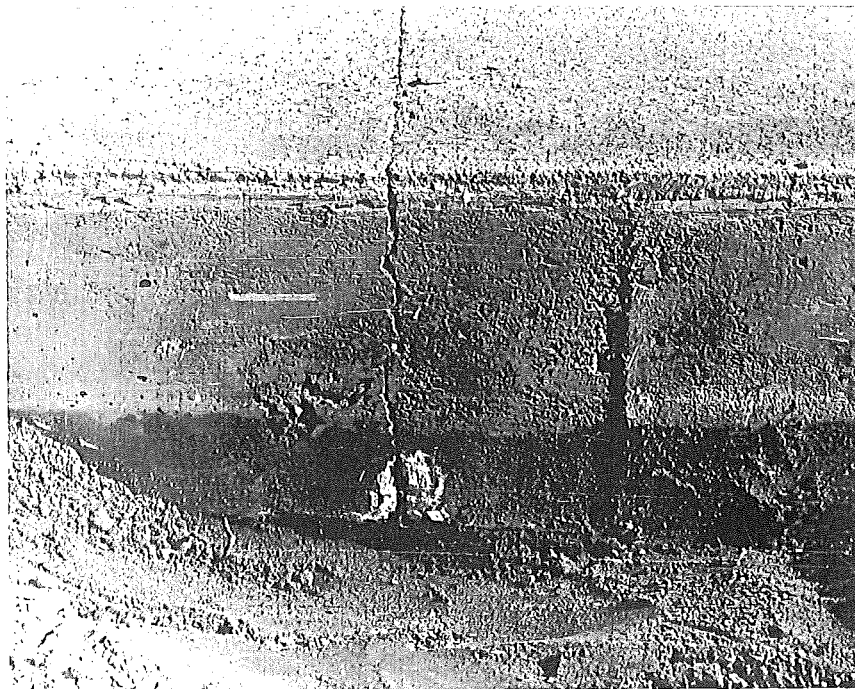
A. Typical Cracking at Plane of weakness Joint without Parting Strip at Bottom

B. Typical Cracking when Parting Strip is Properly Installed

Figure 37. Effect of Bottom Parting Strip on Joint Cracking.

In order to attain proper results with the metal parting strip placed at the bottom of the joint careful workmanship must be exercised. Methods must be employed that will insure the proper placing of the metal parting

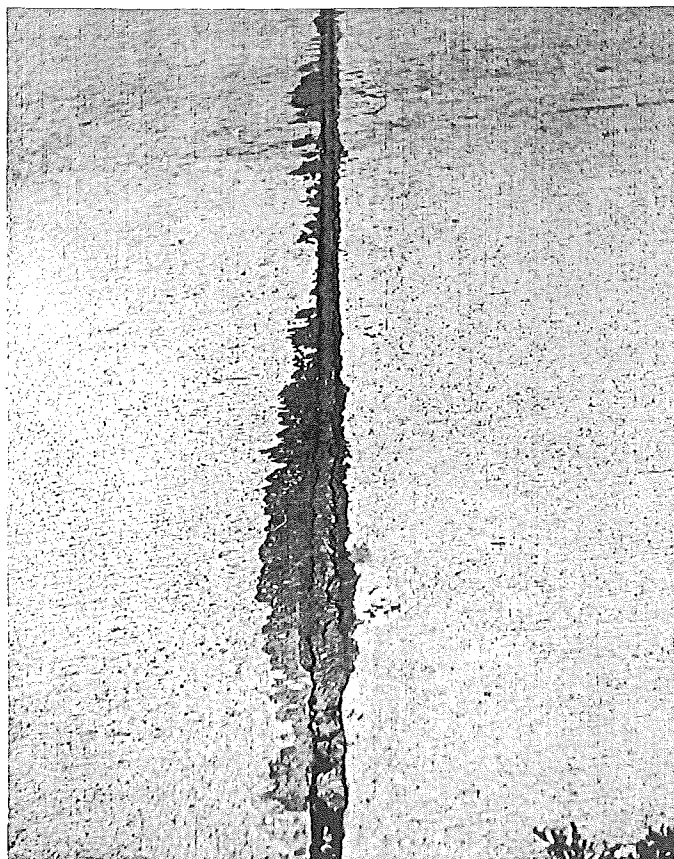
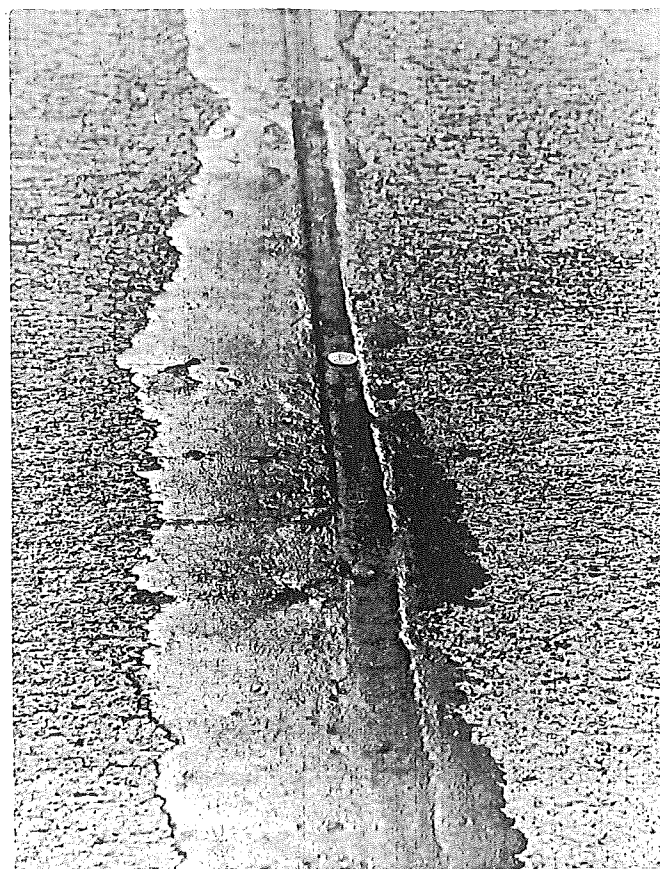
A. Asphalt-latex Sealing Compound.

B. Thermoplastic Sealing Compound.

Figure 33. Present Condition of Bituminous-rubber Material After 10 Years.

One type of asphalt-latex compound, designated Type 1, consisted of a mixture of 70 parts of asphaltic oil SC-6A, 30 parts of normal rubber latex and 2 parts of hydrated lime. The materials were mixed together under controlled conditions immediately prior to sealing the joint. The other type, designated Type 2, was identical with Type 1,

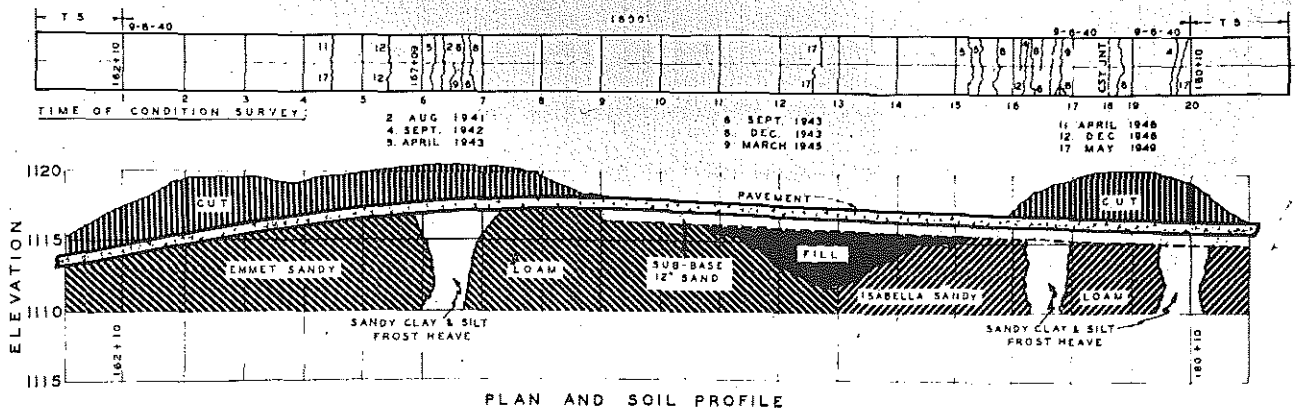
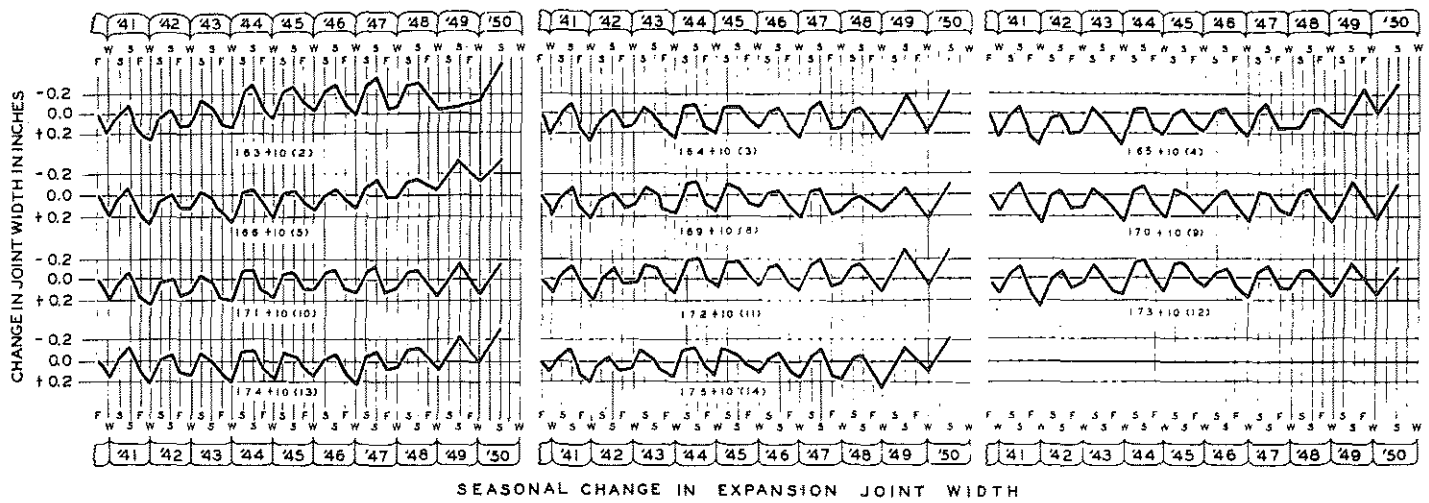
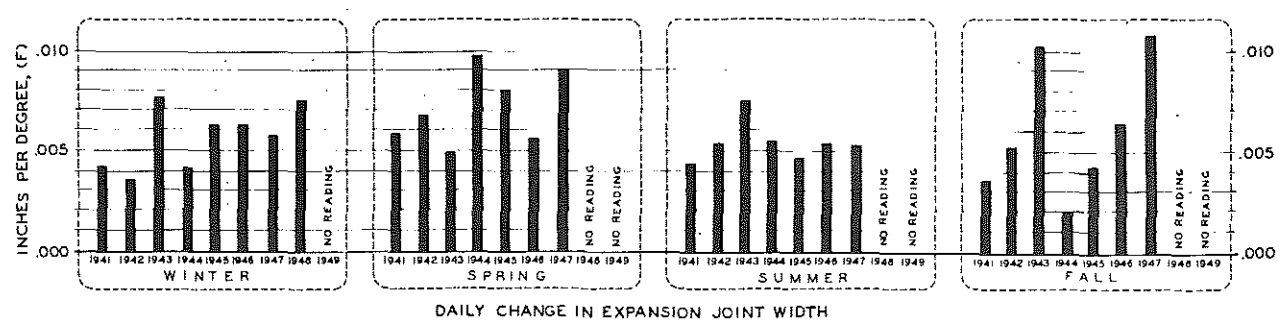
**STRESS CURED CONCRETE**

At the end of 10 years, 10 of the 18 slabs are in apparently perfect condition. The remaining 8 slabs have cracked as shown in Figure 40. The first crack in the entire test section occurred in the slab between Joints 6 and 7 prior to the survey conducted in August, 1941. The progressive development of cracks is also illustrated in Figure 40 by the numbers appearing at each crack.

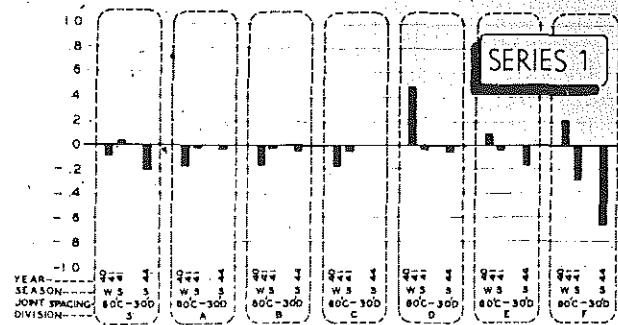
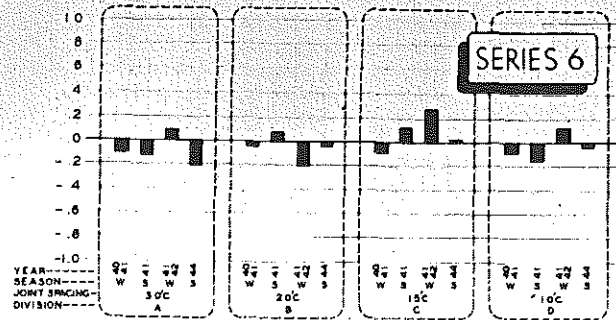
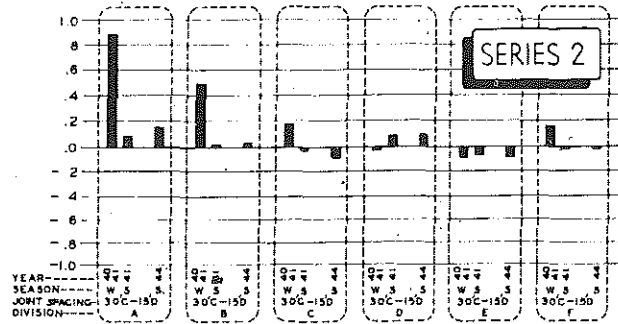
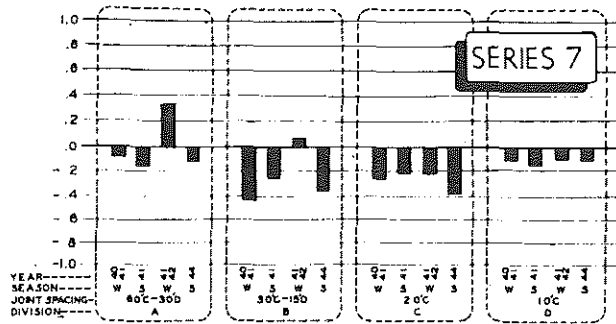
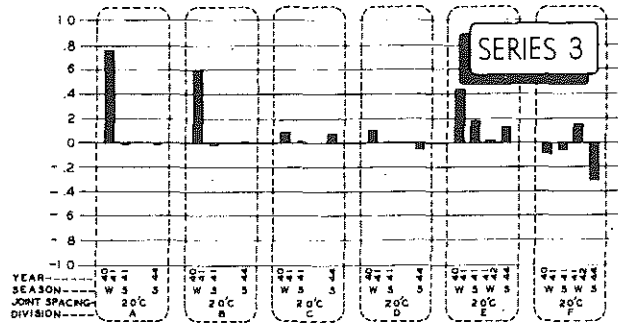
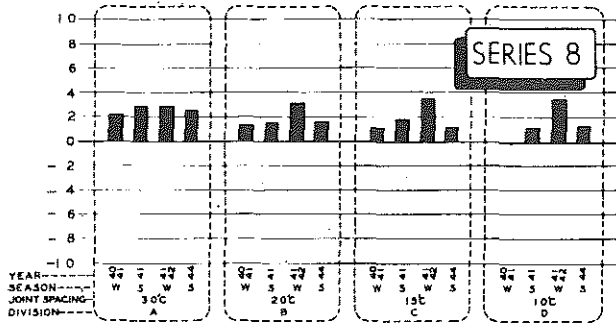
VERTICAL DISPLACEMENT IN INCHES

**AVERAGE VERTICAL DISPLACEMENT OF PAVEMENT BY SERIES**

In general, the data in Figure 41 show that the average vertical displacement of the pavement throughout the Test Road has not exceeded 1 in. and in most cases it is less than 1/2 in. However, in localized areas changes in elevation of as much as 1.95 in. occurred during the winter season, and were evidently caused by heaving. Extreme displacements are not shown in Figure 41. Some permanent settlement has occurred ranging on an average less than 1/2 in. In some cases the pavement has raised permanently between 0.2 and 0.4 in.

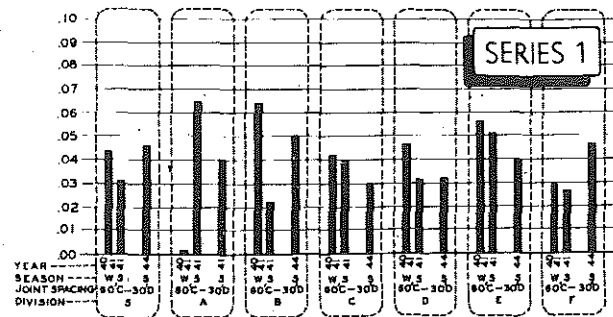
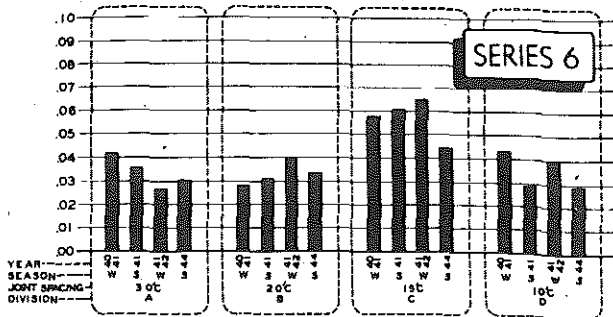
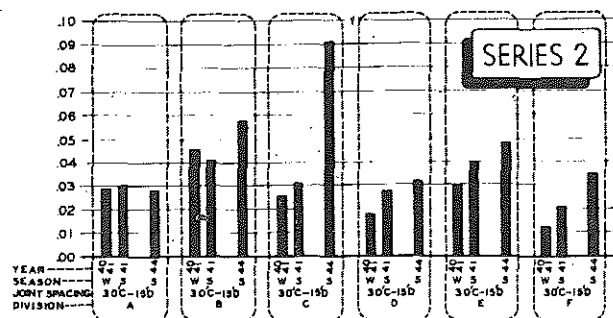
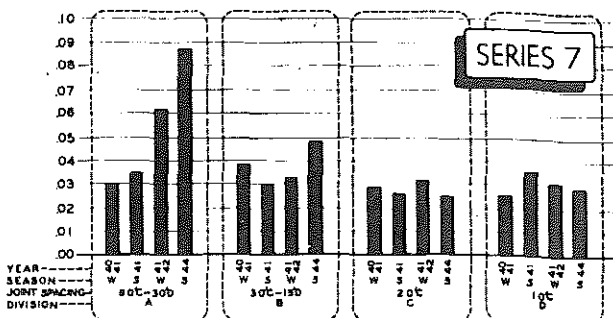
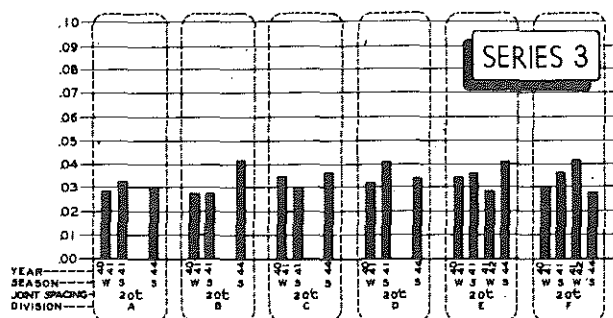
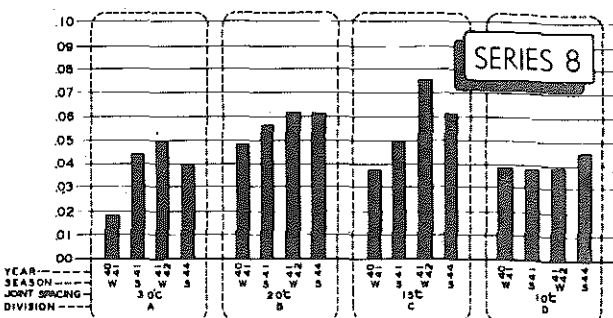
Figure 42

V E R T I C A L   D I S P L A C E M E N T   I N   I N C H E S

AVERAGE RELATIVE DISPLACEMENT OF SLAB ENDS

Data showing the average relative displacement of slab ends, or faulting at joints, are presented in Figure 42. The maximum average faulting for the entire Test Road is less than 1/8 in. A majority of the sections show faulting of less than 1/16 in. or, for all practical purposes, zero.

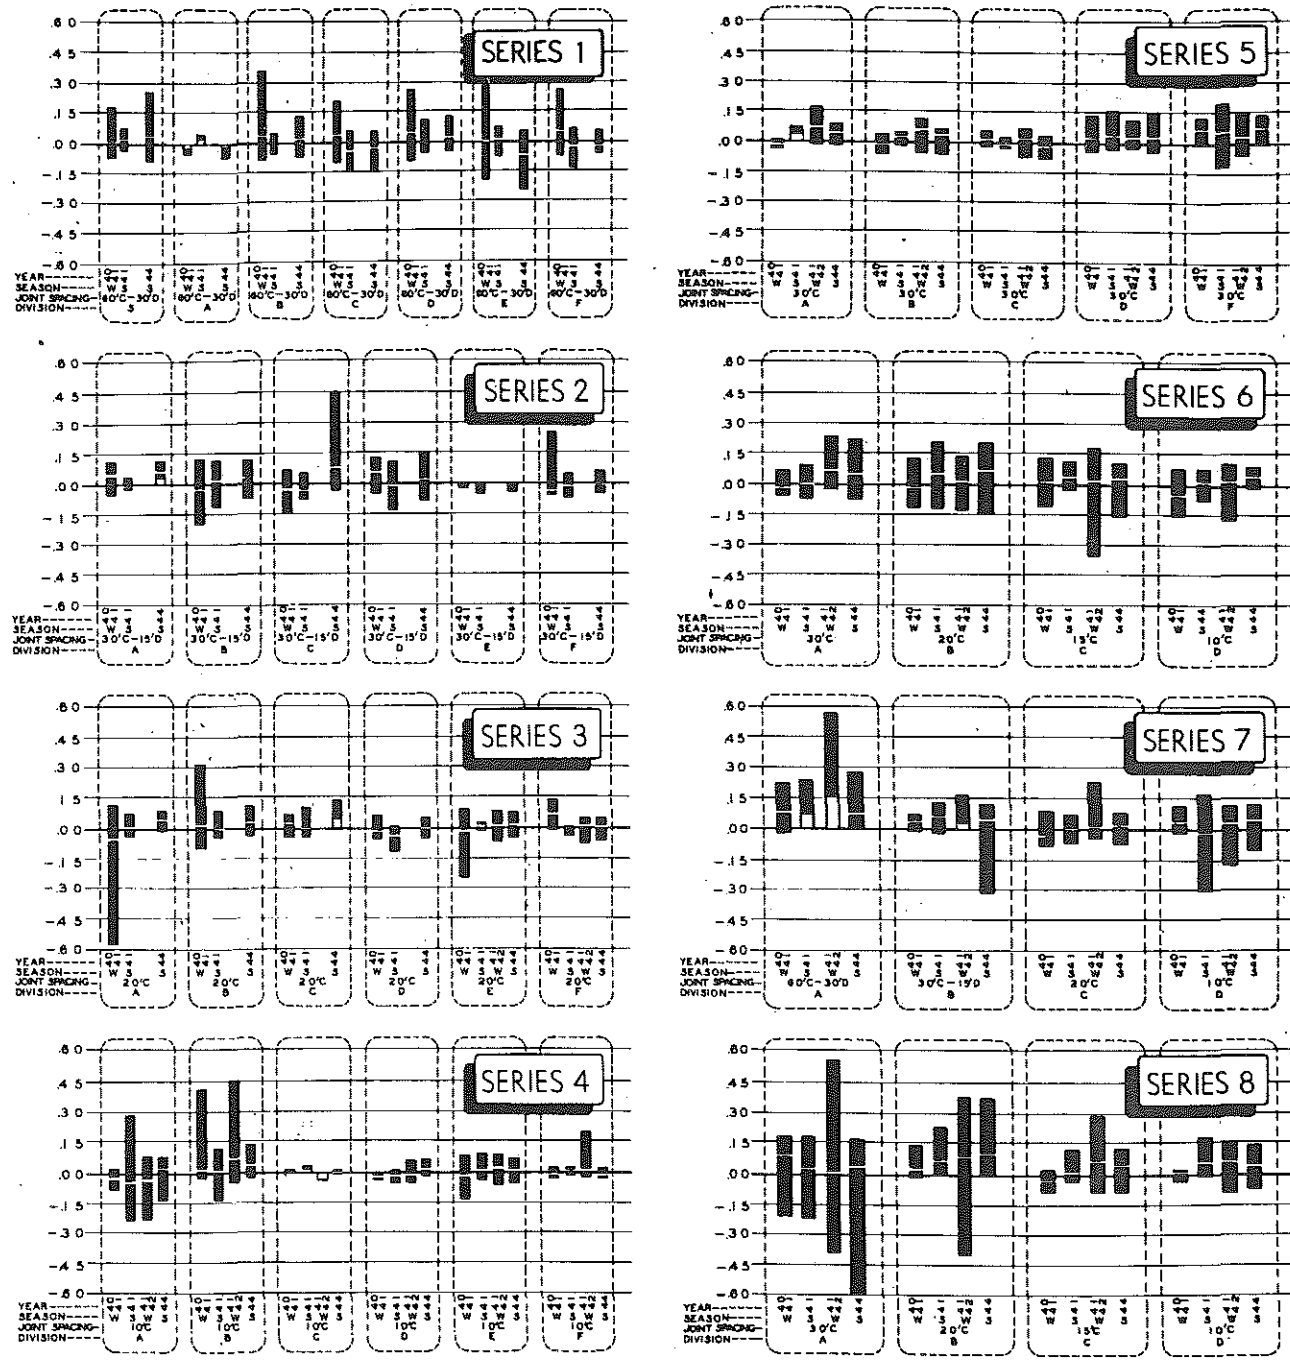
Figure 43

VERTICAL DISPLACEMENT IN INCHES
