1. Report No. R-1512	2. Government Accession No.	3. MDOT Project Manager	
4. Title and Subtitle Evaluation of Grout-Filled Mechanical Splices for Precast Concrete Construction		5. Report Date May 2008

**Evaluation of Grout-Filled Mechanical Splices for
Precast Concrete Construction**

**Structural Section
Construction and Technology Division
Report 07 TI-2094
Research Report R-1512**

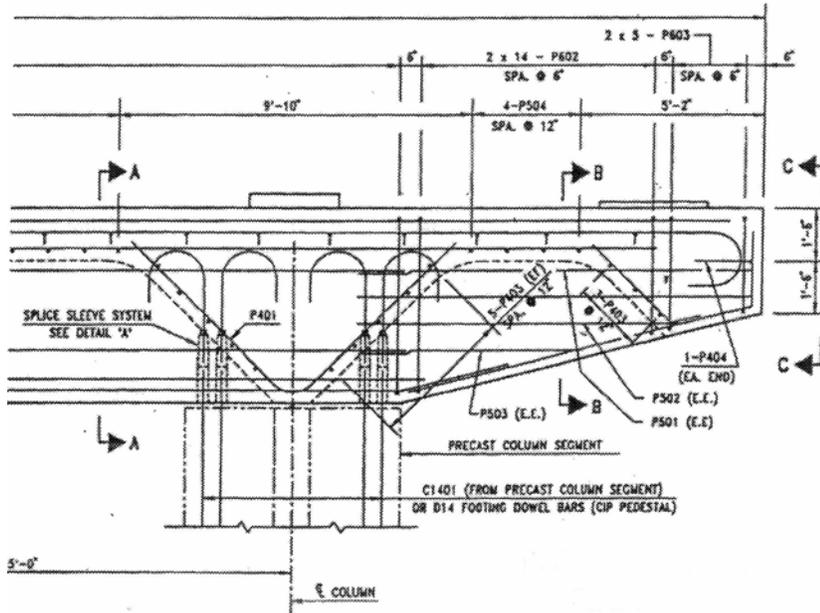
Figure 1.2 Edison Bridge pier cap

The types of connections shown in Figure 1.1 were utilized in the design and construction of the Edison Bridges over the Caloosahatchee River in Ft. Myers, Florida, beginning in 1990, for the Florida Department of Transportation. Similar structures approximately one mile in length, these structures were constructed with precast columns and precast pier caps with connections made using grout filled splices. The original column design was for segments no more than 15 feet in length, but the contractor proposed to make all columns one segment, which resulted in fewer joints and quicker erection. Short varying height pedestals were cast on site at the base of each column, with the pedestal to footing and pedestal to column connections both made using grout filled splices. The columns were I-shaped and the pier caps were inverted U-shaped to reduce dead load and facilitate easier inspection. Details can be seen in Figures 1.2 through 1.4. With a total of 136 columns and 68 pier caps, the use of precast elements with grout filled splice connections saved an estimated two months for each structure.

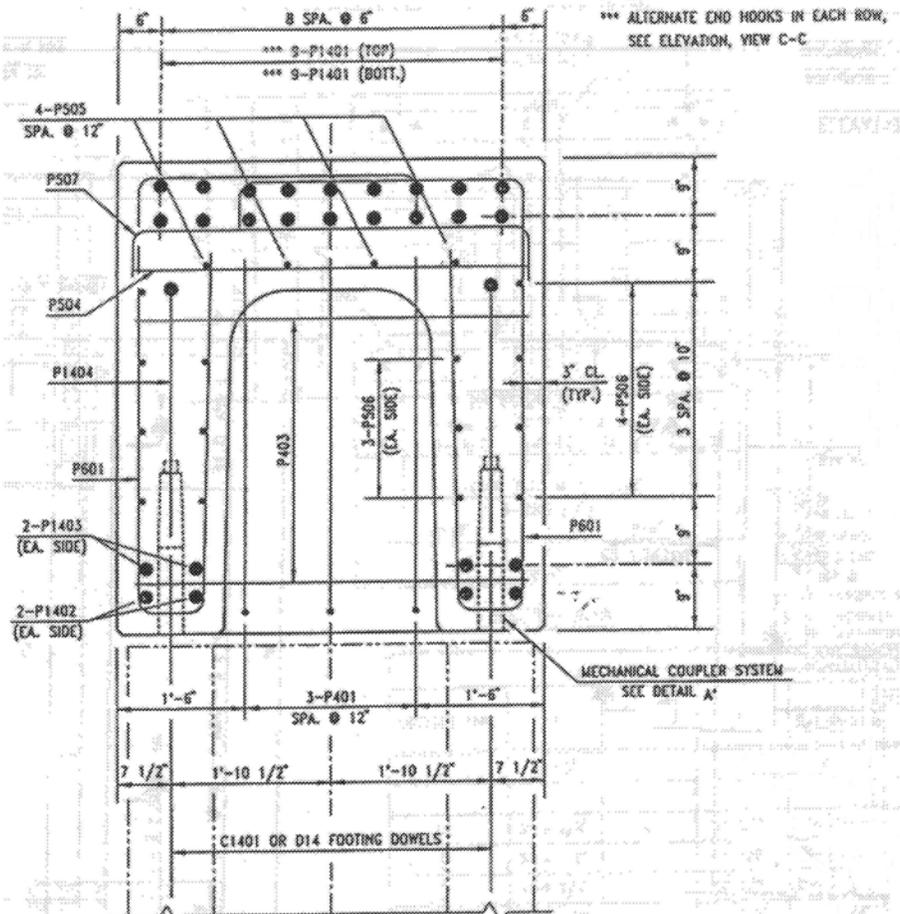
Figure 1.3 Section A-A from pier cap in Figure 1.2

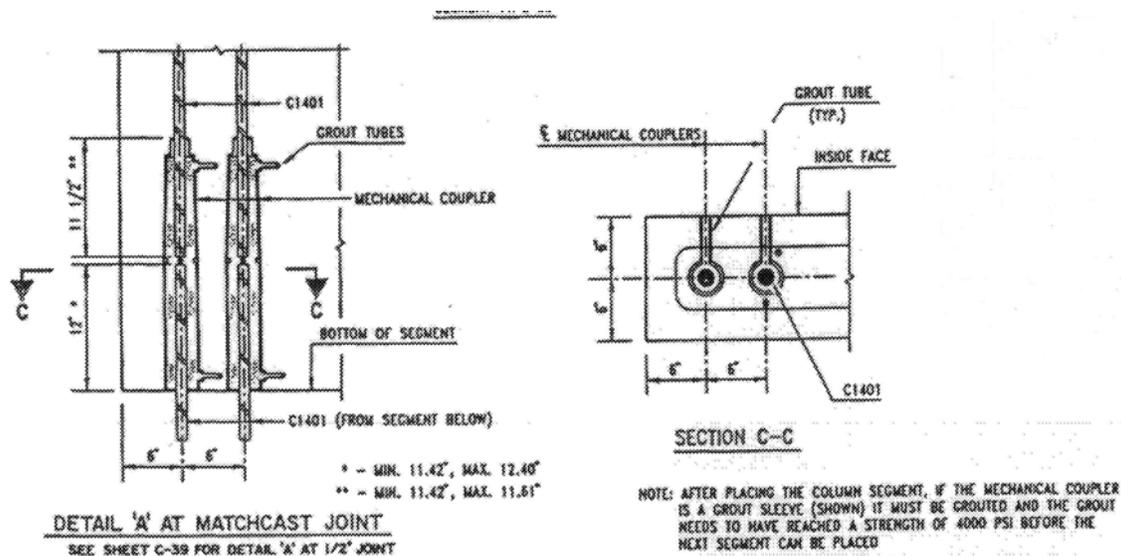
Figure 1.4 Splice detail in pier cap from Figure 1.2

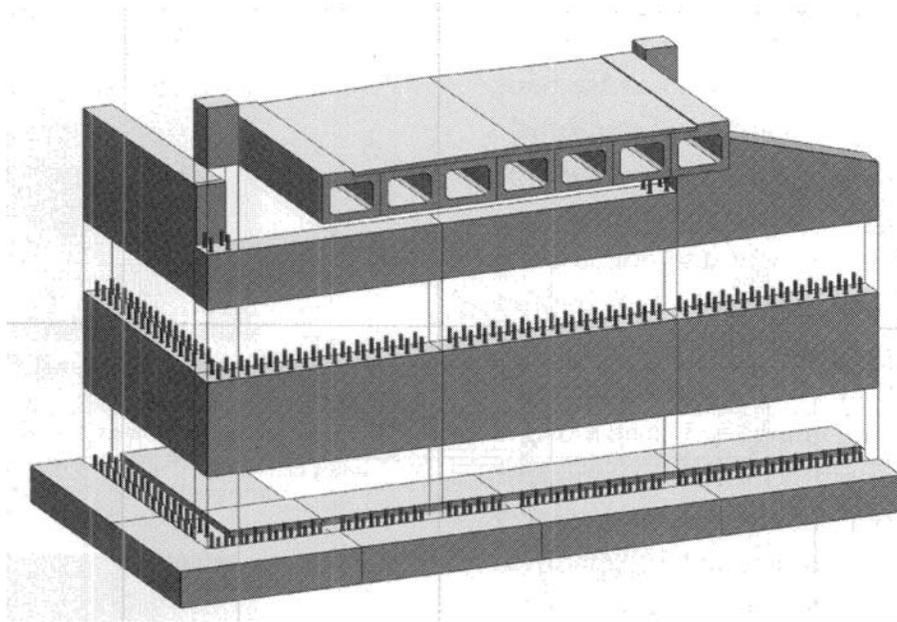
Figure 1.6 Precast bridge schematic

Figure 1.6 illustrates the precast schematic for the Mill Street Bridge in Epping, New Hampshire, constructed in 2004 for the New Hampshire Department of Transportation. Utilizing a fast track approach that allowed for only two weeks assembling the new bridge and opening it to traffic, the new bridge comprised of prestressed box beams and a precast substructure, was completed in eight days.

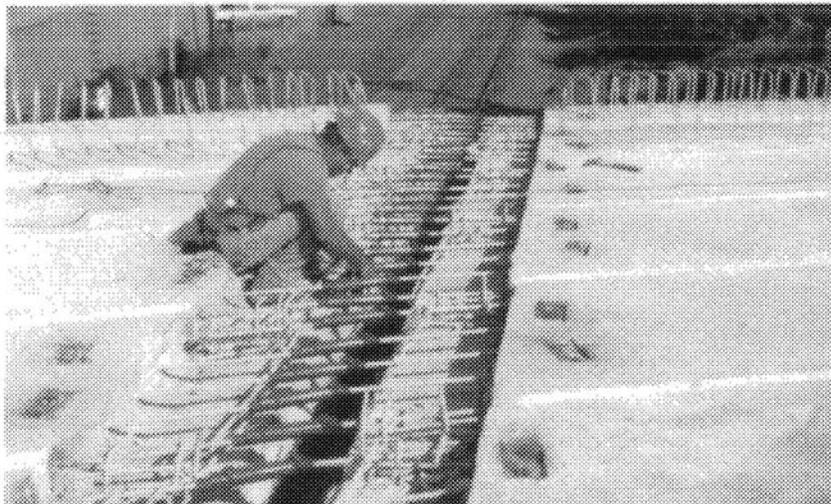
Figure 1.7 NMB Splice Sleeves providing live load continuity over piers

Figure 1.7 illustrates grout filled splices used to create live load continuity as negative moment reinforcement over a pier. This detail was used for the North Street Bridge in Medford, Massachusetts, for the Massachusetts Highway Department. The negative moment reinforcement was cast into the top of the precast prestressed deck-beams and connected with splices over each pier joint eliminating the need for the usual six inch composite topping resulting in extra clearance.

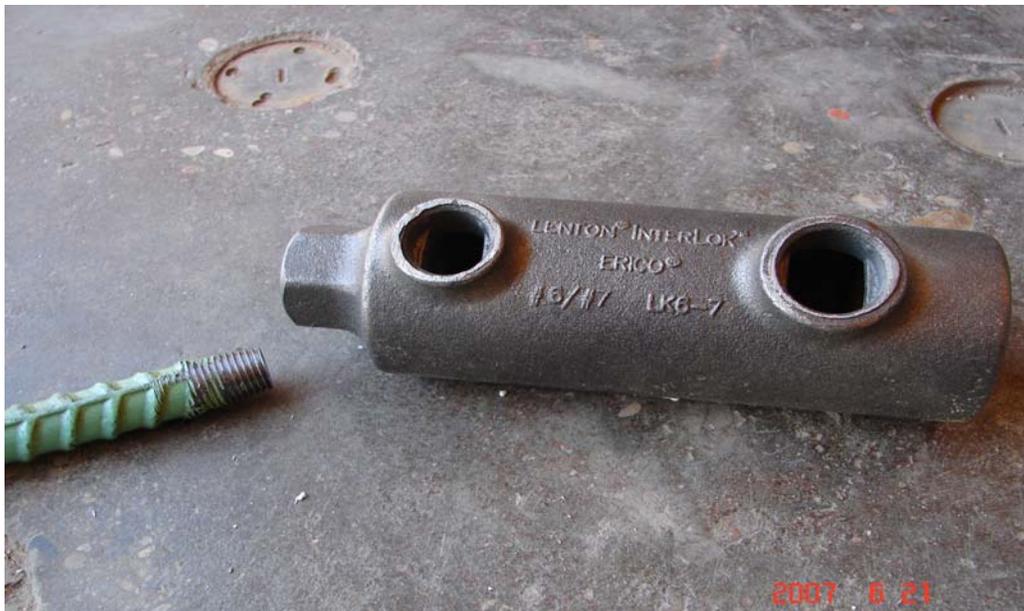
Figure 1.8 Lenton Interlok for #6 steel reinforcing bar

The Lenton Interlok is a ductile iron casting which connects two reinforcing bars by using a tapered thread on one bar with the second bar being grouted inside the sleeve. Similar to deformations on reinforcing bars which increase pull-out resistance when embedded in concrete, the sleeves contain equally spaced concentric ribs on the interior surface to increase resistance to bond failure between the sleeve and the grout. The tapered bar is to be tightened to a specified torque dependent on the bar size. The Lenton Interlok is shown in Figure 1.8. It is available for connecting U.S. customary rebar sizes #6 through #18 and can connect two different sizes. The Lenton Interlok is available uncoated or epoxy coated. The grouted rebar is meant to be fully embedded although the manufacturer lists allowable tolerances for minimum embedment which can be one to two inches less than full embedment depending on bar size. Once cast into concrete the Lenton Interlok can be grouted either by gravity filling prior to connecting the precast element, or by using a grout pump with inlet and outlet hoses cast into the concrete after the precast element has been set in place.

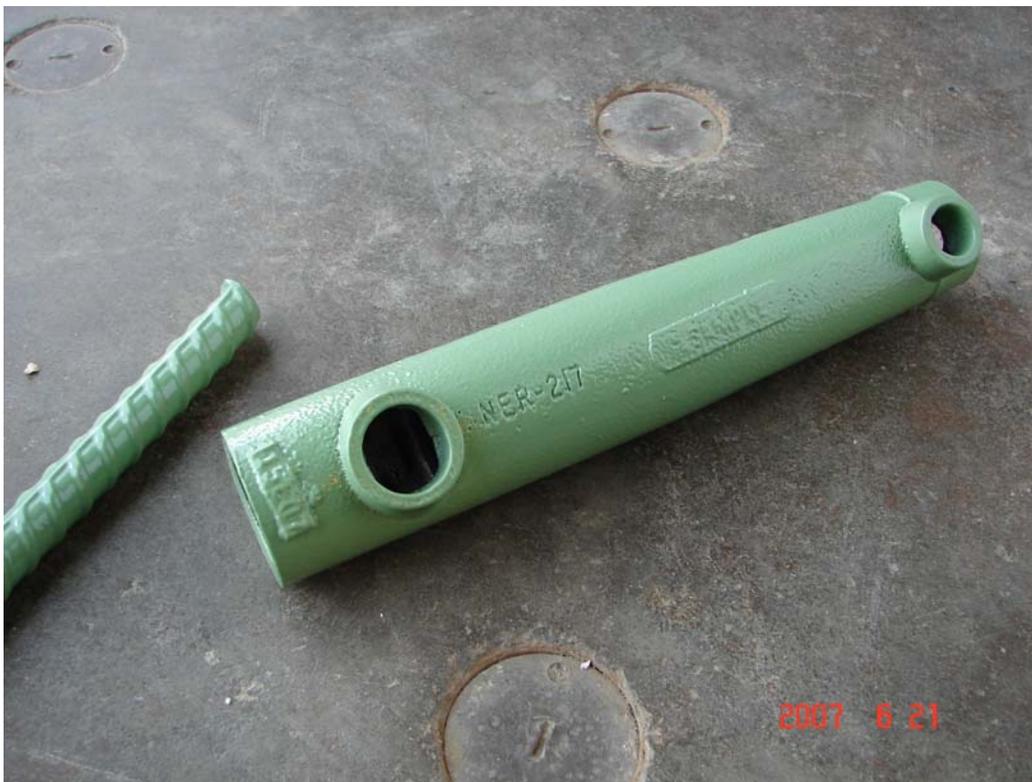
Figure 1.9 NMB Splice Sleeve for # 6 steel reinforcing bar

The NMB Splice Sleeve is also a ductile iron casting but differs from the Lenton Interlok in several ways, the most obvious being that there is no threaded connection. Both reinforcement bars spliced by the NMB Splice Sleeve are grouted into the sleeve, with a stop in the middle of the sleeve providing assurance that each bar is satisfactorily embedded. The tapered end also contains guides on the interior surface to help center one bar in the splice; the other end does not have guides in order to allow some flexibility of steel reinforcement placement when connecting a precast element with protruding steel reinforcement. The manufacturer lists minimum required embedment depths which range from 0.2 inch to 1.1 inches less than full embedment depending on bar size. With both bars requiring a grouted connection, the overall sleeve length is approximately 50 percent longer than the Lenton Interlok; the sleeve diameter is slightly smaller varying with sleeve size. The NMB splice is shown in Figure 1.9. Longitudinal ribs (see Figure 1.10) are cast on the outside tapered end of splices for bars #7 through #14 in order to provide a constant outer dimension to permit uniform sizes of stirrups or column ties. For reference in the photographs, the circular tie-down covers in the floor are 2 3/8-inch diameter and spaced one foot on center. The NMB Splice Sleeve is available for steel reinforcement sizes #5 through #18, and can connect steel reinforcement of two different sizes. The NMB splice also has concentric ribs on the interior surface to increase pull-out resistance, and with the deformations on the steel reinforcement, this assures that grout can flow between the steel reinforcement and the splice in case the steel reinforcement is offset from center. The splices can also be supplied uncoated or epoxy coated, and can be grouted either by gravity filling or use of a grout pump.

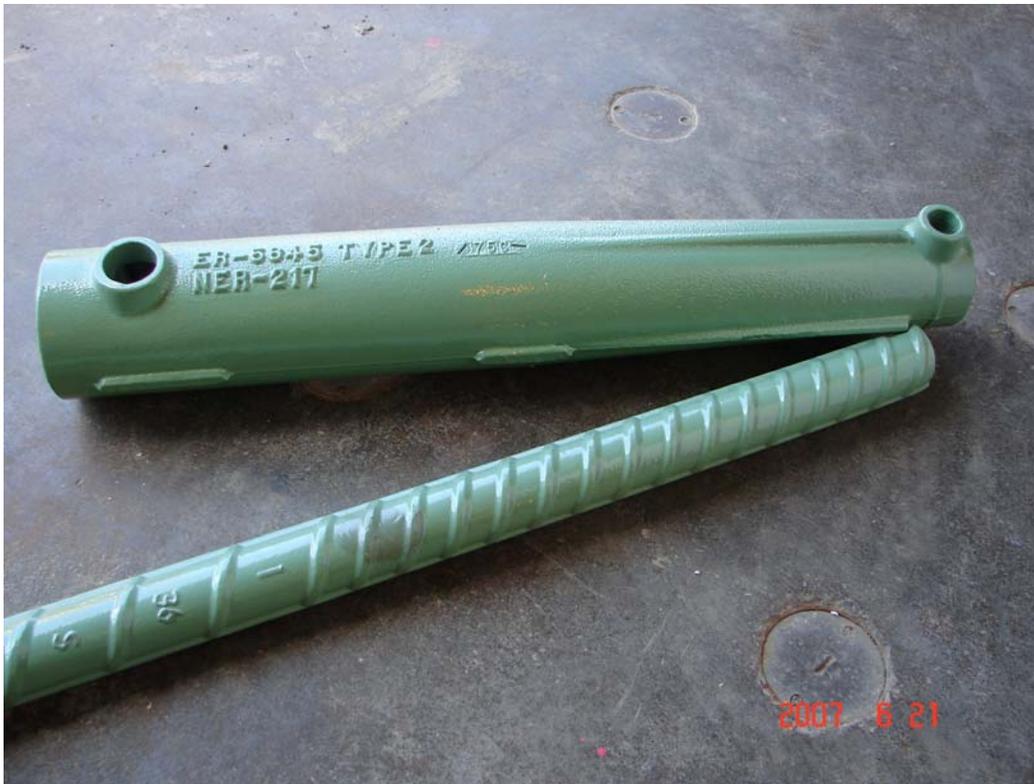
Figure 1.10 NMB Splice Sleeve for #11 steel reinforcing bar with longitudinal ribs

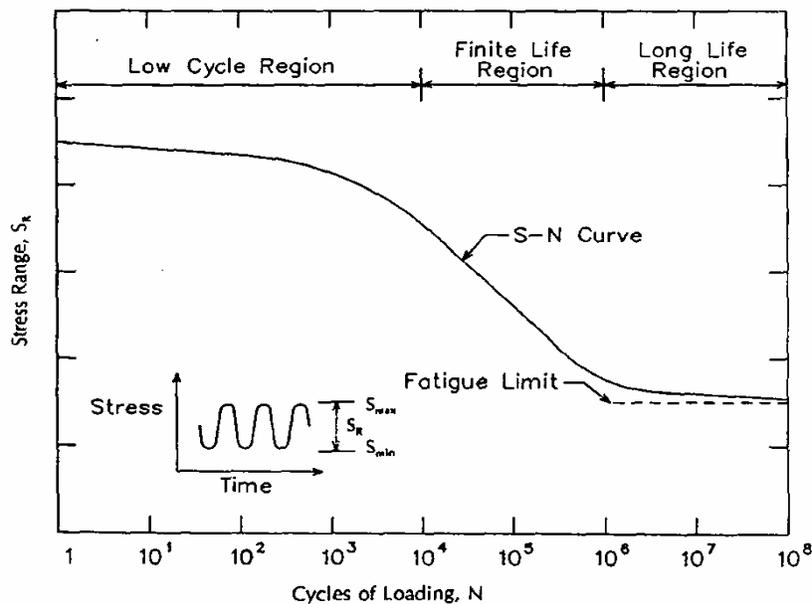
Figure 2.1 Representative S-N curve for steel reinforcing bars, NCHRP Research Results Digest No. 197

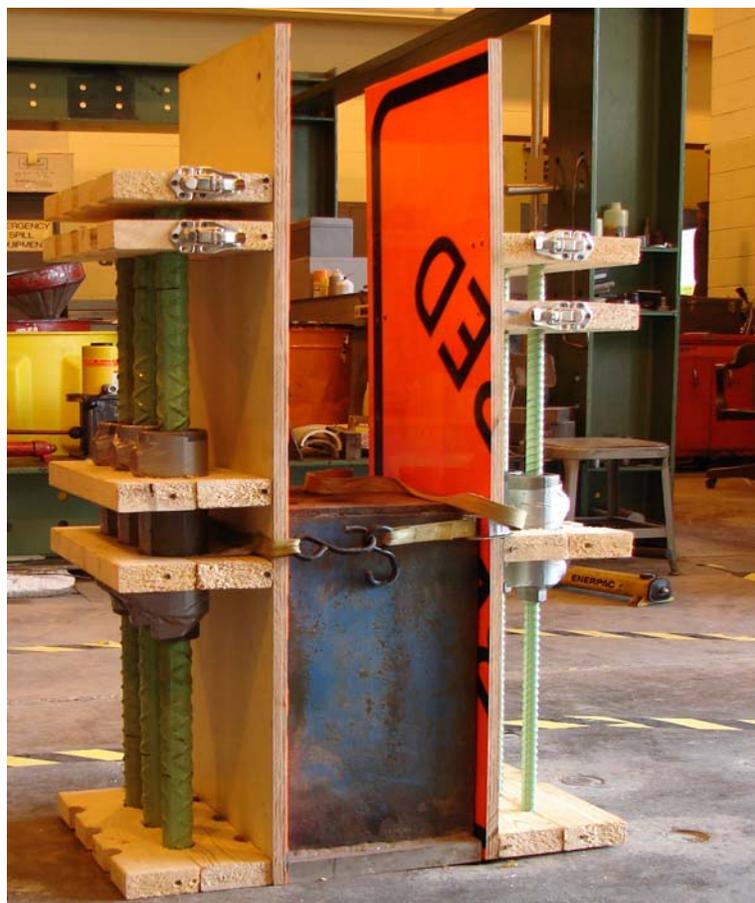
Figure 3.1 Lenton Interlok specimens

To assure that the specimens would be secure and stable during the initial curing process, fixtures were constructed, which also permitted the reinforcing bars to be positioned in the center of the grout sleeves as seen in Figure 3.1.

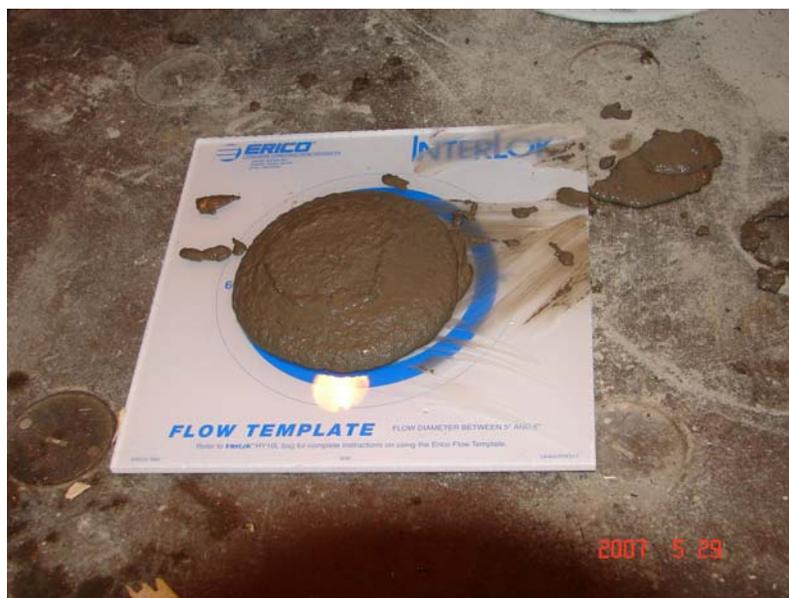
Figure 3.2 Flow template for Erico HY10L Grout

A representative from Erico, Inc. was present to assist with mixing and placing the grout. The prepackaged grout was mixed per the manufacturers instructions, with the initial addition of 0.63 gallon of water to the 50-pound bag of prepackaged grout producing a flow measurement of less than 3 inches. The flow was measured using a piece of 2-inch diameter plastic pipe, 4 inches in length, placed on the flow template and filled with grout and slowly lifted. This procedure is described in the manufacturer's product literature and the desired consistency is a flow measurement of 5 to 6 inches, when the averages of two readings are taken at 90 degree angles to each other. With the addition of 0.04 gallon water the consistency was measured again and an average reading of 5.3 inches was obtained, as seen in Figure 3.2. After each addition of water the grout was mixed thoroughly for at least 5 minutes with a paddle mixer attached to a hand held drill. At this point the grout was poured into the sleeves while the sides were tapped to eliminate any air voids. Although the manufacturer's user manual indicates that the working time for the grout is approximately 50 minutes at 75 degrees Fahrenheit (the ambient temperature at the time of grouting), the actual working time was estimated at 25 to 30 minutes. Once the sleeves were grouted the top bars were fully embedded in the grouted sleeves, secured to the fixture and left undisturbed to cure. Grout specimens were also cast to determine compressive strength at 24 hours, 3 days, 7 days, and 28 days. The splice specimens were removed from the fixtures at 24 hours and stored until testing at 28 days.

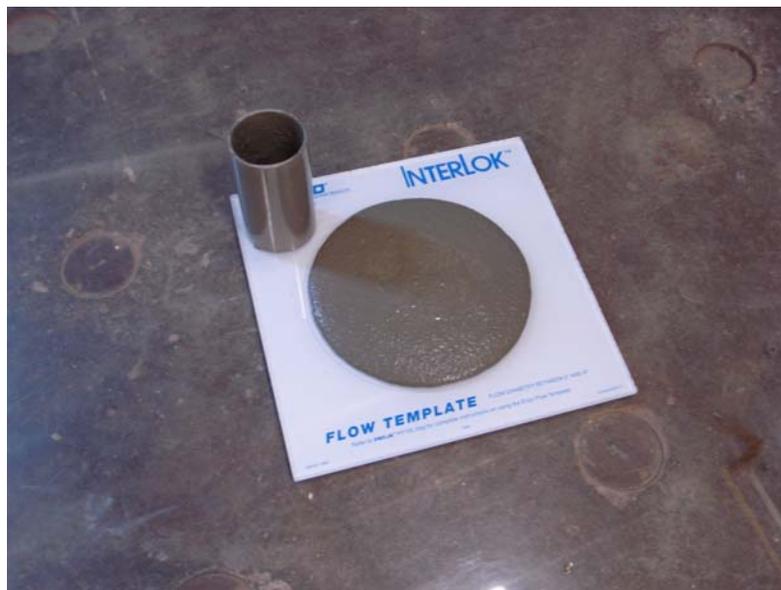
Figure 3.3 Flow template for Nisso SS Mortar

A representative from Splice Sleeve North America was present to assist with mixing and placing the grout. The prepackaged grout was mixed per the manufacturers instructions, with the entire contents of the 55 pound bag of prepackaged grout poured into a metal bucket containing water over a time period of 20 to 30 seconds, while continuously mixing the grout with a hand held drill mounted paddle mixer. The bucket contained 0.99 gallon of water; the manufacturer's instructions suggested 0.98 gallon of water per bag of grout, with a maximum 1.03 gallons of water. The grout was mixed for 3 minutes, at which time the consistency was checked and measured at 6.875 inches, within the manufacturer's specified range of 5 to 8 inches. The consistency as tested can be seen in Figure 3.3. The working time is listed as 40 minutes at 70 degrees Fahrenheit.

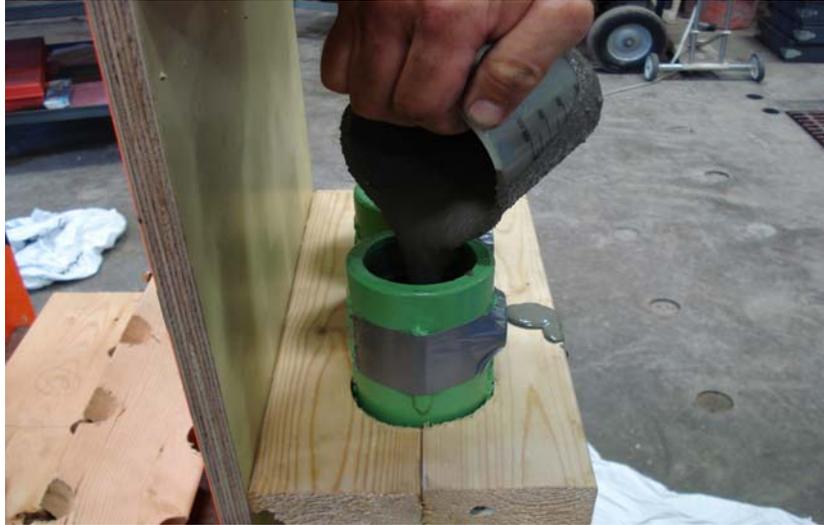
Figure 3.4 Pouring grout in #11 NMB splices

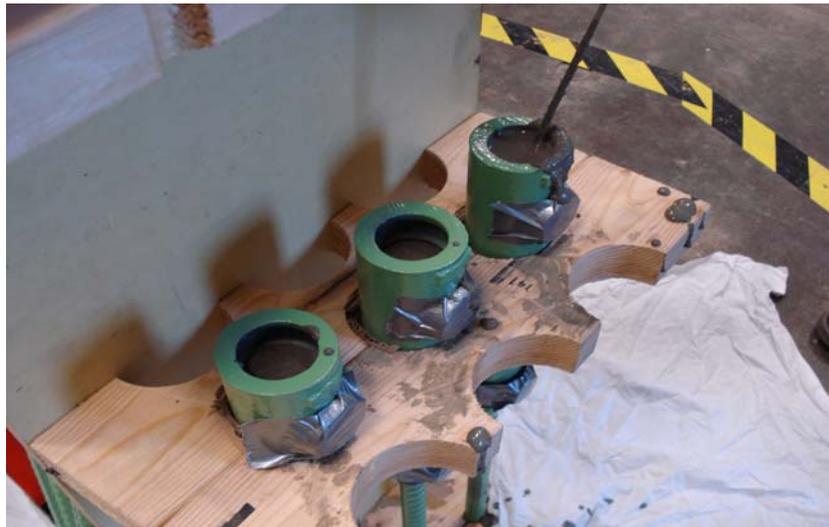
Figure 3.5 Rodding grout in #6 NMB splices

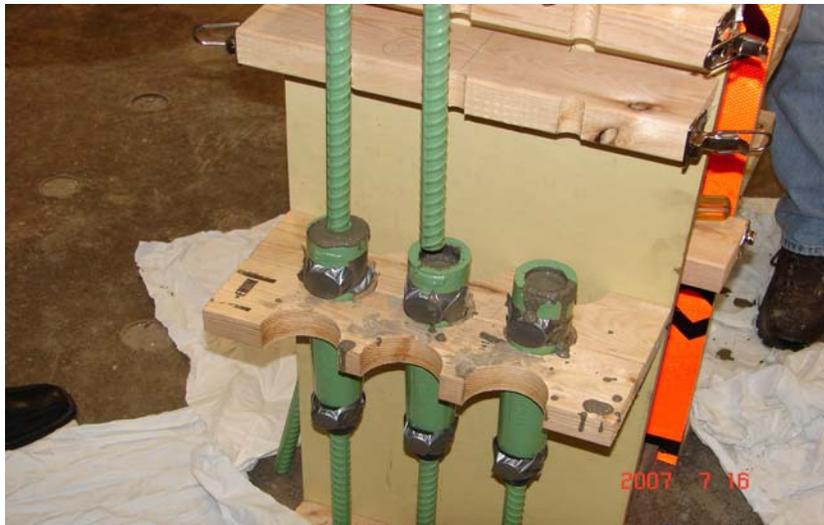
Figure 3.6 Inserting #6 bars in NMB splices

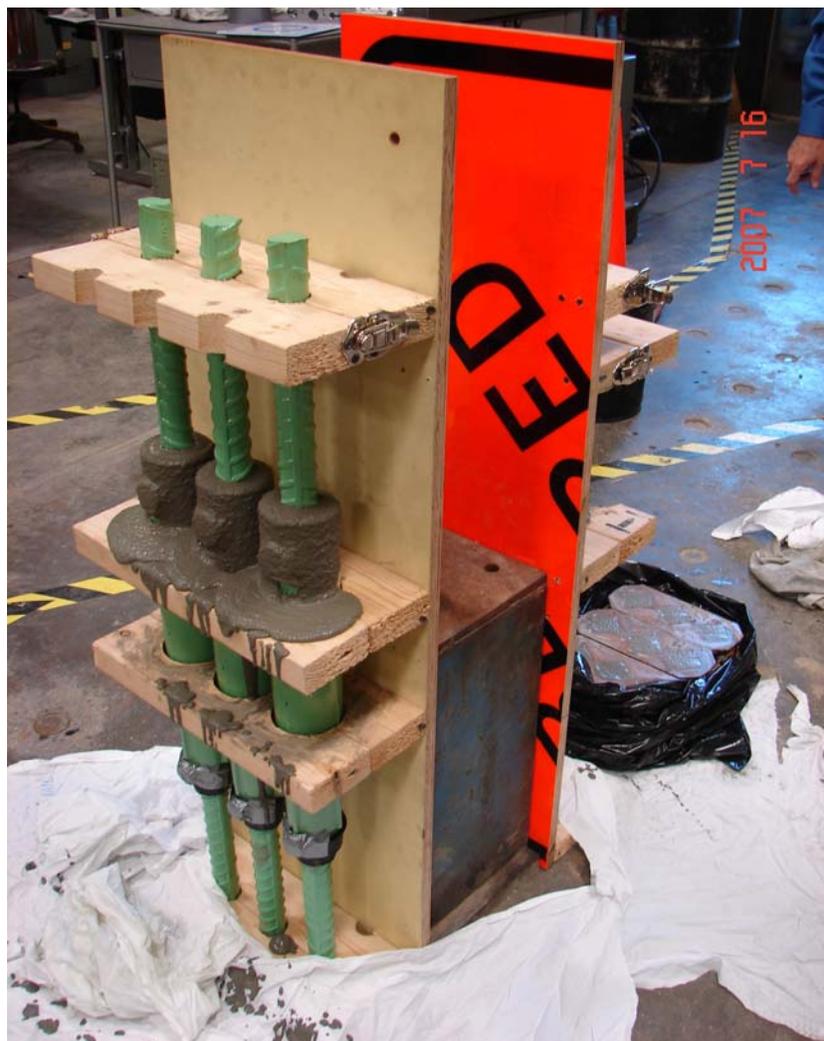
Figure 3.7 Cast #11 NMB splices

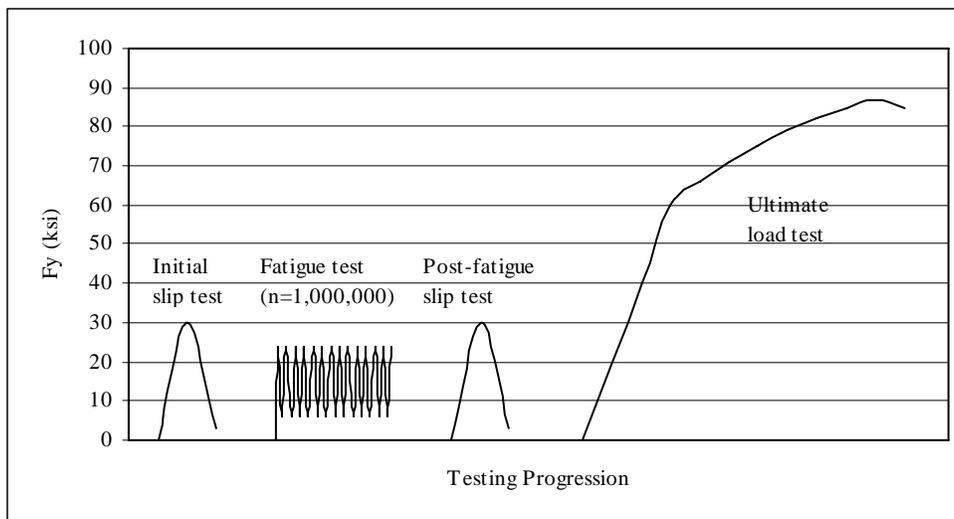
Figure 3.8 Tension testing progression

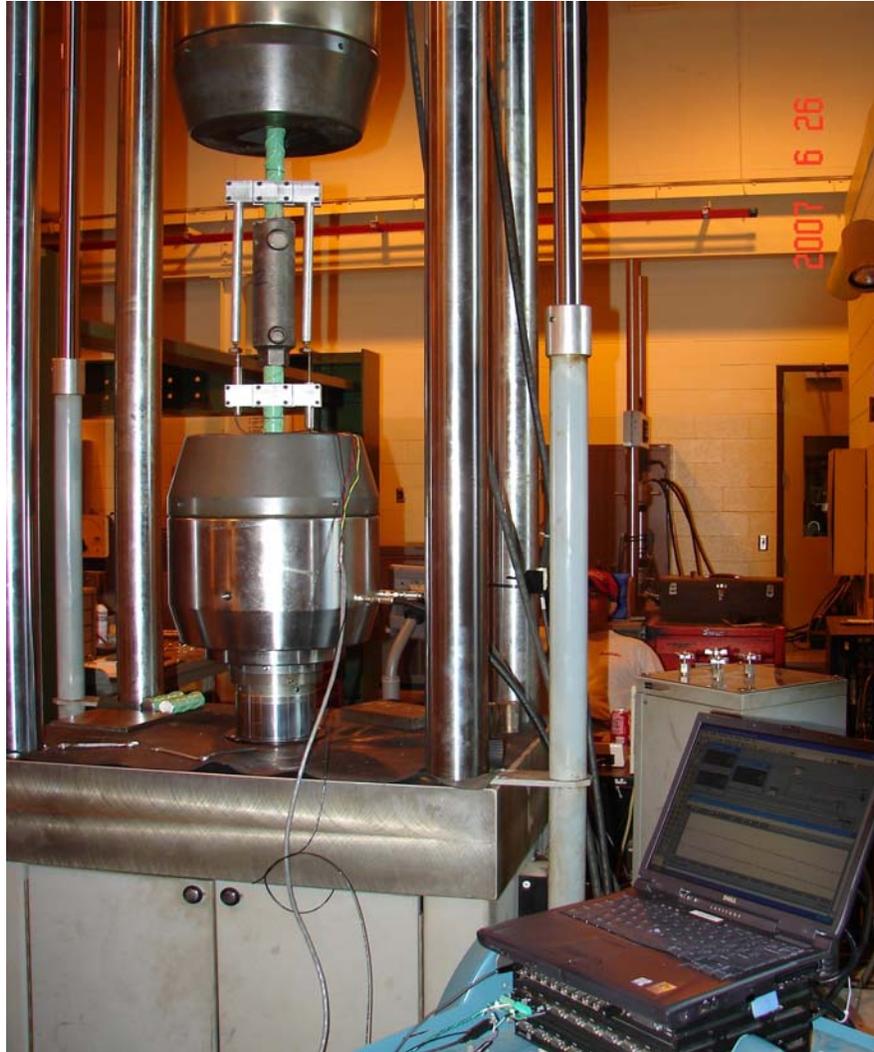
Figure 3.9 Slip test with data acquisition set up for #11 Lenton Interlok

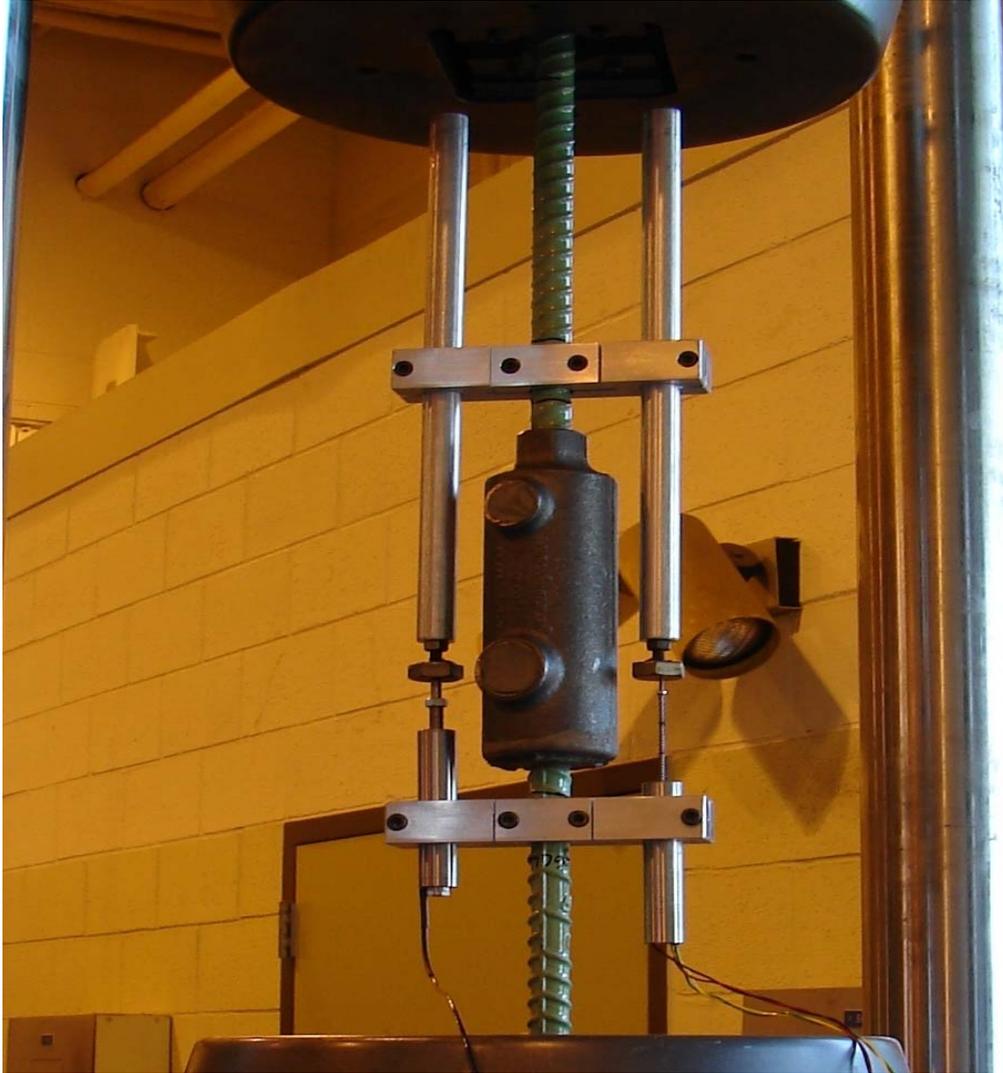
Figure 4.1 Slip test set up with DCDTs

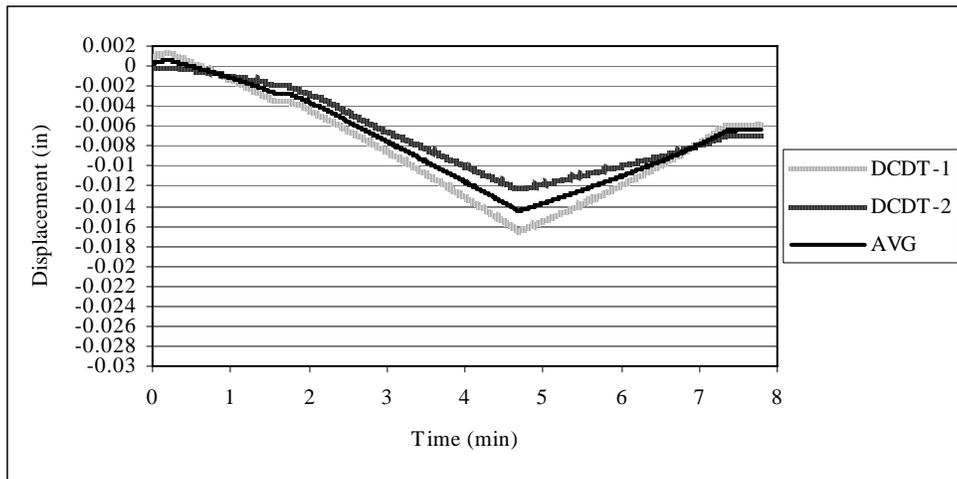
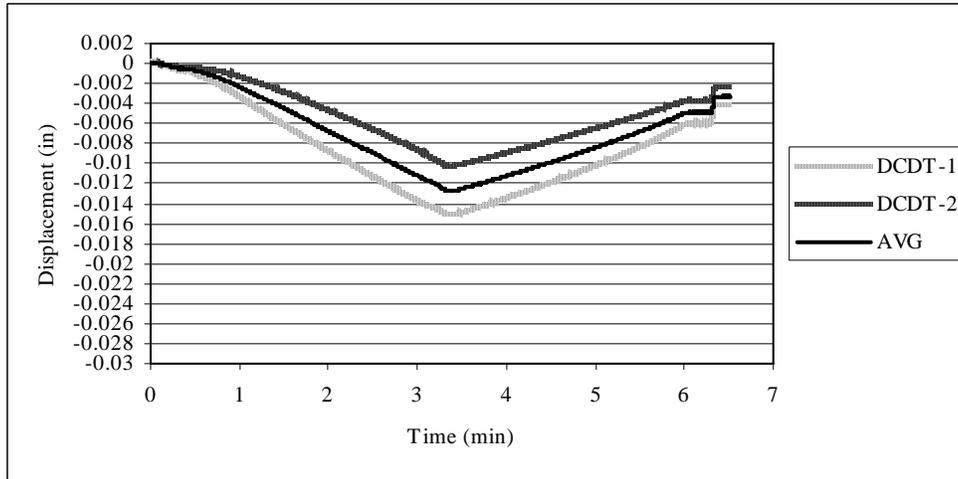
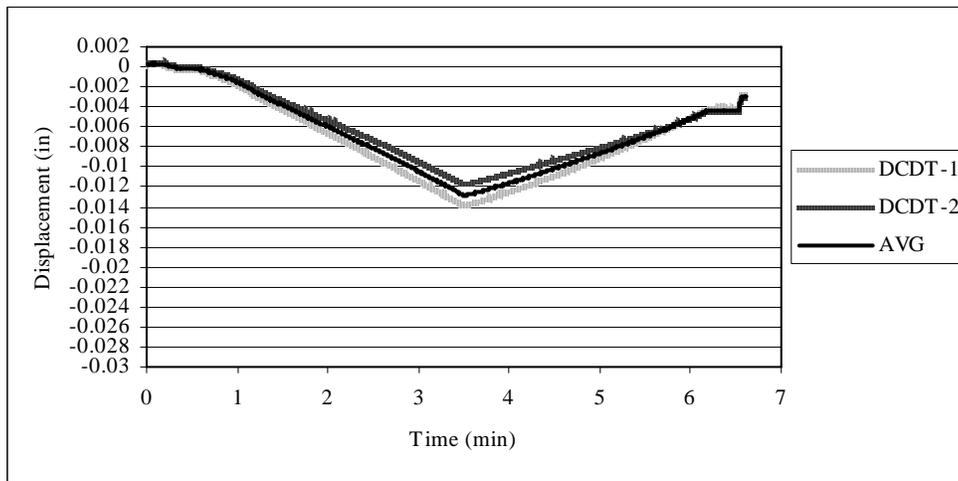
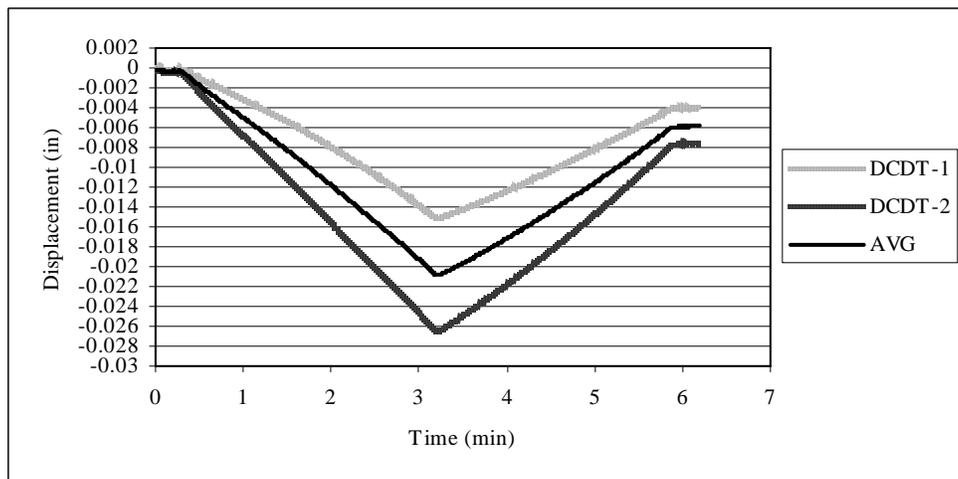
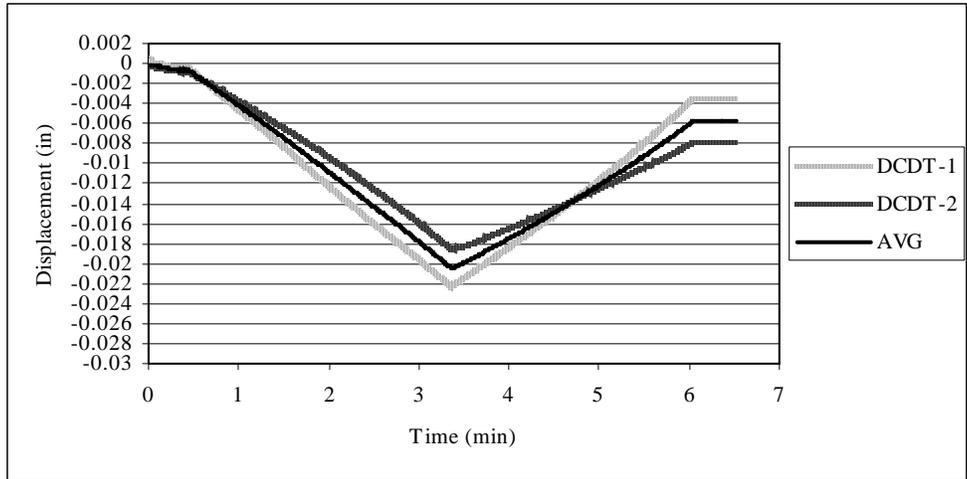
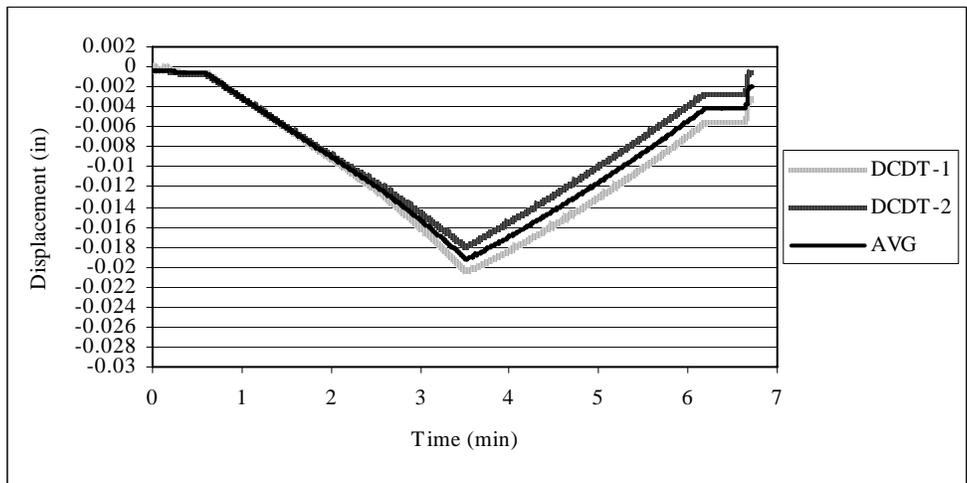
All six specimens conformed to the slip criteria specified in AASHTO LRFD, less than or equal to 0.010 inch of displacement measured after being loaded to 30 ksi and then relaxed to 3 ksi. The slip measured for the #6 bars ranged from 0.003 inch to 0.005 inch and averaged 0.004 inch. The slip measured for the #11 bars ranged from 0.003 inch to 0.006 inch and averaged 0.005 inch. A close-up of the test set up can be seen in Figure 4.1. Figures 4.2-4.7 show graphs of the displacement as a function of time during the slip tests. The measurements of interest, or the reported values of the slip tests, can be seen in the graphs as the horizontal portions of the average readings in the six to eight minute range, when the specimens were unloaded to 3 ksi. Regarding sign convention in Figures 4.2-4.7, negative values indicate tension.

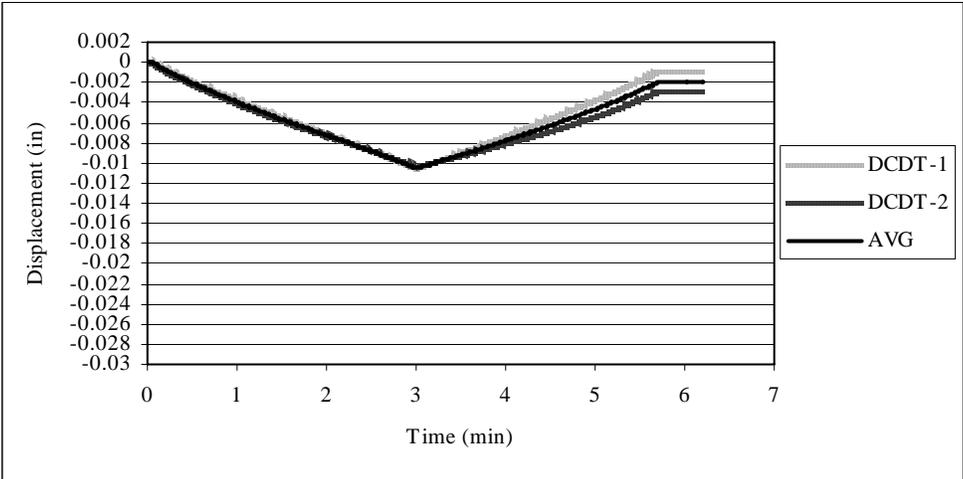
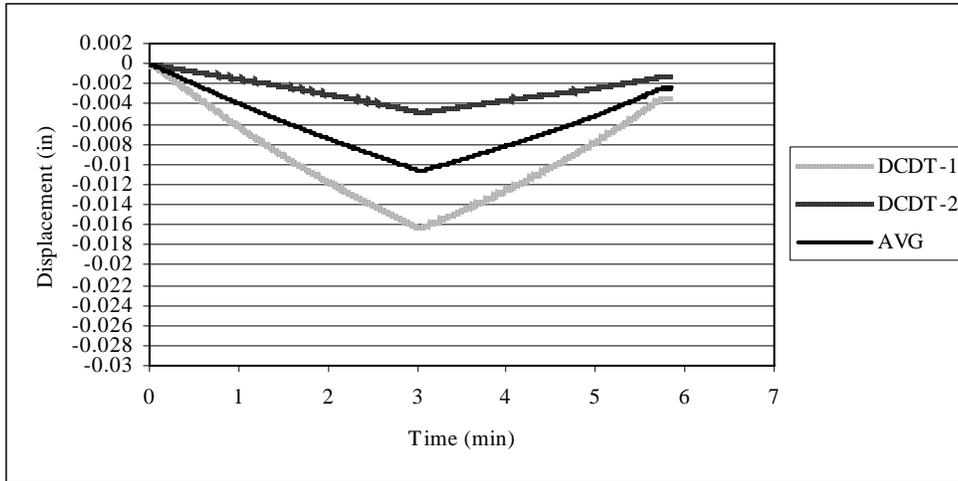
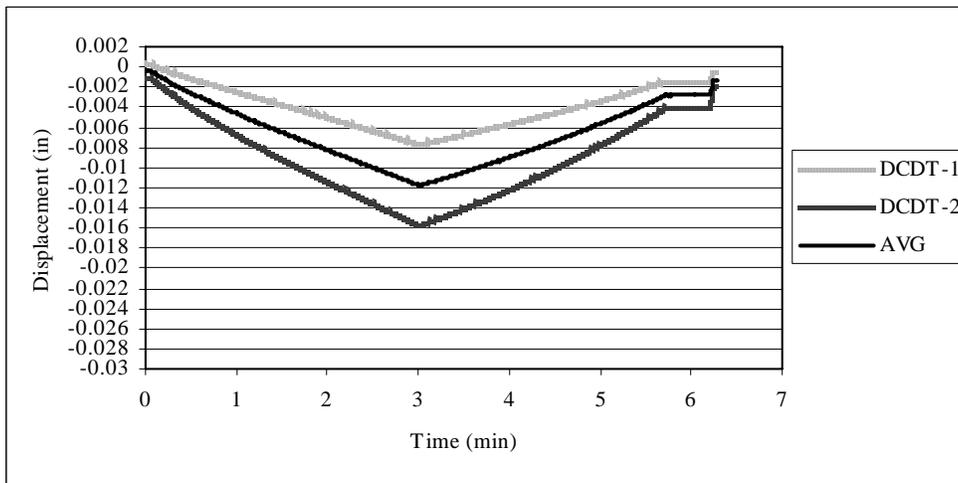
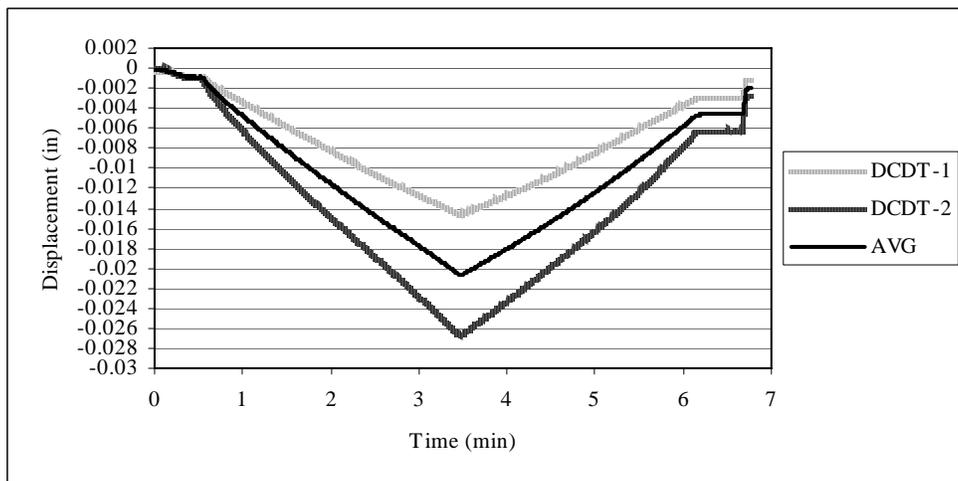
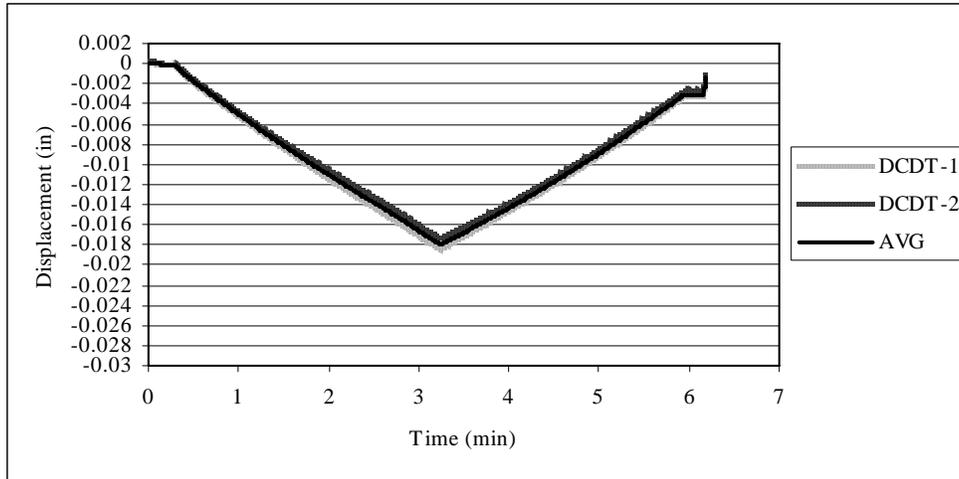
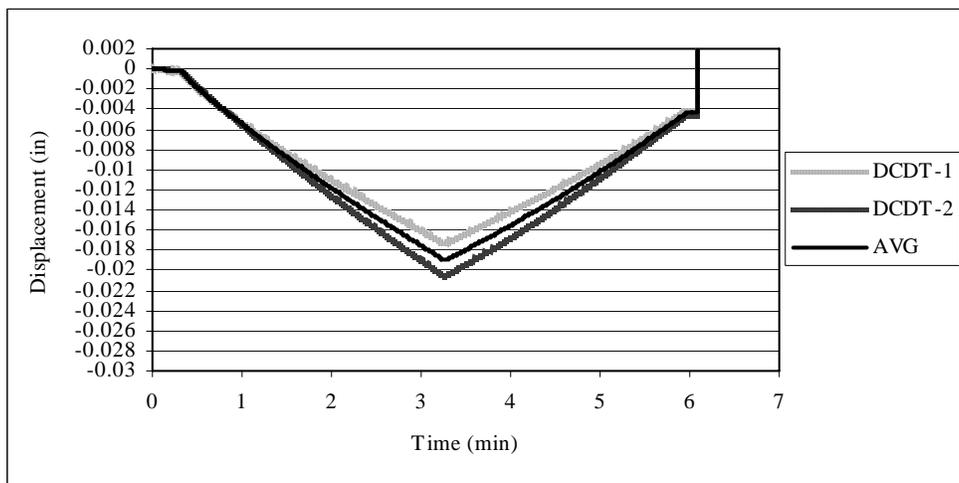
After the fatigue tests were completed, the splices were tested for slip using the same procedure as before, to document the effect of high cyclic loading on slip. The slip measured for the #6 bars ranged from 0.002 inch to 0.003 inch and averaged 0.002 inch. The slip measured for the #11 bars ranged from 0.003 inch to 0.005 inch and averaged 0.004 inch. Figures 4.12-4.17 show graphs of the displacement as a function of time during the post fatigue slip tests. Only one of the splices showed an increase in slip after fatigue testing, and the amount was negligible. All six splices were able to meet the AASHTO LRFD requirement of less than 0.010 inch of slip after fatigue testing.

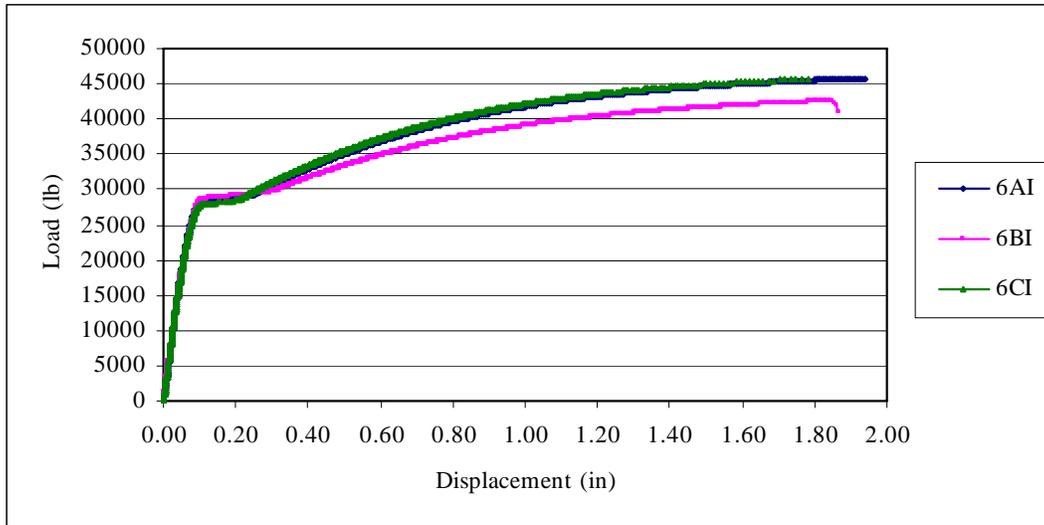
Figure 4.18 Load versus Displacement for specimens 6AI, 6BI, 6CI

After post fatigue slip testing, the splices were tested to tensile failure. The #6 bars all exceeded the AASHTO LRFD and MDOT requirement of 125 percent of F_y , the ultimate load ranging from 42.4 to 45.7 kips and averaging 44.6 kips, or 169 percent of F_y . The ultimate loads of the #11 bars ranged from 115.6 to 154.2 kips averaging 138.2 kips, or 148 percent F_y . Specimen 11AI failed at 115.6 kips, or 124 percent of F_y , slightly less than the required 125 percent of F_y . Load versus displacement plots can be seen in Figures 4.18 and 4.19.

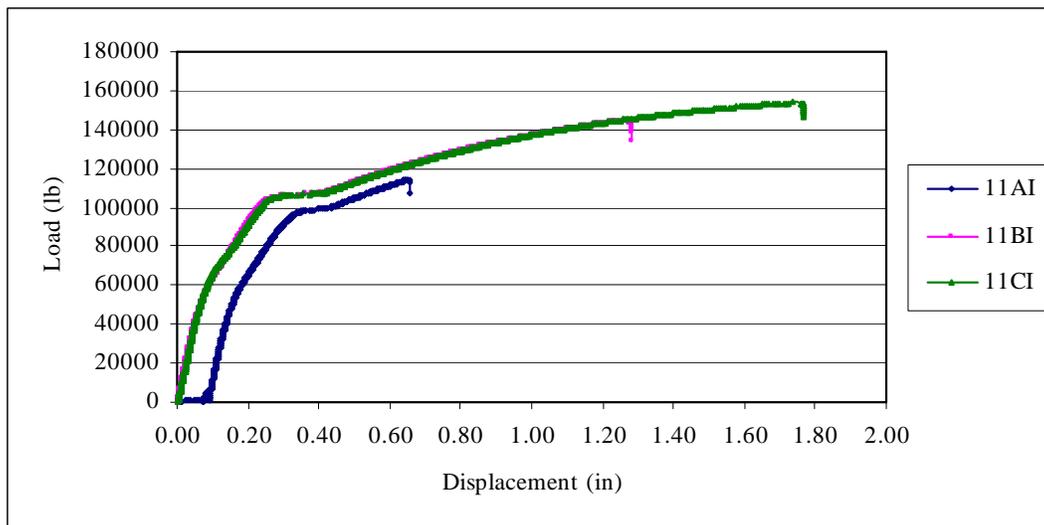
Figure 4.19 Load versus Displacement for specimens 11AI, 11BI, 11CI

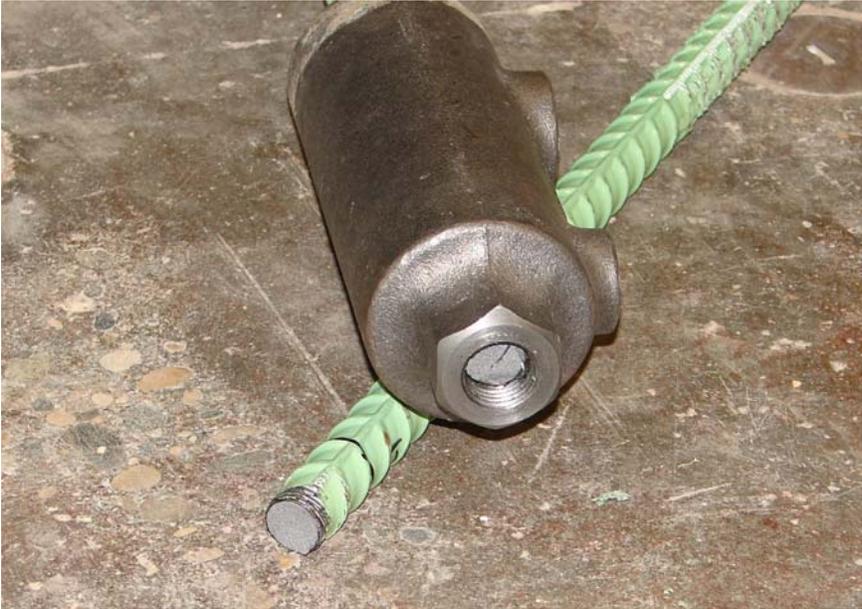
Figure 4.20 Bar fracture of specimen 6CI

Specimens 6AI, 6BI, and 6CI exhibited the same failure mode, bar fracture at the threads accompanied by a small amount of spalling at the grouted connection, as demonstrated by specimen 6CI in Figures 4.20 and 4.21. Displacement of the grouted bar was evident during ultimate load testing but was not instrumented due to the risk of damage to instrumentation during failure. Although displacement of the grips was measured by the MTS system, it was not possible to differentiate between displacement of the connection via bond failure and displacement due to elongation of the bar. Displacement of the connection was visually estimated at 0.25 to 0.5 inch.
