1. Report No. R-1512	2. Government Accession No.	3. MDOT Project Manager	
4. Title and Subtitle Evaluation of Grout-Filled Mechanical Splices for Precast Concrete Construction		5. Report Date May 2008

**Evaluation of Grout-Filled Mechanical Splices for
Precast Concrete Construction**

**Structural Section
Construction and Technology Division
Report 07 TI-2094
Research Report R-1512**

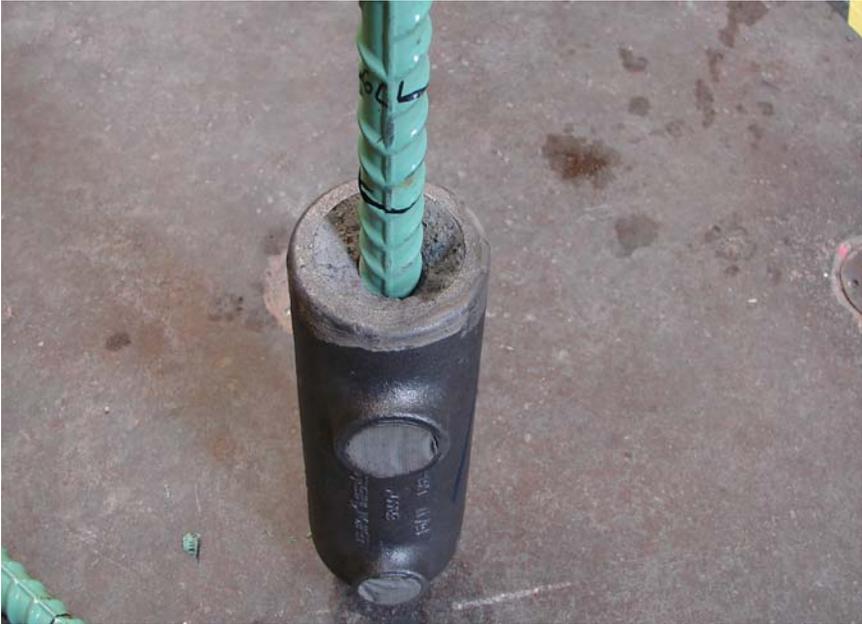
Figure 4.21 Spalling of specimen 6CI (typical of 6AI and 6BI)

Specimens 6AI, 6BI, and 6CI exhibited the same failure mode, bar fracture at the threads accompanied by a small amount of spalling at the grouted connection, as demonstrated by specimen 6CI in Figures 4.20 and 4.21. Displacement of the grouted bar was evident during ultimate load testing but was not instrumented due to the risk of damage to instrumentation during failure. Although displacement of the grips was measured by the MTS system, it was not possible to differentiate between displacement of the connection via bond failure and displacement due to elongation of the bar. Displacement of the connection was visually estimated at 0.25 to 0.5 inch.

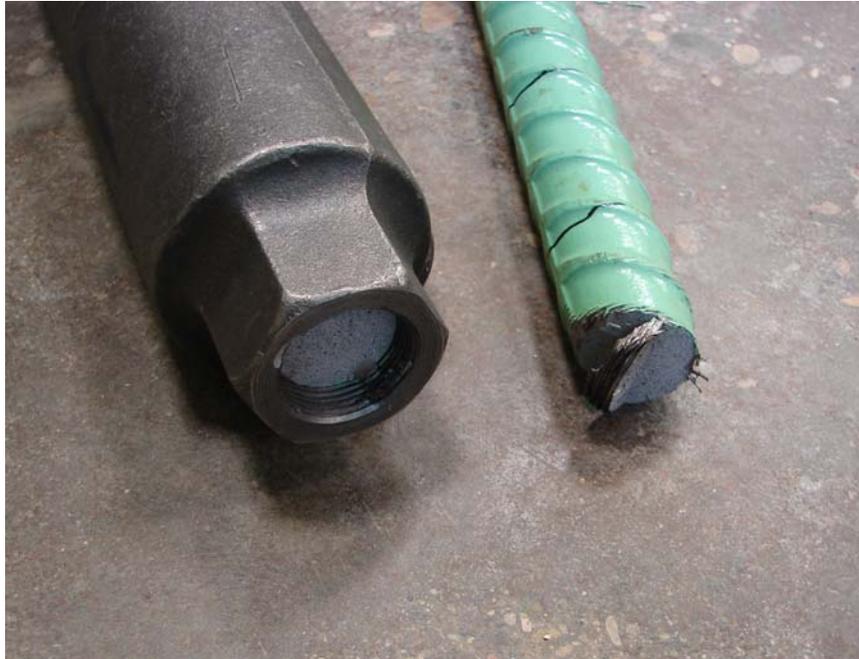
Figure 4.22 Bar fracture at threads of specimen 11AI

The #11 splices exhibited two different failure modes. Specimen 11AI fractured at the threads similar to the #6 splices, but the threads failed in shear for specimens 11BI and 11CI. Similar to the #6 splices, the failure of the threaded bars was accompanied by a small amount of spalling at

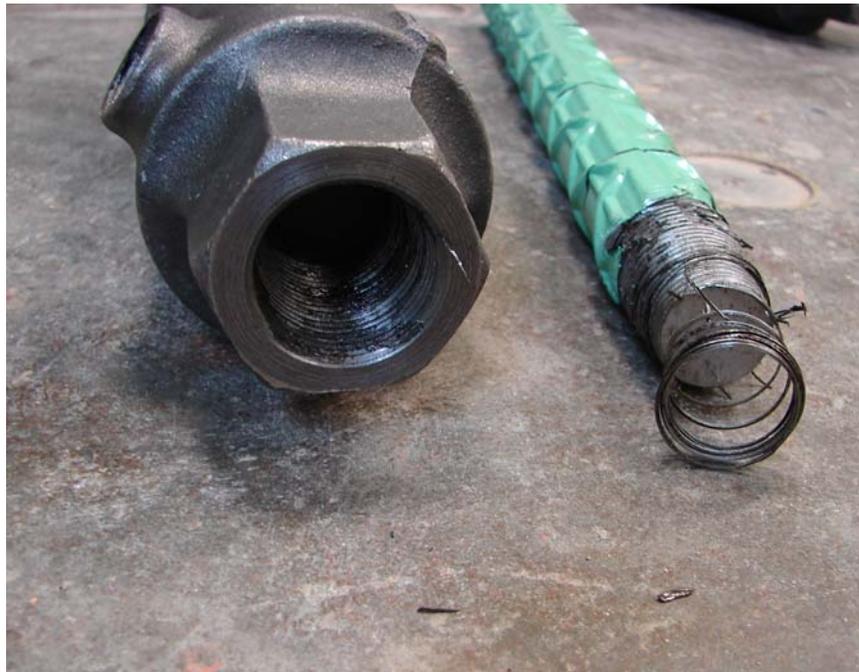
Figure 4.23 Thread failure of specimen 11BI

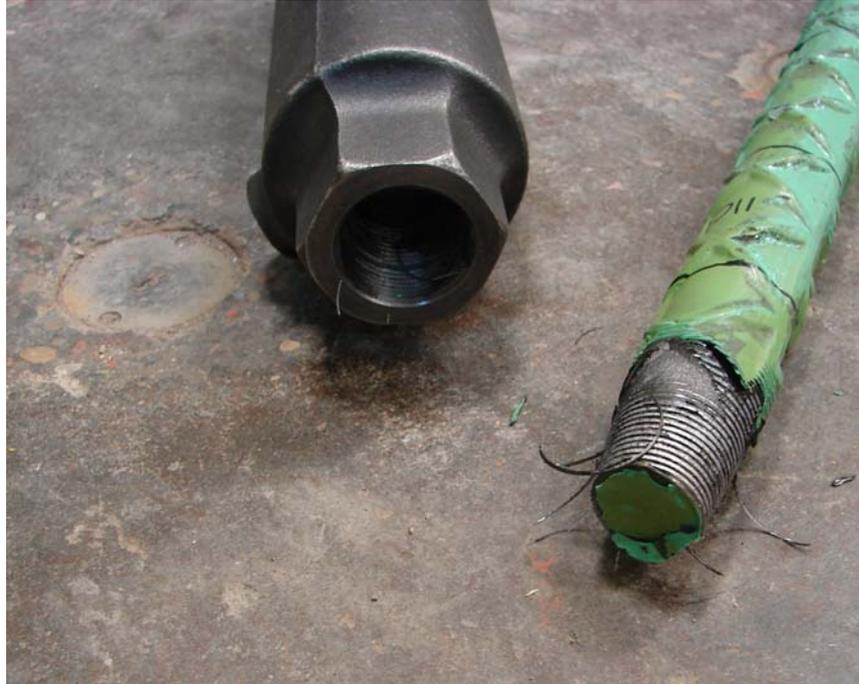
Figure 4.24 Thread failure of specimen 11CI

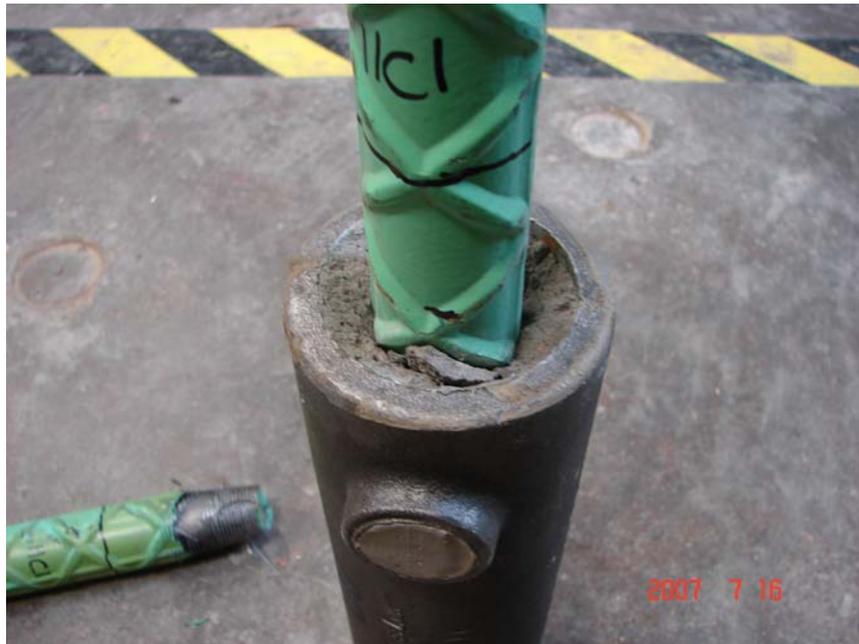
Figure 4.25 Spalling of specimen 11CI (typical of 11AI and 11BI)

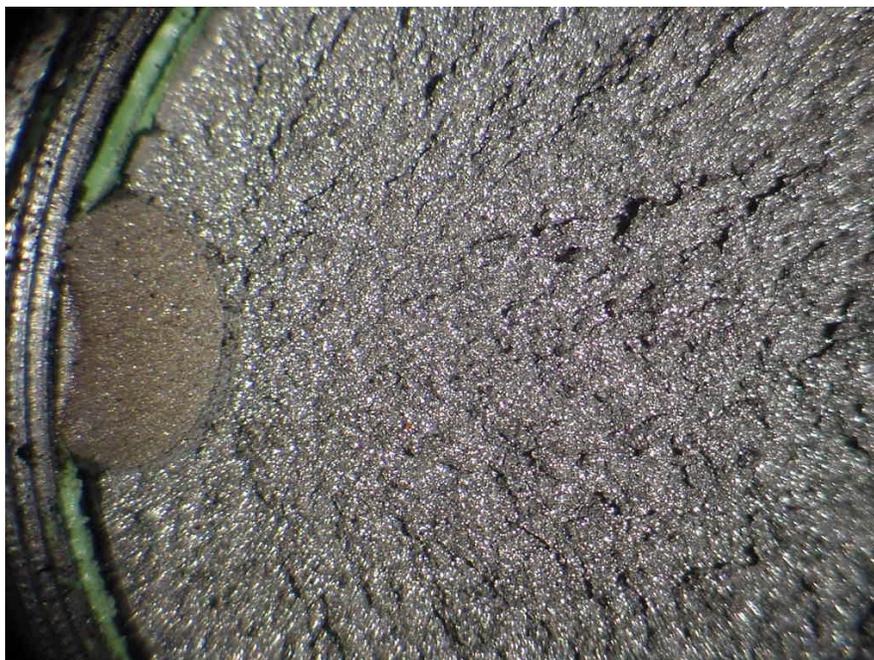
**Figure 4.26 Fracture surface close up of Specimen 11AI
(note defect at left – 6X magnification)**

Upon further inspection of Specimen 11AI, a defect was found on the fracture surface which likely explains the lower than expected tensile strength when compared to 11BI, 11CI, and the independent test data. The defect can be seen on the left side of Figure 4.26, and was the likely origin of fracture, which is supported by the visible striations seen emanating from the defect. Therefore, the lower than expected ultimate load for Specimen 11AI is most likely due to the defect in the steel reinforcement and not substandard performance of the spliced connection.

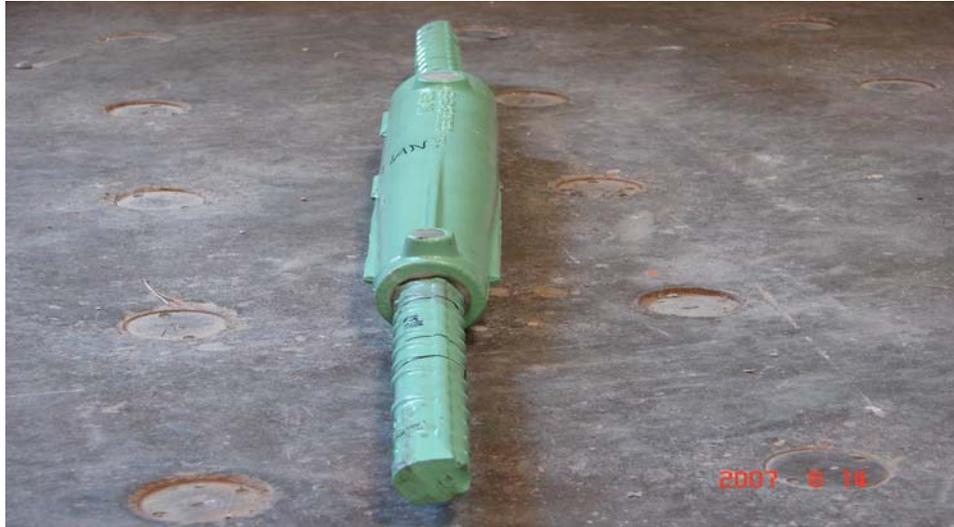
Figure 5.1 Specimen 11AN after 65 kip compressive load

When unloading Specimen 11AN after slip testing was complete, the MTS was inadvertently put into compression resulting in a compressive load of approximately 65 kips (69 percent of F_y) being put on Specimen 11AN. This compressive load buckled the specimen as seen in Figure 5.1, which resulted in a misalignment of approximately 0.5 inch over 11 inch for each of the two spliced bars.

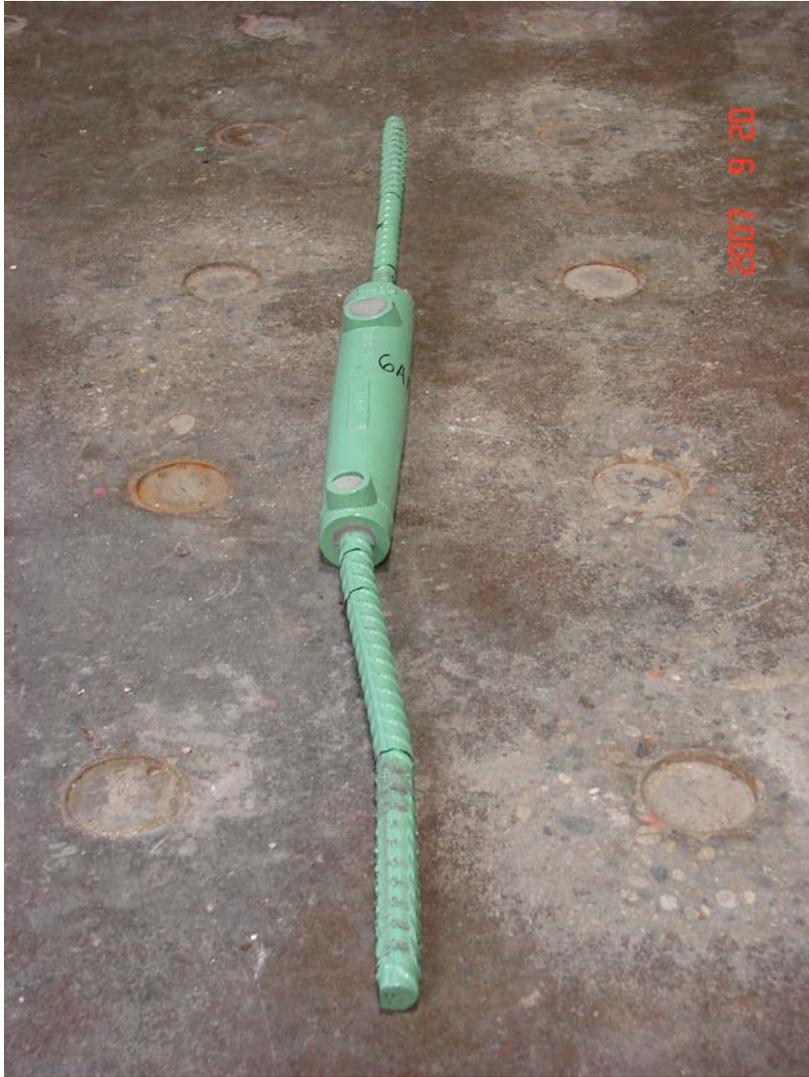
Figure 5.13 Specimen 6AN after buckling

After the fatigue tests were completed, the splices were tested for slip using the same procedure as before, to document the effect of high cyclic loading on slip. The slip measured for both the #6 and the #11 bars ranged from 0.003 inch to 0.004 inch. Figures 5.14-5.17 show graphs of the displacement as a function of time during the post fatigue slip tests. All six splices were able to meet the AASHTO LRFD requirement of no more than 0.010 inch of slip after fatigue testing. Specimen 6AN, which was inadvertently put into compression similar to specimen 11AN (Figure 5.1), and seen in Figure 5.13, was not tested along with 11AN for post fatigue slip in order to preserve it for ultimate load testing.

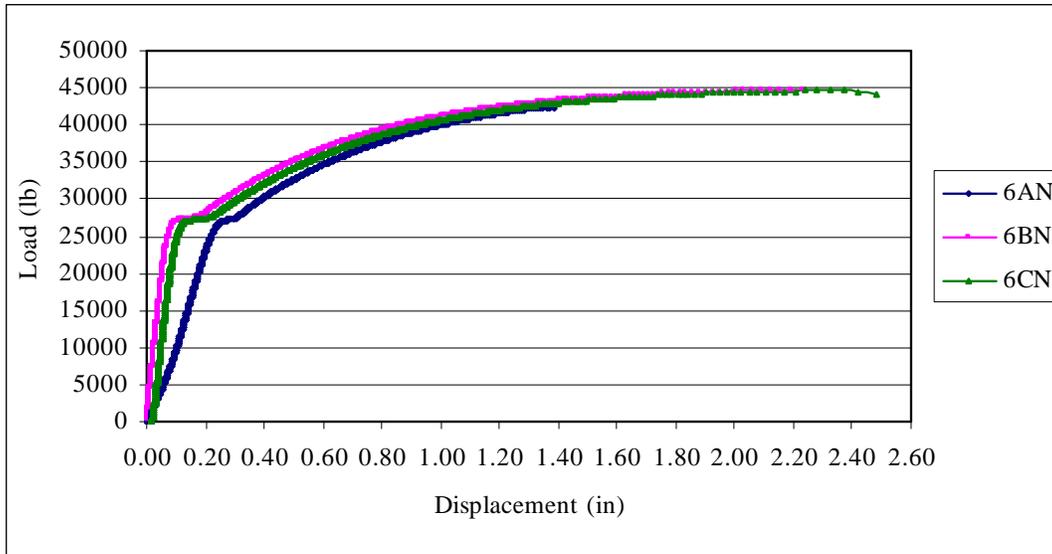
Figure 5.18 Load versus Displacement for specimens 6AN, 6BN, 6CN

After post fatigue slip testing, the splices were tested to tensile failure. The #6 and #11 bars all exceeded the AASHTO LRFD and MDOT requirement of 125 percent of F_y , the ultimate load ranging from 42.4 to 44.7 kips and averaging 43.9 kips, or 166 percent of F_y . The ultimate loads of the #11 bars ranged from 160.9 to 165.8 kips averaging 163.4 kips, or 175 percent F_y . Load versus displacement plots can be seen in figures 5.18 and 5.19. Figures 5.20 to 5.25 illustrate the specimens after failure.

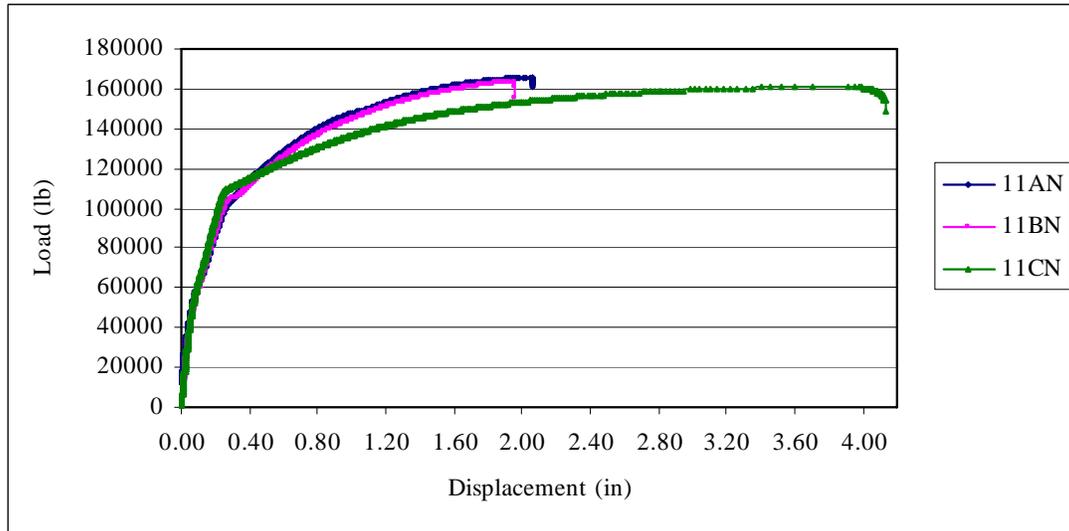
Figure 5.19 Load versus Displacement for specimens 11AN, 11BN, 11CN

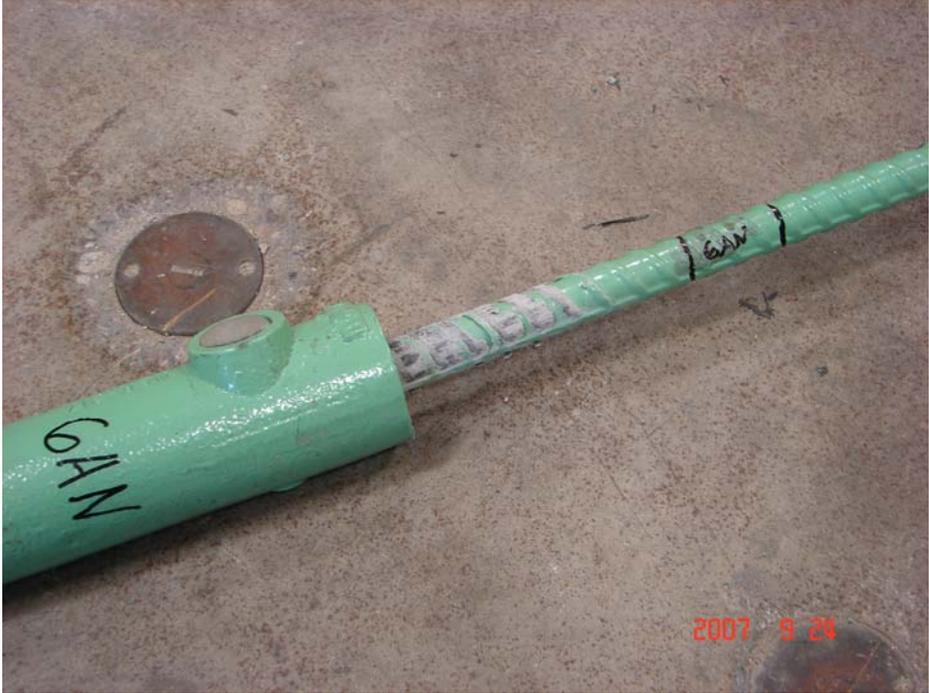
Figure 5.20 Pull-out failure of specimen 6AN

Several different failure modes were observed during the ultimate load testing. Two of the #6 specimens, 6AN and 6BN, and one of the #11 specimens, 11AN, failed by pull out of one of the reinforcement bars, as seen in Figures 5.20, 5.21, and 5.23. The failure mode of specimen 6CN

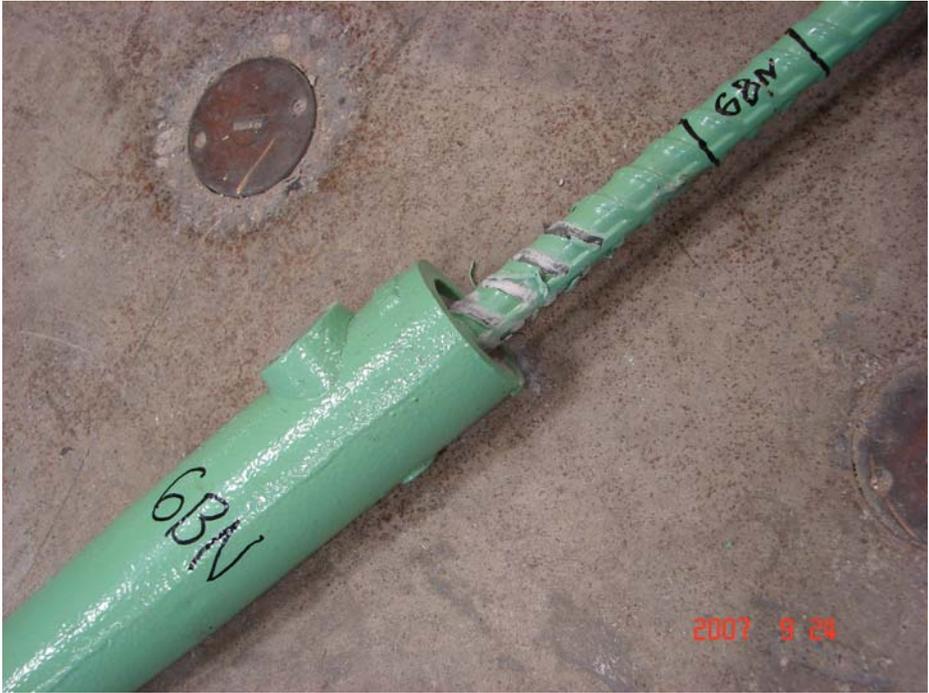
Figure 5.21 Pull-out failure of specimen 6BN

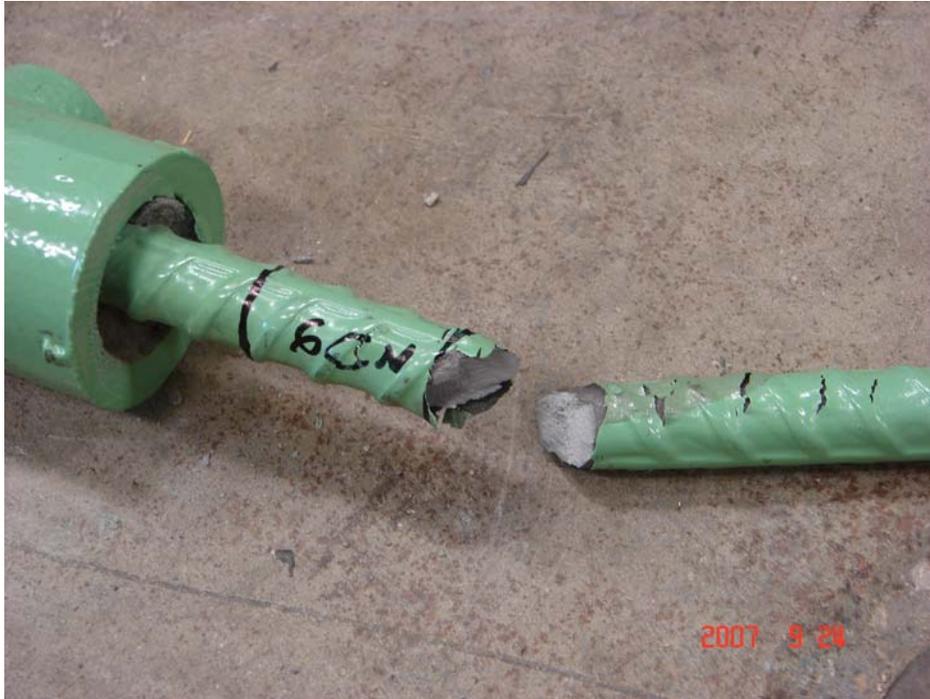
Figure 5.22 Bar fracture of specimen 6CN

was bar fracture several inches above the grout interface, as seen in Figure 5.22. The failure mode of specimens 11BN and 11CN was fracture of the splice itself, in the middle where the two reinforcement bars meet, as seen in Figures 5.24 and 5.25.

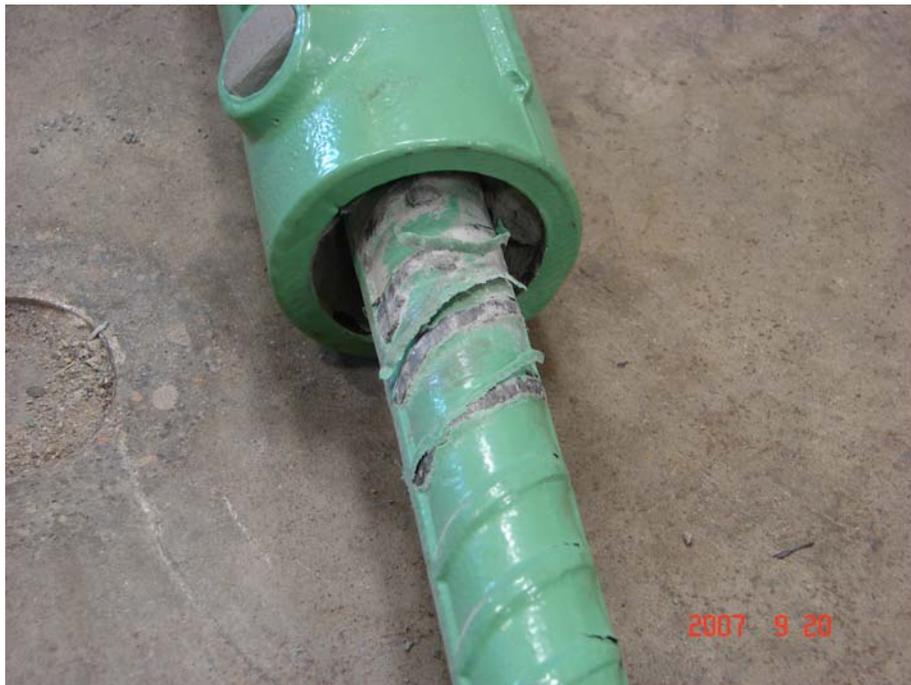
Figure 5.23 Pull-out failure of specimen 11AN

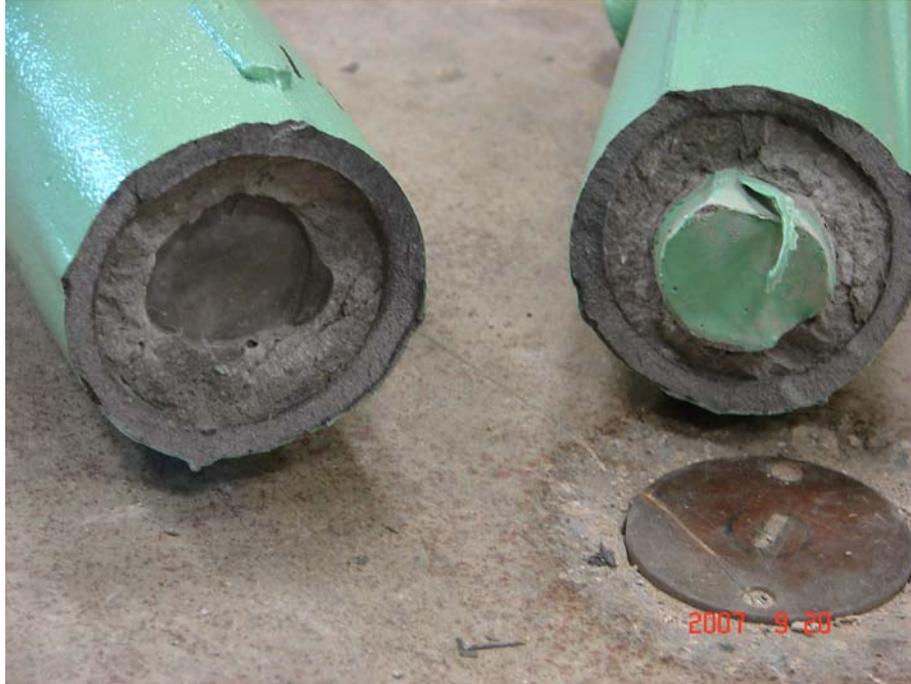
Figure 5.24 Splice fracture of specimen 11BN

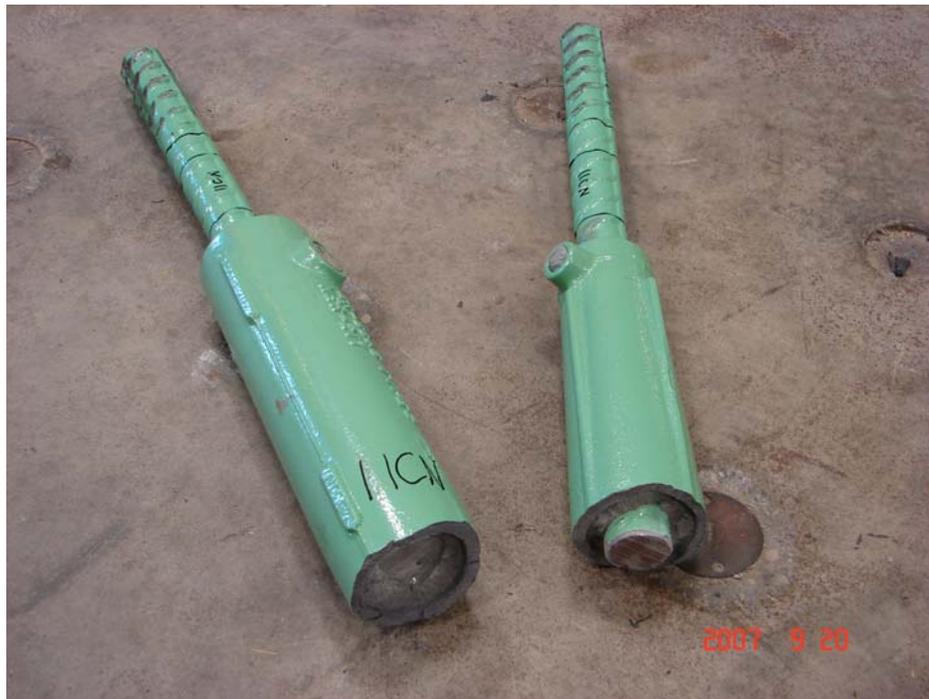
Figure 5.25 Splice fracture of specimen 11CN

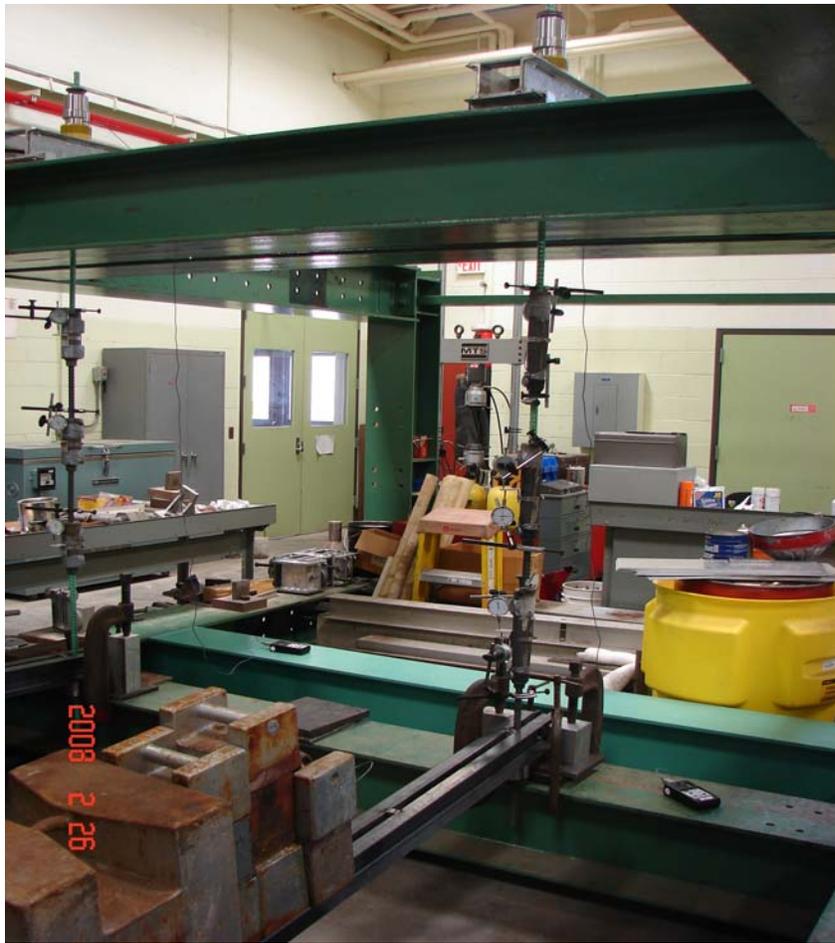
Figure 6.1 Creep test set-up

Three #6 splices for each manufacturer were connected in series and subjected to a sustained load of 40 percent of the ultimate strength of the reinforcement. Figure 6.1 illustrates the testing set-up.

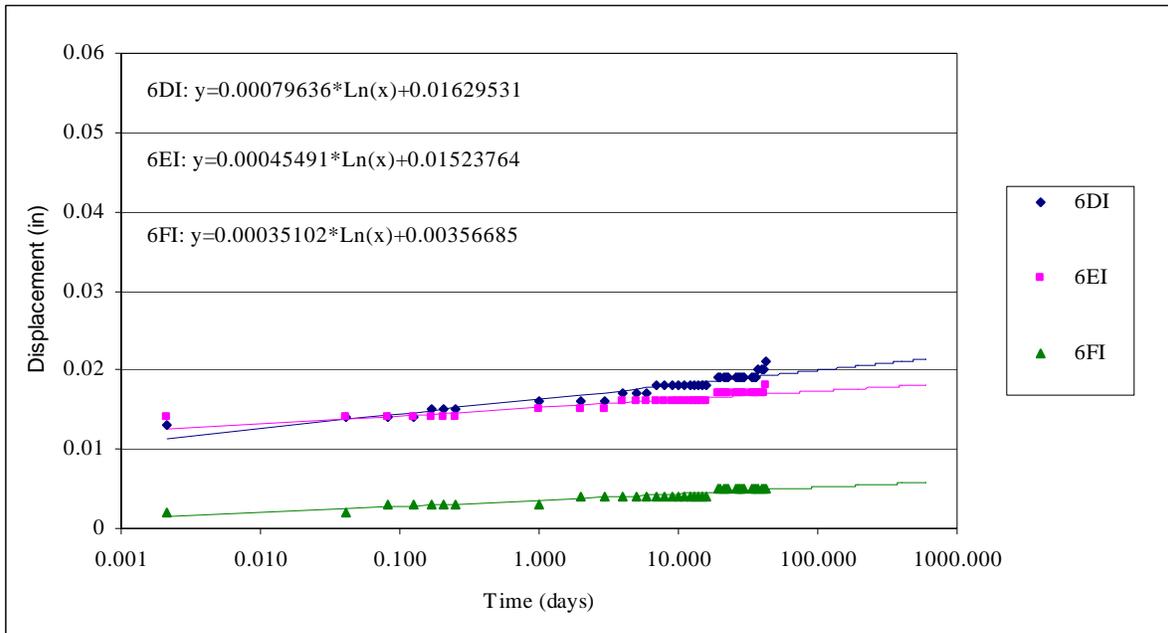
Figure 6.2 Displacement of Lenton Interlok specimens

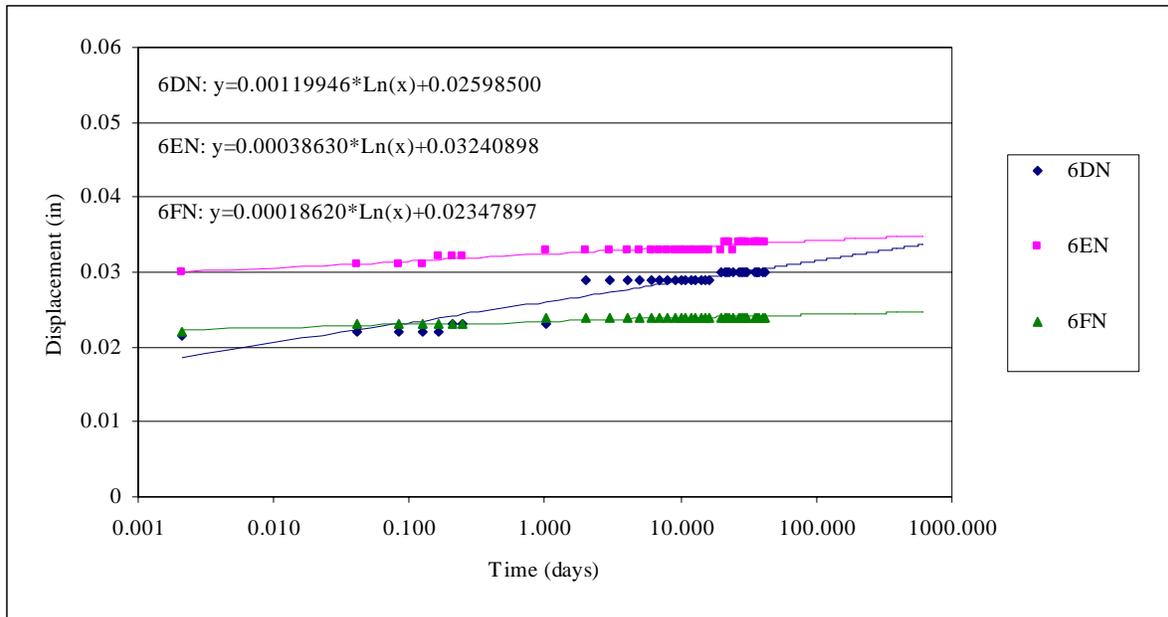
Figure 6.3 Displacement of NMB Splice Sleeve specimens

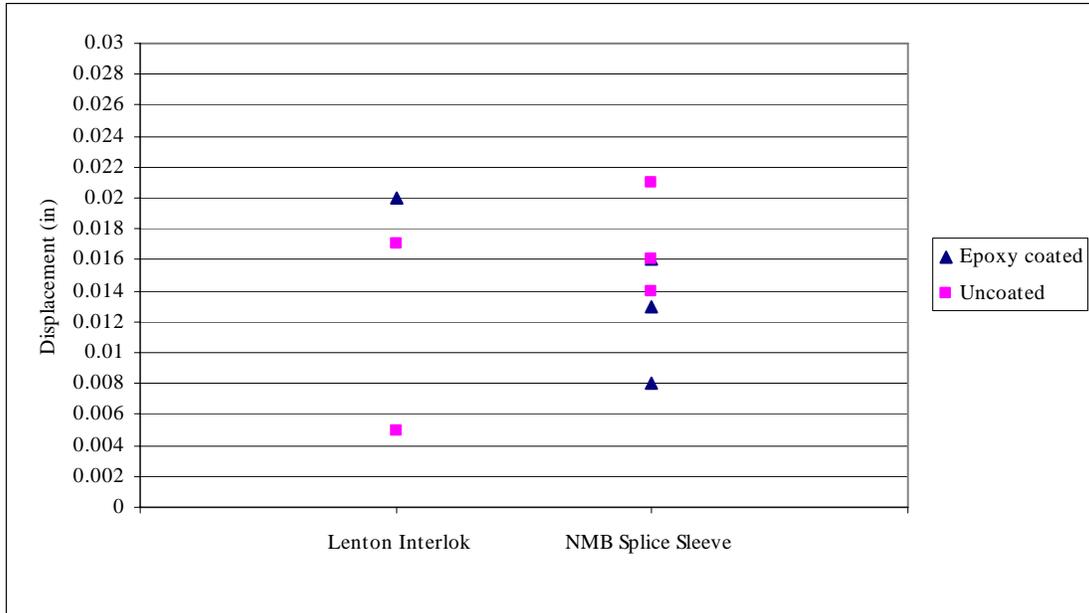
Figure 6.4 Effect of coating on creep displacement

Figure 6.4 compares the creep displacements from the specimens as a function of coating type. When comparing the performance of epoxy and uncoated bars with the NMB Splice Sleeves, displacements from the two grouted ends were plotted separately. The epoxy coated bars did not displace significantly more than the uncoated bars. For the Lenton Interlok, the epoxy coated bar displaced slightly more than the uncoated bars. For the NMB Splice Sleeve, the epoxy coated bars displaced slightly less than the uncoated bars.

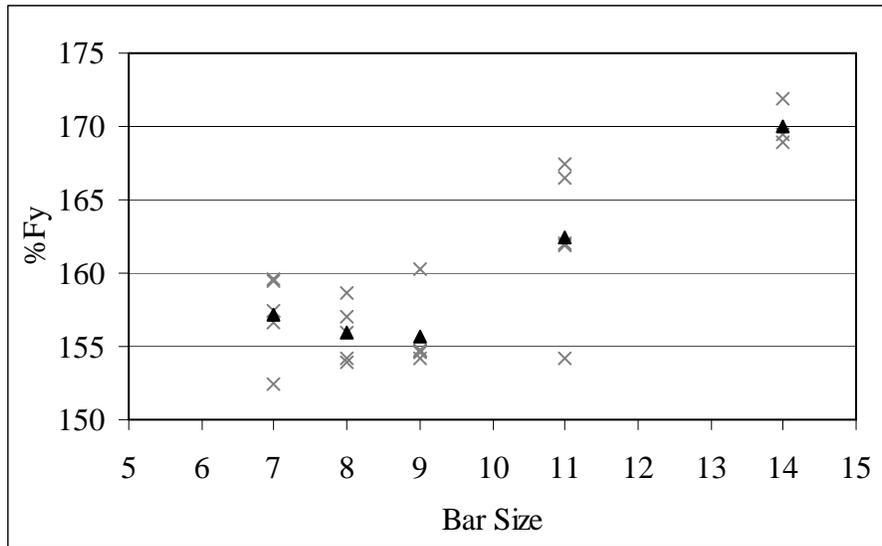
Figure A.1 Ultimate load data for the Lenton Interlok Splice, Erico, Inc. 2002

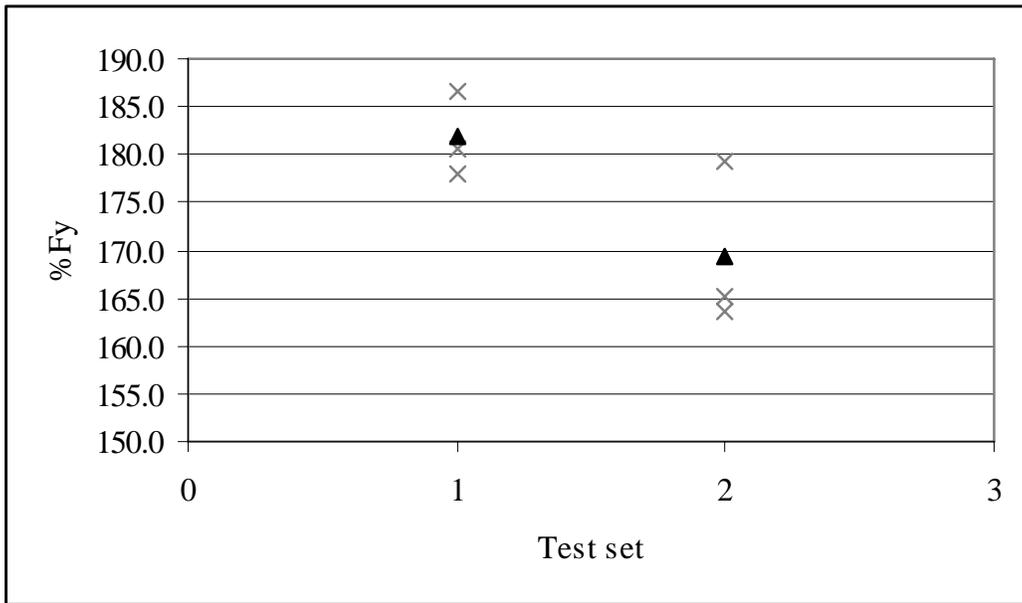
Figure B.1 Ultimate load data for the NMB Splice Sleeve, plain (1) and epoxy coated bars (2), California Department of Transportation, 1987

Although the epoxy coating did not appear to detrimentally effect creep displacement, the creep tested epoxy coated bars tested to failure in tension exhibited lower values than the uncoated bars, for both the Lenton Interlok and the NMB Splice Sleeve, as seen in Table 6.5. This may be in part indicative of the ultimate load performance of epoxy coated bars compared to uncoated bars in general, not solely a result of creep testing. The previous ultimate load testing seen in Tables 4.1 and 5.1 used epoxy coated bars exclusively, so the data comparing the ultimate load performance of epoxy coated bars to uncoated bars are limited. Test data provided by Splice Sleeve North America, Inc., for the NMB Splice Sleeve, shown in Appendix Figures B.1 and B.2, show slightly lower ultimate loads for epoxy coated bars.

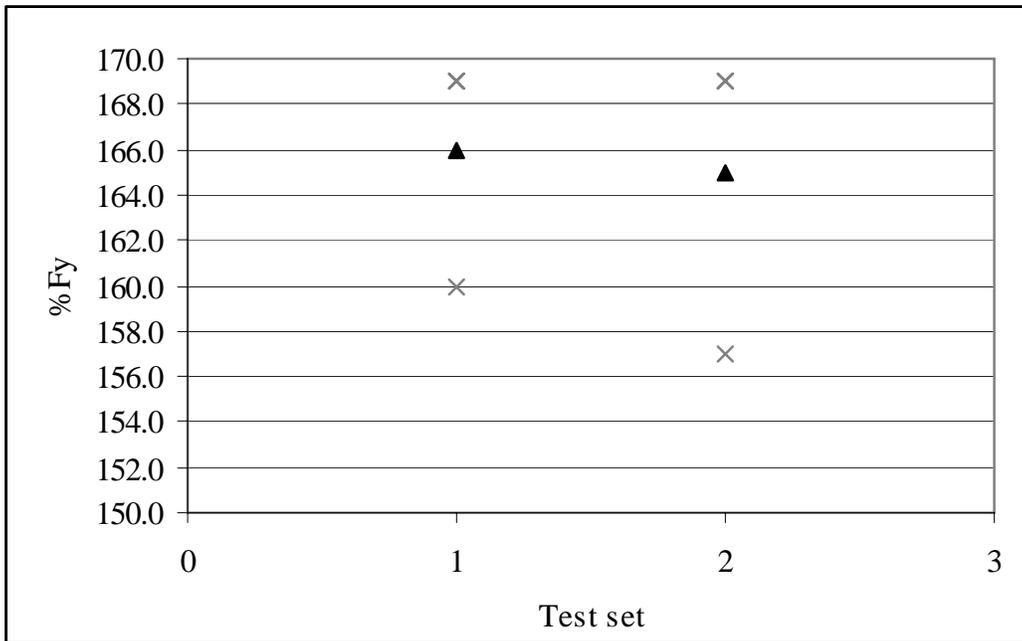
Figure B.2 Ultimate load data for the NMB Splice Sleeve, plain (1) and epoxy coated bars (2), Nisso Master Builders Laboratory

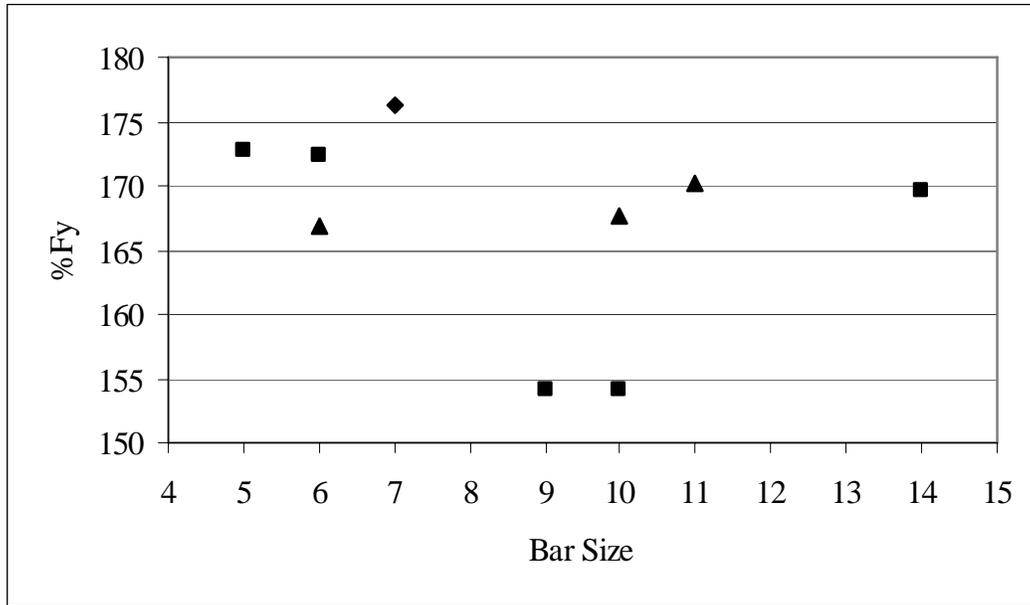
Figure B.3 Ultimate load data for the NMB Splice Sleeve, Science University of Tokyo, 1987
