MICHIGAN  
STATE HIGHWAY DEPARTMENT  
Charles M. Ziegler  
State Highway Commissioner

EXPERIMENTAL CAPPING STUDY  
CONSTRUCTION PROJECT F 33-54, C4 on US-127  
PROGRESS REPORT NO. 1

Research Project 53 F-29

Research Laboratory  
Testing and Research Division  
Report No. 215  
December 1, 1954

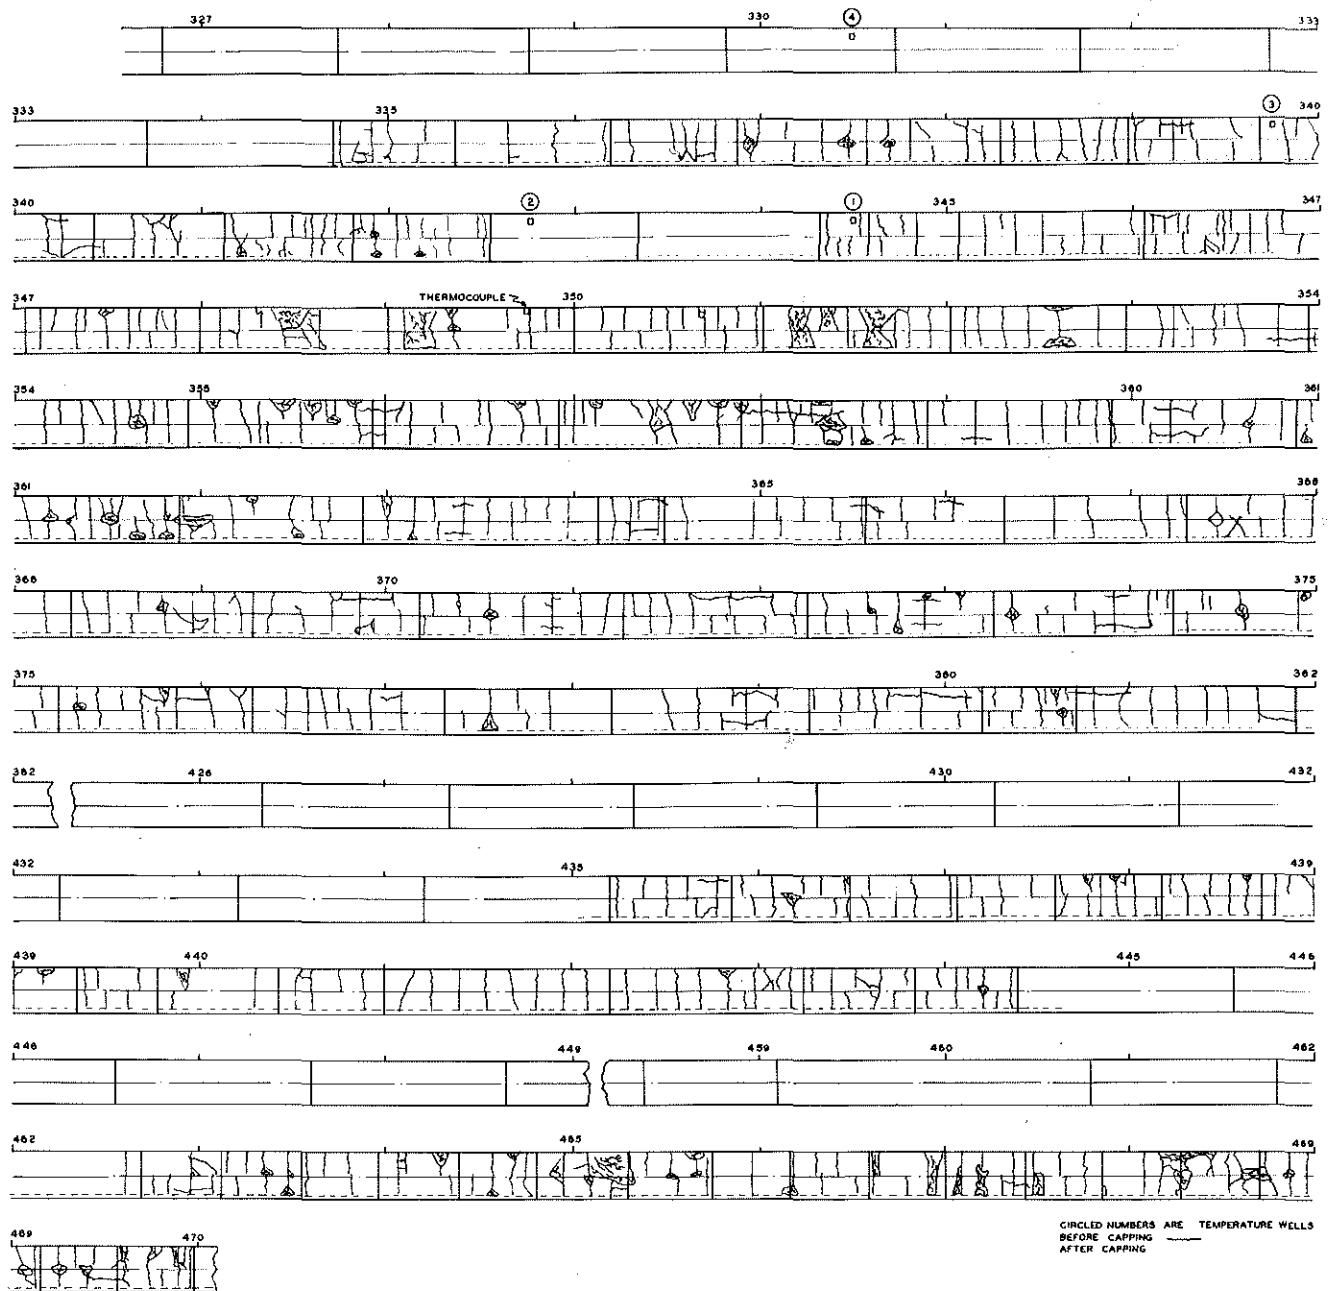
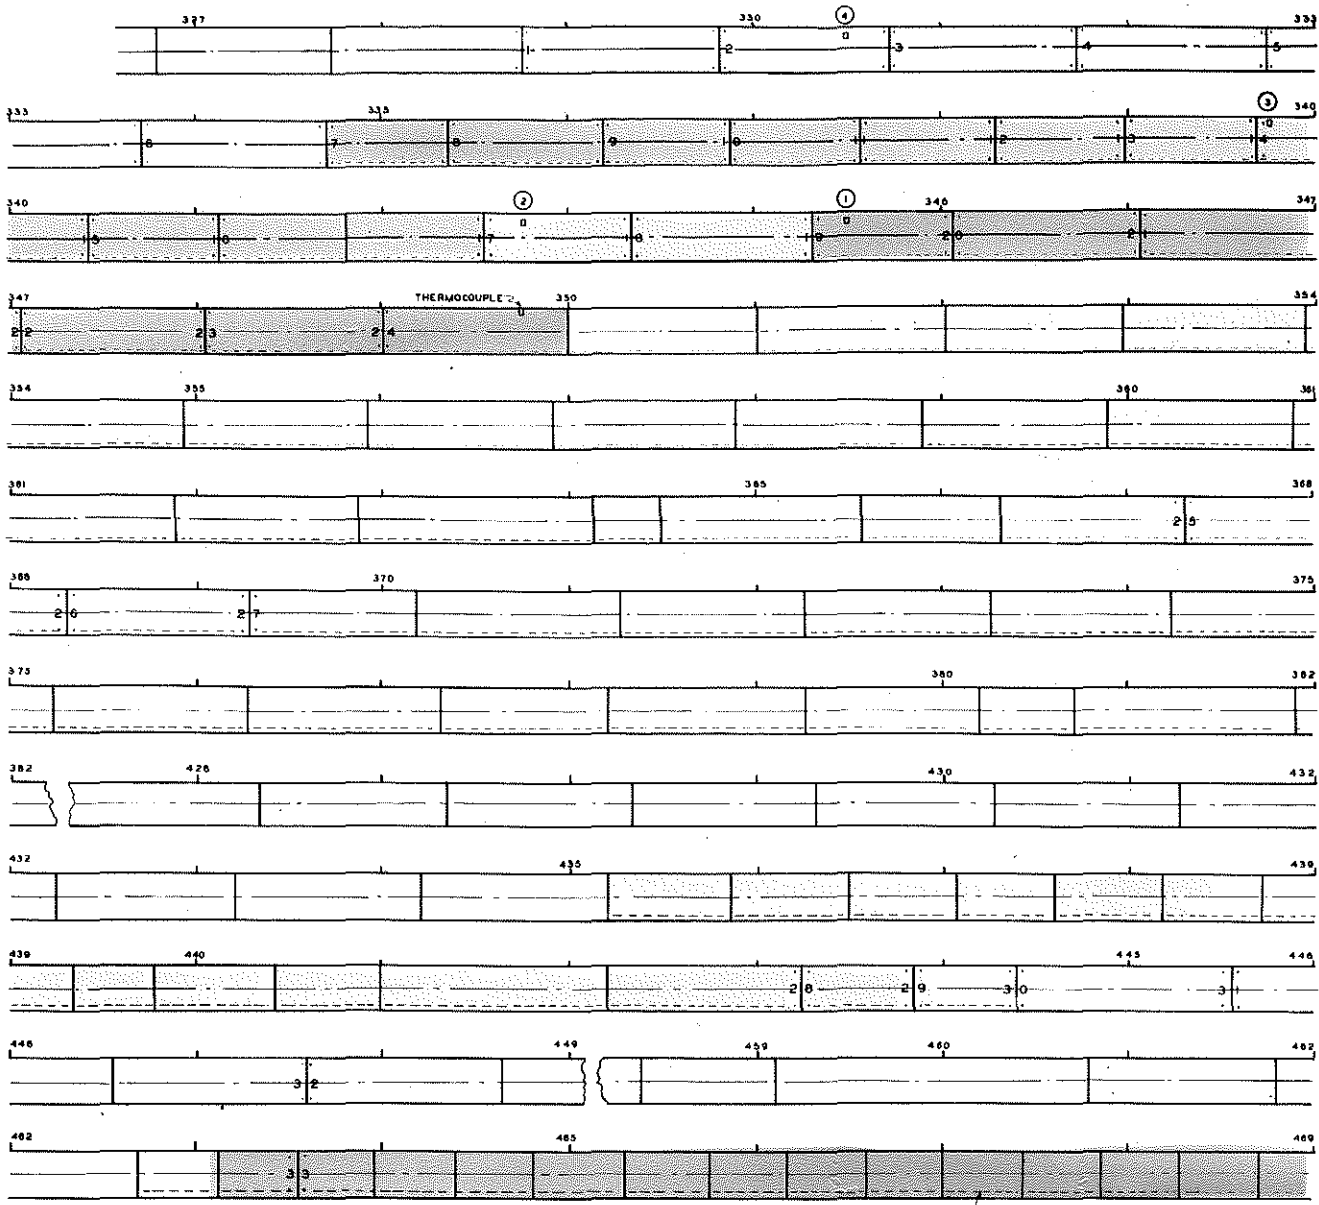
FIGURE 1

CONDITION SURVEY OF PAVEMENT  
BEFORE AND AFTER EXPERIMENTAL CONCRETE CAPPING

Prior to construction of the test sections, a complete condition survey was made of the existing concrete surface. Figure 1 shows the cracked condition of the pavement. The concrete capping has been super imposed on the condition survey map to show the location of the joints with respect to the cracks underneath.

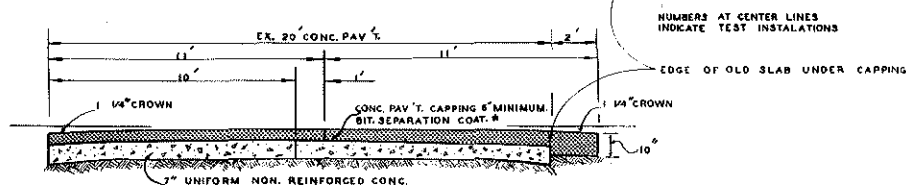
FIGURE 2

**EXPERIMENTAL CONCRETE CAPPING  
LAY OUT OF TEST AREAS**

Figure 2 is a schematic showing the location of the various test sections as identified by color.

Pins were installed at certain joints in each test section to study the changes in slab length. The location of these joints is shown in Figure 2. Temperature wells (for thermometer readings) were installed at locations also shown in Figure 2, to obtain the pavement temperature. In addition, a thermocouple installation was made at Station 349+75 in the concrete capping area to study the temperature gradient through the existing pavement and the capping.

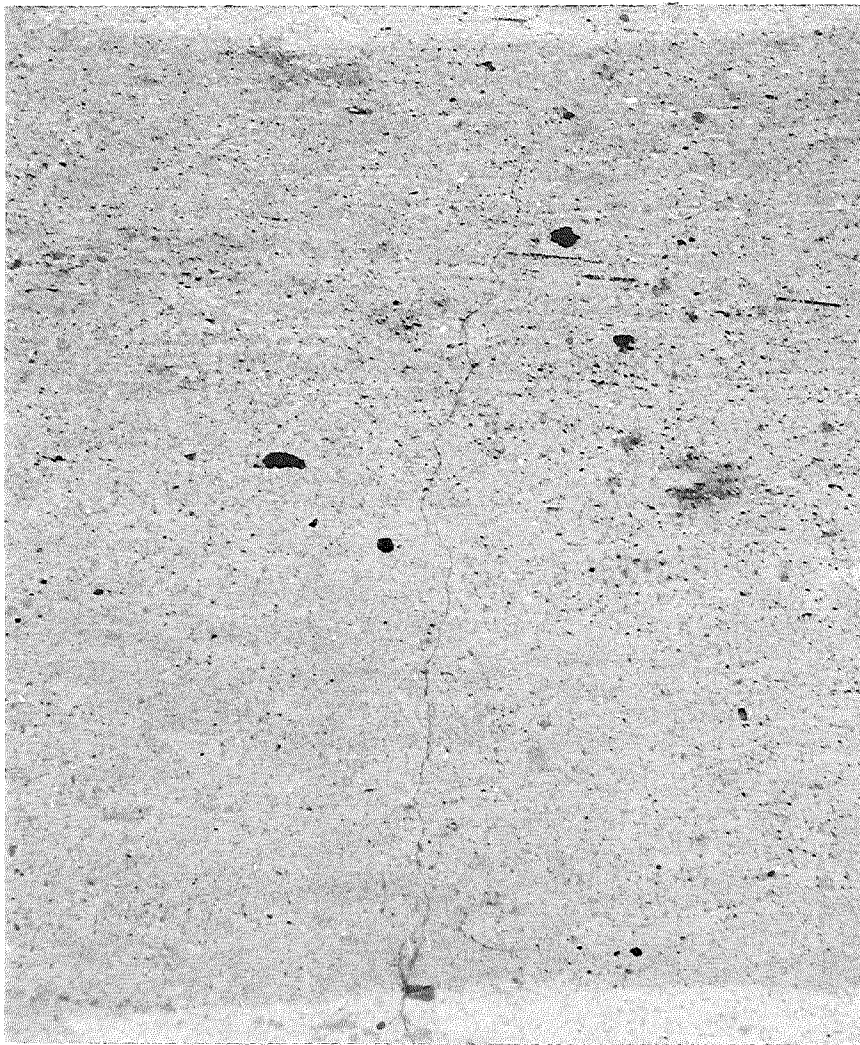
As of August 26, 1954, only two slabs of these capped had developed a visible crack. This first crack showed up in the traffic lane of the southbound pavement at Station 346+50 when the December, 1953 condition survey was made. In the August 26th condition survey, a crack had developed across the passing lane of the southbound pavement at Station 346+48 approximately 2 feet back of the crack in the traffic lane. This cracking is shown in Figure 1 by a red line and also by pictures identified as Figures 3 and 4. These cracks developed over a very badly cracked section of the existing pavement which was capped with a concrete slab with a 33 foot joint spacing and with a separating or breaker strip between the old and new concrete which consisted of one layer of 0.25 gallons of AE-3 and 25 pounds of 2 NS sand. A picture showing a typical view of the existing pavement before reconstruction is shown in Figure 5.

Figure 3. First crack appeared in southbound traffic lane of capped portion, F 33-54, C 4 Station 346+50 during fall 1953.

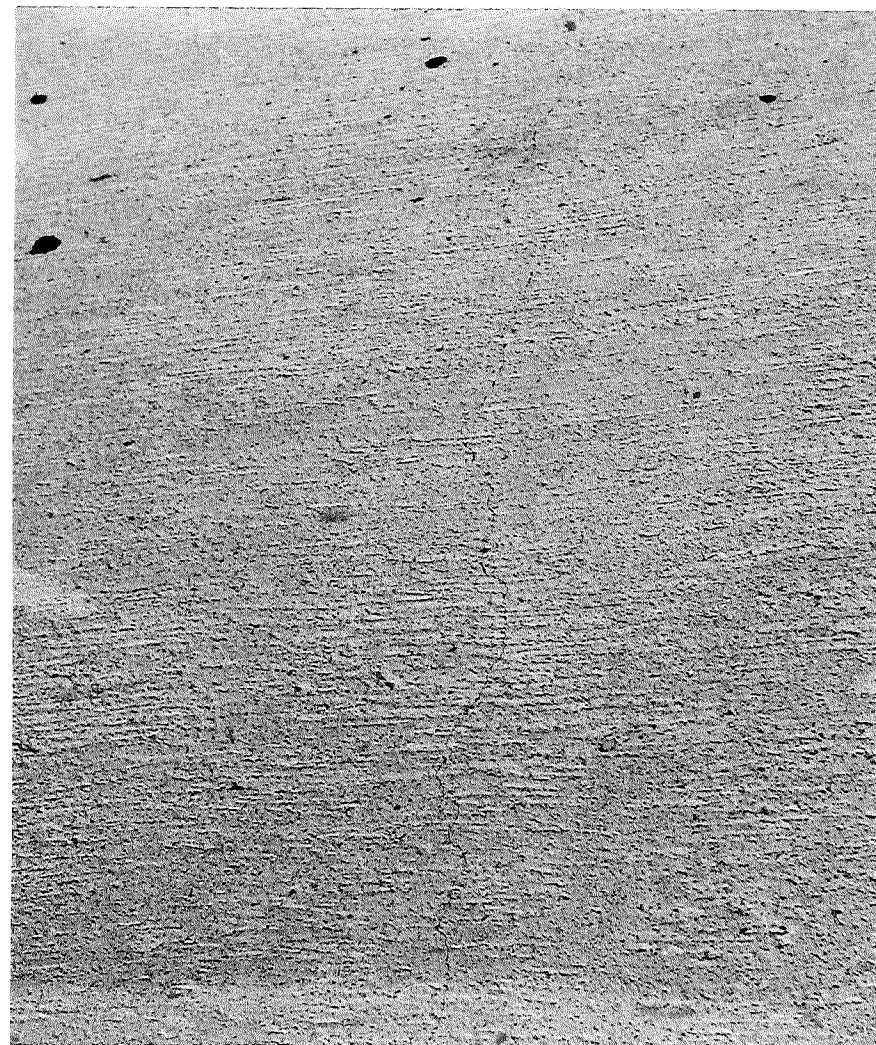
Figure 4. Second crack appeared in southbound passing lane of capped portion, F 33-54, C 4 Station 346+48, noticed in summer 1954.

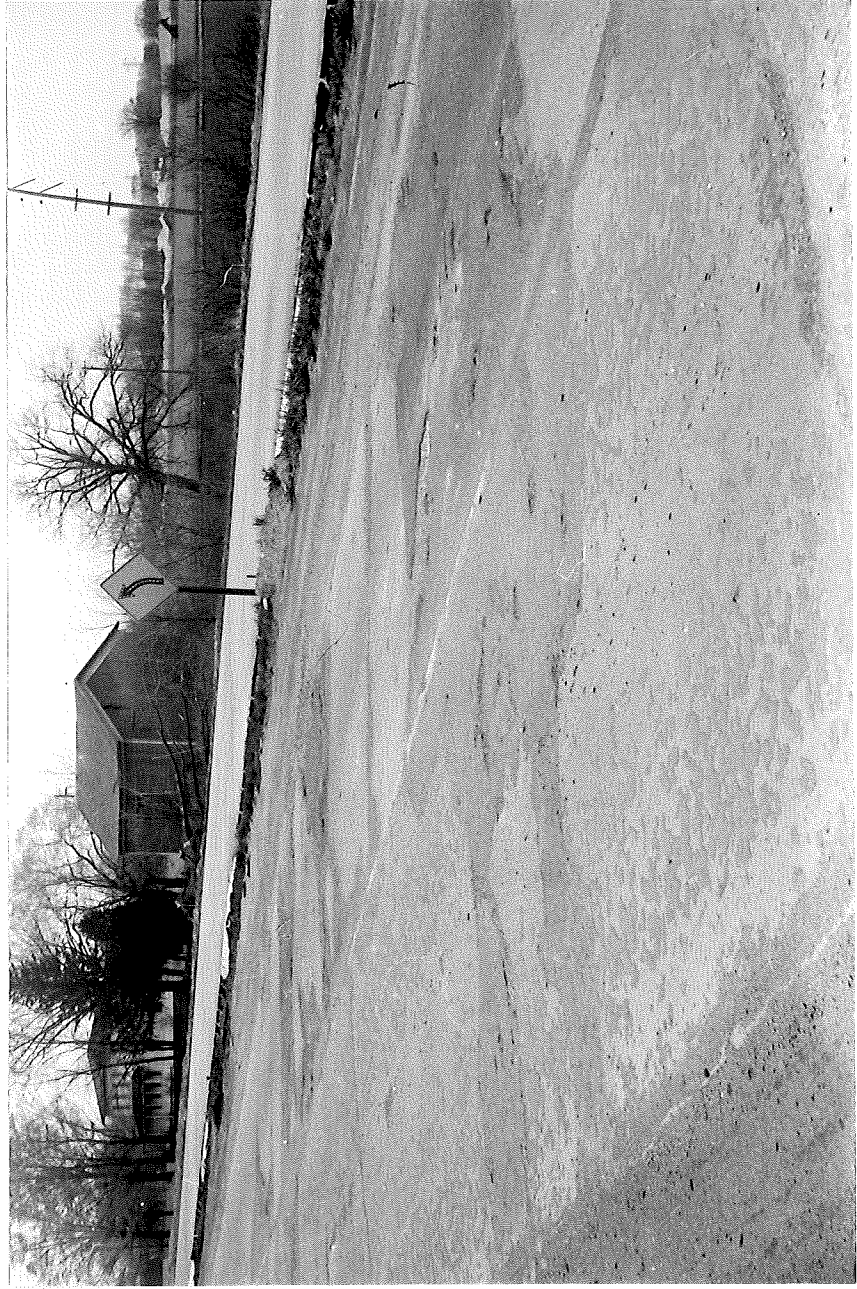
Figure 5. Example of type of old surfacing that was capped as F-88-54-C4.
