Uses of Recycled Concrete in Michigan

**Final Report
to the
Michigan Concrete Paving Association
and the
Michigan Promotion Fund**

**TESTING AND RESEARCH SECTION
CONSTRUCTION AND TECHNOLOGY DIVISION
RESEARCH REPORT NO. RC-1457**

November 9, 1995

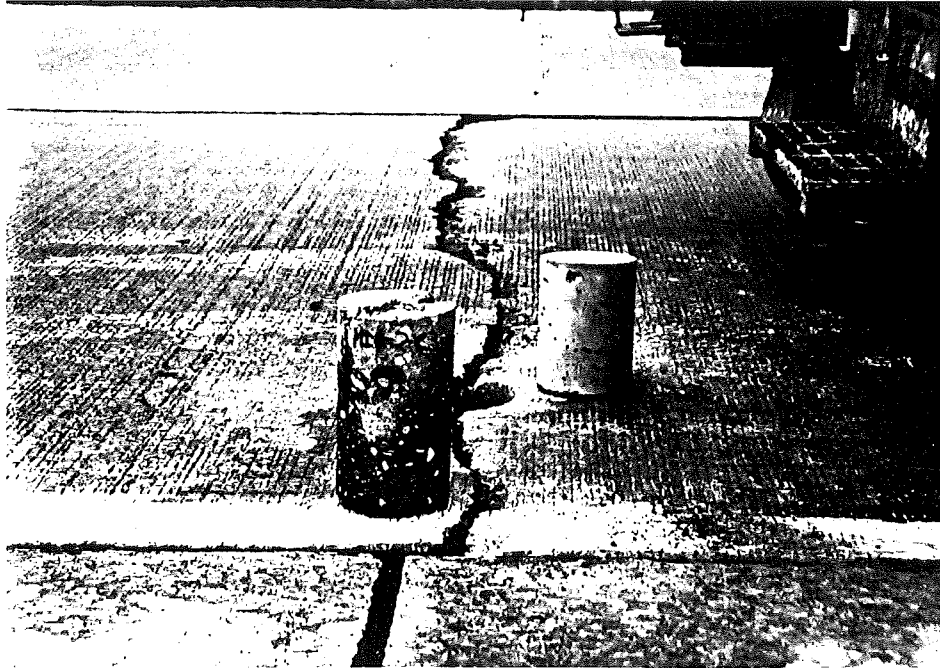
Photo #2: Typical crack in section MI1-2, recycled concrete on open-graded drainage course.

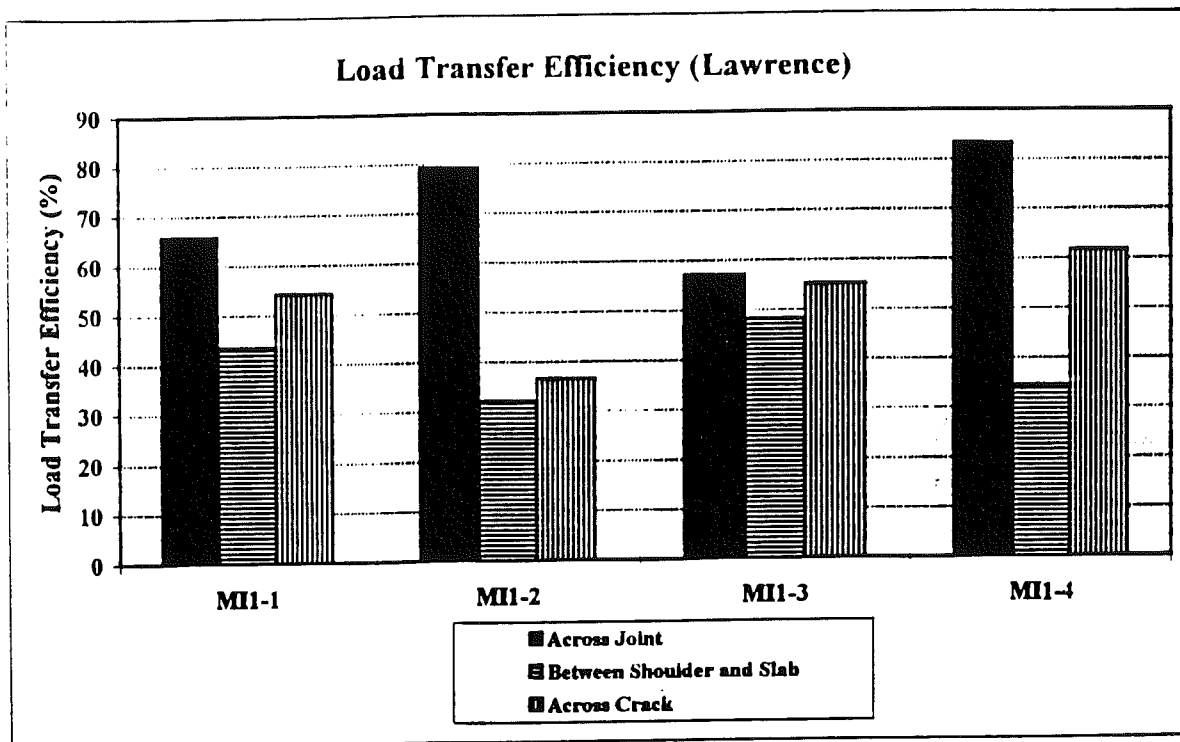
Figure #4: FWD analysis: load transfer for Lawrence project

The severity of many of the sympathy cracks in the recycled and peastone concretes alike and the low load transfer efficiencies for these cracks indicate the lack of adequate aggregate interlock. It is likely that the small nominal aggregate size plays a role for the peastone, and lack of premium grade aggregate is a factor for the recycled aggregate. Premium aggregate is important to preserve the texture of the shearing faces of cracks. Weaker aggregates are more likely to break down, causing the cracks to become smooth.

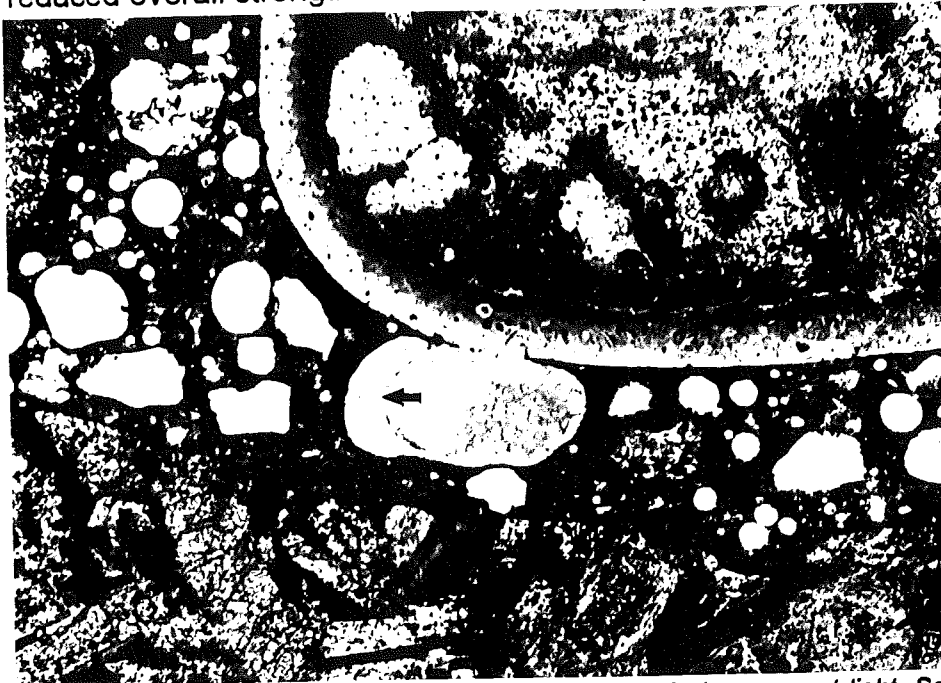
Photo #5: Microphoto of a sample from section MI1-3, taken in transparent light. Scale: 1 cm = 0.26 mm. ASR gel is present in the recycled concrete. No cracking is observed that can be attributed to ASR.

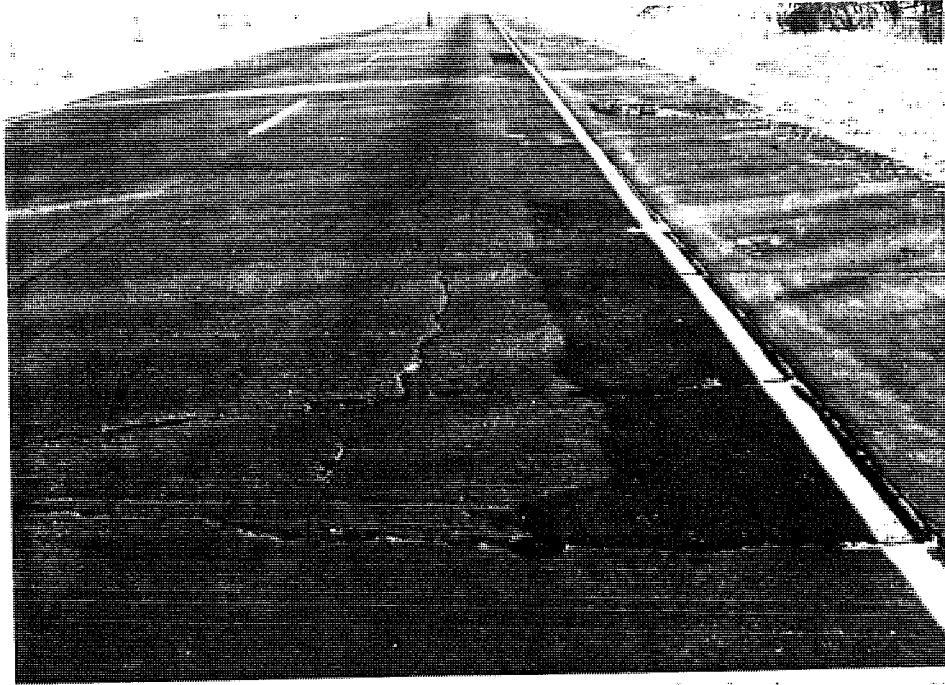
Photo #10: View of section M12-2 (East bound Galesburg) showing transverse and longitudinal cracking. Note that asphalt patching has been placed to fill in a lane shoulder dropoff of roughly one inch.

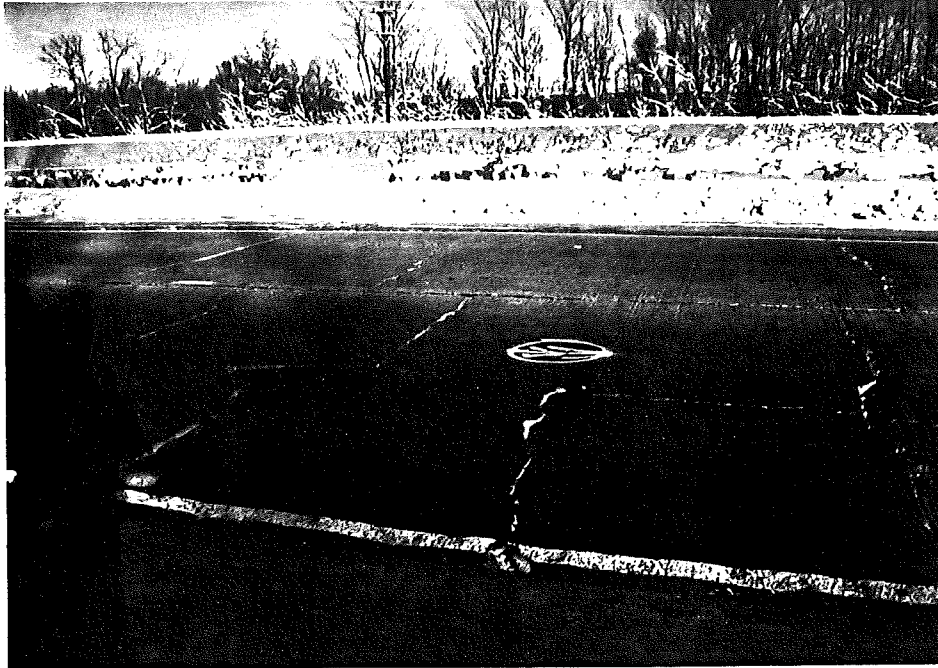
Photo #12: Pavement in the East bound test section (MI2-2). Notice the shattered slab and the spalling at the cracks.

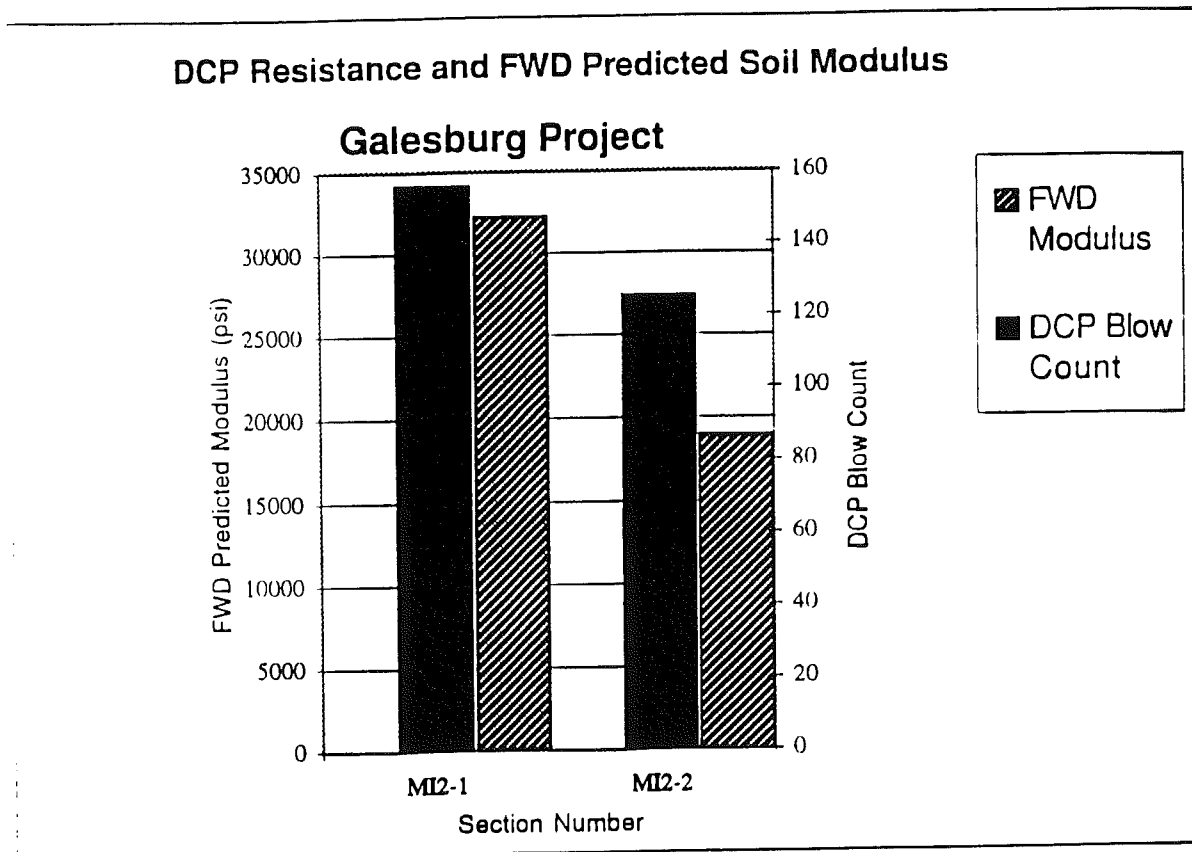
Figure #11 DCP and FWD analysis of foundation stiffness for the Galesburg project.

area indicating a large compression bowl and good load distribution through the system. Effective soil stiffness is calculated using the Bousdef program and the measured concrete stiffness from lab testing. Lower effective stiffness East bound could possibly be attributed to a weaker subgrade.

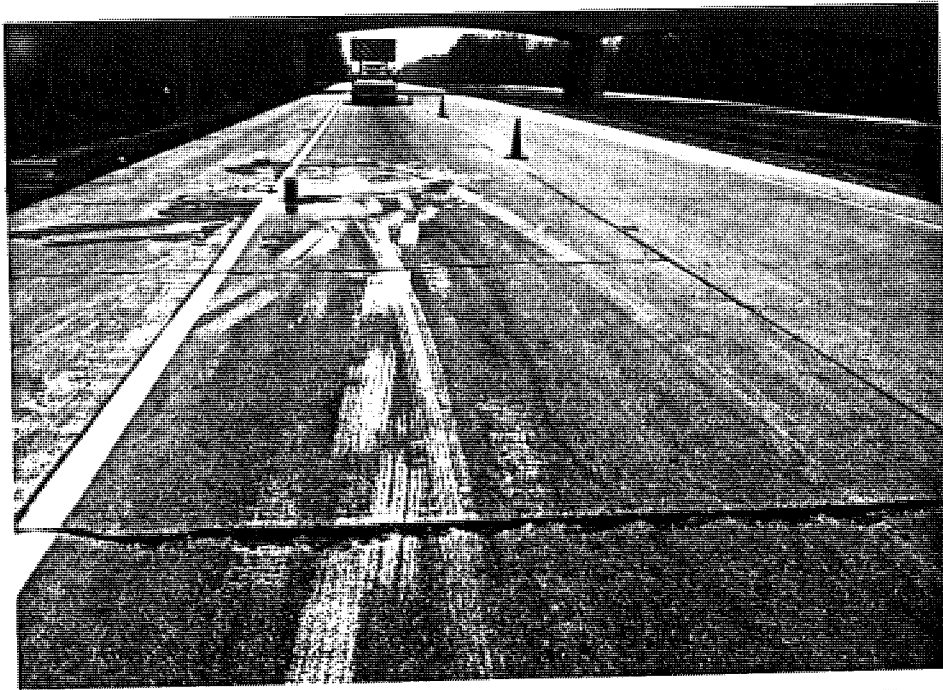
View of several spalled sympathy cracks near the beginning of section M11-1. The slope on the left shoulder is the bridge embankment. In general, the test section is on level ground.

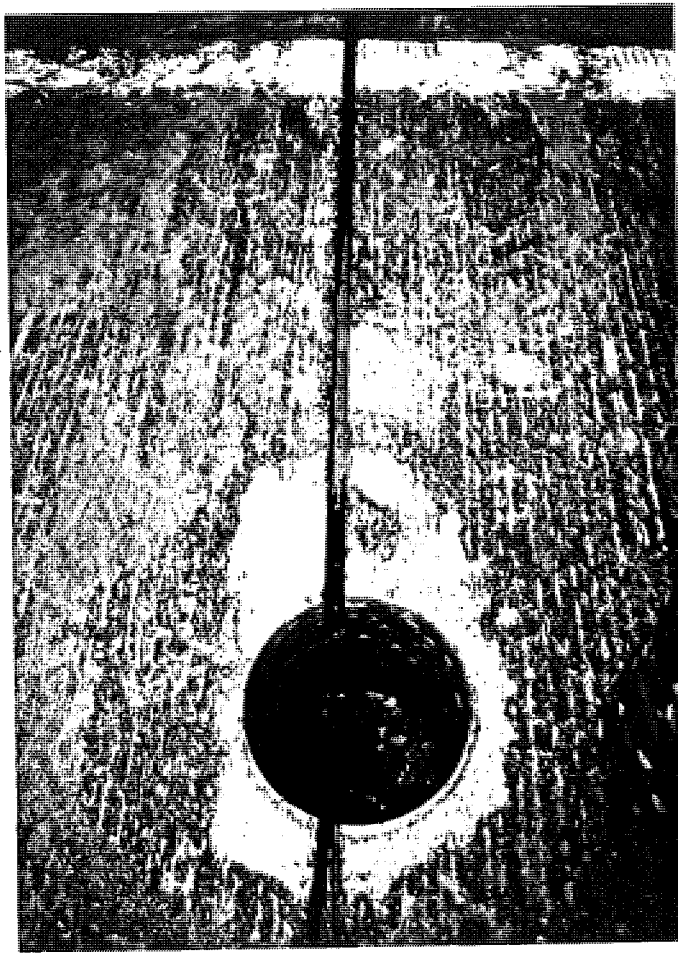
Close-up view of a core hole through a transverse joint in section MI1-2. The joint is in good condition. The OGDC is visible in the core hole. Coring water drained rapidly from the hole.

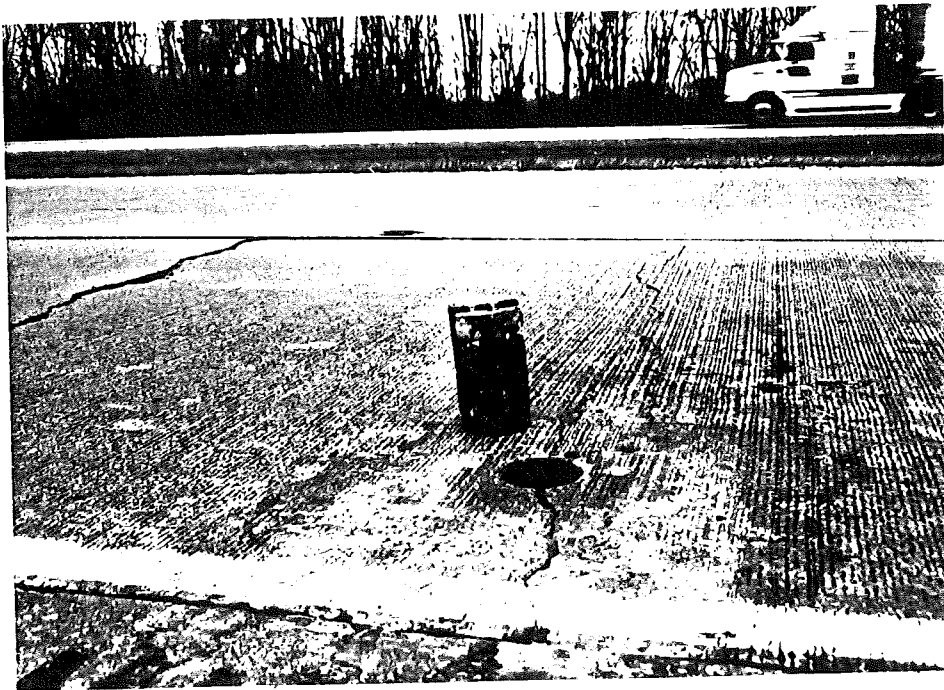
This photo shows two cracks of different severities in section MI1-2. Spalled and faulted cracks are common to this pavement section, though as seen here, some less severe cracks are also present. The more severe crack in this photo is a sympathy crack, while the other is not.

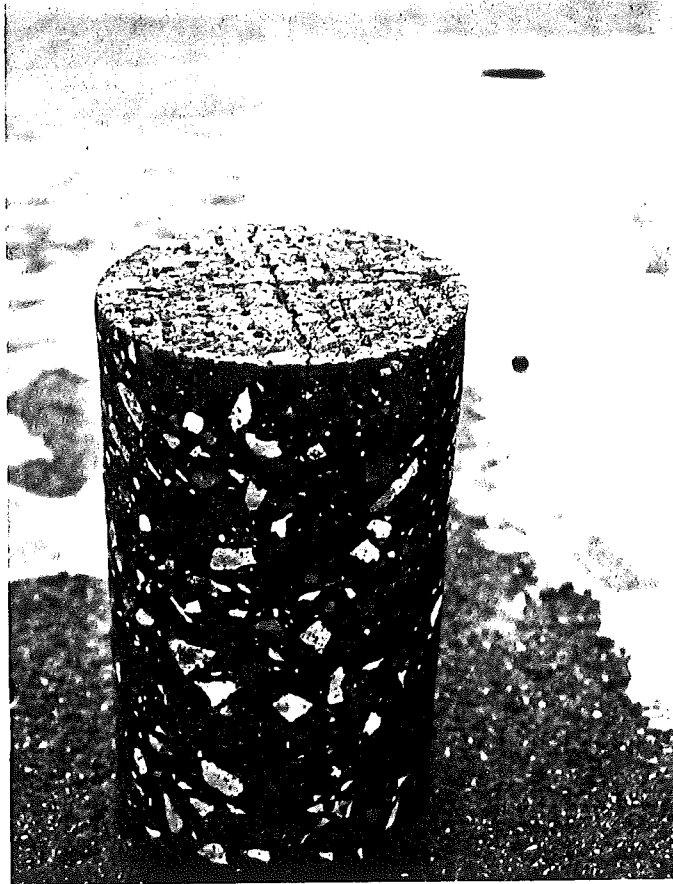
Close-up view of a cored sample in section MI-2 showing a shrinkage crack. The crack follows the tining pattern in the pavement, and extends approximately one inch deep into the concrete. This section contains recycled concrete.

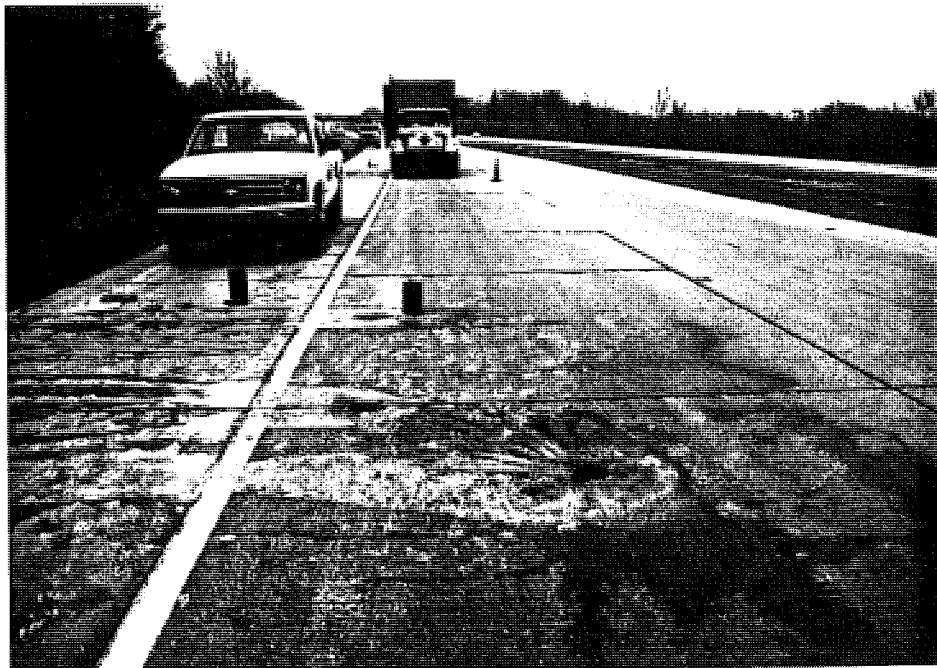
Overview of part of section MI1-2. Note the level terrain. Seen here are core holes from midpanel, crack, and joint section cores. The sympathy cracking pattern is evident.

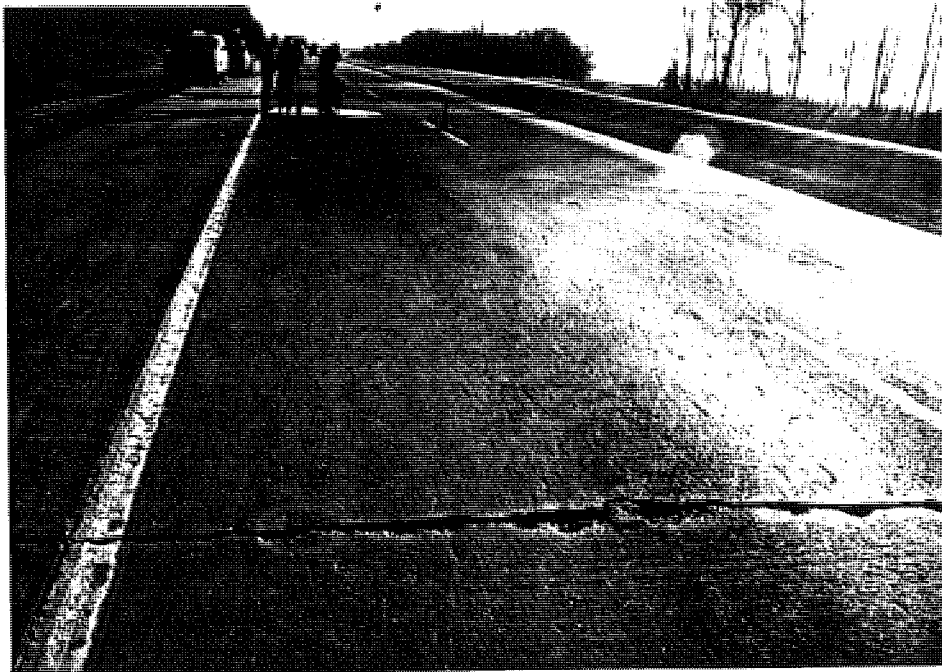
Overview of section MI1-3, showing a spalled sympathy crack in the foreground. The terrain is relatively level in this test section.

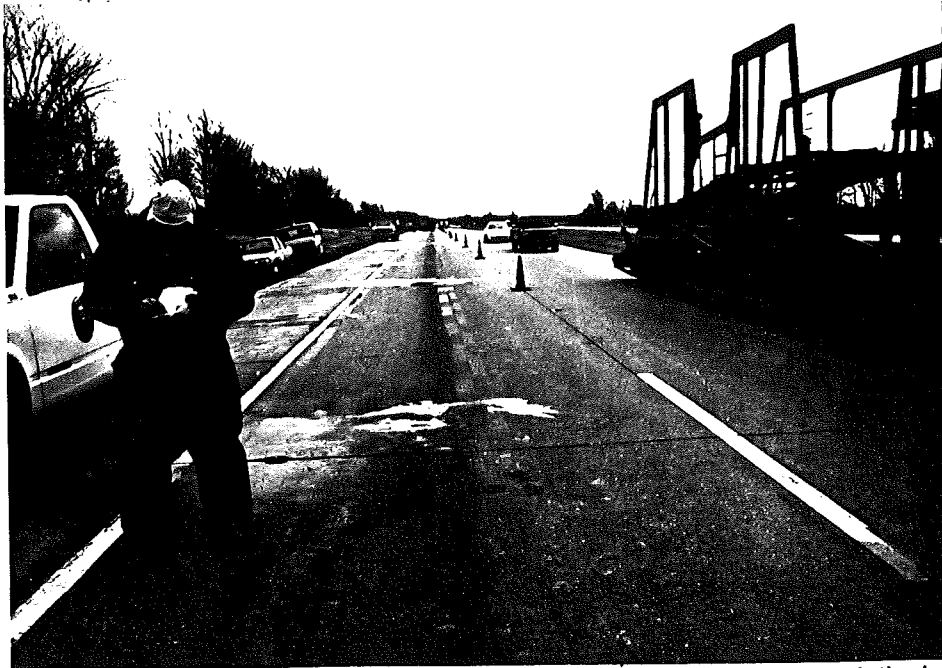
Overview of section MI1-4. This, as all sections of the Lawrence project, is on relatively level ground, with little cut or fill necessary. An intact transverse joint is visible in the foreground.

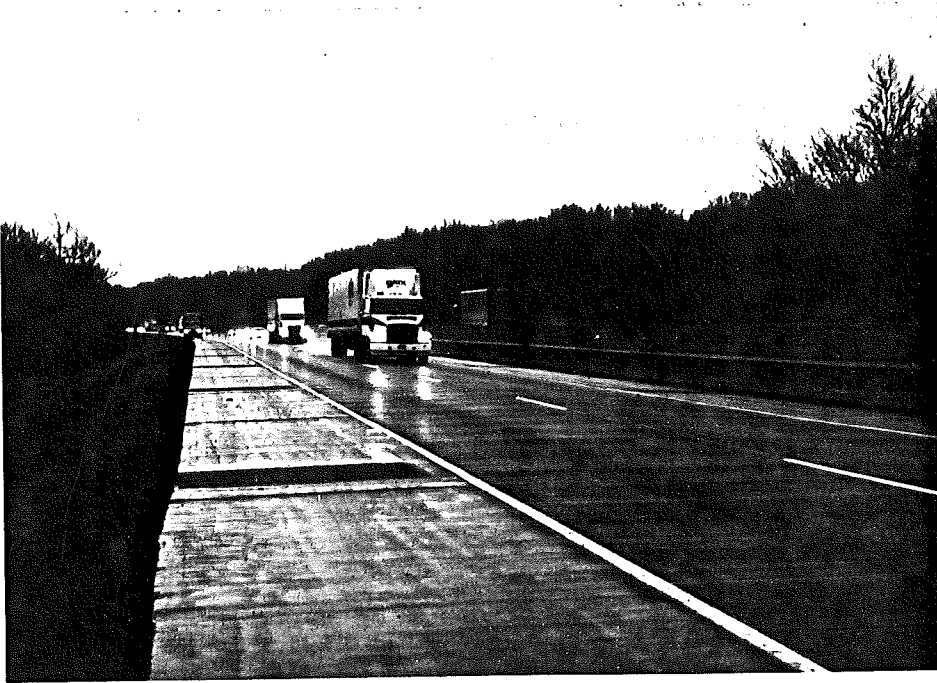
Overview of section MI2-1. This section (west bound) is on a gentle fill slope. The pavement is in excellent condition, with only two minor cracks found in the test section.

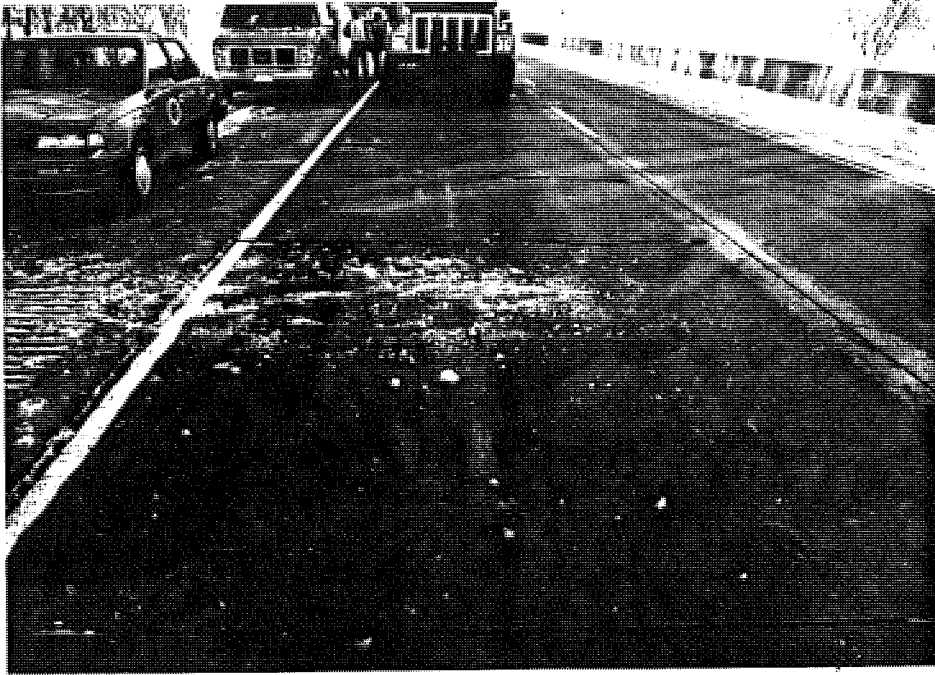
View of transverse and longitudinal cracking in section MI2-2 (east bound). Note the severity of the cracks including faulting. Asphalt patching is already in place to fill in the lane-shoulder dropoff.

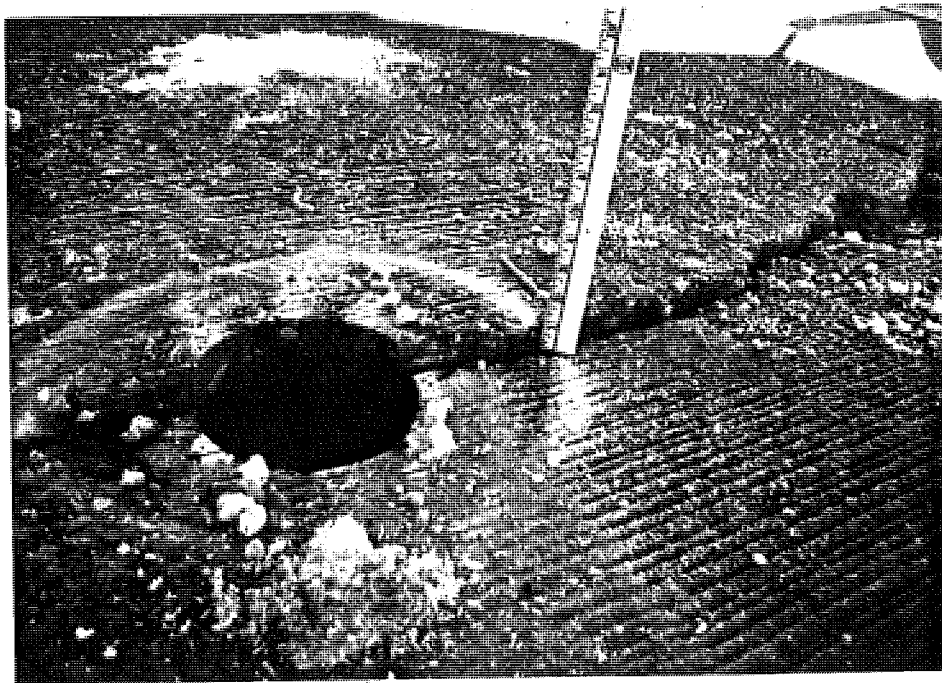
View of crack core hole in section MI2-2. Note the severe settlement of the panel with faulting of approximately one inch.
