# Capacity Prediction of Repaired and Unrepaired Bridge Beams with Deteriorated Ends

**FINAL REPORT – SEPTEMBER 2025**

**Western Michigan University**

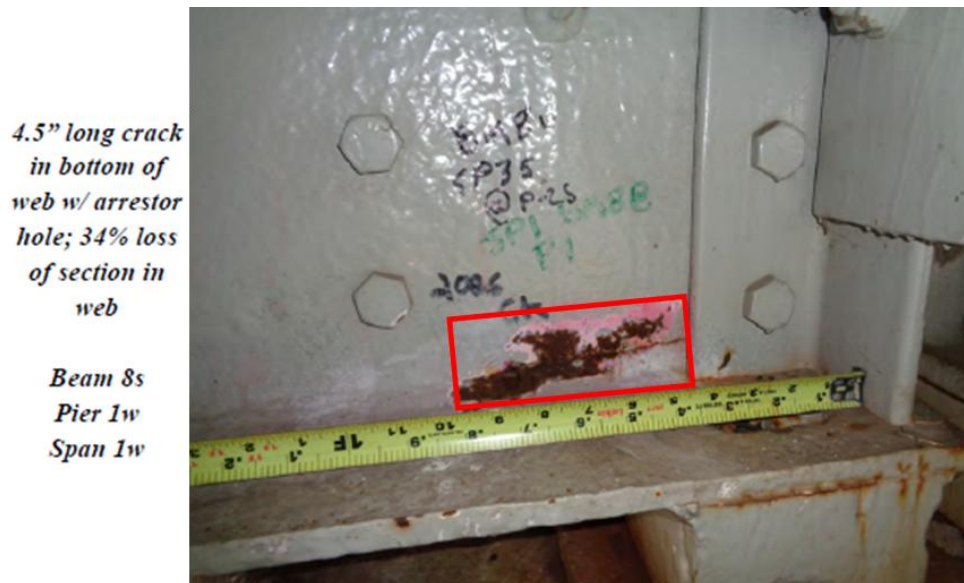
Figure 8-2. Beam end with a 4.5 in. long crack (STR 10907).

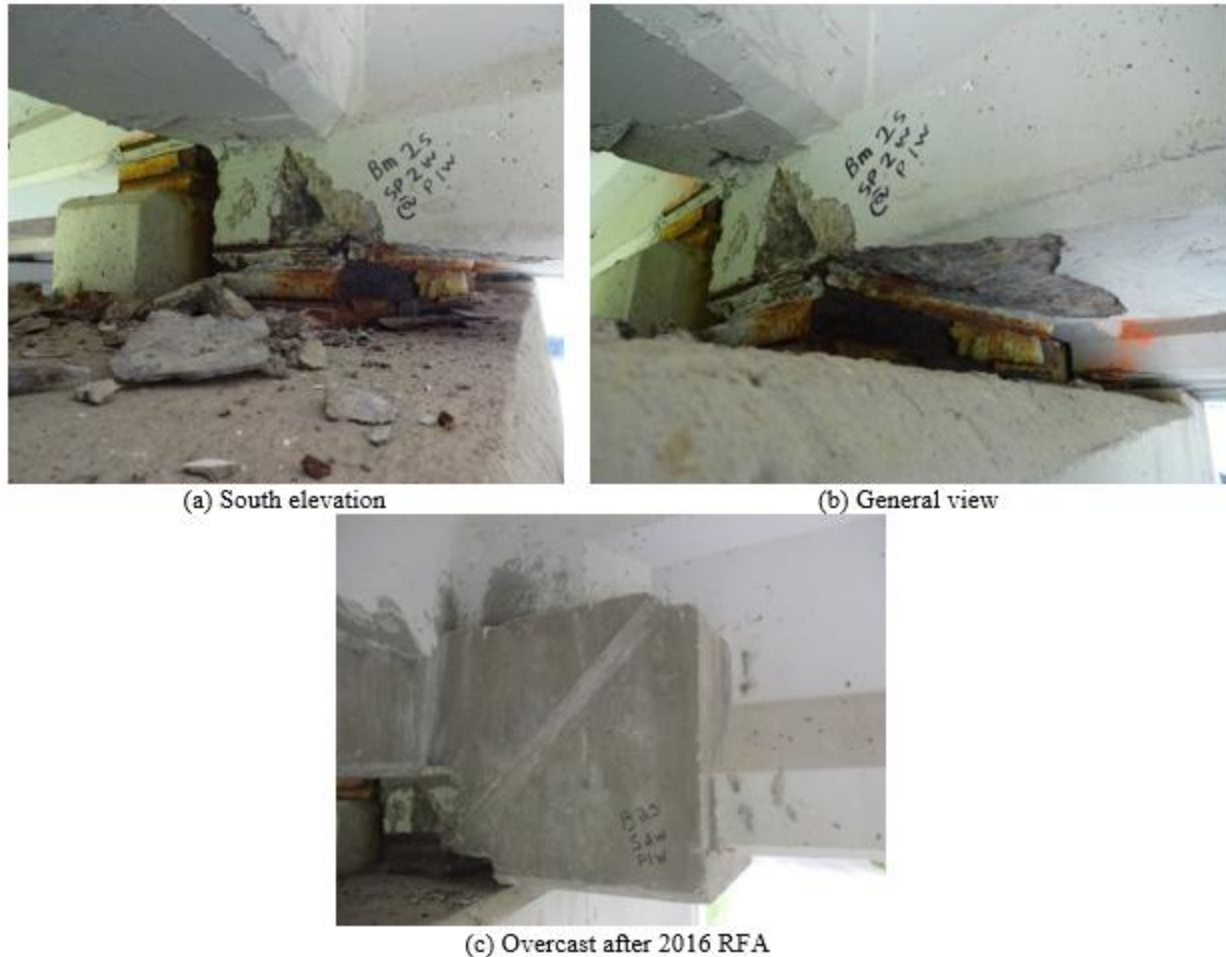
**Figure D-62. The condition of beam 2s in span 2w at pier 1w as of 06/09/2016 and the subsequent repair of the beam end.**

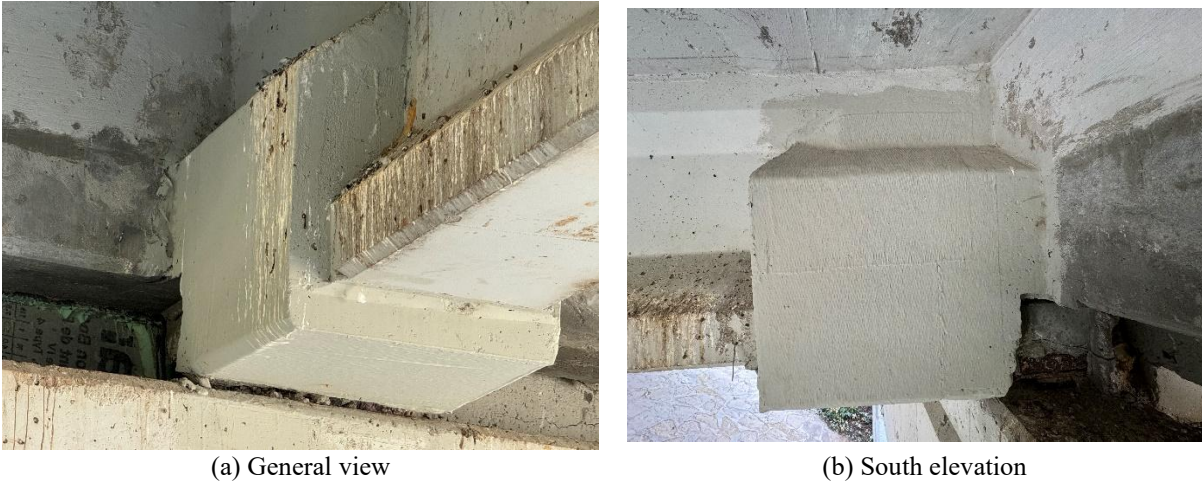
**Figure D-67. The overcast with CFRP wrapping at beam 4s in span 1w at pier 1w as of 10/04/2024.**

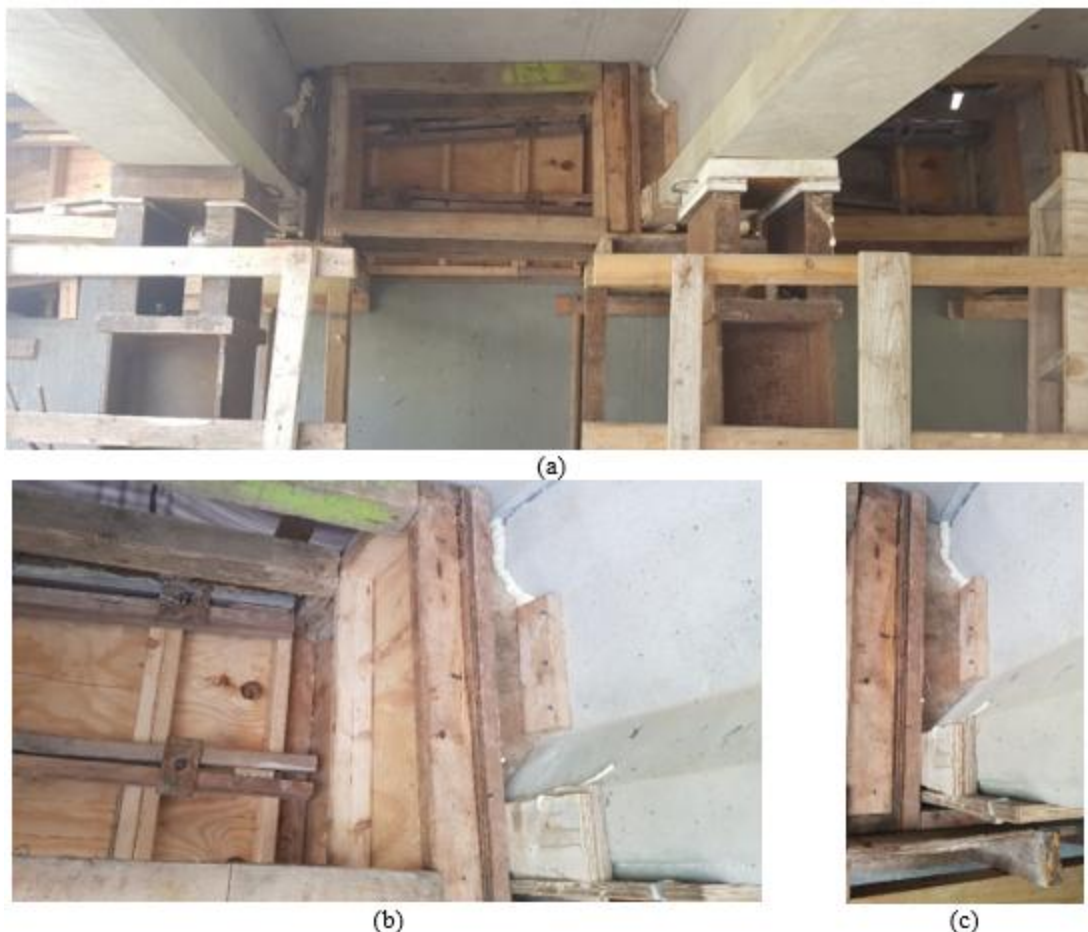
**Figure F-14. Formwork for an interior beam end overcast with an end diaphragm.**
