A MODEL STUDY
of
SLAB ACTION IN CONCRETE PAVEMENTS

A Joint Research Project Between
Engineering Research Laboratory,
University of Michigan and the
~~Michigan State Highway Department~~

Engineering Research Project No. M-561
Highway Department Project No. 44 F-11

Report No. F-72
July 16, 1945

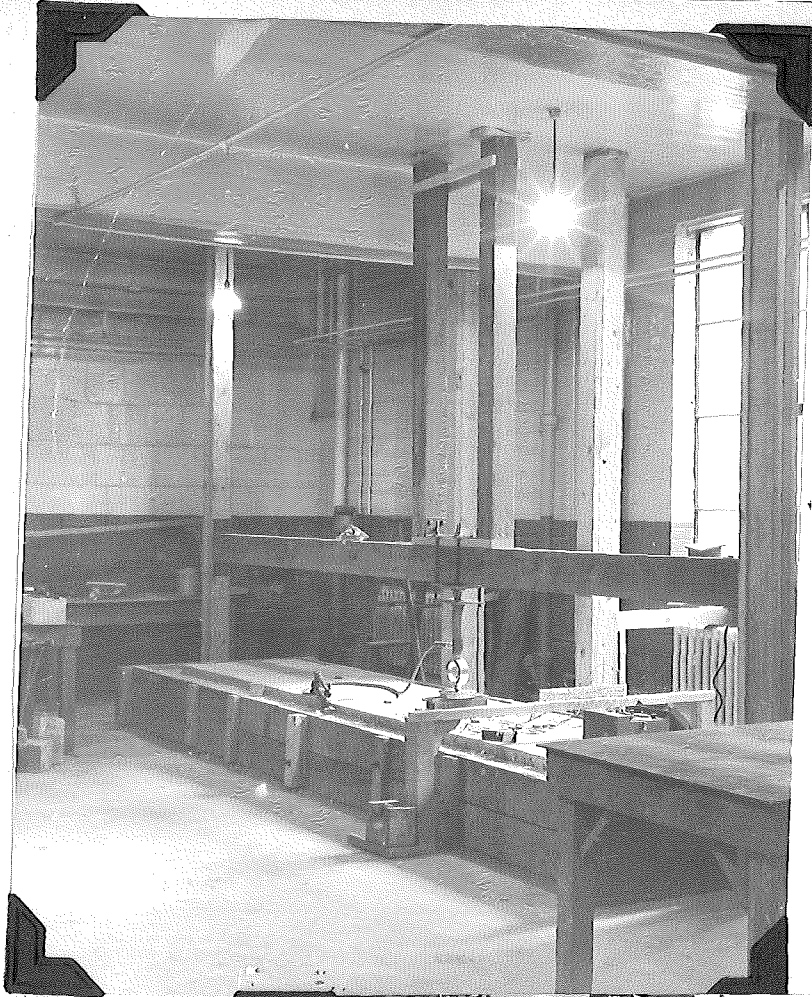
Figure 5. Superstructure and loading beam used to furnish reaction against jack during loading.

The original loading device was a cantilever beam. This was later replaced by a hydraulic jack. A heavy wooden superstructure and loading beams were built above the slab to provide reaction for the jack when the load was applied. This structure may be seen in Figure 5.

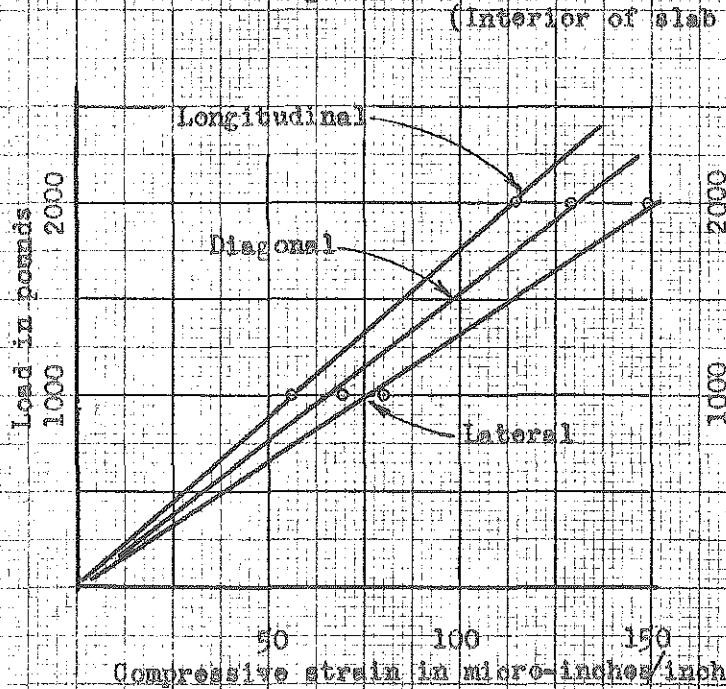
STUDY TO DETERMINE DIRECTION OF MAXIMUM STRAIN

(A) Comparison of strain values in three directions due to single wheel loading.

(B) Relation between strains on top and bottom of slab.

(C) Comparison of lateral and longitudinal strain under 3 types of loading. (Interior of slab - Stabilized subgrade - Single axle)

Sets of three gages each, one longitudinal, one lateral and one diagonal, were attached to the bottom of the slab directly beneath corresponding sets on the top. Loads were applied with results as shown in graphs A and B of Plate II. It was anticipated that the strains would be radial and of about equal intensity when the load was impressed through a single wheel. However, the wheel could not be located directly at the point of intersection of the gage lines without destroying the gages. This fact may have caused the discrepancy in the results. Graph B is evidence that the state of tension on the bottom of the slab

under a load is well indicated by the compression reading on the top. This is very advantageous because of the difficulty of attaching gages to the bottom, and the ease with which they may be cemented to the top.

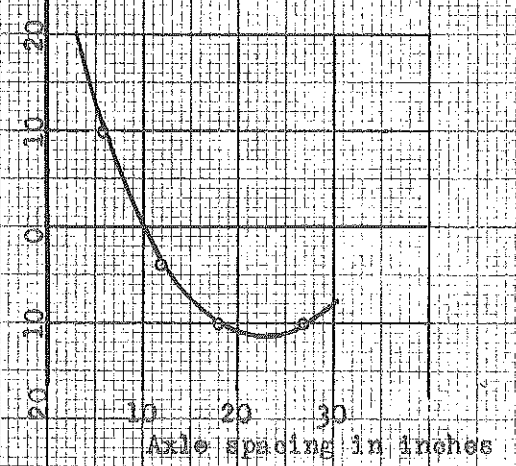
STUDY OF EFFECT OF AXLE SPACING

(A) Deflection and strain curves for loads on two axles.
 (15" spacing, 6 wheels per axle, 2000 lbs. per axle, sand subgrade)

(B) Effect of 2nd load upon strain under first at interior of slab.
 (6 wheels per axle)

(C) Effect of 2nd load upon strain under first at edge of slab.
 (2 wheels per axle)

Curves (B) and (C) in Plate VI present a relation between stress change under the first load caused by the application of the second load. Graph (C) for the edge of the slab seems to be better than B, the curve for the interior. The discrepancy was probably caused by variations in subgrade modulus or subgrade bearing. The curves are a good indication that any axle spacing under 12 inches must be accompanied by a reduction in axle load if the strains are not to be increased beyond those caused by a single axle. Apparently a spacing of 25 inches will produce minimum strains. Since the axle lengths used in the project were about 12 inches, it may be roughly stated that axles must be spaced at least one axle length apart if the two axle systems are to carry twice the load of a single axle. If the spacing is twice an axle length the total load could be increased about 10%.

The axle spacing effect for the edge was exhibited by Plate VI, Graph C. The critical spacing is seen to be 10 inches, and the spacing for minimum stress is 23 inches. These values are in fair agreement with the results of the center study.

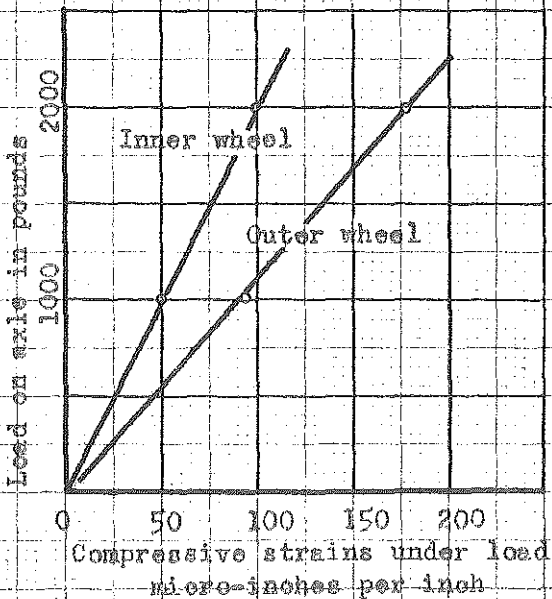
COMPARISON OF STRAINS AT CENTER, EDGE, END, AND CORNER OF SLAB

(A) Comparison of strains at slab center and edge
1 axle, 2 wheels, sand subgrade

(B) Comparison of strains at corner and end
1 axle, 2 wheels, sand subgrade

(C) Relation between strains under outer and inner wheel at edge

(D) Strains at corner caused by
(a) single wheel
(b) 1 axle with 2 wheels

The strain and deflection patterns for this location were similar in appearance to those found at the slab center with the qualification that the amplitudes of the curves were greater. Graph A of Plate

IX indicates that the strains at the edge exceed those for the center by 25 percent.

Stresses due to corner loading exceed those caused by any other type of loading. A study of Plate IX shows that the end stresses are less than 50 percent of the corner stresses; edge values are about 94 percent, and the center values are 75 percent of those at the corner. Graph D, Plate IX compares the effect of a single wheel load with that of a single axle and shows a strain increase of almost 45 percent over the values of axle loading.
