# EVALUATION OF R1-6 GATEWAY TREATMENT ALTERNATIVES FOR PEDESTRIAN CROSSINGS: FOLLOW UP REPORT

Prepared by:  
Western Michigan University

December 2016

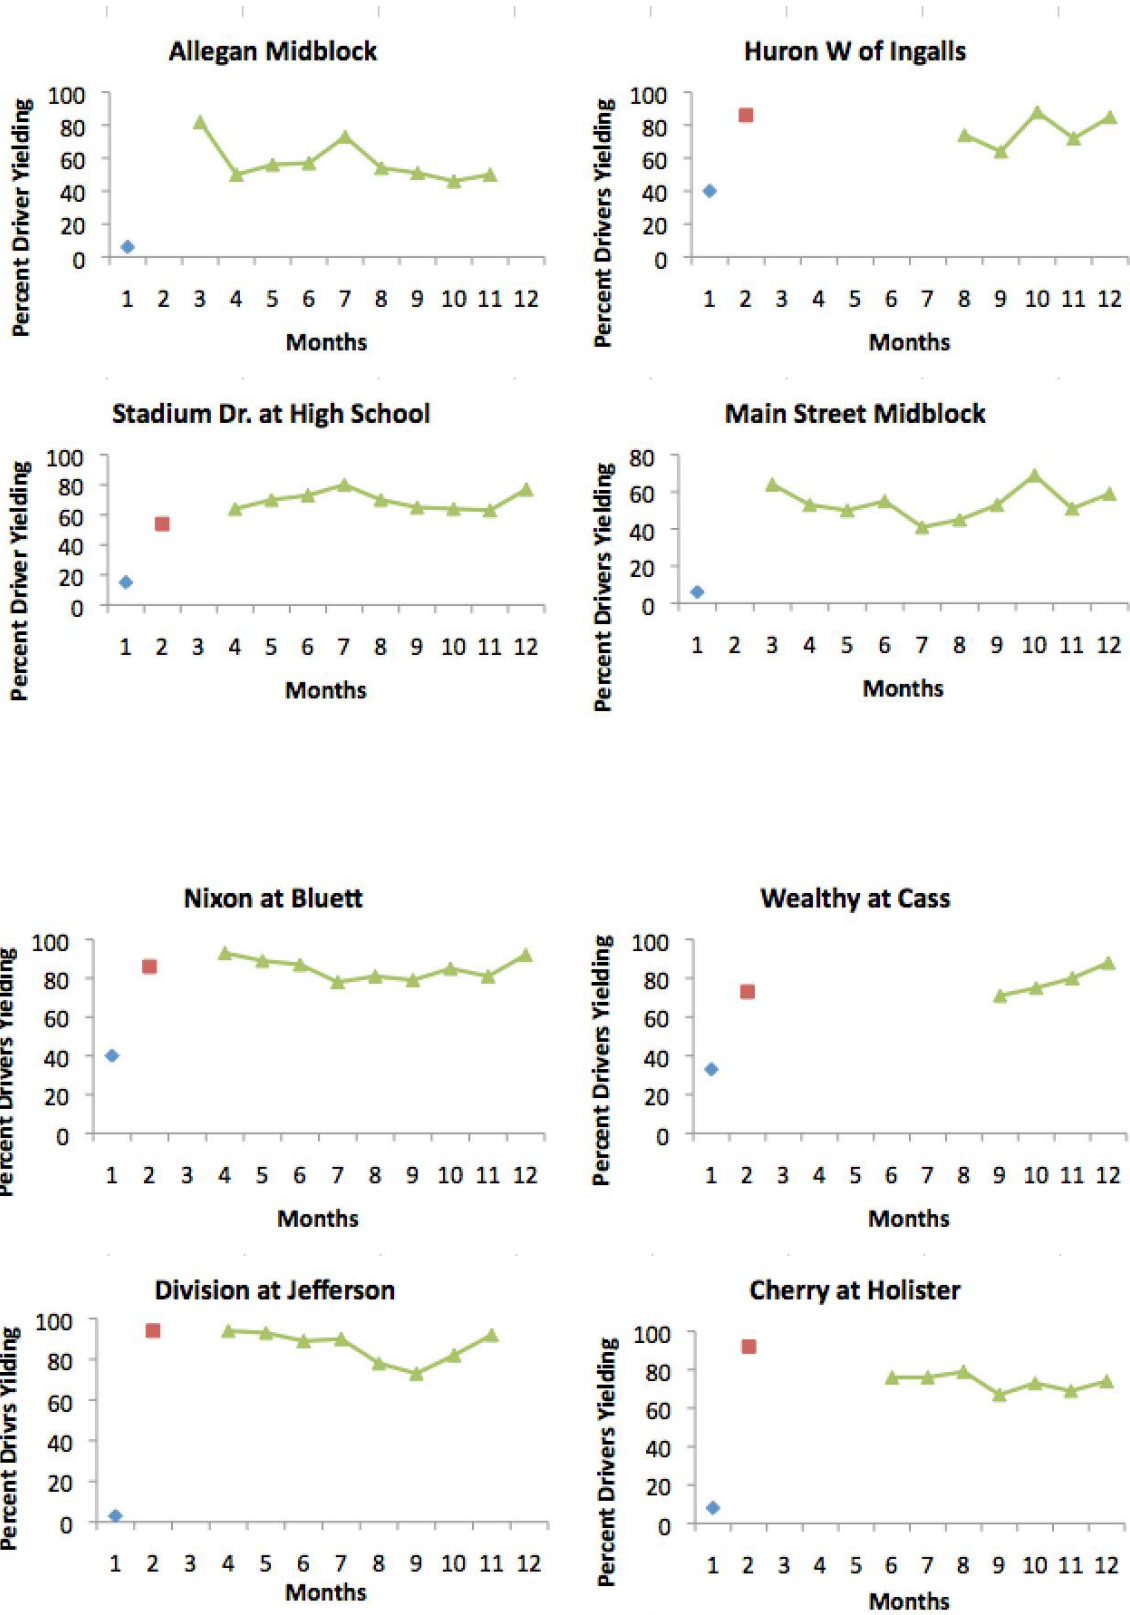
Figure 1.2. The percentage of drivers yielding during baseline (blue triangle), temporary gateway condition (red square) and during each month after the permanent installations (green triangles) at eight midblock and intersection sites.

Figure 1.2, and 1.3 show the percentage of drivers yielding at each of the midblock and intersection crosswalk sites with a straight approach across all sites as line graphs. The blue diamond shows the average percentage of drivers yielding during baseline before the gateways was installed. The red square shows the average level of yielding behavior during days when a temporary gateway configuration was installed. The green diamonds show the percentage of drivers yielding during each month after the permanent gateway was installed. The final figure shows the average for all sites. These data show that the gateway treatment produces a marked and sustained increase in the percentage of drivers yielding right of way to pedestrians at each of the sites and that the effect sizes are similar to those produced by an RRFB. Another important finding is that the effects persisted over time. This shows that the increased yielding behavior produced by the gateway treatment is not a novelty effect. It should be noted that the effects are larger at midblock and intersection sites and smaller at sites with curvature such as roundabout and traffic circle sites. Note that vehicle speeds are considerably lower at roundabouts and traffic circles and that site distance is typically poorer.

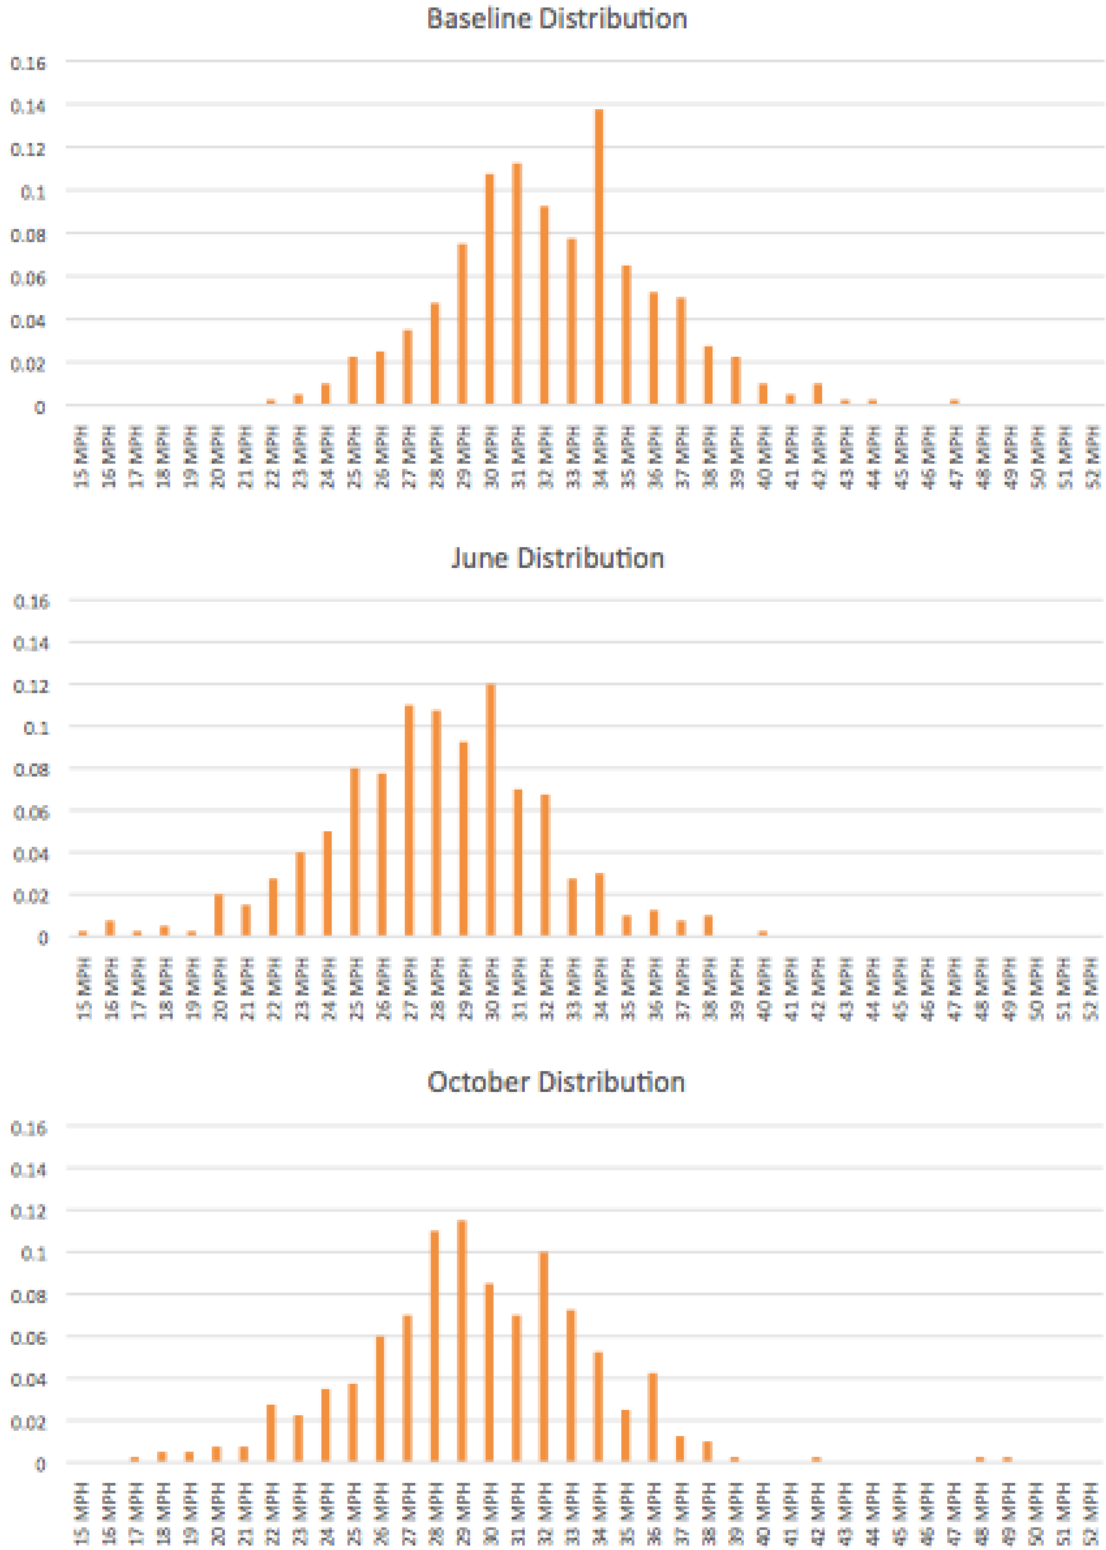
Figure 2.1. Speed distribution at the crosswalk for Nixon at Bluett. The top frame shows the distribution of speeds for baseline, the middle frame shows the distribution in June and the bottom frame shows the distribution in October.

At the Nixon Rd. crosswalks 758 vehicles that slowed at the crosswalk were observed and no instances of hard braking were observed. At the S. Division crosswalk 912 vehicles that slowed were observed and only one instance of hard braking was observed. These data were collected several weeks after the permanent installations.

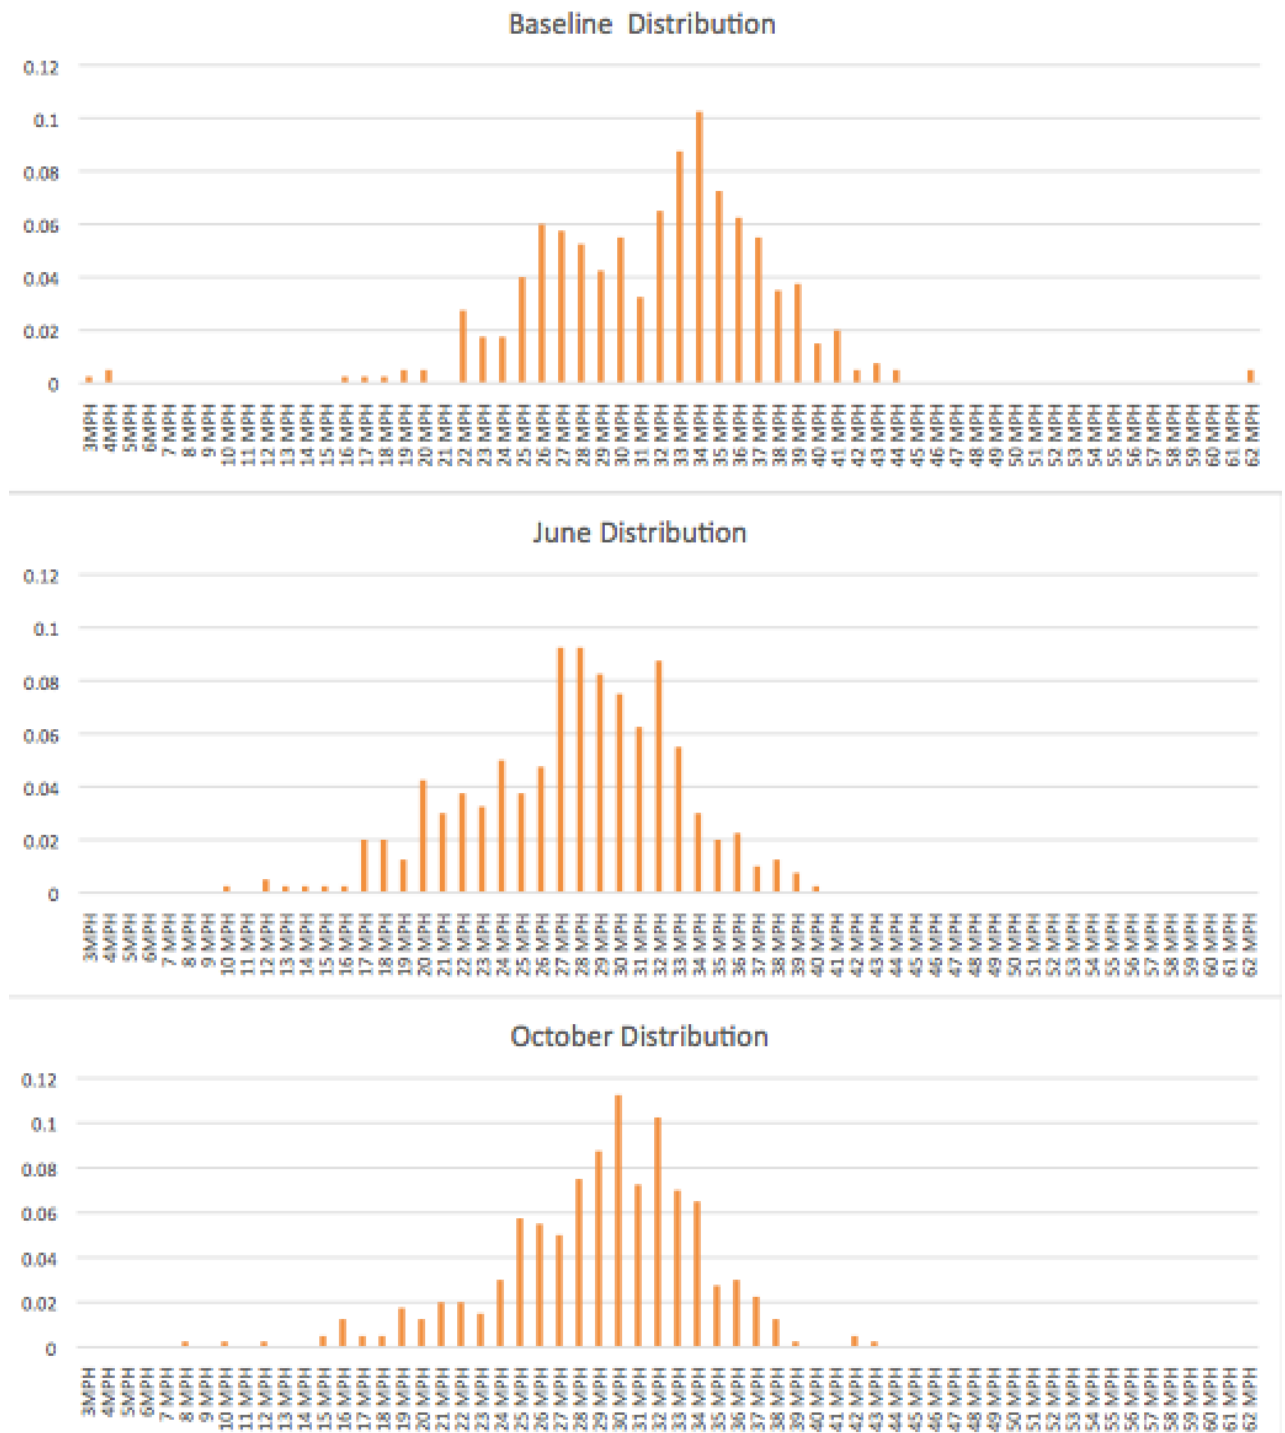
Figure 2.4. The speed distribution at the crosswalk for Stadium Drive. The top frame shows the distribution of speeds for baseline, the middle frame shows the distribution in June and the bottom frame shows the distribution in October.

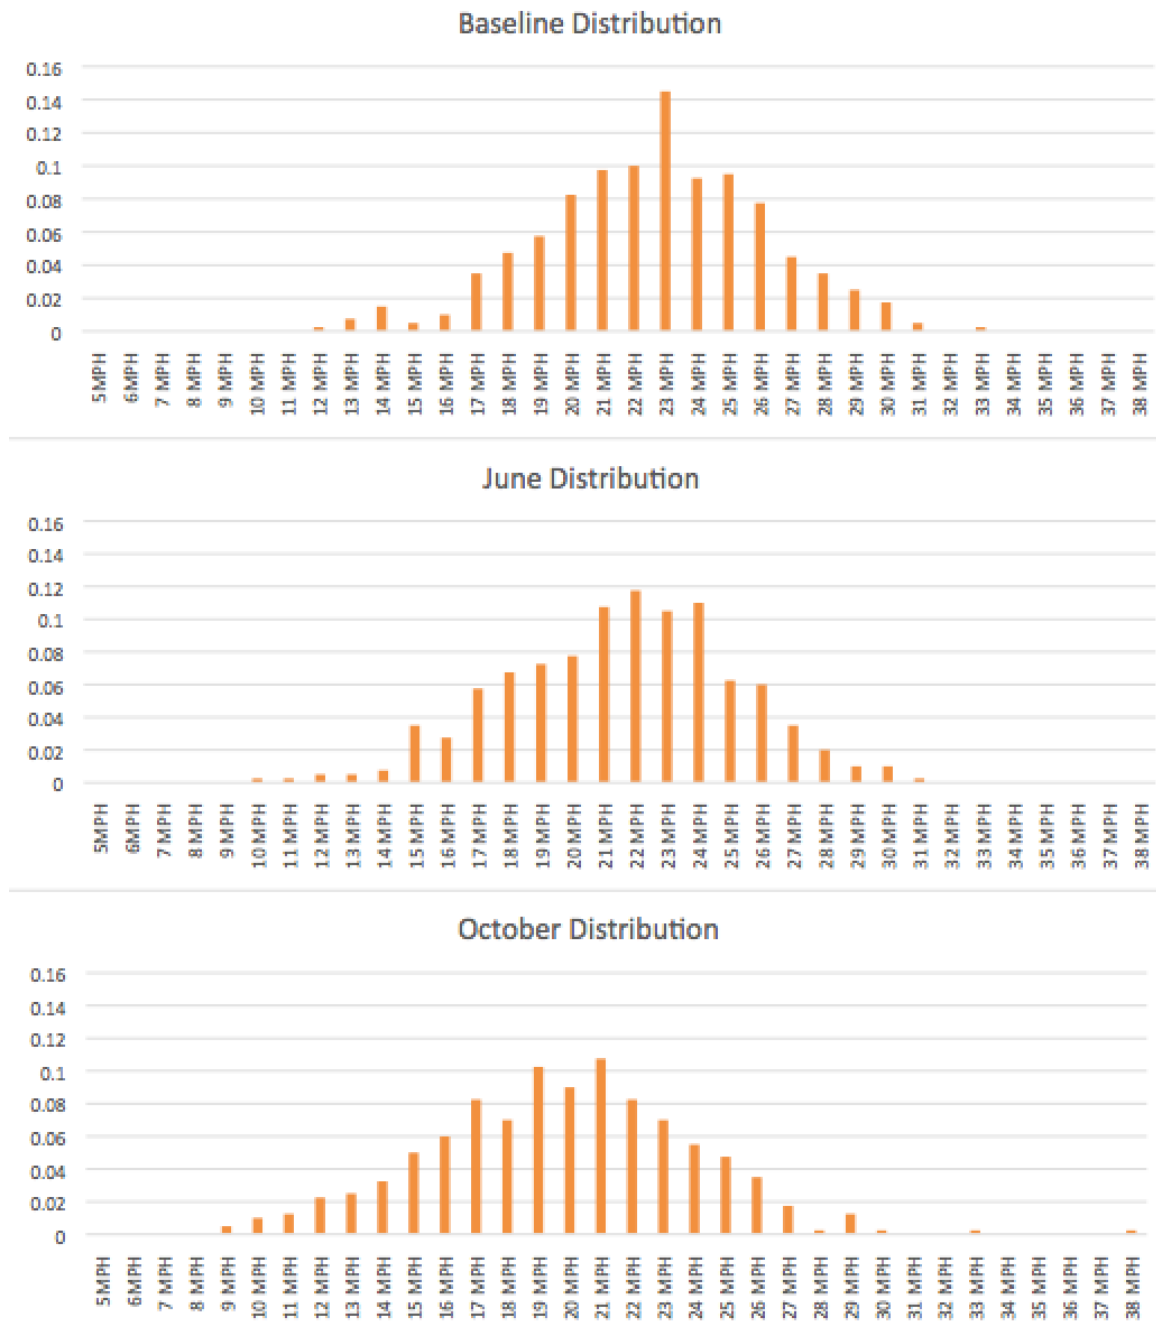
Figure 2.9. The speed distribution at the midblock crosswalk on Main Street in Three Rivers. The top frame shows the distribution of speeds for baseline, the middle frame shows the distribution in June and the bottom frame shows the distribution in October.

Figure 2.8 shows the speed reductions entering one of the roundabouts in Benton Harbor. At this site a similar progressive shift toward slower speeds was observed with a larger shift in October than in June. Figure 2.9 shows a similar progressive shift in speed after the gateway was introduced at a midblock site in Three Rivers.

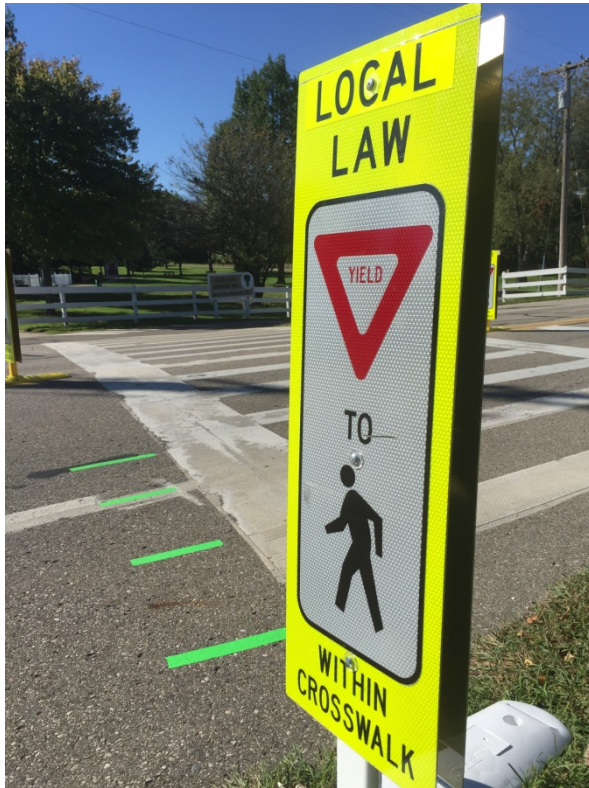
Figure 3.2. Tape lines marking placement of sign for each gateway width.

Initially, data were planned to be collected on widths ranging from 16ft to 10ft, as well as baseline, however when the signs were placed at the 10ft interval, one experimenter became concerned that this might increase the probability of a sign being struck. In response to this, it was agreed to make the fourth sign width 18ft, which maintained the parametric nature of the study. Taped lines were placed on the ground at the set distances, and the signs moved to these positions with each change in conditions (see Figure 3.2).

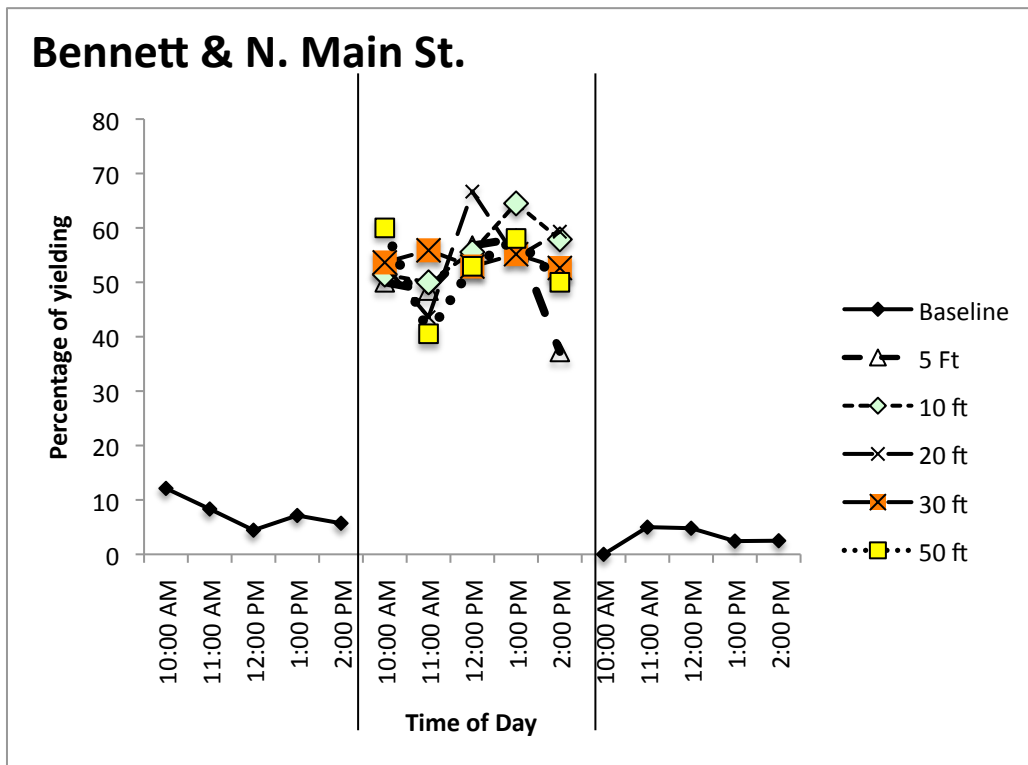
Figure 4.1. The percentage if drivers yielding right-of-way to pedestrians when the sign was placed 5 ft, 10 ft., 20 ft. 30 Ft. and 50 ft. in advance of the crosswalk.

The results of this study are presented in Figure 4.1. During the baseline condition 7.5% of drivers yielded right-of-way to pedestrians. When the gateway was 5 ft. in advance of the crosswalk, 50.1% of drivers yielded, when it was installed 10 ft. in advance of the crosswalk 55.9% of drivers yielded. When the sign was 20 ft in advance of the crosswalk 55.4% of drivers yielded to pedestrians, when the signs were installed 30 ft. in advance of the crosswalk 54% of drivers yielded to pedestrians, and when the signs were 50 ft. in advance of the crosswalk 52.3% of drivers yielded to pedestrians.

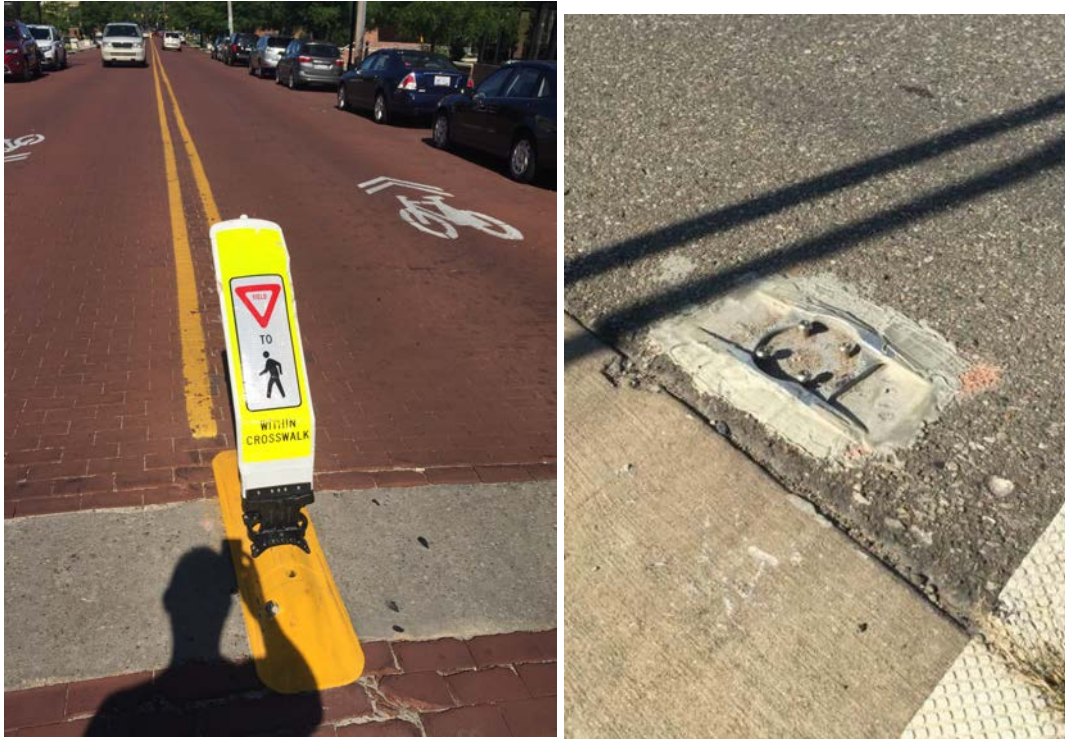
Figures 5.2-a. (above left) shows an R1-6 sign installed on a removable curb base that was damaged during the study. Figure 5.2-b (above right) shows a sheared base of a flush mounted sign.

One type of R1-6 mounting (Flush mounted with a spring loaded pivot performed less well than the others. All of the R1-6 signs lost were of this type. Those mounted with a flexible rubber linkage on a curb type base all survived although one of the paddles was bent on one of these signs. It was decided not to replace lost signs to determine if the partial gateways offered some degree of effectiveness. The results indicated partial effect if one element was lost. At one site (Westnedge and Ranney) two out of three signs were lost and yielding returned to close to baseline levels.
