EVALUATION OF COLD-MIX EMULSION BLACK BASE
(M 150 and Auburn Road, Oakland County)

J. H. DeFoe

**Research Laboratory Section
Testing and Research Division
Research Project 72 D-27
Research Report No. R-1048
Work Plan No. 20**

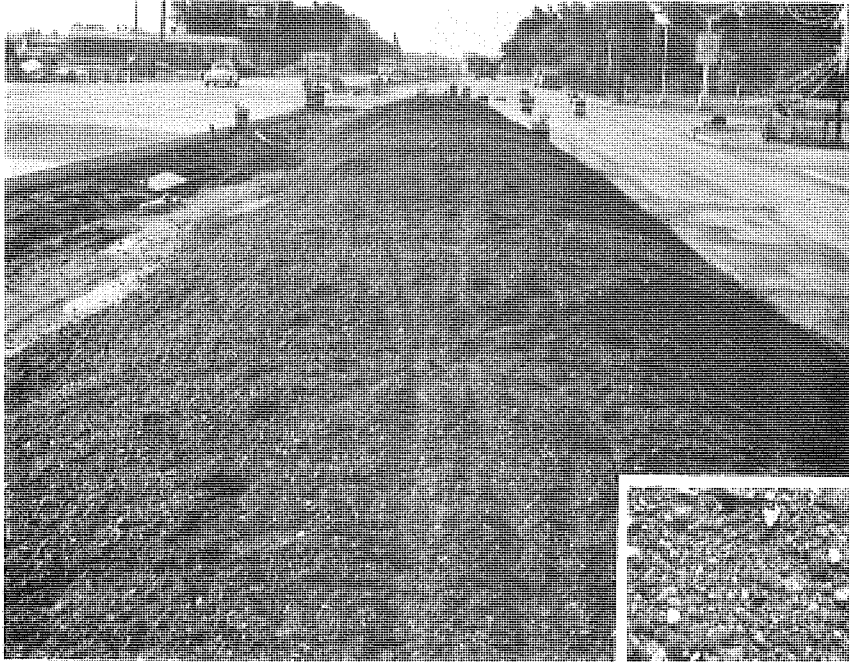
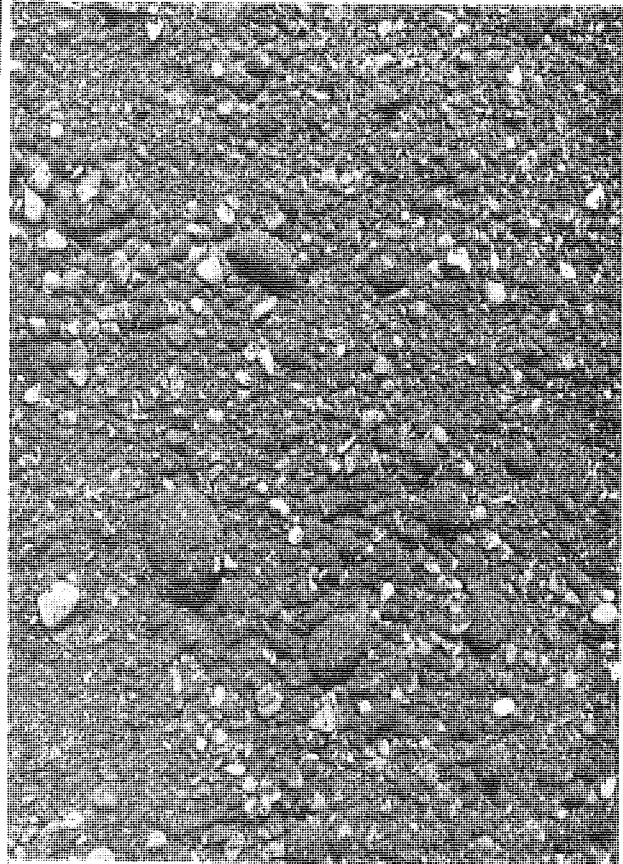
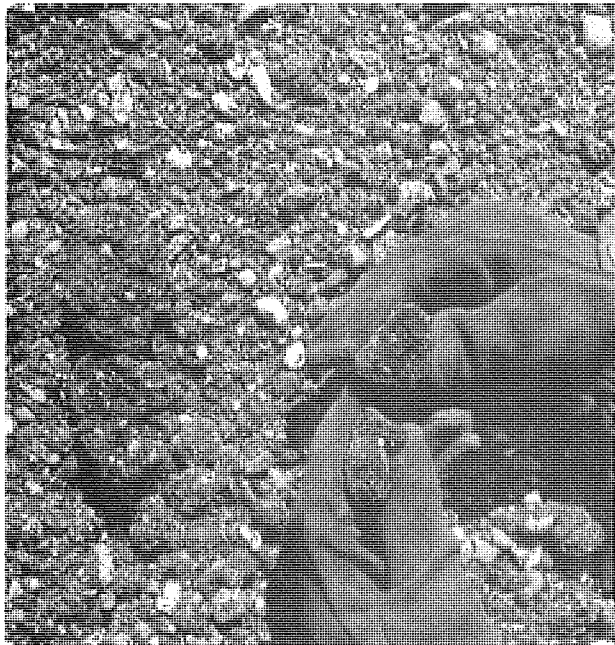
Figure 3. Stockpiled emulsion cold-mix black base material.

Some problem with balling was experienced during mixing. Change in asphalt formulation and reduced mixing time seemed to minimize this problem. Aggregate coating and asphalt distribution were not as complete and uniform as would be expected using hot plant mixes. The mixture was stockpiled about 10 days prior to placement as recommended by the asphalt supplier for the purpose of allowing for some drying of the material prior to placement and compaction. General appearance of the stockpiled mixture is shown in Figure 3.

▲ Stockpiled cold-mixed emulsion black base material.

Texture and appearance of emulsion black base material.

◀ Balling of asphalt and fines in emulsion black base mixture.

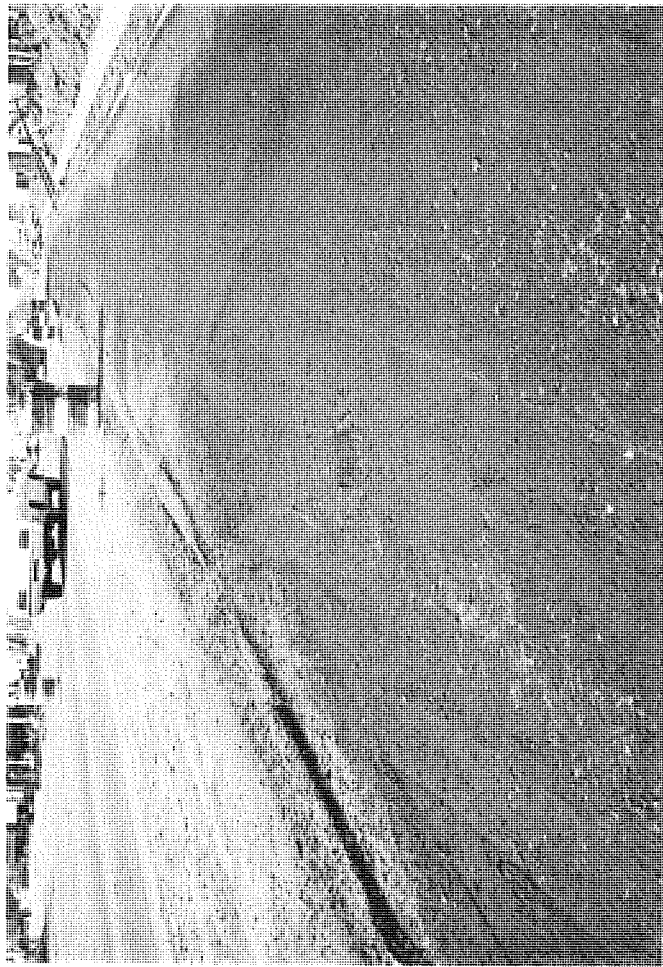
Figure 4. Moist appearance of the compacted cold-mix base material. Drying, generally progressing inward from the edges is accompanied by increased stability.

High moisture content, about 10 percent, caused some compaction difficulty but drying weather conditions permitted the attaining of adequate stability after one or two days. The moist, but drying, appearance of the material one day after compaction is shown in Figure 4. Although roller marks are visible, the material seemed stable under traffic at this time.

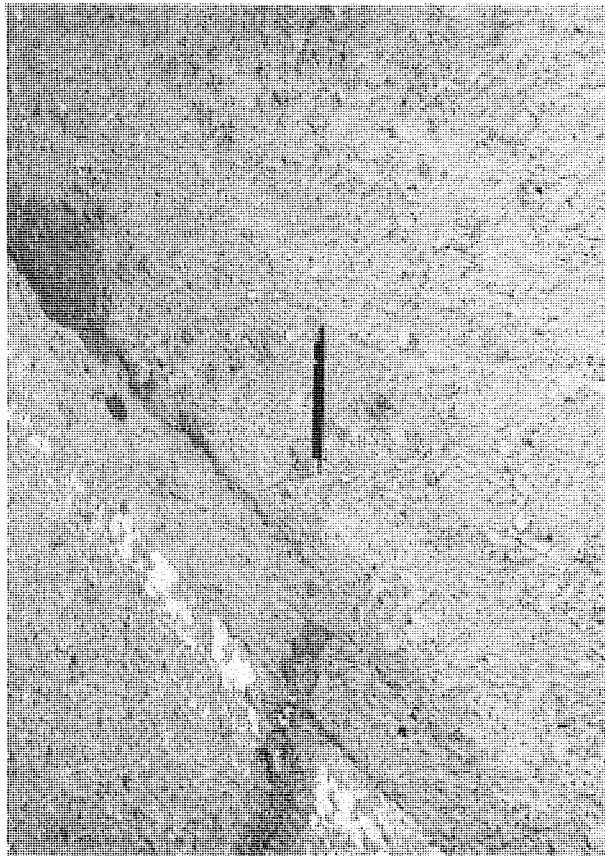
Figure 6. Condition of cold-mix black base widening and trench cut after exposure to traffic and weather over the winter.

After the experimental base material was placed and compacted the test area was opened to traffic without surfacing until July 1974. This afforded an opportunity for observing the performance of the experimental area throughout the winter and spring. At two locations, trenches were cut across the old pavement for installation of sewer pipe. Nine inches of cold-mix base was placed over the backfill material (Fig. 5). Because the road would be open to traffic the trench areas were temporarily surfaced with a cold-patching mixture. As shown in Figure 6, no signs of failure attributable to the cold-mix base material developed over the winter and spring of 1974.

Surface condition of the cold-mix material is exposed along the lower left edge of the photograph.

Sewer trench cut with 1-1/2 in. of cold patch over cold-mix black base.

Surface condition of widening strip in area exposed to traffic during the 1973-74 winter (same exposed area as above).

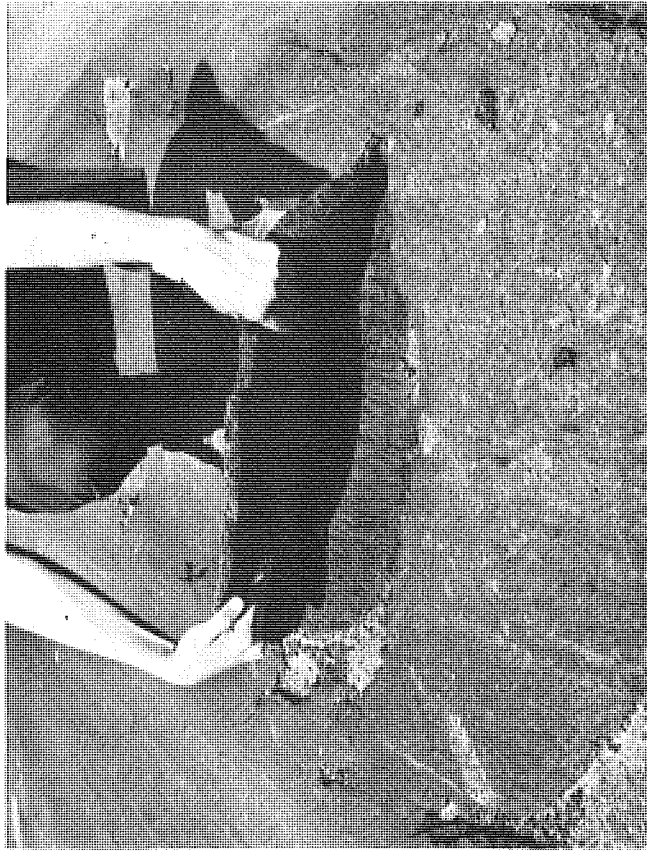
Figure 7. Surfacing problems originating from wet unstable cold-mix black base.

In July 1974 the test area was paved with 250 lb/sq yd of bituminous concrete surfacing. During the paving operation the leveling course shoved and pulled away from the base in about 15 percent of the experimental base area (Fig. 7). Tests showed moisture contents ranging from 5 to 7 percent in the base mixture. Construction notes indicate that the existing clay subgrade had been primed in these areas for some reason; this may have trapped water in the base mixture to cause the problem. The unstable base in these areas was removed and replaced with a hot plant-mix black base to expedite completion and no further problems have been observed.

Distressed surfacing placed on wet, unstable emulsion black base.

Leveling course separating from emulsion black base.

Saturated condition of emulsion black base in area of distressed surfacing.

2) If emulsion cold-mix base materials are to be used they should be relatively dry when placed and compacted, 3 percent moisture or less, and should be placed only over well drained subbase or subgrade materials. Reduction of water content by drainage as well as surface evaporation is necessary to achieve initial stability adequate for surface paving.

3) The stable cold-mix base should be surfaced as soon as possible to prevent further moisture accumulation. Long term curing, to provide additional stability, can then proceed without the presence of excessive environmental moisture.

5) A dependable method of inspecting for adequate initial stability prior to paving should be developed. At the present time, test rolling over the entire area is recommended with an inspector walking beside the roller to watch for excessive deflections, cracking, and the soft rubbery appearance associated with moist unstable base conditions.
