**DEVELOPMENT OF THE
PROCEDURE FOR EFFICIENT
EVALUATION OF BRIDGE DECKS**

**CONTRACT NO. 98-1303 DIR
Report submitted to
The Michigan Department of Transportation**

Report provides the background information for the Michigan Deck Evaluation Guide. It consists of chapters dealing with material models for deck analysis, field inspection and field test results, finite element analysis of bridge superstructure, and additional analysis on punching shear failure mode.

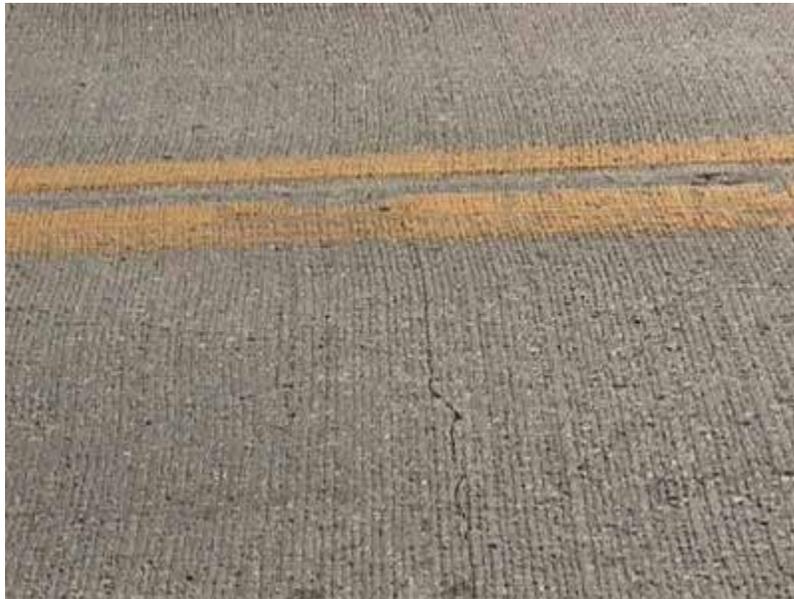
Figure 3-1. Transverse Shrinkage Cracks.

The possible types of deck damage, like categories of cracks and holes, crushed concrete and delamination are described in Michigan Deck Evaluation Guide, are presented below in photos from field inspections, Figure 3-1 to Figure 3-9.

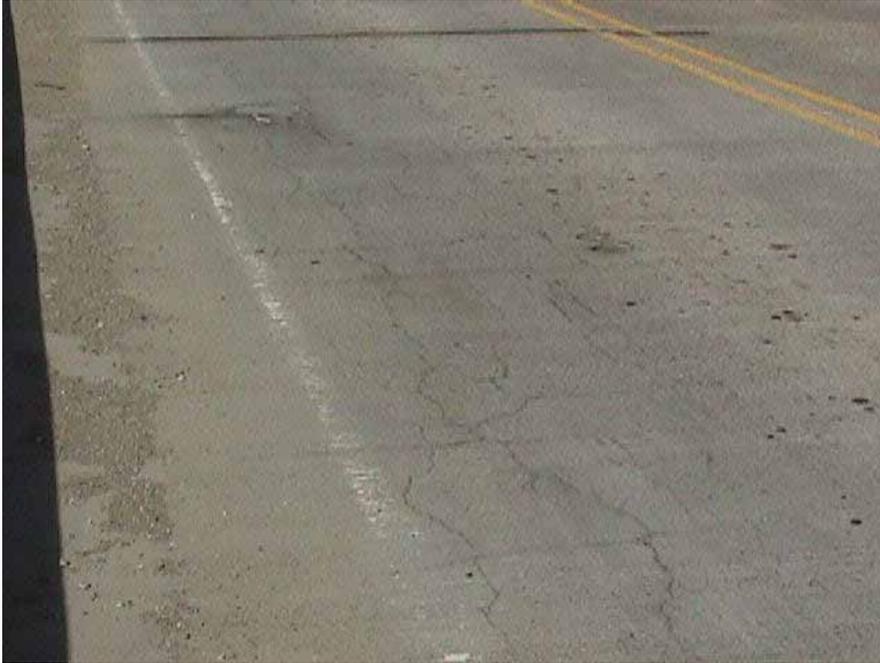
Figure 3-2. Longitudinal Cracks.

bridges, along the longitudinal joints between boxes. Transverse cracks often continued across the full width of the deck. In majority of decks, pot –holes were located along the wheel line of truck traffic, and mostly in the lane used by trucks rather than in a passing lane. Latex overlays were subject to delamination.

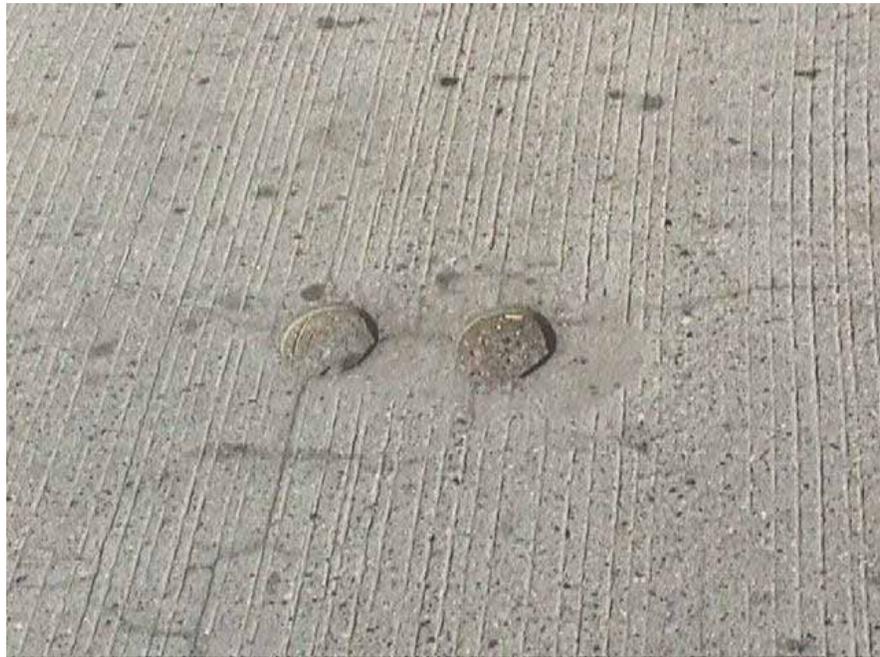
Figure 3-3. Cracks in Latex Overlay; Core Samples.

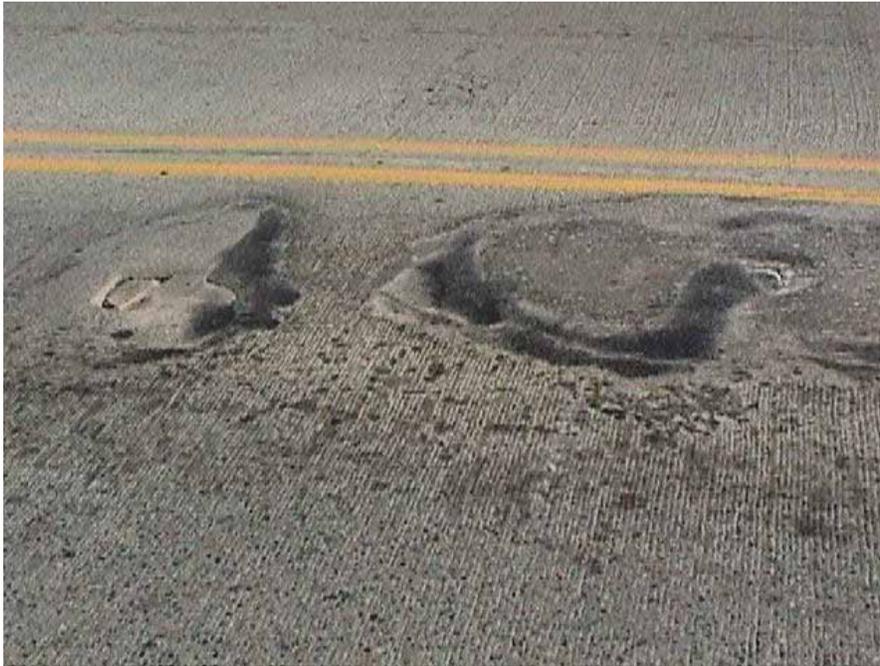
Figure 3-4. Potholes in Latex Overlay.

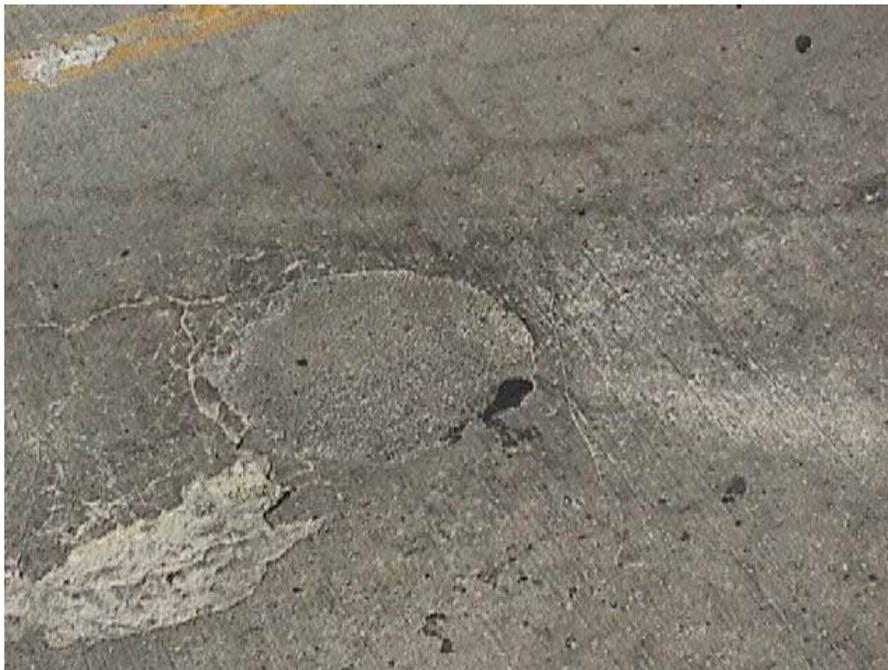
Figure 3-5. Pothole with Map Cracks.

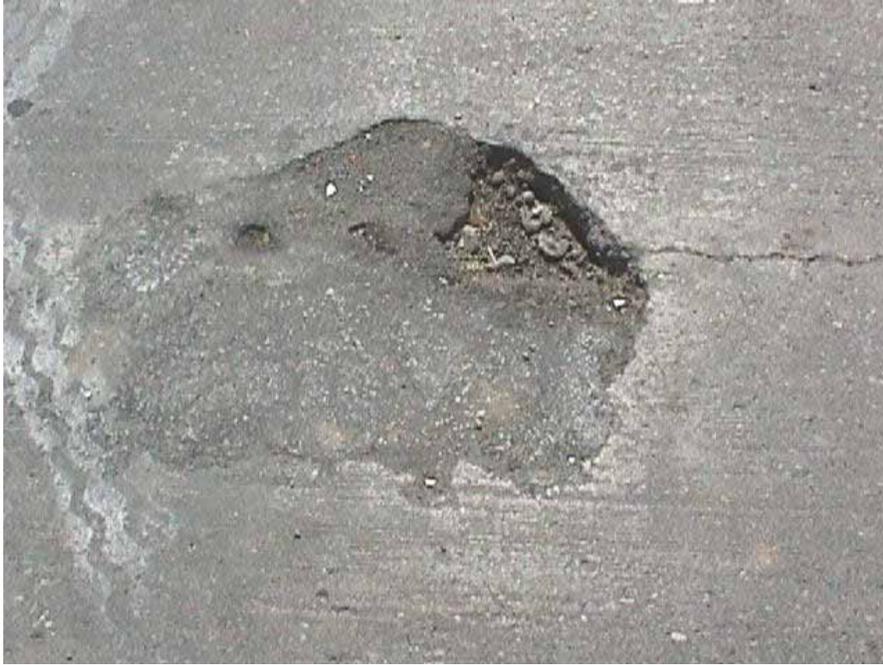
Figure 3-6. Pothole on the Way of Major Crack.

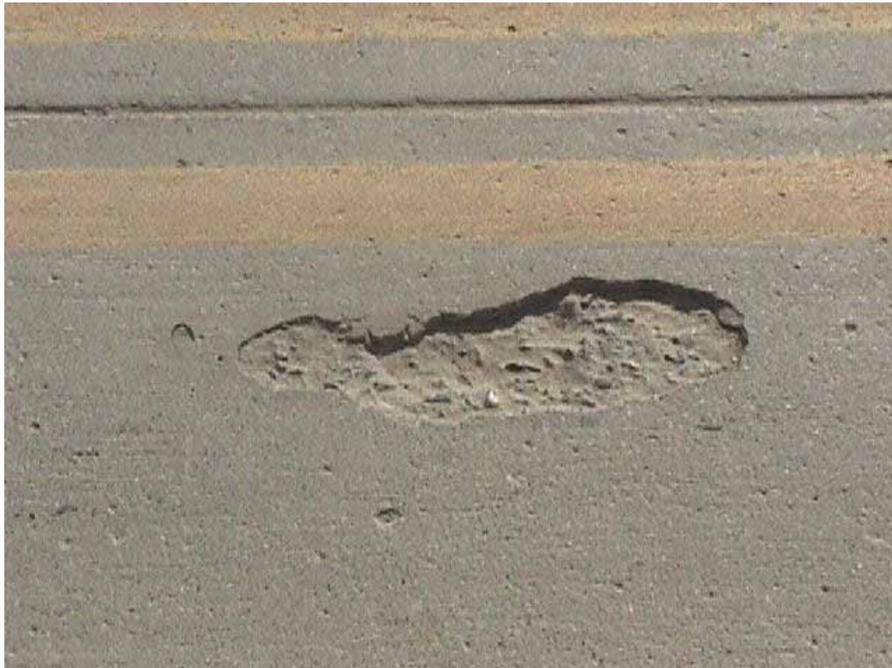
Figure 3-7. Pothole in Latex Overlay.

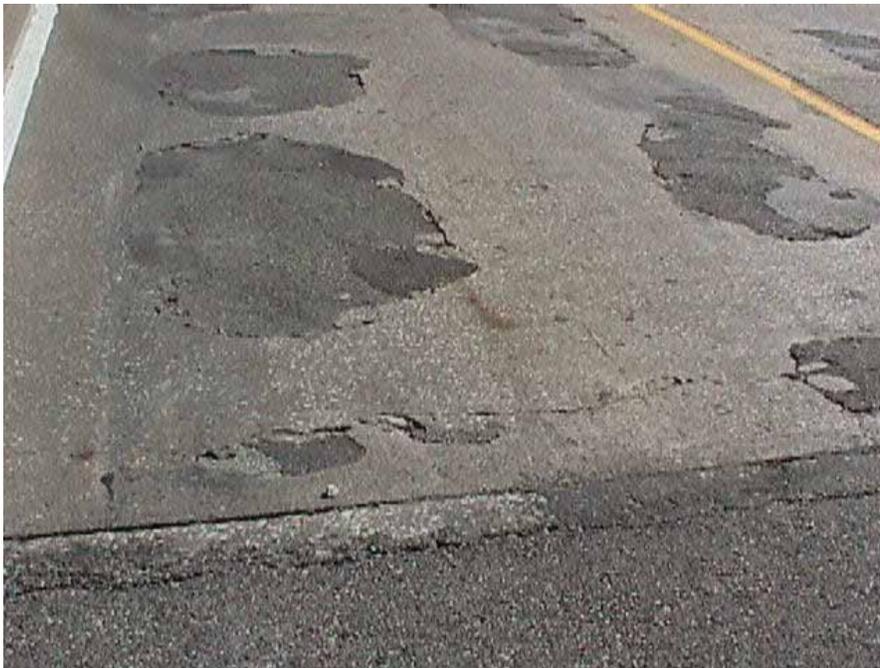
Figure 3-9. Holes on the Way of Wheels; Cracks Close to Joint.

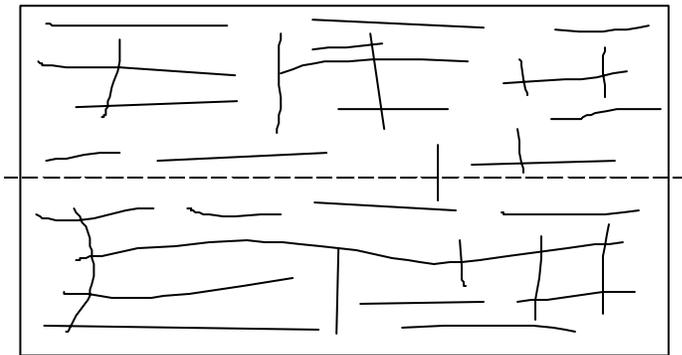
#27

Cracks could occur because of temperature changes. They are about in the same distance that concrete box girders.

map of small cracks on both lanes.

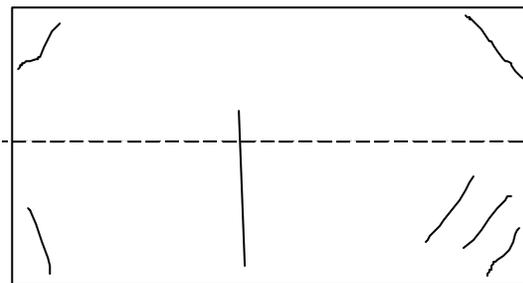
#33

Deck in rather good
condition, only a few
cracks.
One major crack.

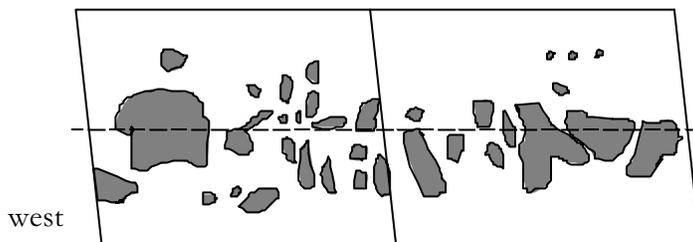
#35

Deck is in very bad
condition, deep holes,
upper reinforcement
is visible.

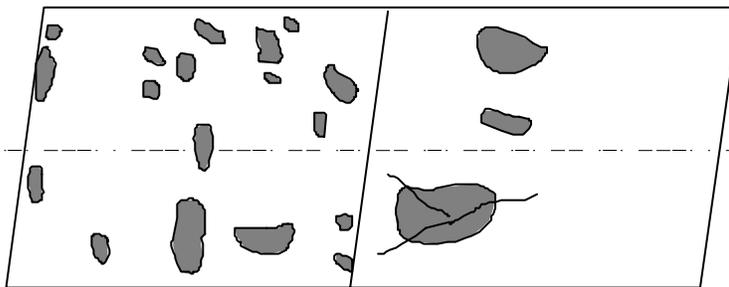
#38

Deck is deteriorated,
deep holes, some of them
are 3 inch deep. About
25% of the surface is
destroyed.

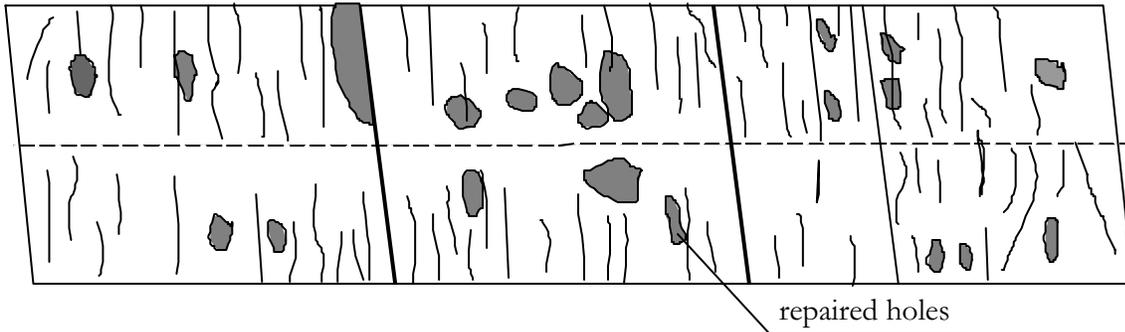
#43

Bridge # S04-47014, B2 of 47-9-6, EBF 219 (20) on Crouse Rd over I23
built in 1961; reviewed 10/12/99; steel girders very corroded

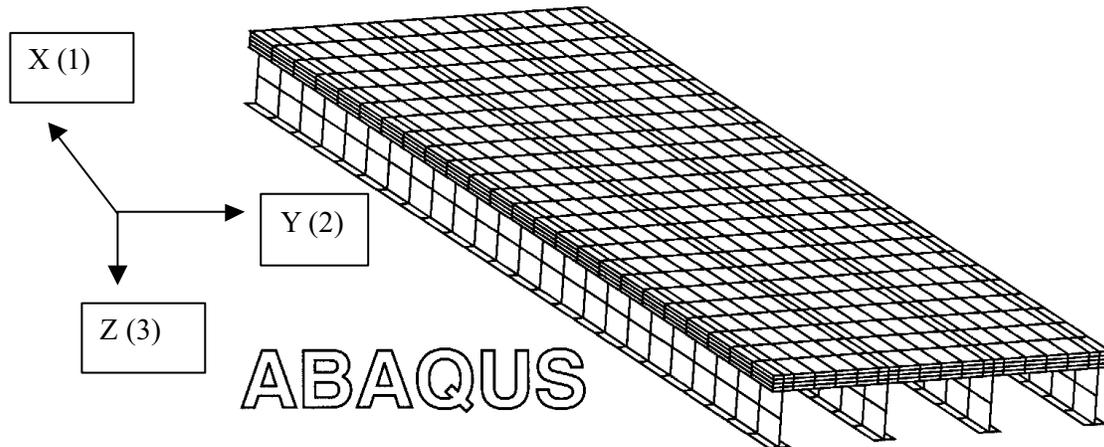
A typical FE model for a deck slab bridge used here is presented in Figure 6.1. Longitudinal (traffic) direction is noted as X or 1 and transverse direction is named Y or 2. Z or 3 refers to the vertical direction of the superstructure. Two or four layers of solid elements represent deck slab (Figure 6.2). All of these elements have the same length.

Figure 6.1 Isometric view of FE model for deck slab bridge.

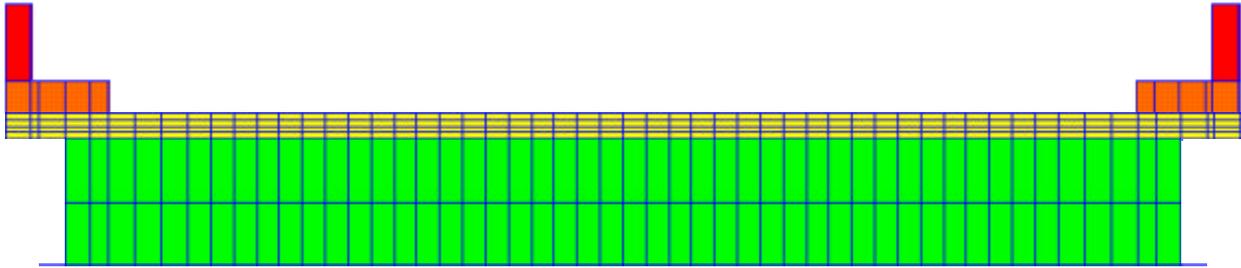
The nodal representation of live loads is strictly connected with n_e . The width of the elements (dimension in transverse direction noted as Y or 2) varies depending on the distance between girders, the flange width and on the transverse dimensions of edge parts of the slab such as curbs and barriers (if they are taken into account). Usually, the slab strip touching the upper flange is divided into two elements and the part of the slab between two flanges is divided into four rows of elements (Figure 6.2). These numbers can be easily changed. The transverse division of the sidewalk depends on its width and the position of the first girder.

Figure 6.2 Cross-section of the FE model.

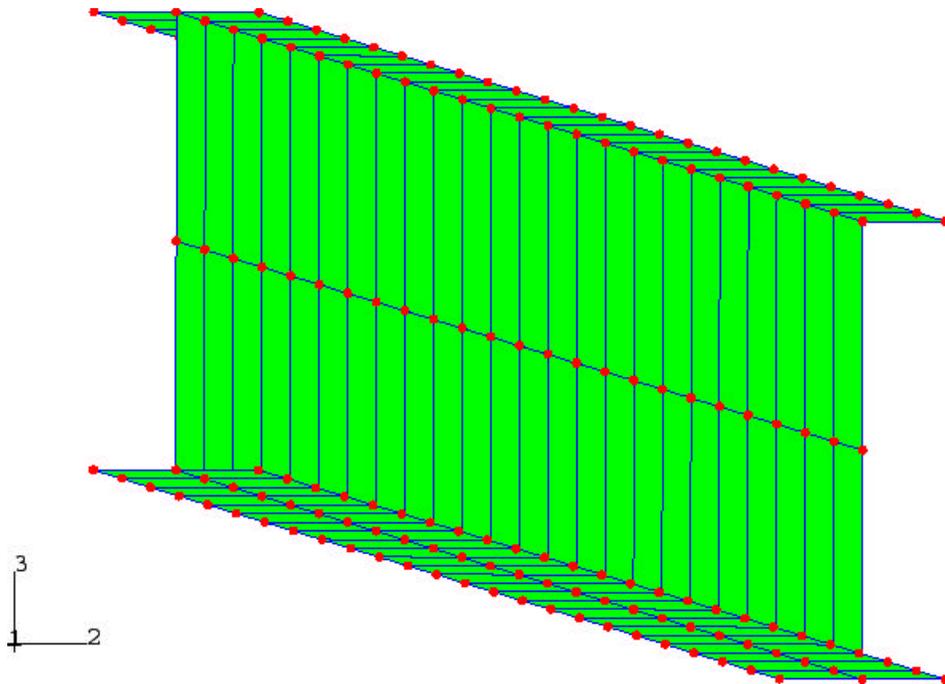
Girders are modeled using shell elements. As shown in Figure 6.4, the cross-section of a girder is divided into 6 elements. This is the coarsest division used and it can be easily refined. This means that one girder in the model has at least $6 \times 24 = 144$ elements.

Figure 6.4 Girder modeled with shell elements

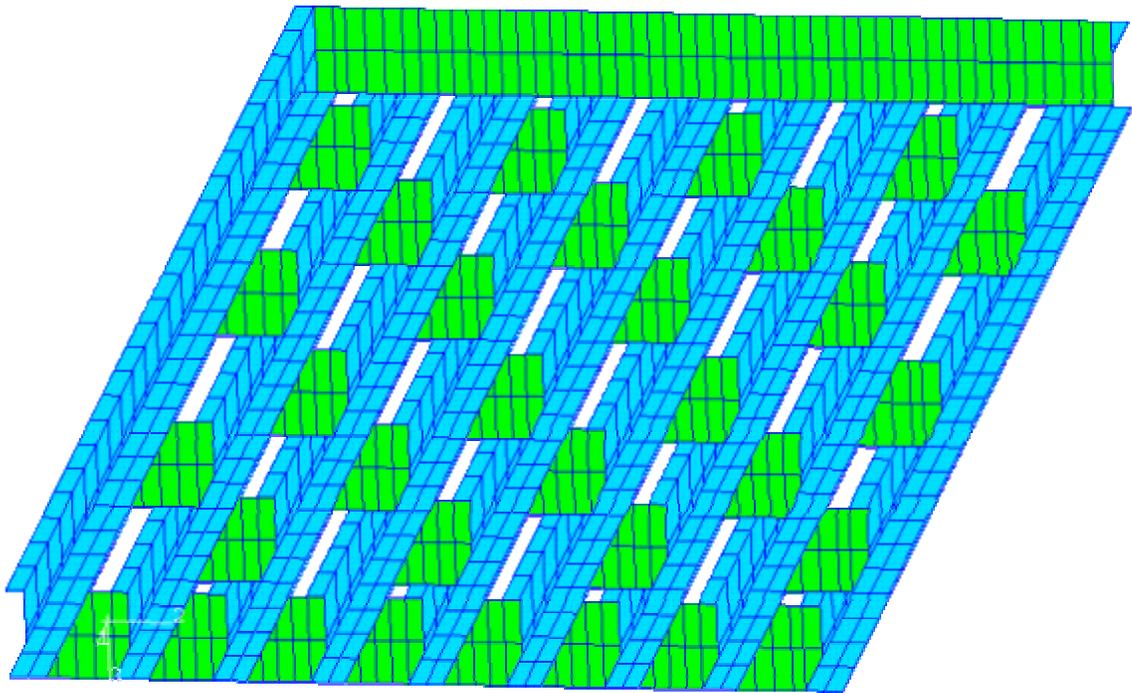
In highway bridges there are different kinds of transverse bracing used between girders. Steel and concrete diaphragms are modeled using shell elements with the same transverse division as in the slab and two layers in Z direction (Figure 6.5). Transverse bracing is represented by beam elements. Sometimes better results are received without diaphragms, especially for old bridges with concrete diaphragms. The influence of concrete diaphragms on girder deflections is sometimes very small and can be neglected. After many years of service and cyclic deformations caused by temperature changes, the bonding between the concrete diaphragms and steel girders can be drastically reduced, especially if there are no additional steel connectors. These diaphragms still provide protection against transverse buckling of the girders however. In the model, shell elements representing diaphragms are connected with girder elements at the same nodes. Such a connection may give too stiff of a response of the superstructure.

Figure 6.5 Girders and diaphragms modeled with shell elements

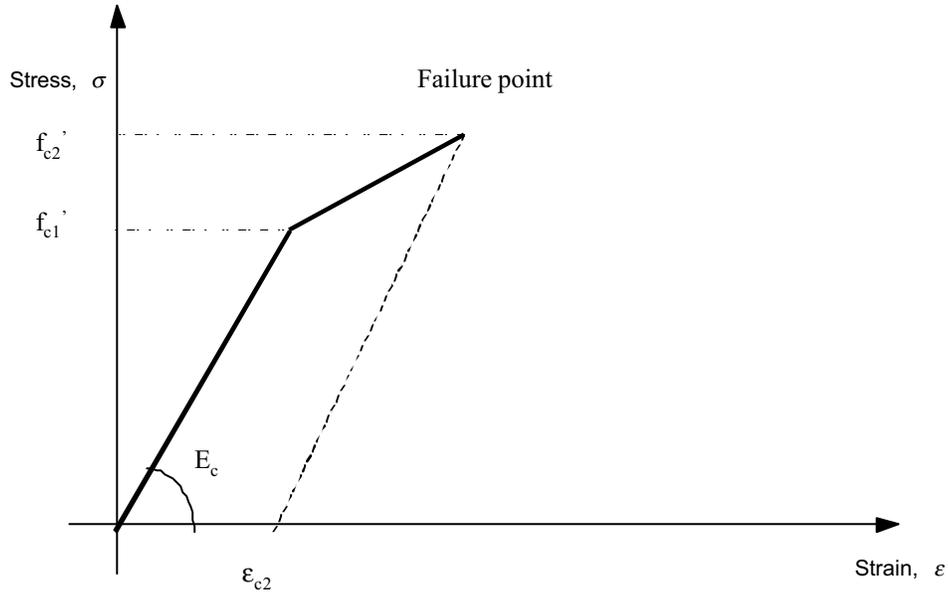
Figure 6.7 Stress-strain curve for uniaxial compression used in ABAQUS/Standard User's Manual (1996)

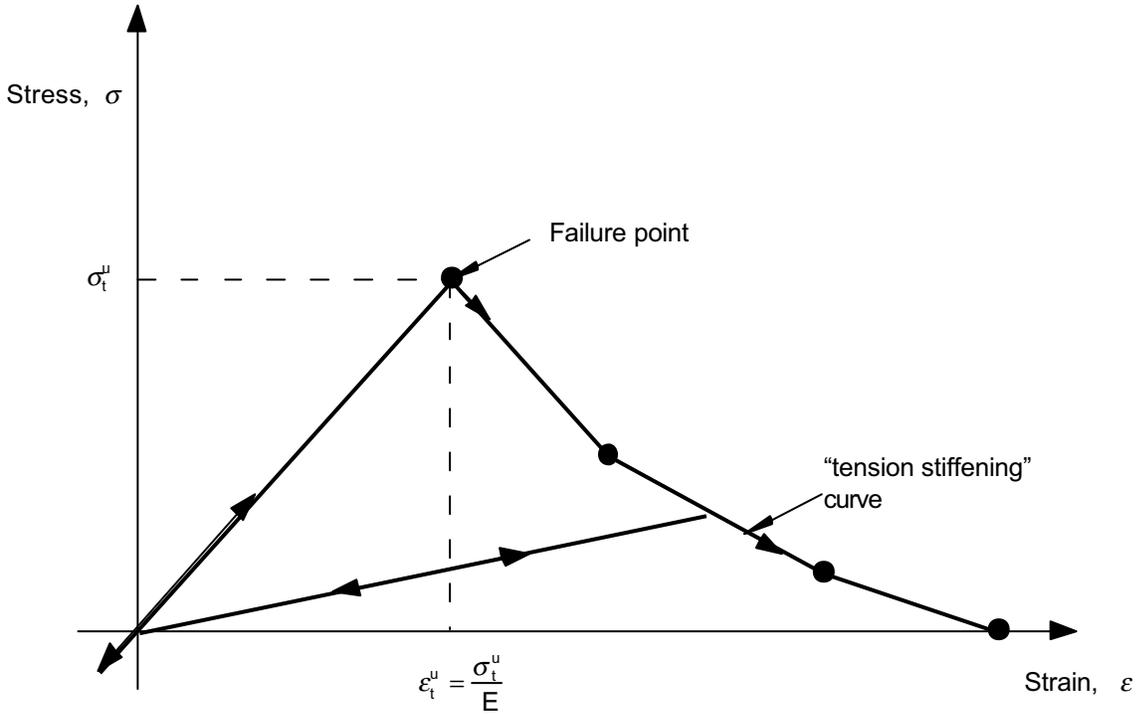
The concrete behavior is modeled in ABAQUS as a smeared crack model, which does not involve individual “macro” cracks. The strain-softening behavior for cracked concrete is determined by the user who has to define at least two parameters; fraction of remaining stress to stress at cracking, and the absolute value of direct strain minus the direct strain at cracking. This way the user specifies the postfailure stress as a function of strain across the crack (Figure 6.8). In the presented work a linear reduction of stress after failure is assumed. For standard concrete, strain at failure is usually 10^{-4} and the total strain, which reduces stress to zero, is 10^{-3} ABAQUS/Standard User's Manual (1996).

Figure 6.8 Tension stiffening model.

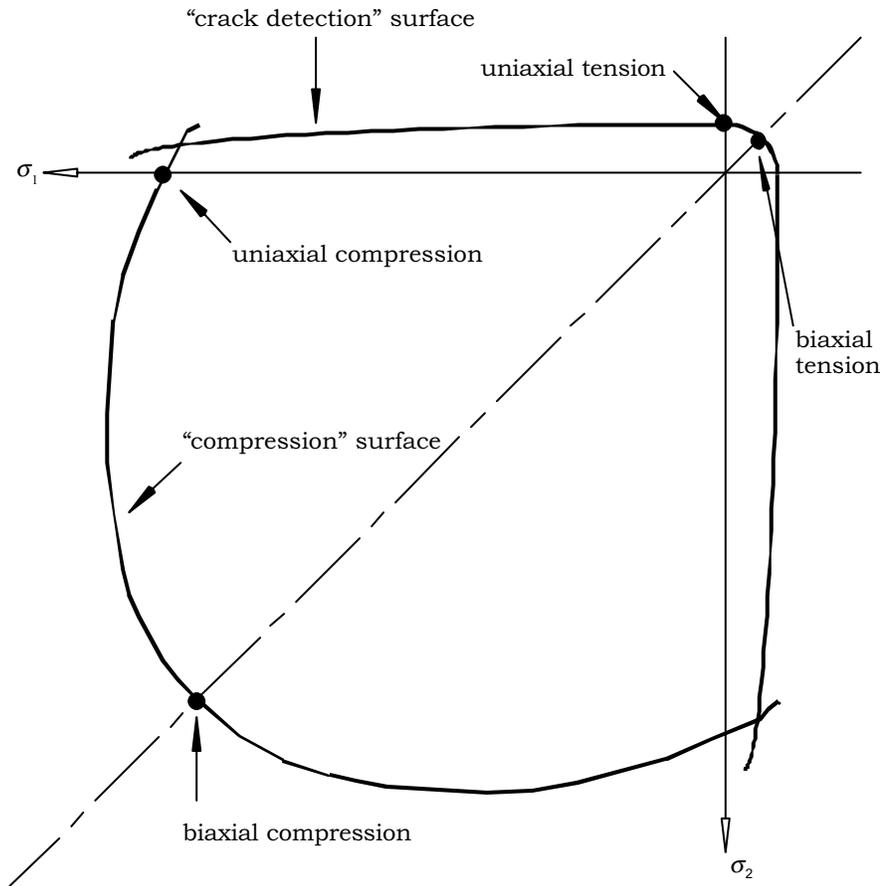
The multiaxial stress surface of failure is shown in Figure 6.9 ABAQUS/Standard User's Manual (1996). The user can define the behavior of concrete with the following ratios:

Figure 6.9 Yield and failure surfaces in plane stress

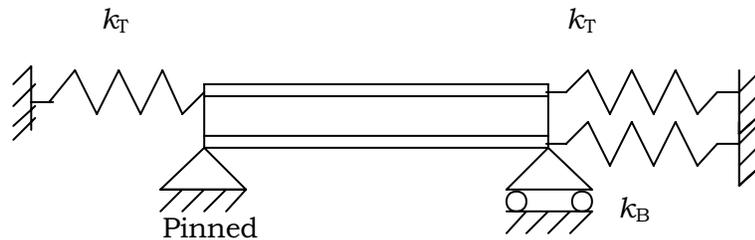
All bridges investigated here are one span superstructures, designed as simply supported. In old bridges, corrosion of the bearings usually causes additional constraints both for rotations and longitudinal displacements. Examination of these examples verified what was also reported by other authors Schultz et al. (1995), that even slight changes in boundary conditions have large effects on the results. To improve support conditions in the model, additional linear elastic spring elements were introduced as shown in Figure 6.10. Springs are attached to the bottom and upper flanges on the ends of each girder. The magnitude of stiffness k was calibrated with field measurements. A comparison of calculated strain values with test data enables the determination of k . Different values of spring stiffness for different girders can also be applied.

Figure 6.10 Girder simply supported with spring elements.

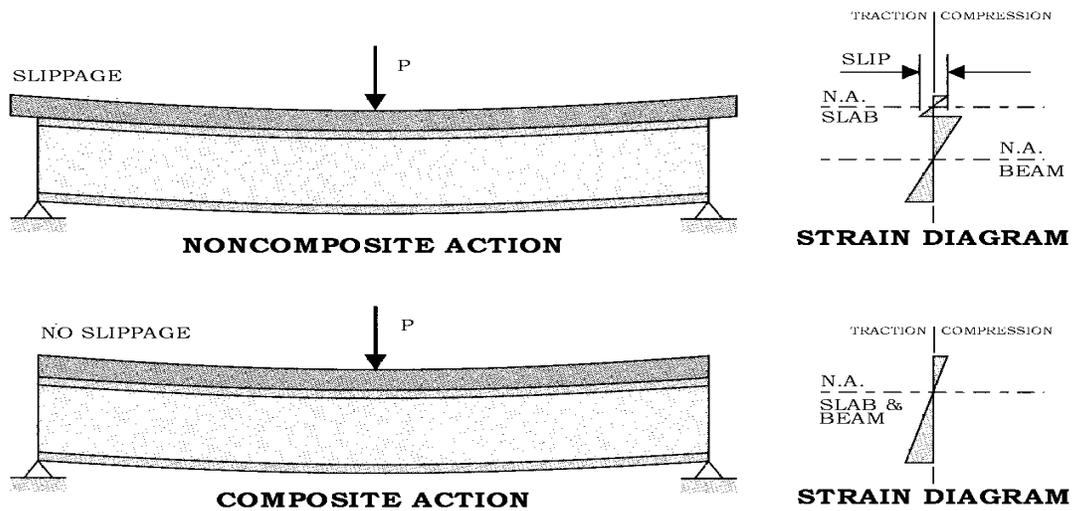
Most of the old slab on girders bridges were designed as noncomposite superstructures. This means that to estimate the maximum stresses induced by bending moments, only steel girders (without concrete slab) were taken into account. Field tests by Schultz et al. (1995) proved that even

Figure 6.11 Noncomposite and composite action

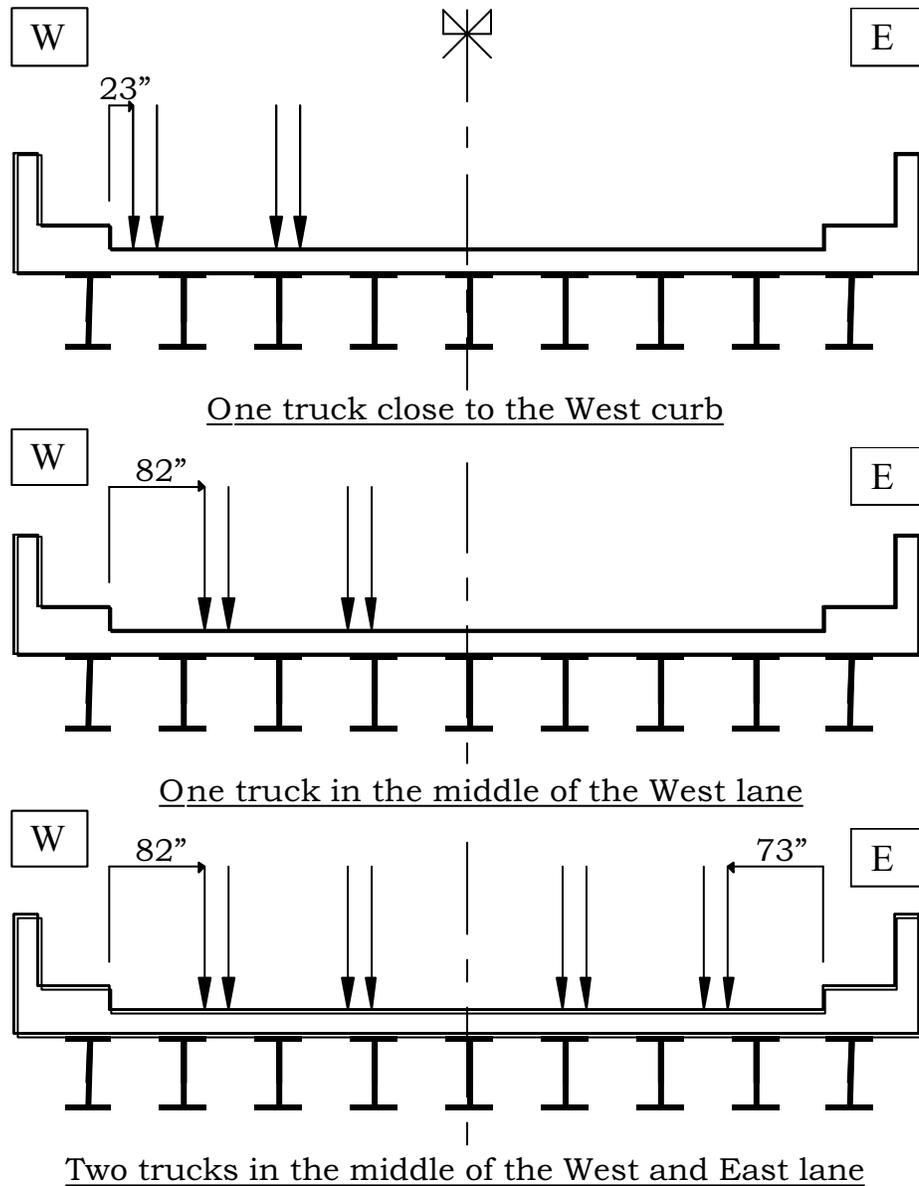
Figure 6.15 Transverse truck positions.

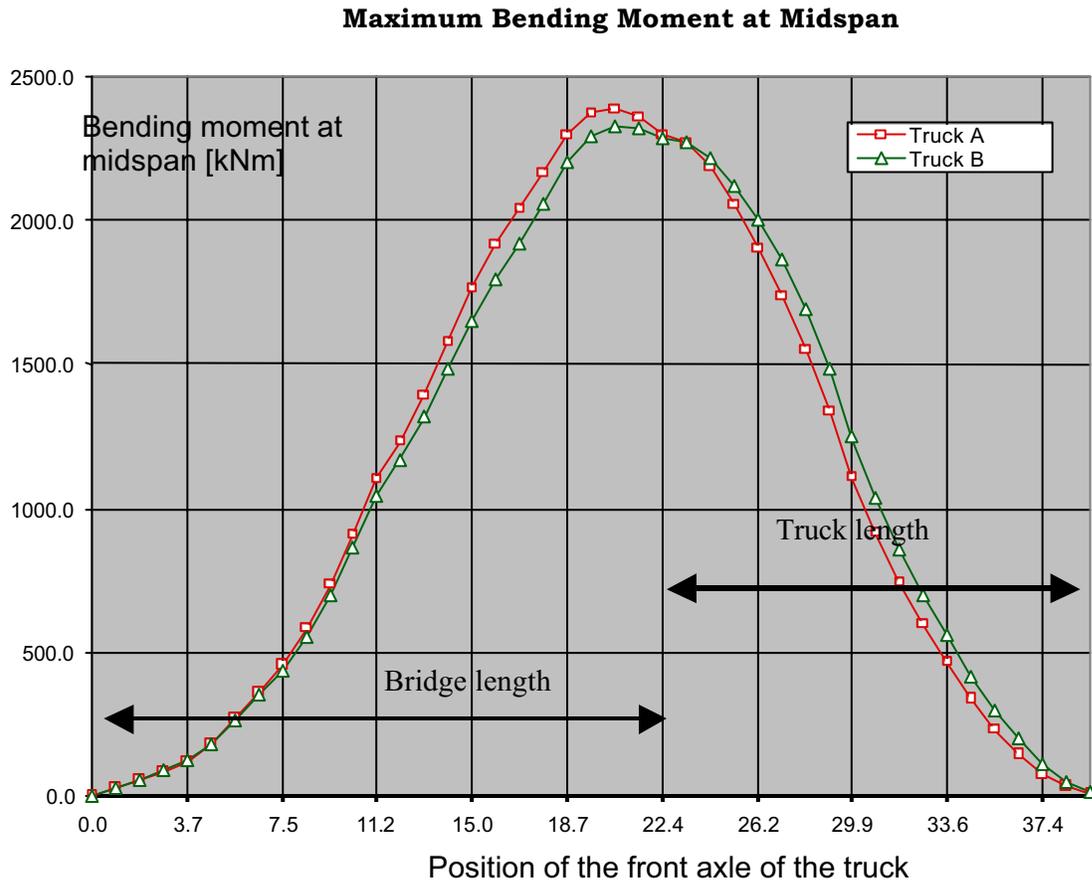
moment at midspan, where strain transducers were located. Figure 6.16 shows bending moment diagrams for different positions of the truck. On the horizontal axis, the location of the first truck axle is given. This is changing using an increment equal to eq. (6-1) and is applied with an assumed longitudinal division of the span into 24 elements. Bending moment at the midspan is calculated using influence curves for the bridge span treated as a simply supported beam.

Figure 6.16 Determination of the longitudinal truck position giving the maximum bending moment at midspan.

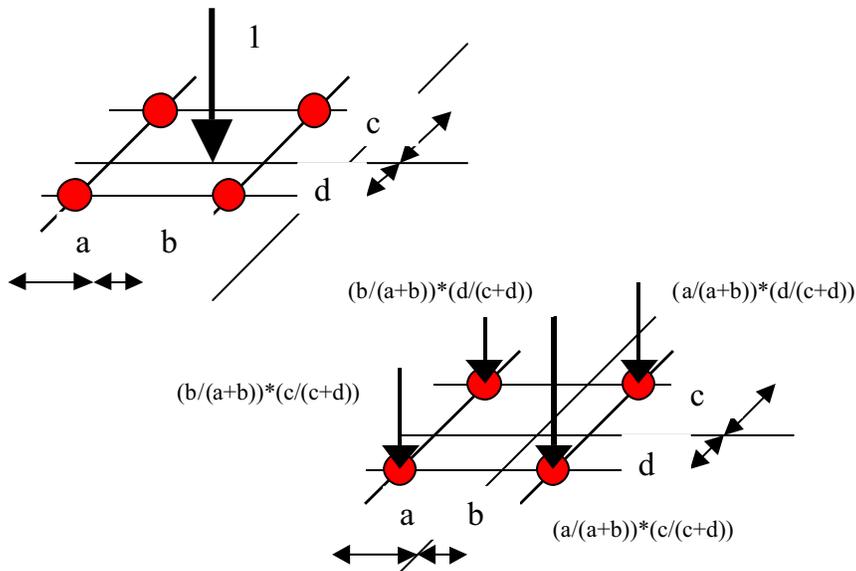
Figure 6.17 Distribution of a concentrated load to adjacent nodes.

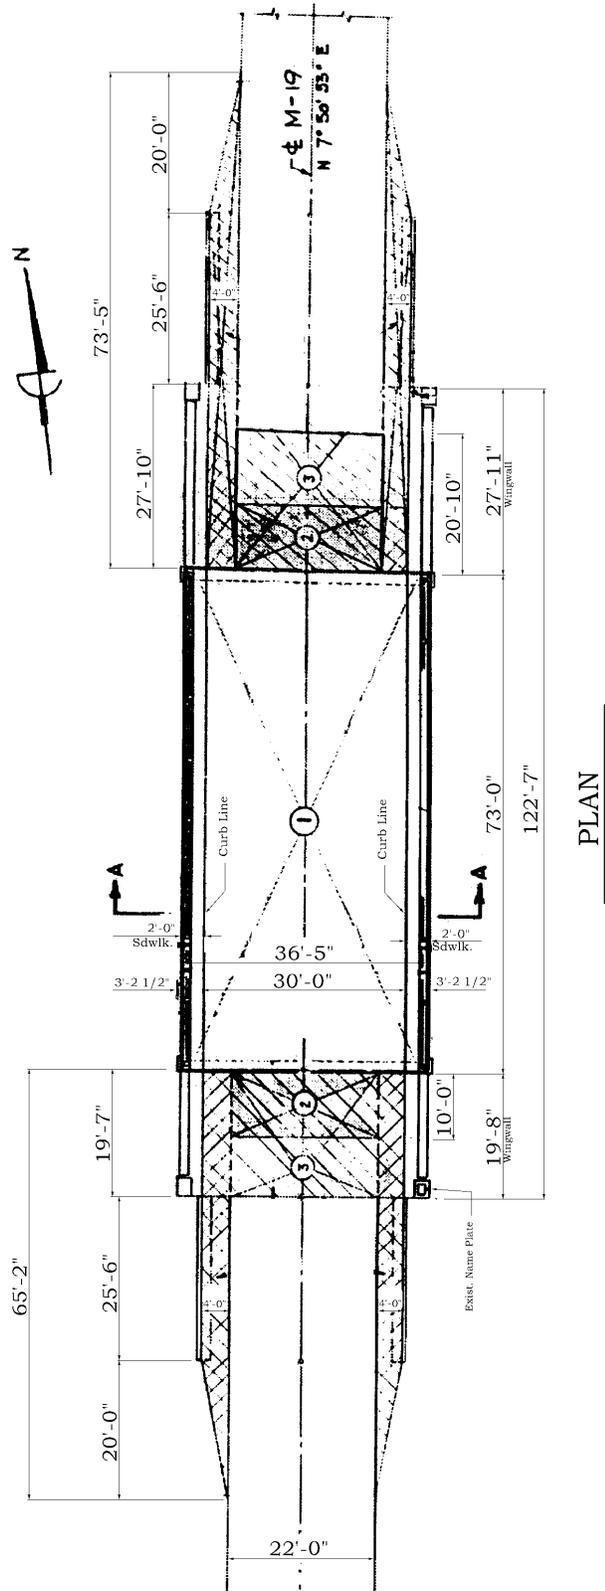
The deck slab is in good condition probably because of the slope and good water drainage. Only few small cracks were found during visual inspection. Corrosion was observed at the support areas.

Figure 6.18 – Plan View of the Bridge M-19 over Mill Creek in Brockway
(conversion factor for SI units: 1' = 0.305m, 1" = 0.025m)

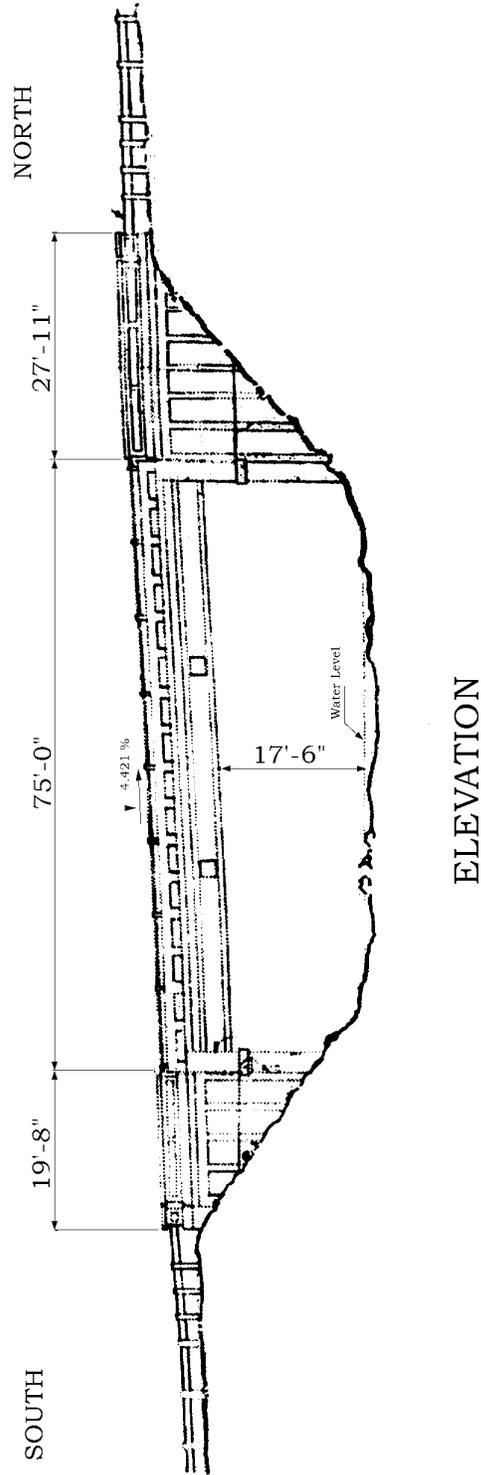
Figure 6.19 – Elevation of Bridge M-19 over Mill Creek in Brockway
(conversion factor for SI units: 1' = 0.305m, 1" = 0.025m)

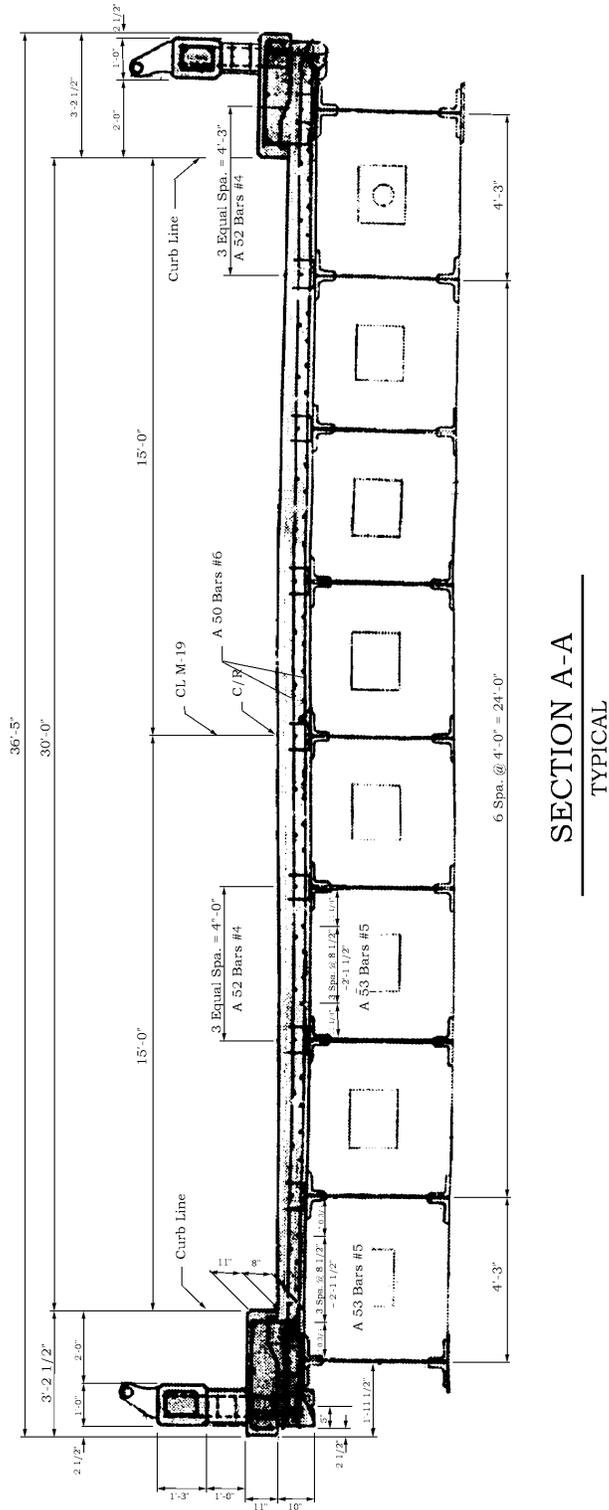
SECTION A-A
TYPICAL

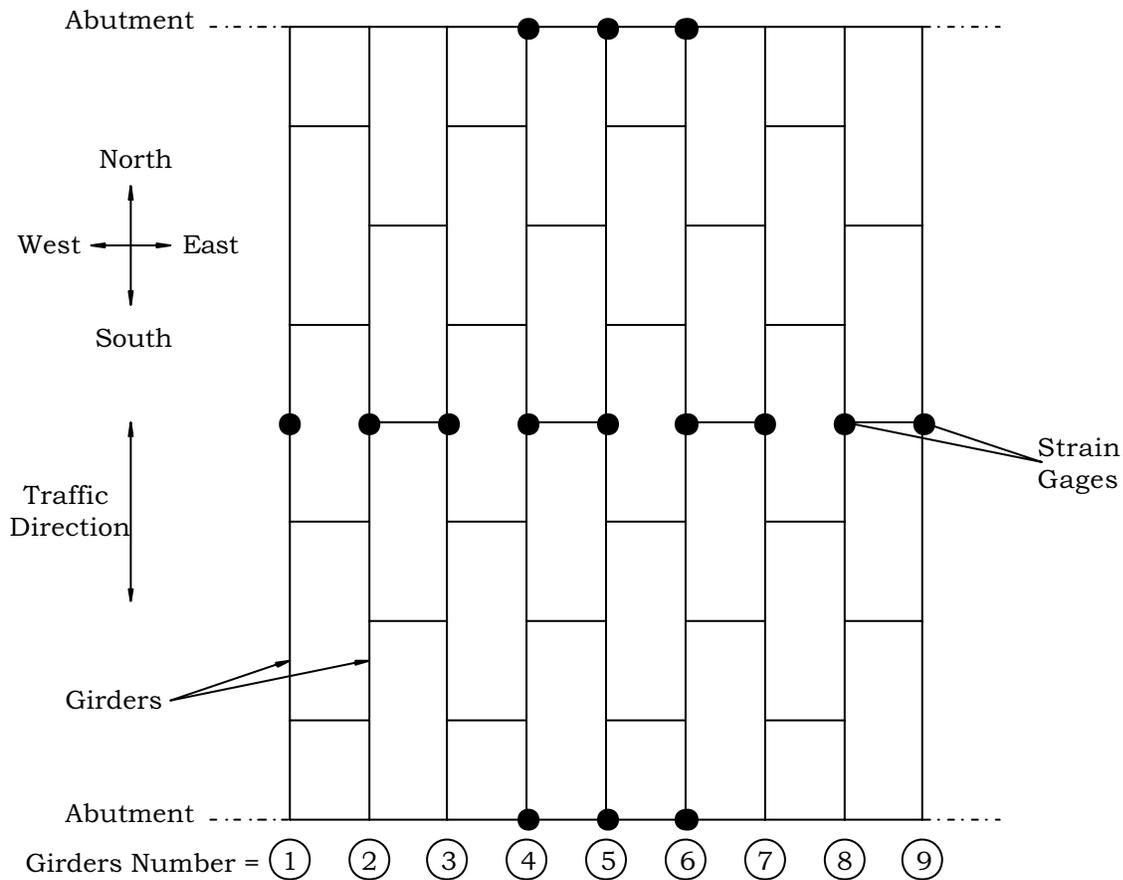
The field test was performed on June 24, 1999. Strain transducers were installed on the bottom flanges of girders in the middle of the span and close to the supports as it is shown in Figure 6.21. Two gravel hauling trucks, A and B were used with axle configurations as shown in Figures 6.22 and 6.23. The test included 16 runs. Each run is described in Table 6.1 where transverse position and speed are given. There were two transverse positions for each truck, close to curb named WC for West lane and EC for East lane and center of lane named EL or WL. For every run precise transverse position of the truck was measured.

Figure 6.21 – Strain transducer locations in Bridge M19/MC in Brockway.

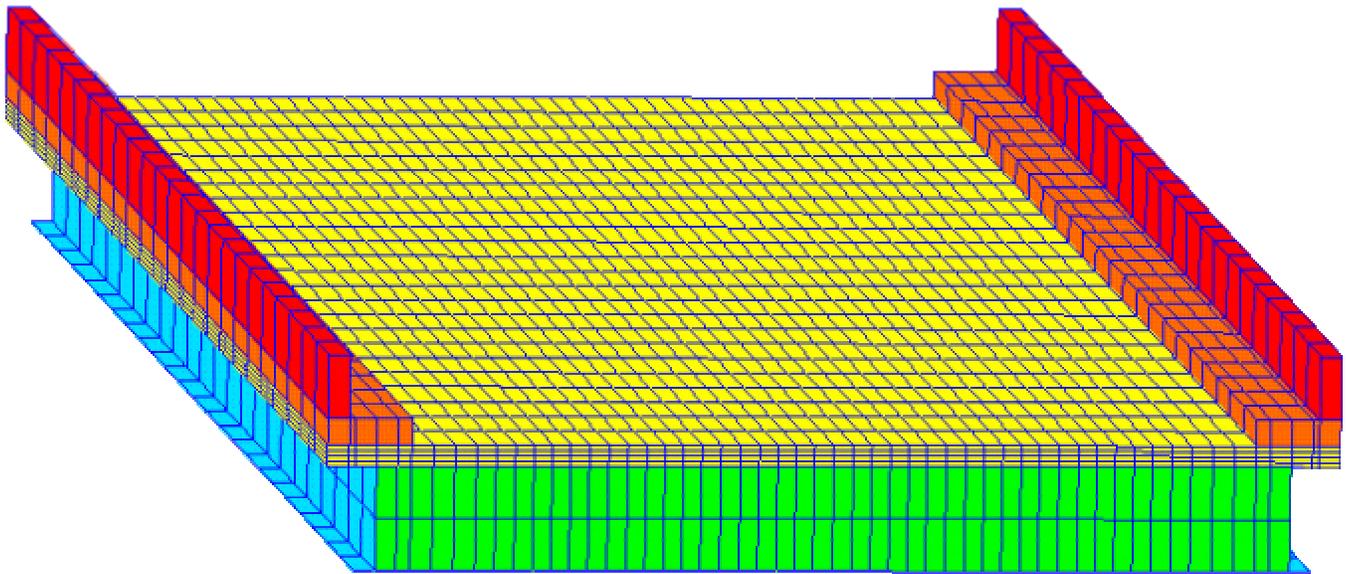
Figure 6.24 Isometric view of FE model

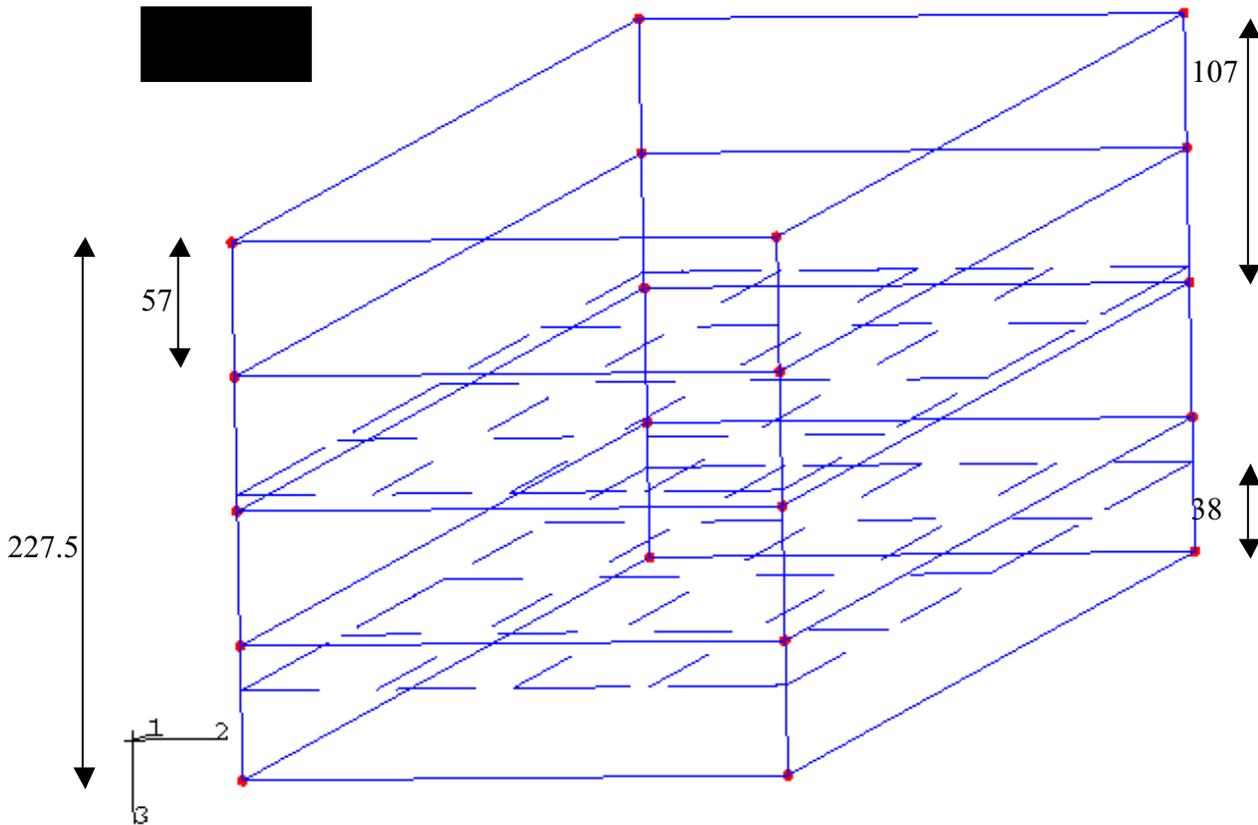
Figure 6.26 Layers of uniformly smeared reinforcement

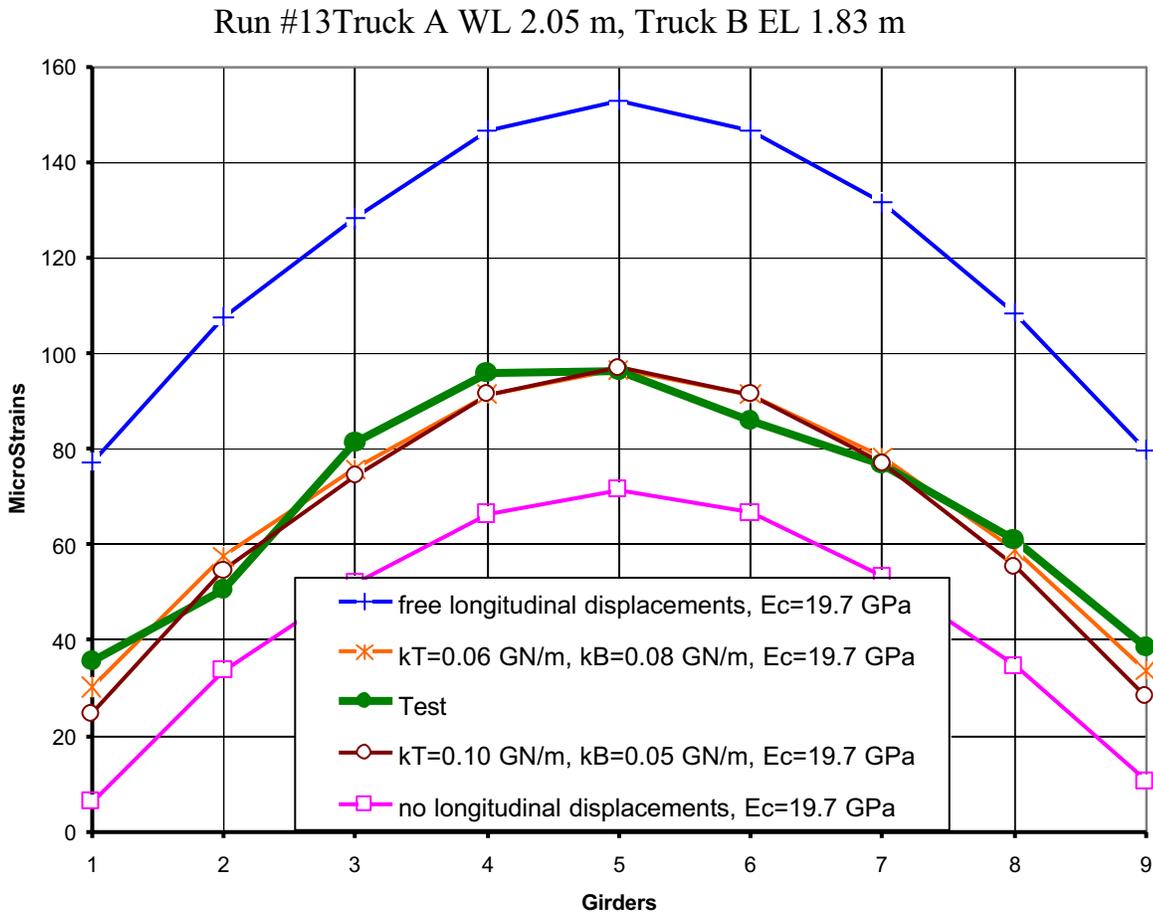
Figure 6.27 Strains in girders for different boundary conditions.

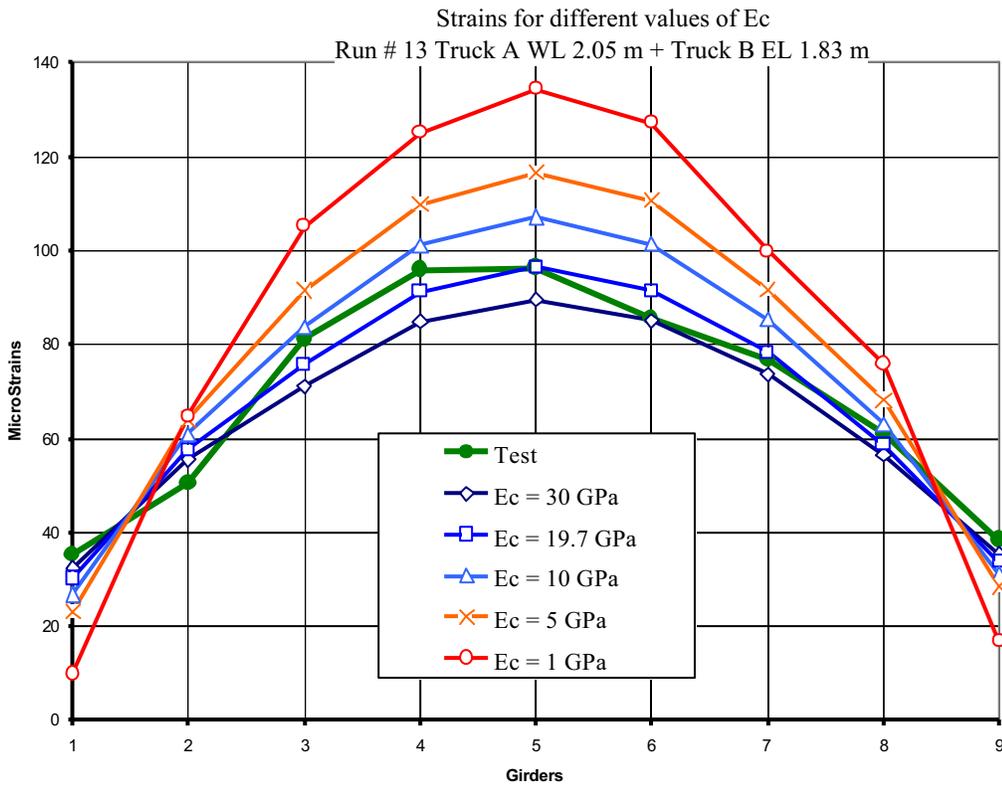
Figure 6.28 Strains for different values of E_c .
