**DEVELOPMENT OF THE
PROCEDURE FOR EFFICIENT
EVALUATION OF BRIDGE DECKS**

**CONTRACT NO. 98-1303 DIR
Report submitted to
The Michigan Department of Transportation**

Report provides the background information for the Michigan Deck Evaluation Guide. It consists of chapters dealing with material models for deck analysis, field inspection and field test results, finite element analysis of bridge superstructure, and additional analysis on punching shear failure mode.

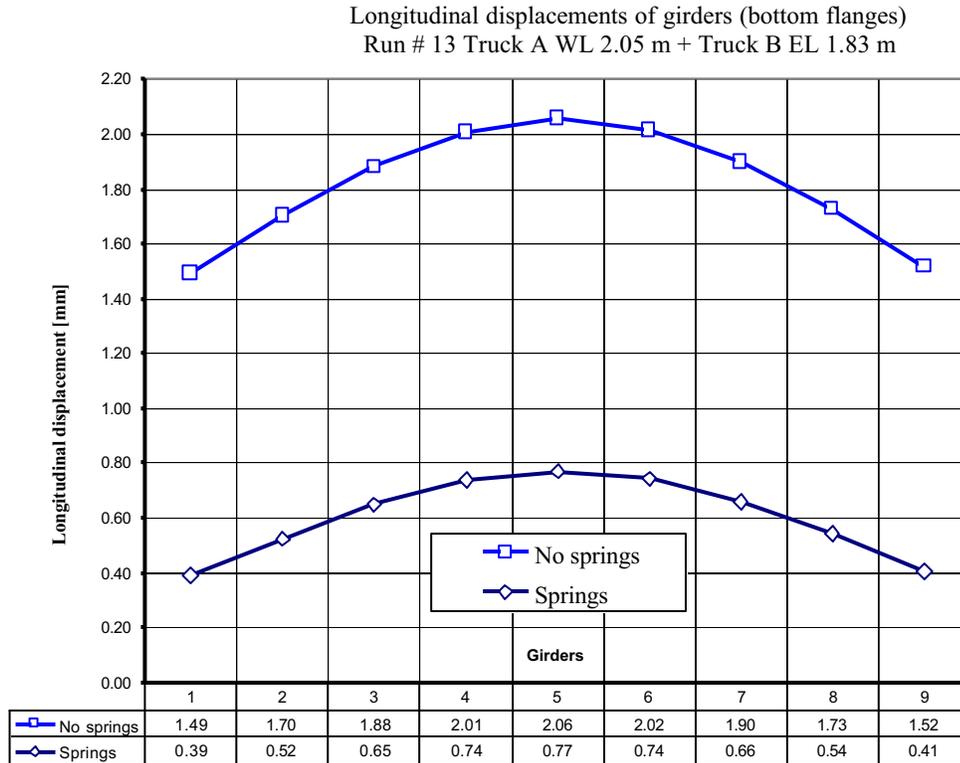
Figure 6.29 Longitudinal girder displacements

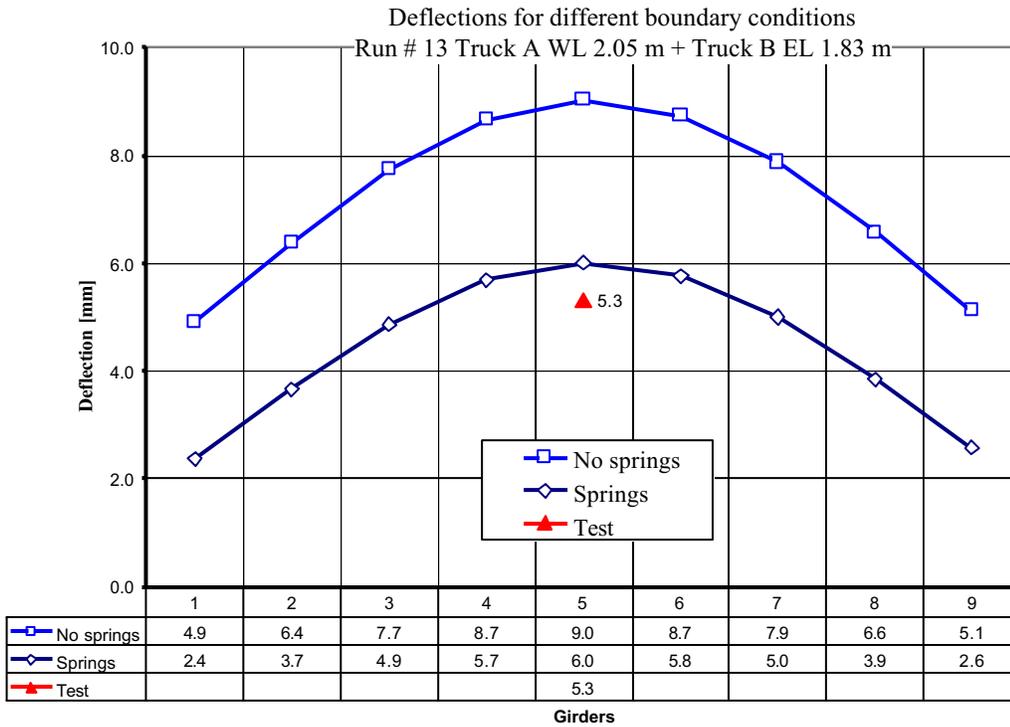
Figure 6.30 Deflections for different boundary conditions

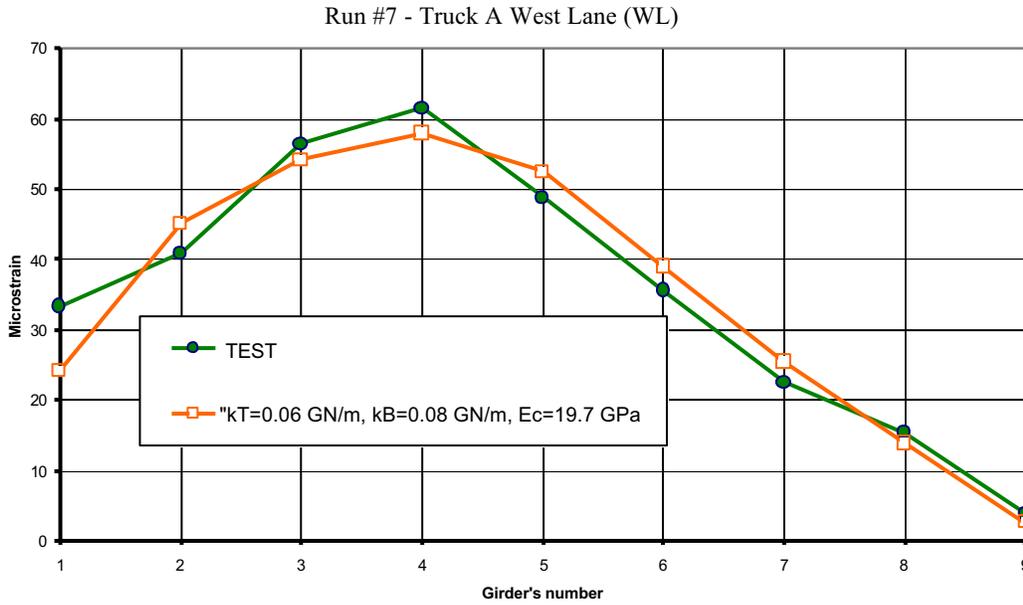
The correlation between test data and numerical results for different load configurations is presented in Figures 6.31 - 6.33. Because of the limitation of available test data, the presented correlation is recognized as the best possible.

Figures 6.31 Comparison of calculated and measured strains for run # 7

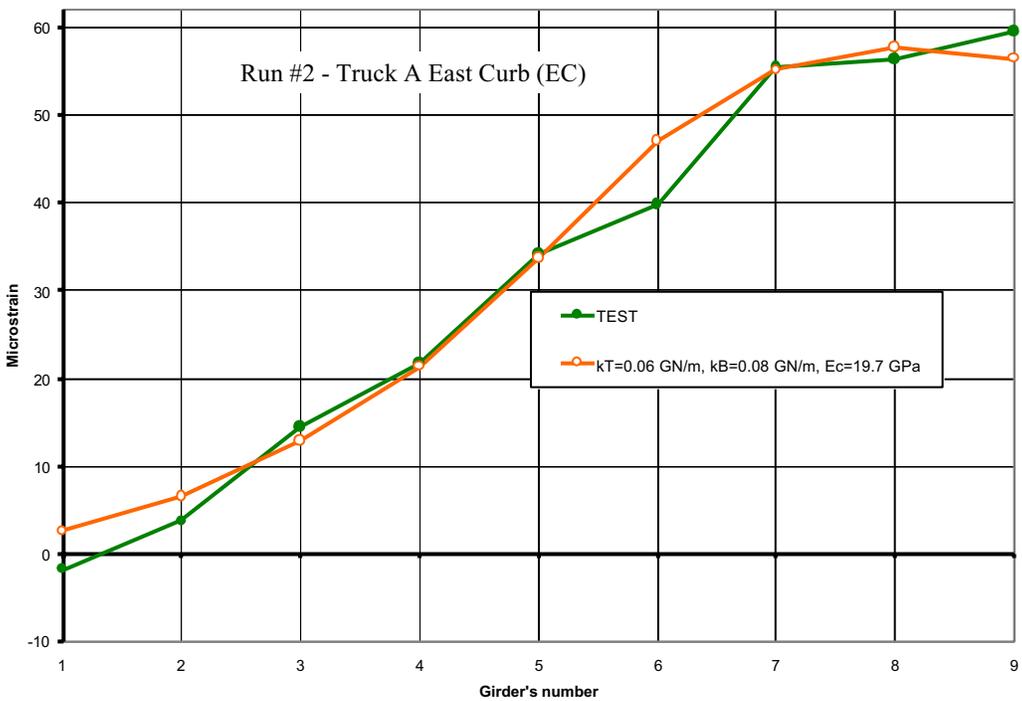
Figure 6.33 Comparison of calculated and measured strains for run # 2

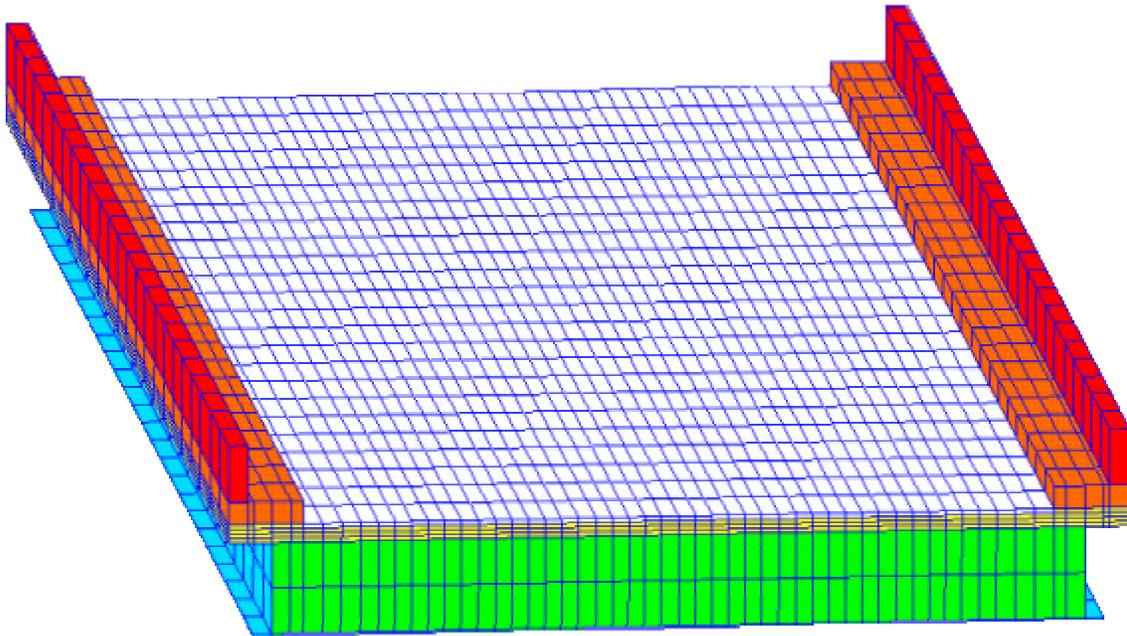
Figure 6.34 FE model with top layer deteriorated $E_c \approx 0$ GPa

value of zero Figure 6.34. In Figure 6.35 calculated values of strains for this case are compared with data from test measurements. The case when a live load consisted of two trucks placed in the center of traffic lanes is concerned. It can be seen that the change in structural stiffness is small. In Figure 6.36 the comparison is made for dead load (gravity) and the same live load taken together.

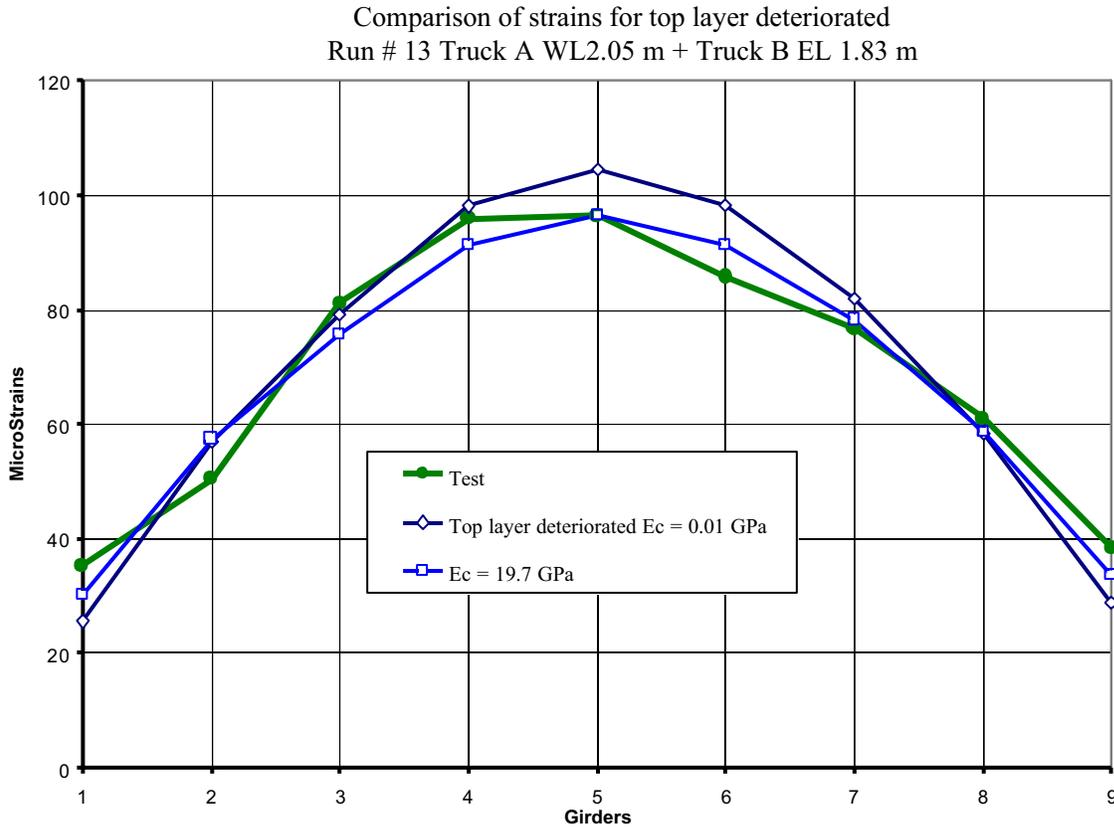
Figure 6.35 The influence of the deterioration of top deck layer on strains caused by live loads.

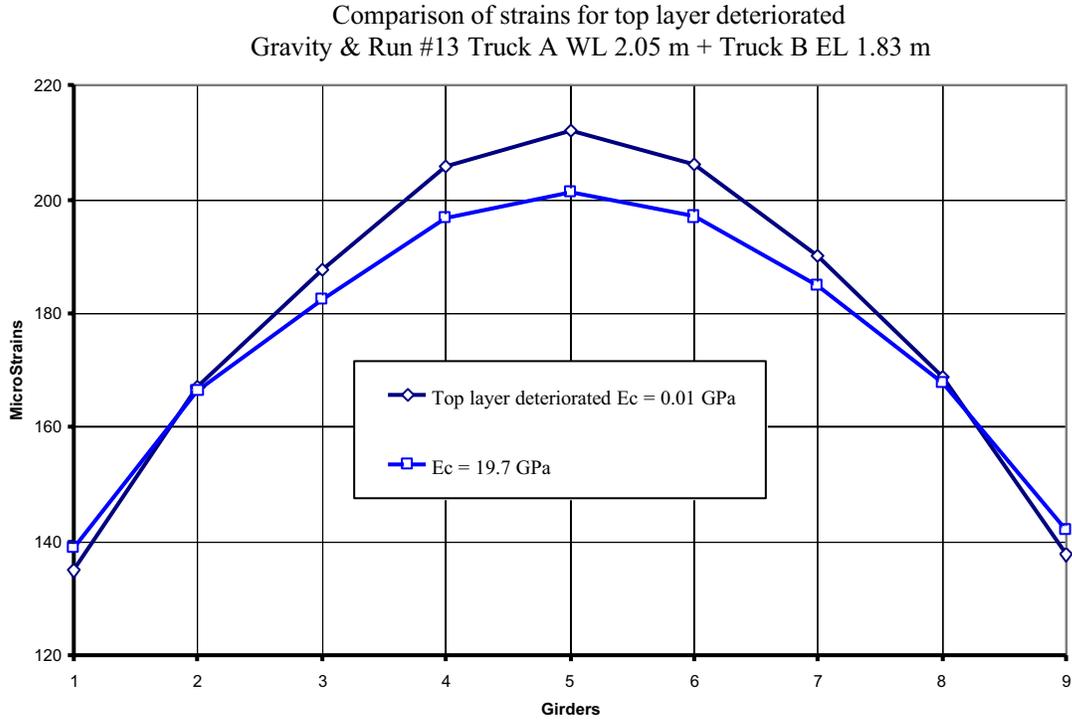
Figure 6.36 The influence of the deterioration of top deck layer on strains caused by dead and live load.

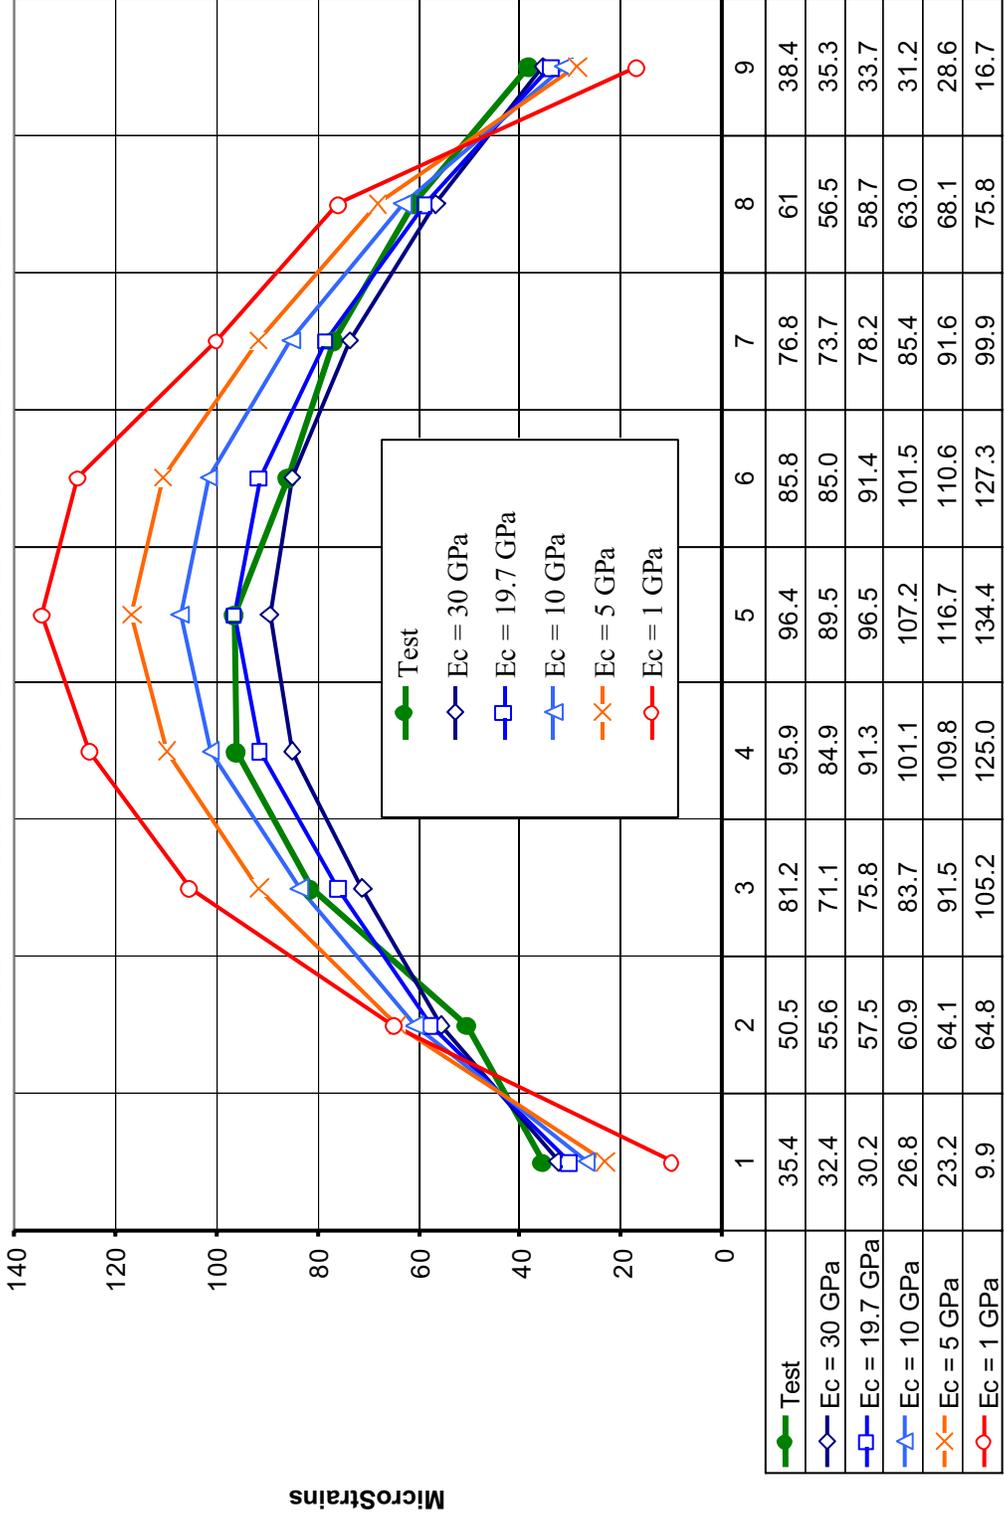
Strains for different values of E_c
Run # 13 Truck A WL 2.05 m + Truck B EL 1.83 m

Figure 6.37 Girder strains caused by live load for different values of E_c .

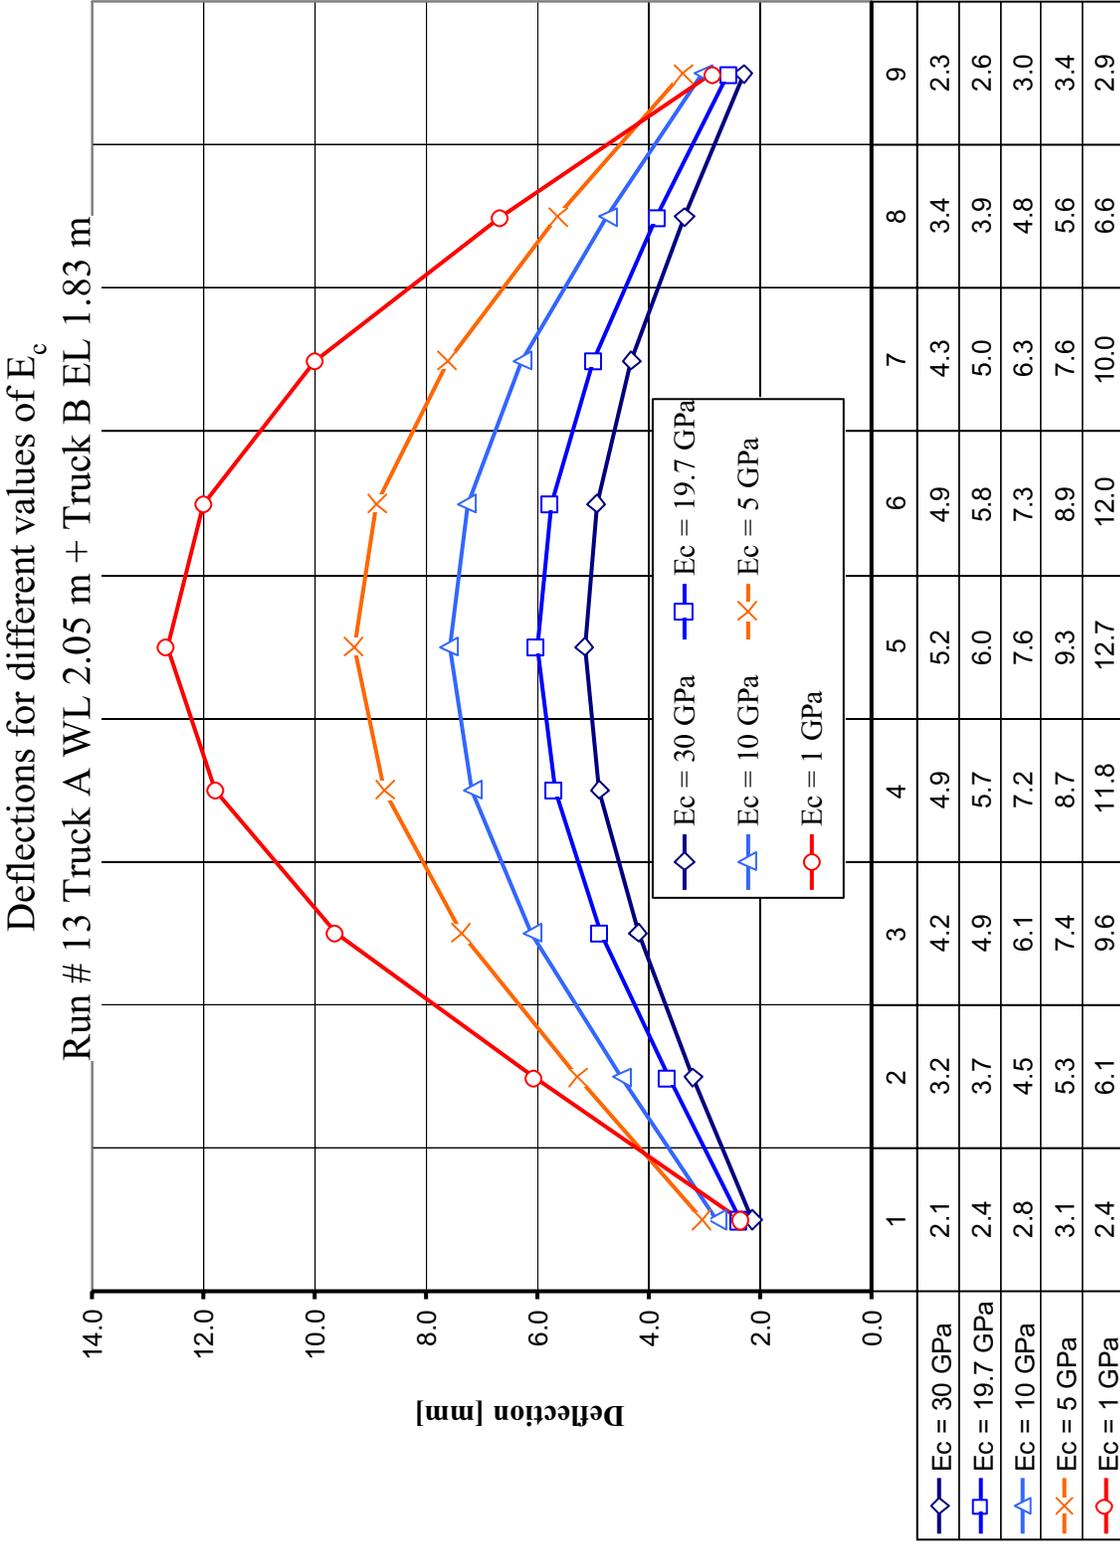
Figure 6.38 Deflections for live loads with different values of E_c .

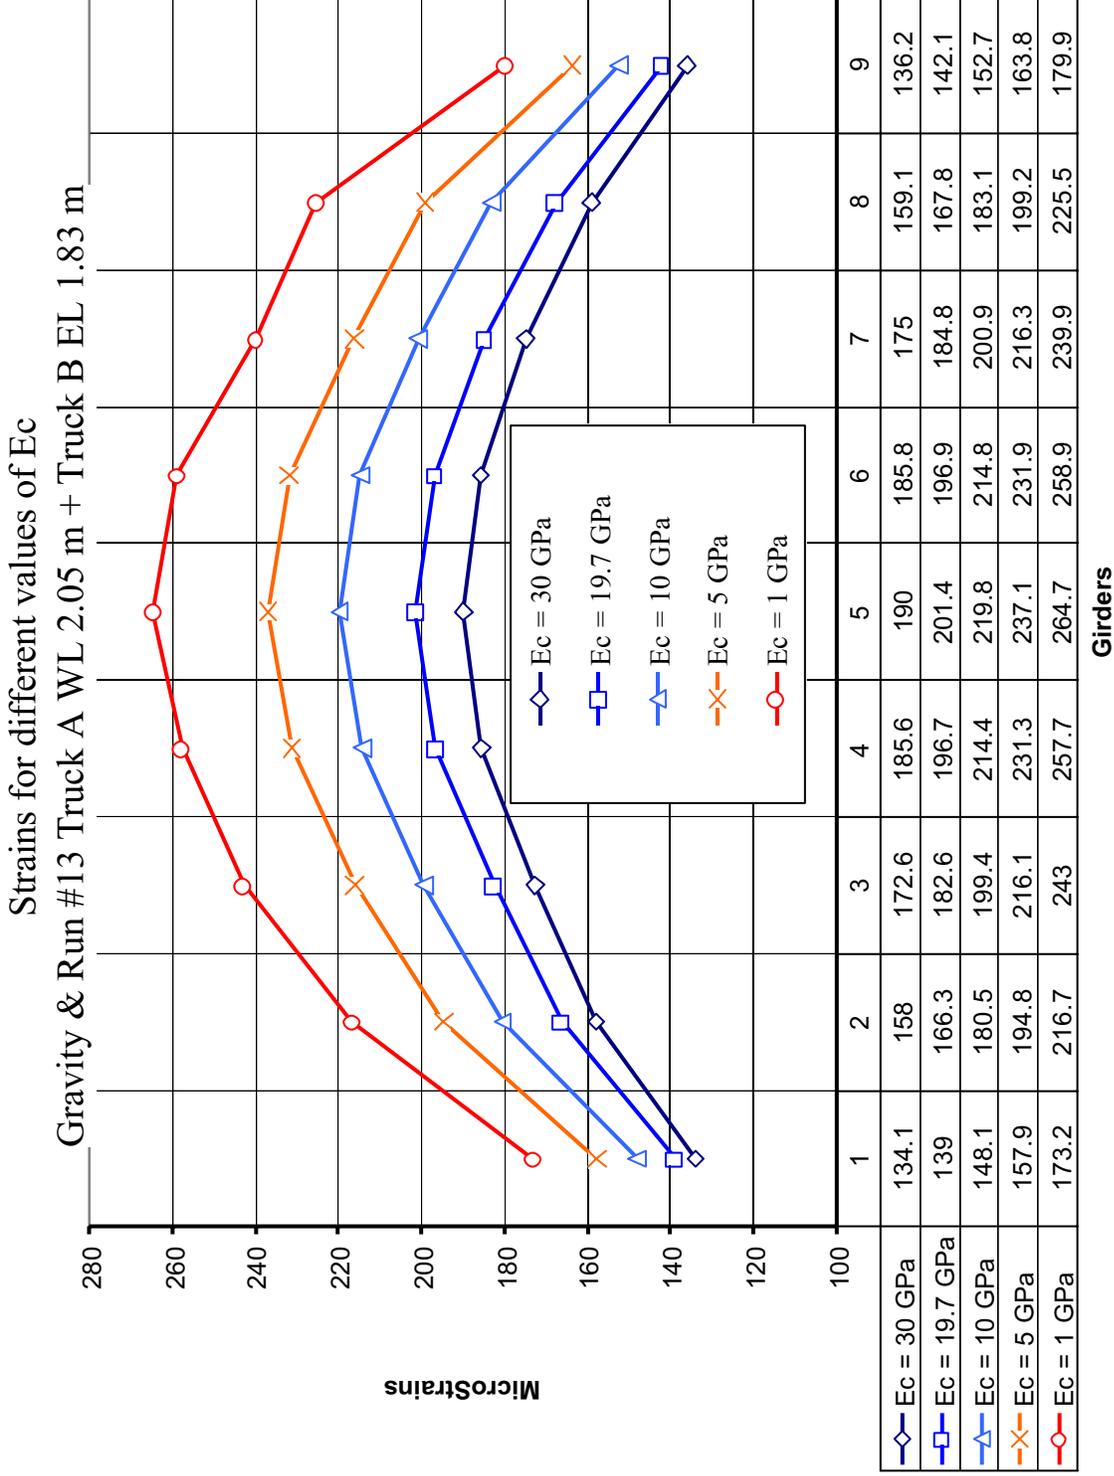
Figure 6.39 Strains of gravity and live loads with different E_c values.

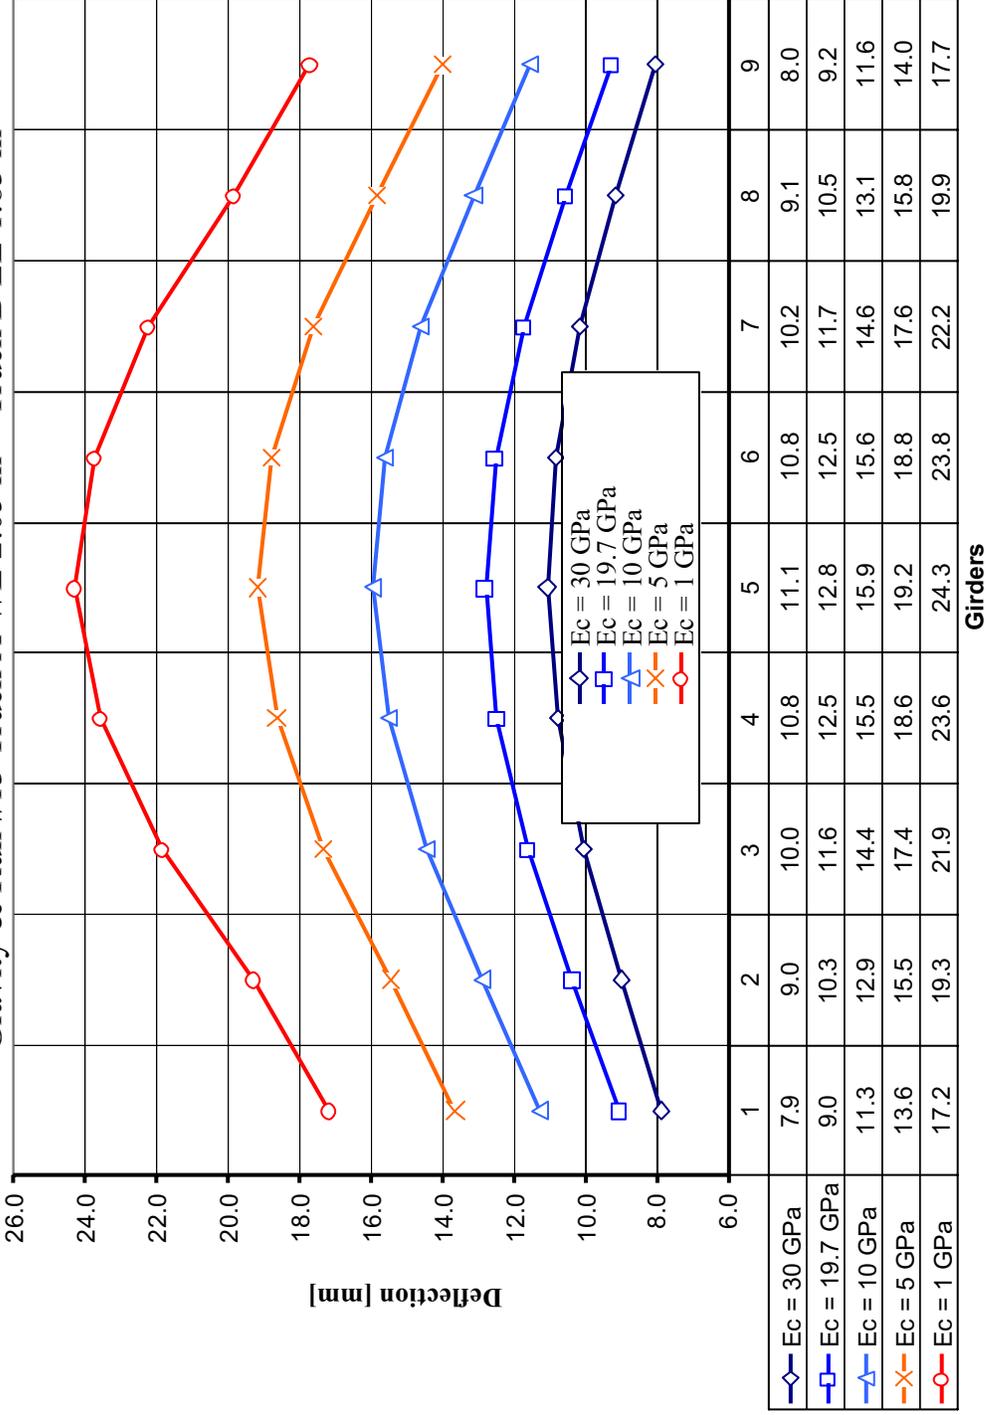
Deflections for different values of E_c
Gravity & Run #13 Truck A WL 2.05 m + Truck B EL 1.83 m

Figure 6.40 Deflections of gravity and live loads with different E_c values.

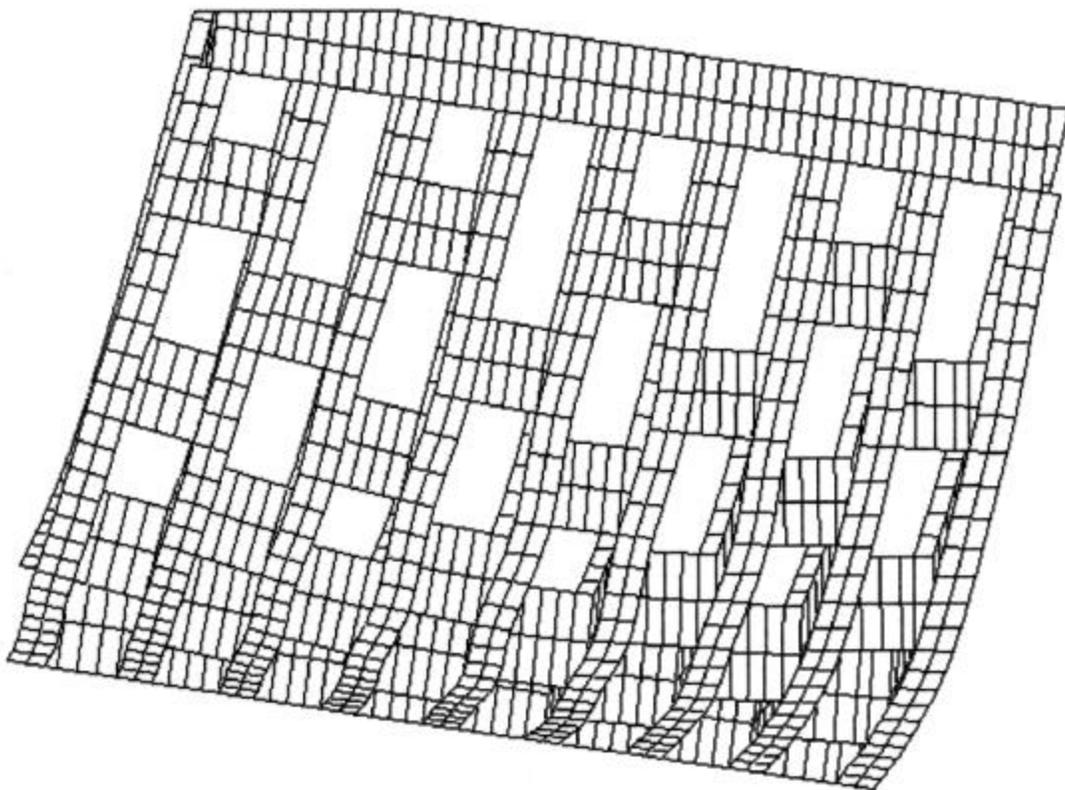
Figure 6.43 Deformed girders and diaphragms.

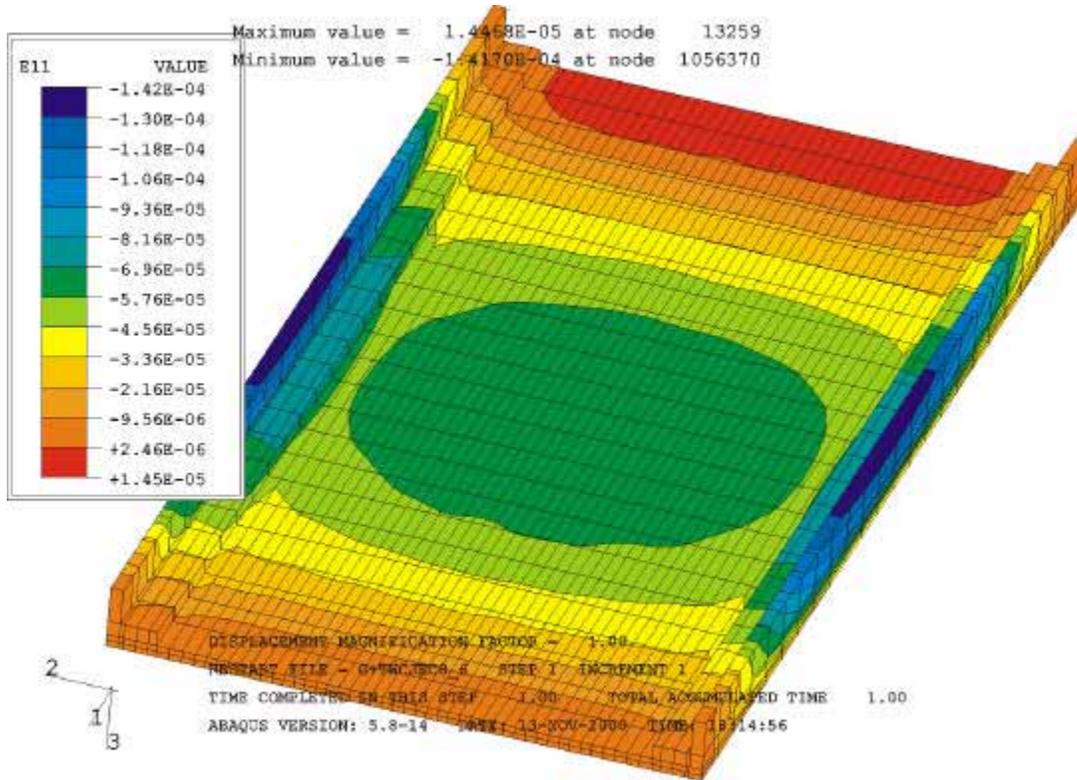
Figure 6.47 Contours of longitudinal strain for dead loads.

In Figures 6.47-6.56 contours of longitudinal and transversal strains are presented. All contours here are plotted for the slab only. Figures 6.47-6.48 show strains for dead load. In Figures 6.49-6.54 different configurations of live loads described in Table 6.1 are taken into account. Figures 6.55-6.56 present strain contours for dead and live loads together. In Table 6.3 maximum values of calculated compression and tension strains in the slab are included.

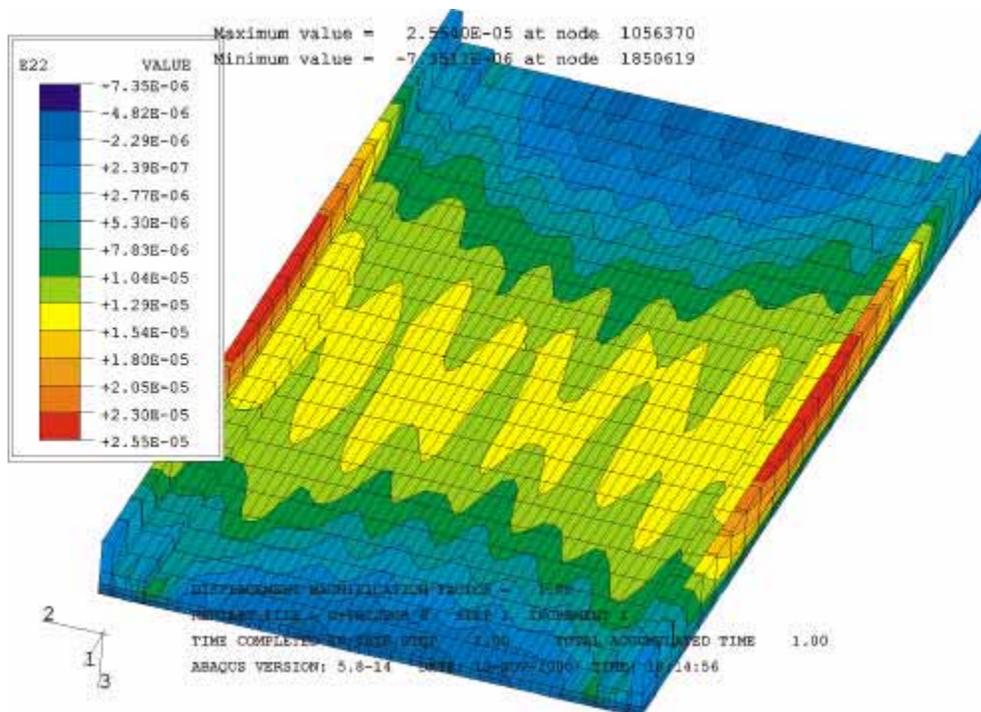
Figure 6.48 Contours of transverse strain for dead loads.

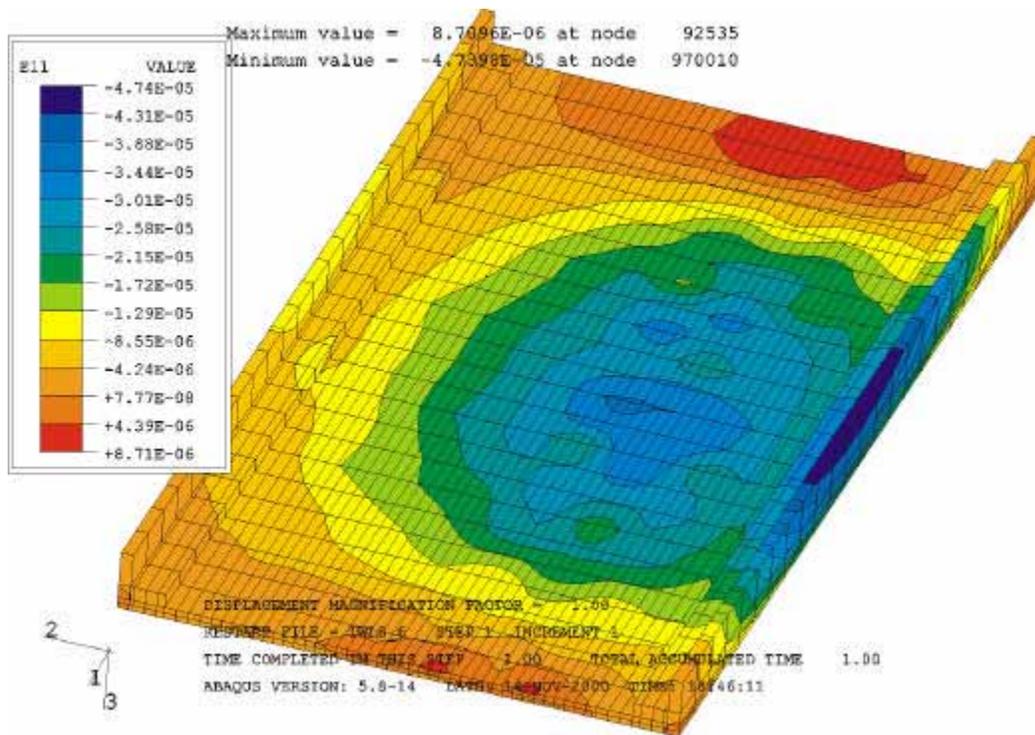
Figure 6.49 Contours of longitudinal strain for live load, run #7 – truck A, center of lane.

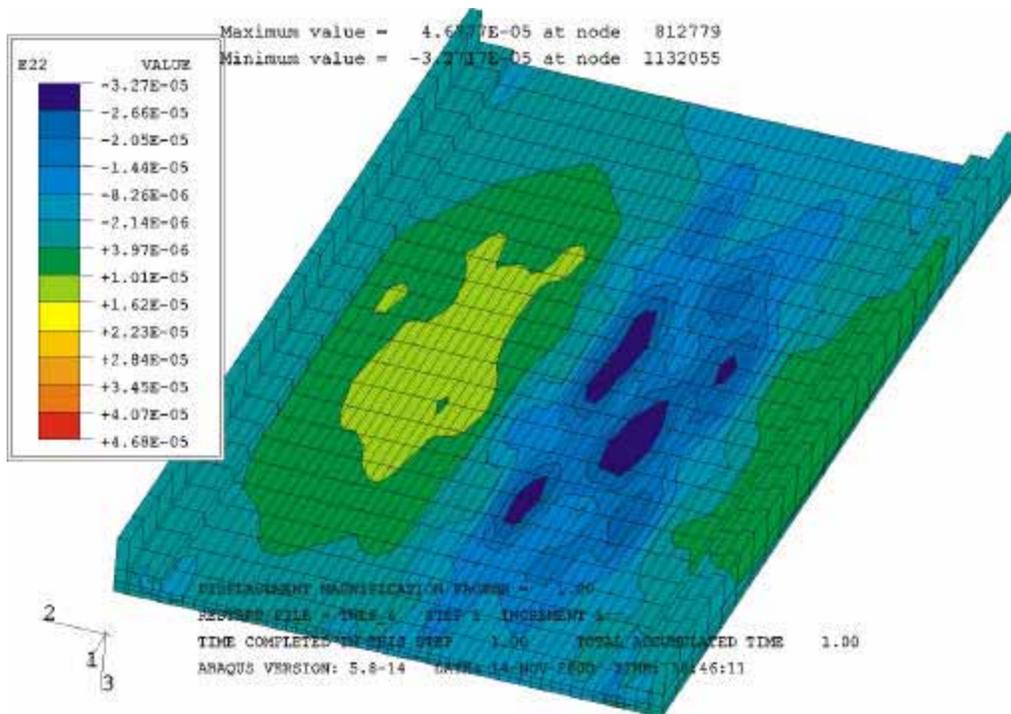
Figure 6.50 Contours of transverse strain for live load, run #7 – truck A, center of lane.

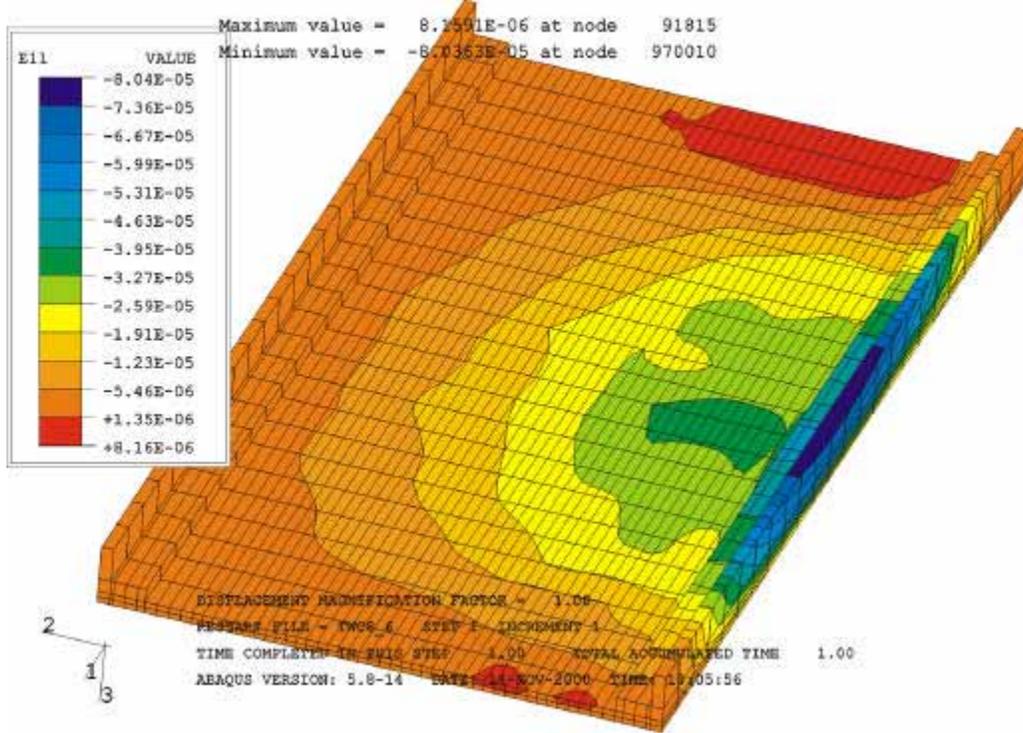
Figure 6.51 Contours of longitudinal strain for live load, run #8 – truck A, close to curb.

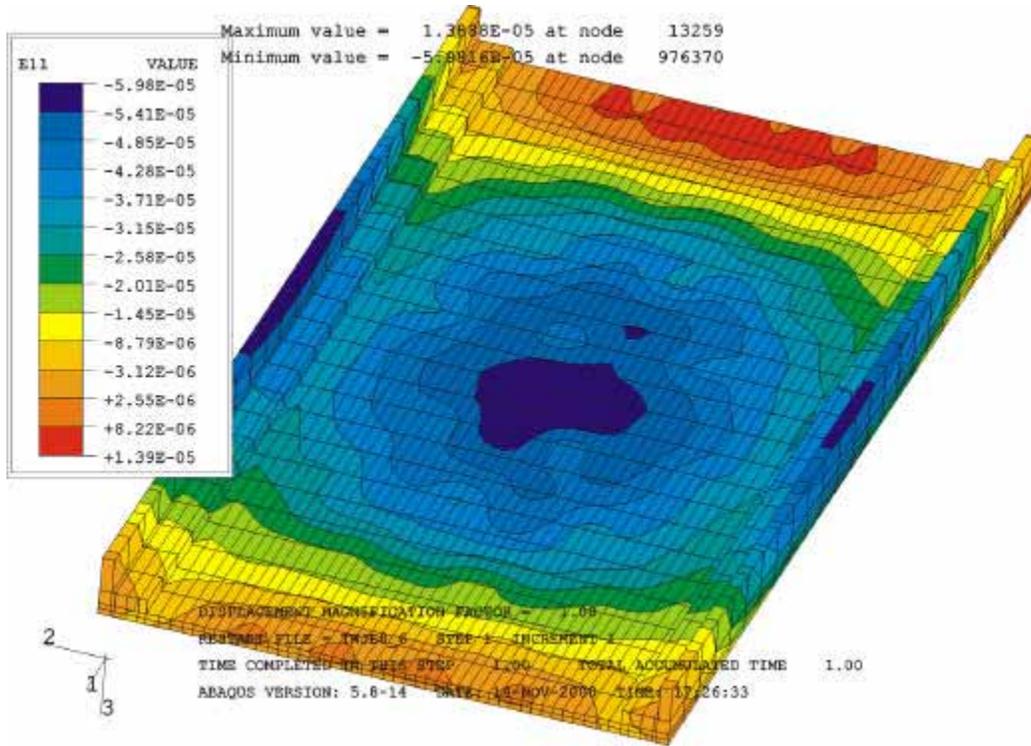
Figure 6.53 Contours of longitudinal strain for live load, run #13 – truck A and B, center of lanes.

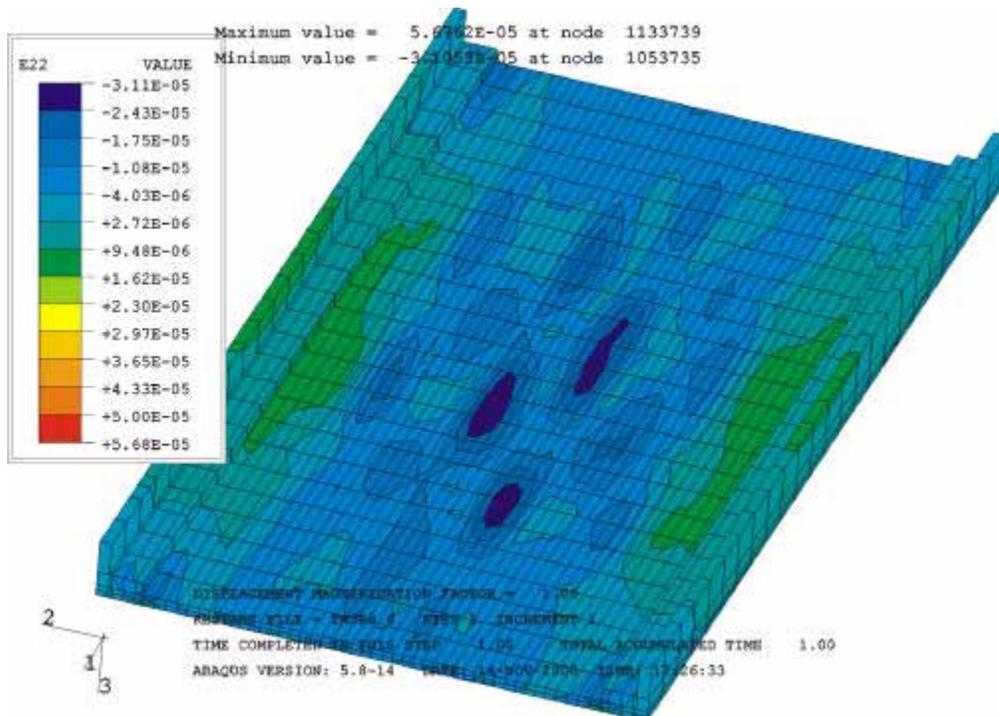
Figure 6.54 Contours of transverse strain for live load, run #13 – truck A and B, center of lanes.

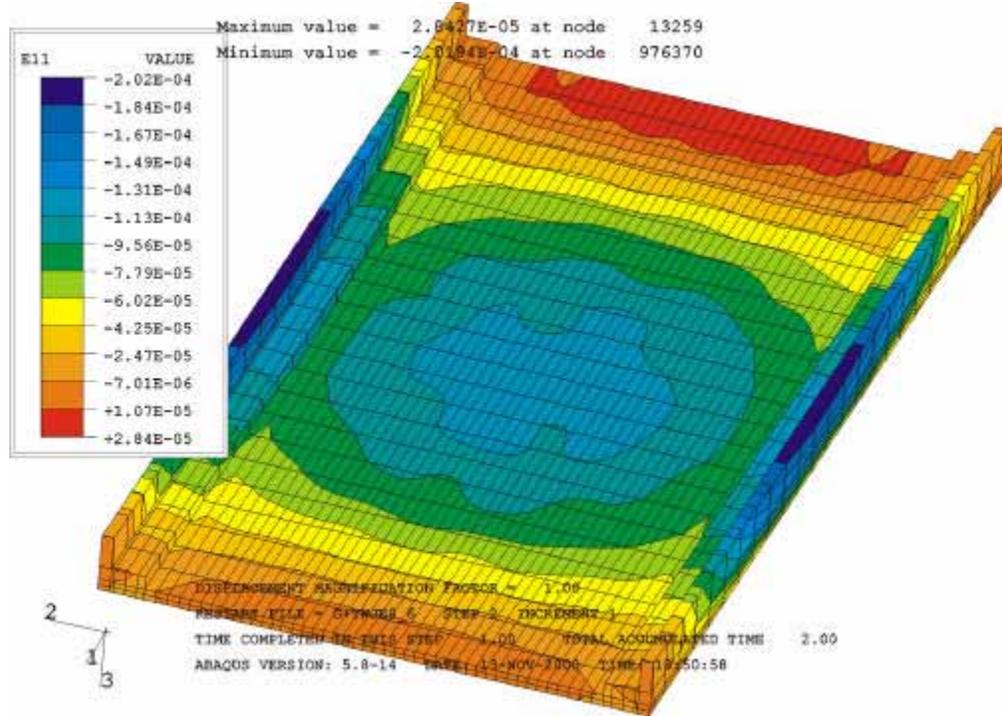
Figure 6.55 Contours of longitudinal strain for dead and live loads – gravity and run #13.

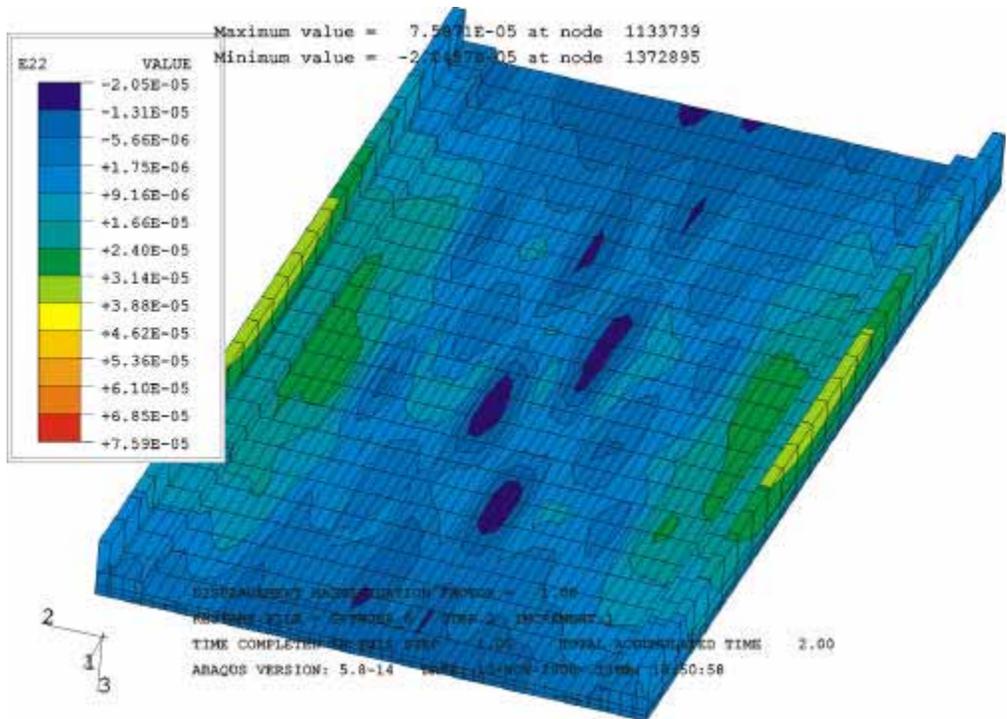
Figure 6.56 Contours of transverse strain for dead and live loads – gravity and run #13.

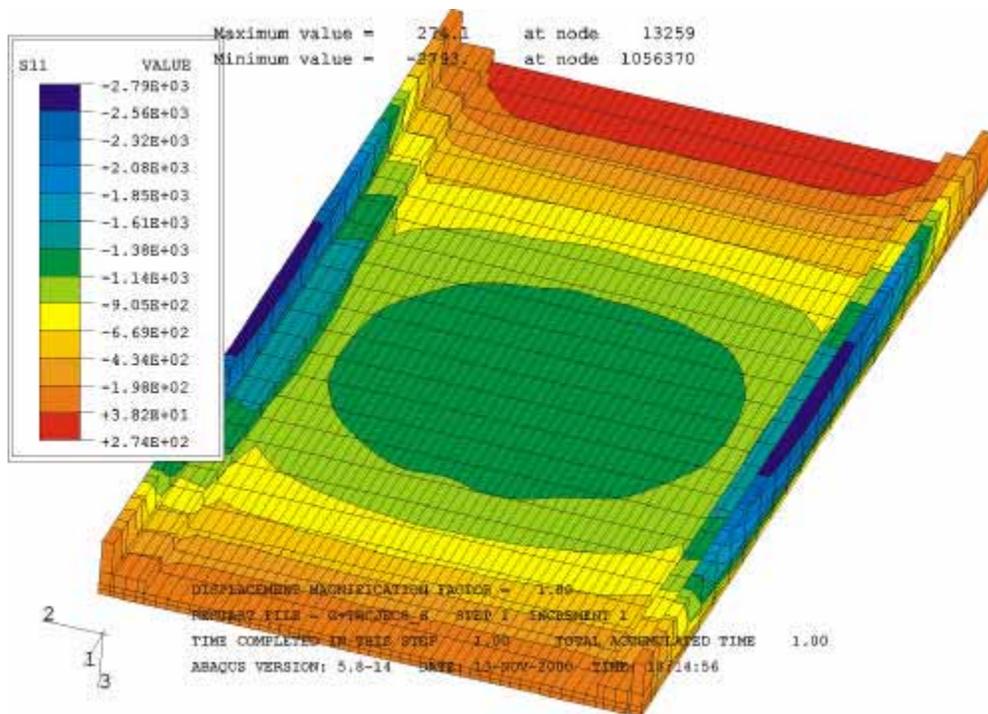
Figure 6.57 Contours of longitudinal stress for dead load – gravity. Top surface of deck

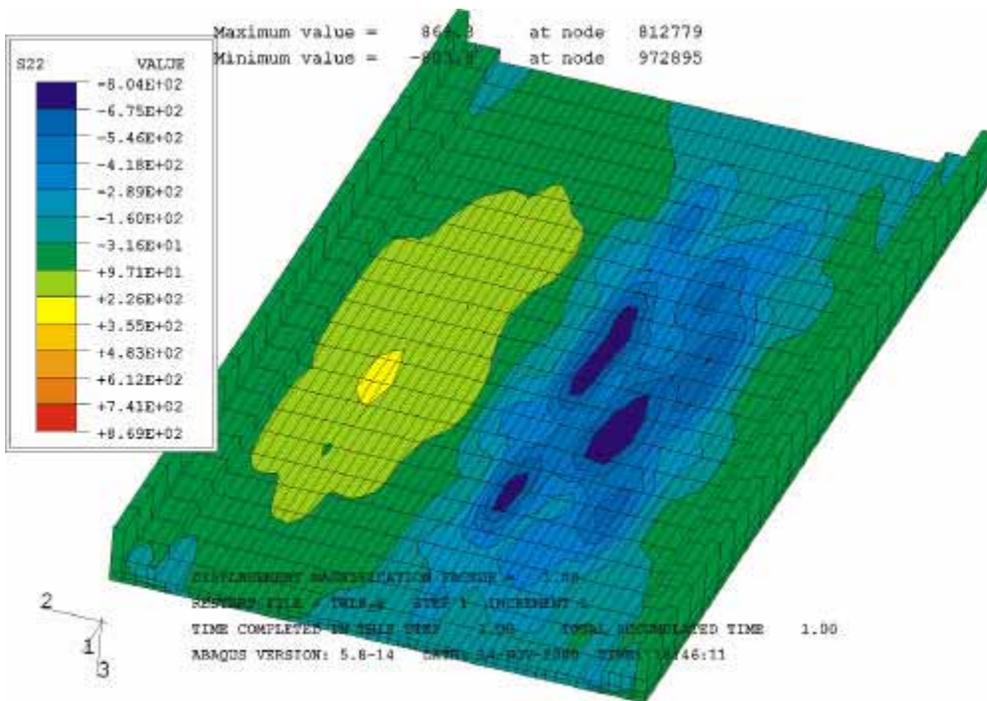
Figure 6.60 Contours of transverse stress for live load, run #7 – truck A, center of lane. Top surface of deck

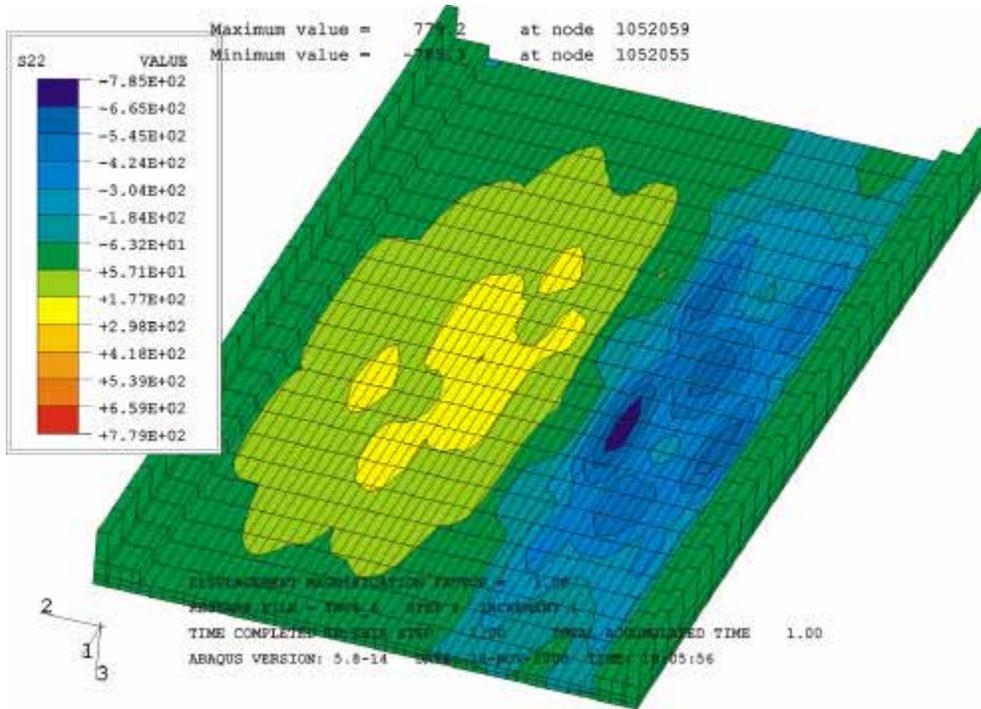
Figure 6.62 Contours of transverse stress for live load, run #8 – truck A, close to curb. Top surface of deck

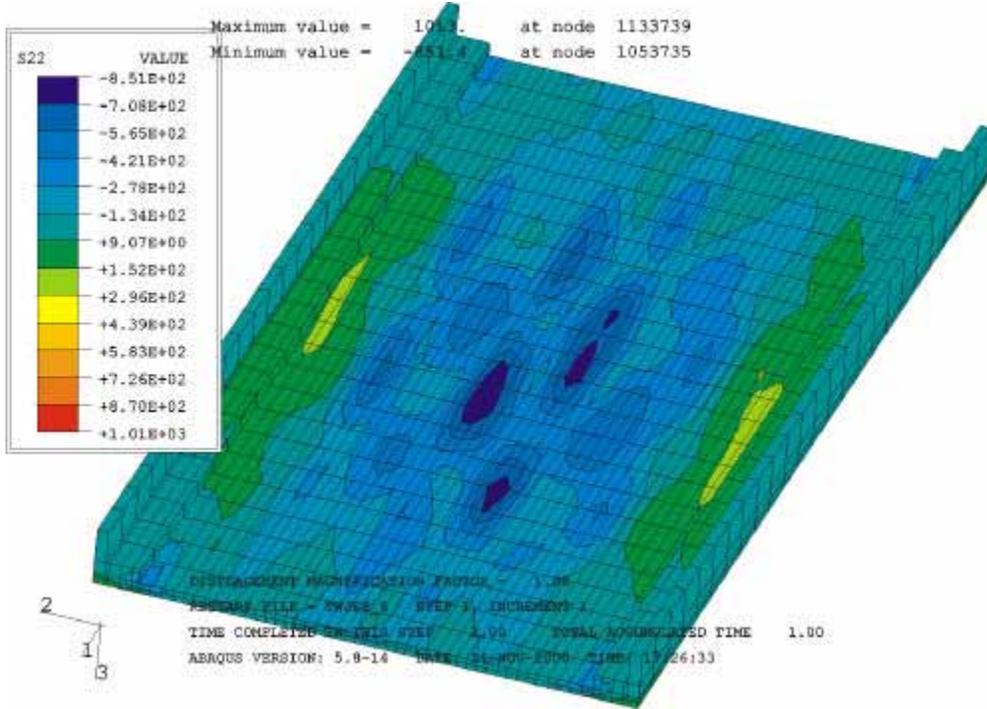
Figure 6.64 Contours of transverse stress for live load, run #13 – truck A and B, center of lane. Top surface of deck
