**DEVELOPMENT OF THE
PROCEDURE FOR EFFICIENT
EVALUATION OF BRIDGE DECKS**

**CONTRACT NO. 98-1303 DIR
Report submitted to
The Michigan Department of Transportation**

Report provides the background information for the Michigan Deck Evaluation Guide. It consists of chapters dealing with material models for deck analysis, field inspection and field test results, finite element analysis of bridge superstructure, and additional analysis on punching shear failure mode.

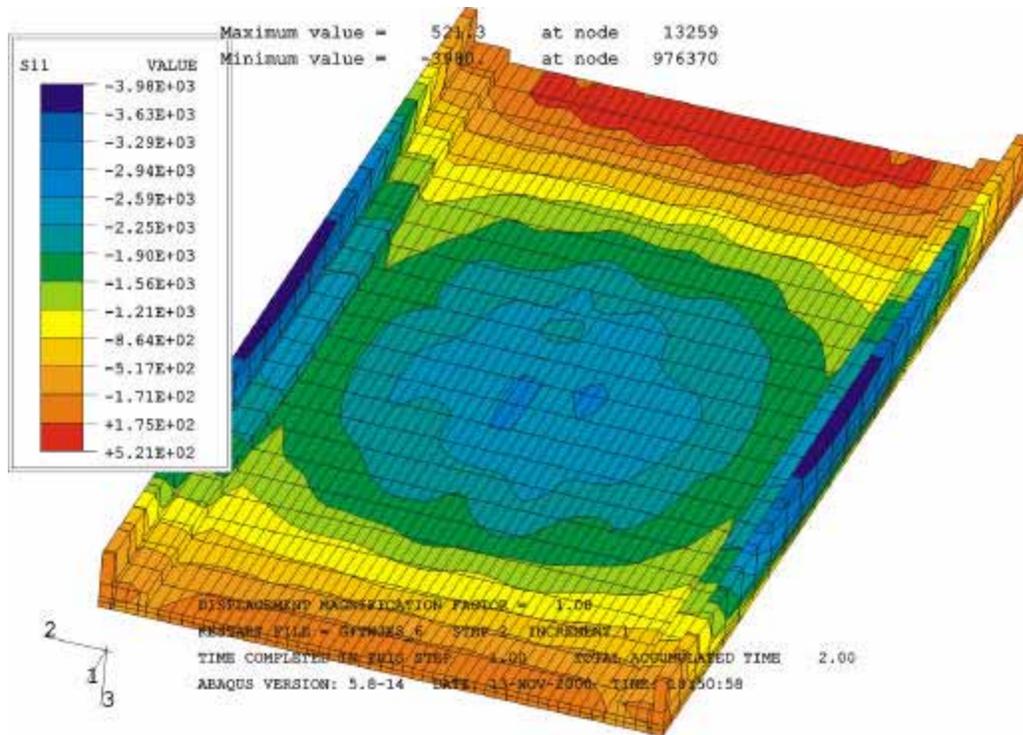
Figure 6.65 Contour of longitudinal stress for dead and live loads – gravity and run #13. Top surface of deck

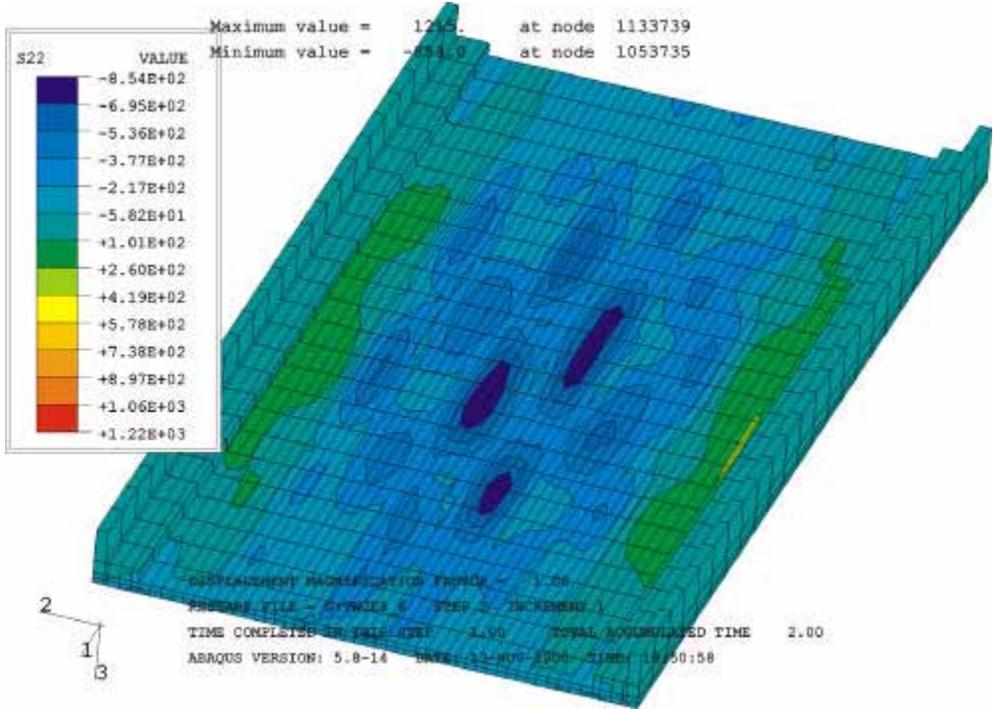
Figure 6.66 Contour of transverse stress for dead and live loads – gravity and run #13. Top surface of deck.

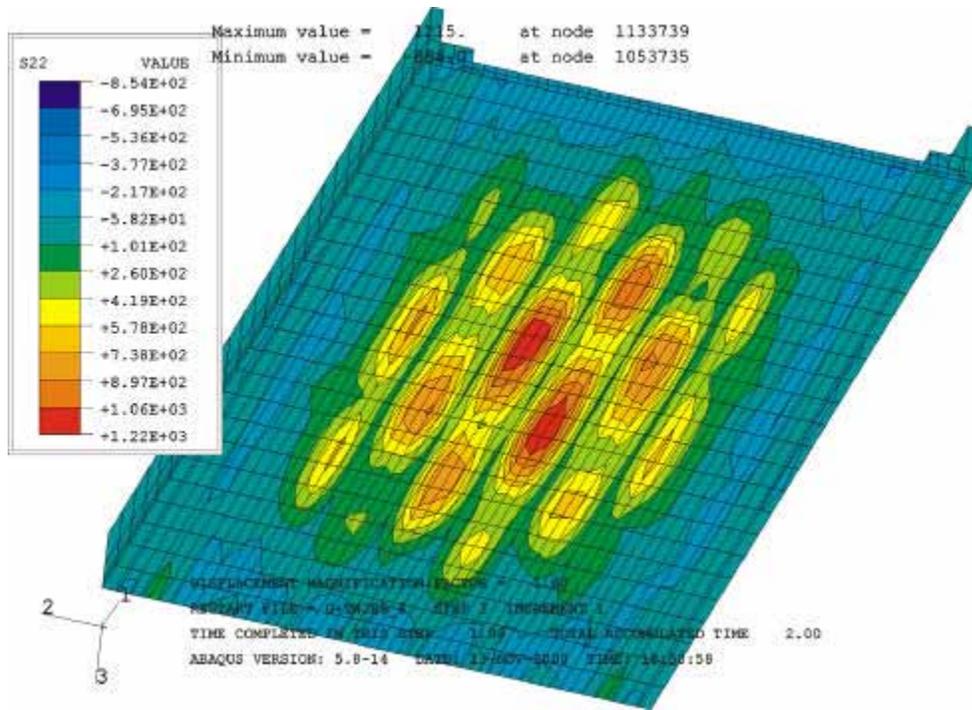
Figure 6.68 Contour of transverse stress for dead and live loads – gravity and run #13.
 Bottom surface of deck

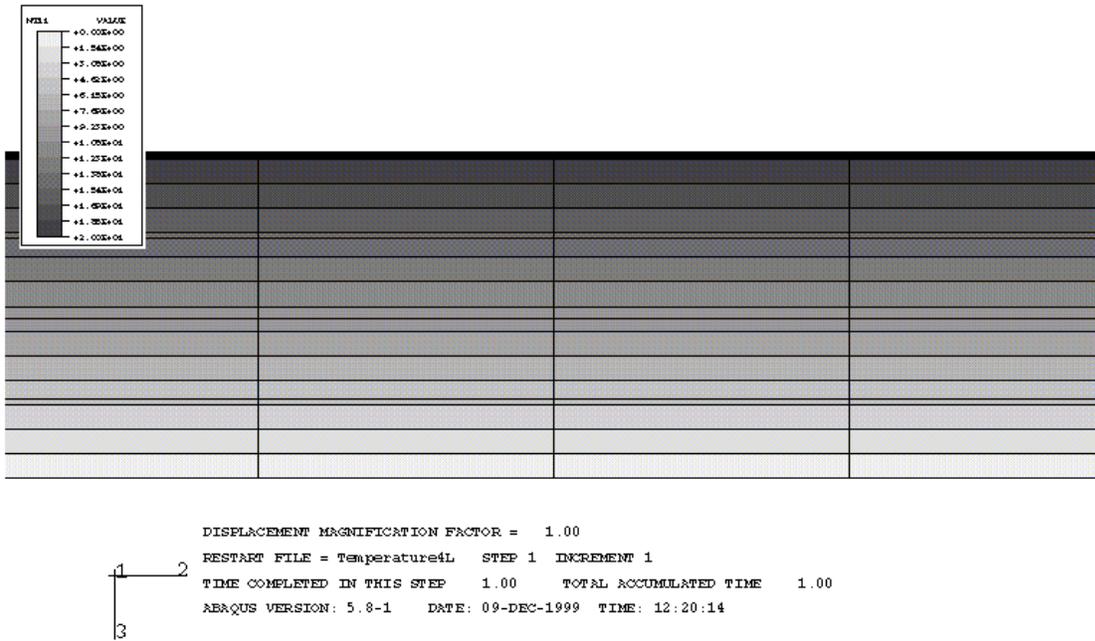
Figure 6.69 Distribution of applied temperature gradient in the slab thickness.

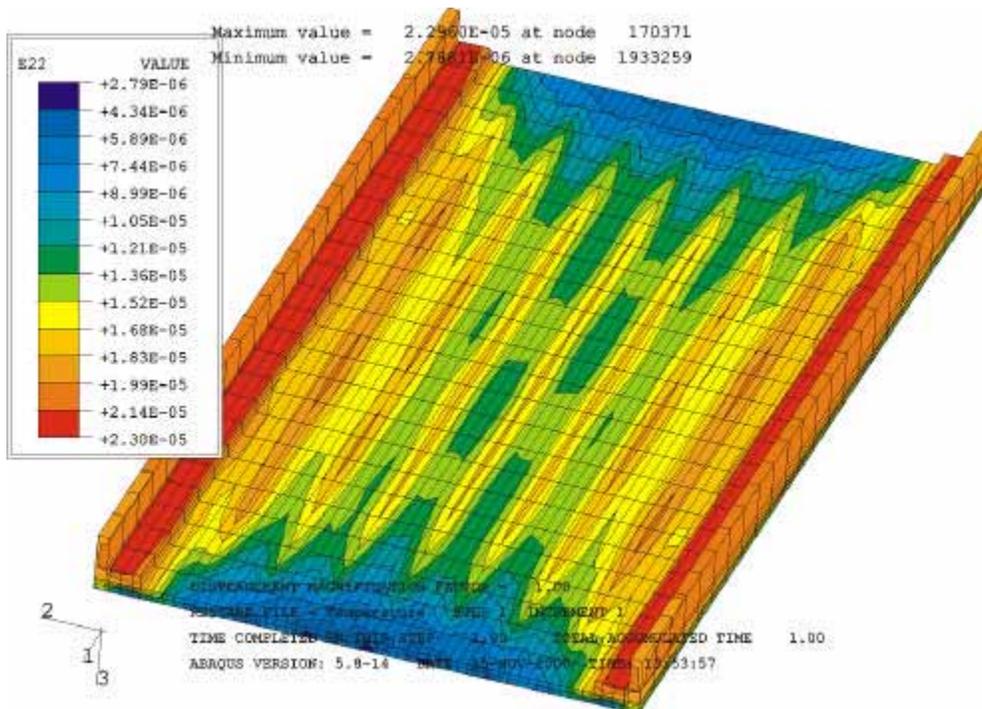
Figure 6.72 Contours of transverse strains in the slab for temperature gradient $\Delta t = 15$ °C. Tension on top surface

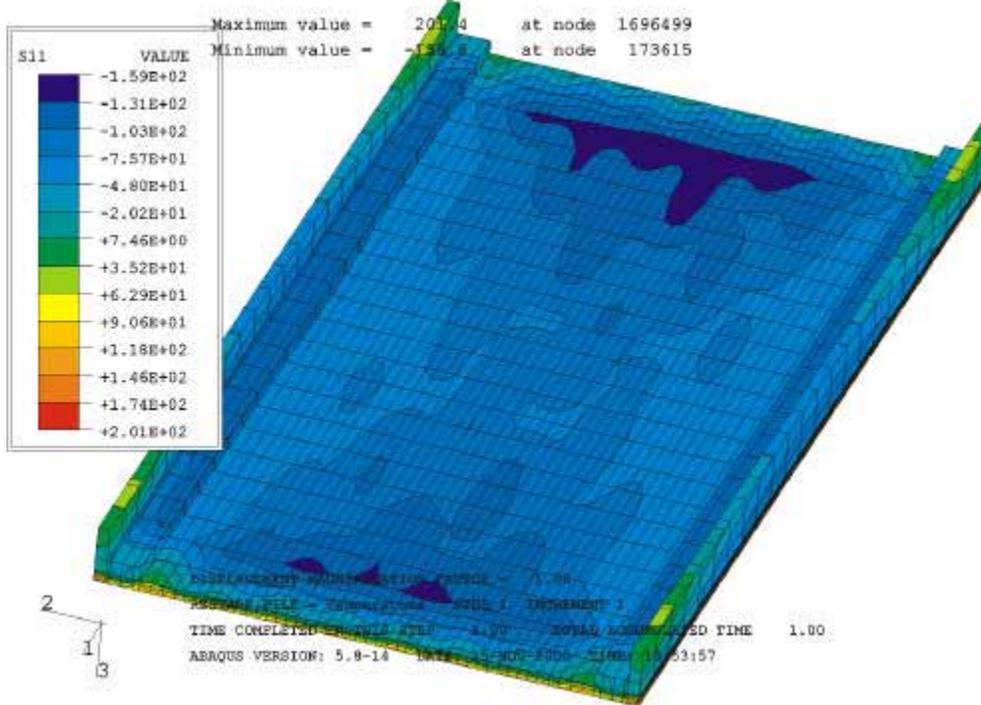
Figure 6.73 Contours of longitudinal stresses in the slab for temperature gradient $\Delta t = 15$ °C. Top surface of deck; maximum value in tension = 201.4 kPa, minimum value in compression = 156.8 kPa.

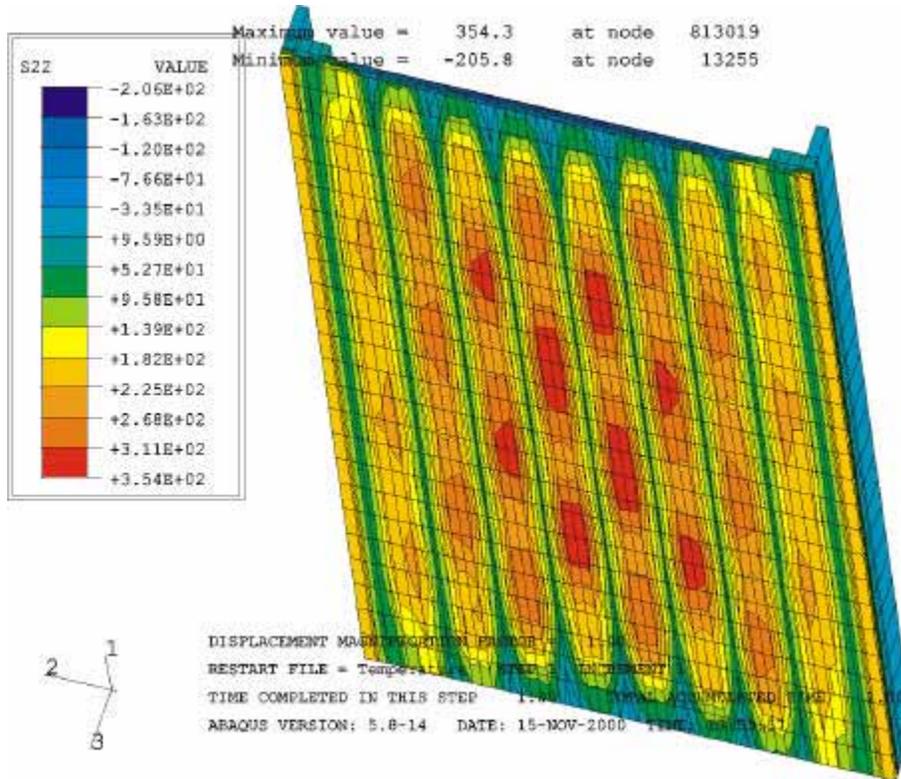
Figure 6.75 Contours of transverse stresses in the slab for temperature gradient $\Delta t = 15$ °C. Bottom surface of deck; maximum value in tension = 354.3 kPa, minimum value in compression = 205.8 kPa.

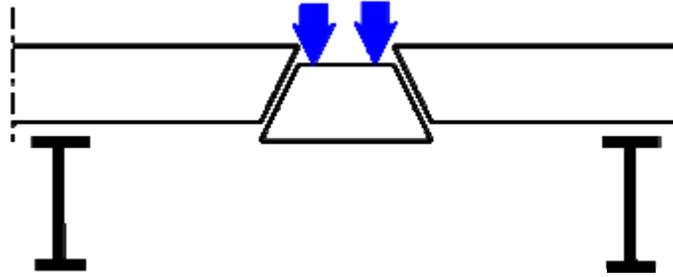
Figure 7.1. Punching shear failure.

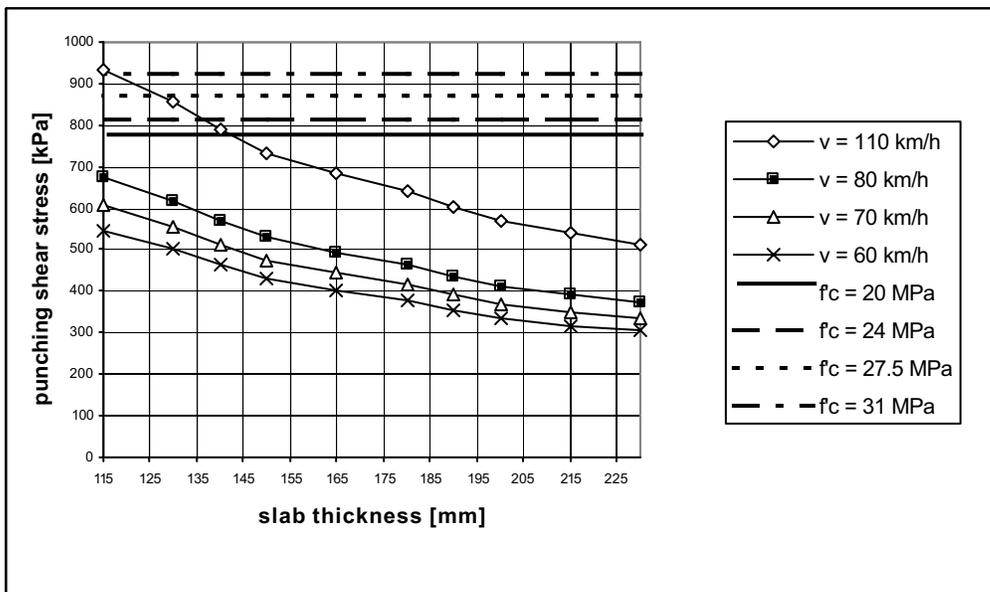
Figure 7-4. Punching Shear Stress versus Slab Thickness, Probability = 0.10.
