MICHIGAN DEPARTMENT OF STATE HIGHWAYS

**AN EVALUATION OF MASTIC-TYPE PAVING MIXTURES
FOR RESURFACING A ROADWAY AND A BRIDGE DECK**

**Testing and Research Division
Research Project 72 C-14
Research Report No. R-861**

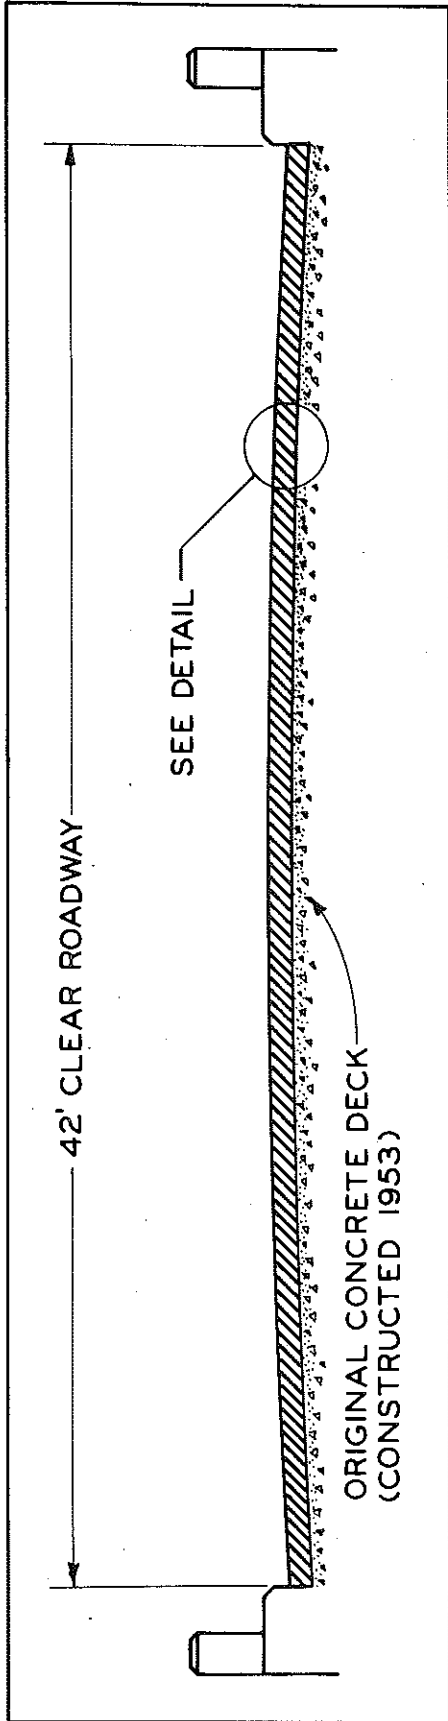
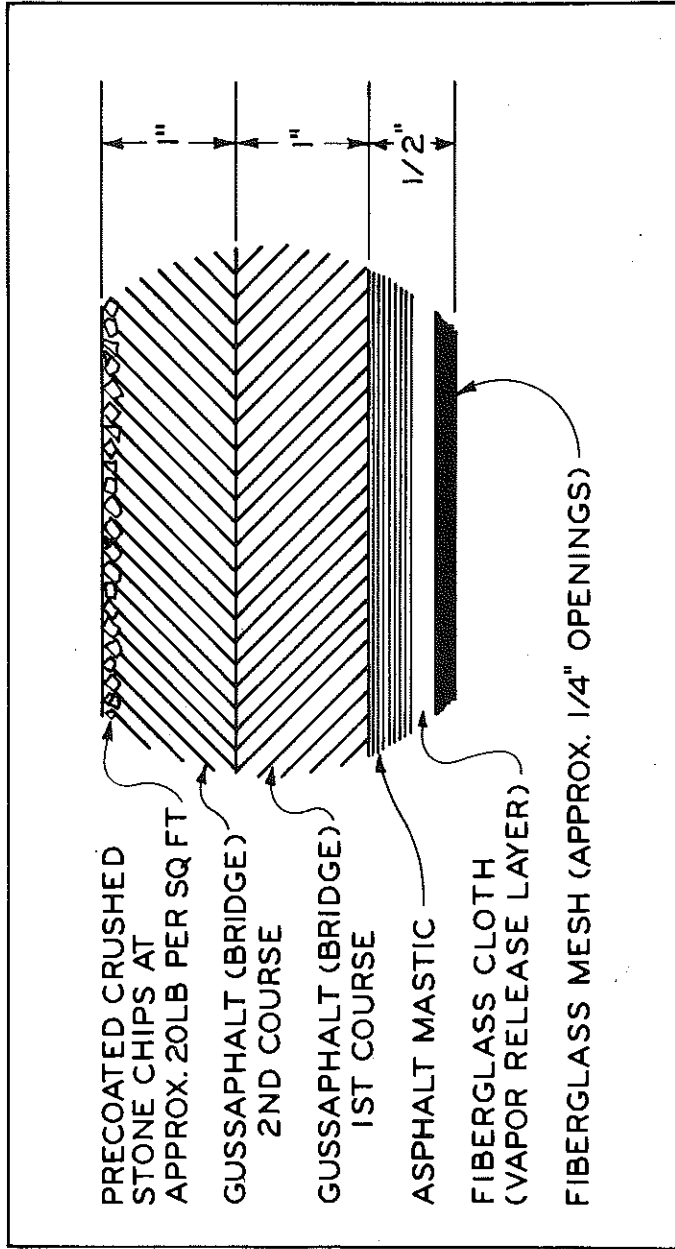
Figure 2. Typical proposed cross section of Gussasphalt waterproofing membrane.

Contingent upon satisfactory results on the roadway, Gussasphalt was to be constructed to a nominal thickness of 2 in. as the upper layer of a bridge deck waterproofing membrane. The membrane, shown in cross section in Figure 2, contained a fiberglass mesh layer next to the bridge deck to transfer water toward a row of weep holes 1/2 to 3/4 in. in diameter. Weep holes were drilled through the deck and lined with a tube projecting about 2 in. below the bottom of the deck. Thus, moisture in the deck vaporized by the hot Gussasphalt, would be transferred by the fiberglass to the weep holes and the lined weep holes would then permit moisture to drip cleanly without soaking the bottom of the deck. If provision for moisture release were not provided, the membrane surface would blister.

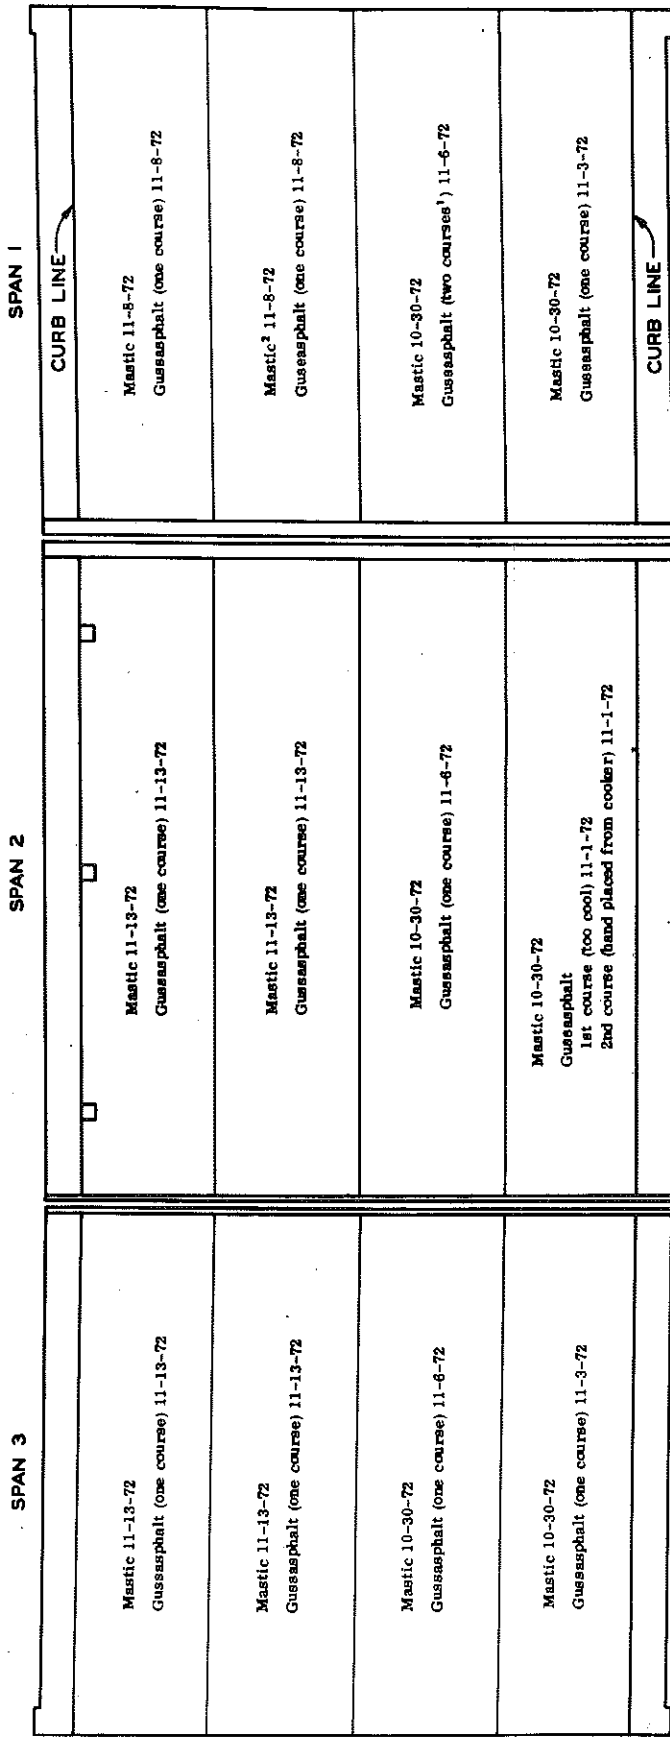
¹Paver slipped off forms causing low grade and necessity for second course.

²Center two rows of top fiberglass mat are of United States manufacture.

Method of curb line seal:

Span 1 Gussasphalt placed directly against curb face.

Span 2 Joint formed and filled with Para-Plastic hot pour seal.

Span 3 Curb face coated with epoxy and Gussasphalt then placed against the curb face.

Weep holes placed along west curb face.

Figure 3. Construction sequence and placement dates of Gussasphalt waterproofing membrane (B02 of 64013).

For sealing the membrane - curb interface, a different method was planned for each of the three spans: 1) placing the membrane directly against the curb face; 2) applying a coating of epoxy resin on the curb face and bridge deck extending about 6 to 10 in. from the curb, and; 3) using a formed-joint filled with conventional hot-pour joint sealer. Figure 3 is a diagram locating the span on which each type of sealer was used. Transverse joints in the bridge deck were to be built up in height to be flush with the Gussasphalt surface.

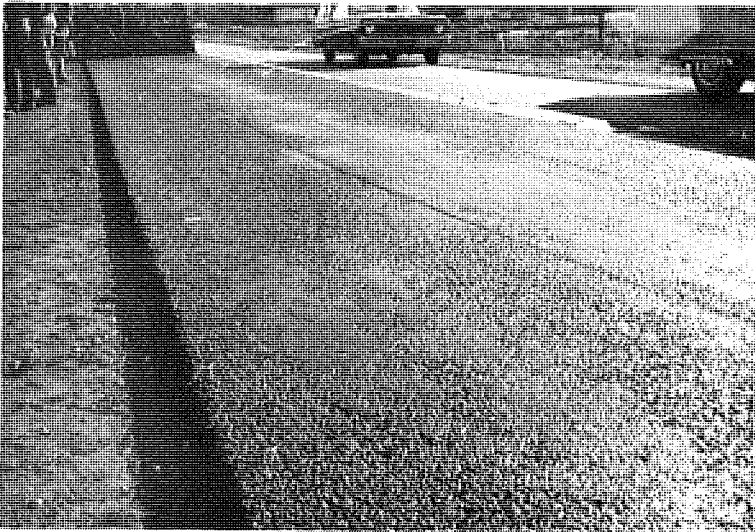
Figure 4. Mastiphalt pavement. Typical texture of surface is shown above. Note variation in surface texture caused by segregation in view at left.

Some segregation was noticed in the Mastiphalt placed on the road but since none had been noticed on the test pad, it was concluded that segregation was caused by trucking over rough roads between the plant and job site. The distance from the plant to the job site was about 3-1/4 miles. Figure 4 shows typical Mastiphalt appearance.

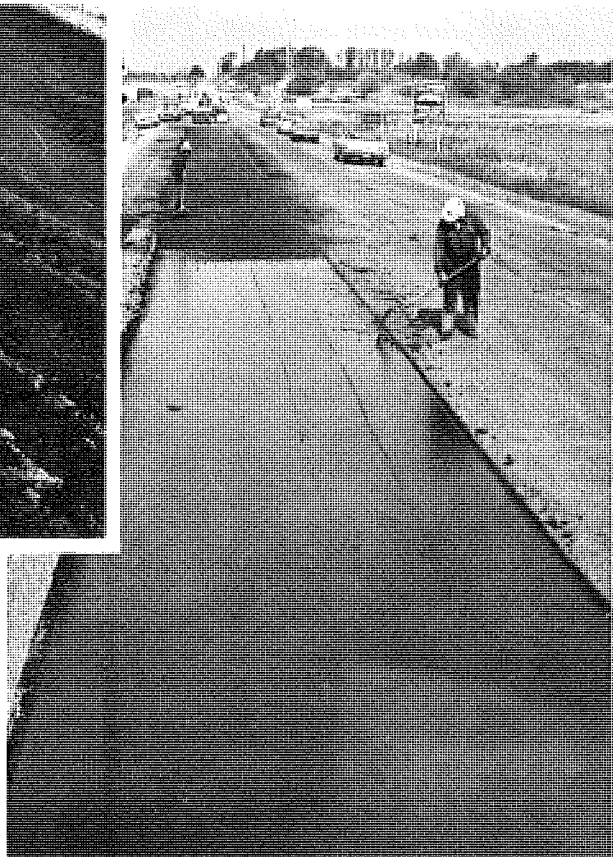
Figure 6. Typical appearance of Gussasphalt surface immediately after paving. Note surface stone being applied in background.

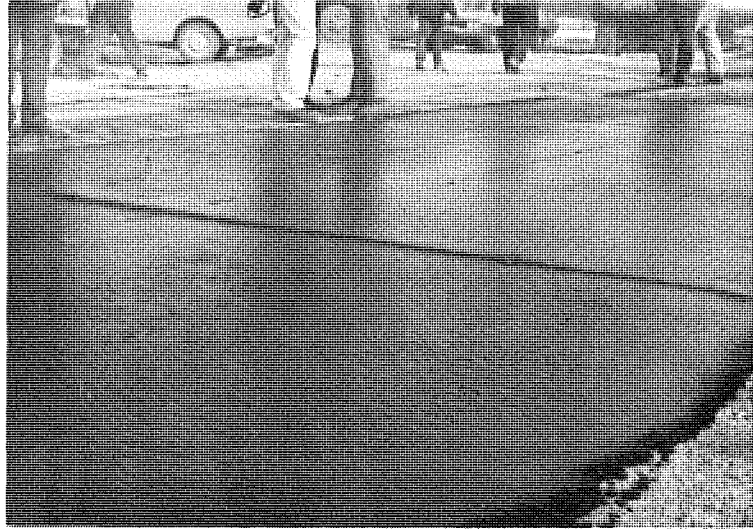
Figure 7. Transverse fault in Gussasphalt caused by settlement on screed when paver stopped moving.

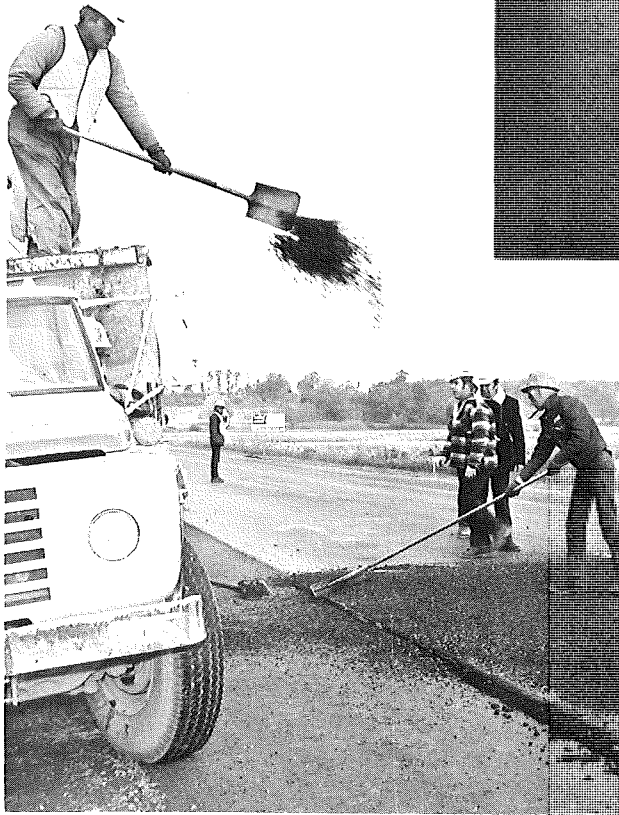
Figure 8. Spreading cover stone on Gussasphalt.

Cover stone precoated with 0.75 percent asphalt was spread by hand directly behind the paver (Fig. 8). After the mat had cooled sufficiently, the cover stone was rolled into the mat surface with a 1/2-ton steel roller and then finish rolled with a 14-ton pneumatic roller. Figure 9 shows the appearance of the surface before excess cover stone was swept off. It appears that excessive cover stone was used. The 31A cover stone was larger than specified or desired but the contractor could not obtain specification size (100 percent passing No. 4 sieve - 100 percent retained No. 8 sieve). The Strabag Bau A. G. consultant wanted the cover stone applied to provide high initial skid resistance. Traffic would then wear away the cover stone together with the asphalt sheen leaving aggregate exposed to provide long-term skid resistance.

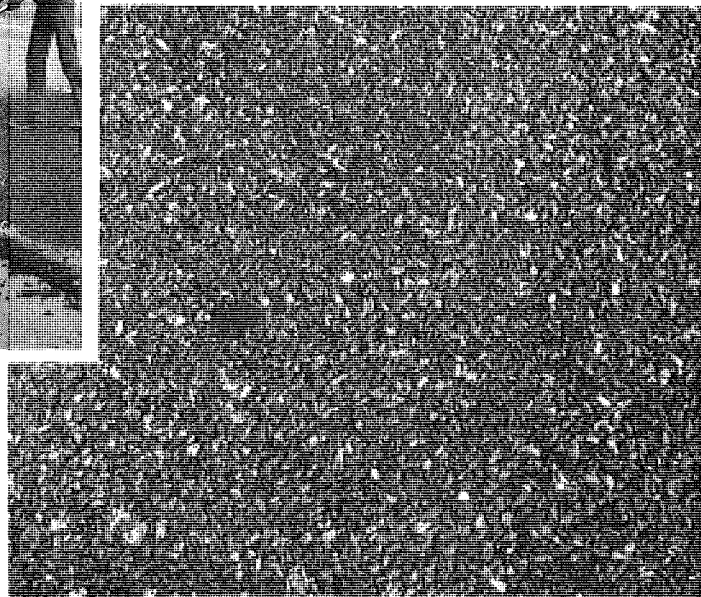
Figure 9. Cover stone after being rolled into Gussasphalt surface.

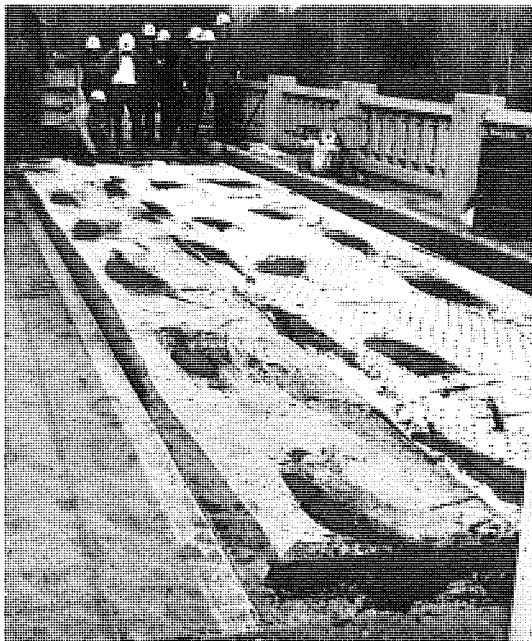
Figure 10. Installation of fiberglass on bridge deck. Note fiberglass mesh lying directly on deck and covered by fiberglass cloth. Patches of asphalt were used to cement mats to deck.

Fiberglass to transport residual moisture from the bridge deck and prevent surface blistering was installed as shown in Figure 10. A coarse weave mesh of fiberglass (Fig. 11) with approximately 1/4-in. square openings was placed directly upon the existing concrete bridge deck. Moisture condensing in the mesh was supposed to flow to weep holes and then drain through the deck. Fine weave fiberglass cloth with 3/4-in. circular holes, spaced 3 in. center to center was placed on top of the coarse weave layer. This upper cloth was to protect the mesh from being impregnated by a special hot sealing mastic and the holes would permit the mastic to bond to the bridge deck.

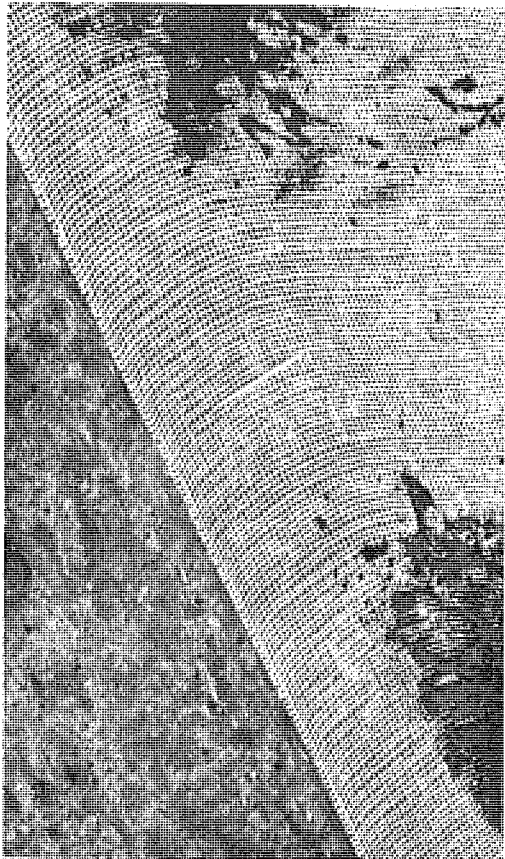
Figure 11. Fiberglass mesh placed directly on bridge deck.

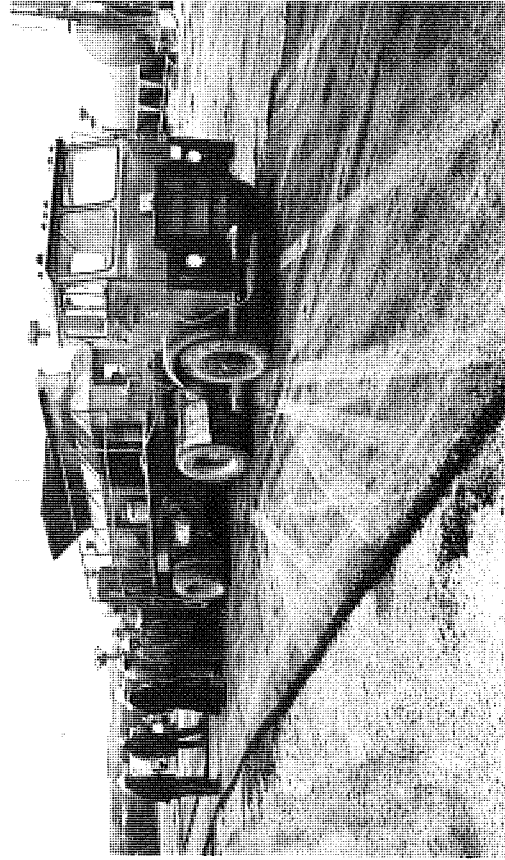
Figure 12. Cooker for transporting asphalt. Cookers provided continuous agitation and heat.

The special mastic was transported to the job site in German made cookers which kept the material agitated and at a high temperature (Fig. 12). As shown in Figure 13, the material was spread manually using a squeegee. Mix design and laboratory extraction test results for the mastic are as shown in Appendix C.

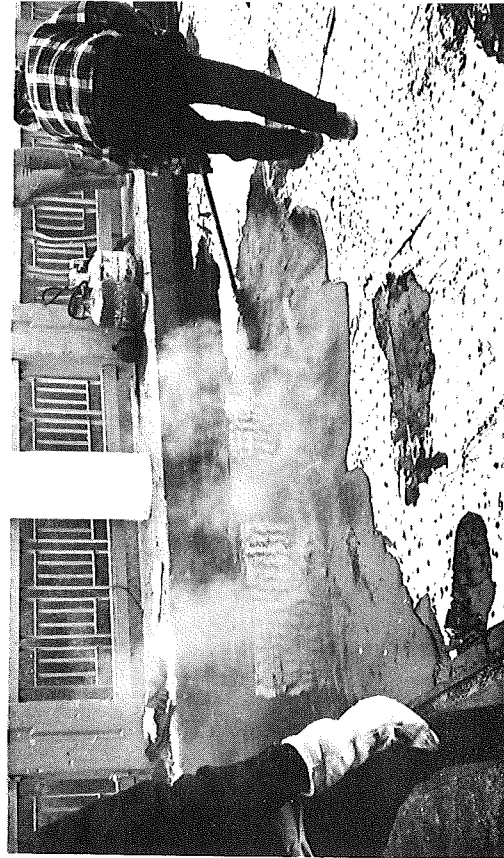
Figure 13. Manual spreading of mastic asphalt on bridge deck.

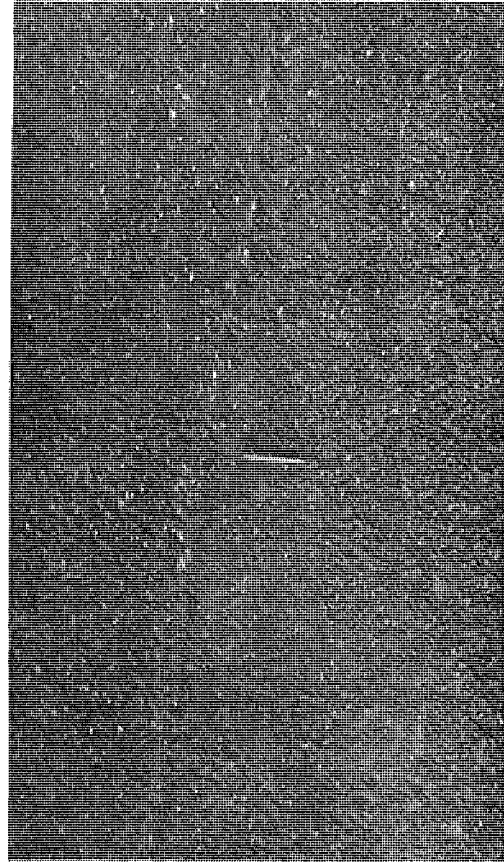
Figure 14. Surface of Gussasphalt after a few days service. Transverse ridge was caused by screed setting when paver stopped moving.

It was mentioned earlier that riding quality of the surfaces was not exceptionally good. The problem of obtaining a smooth surface was especially noticeable on the bridge deck which was superelevated and where the pavement had to be matched carefully to transverse joints. The bridge deck
