EVALUATION OF CALCIUM MAGNESIUM ACETATE
AS AN ICE CONTROL AGENT

FINAL REPORT

Research Laboratory Section
Testing and Research Division
in Cooperation with the
Maintenance Division
Research Project 82 G-259
Research Report No. R-1248

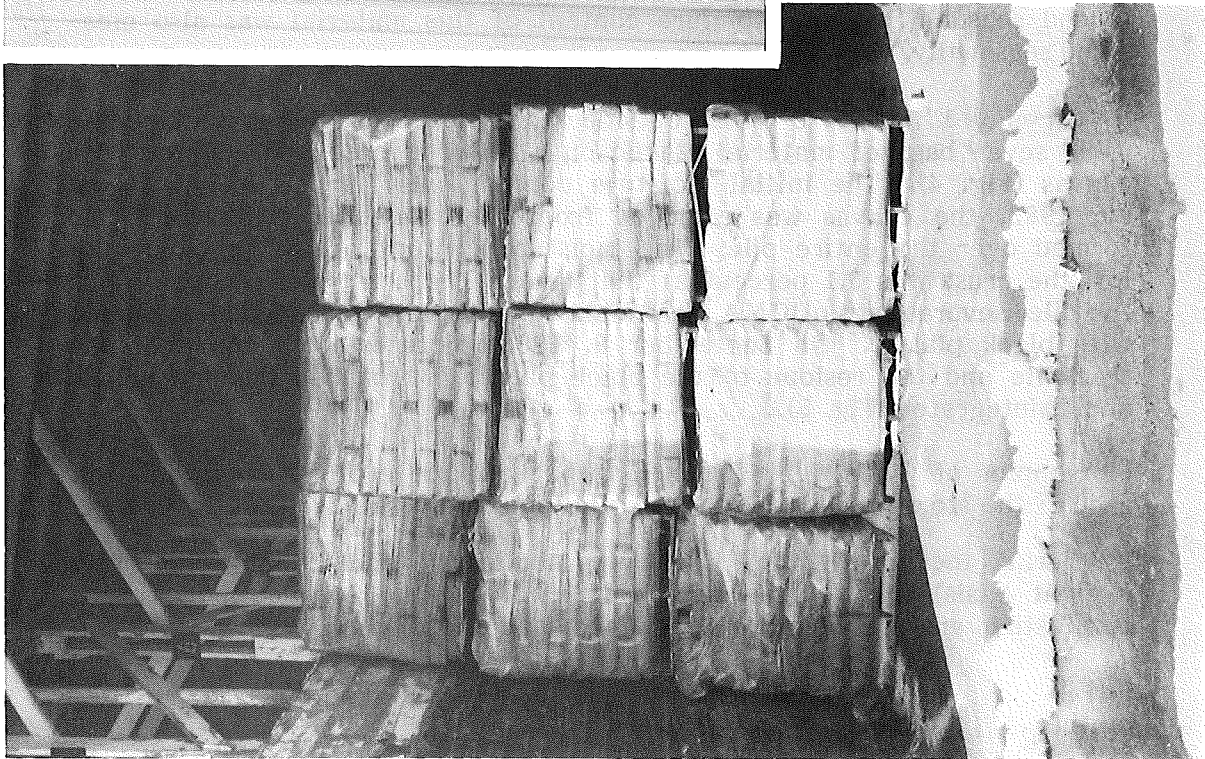
Figure 2. Storage of CMA during the evaluation period.

◀ Operating pile in the covered storage shed.

◀ Long-term storage of bagged and palletted material.

In addition to the ice melting performance, as measured on the road, storage and handling features were also observed and measured. Storm applications were made during two winters, thus requiring storage of some CMA for nearly a year. An operating stockpile was provided in an open-end shed to permit rapid loading of trucks during storms (Fig. 2). Moisture content and crusting of this pile were measured and observed periodically. CMA was loaded from the operating storage pile into a conventional salt spreader as shown in Figure 3. CMA not used during the first winter was stored in the original sealed bags in a covered storage shed until the second season (Fig. 2). Moisture content of this material was also measured seasonally.

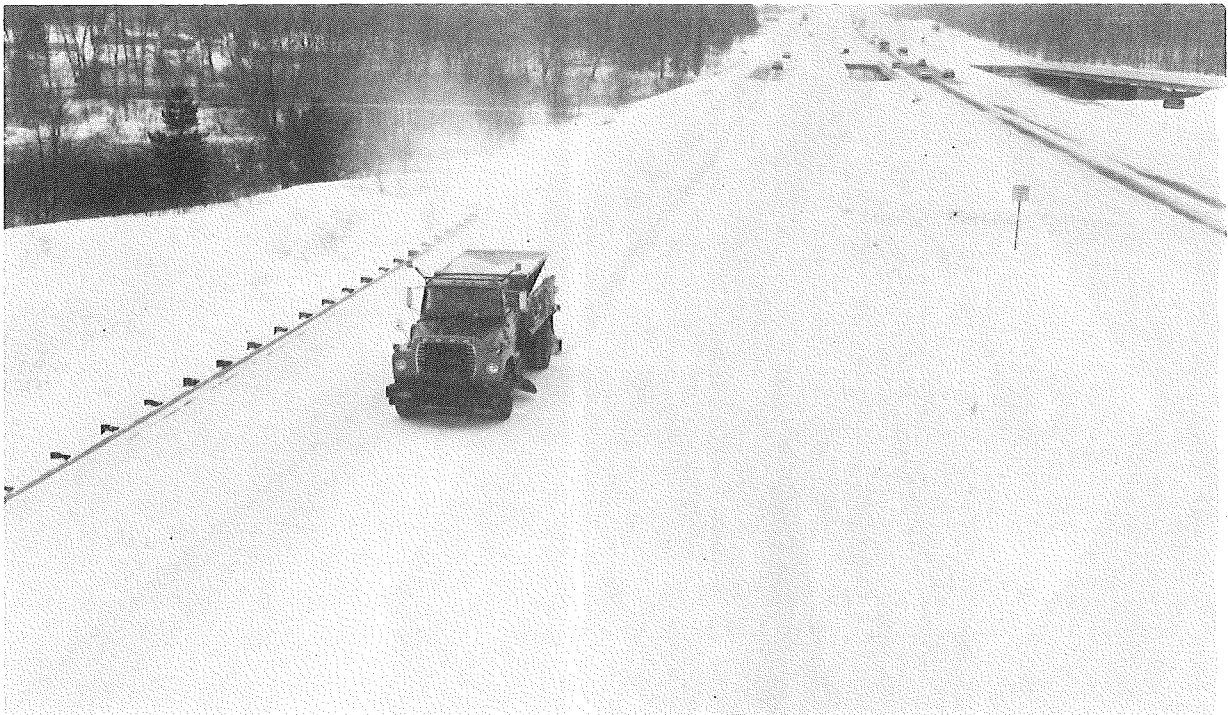
Figure 3. Loading and applying CMA.

Loading CMA into spreader truck. Note CMA dust at upper right.

CMA application on test section is the dark band behind the truck near the centerline.

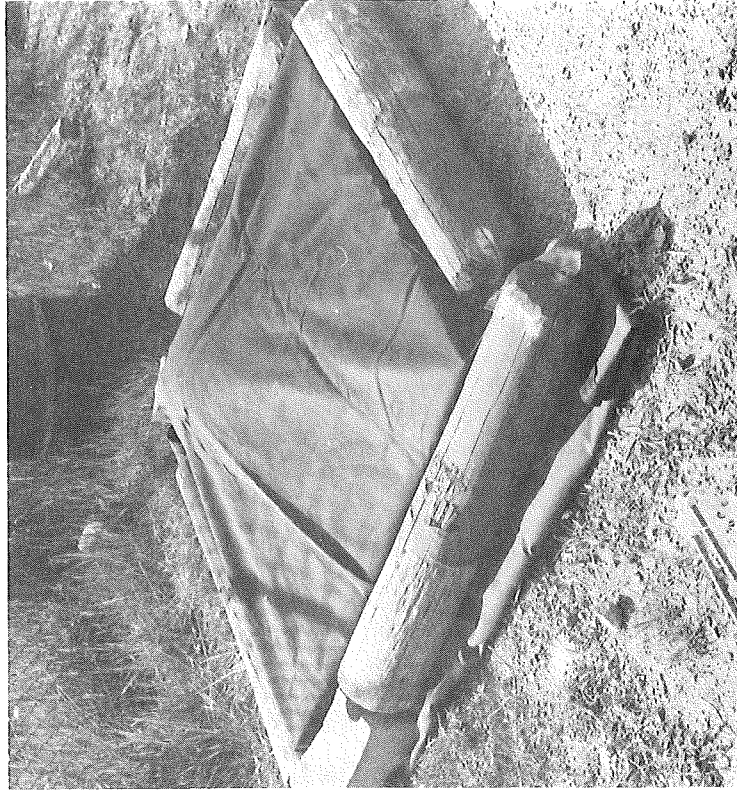
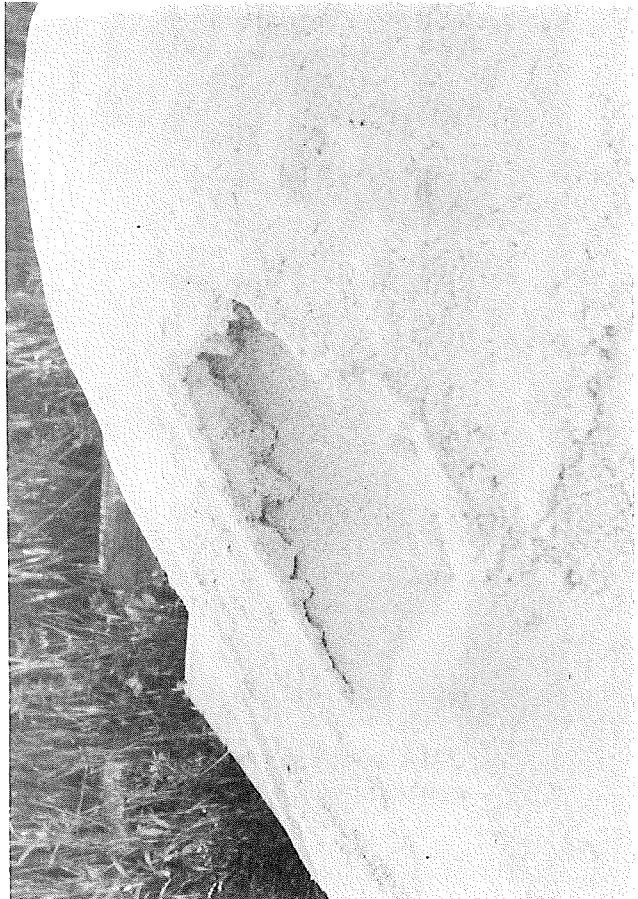
Figure 4. Experimental storage of CMA under canvas cover.

Initial condition of CMA prior to covering with canvas. Moisture content 1.9 percent.

Canvas cover in place.

Crusted condition of CMA after one month under canvas. Moisture content 5.1 percent.

On May 17, 1983, a small outside stockpile of CMA was constructed using seven bags of material placed on a plywood base and covered with canvas (Fig. 4). The initial moisture content was 1.9 percent. On June 10, 1983, the canvas was removed from the stockpile; thick crust had formed over the entire pile. The moisture content of the stockpile below the crust was 5.1 percent at that time. The crust was removed from the pile, several bags of CMA were added, and the pile reshaped and covered with black plastic. On September 9, 1983, pictures were taken of the stockpile and the residue of the black plastic which had become brittle and disintegrated (Fig. 5).

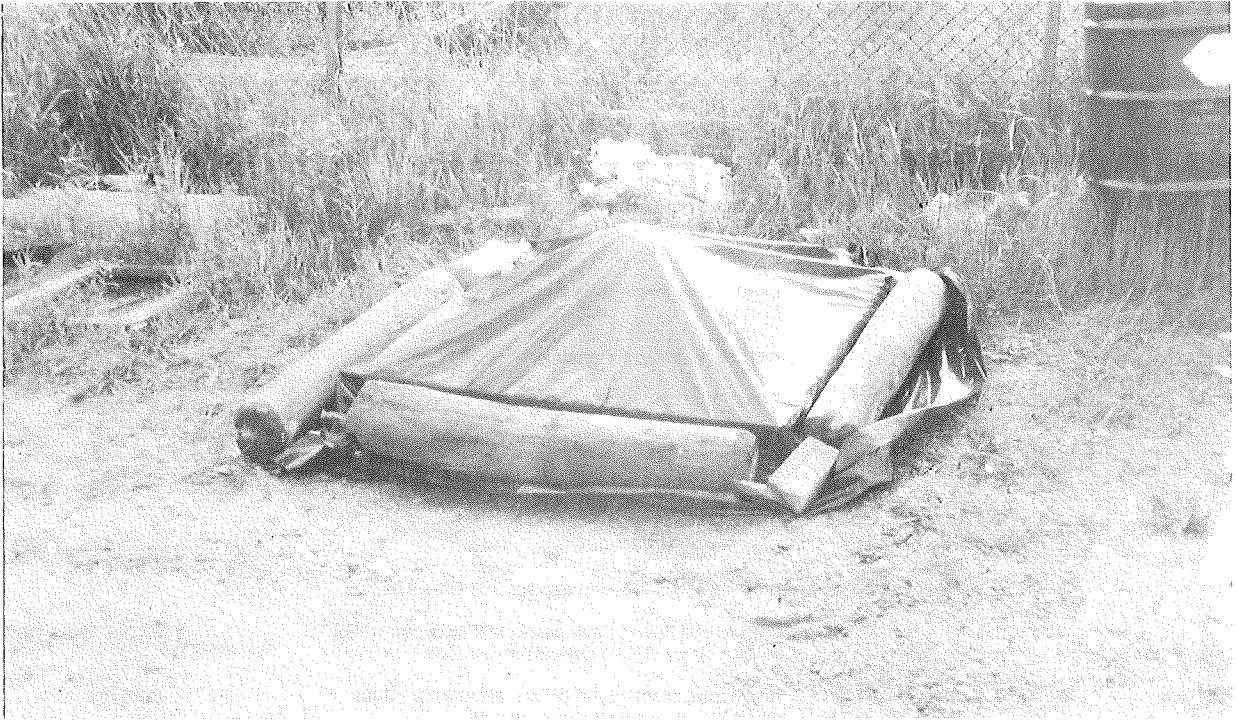
Figure 5. Storage of CMA under plastic cover.

Initial condition of plastic covered pile.

Condition of stockpile and plastic cover after three months.
