REVENUE SERVICE BRAKE LINING TEMPERATURE  
MEASUREMENTS FOR A RETARDER EQUIPPED BUS

Research Laboratory Section  
Testing and Research Division  
Research Project 81 TI-728  
Research Report No. R-1215

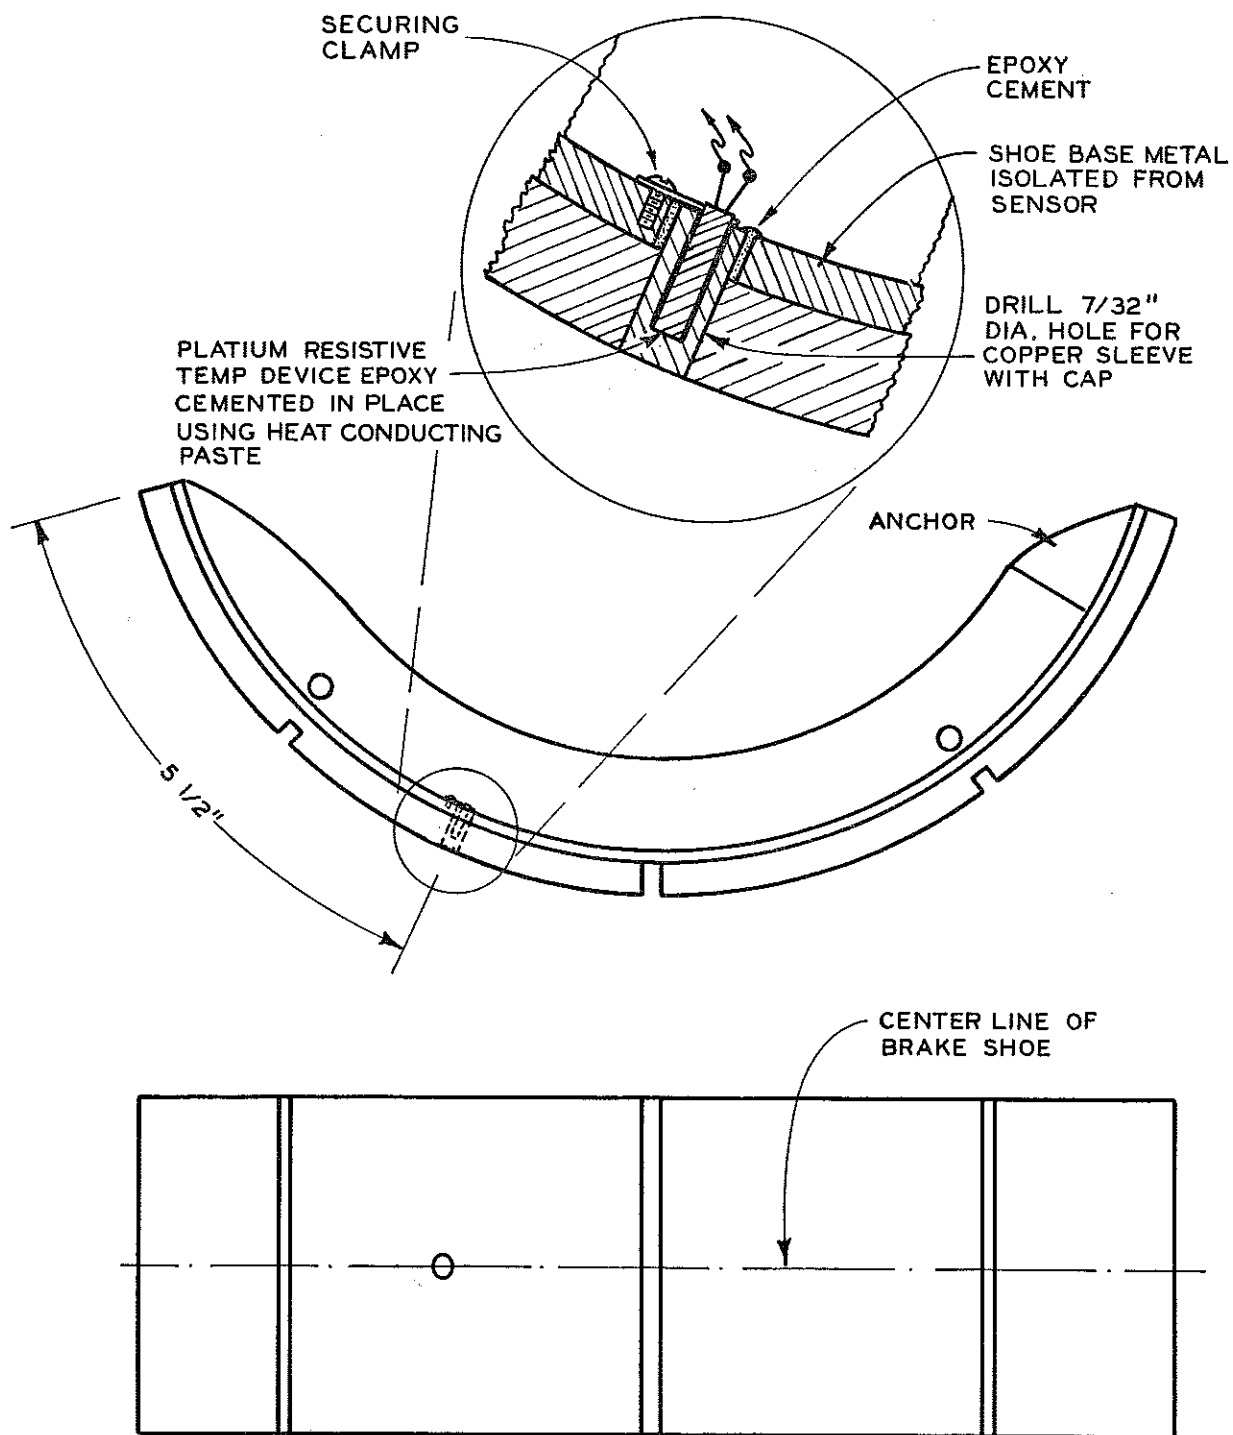
Figure 1. Instrumentation of brake shoe linings using RTD transducer.

The brake lining temperature transducers were installed as shown in Figure 1. Placement of these devices was in accordance with SAE Procedure J 786a with the exception of using the RTD transducers in lieu of thermocouples. The instrumentation procedure allowed the temperature at the drum/lining interface to be measured. The RTD transducers were installed on both linings of all four wheels.

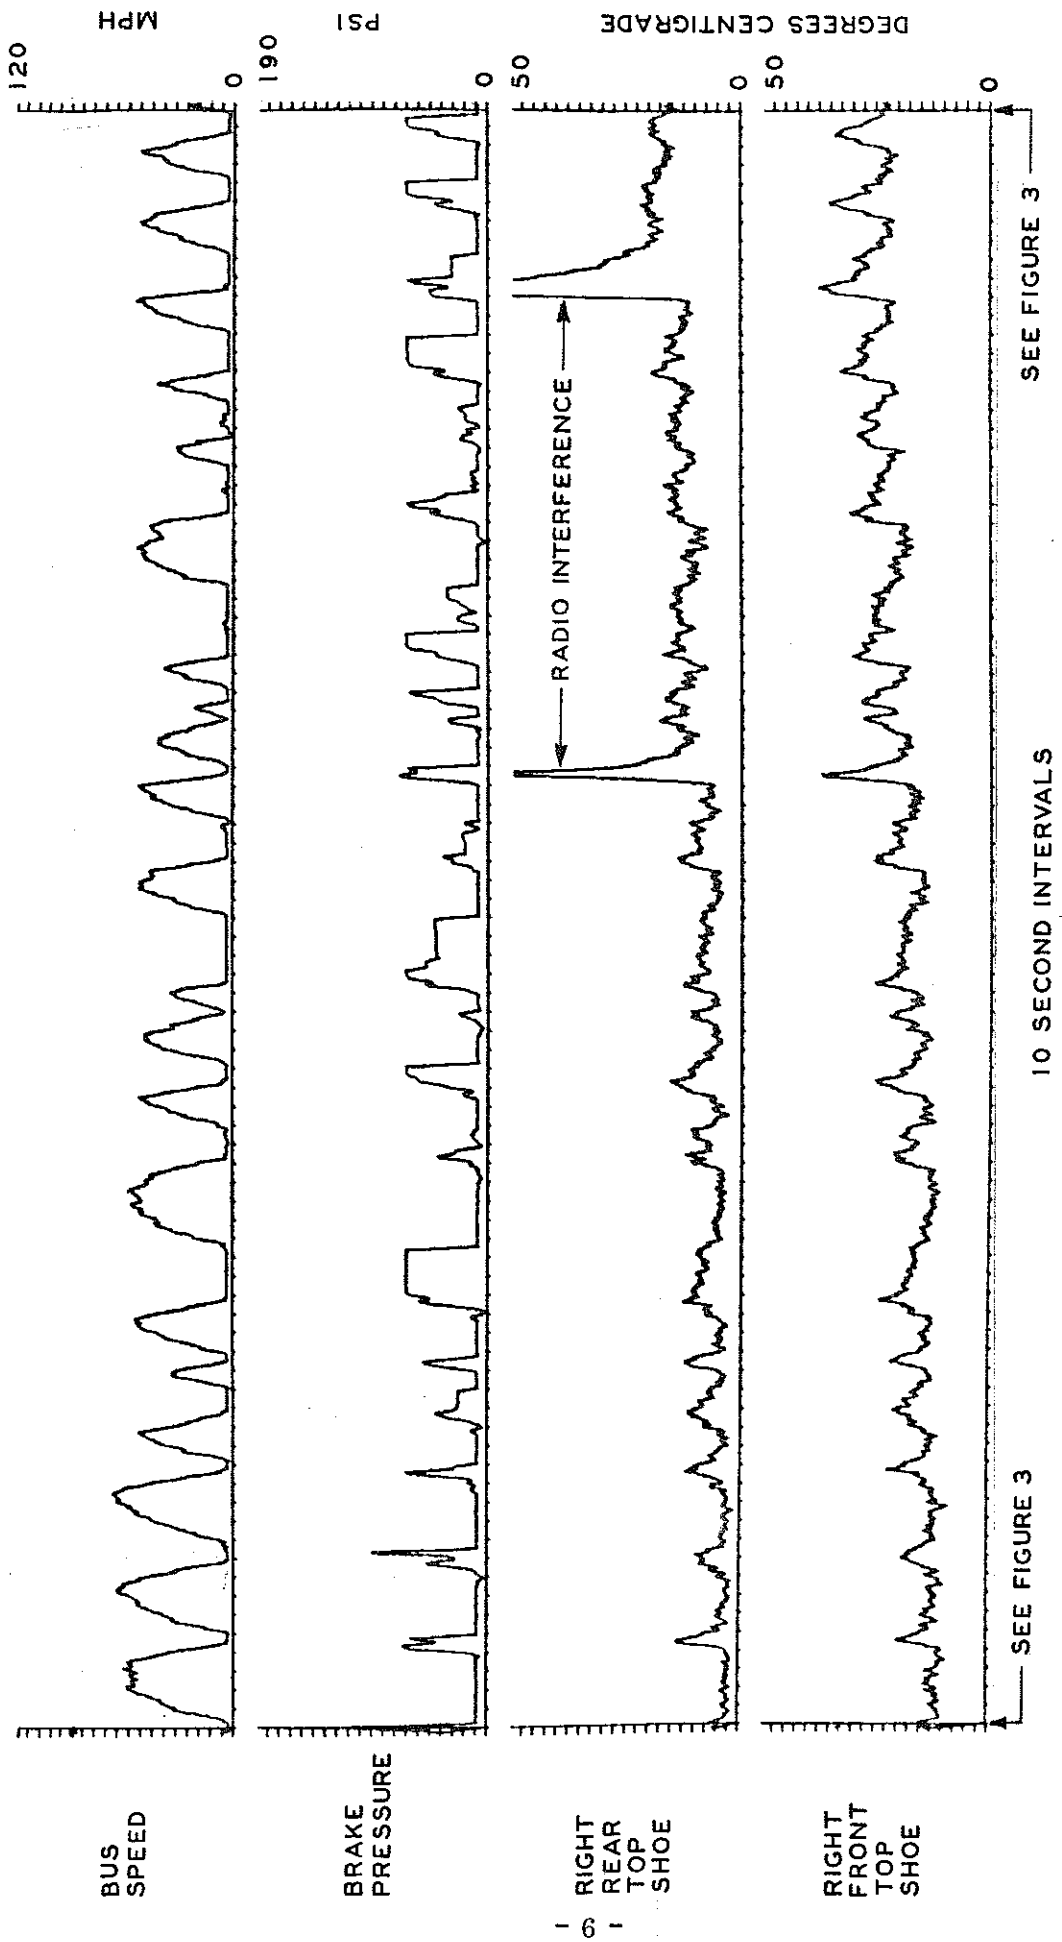
Figure 2. Brake lining temperature measurements (Run No. 1) with retarder in operation.

A typical sample of the recorded test temperatures showing the variation in brake lining temperature for each of the four trips is shown in Figures 2 through 6. The large spike in the temperature data was caused by radio transmitter interference which occurred at several places along the route.

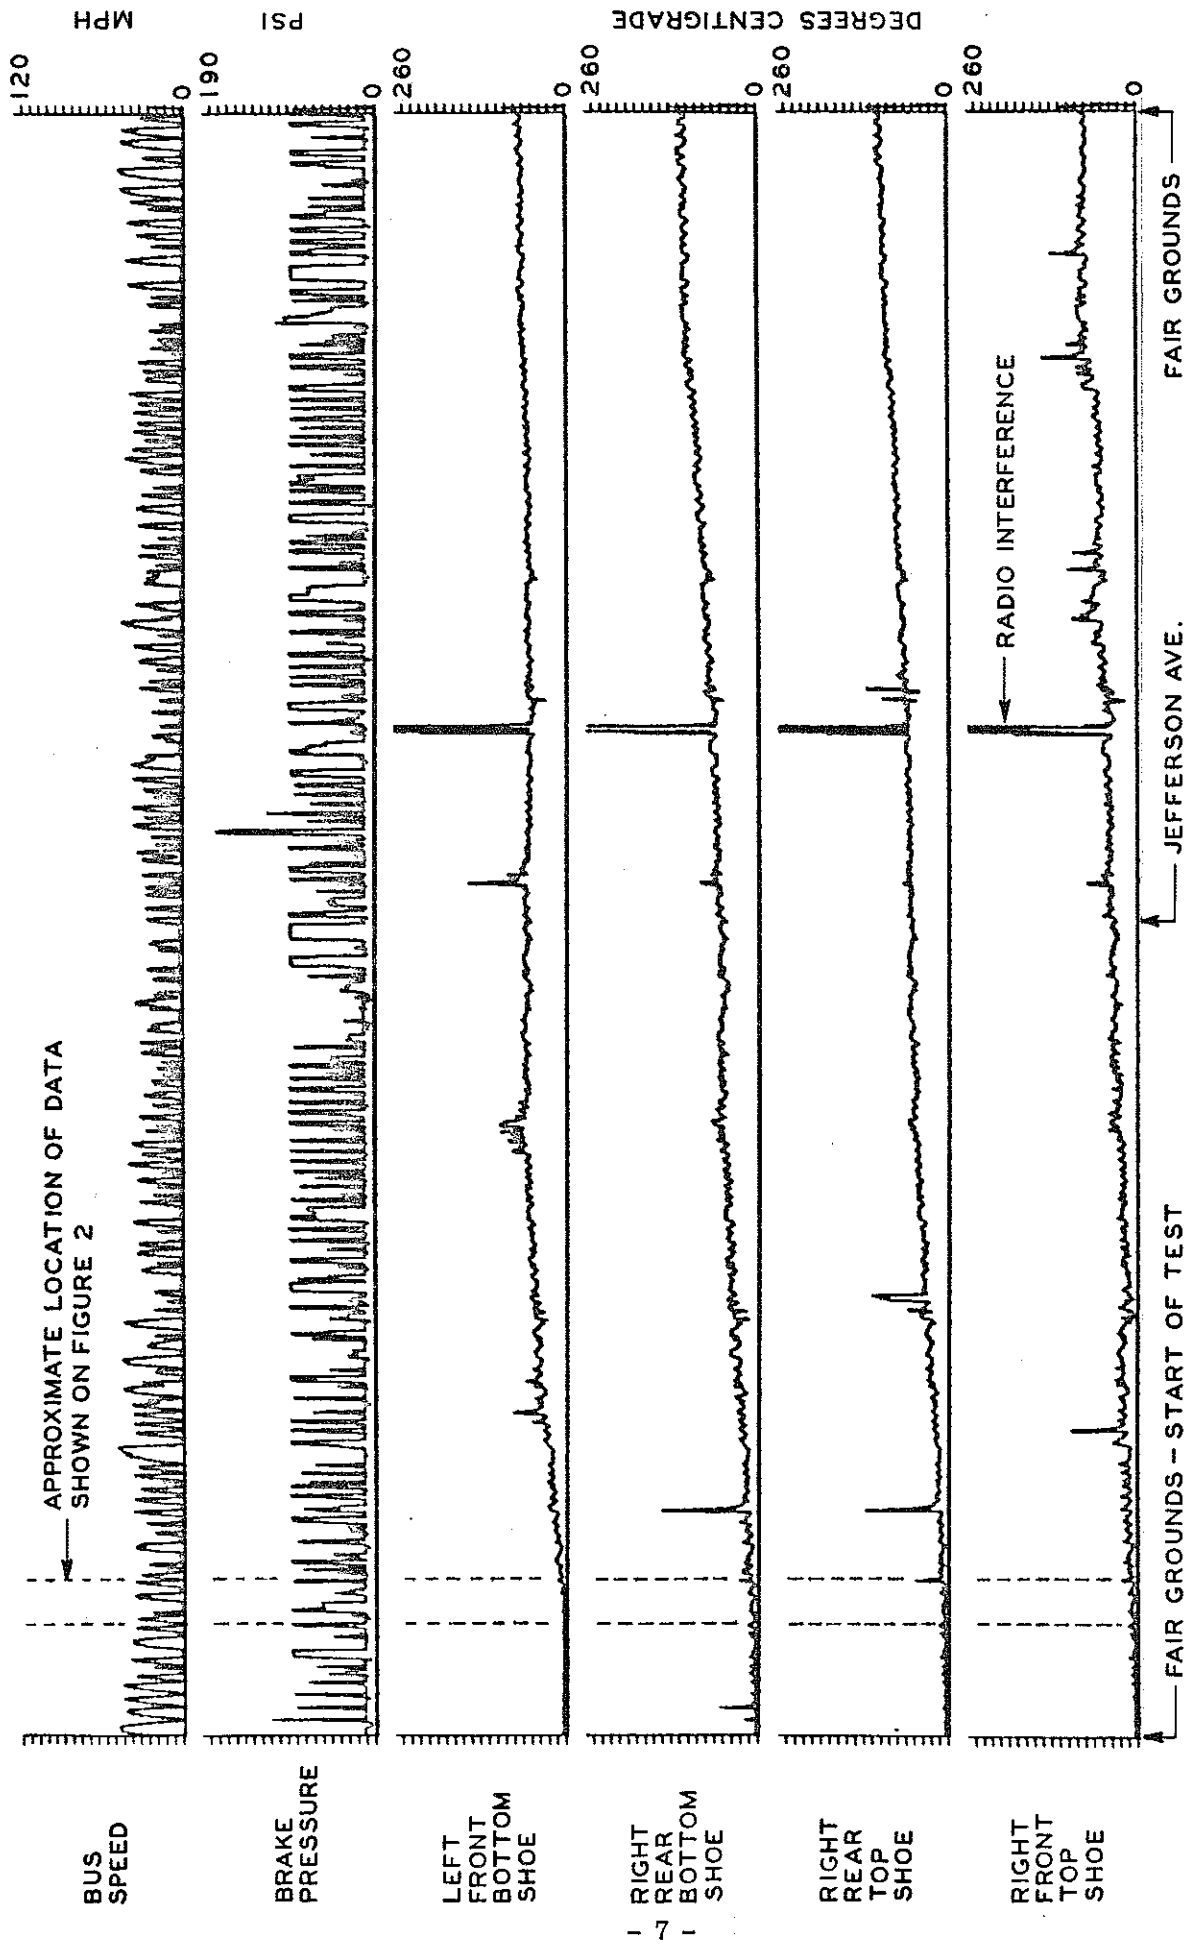
Figure 3. Brake lining temperature measurements (Run No. 1) with retarder in operation.

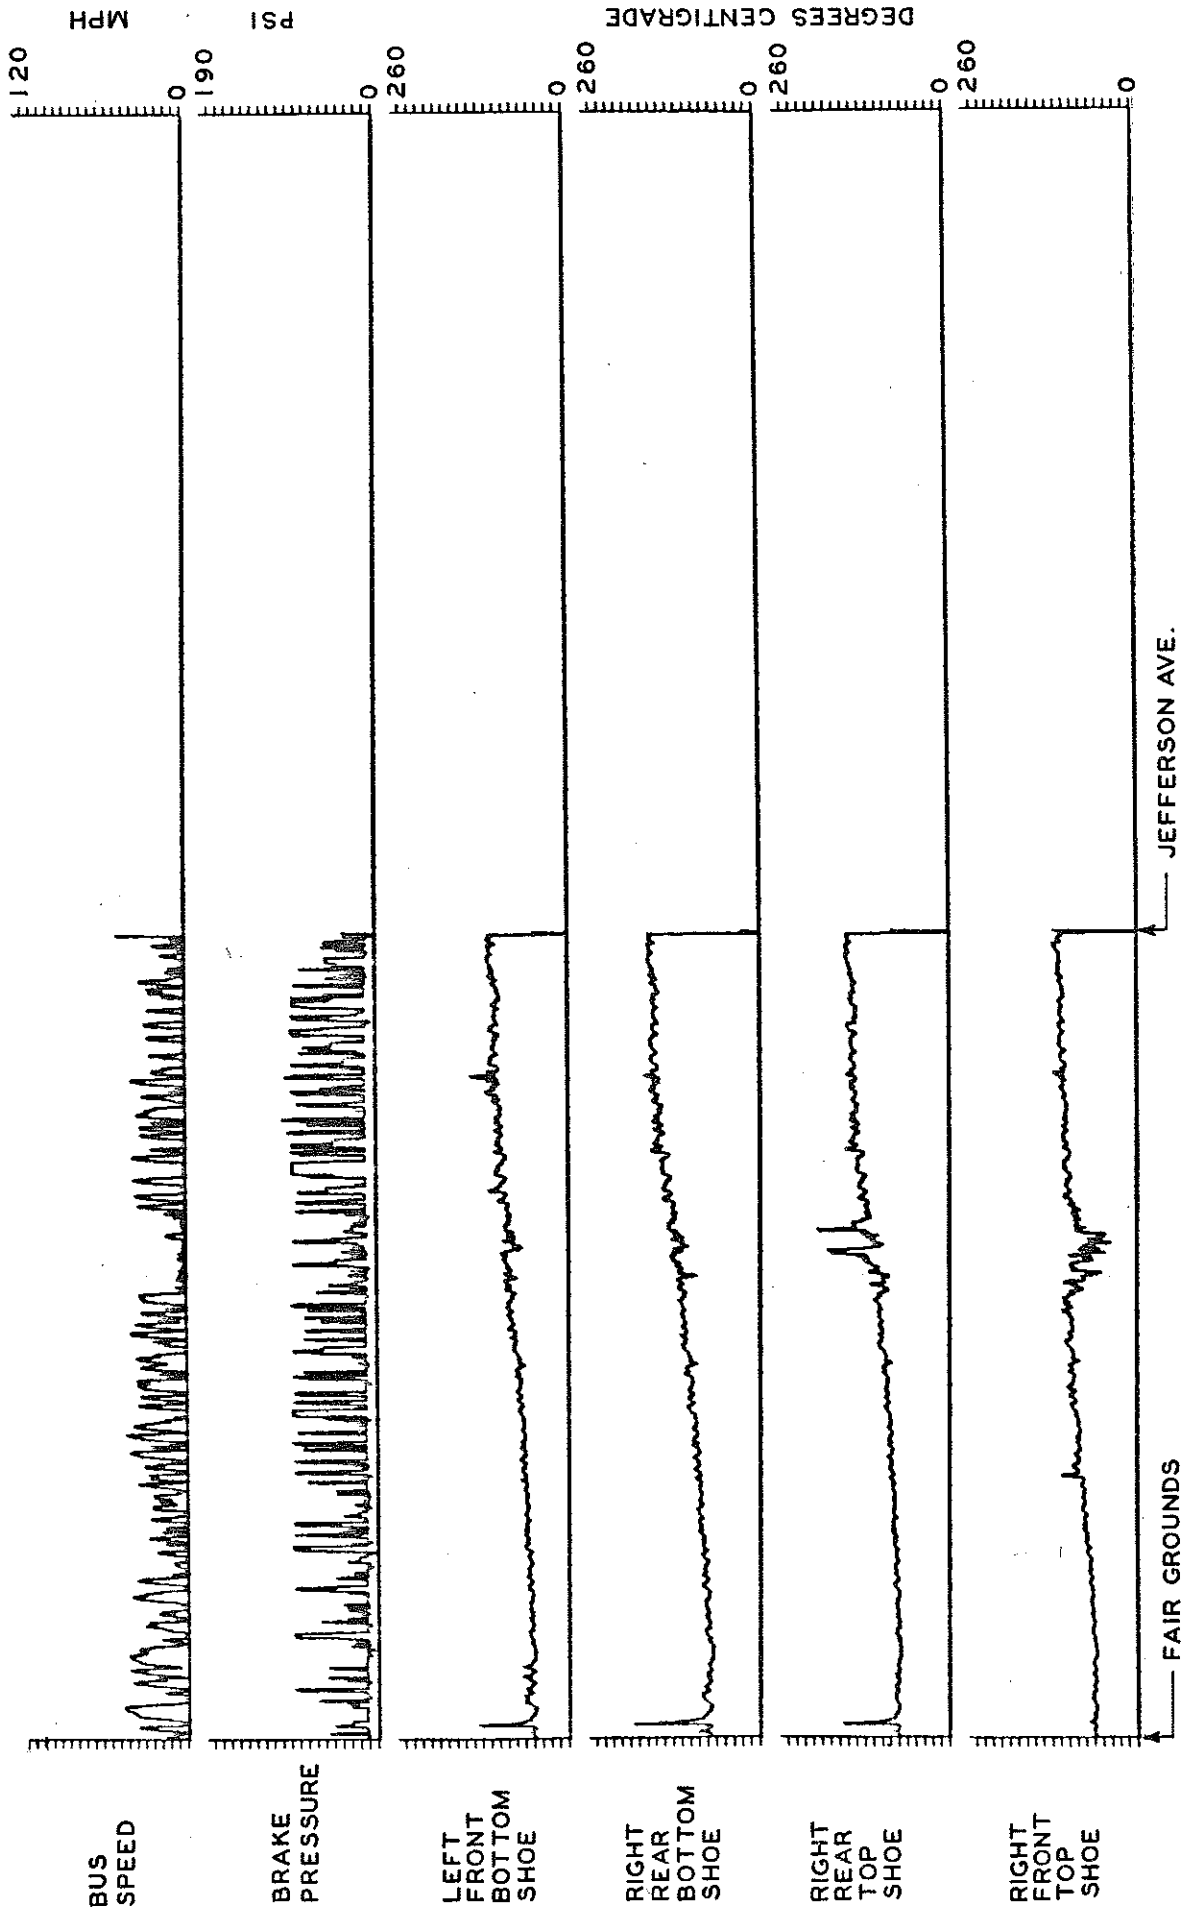
Figure 4. Brake lining temperature measurements (Run No. 2) with retarder not in operation.

Peak brake lining temperatures obtained from the data were 110 C during Run No. 1 (retarder in operation), and 175 C during Run No. 2 when the retarder was not in operation. When the retarder was taken out of operation, during Run No. 2, the rise in lining temperature is apparent in Figure 4. The lining temperatures seem relatively constant during Run No. 3. The decrease in lining temperatures during Run No. 4 is also apparent in Figure 6.

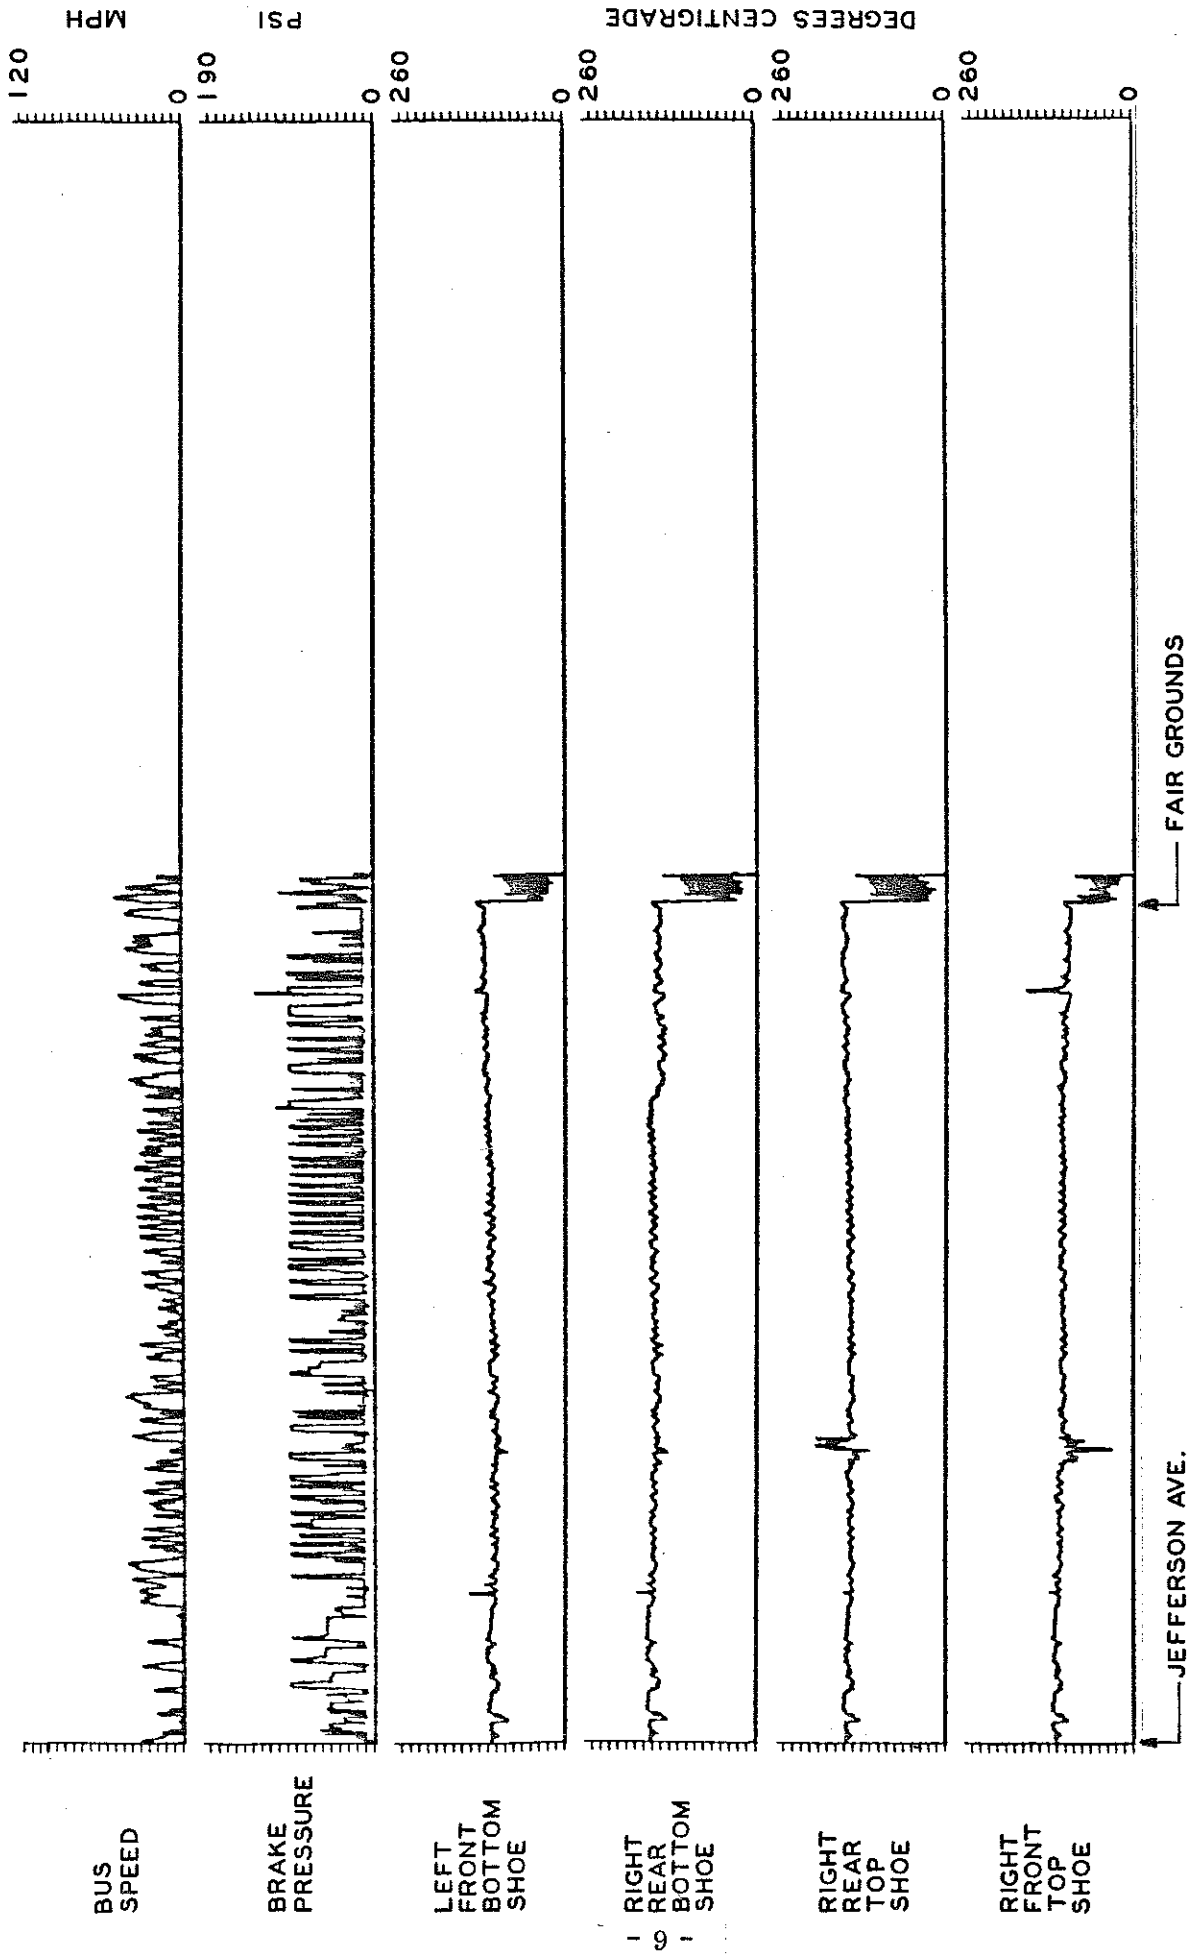
Figure 5. Brake lining temperature measurements (Run No. 3) with retarder not in operation.

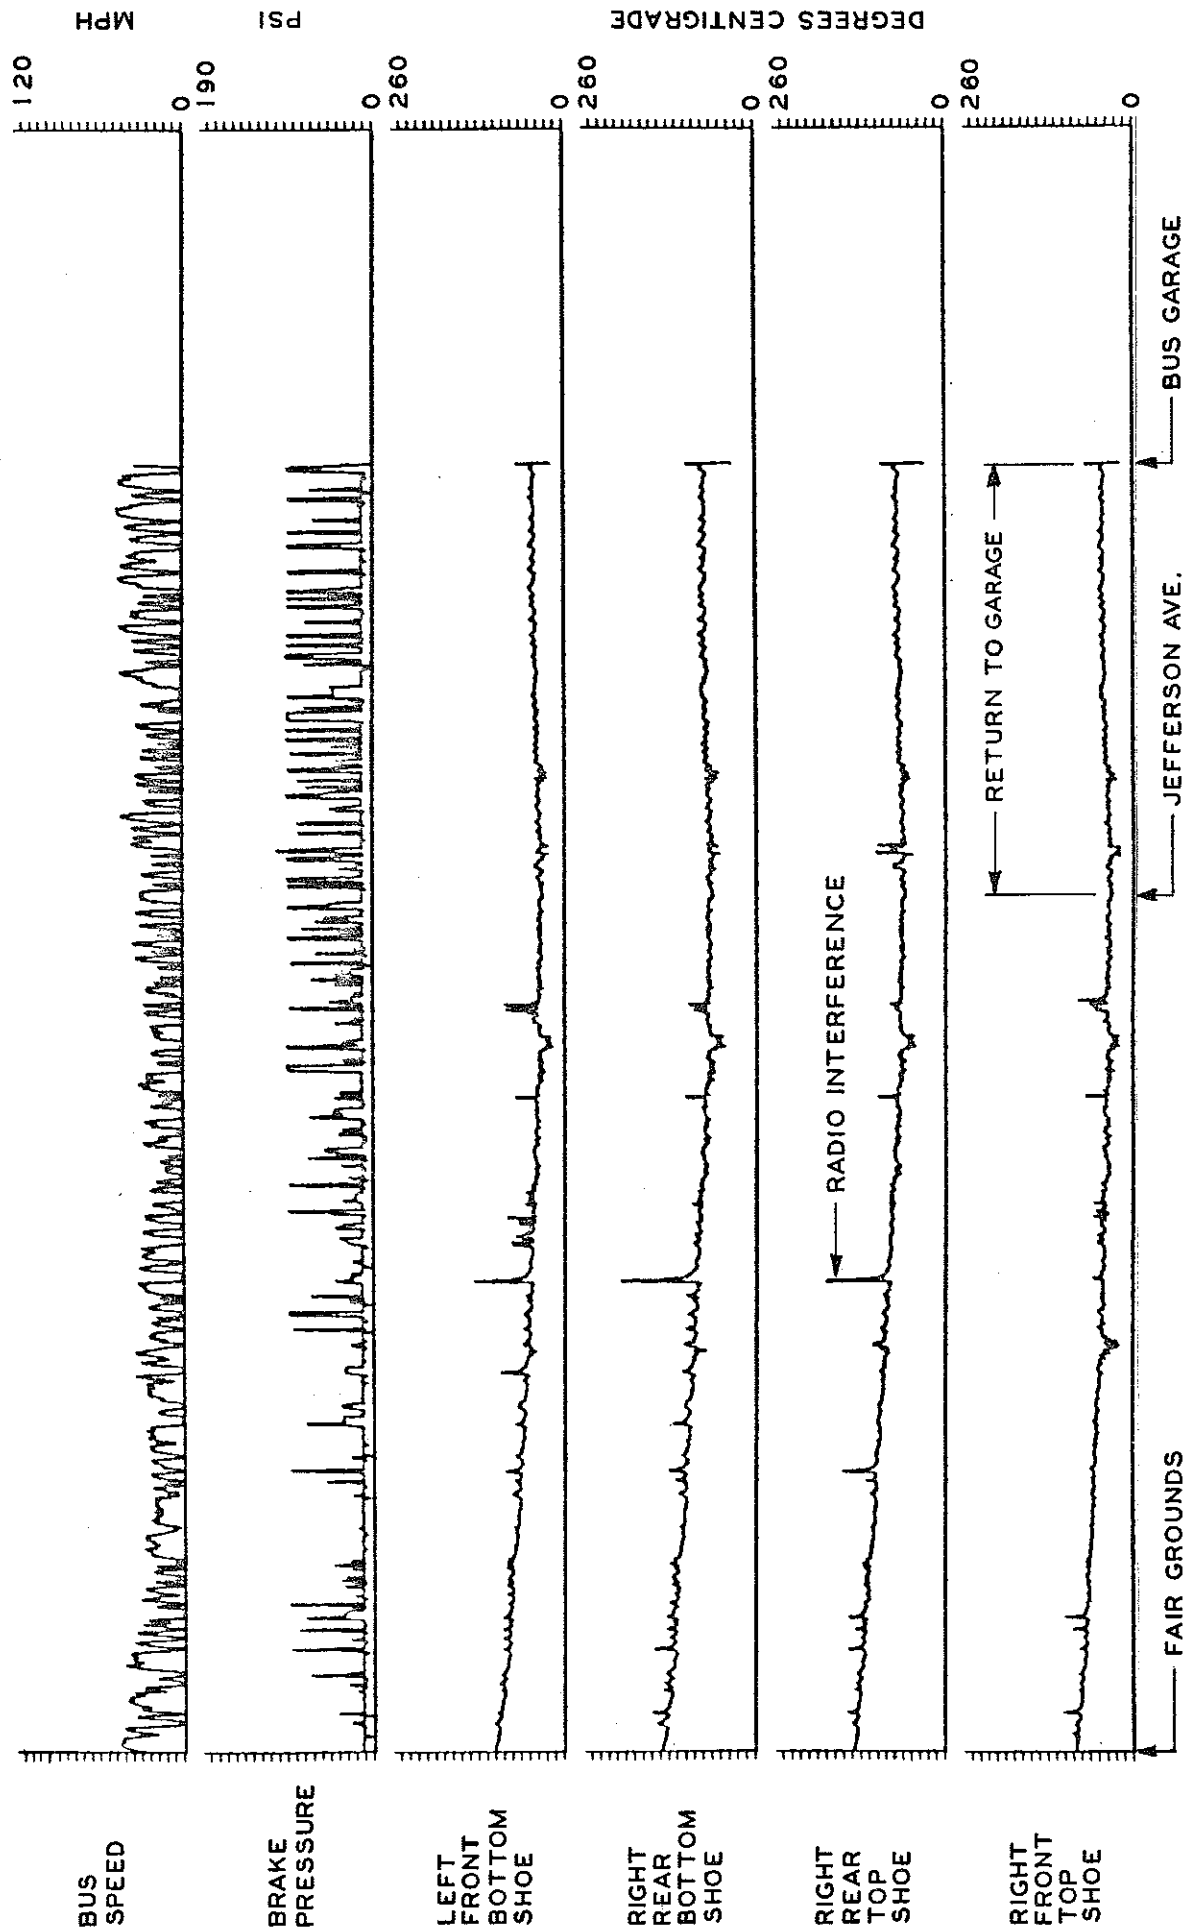
Figure 6. Brake lining temperature measurements (Run No. 4) with retarder in operation.
