EXPERIMENTAL CONCRETE AND BITUMINOUS SHOULDERS
Interim Report

Research Laboratory Section
Materials and Technology Division
Research Project 72 F-126
Research Report No. R-1271
Work Plan No. 13

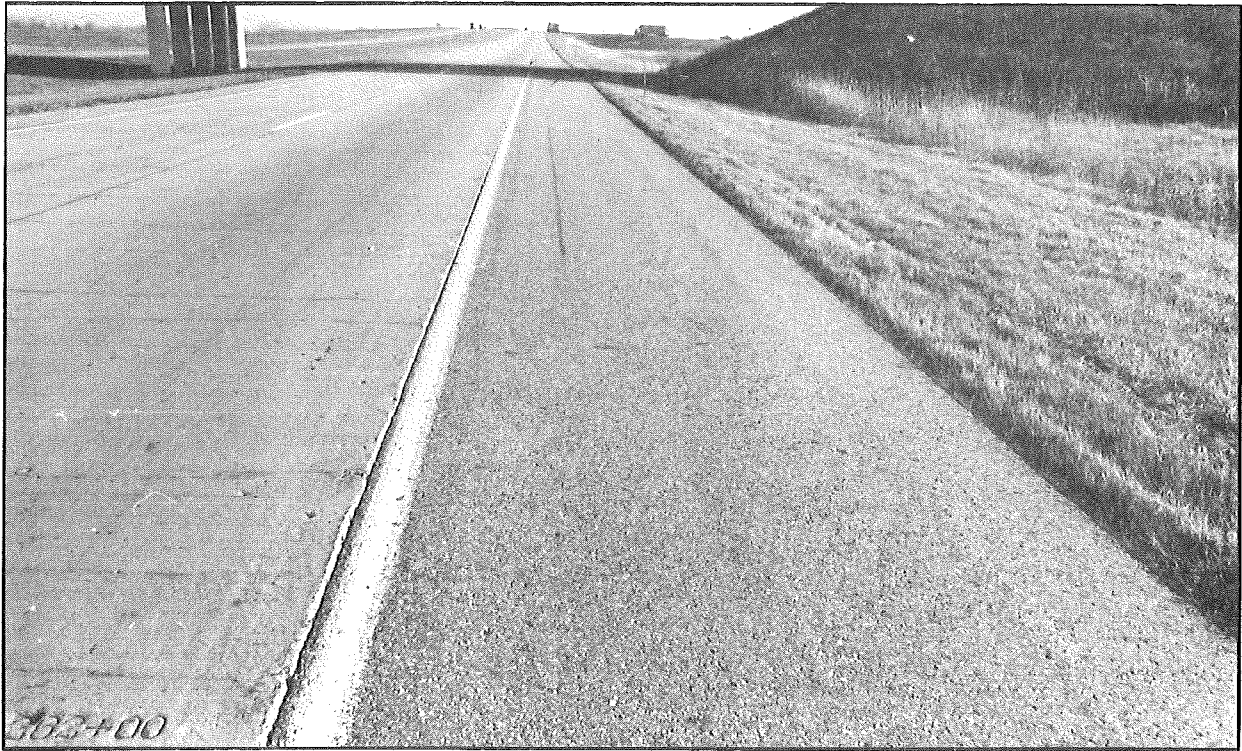
The improved bituminous stabilized shoulders are in generally good condition. Figure 4 shows the typical condition of the bituminous shoulder in the fall of 1984. An evaluation of the condition survey by test project is given in Table 5. Specific comments for test projects 1, 3, 4, 9, 10, and 11, are as follows.

Figure 4. Showing the typical condition of the experimental bituminous shoulders in the fall of 1984 (project 1).

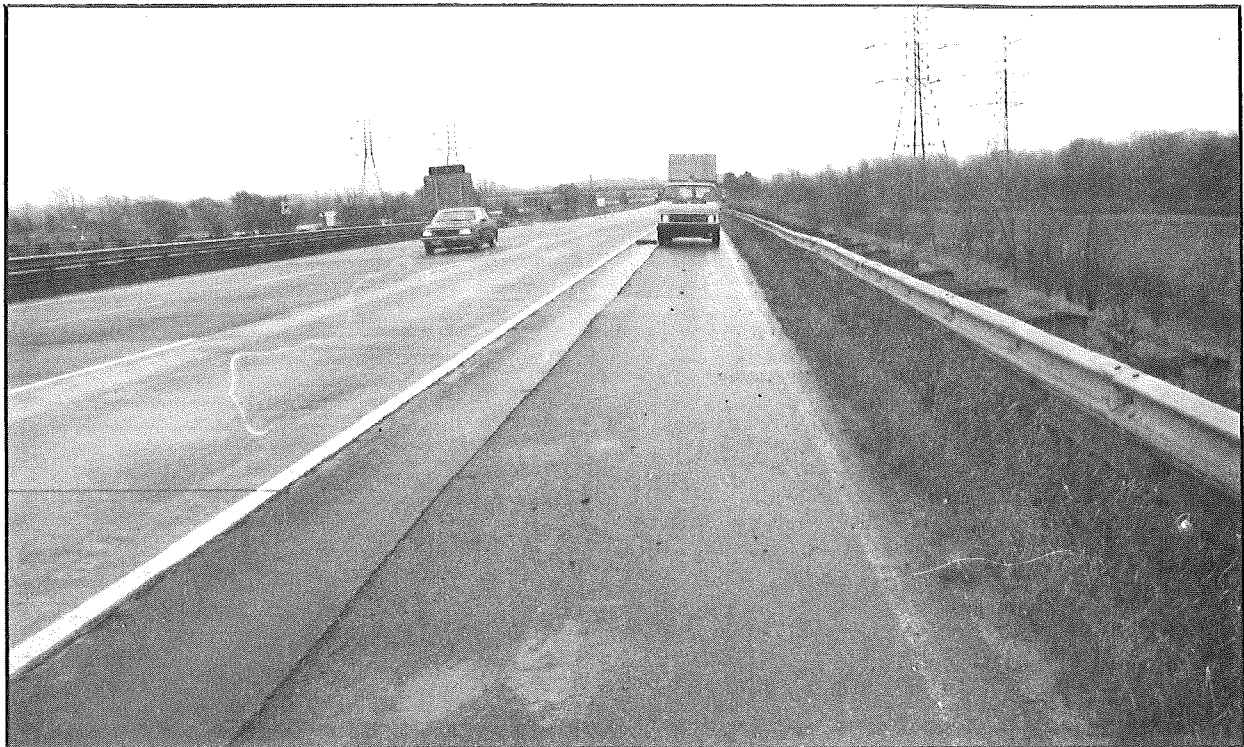
Project No. 4 - The northbound shoulders are brand new concrete shoulders and were not surveyed; however, the southbound shoulders are still the original improved bituminous stabilized shoulders and they were surveyed. There is a 2-ft bituminous strip in the southbound shoulder next to the concrete pavement (Fig. 5). This was placed in 1982 to bring the shoulder edge back to the pavement edge elevation after the shoulder had been used to carry traffic during replacement of the two inside pavement lanes in 1981. In 1984, the outside lane was replaced but the shoulder was not touched. The 2-ft strip is not full-depth bituminous but the rest of the shoulder is still as placed in 1974.

Figure 5. Two-foot bituminous strip in shoulder next to the concrete pavement (project 4).

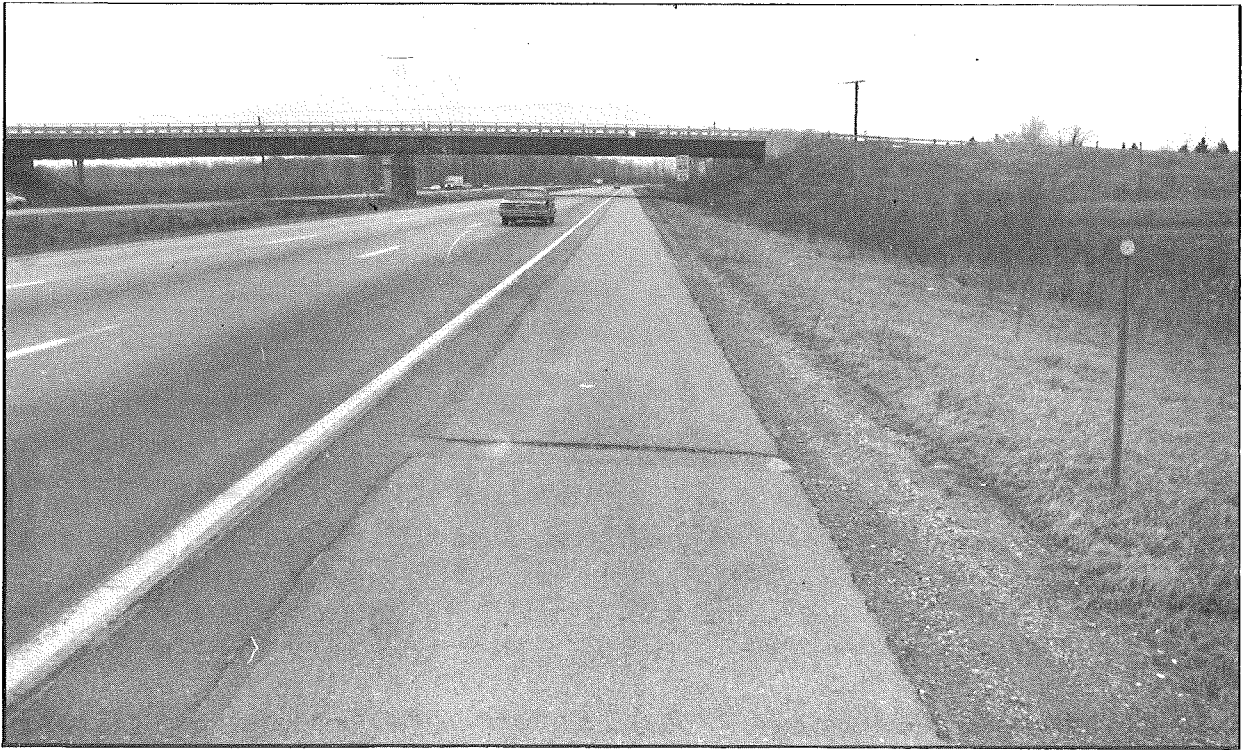
Project No. 10 - The northbound roadway has a 2-ft bituminous strip next to the pavement edge and at intervals of approximately 500 ft a 2-ft bituminous strip leading to the outside edge of the shoulder that were placed when edge drain was placed after the project was completed (Fig. 6). The 2-ft strip is not full-depth asphalt but the rest of the shoulder is the original IBS shoulder.

Figure 6. Two-foot bituminous strip next to pavement edge and two-foot bituminous strip leading to edge of shoulder for retrofit drainage system (Northbound roadway of project 10).

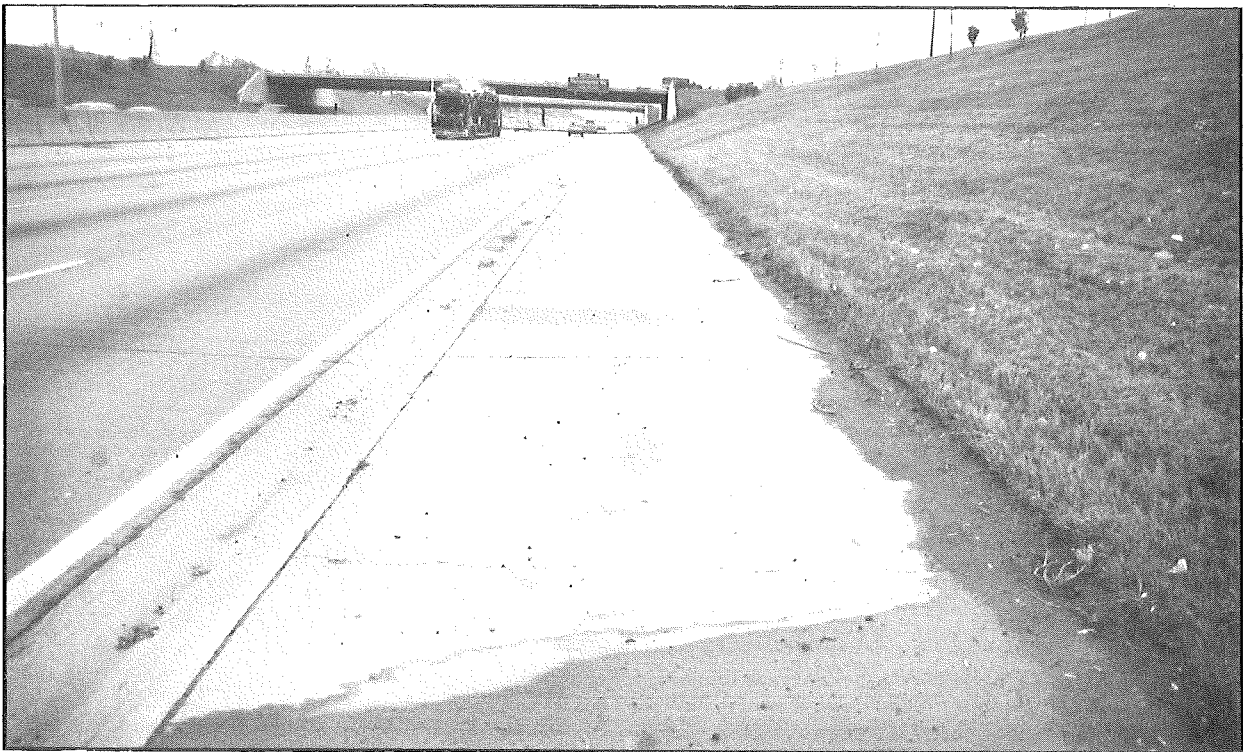
The portland cement concrete shoulders are in generally good condition. Figure 7 shows the typical condition of the concrete shoulders in the fall of 1984. An evaluation of the condition survey by test project is shown in Table 6. Comments on non-typical conditions found in test projects 12, 13, 14, 15, 16, 17, 18, 19, and 20 are as follows.

Figure 7. Showing the typical condition of the experimental concrete shoulders in the fall of 1984 (project 20).
