PAVEMENT EVALUATION OF I 94 CONTROL SECTIONS

81041, 81062, AND 81063

Detroit Industrial Expressway from Carpenter Rd. to
Rawsonville Rd. (Washtenaw-Wayne County Line)

Research Laboratory Division
Office of Testing and Research
Research Project 39 F-7(14)
Research Report No. R-539

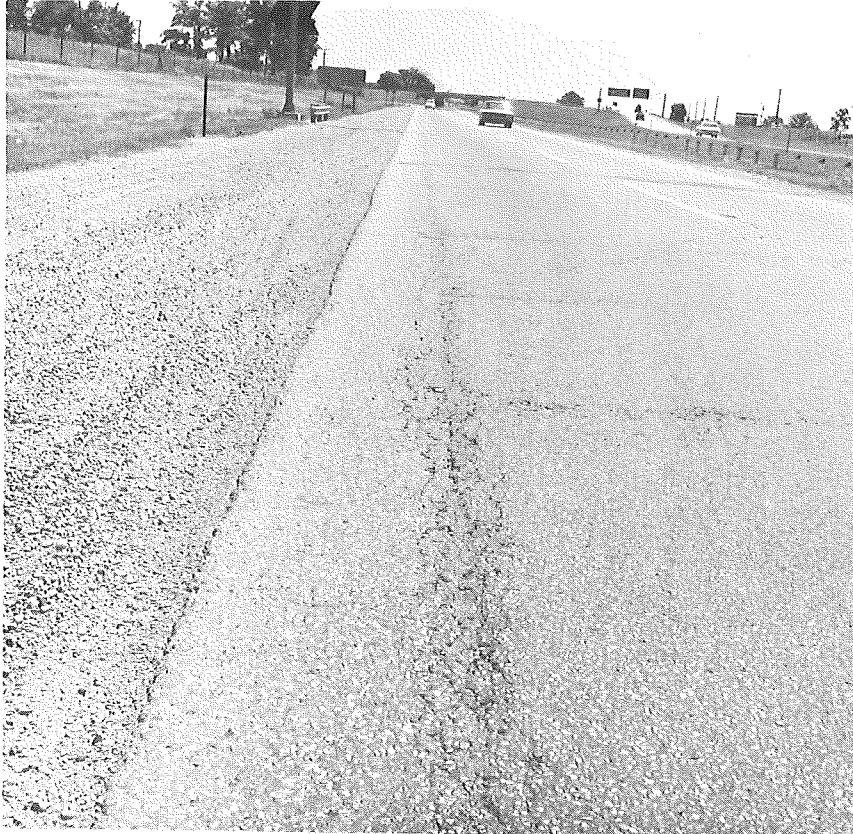
Figure 2 (left). Typical reflection cracking over the longitudinal widening strip joint.

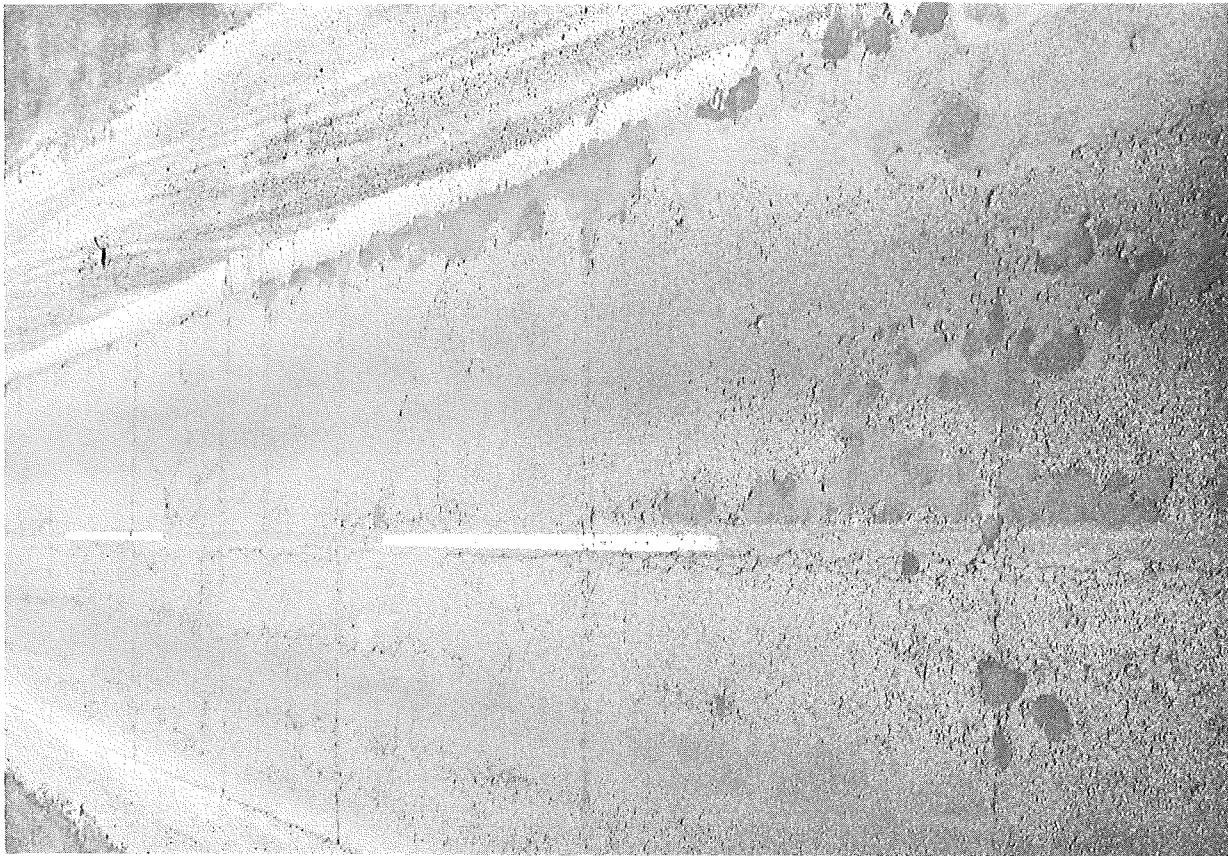
strip joint had reflected through the bituminous mat. Surface deterioration (Fig. 4) appeared frequently in one portion of the reinforced bituminous section (Stas. 16+00 to 46+06), and occasionally for short 200- to 300-ft lengths in other areas. However, most of the bituminous surface appeared as shown in Fig. 5 and exhibited no notable deterioration.

Figure 4. Advanced deterioration in evidence over a large portion of reinforced bituminous surface.

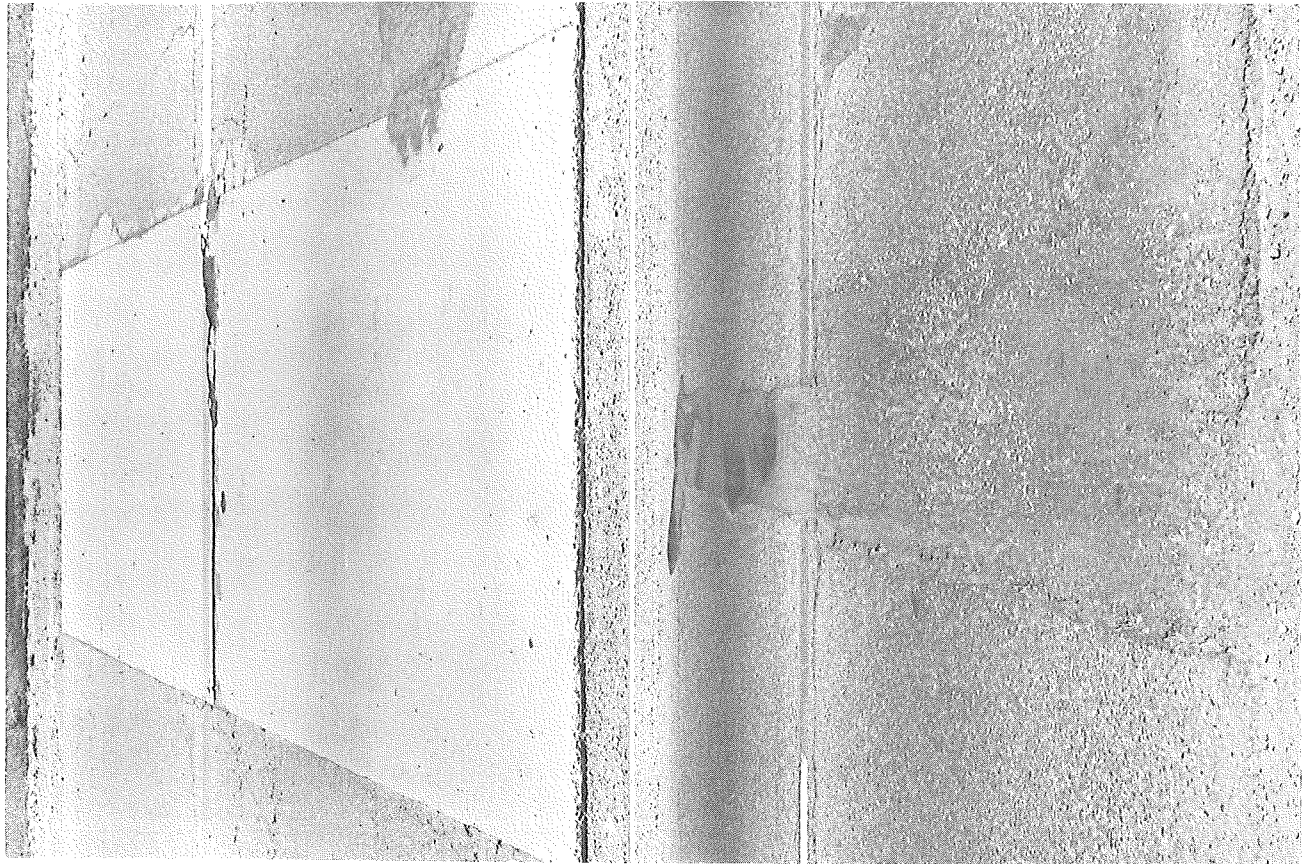
Several joint repairs were found in the resurfaced pavement (Fig. 6); it is assumed that these were required because of joint blowups in the portland cement concrete base. Defining "joint repair" as pavement replacement for the full width of one lane, these totaled 37 in the eastbound roadway (6.1 per mile of resurfaced pavement) and 28 in the westbound (5.9 per mile of resurfaced pavement).

Figure 6 (left). Typical joint repairs in resurfaced pavement.

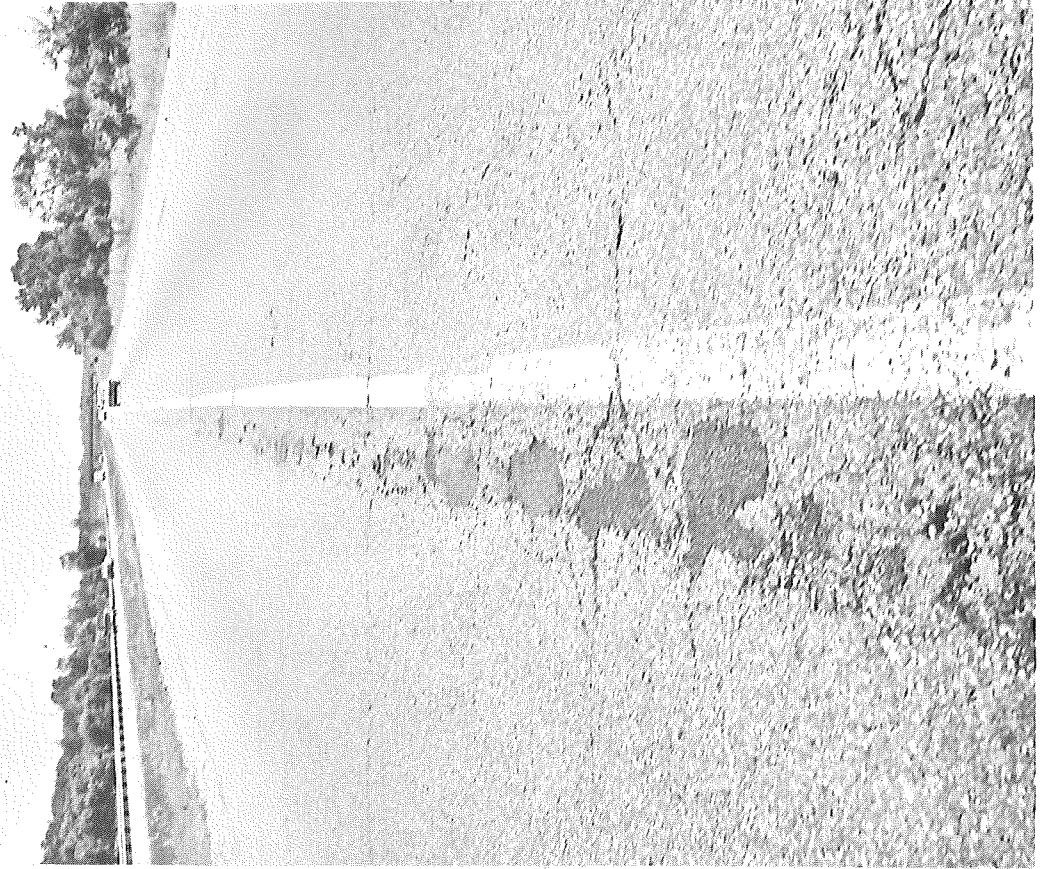
Figure 7 (below). Deterioration along reflection crack, on east-bound roadway.

after about 2 years of service.² Deterioration usually occurs in a narrow band parallel to reflection cracks (Fig. 7), and riding quality degenerates. It has been found that a soil aggregate cushion about 4-in. deep can reduce reflection cracking to less than 10 percent. Further, a soil-aggregate cushion could provide an insulating layer effective in reducing joint blowups in the resurfaced rigid pavement.
