# Concrete Deterioration of Prestressed Bridge Beams

FINAL REPORT – SEPTEMBER 2022

**Western Michigan University**

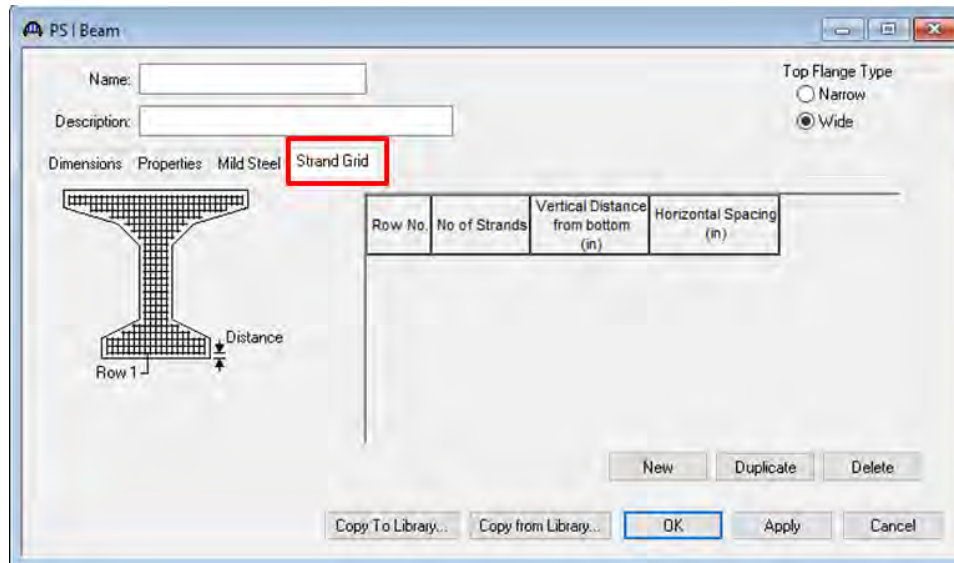
Before developing a prestressing strand layout, a prestressing strand grid is defined. As shown in Figure 2-24, the strand grid is developed by defining the number of rows of prestressing steel (*Row No.*), the number of strands in each row (*No. of Strands*), the vertical distance to each row from the beam bottom (*Vertical Distance from bottom*), and the horizontal spacing between the strands in a row (*Horizontal Spacing*).

Figure 2-24. *Strand Grid* tab in the PSC I-beam section property data input window

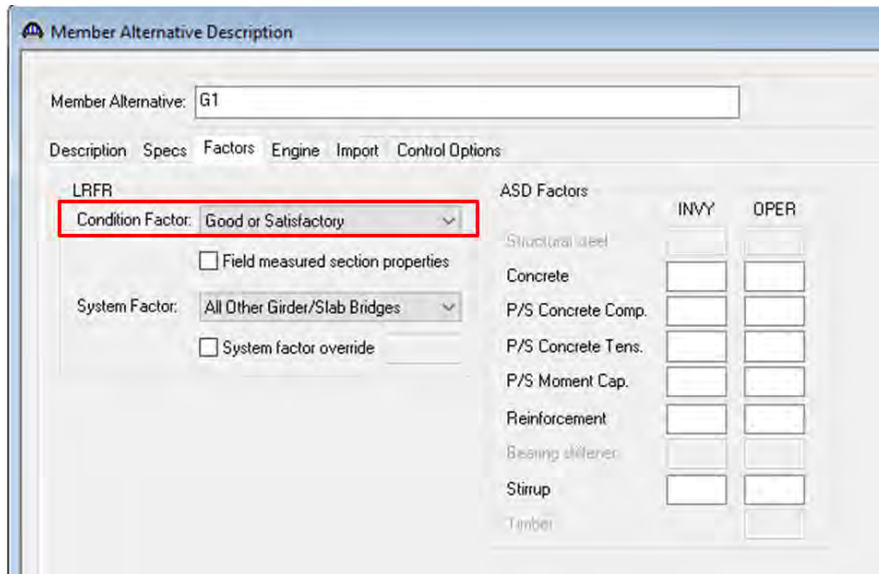
A condition factor ( $\phi_c$ ) is required to compute rating factors using LRFR strength limit states. For a selected member, the condition factor can be defined as shown in Figure 2-29. Based on the physical condition of the member, the condition factor can be selected as *Good or Satisfactory*, *Fair*, or *Poor*.

**Figure 2-29. Dialog box to assign a beam condition factor**

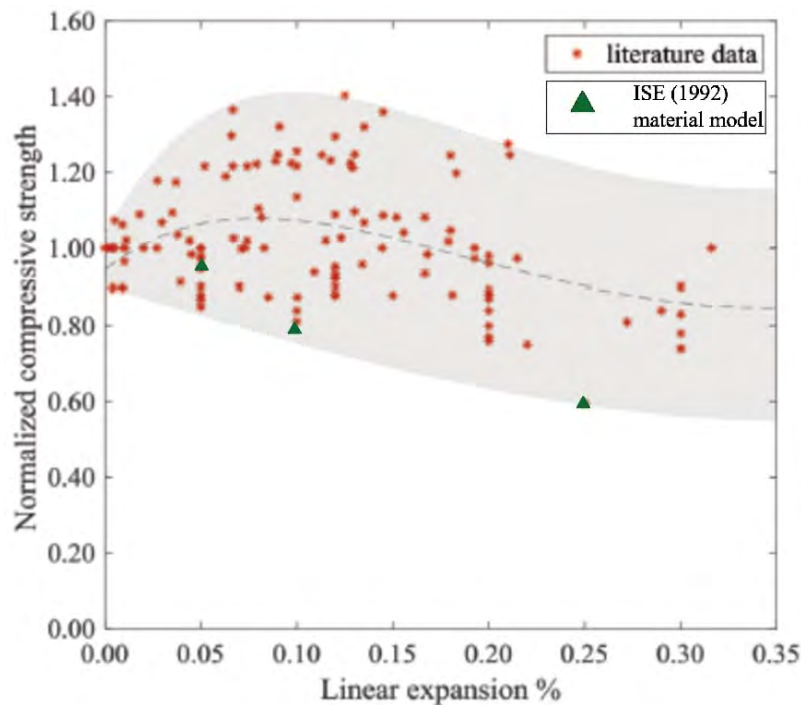
**Figure 2-34. Variation of normalized concrete compressive strength with % expansion due to ASR (Abd-Elssamad et al. 2020 and ISE 1992)**

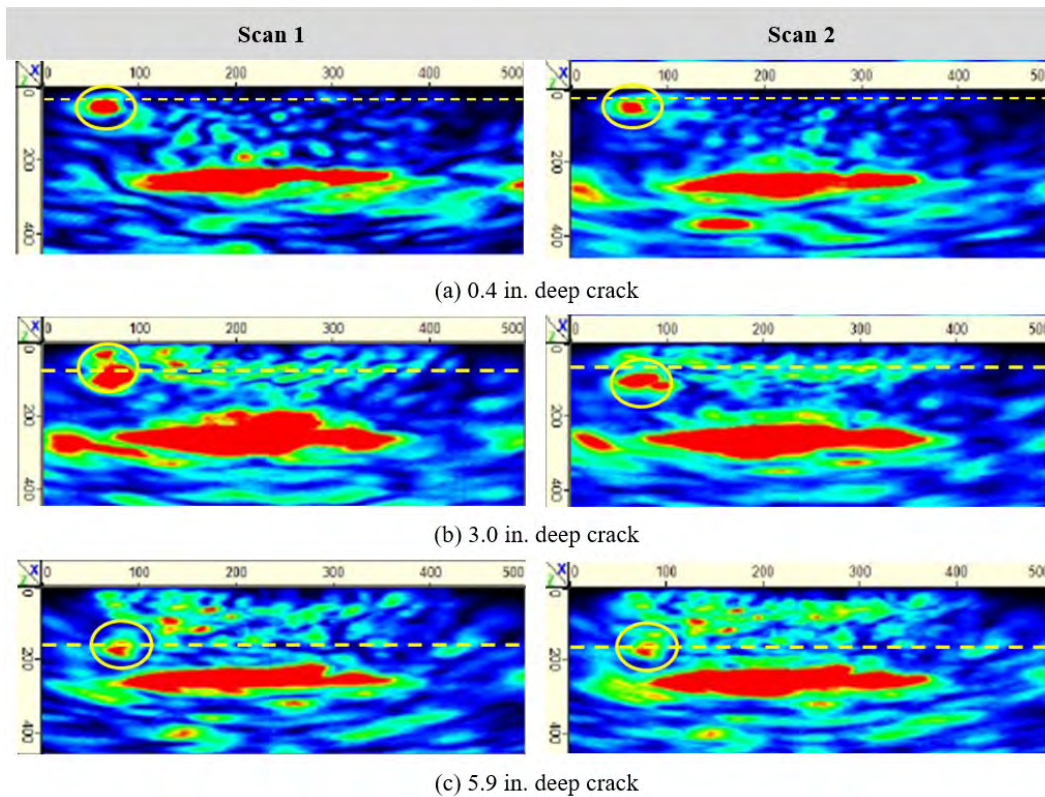
**Figure 2-56. B-scans recorded with the unit offset from the crack (Popovics et al. 2017)**

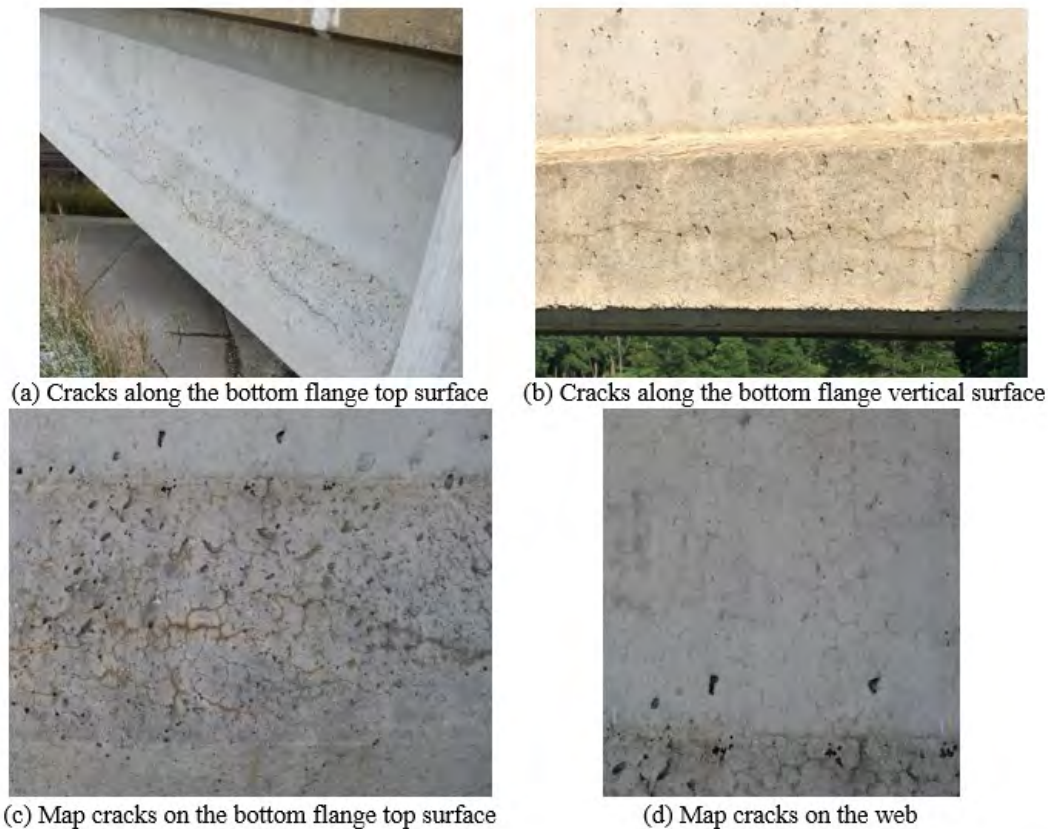
**Figure 3-9. Map and longitudinal cracks in PSC I-beams**

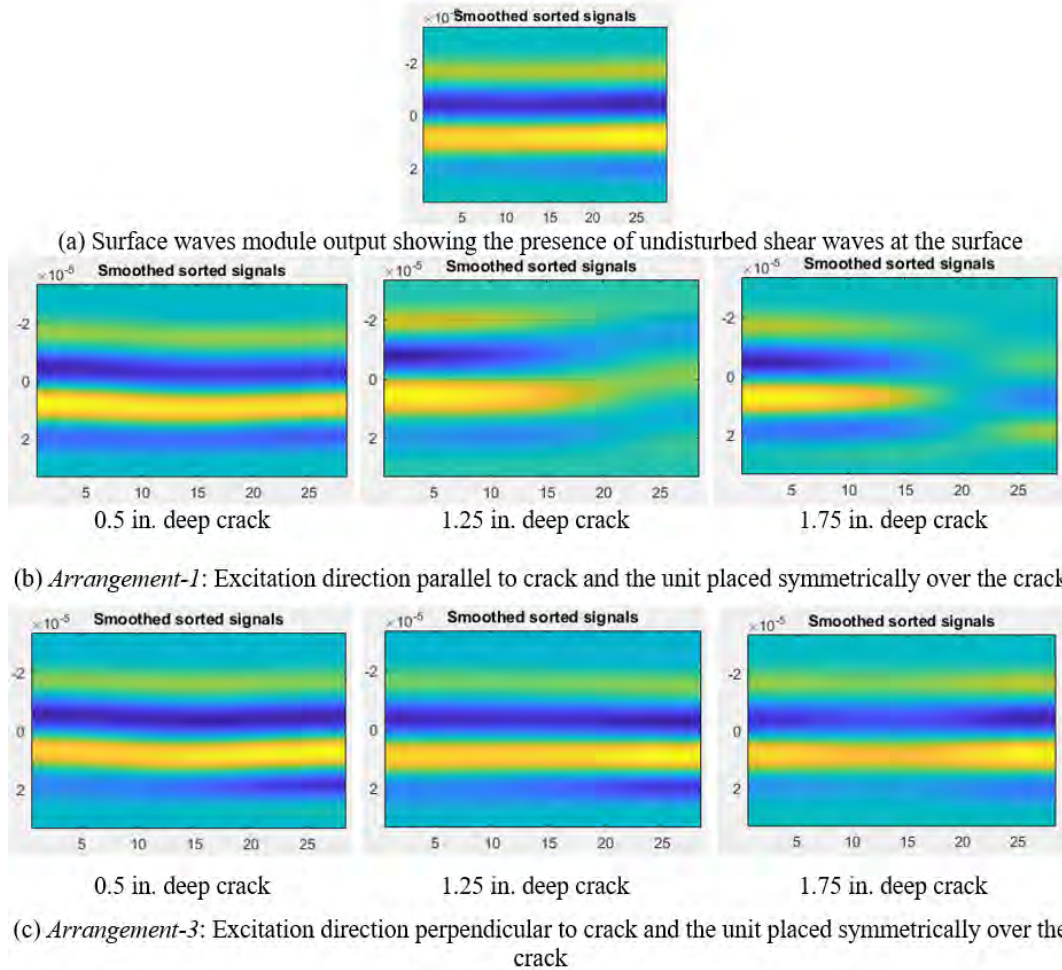
**Figure 3-22. The impact of crack depth and transducer arrangement on surface wave propagation**

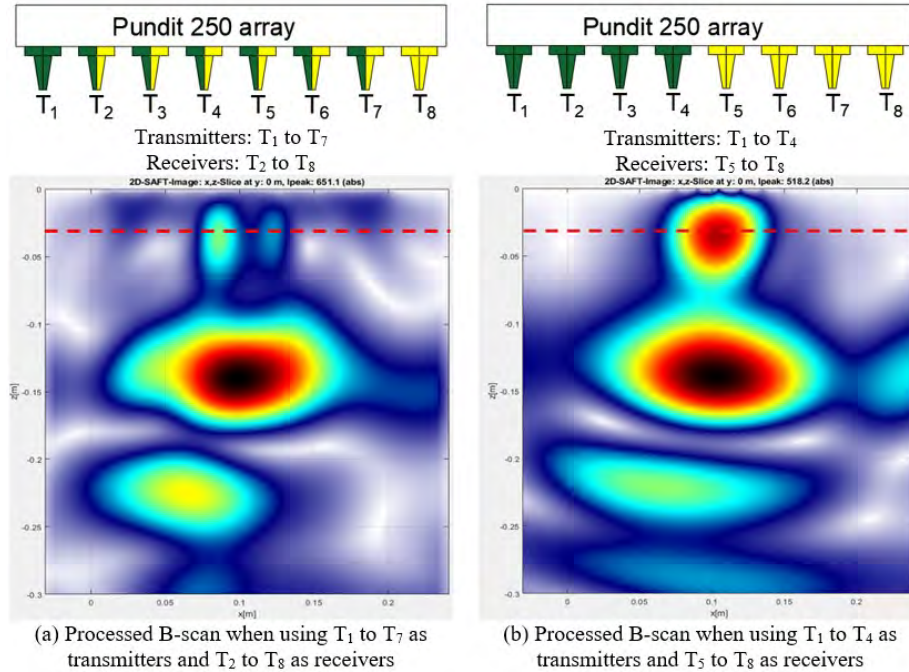
**Figure 3-23. Processed B-scans using *Arrangement-1* data with two transmitter-receiver combinations for the slab with a 1.25 in. deep crack**

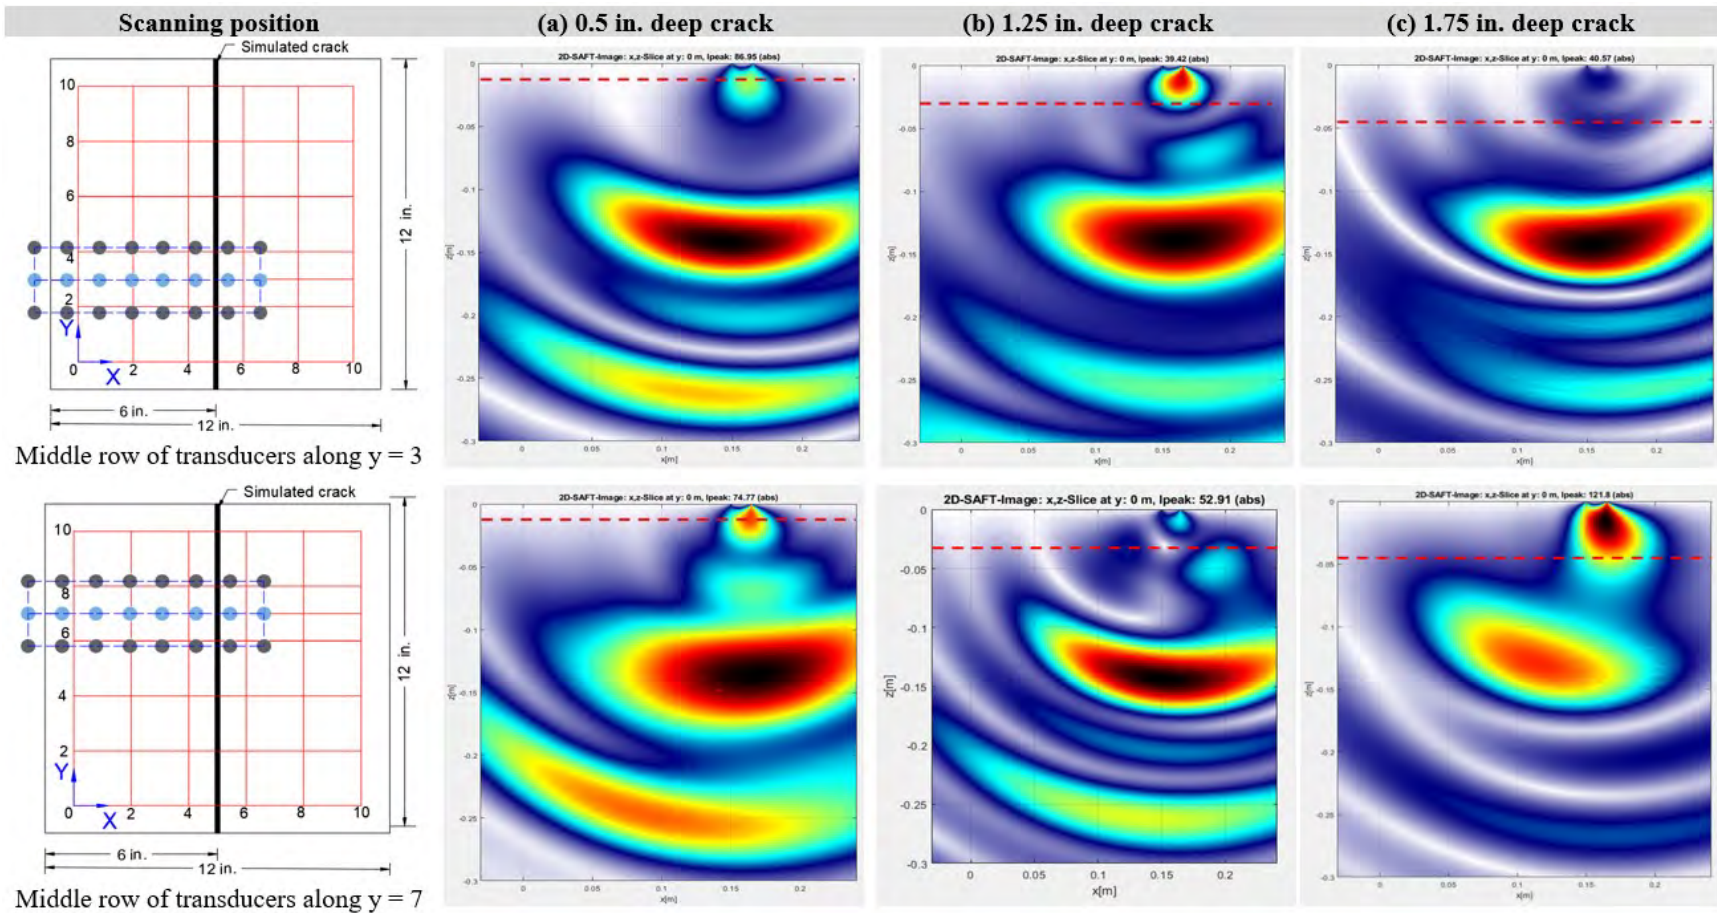
**Figure 3-26. B-scans of slabs reconstructed using *Arrangement-2* data**  
 (The red dashed lines represent the crack tip locations in the slabs.)

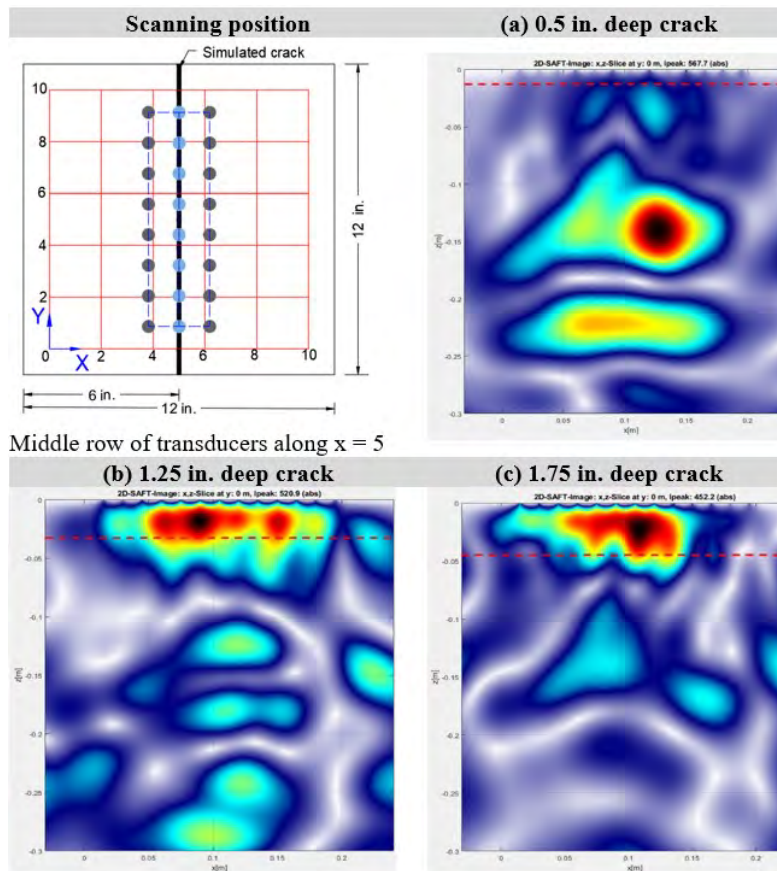
**Figure 3-27. B-scans of slabs reconstructed using *Arrangement-3* data**  
(The red dashed lines represent the crack tip locations in the slabs.)

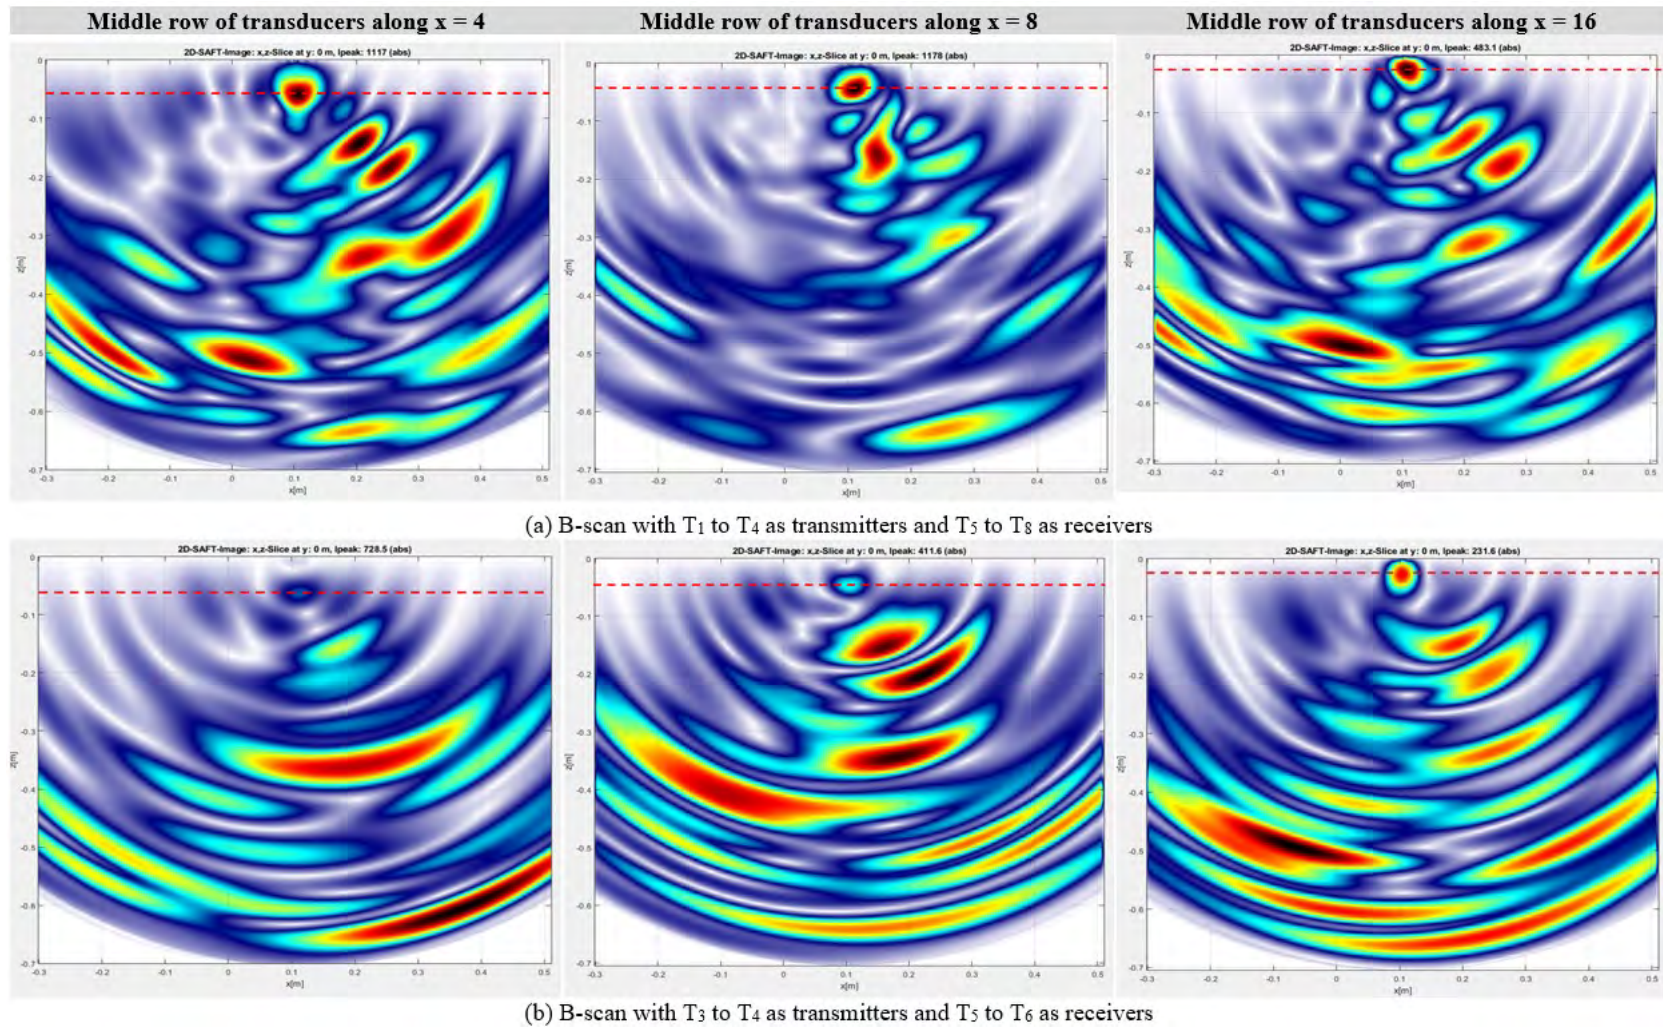
Figure 3-29. B-scans of the PSC I-beam of the S.N. 424 bridge reconstructed using transducer *Arrangement-1* data at lines  $x = 4, 8,$  and  $16$  (The red dashed line represents the potential crack tip location.)

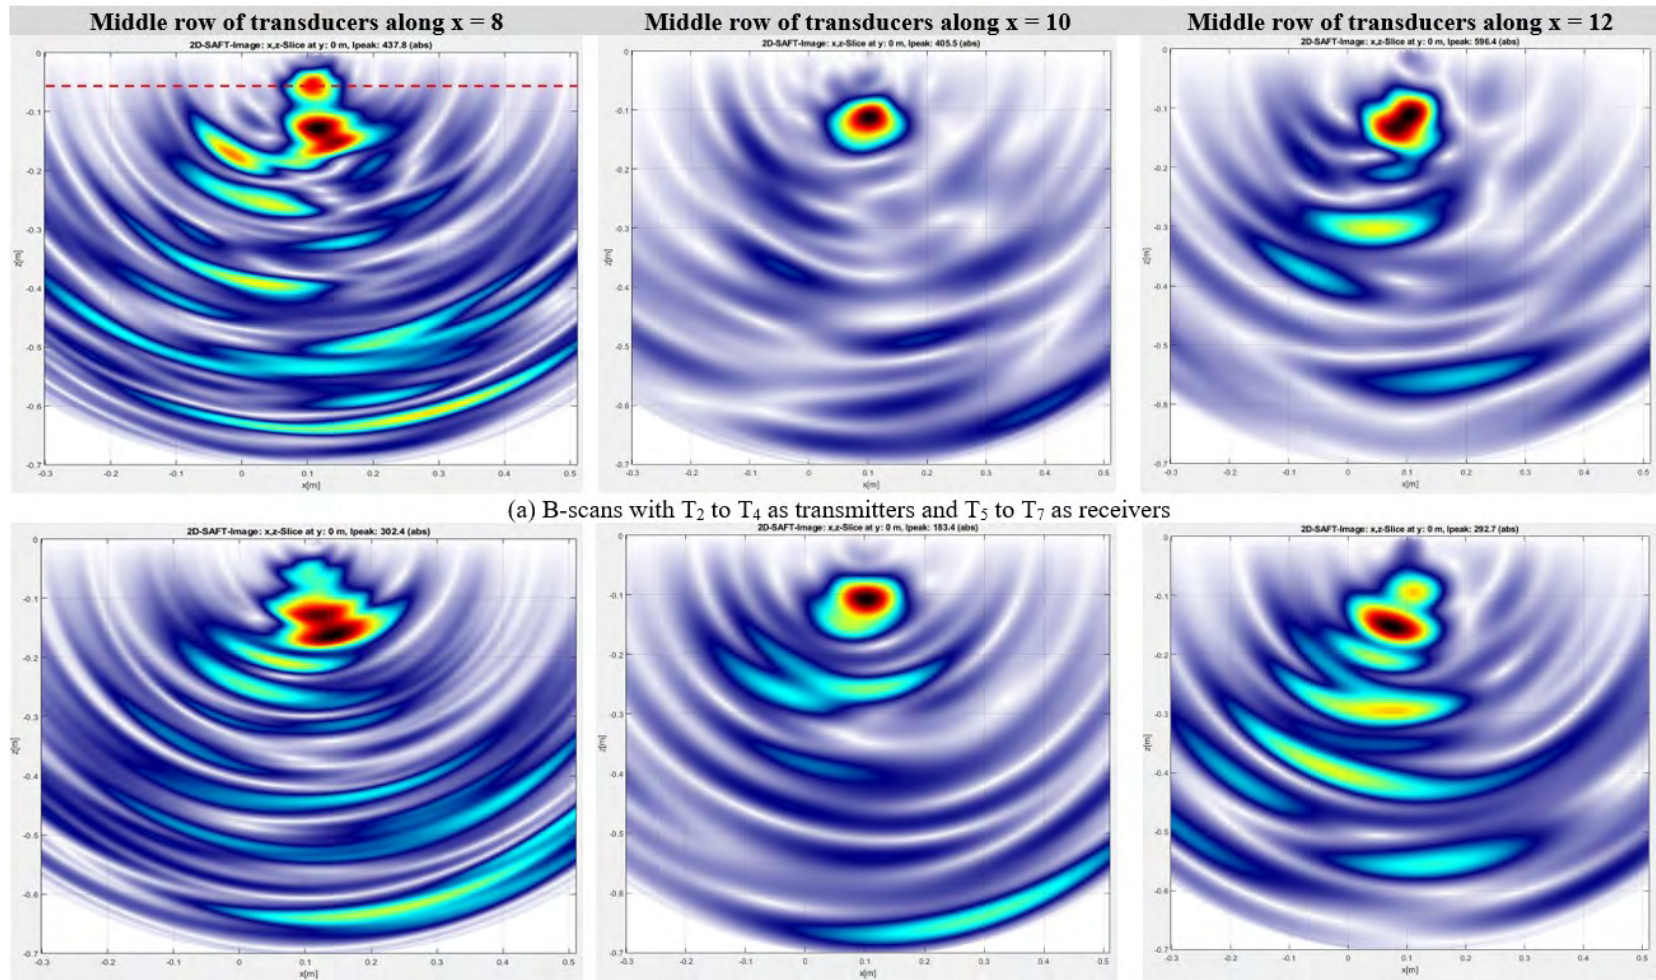
**Figure 3-34. B-scans of the PSC I-beam of the S.N. 2618 bridge reconstructed using transducer *Arrangement-1* data at  $x = 8, 10,$  and  $12$  (The red dashed line represents the potential crack tip location.)**

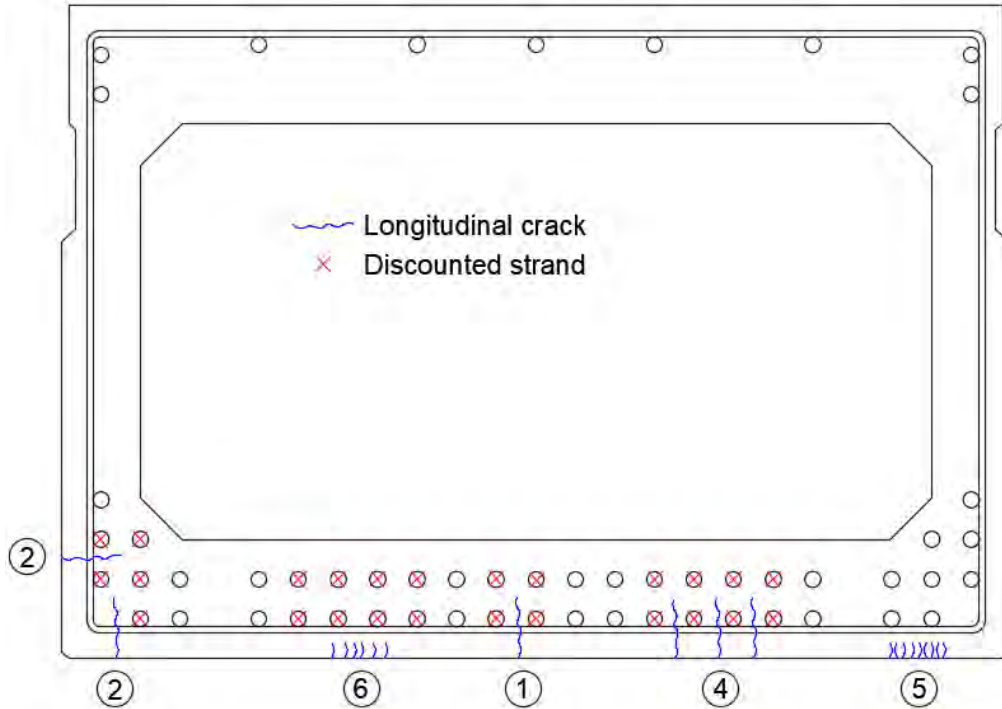
**Figure 6-2. Guidelines for excluding ineffective strands in the presence of longitudinal, map, and random cracks in box-beams (Case #3 is not shown)**

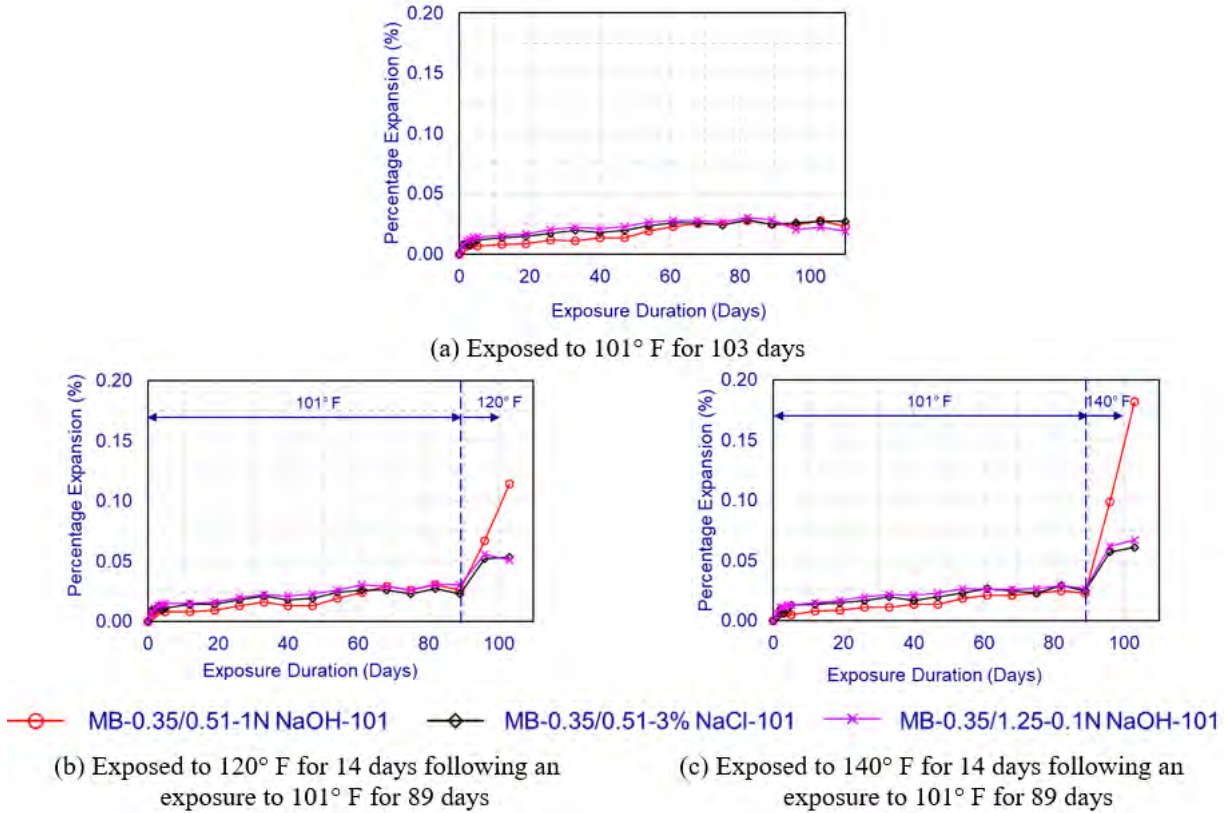
**Figure 7-2. Expansion of mortar bars with 0.35 w/c under different exposure conditions**

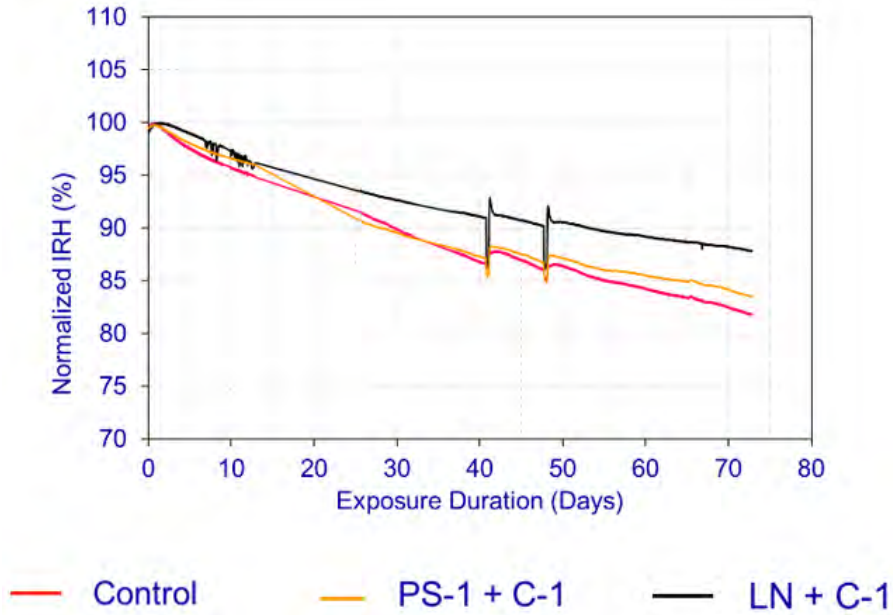
**Figure 7-18. Variation of IRH in the slabs with multi-coating systems against drying time**

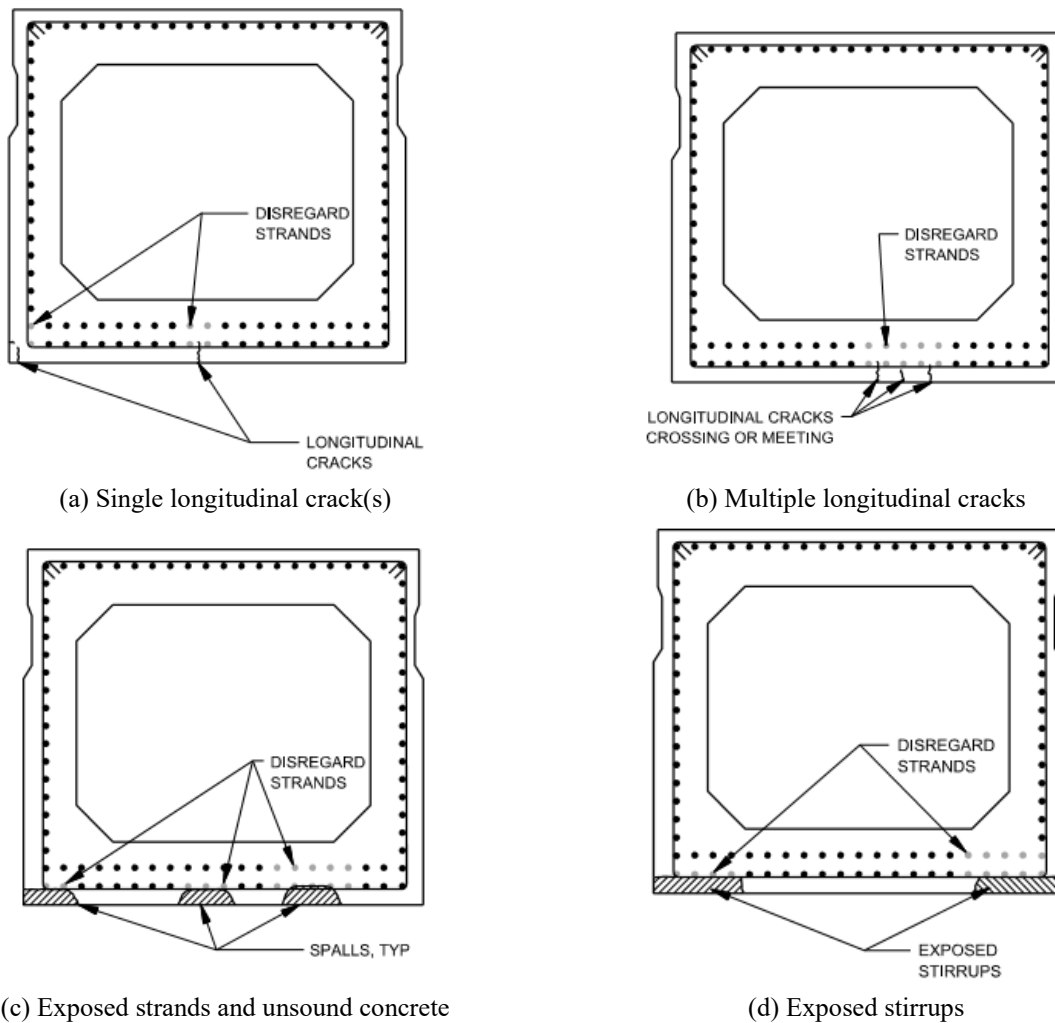
**Figure A-5. Prestressing strand disregarding procedure in PC deck girders based on the damages in the cross section (UDOT 2017)**

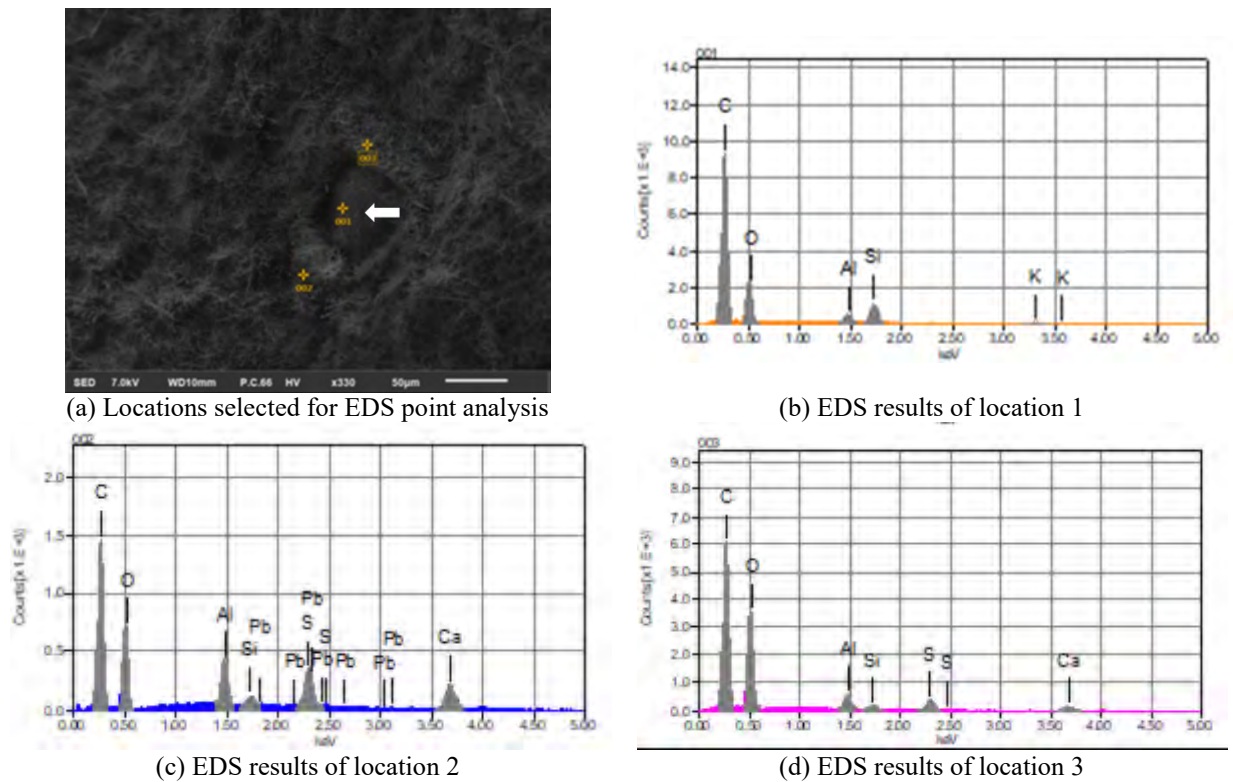
**Figure D-17. EDS point analysis results**
