**SOIL-AGGREGATE CUSHIONS FOR PREVENTION OF  
REFLECTION CRACKING OF RESURFACED PAVEMENTS**  
First Progress Report

Research Laboratory Division  
Office of Testing and Research  
Research Project R-62 F-70  
Research Report No. R-423

Michigan State Highway Department  
John C. Mackie, Commissioner  
Lansing, May 1963

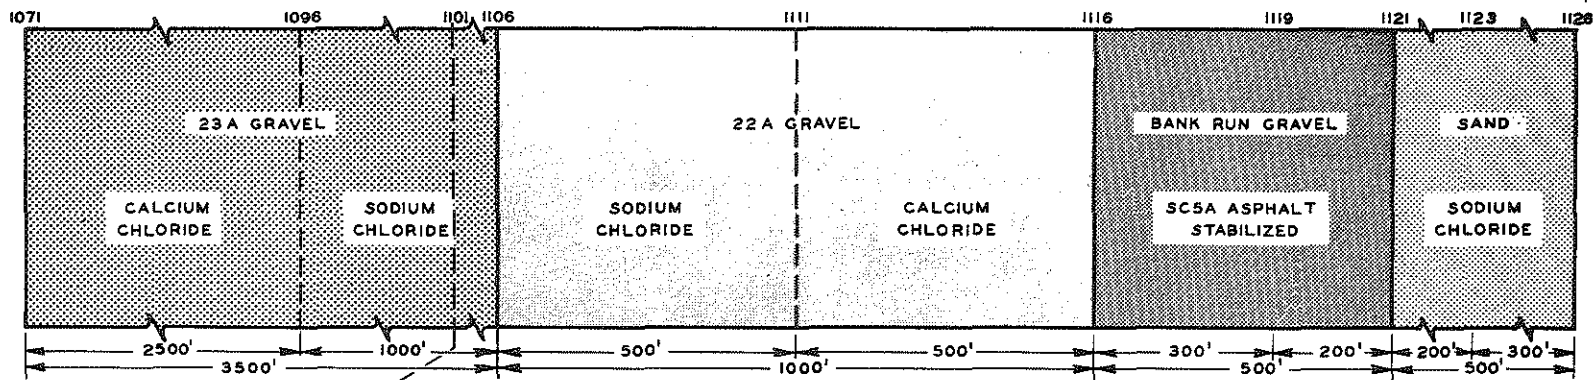
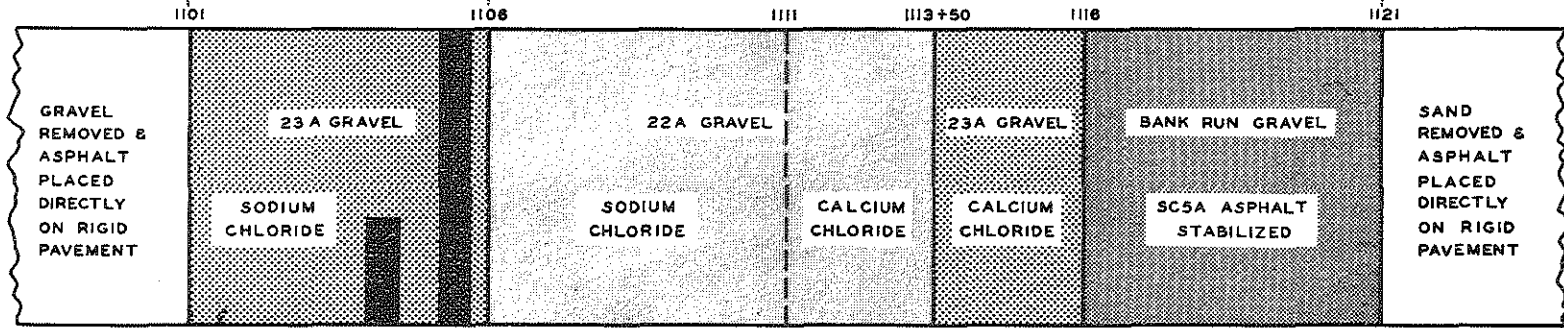
Figure 1. M 60 test site for soil aggregate cushions.

PROPOSED LAYOUT OF SOIL AGGREGATE CUSHION

ACTUAL LAYOUT OF SOIL AGGREGATE CUSHION

23 A GRAVEL REMOVED & REPLACED WITH 20 A GRAVEL

A 3-mile section of M 60, northeast of Leonidas in St. Joseph County, was selected for the investigation (Fig. 1). Before initiation of the research project, this highway was being widened and resurfaced under Construction Project F 78042C, C3. The rigid pavement apparently had been constructed over an old gravel road and directly on B-horizon soil. In preparation for resurfacing, the rigid pavement was widened to 24 ft. In areas of considerable frost heave the old base material had been replaced with granular soil and surfaced with new concrete over the rebuilt areas.

Inspections of the distressed areas revealed that no bond existed between the asphalt and the 23A gravel. There was a thin film of moisture between the asphalt and gravel which appeared to act as a lubricant. The asphalt could be rolled up like a rug from the 23A gravel (Fig. 9). Tests indicated a moisture content of about 10 to 12 percent in the top 1/2-in. surface of the soil. Below this, the soil moisture content was 4 to 5 percent. Except for a few small soft spots, the 23A gravel still appeared to be smooth and stable when the asphalt leveling course was peeled up from it (Fig. 9). Fig. 1 shows where areas of soil-aggregate cushion were removed from the road.

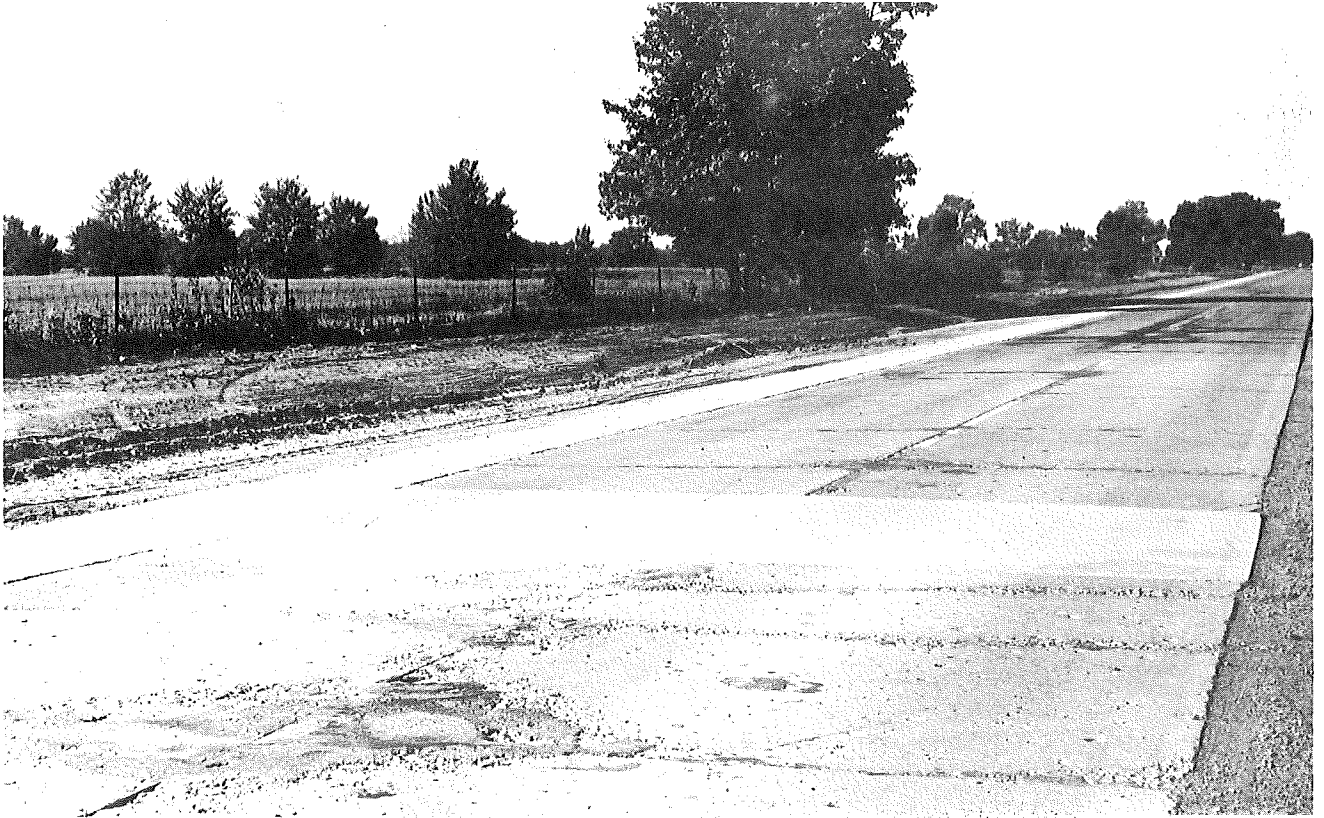
Figure 3. Original rigid pavement. Note transverse patch replacing blowup.

The old pavement was condition surveyed (Fig. 2) and roughness measurements were taken using the Michigan Roughometer. These procedures are to be repeated periodically to provide a performance history of the resurfaced pavement. Figs. 2 and 3 show the generally poor condition of the rigid pavement prior to resurfacing. This pavement had a mean average of about 10 transverse cracks per slab and a history of blow-ups. Fig. 3 shows a patch applied at the site of an old blow-up. This surface was likely to provide a rigorous test for the soil-aggregate cushion. Construction data were as follows:

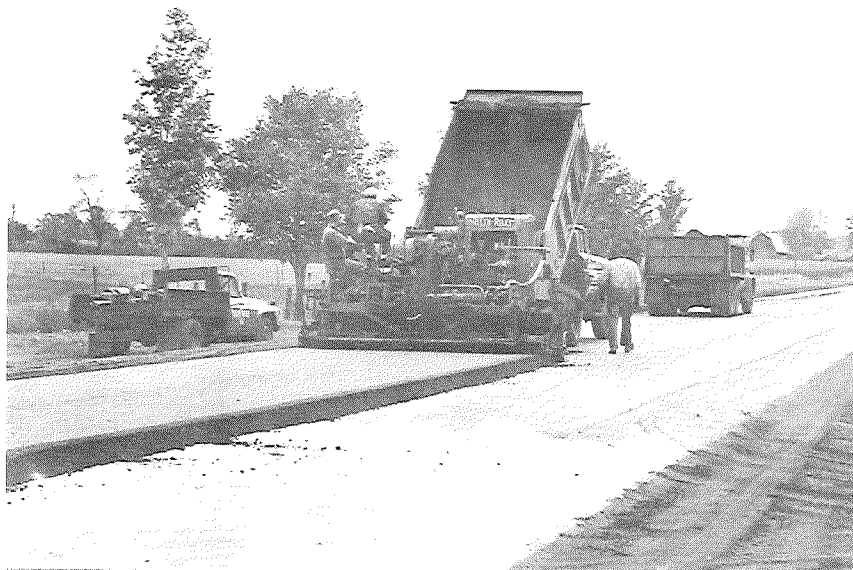
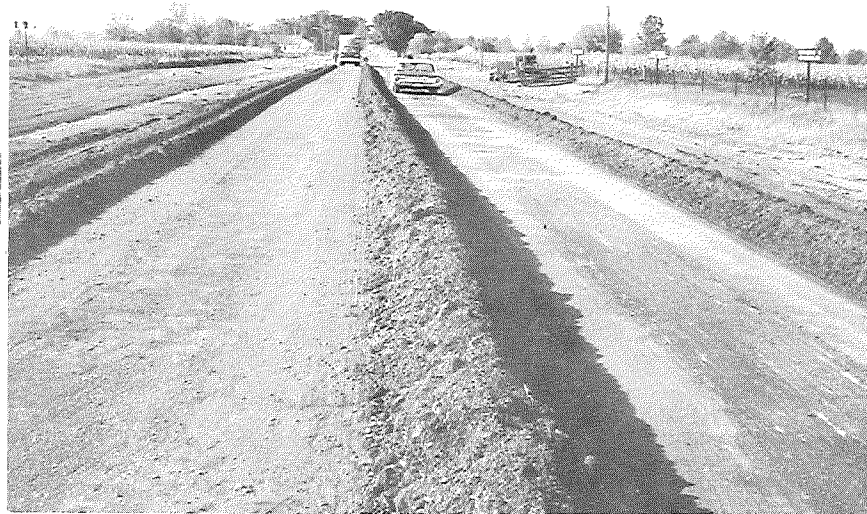
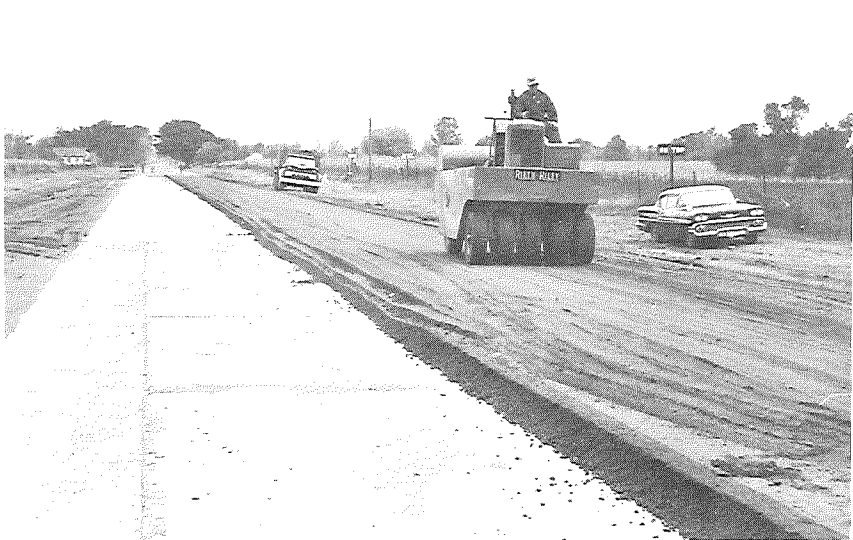
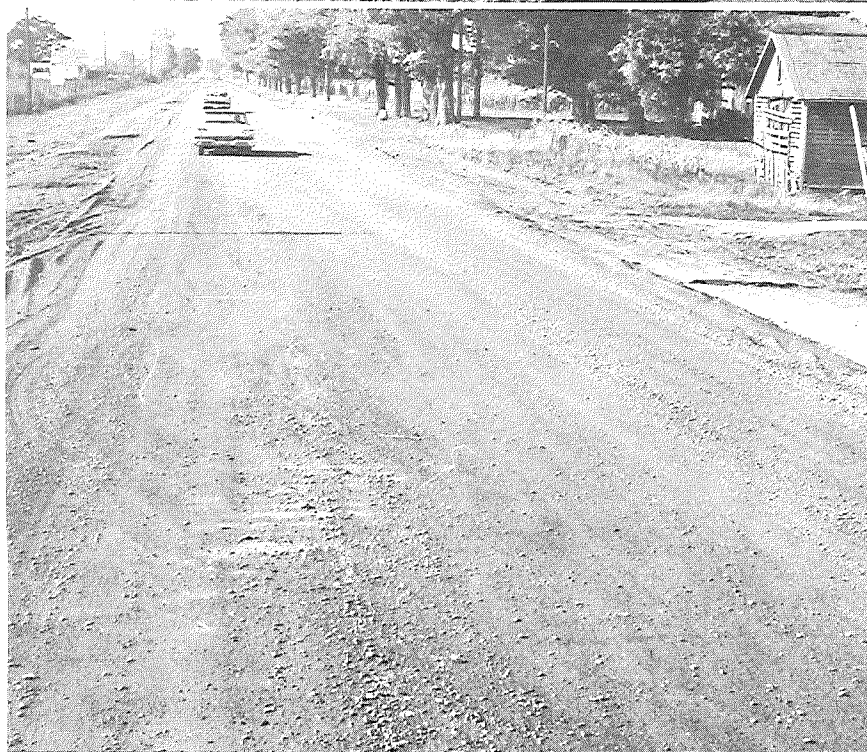
Figure 5. Construction of 23A gravel section, showing placement of gravel with asphalt paver (upper left), drying of cushion by use of windrow (upper right), compaction in progress (lower left), and appearance of completed cushion (lower right).

1. Calcium Chloride-Treated 23A Gravel. The first section of the soil-aggregate cushion to be placed was the 23A gravel containing only calcium chloride (Sta. 1071+00 to 1096+00). The first portion of this gravel section was placed with a Barber Greene Asphalt Paver (Fig. 5), which performed very efficiently in placing the cushion, but broke down after operating for only a few hundred feet. The remaining gravel was placed by dumping from a moving truck. Compared with the asphalt paver, the dumping method of placement resulted in more wasted gravel and extra effort was required to shape the cushion.

The maximum dry density for this material, based on the standard Proctor test, was about 135 pcf. This density was easily obtained with a self-propelled rubber-tired roller (Fig. 5). Some trouble, however, was experienced in eliminating moist spongy areas in the cushion. Traffic was easily maintained during construction, and upon completion of the cushion, the roadway appeared smooth and stable (Fig. 5).

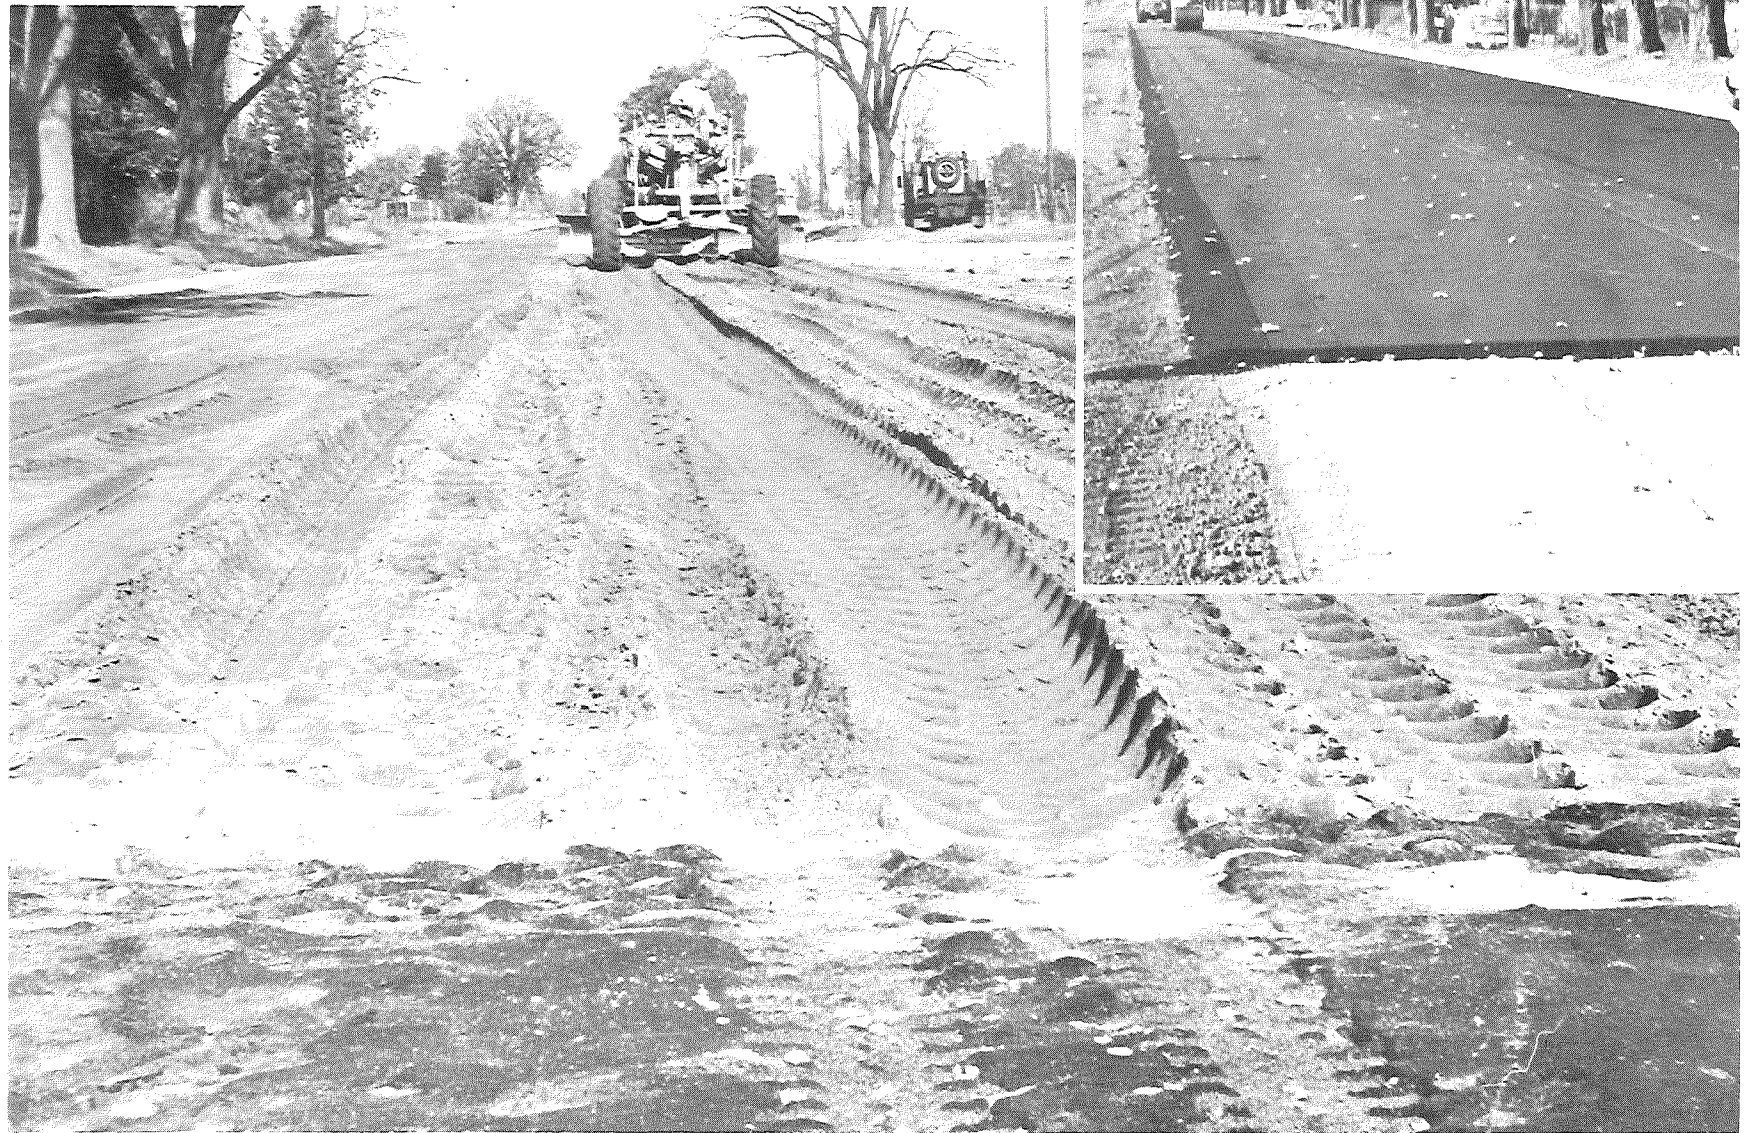
Figure 6. Asphalt-stabilized bank run gravel (right), and attempted compaction of bank run sand (left).

5. Asphalt-Treated Bank-Run Gravel. The gradation of the gravel used in this test section is given in Table 1. The asphalt and gravel were mixed at an asphalt mixing plant and hauled about 20 miles to the construction area in trucks (Sta. 1116+00 to 1121+00). The bitumen content of the mixture was 4 percent by weight. The temperature of the mix was 250 F. The material was placed with a Cedar Rapids paver and was easily compacted with a steel-wheeled roller (Fig. 6). About 6 hr after compaction, traffic was permitted to travel over the cushion. Slight rutting was evident in the wheel tracks for a distance of about 5 ft at each end of

the cushion, and also some flattening at the sides of the cushion caused by traffic running off of the transverse edges. The cushion held up very well under traffic, however, especially in view of the heavy trucks traveling over it after such a short curing period. The compacted cushion appeared to be somewhat "rich" in bituminous material and it appears that even better results could be obtained by slight reduction of the bitumen content of the gravel. The unit cost of this asphalt stabilized gravel was about four times that of the 22A gravel.

6. Sodium Chloride-Treated Bank Run Sand. This material was produced specifically for use in this section (Sta. 1121+00 to 1126+00). It contained about 8 percent silt, which proved to be ineffective as a binder material. Each ton received about 8 lb of sodium chloride and was placed with an asphalt paver. The self-propelled rubber-wheeled roller would not operate over it, so a grader was used in an attempt to gain compaction. Despite the addition of water and considerable rolling, the sand could not be compacted well and would not carry traffic (Fig. 6). As a result, the sand was taken away to be used elsewhere and the bituminous concrete placed directly on the old rigid pavement.

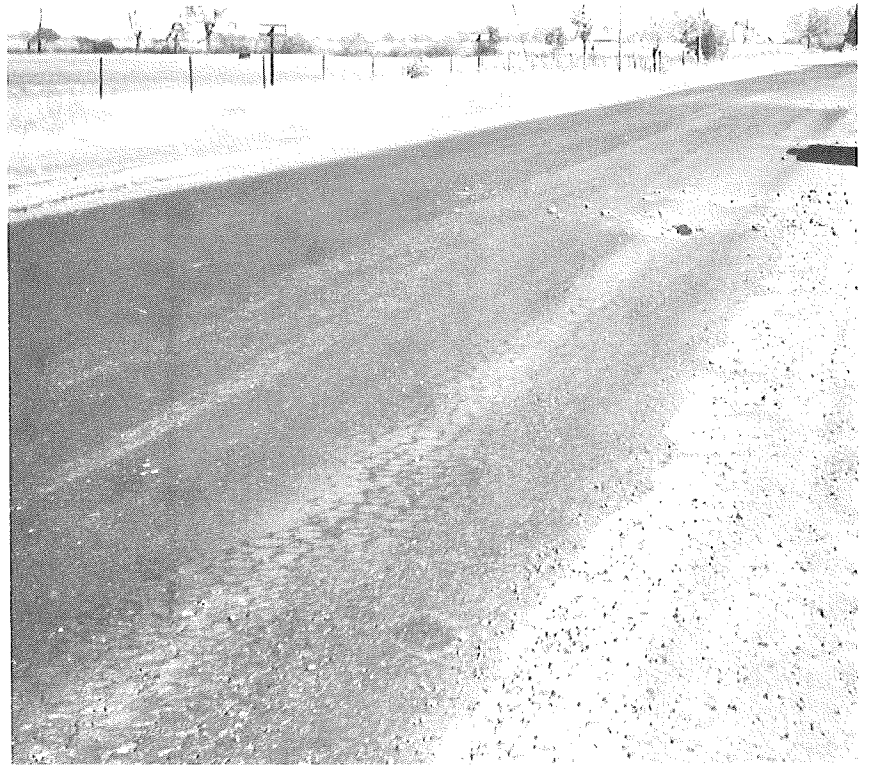
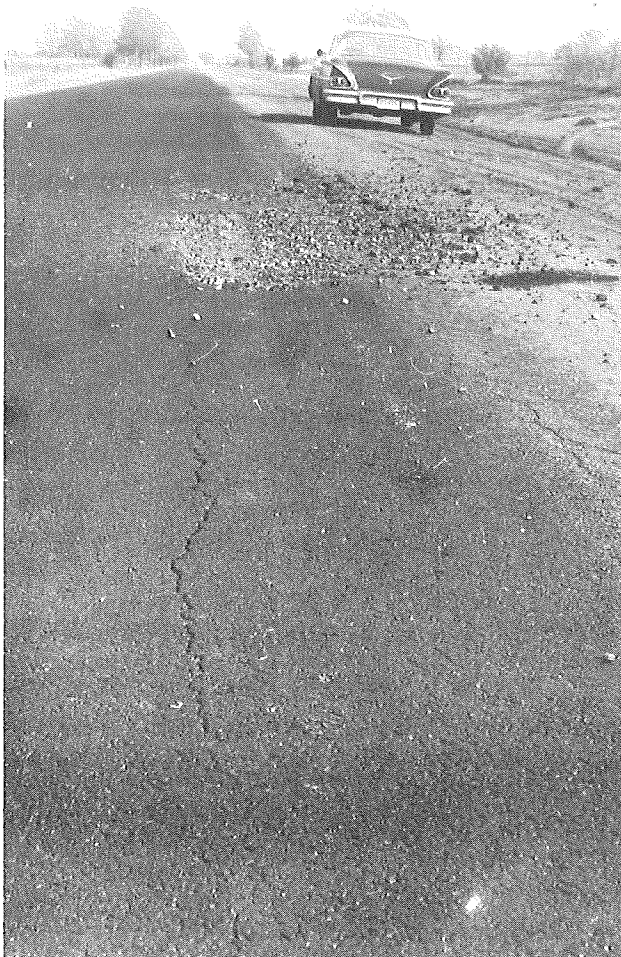
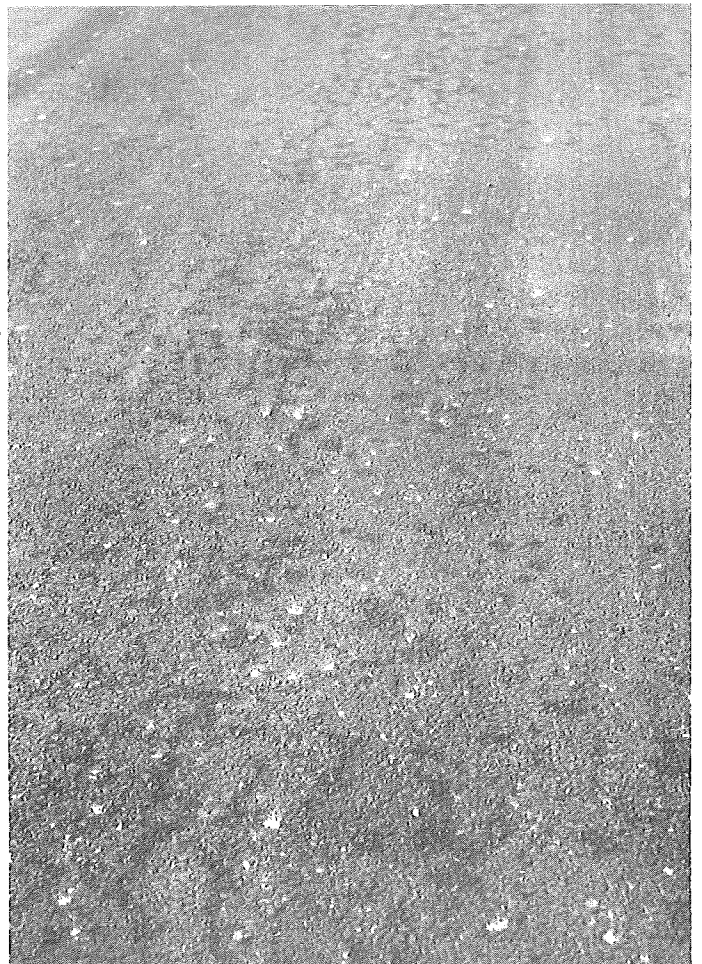
Figure 7. Behavior of asphalt leveling course, showing map cracking and disintegration (upper right), longitudinal cracking and disintegration (lower left) and moisture spotting (lower right).

After carrying traffic for about one day, signs of failure began to appear in the bituminous leveling surface over the 23A gravel cushion (Figs. 7 and 8). The asphalt surface was spotted with moisture, giving the appearance of water migrating up from the base, and areas of map cracking or longitudinal cracks appeared. Then the asphalt appeared to disintegrate, the damage spreading into large broken areas. However, these failures were confined to the areas of asphalt placed over the 23A gravel, and did not appear to be nearly as frequent or as serious in those areas in which the 23A gravel contained sodium chloride admixture. Attempts were made to patch the distressed areas but the failure became so widespread that it was necessary to remove large areas. These were replaced by asphalt applied directly on the rigid pavement surface.

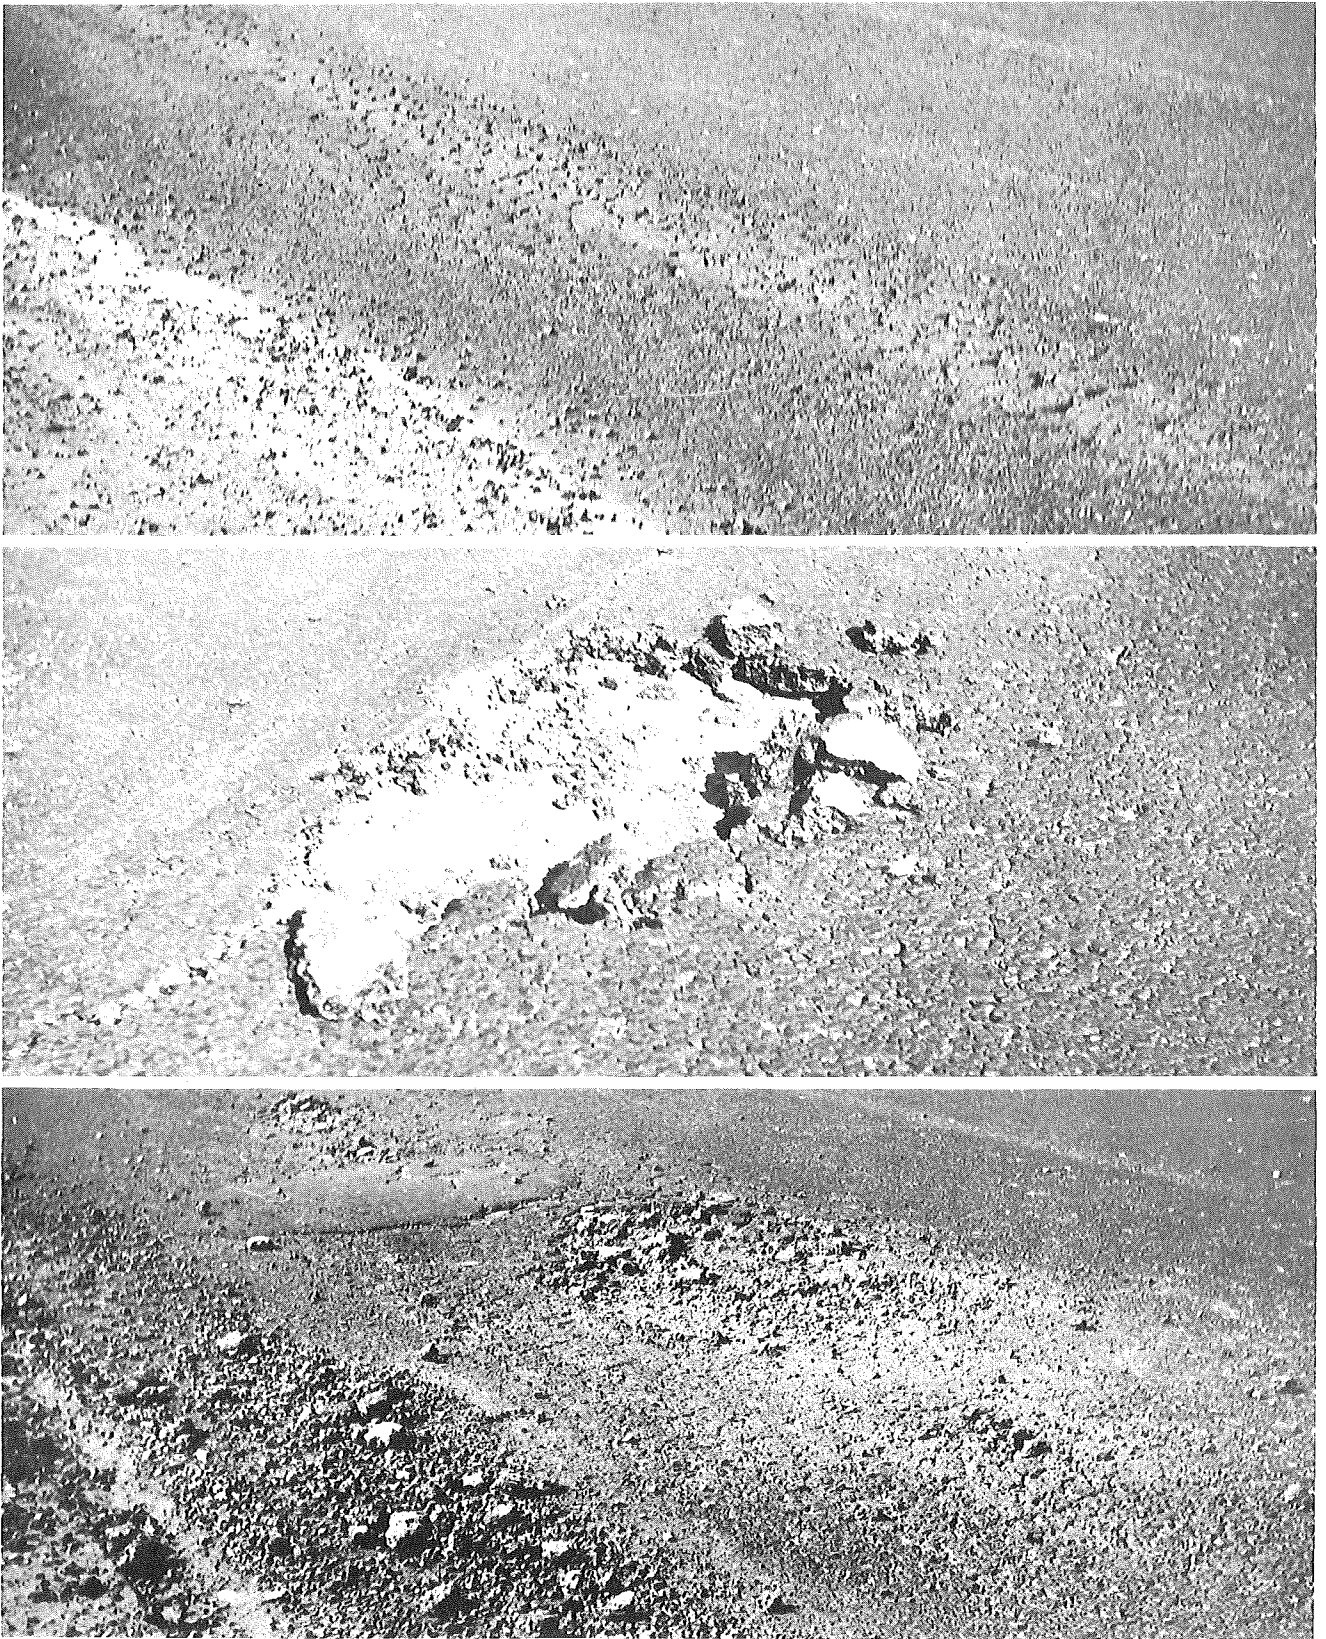
Figure 8. Behavior of asphalt leveling course, showing severe alligator cracking (top) and localized distress (center and bottom).

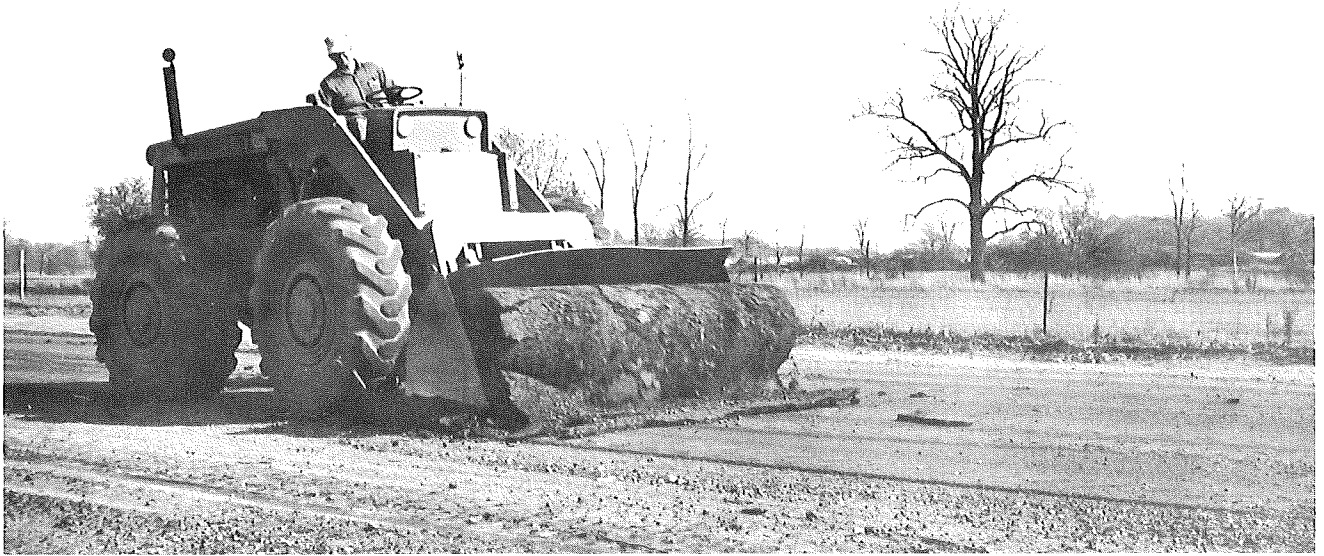
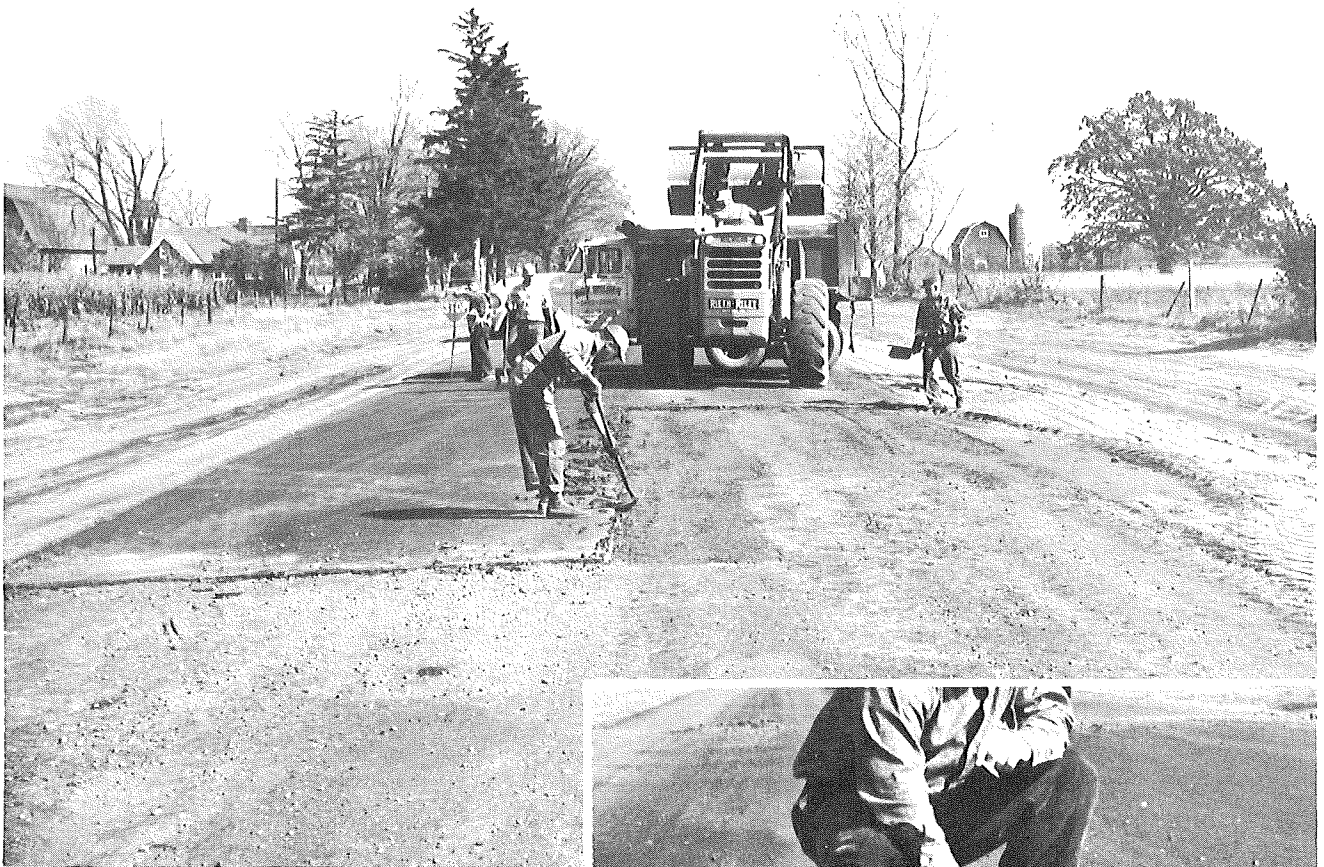
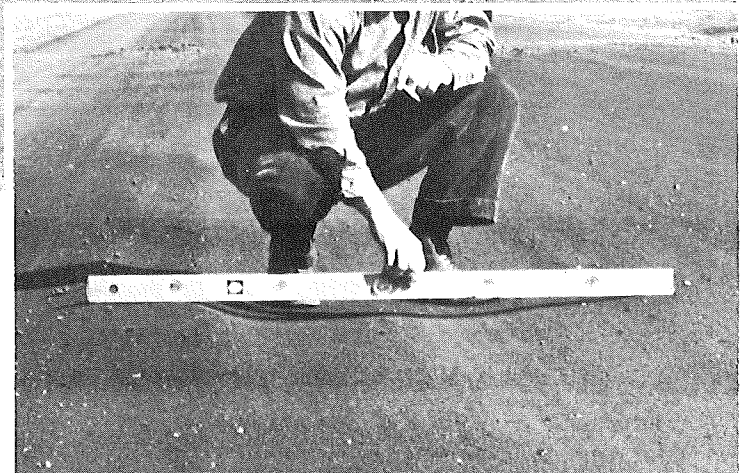
Figure 9. Removal of asphalt leveling course from distressed 23A gravel cushion (top), and appearance of cushion when exposed (center). Rutting is shown at bottom.
