EXPERIMENTAL CONCRETE CAPPING ON GROESBECK HIGHWAY  
Project F 50-7, C5  
Third Progress Report

Report No. 331  
Research Laboratory Division  
Office of Testing and Research  
Research Project 52 F-25

Michigan State Highway Department  
John C. Mackie, Commissioner  
Lansing, May 1960

EXPERIMENTAL CONCRETE CAPPING ON GROESBECK HIGHWAY  
Project F 50-7, C5

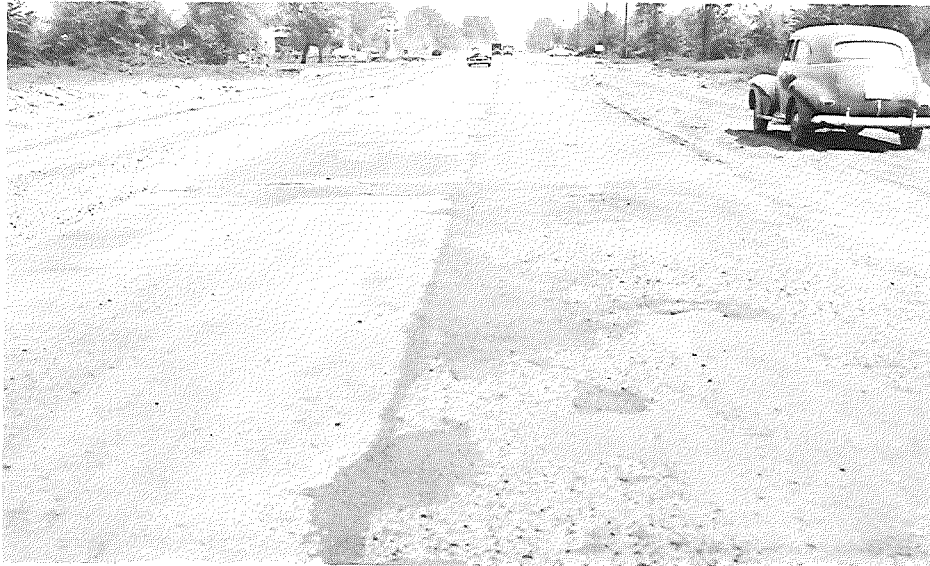
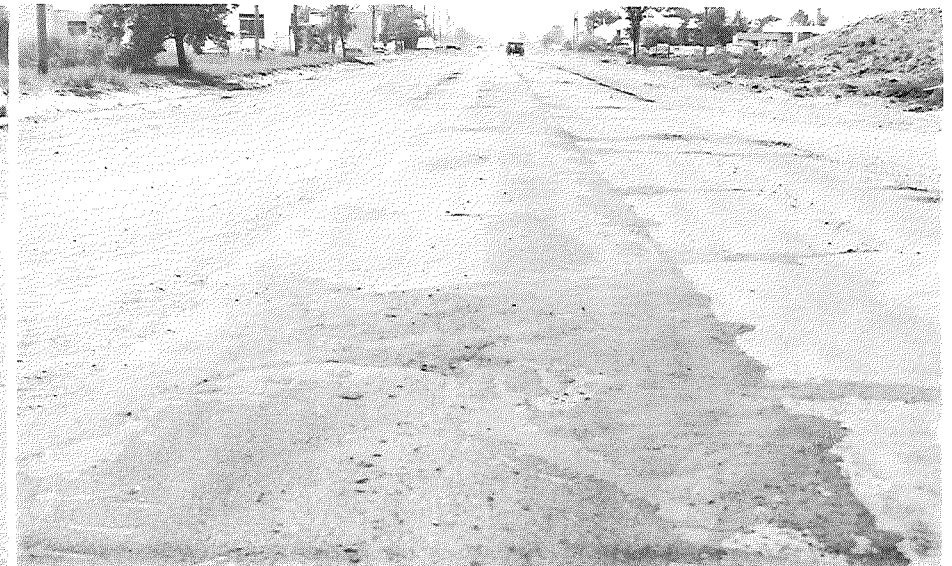
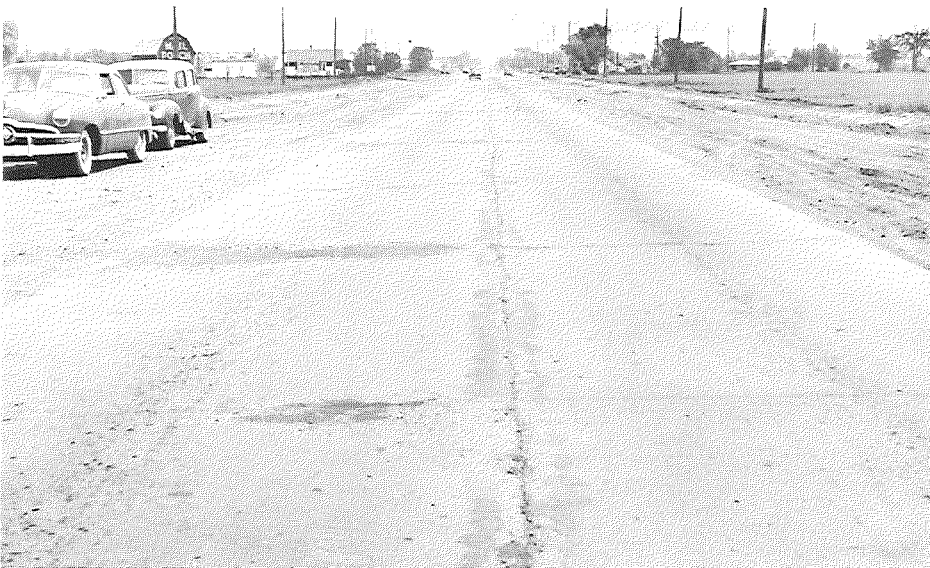
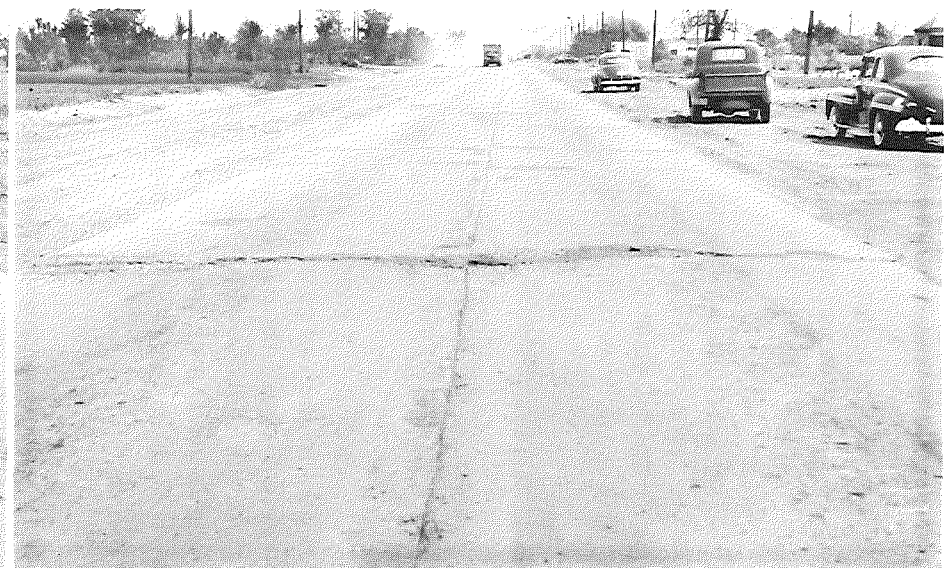
Figure 2. Typical condition of 24-year-old concrete pavement prior to capping and widening (photos: June 1952).

The original pavement had deteriorated considerably in its quarter-century of service. In addition to the influences of heavy traffic and of notably poor foundation materials and drainage, the pavement surface was heavily marked with scaling and bituminous patching (Fig. 2).

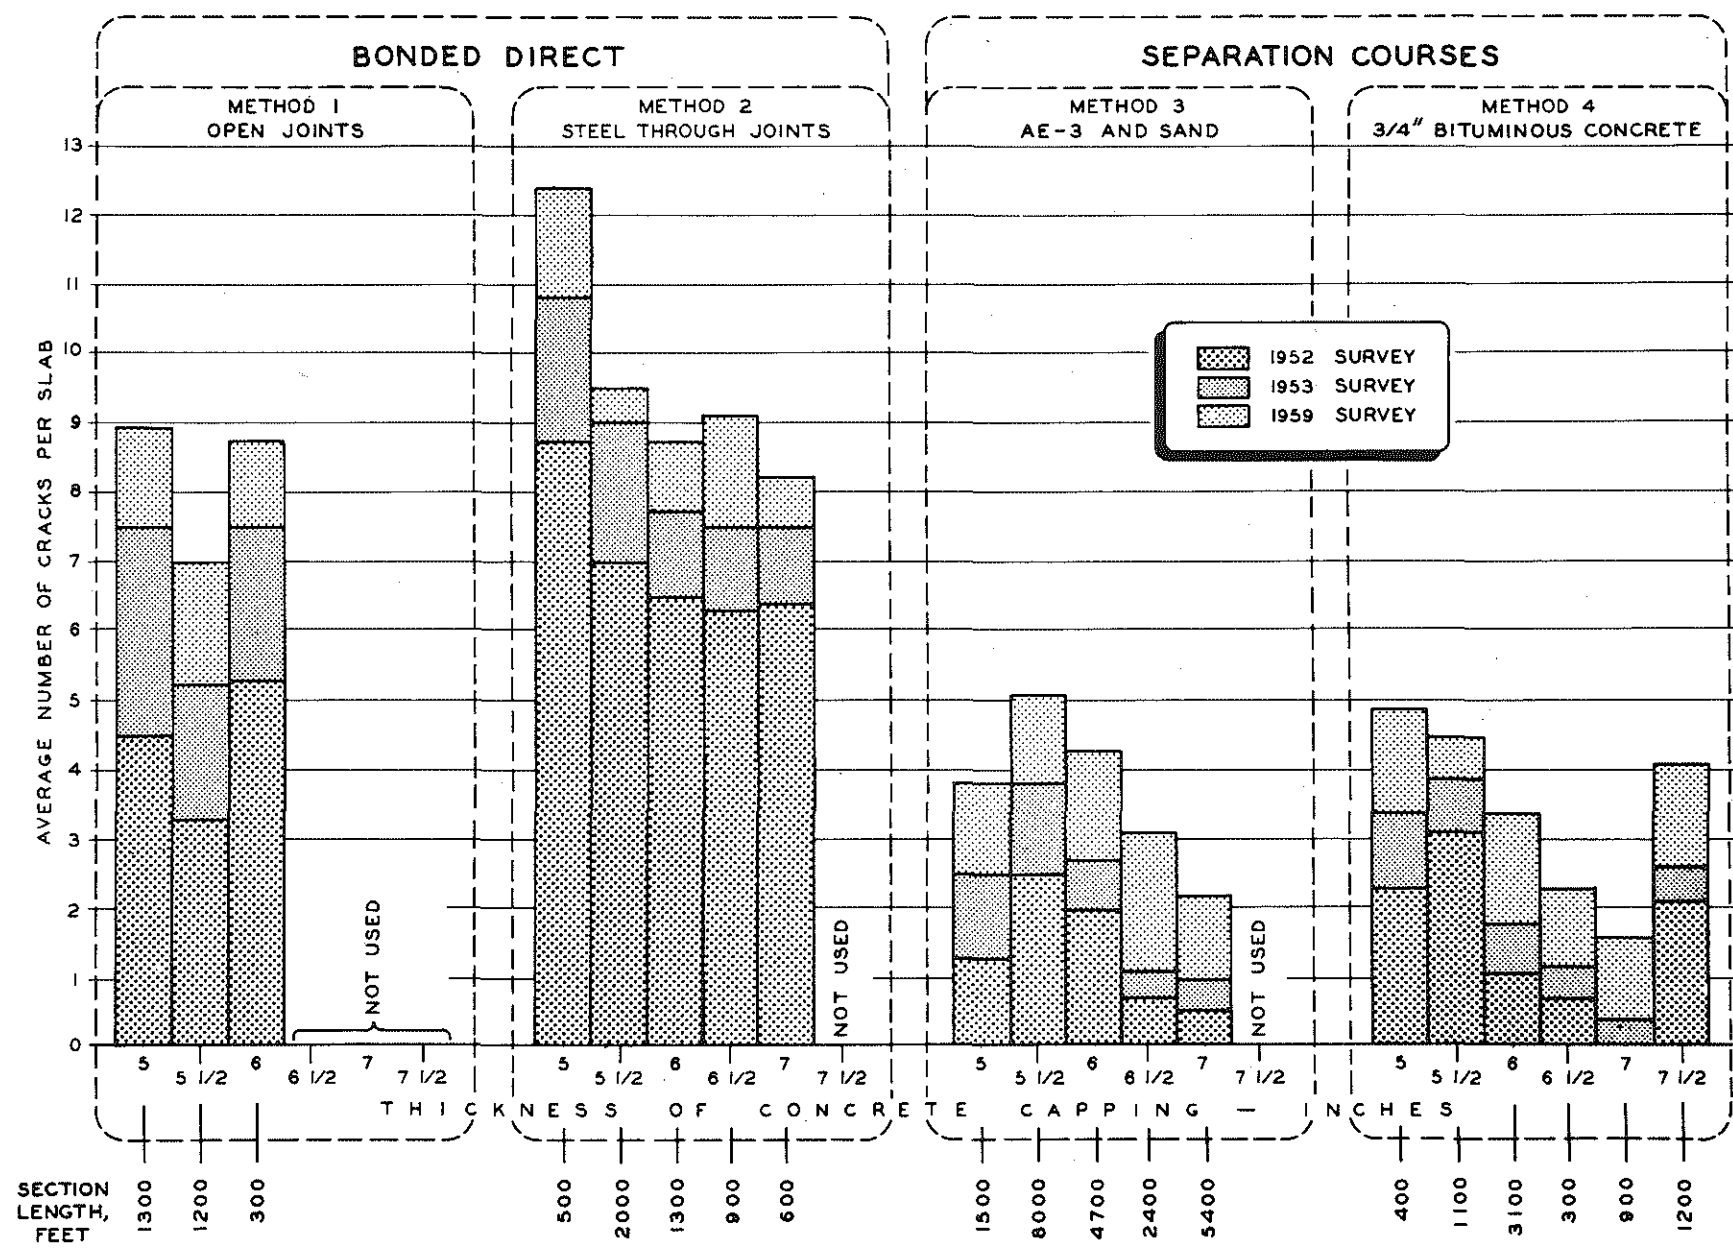
Figure 4. Relation of capping methods and thicknesses to number of cracks per slab prior to opening (1952), after one year (1953) and after seven years (1959).

Figure 4 shows the relation of capping method and thickness to the number of cracks per slab. The graph shows the general tendency toward greater resistance to cracking with increasing cap thickness. Some bars diverge from this pattern; several explanations may be offered for these apparent inconsistencies:

However, the greatest portion of the evidence in Table 1 and Figure 4 indicates that Methods 3 and 4, involving introduction of separation courses before application of concrete caps, are for all practical purposes comparable and similar in performance and are both superior from the standpoint of crack experience to methods in which capping was bonded directly to the old pavement.

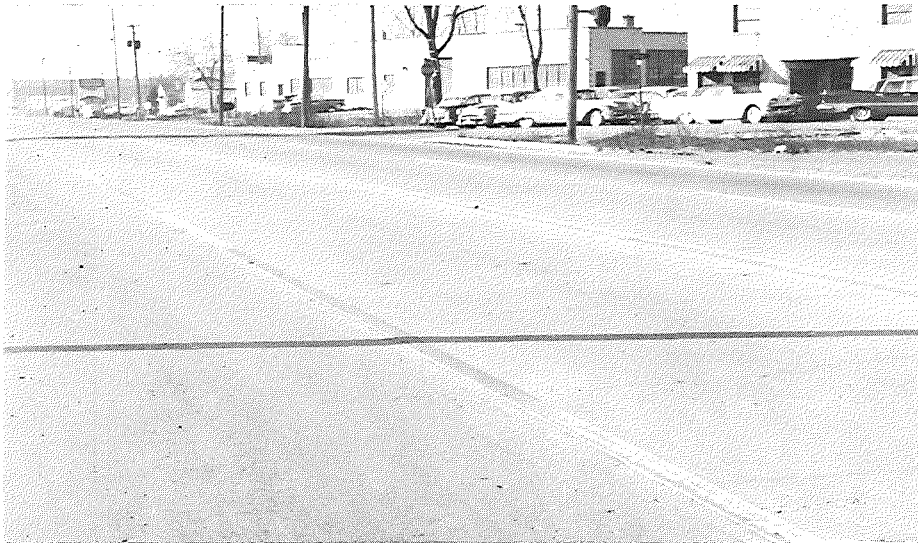
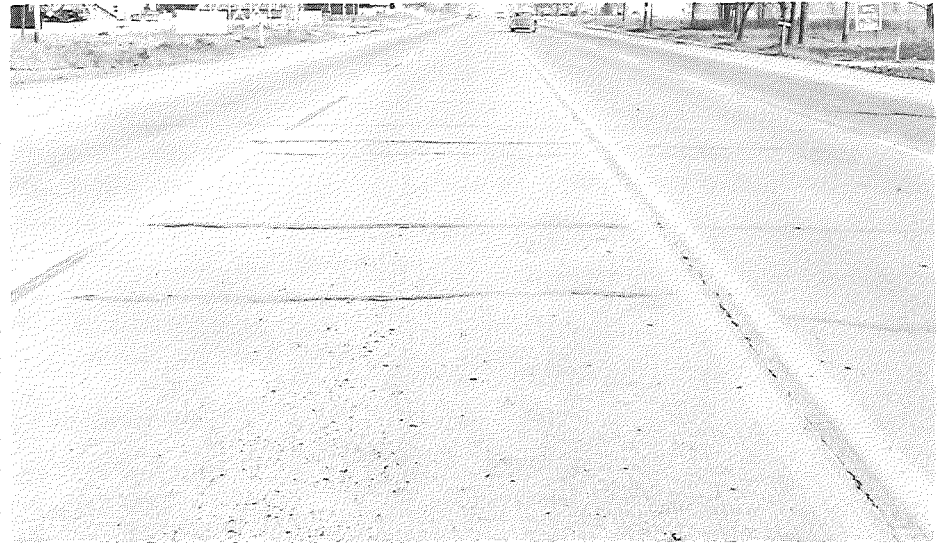
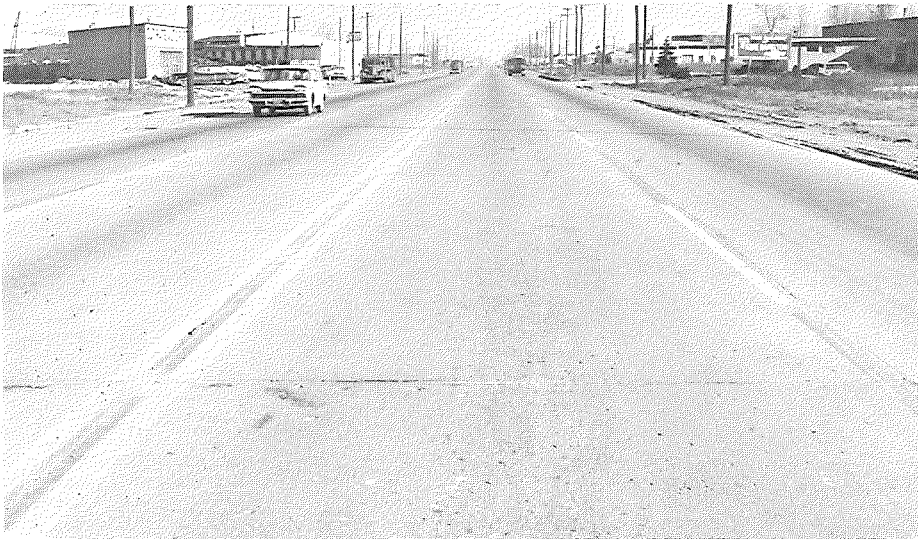
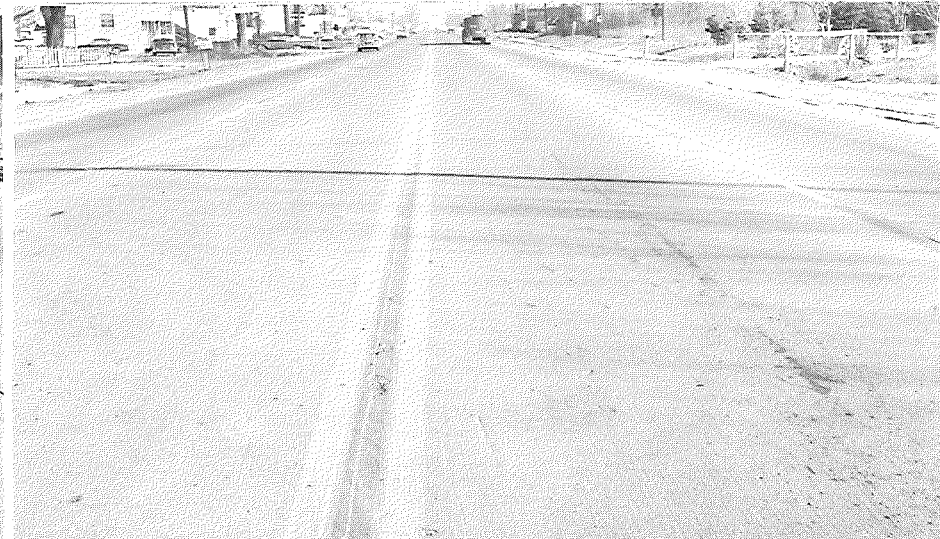
Figure 5. General views of surface condition of 7-year-old concrete capping (Feb. 1960)

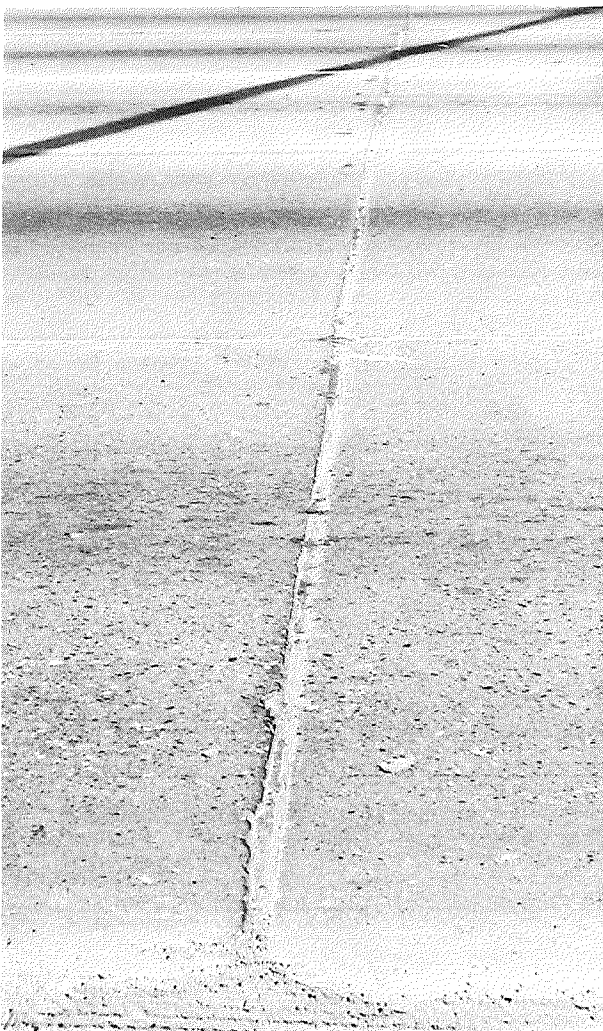
**Figure 6. Typical sound contraction joint in 5-in. capping and adjacent widening (foreground), after 7 years. (Feb. 1960). 4+41 - Method 1.**

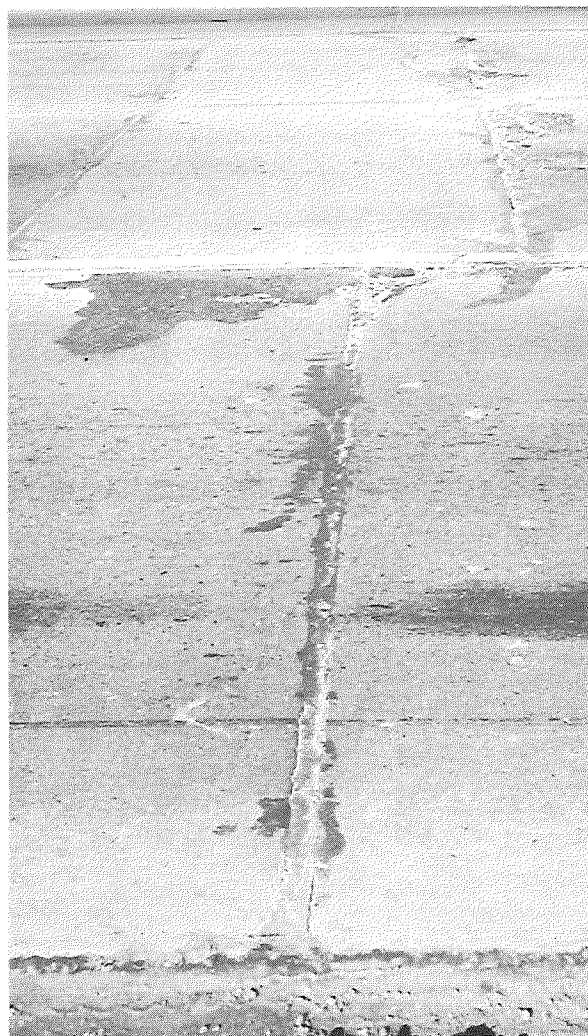
**Figure 7. Joint failure in 5-1/2-in. capping, resulting in patching of center lanes (Feb. 1960). 7+35 - Method 1.**

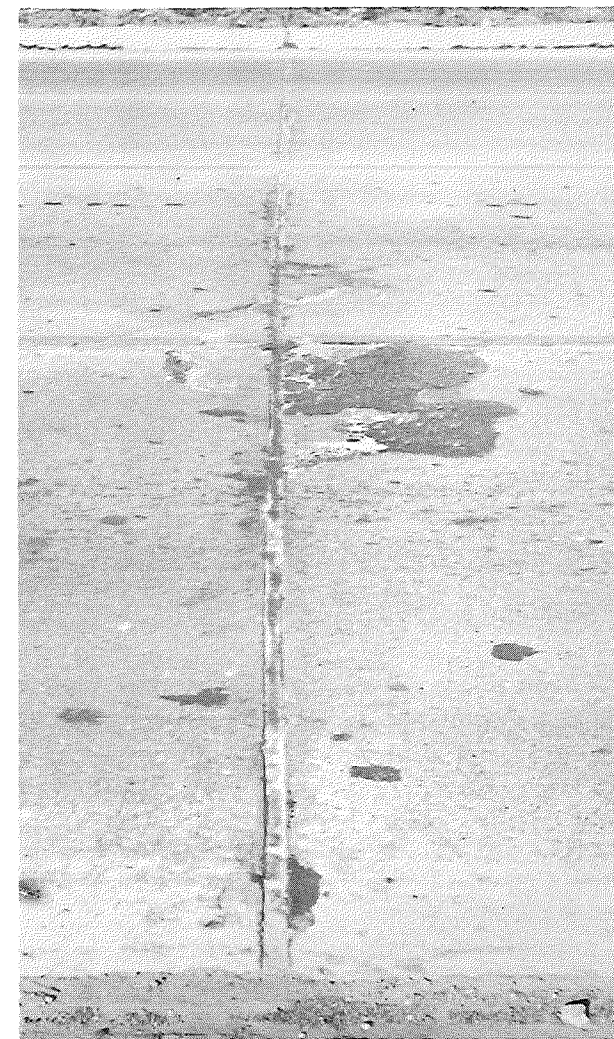
**Figure 8. Minor joint deterioration in 5-1/2-in. capping and adjacent widening (Feb. 1960). 28+33 - Method 1.**

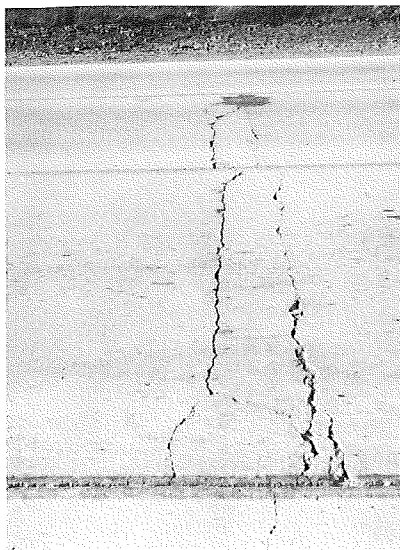
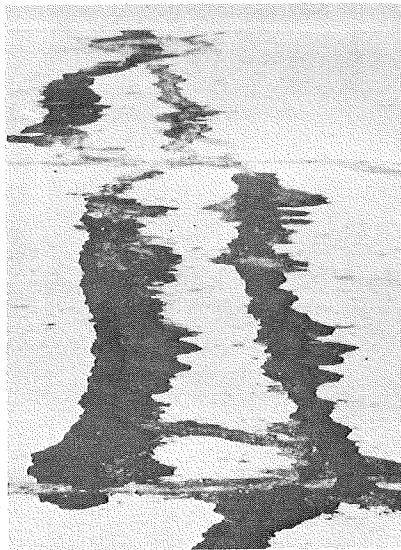
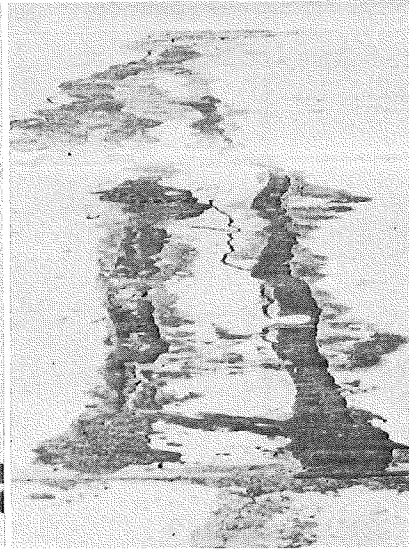
Figure 12. Adjacent cracks eventually required patch in 6-in. capping; note transverse crack at same point in foreground widening lane. 368+20 - Method 2.

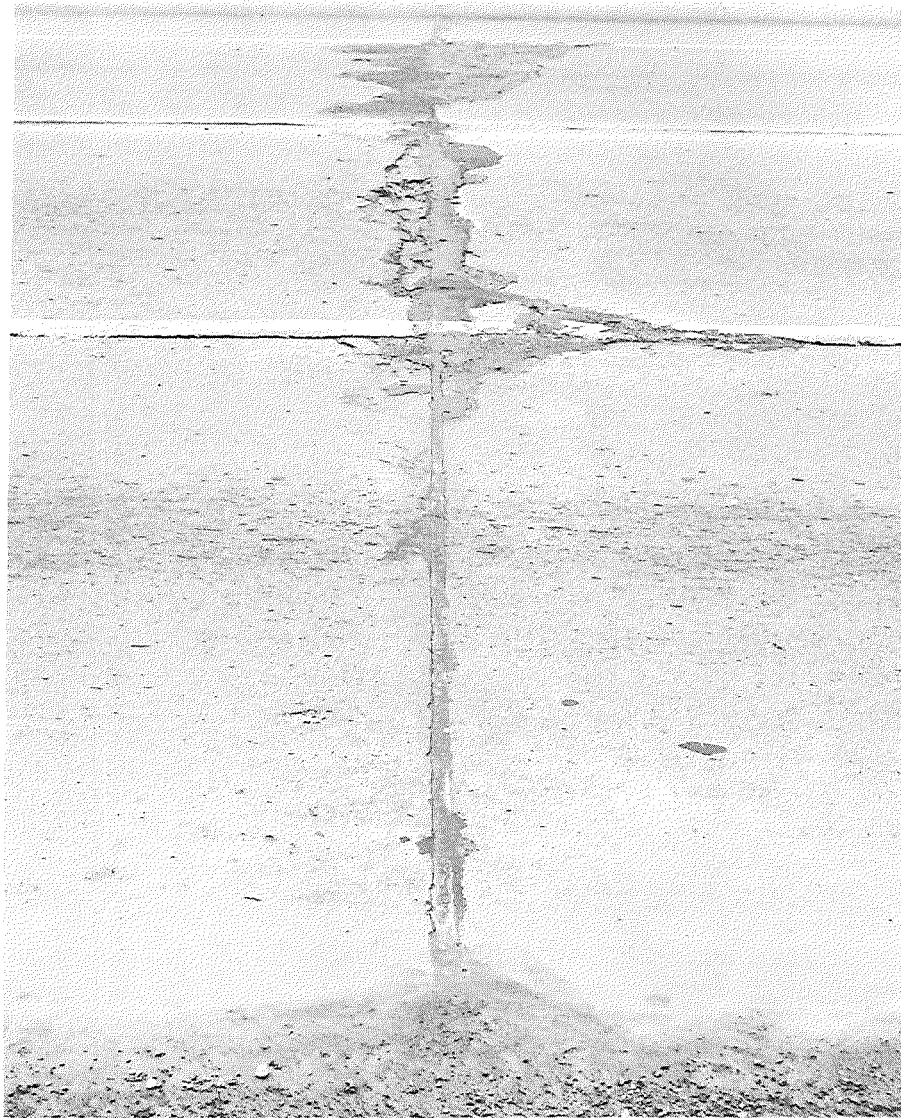
Figure 14. Contraction joint deterioration in 6-1/2-in. capping (center lanes) after 7 years (Dec. 1959). 353+67 - Method 2.

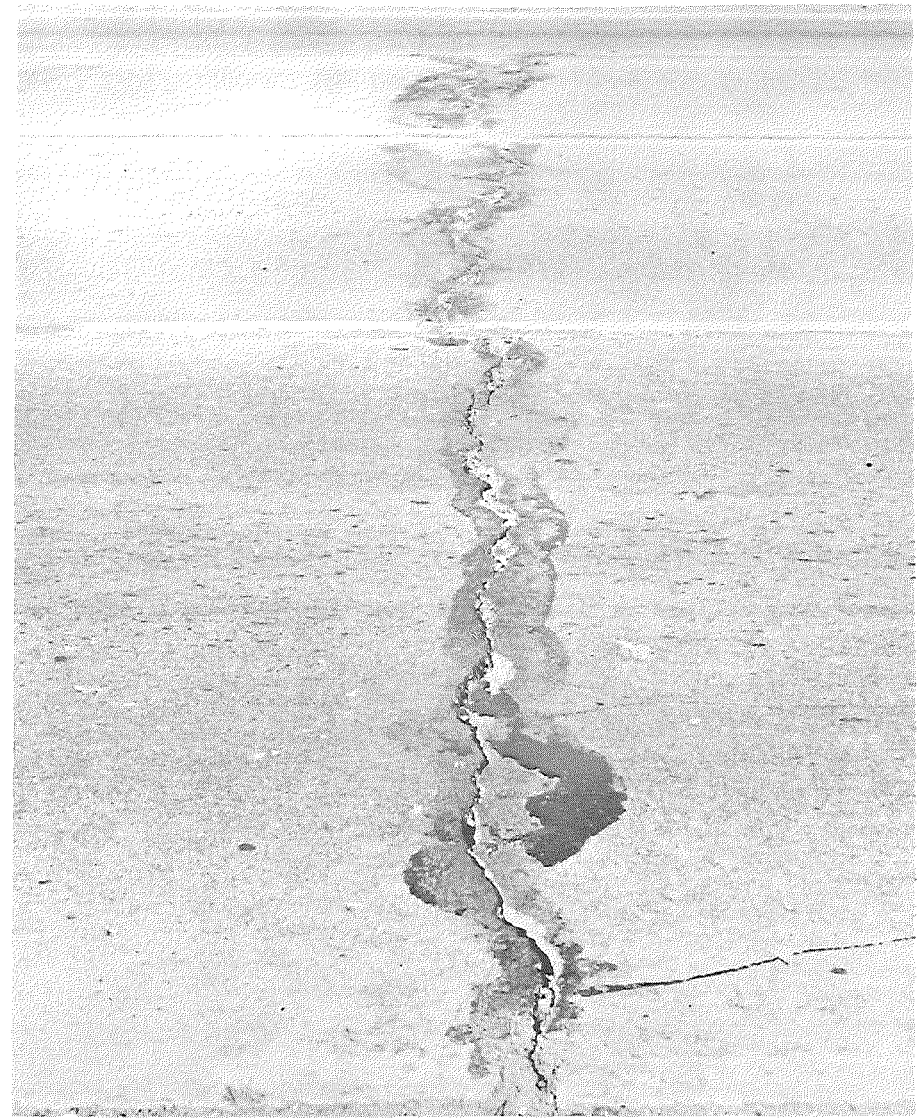
Figure 15. Crack in 6-1/2-in. capping continued in foreground widening lane, after 7 years (Feb. 1960). 350+48 - Method 2.

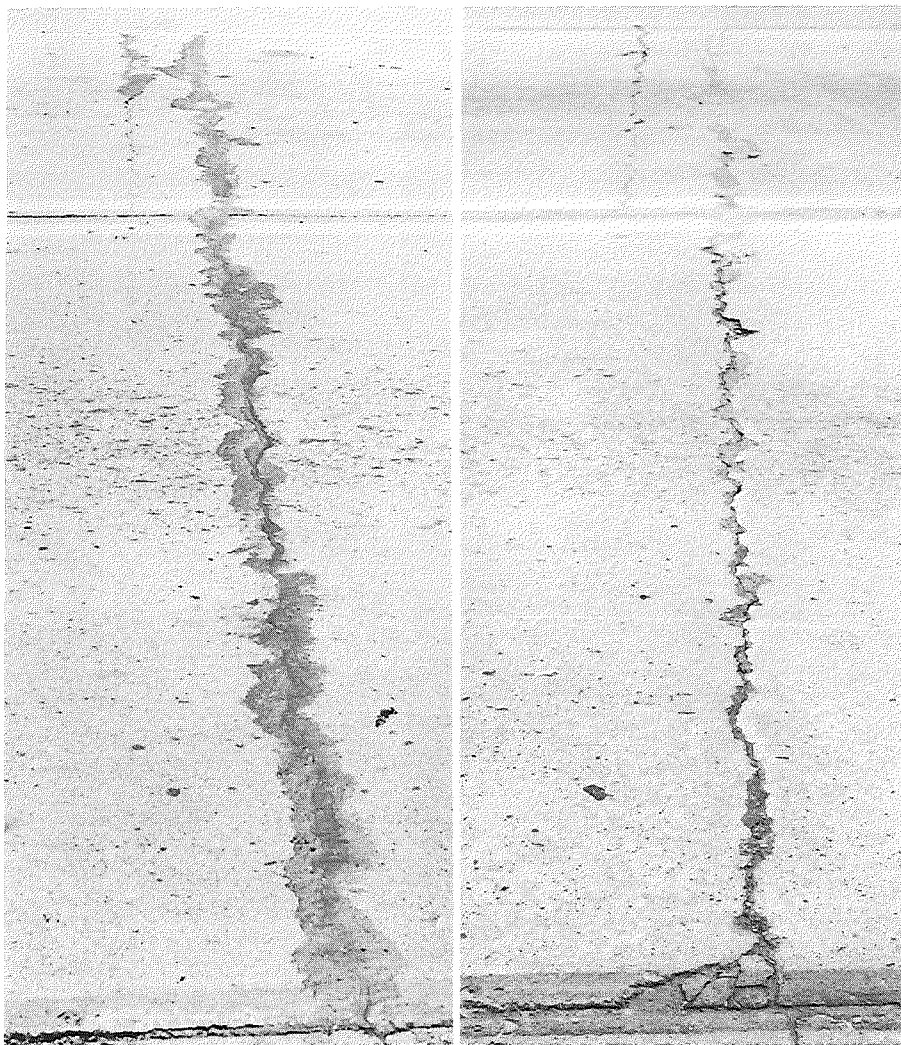
Figure 16. Transverse crack in 6-in. capping at 3 and 7 years. 154+09 - Method 3.

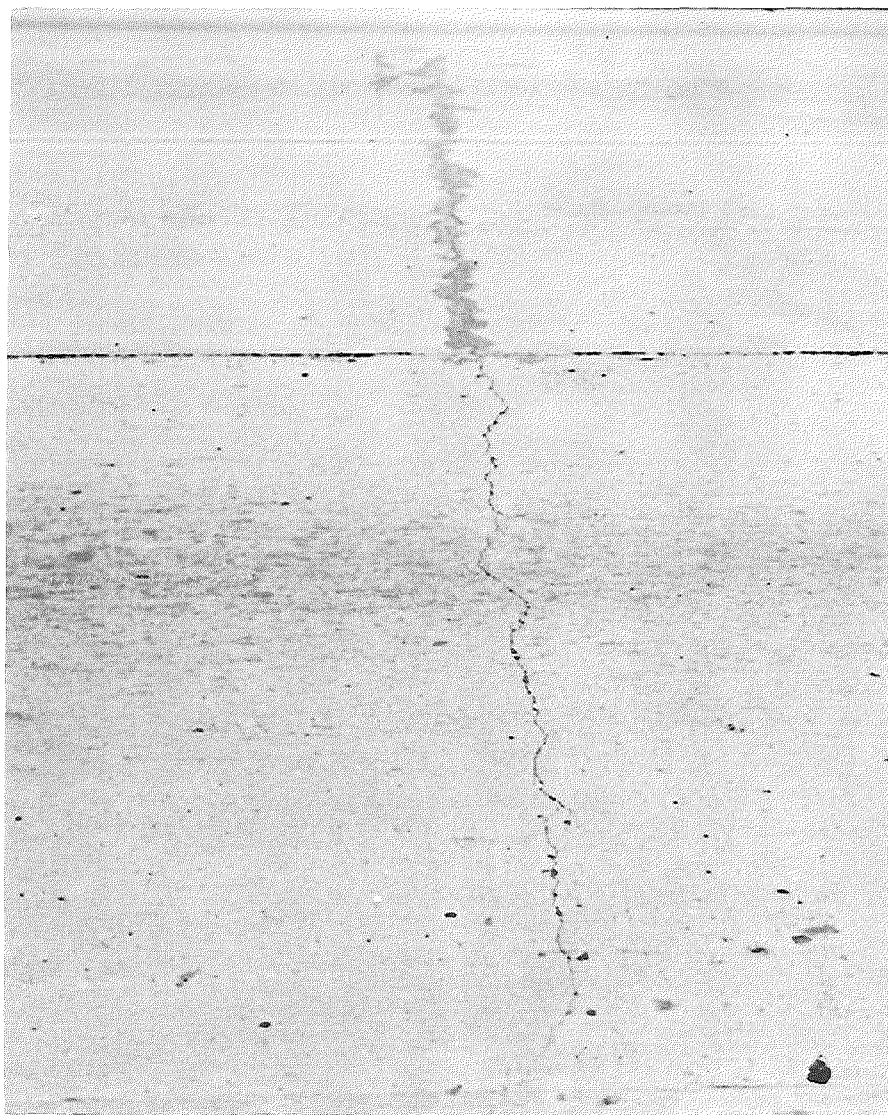
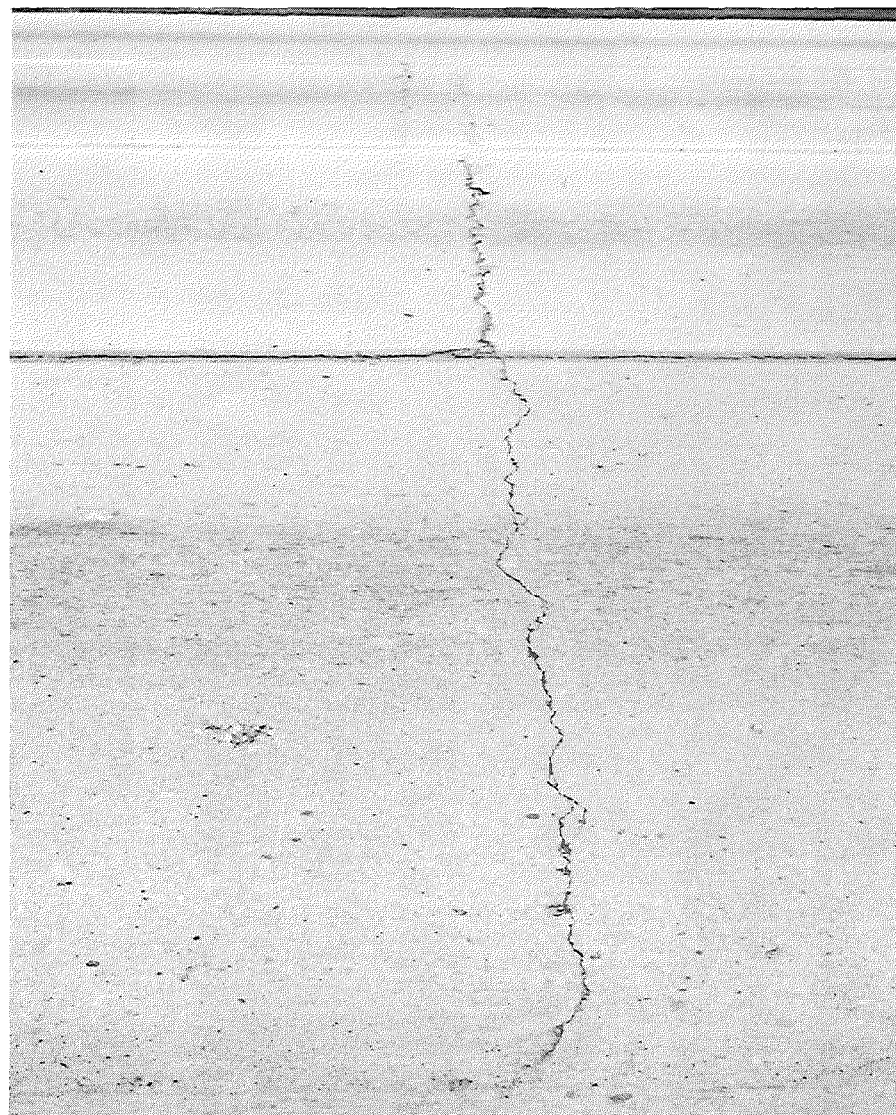
Figure 18. Widening of transverse crack in 7-in. capping in center lanes, continued in foreground widening lanes. 159+09 - Method 3.

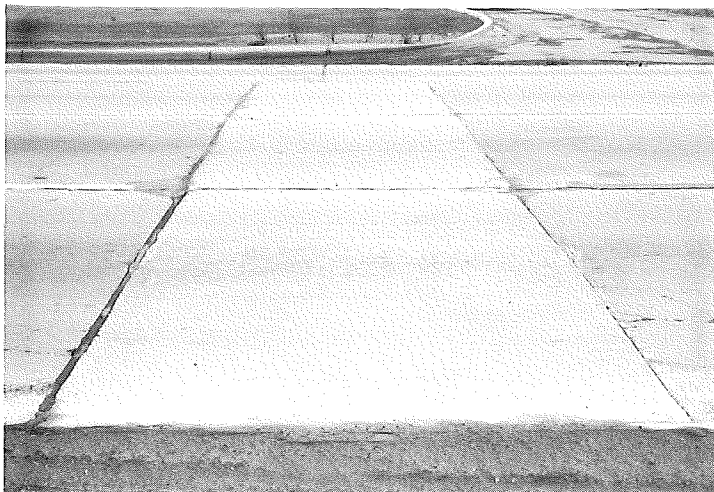
Also, the greater amount of joint repair required in areas with separation courses might be attributed to differential curling of the cap and old pavement, as opposed to the more monolithic curling of old pavement with a directly bonded cap. If differential curling is greater when separation courses are used, then the concrete cap would be subjected to impact forces; in the curled condition, the cap would be deflected downward by a wheel load at a joint, suddenly striking the firm and rigid mass of the old pavement, and eventually incurring physical damage (Figs. 17, 19, 20, 21).

Figure 19. Severe deterioration at contraction joint in 7-in. capping required complete replacement of cap in center lanes and of right widening lane. 192+92 - Method 3.

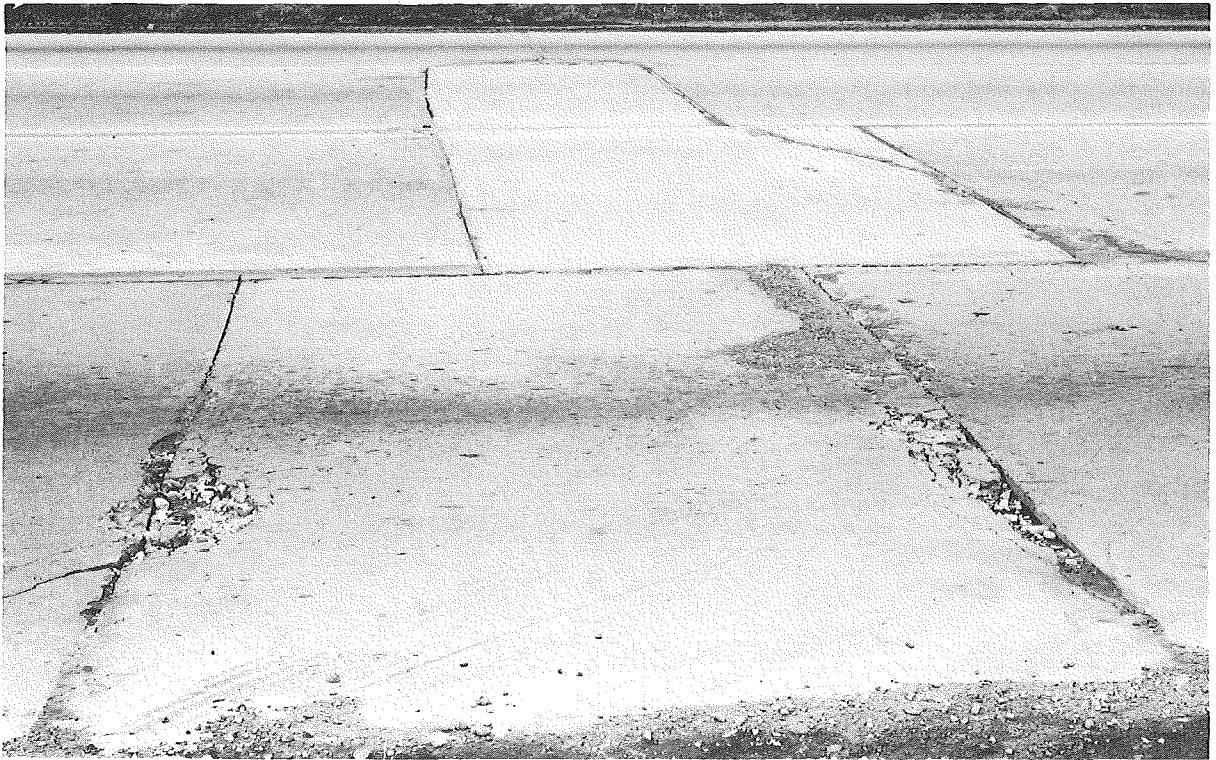
**Figure 20.** Repaired area at contraction joint in 6-in. capping (center lanes), with similar repair in foreground widening lanes; note concrete deterioration in widening patch (Dec. 1959). 301+97 - Method 4.

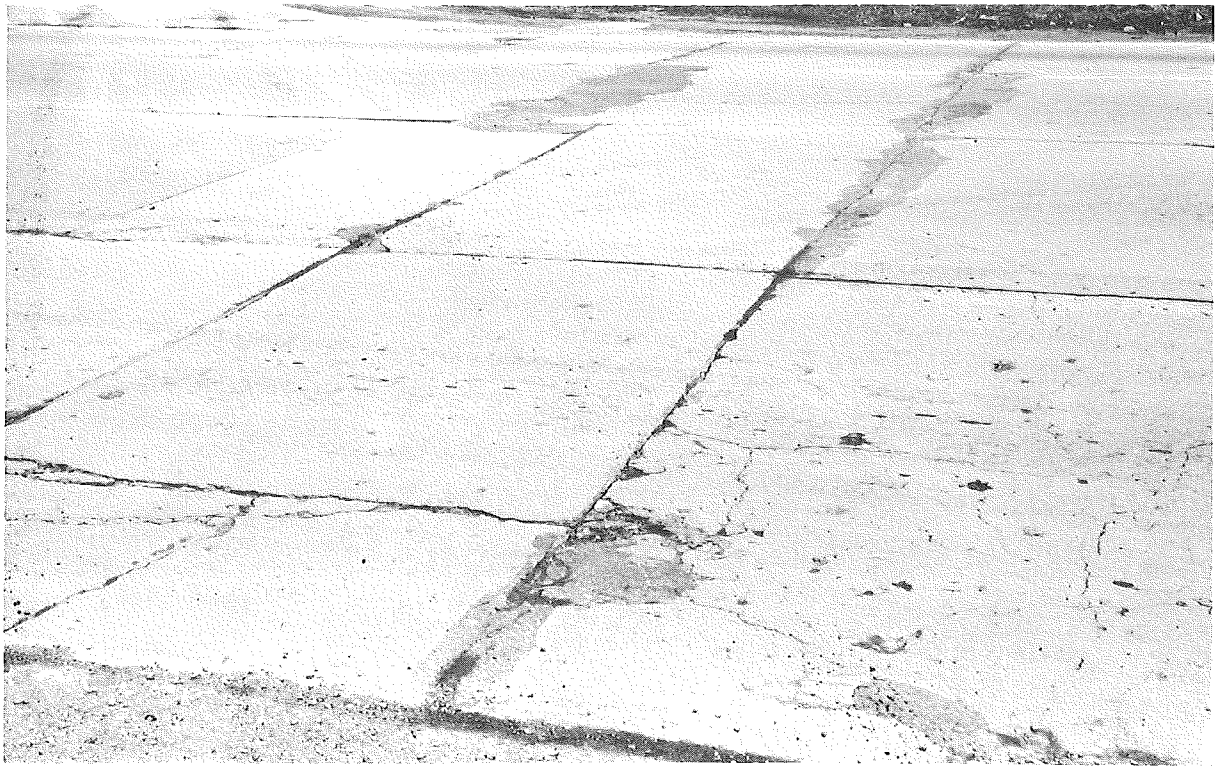
**Figure 21.** Repair at contraction joint in 7-1/2-in. capping with similar repair of foreground widening lane (Dec. 1959). 281+33 - Method 4.
