Research Spotlight

REPORT NAME: Effects of Debonded Strands on the Production and Performance of Prestressed Concrete Beams

RESEARCH REPORT NUMBER:
RC-1546

Strand debonding helps minimize bridge beam end cracking

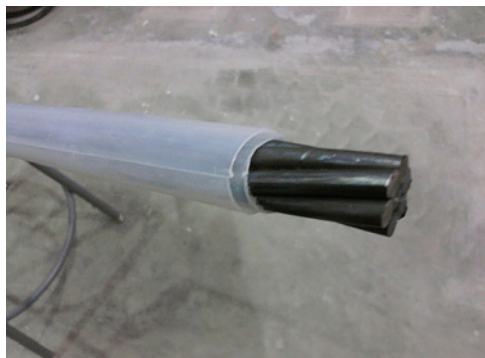
Traditional soft sheathing on the ends of prestressing strands (left) was not producing the desired debonding effect in bridge beams. The use of rigid tubing (right) as an alternative made the difference.

Debonding of prestressing strands is typically achieved by wrapping the ends of the strands with a soft polymer sheathing.

When soft sheathing was used for debonding, researchers found that bonding behavior was present to some extent between the strand ends and concrete, causing excess stress and end cracking. The results of lab tests and models were in close agreement, and they demonstrated that the damage effect was compounded when multiple strands were close to one another.
