# Safety Opportunities in High Friction Surfacing

Crashes on the nation's roadways continue to be one of the leading causes of fatalities and major injuries in the United States, particularly in rural areas. Roughly half of all fatal crashes occur at intersections or on horizontal curves.<sup>1,2</sup> In horizontal curve crashes, it is often the case that the vehicle speed and curve geometry create a "friction demand" higher than what can be achieved with standard pavement surfaces. Intersection crashes often occur when driver error creates an unexpected need for increased friction demand to serve as a "speed countermeasure." One low cost approach that has been shown to be effective in addressing high "friction demand" locations is the installation of a High Friction Surface Treatment (HFST).

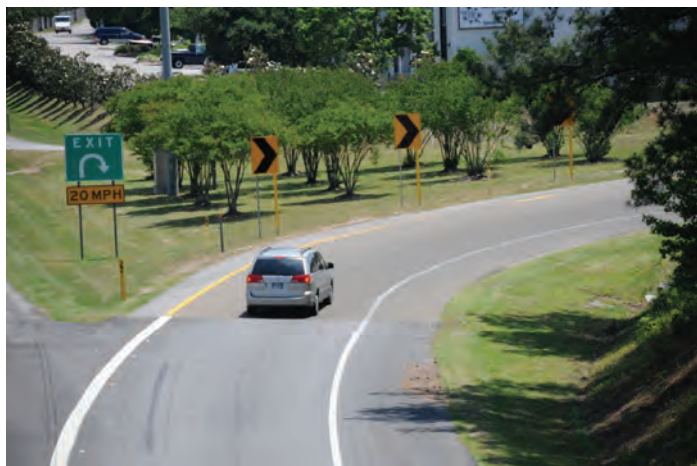
HFSTs can be used in a variety of settings including interchange ramps (Image: South Carolina DOT)

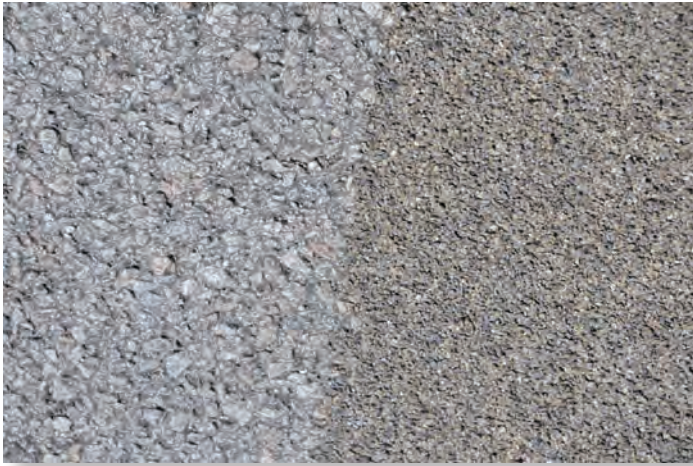
HFSTs (right) provide additional surface microtexture  
(Image: South Carolina DOT)

The combined aggregate-binder treatment forms a pavement surface that is resistant to polishing and provides improved friction and skid resistance. This improvement provides an additional opportunity for a motorist to regain control of a vehicle in situations of excess speed. Given the durability of the aggregate material and the strength of the binder, the combination is able to withstand heavy braking and snowplowing. This makes HFSTs an ideal solution to address friction concerns in any climate.

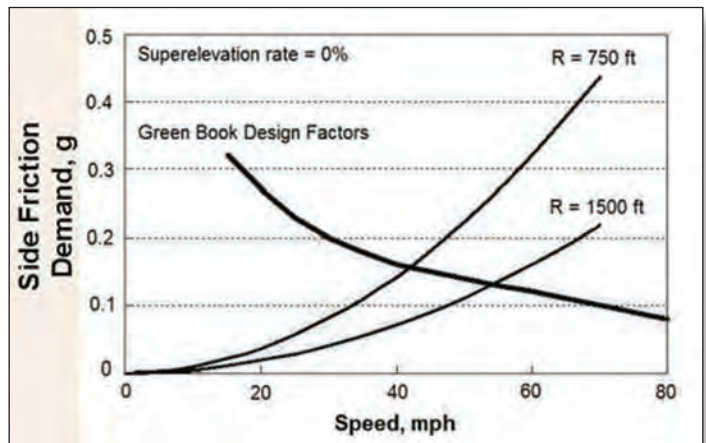
Relationship between curve speed and side friction demand for two radii

The correlation between speed and crashes in horizontal curves has been well documented. Of course this could be said for approach speeds at intersections as well. Speed is a major component of increased friction demand in curves and for stopping at intersections. Since HFSTs work well for both conditions in reducing stopping distance and loss of control, they should be considered a “speed countermeasure” and used at locations where friction demand exceeds the friction provided by traditional pavements.

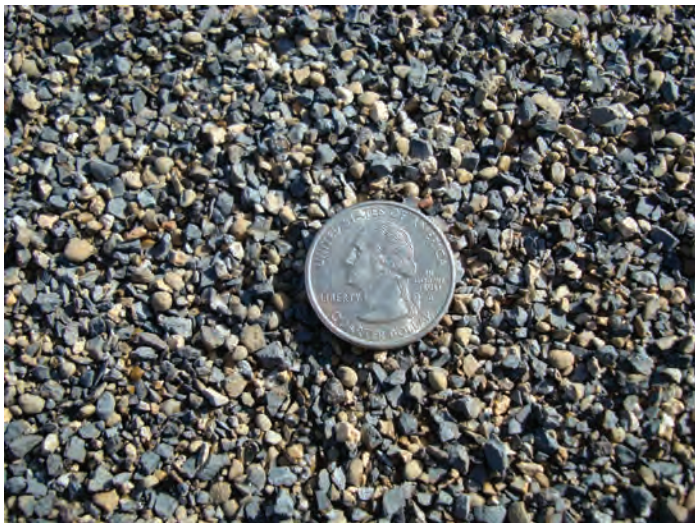
*Calcined bauxite is the most commonly used HFST aggregate (Image: David Merritt)*

Calcined Bauxite – An aggregate derived from aluminum ore that, when heated to a high temperature, increases in physical hardness and stability, resulting in polished stone values in the upper 60s and lower 70s.<sup>21</sup>

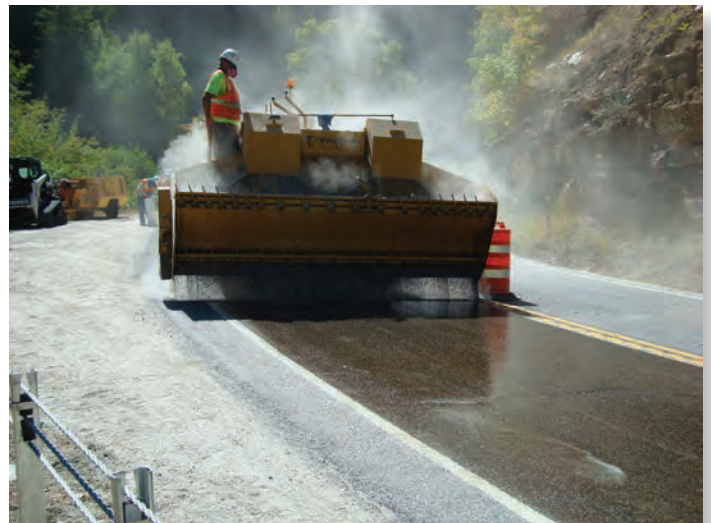
*Mechanical installation of HFST (Image: David Merritt)*

The installation of High Friction Surfaces can be accomplished mechanically or manually. As the technology and application has evolved, the process has become more mechanized and easier to complete. However, for smaller treatment projects (ex. those 100 to 200 feet in length), a manual approach may be more practical. Using this approach, an area of 200 to 300 square yards per hour can be completed.<sup>22</sup>

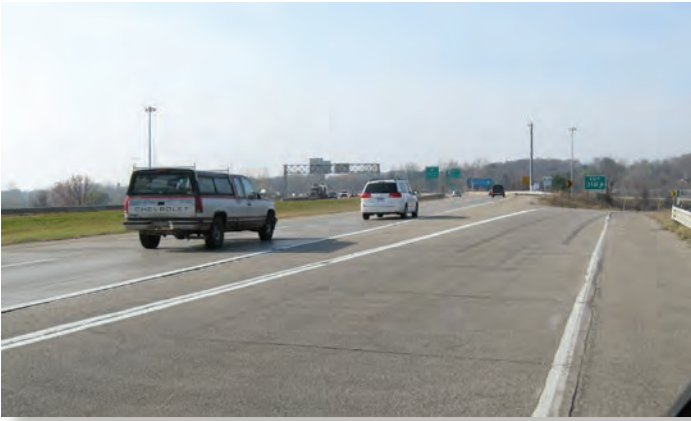
HFSTs can be installed on different surfaces, including jointed pavements when proper masking is used (Image: Michigan DOT)

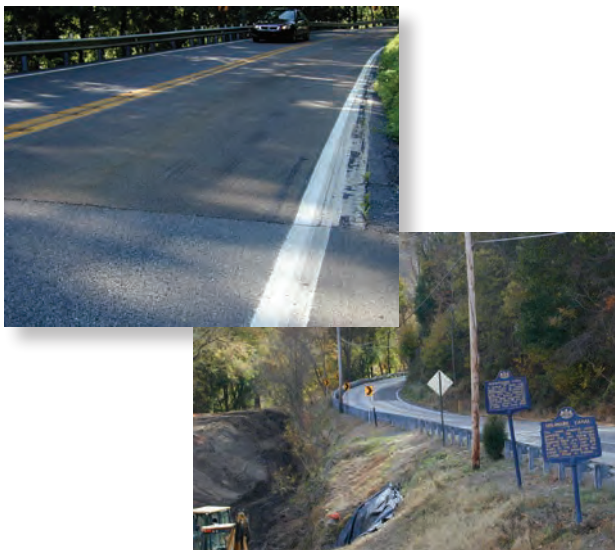
Installation of HFST on SR 611 southbound lane and overall view of the site and its limited right of way (Images: Pennsylvania DOT)

Skid test measurements performed prior to the HFST installation found that the pavement had an average skid number of 24. After the HFST installation, the friction numbers were in the mid-70s. The most recent measurement taken in July of 2010 found an average skid number of 71, illustrating the durability of the calcined bauxite surface over time.

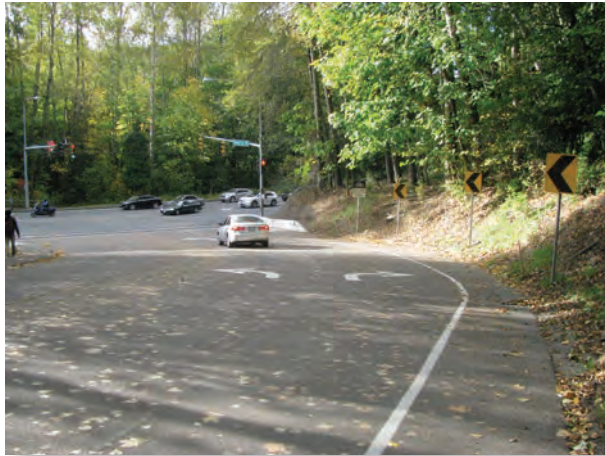
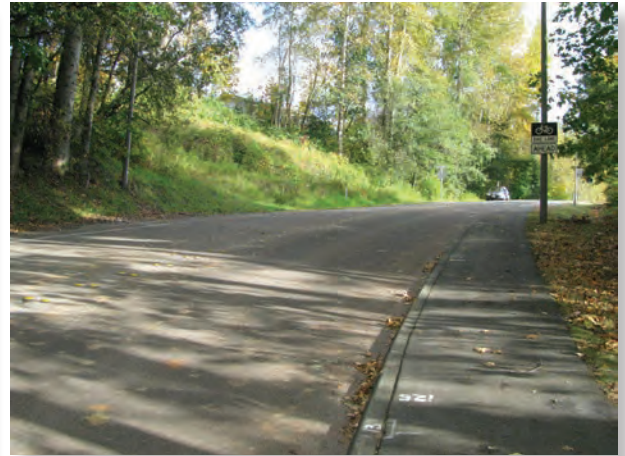
*Installation of HFST on westbound Forest Drive (Images: City of Bellevue, Washington)*

The Forest Drive westbound approach, at its intersection with Cole Creek Parkway, regularly had vehicles sliding down the hill during icy weather. In 2011, the average daily traffic at the approach was 4,941 vehicles. In an effort to combat the problem, a High Friction Surface treatment was applied on this approach in 2004. From 1995 to October of 2004, the City of Bellevue had recorded 2.7 accidents per year that were attributed to grade, skidding, driving too fast for conditions, or run off the road. Subsequent to the installation, the average went down to 0.5 accidents per year. In 2007, due to a surface water problem at the bottom of the hill, the pavement was resurfaced. To determine if the HFST should be reapplied, the City of Bellevue analyzed the effect of it on the crash cost. They found an annual accident cost reduction of about \$25,000 per year to the public. Hence, the City recommended that the HFST be reapplied.

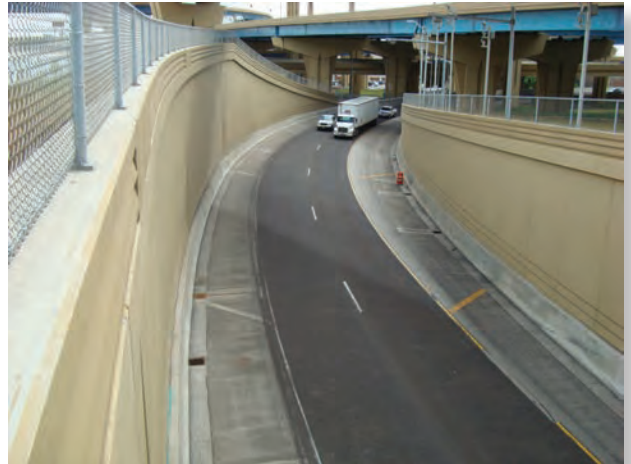
Overview of the Marquette Jct. ramp (Image: Wisconsin DOT)

In 2008, the new Marquette Interchange was completed in Wisconsin. This is a heavily utilized ramp with annual daily traffic of 31,000 vehicles. Part of the design included a ramp connection from I-94 eastbound to I-43 northbound. Unfortunately, during every rain or snow event, vehicles were leaving the traveled way so frequently that the connection was shut down. In just a three-year period, 81 crashes occurred on this ramp. Mike Burns with the Wisconsin Department of Transportation described the walls surrounding the roadway as having “every vehicle paint color you could imagine.” In October 2011, a high surface friction treatment of calcined bauxite was installed. Since this time, only two crashes have occurred. Wisconsin DOT was able to review a video recording of the first crash and observed the vehicle’s wheels drifting into the shoulder area which did not have the High Friction Surface treatment. On a later installation at another site, the HFST was extended out an additional 5 feet onto the shoulder. This was based on experiences from the Marquette Interchange installation, where vehicles were observed to drift onto the untreated shoulder area.

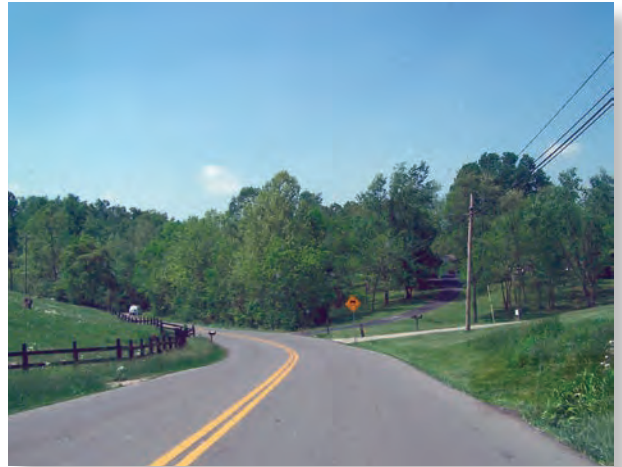
Overview of the KY-21 site at milepost 6.25-6.8  
(Image: Kentucky Transportation Cabinet)

**Installation:** In November 2010, two horizontal curves were located within these mileposts. Prior to the High Friction Surface treatment installation, 10 wet weather crashes and 10 dry weather crashes were recorded at this location over three years. Since the installation, over a period of 1.9 years, five wet-weather crashes and five dry-weather crashes have occurred. Taking into account the relative periods of time before and after, the data suggests a comparable number of 6.67 crashes in the before period and 5.26 crashes in the after period. However, relative traffic volume was not taken into account, and the after-period is short.

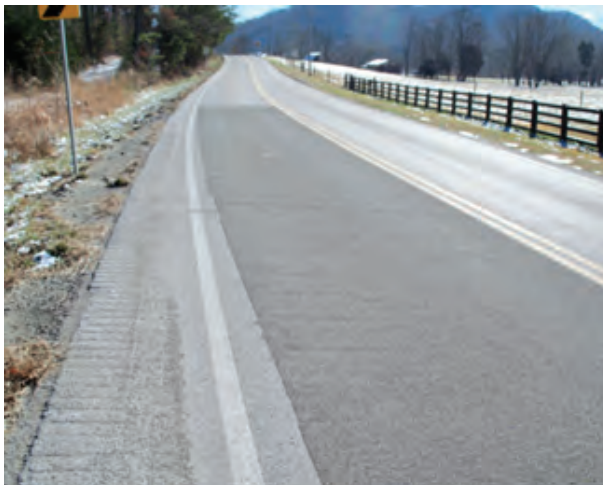
Overview of the KY-21 site at milepost 11.3-13.6  
(Image: Kentucky Transportation Cabinet)

The roadway within this segment was divided into five sections, each containing a horizontal curve. Prior to the High Friction Surface treatment, 57 wet-weather crashes and 16 dry-weather crashes were recorded over a three-year period. After the treatment, nine wet-weather crashes and five dry-weather crashes were observed over 1.5 years. This data suggests a rate of 24.3 crashes per year in the before-period and 9.33 crashes per year in the after-period. Traffic volume was not taken into account, and the after-period is short.

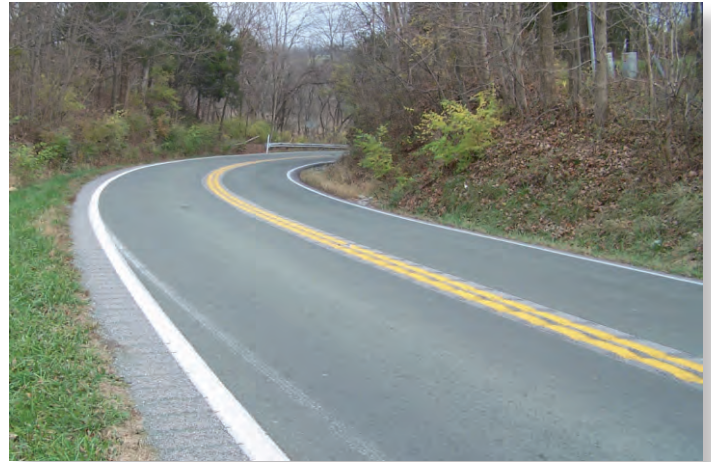
Overview of the KY-22 site at milepost 4.36-4.44 (Image: Kentucky Transportation Cabinet)

One horizontal curve was contained within this section. Prior to the High Friction Surface treatment, 53 wet weather crashes and three dry weather crashes were observed over a three year period. After the treatment, five wet weather and zero dry weather crashes were observed over a period of 3.18 years – a rate of 18.67 average crashes per year before the installation and 1.57 average crashes per year after the installation.

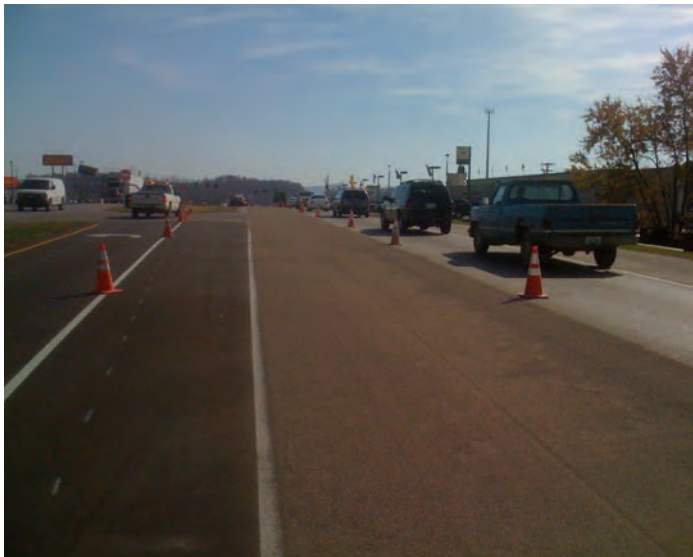
Overview of the US 25 - KY 1629 intersection site (Image: Kentucky Transportation Cabinet)

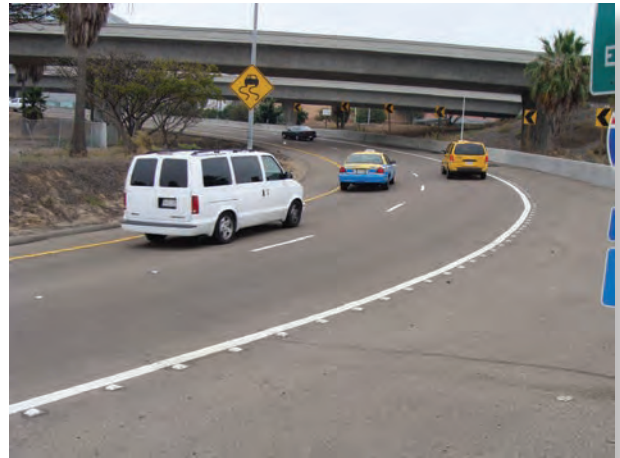
*Sepulveda ramp HFST installation (Image: California Department of Transportation)*

The I-105 Sepulveda Boulevard On-Ramp, a primary egress point from Los Angeles International Airport, was notorious for closures when it rained since based on experience Caltrans had a high expectation that crashes would occur. The average daily traffic on the on-ramp is 31,000. Crashes were occurring as a result of the tight curvature, the low friction, and the aggressive driving of motorists. Caltrans received numerous calls of complaint when this highly-used on-ramp was closed. Collision records showed that 80 percent of the collisions occurred during

wet pavement conditions. As a result, Caltrans applied a High Friction Surface treatment. Since the application, it has not been necessary to close the ramp. The pre-application skid number was 32. The post-application friction value was around 60, but as the installation just occurred recently, post-application crash experience data is not available.

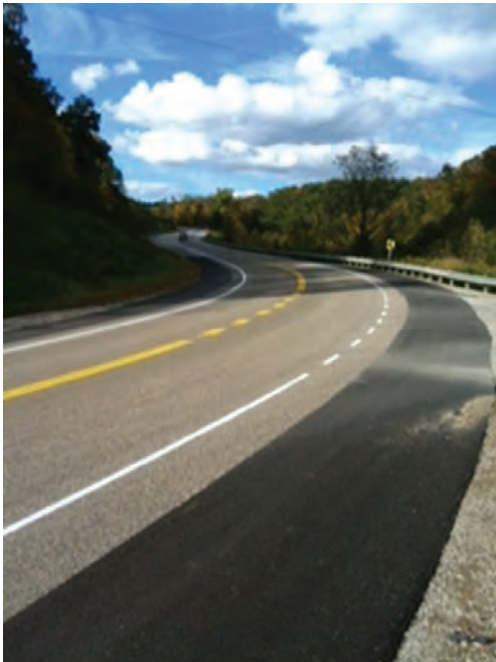
WV14, north of Elizabeth (Image: West Virginia Department of Transportation)

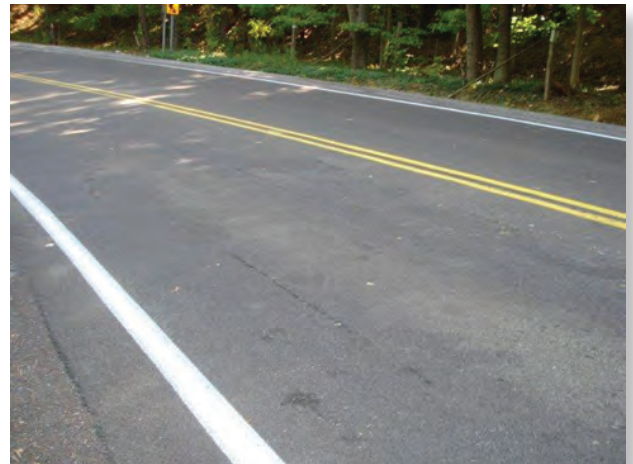
WV20, Between Princeton and Athens (Image: West Virginia Department of Transportation)

A High Friction Surface treatment was installed at milepost 16.42 on WV20, in Mercer County, between Princeton and Athens, West Virginia. It is a two-lane road in southern West Virginia, frequented by commuters. The site is located at a series of horizontal curves. Prior to the application of the High Friction Surface treatment, four run-off-the-road crashes occurred over the course of three years. The West Virginia Department of Transportation is waiting for three years to elapse to analyze the before- and after-accident experience at the site.

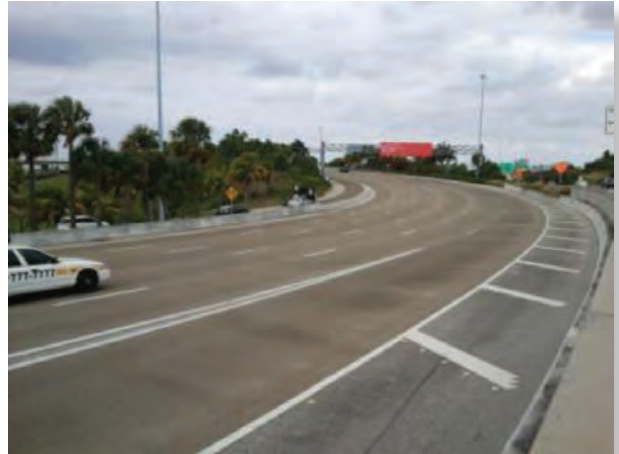
*I-595 ramp to the Ft. Lauderdale airport HFST installation  
(Image: Florida Department of Transportation)*

Both the Royal Palm Blvd. and I-75 northbound ramp location and the I-595 ramp to the Ft. Lauderdale airport location involved sharply curved ramps with increased friction demands. The Royal Palm Blvd. and I-75 ramp has an average daily traffic rate of 14,500, while the I-595 ramp to the airport had an average daily traffic rate of 6,400. The Royal Palm Blvd. and I-75 northbound ramp was installed in 2006 and has performed well. The I-595 - Ft. Lauderdale airport location was installed in 2011 and the airport is pleased with its performance.

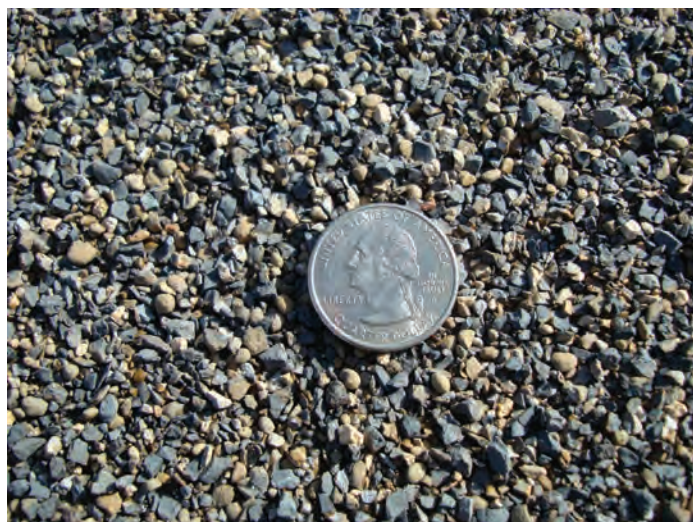
*Calcined bauxite is the most commonly used HFST aggregate (Image: David Merritt)*

Calcined bauxite is the most widely used aggregate in HFSTs. It is derived from aluminum ore that, when heated to a high temperature, increases in physical hardness and stability, resulting in polished stone values from the lower 70s.<sup>21</sup> These characteristics ensure that calcined bauxite will maintain its microtexture and will not polish over time. When correctly bonded with the selected binder, calcined bauxite can withstand a great deal of abuse, including abrasive actions such as snow plowing.

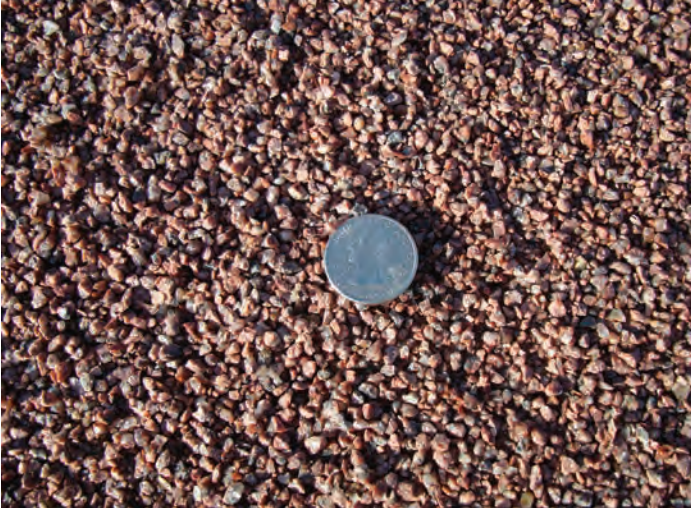
Granite is another commonly used HFST aggregate (Image: David Merritt)

Granite is a combination of quartz and potassium feldspar. Its mineral composition and interlocking crystals result in hardness and abrasion resistance, producing polished stone values greater than 62.<sup>21</sup> These characteristics have led to its use as a High Friction Surface aggregate in past applications.

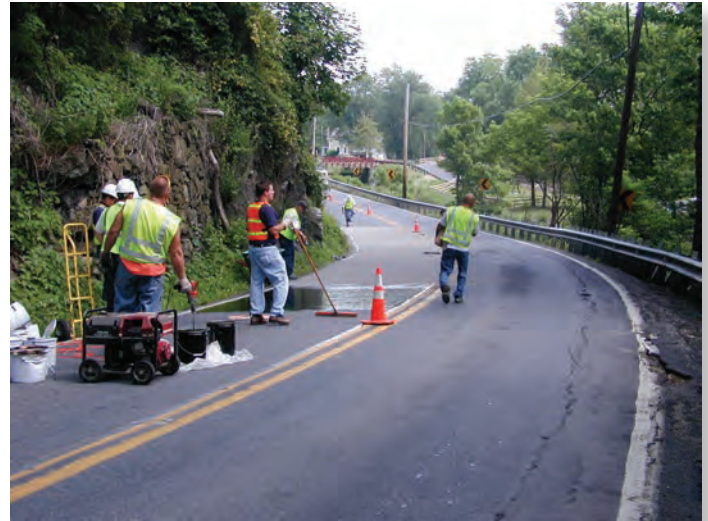
Binder materials can be applied mechanically or by hand, as shown (Image: Pennsylvania DOT)

A number of different binder materials are available for use in HFSTs, and their use is typically determined by factors such as aggregate, climate, and vendor. In general, epoxy-resin is a commonly used binder, although other materials have also been used. Manufacturerssuppliers of the different binder products discussed in the following text can be found on the ATSSA High Friction Surface website at <http://www.highfrictionsurface.net>. Terms used throughout this section of text are defined in the glossary.

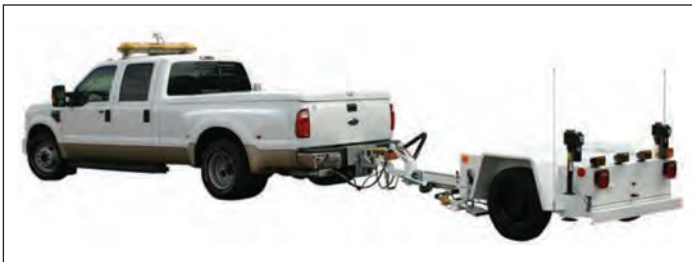
Locked wheel skid trailers are the most commonly used friction measurement device (Image: International Cybernetics)

This device is the one most commonly used for friction measurement in the U.S, particularly for HFSTs. The locked wheel skid trailer is a device that records the steady state friction force of a locked wheel on a wet pavement as the wheel slides along at constant speed, with skid resistance reported as a friction or skid number (typically called a friction number, although the terms are interchangeable).<sup>27</sup> The friction number is reported in a range between zero and 100 (zero being a no friction condition). The measurements can be collected by a vehicle towing the trailer in the travel lane without closing the roadway. It should be noted that skid trailers do not easily measure friction in curves, and alternative approaches to friction measurements may need to be considered depending on the characteristics of a particular site. For more information on this test approach, the reader should consult ASTM Standard E274/E274M-11: *Standard Test Method for Skid Resistance of Paved Surfaces Using a Full-Scale Tire*.<sup>33</sup> Table 1 provides guidance related to friction numbers for normal (not HFST) pavements for reference purposes.

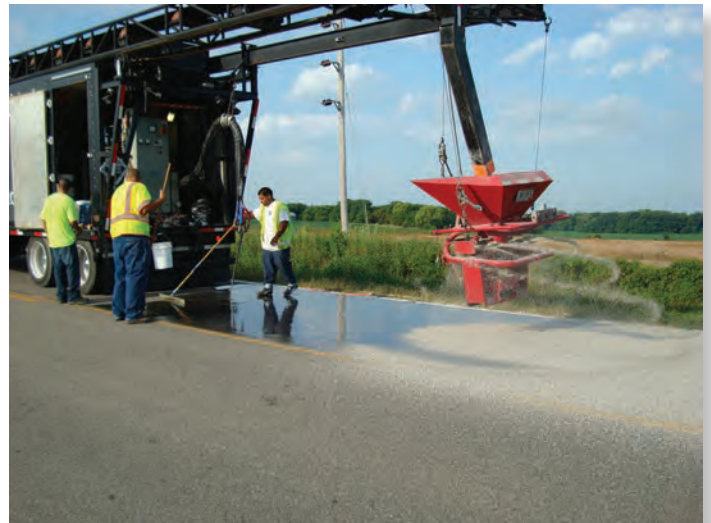
*Different mechanical means can be used to install HFST  
(Image: David Merritt)*
