CONSTRUCTION OF MICHIGAN'S
EXPERIMENTAL TRANSVERSE JOINT PROJECT
I 96 from Meridian Road to Wallace Road
(Projects EBI 33084, C5 and C7; EBI 33085, C1)

Research Laboratory Division
Office of Testing and Research
Research Project R-60 F-58
Research Report No. R-428

Michigan State Highway Department
John C. Mackie, Commissioner
Lansing, January 1964

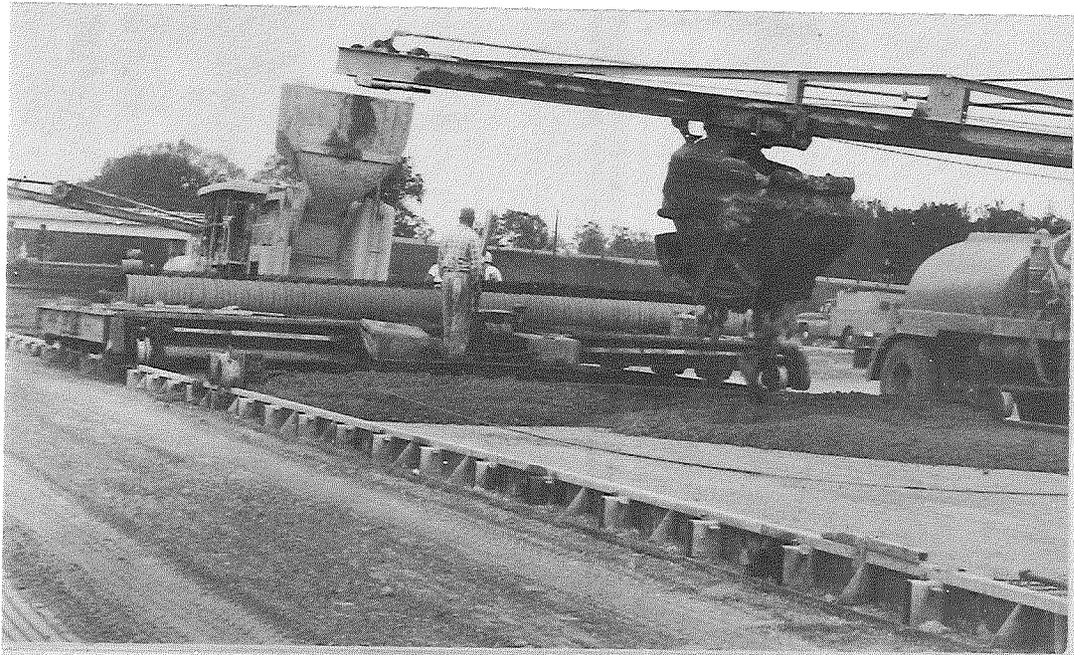
Figure 5. Placing first layer of concrete (upper left).

1. Placing concrete on subbase from first mixer and striking off concrete 3 in. below surface.
2. Placing transverse tie bars.
3. Placing steel reinforcement from carrier.
4. Placing final layer of concrete from second mixer.
5. Spreading and screeding concrete with Jaeger-Lakewood finishing machine.
6. Initial finishing of concrete surface with second Jaeger-Lakewood machine.
7. Final machine finishing of concrete surface with Heltzel Flexplane.
8. Forming transverse joints (installation of fillers or Unitubes).
9. Final hand finishing of concrete surface.
10. Applying burlap drag finish to concrete surface.
11. Applying white membrane curing compound.

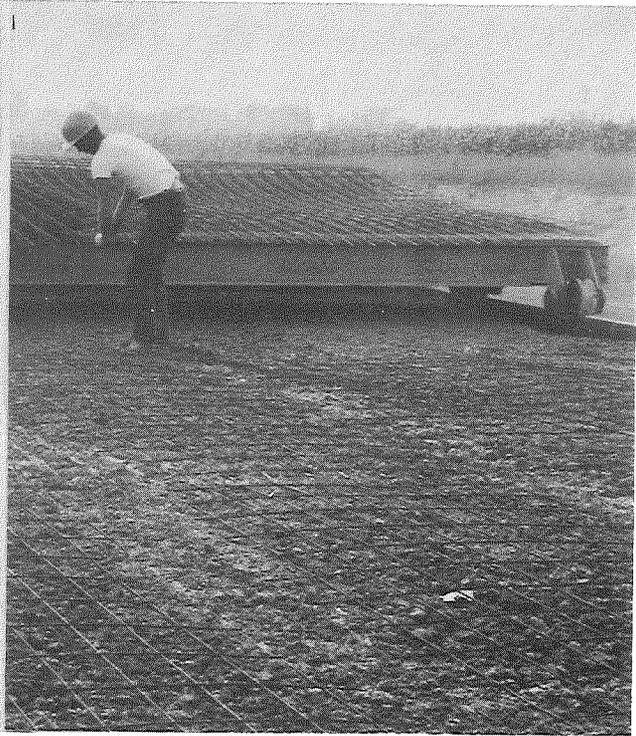
Figure 6. Placing wire mesh reinforcement (upper right).

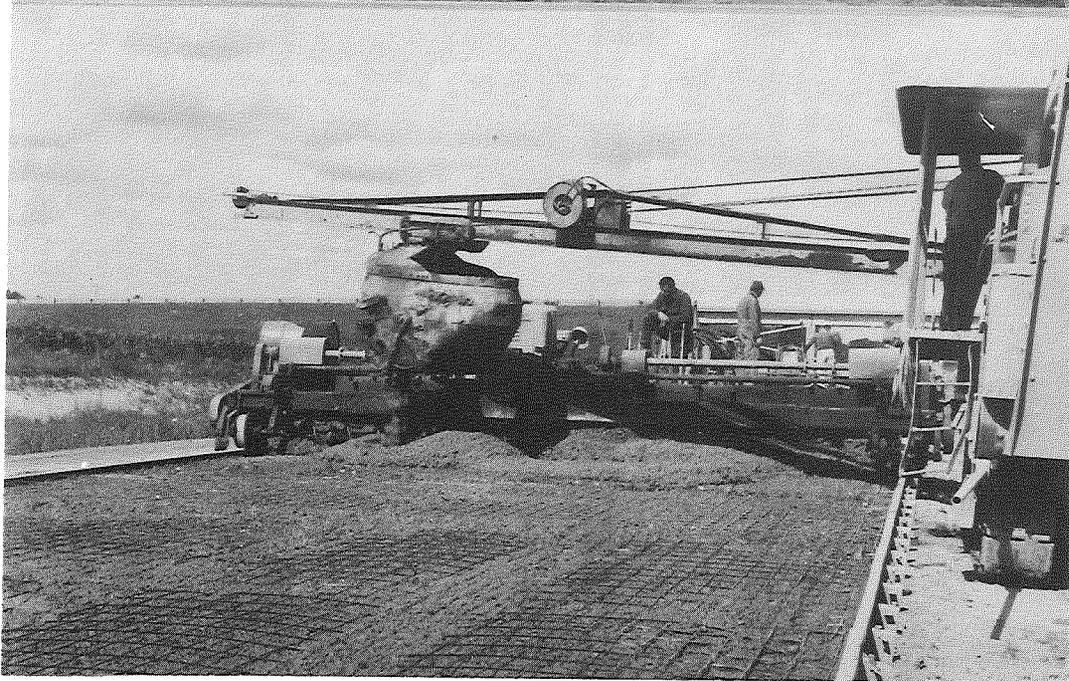
Figure 7. Placing and spreading final layer of concrete with Jaeger-Lakewood finishing machine (lower left).

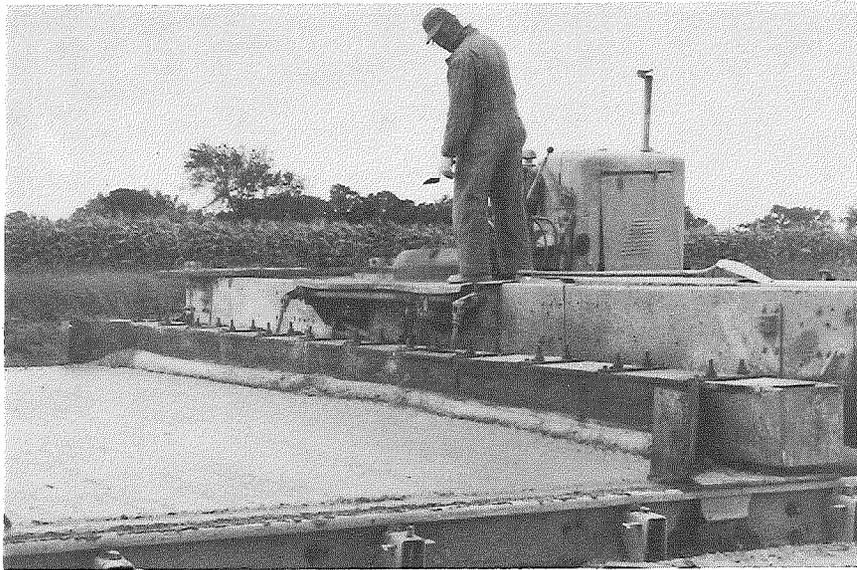
Figure 8. Initial finishing of concrete surface with Jaeger-Lakewood finishing machine.

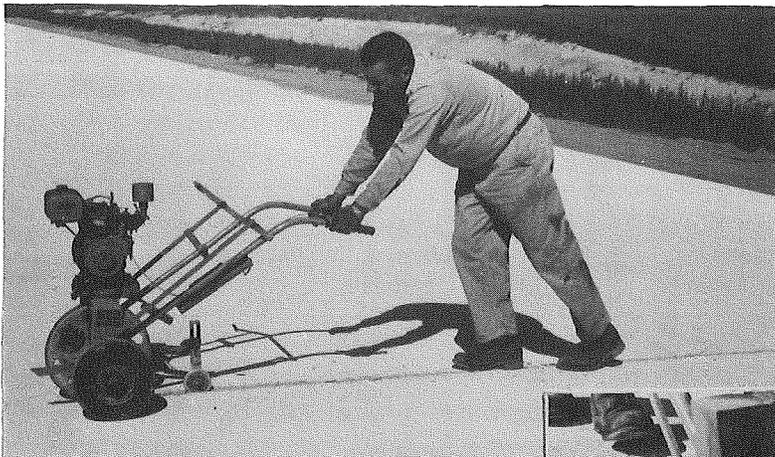
Figure 17. Crimping the Unitube.

After the pavement had cured for seven days, the Unitube was crimped or folded down into itself, exposing from 3/8 to 1/2 in. of joint side wall above the crimped tubing. Fig. 16 shows cross-sectional views of the tube before and after crimping. The crimping machine consists of a circular vibrating disk mounted in a movable frame. Tube crimping consists of lowering the vibrating disk into the tube to the pre-set depth, and then as the machine is pushed forward the tube is crimped. This process is shown in Figs. 17 and 18. The disk penetrates the thin layer of hardened mortar deposited over the tube during final hand finishing operations of the pavement surface, and is deposited along the joint groove as shown in Fig. 19.

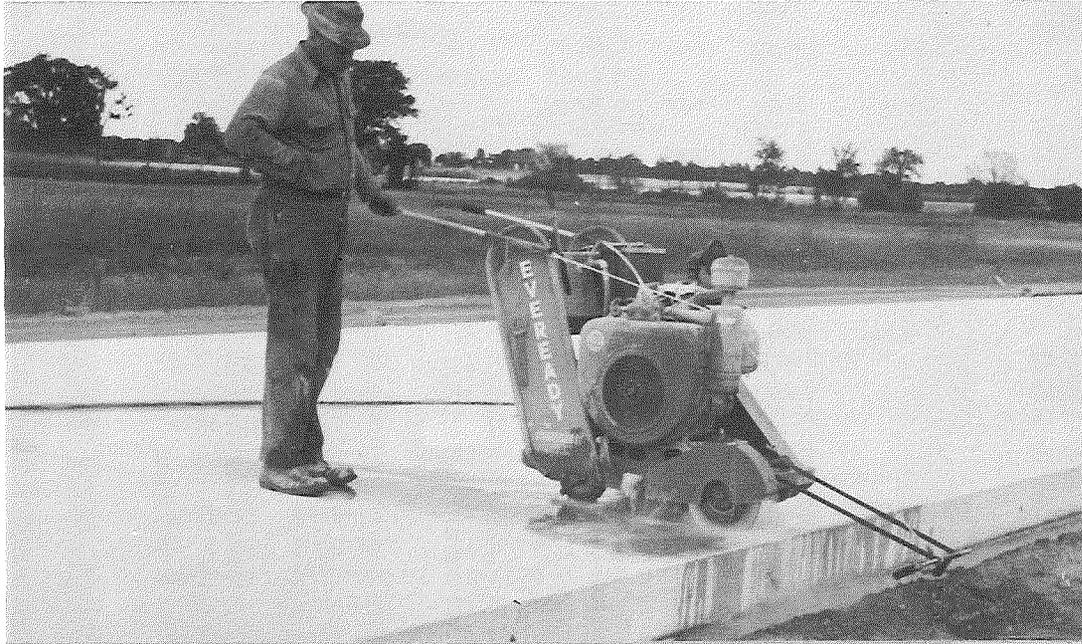
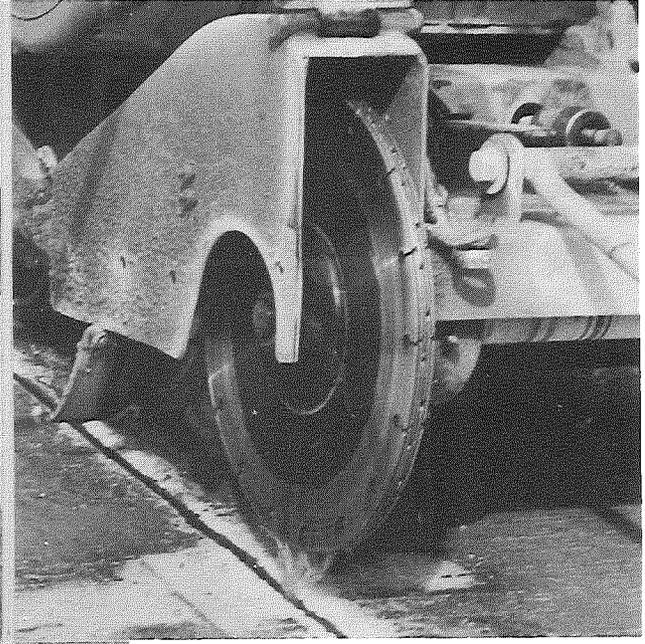
Figure 20. Sawcutting transverse joint grooves with diamond blades is shown above. Typical plane-of-weakness cuts include one at a vibrated joint 6 to 7 hr after pour (lower left), at a vibrated joint 15 to 18 hr after pour (lower center), and at a non-vibrated joint 24 to 25 hr after pour (lower right).

per min was obtained at the 15 joints where the vibration had been omitted. Range in concrete age when the plane-of-weakness was established by sawing in each day's pour, type of blade used, air temperature and average daily weather conditions, are shown in Table 3. Figs. 20 and 21 show the equipment used and typical sawcuts made with both types of blades in concrete at various ages.

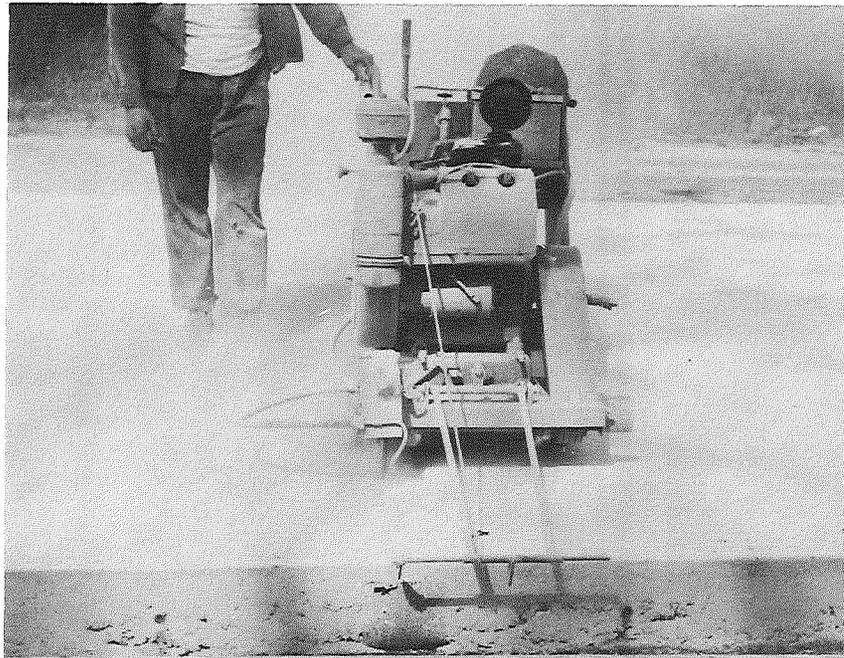
Figure 21. Sawcutting transverse joint grooves with carborundum blades is shown above. Typical plane-of-weakness cuts include one at a vibrated joint 6 to 7 hr after pour (lower left) and one at a vibrated joint 15 to 18 hr after pour (lower right).

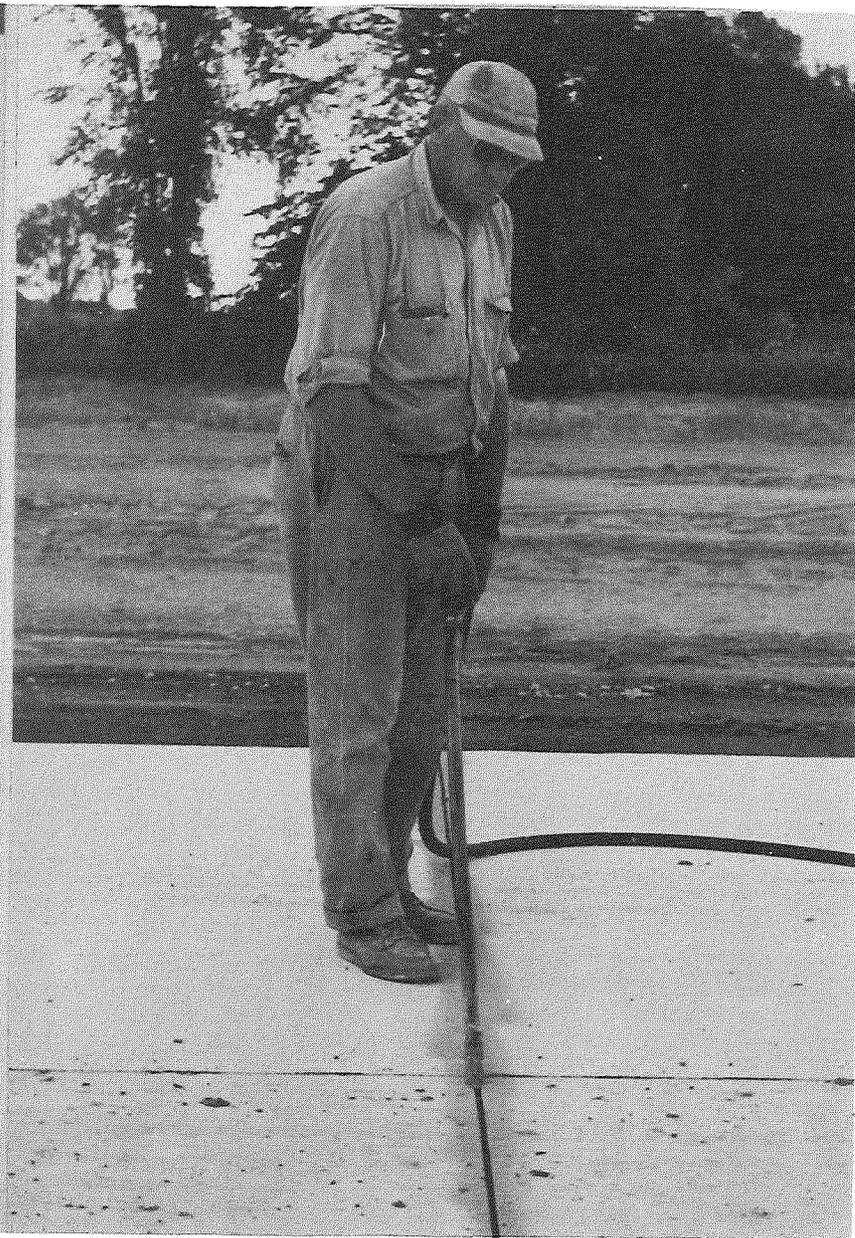
Figure 24. Cleaning joint with compressed air just before sealing.

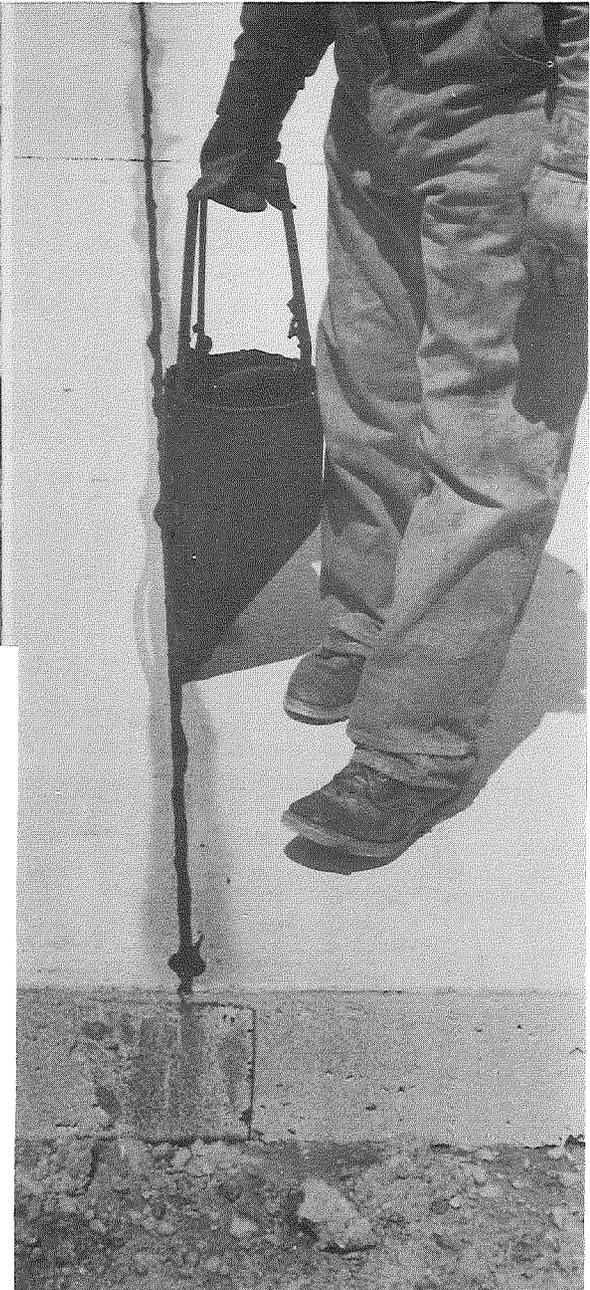
Figure 27. Sealing joint with mechanical pouring pot of the double-boiler type (lower left).
