# PAPER SNOW FENCE INSTALLATIONS 1951-1952

Joint Investigation between Maintenance Division  
and Testing and Research Division

Snow Fence Material Investigation  
Research Project 36 G-3(10)

Research Laboratory  
Testing and Research Division  
Report No. 178  
July 1, 1952

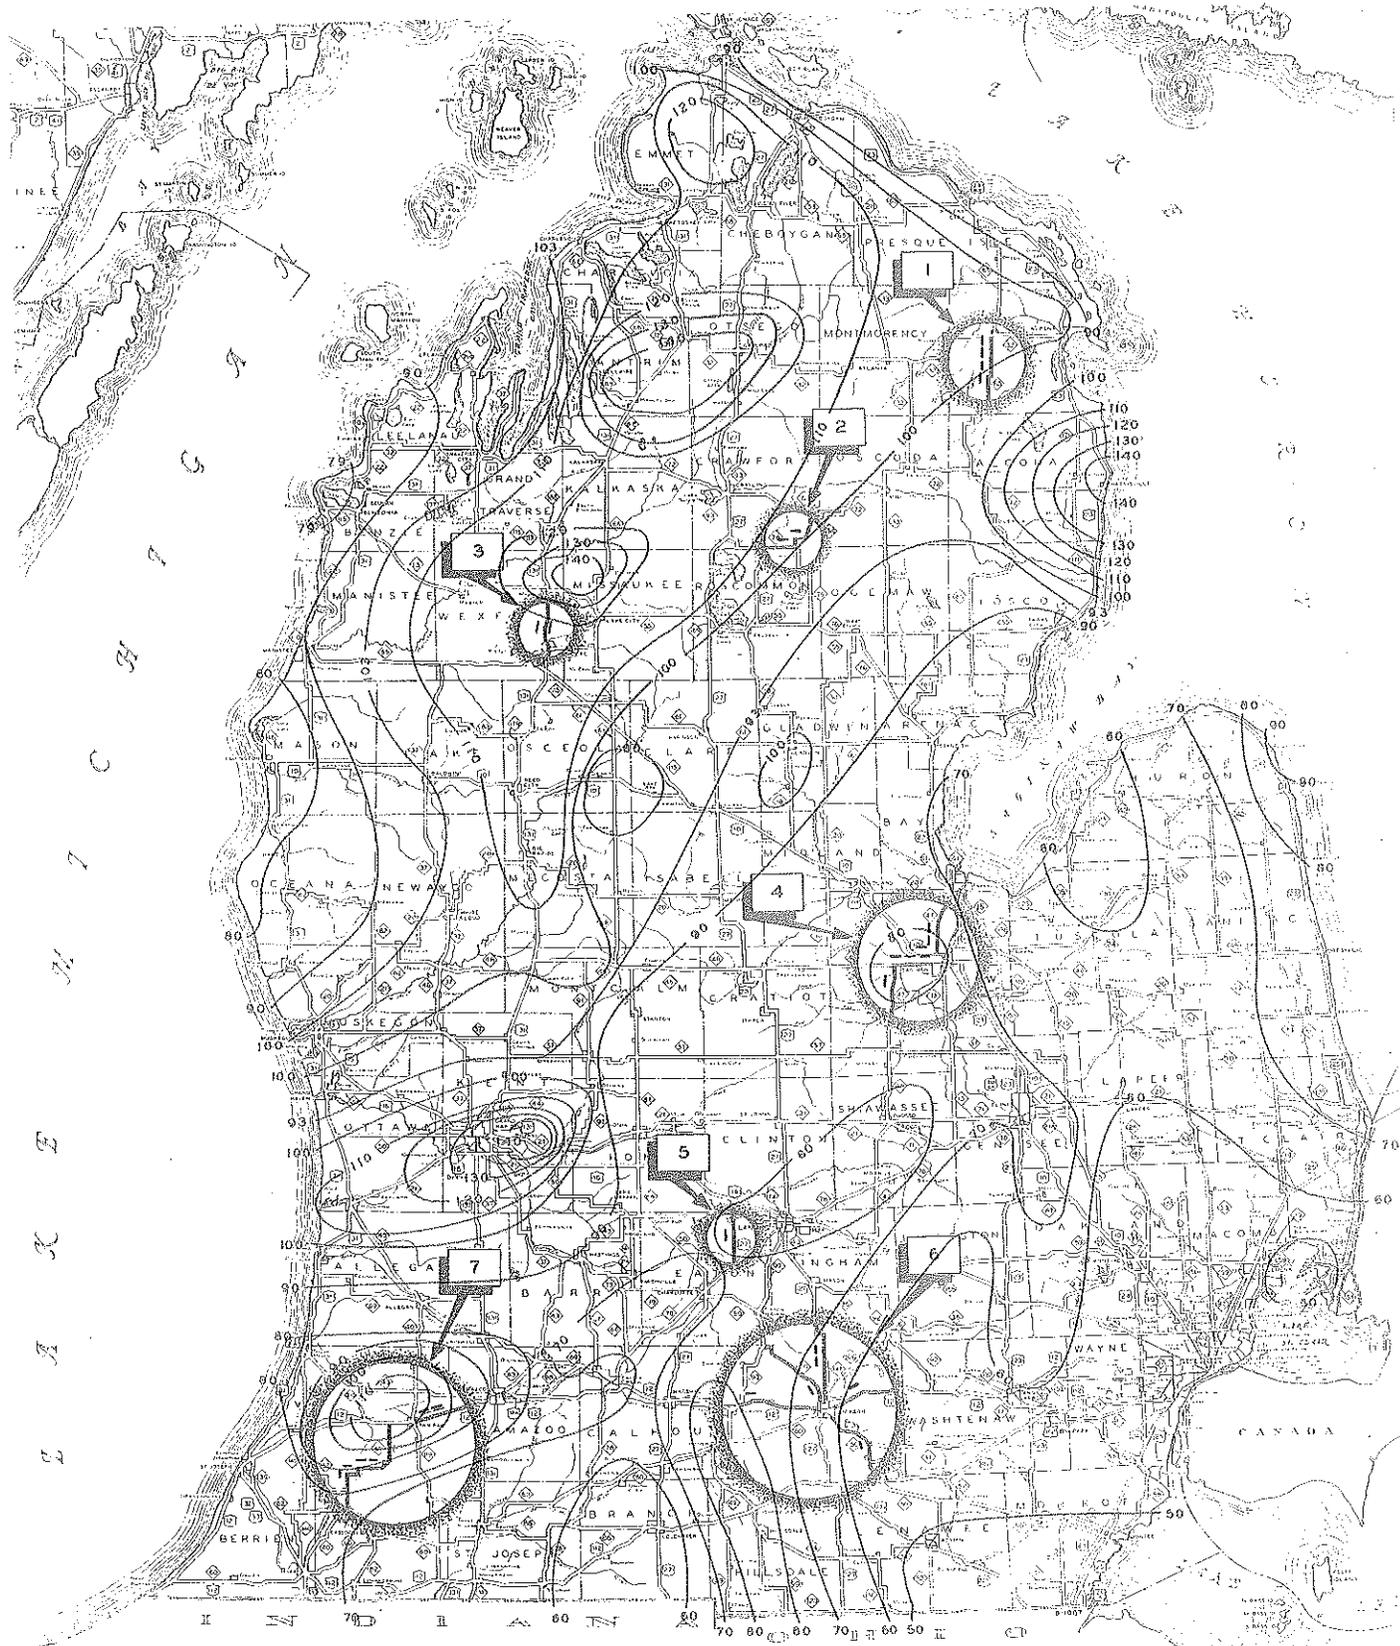
▲ FIGURE 1

— = A SECTION OF FENCE

~80~ = TOTAL SNOWFALL, IN INCHES

MAP SHOWING LOCATION  
OF PAPER SNOW FENCE INSTALLATIONS

Paper snow fence was installed in the counties of (1) Alpena, (2) Crawford, (3) Wexford, (4) Saginaw, (5) Eaton, (6) Jackson, and (7) Van Buren, at the locations shown in Figure 1.

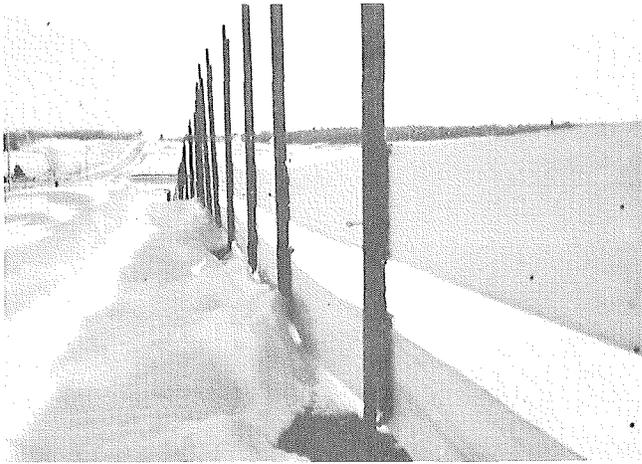
▲ FIGURE 2. ALPENA COUNTY, M-65, 8 MI. SOUTH OF M-32

A field survey in April, 1952, revealed without exception that the paper snow fence installations in all counties came through the winter in fine shape, withstanding bad sleeting, heavy rain, and high winds. Of the five miles of fence, approximately 300 feet was found to be damaged. Any damaged panel could have been readily repaired by replacement with new material. See Figures 2 - 6.

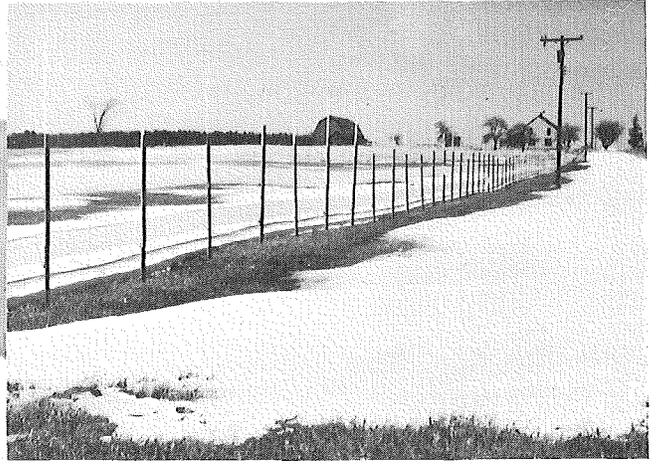
▲ FIGURE 3. ROSCOMMON COUNTY, M-144

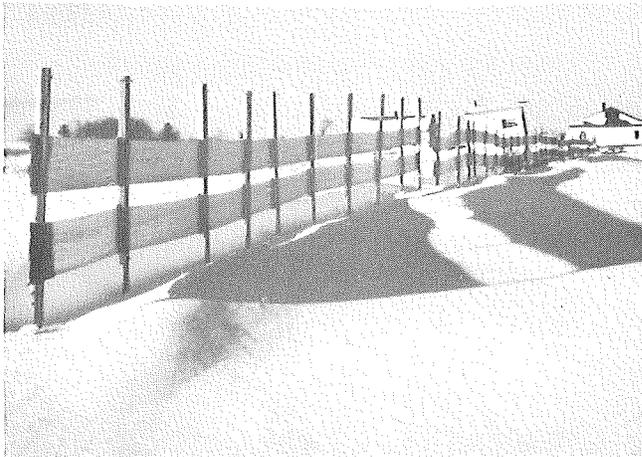
▲ FIGURE 4. WEXFORD COUNTY, US-131

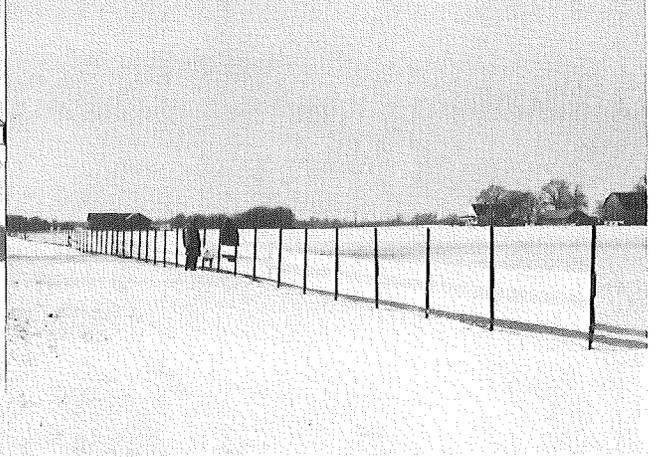
▲ FIGURE 5. SAGINAW COUNTY, M-46

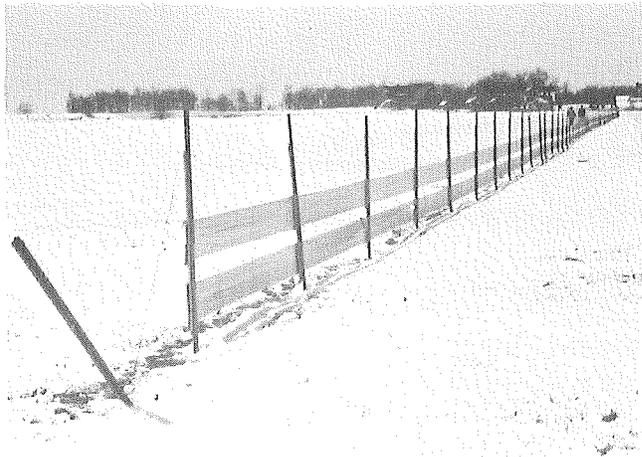
▲ FIGURE 6. JACKSON COUNTY, M-50

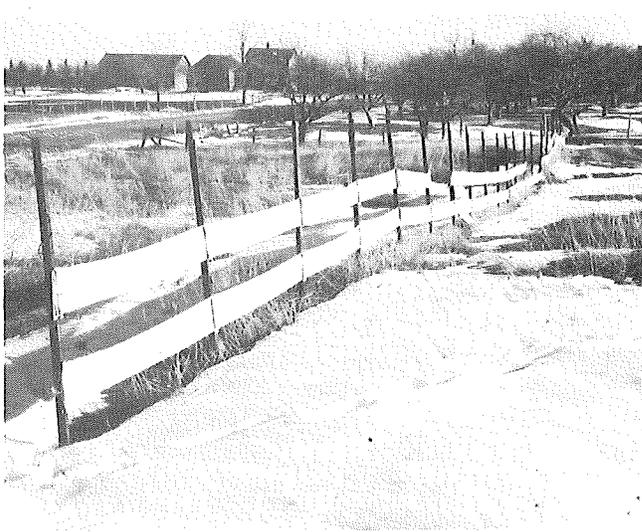
It was determined that the majority of the damage was attributable to loose stock and thoughtless persons, especially school children. It is believed that on future installations this difficulty can be overcome to a large extent by providing a gap in the fence at definite intervals to permit passage through the barrier. Other damage resulted from improper installation and snow. See Figures 7 - 10.

▲ FIGURE 7. DAMAGE CAUSED BY PEOPLE CLIMBING OVER FENCE

Wherever long stretches of fences are required, it is desirable to provide gaps at regular intervals to permit passage of livestock and people through the barrier, thus avoiding possible damage to the fence.

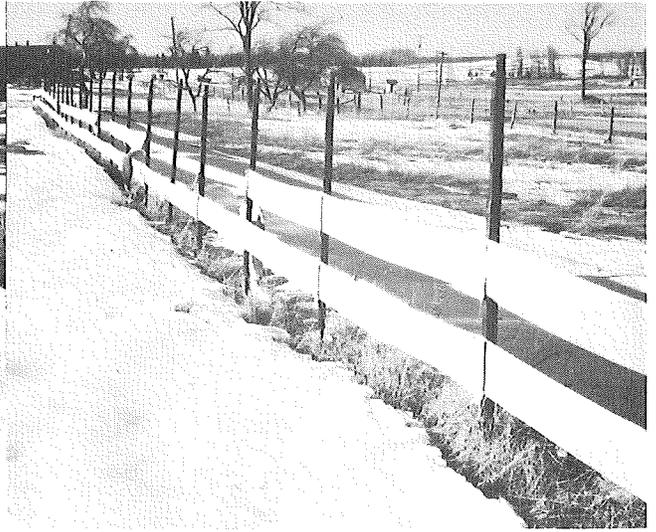
▲ FIGURE 8. DAMAGE CAUSED BY LIVESTOCK

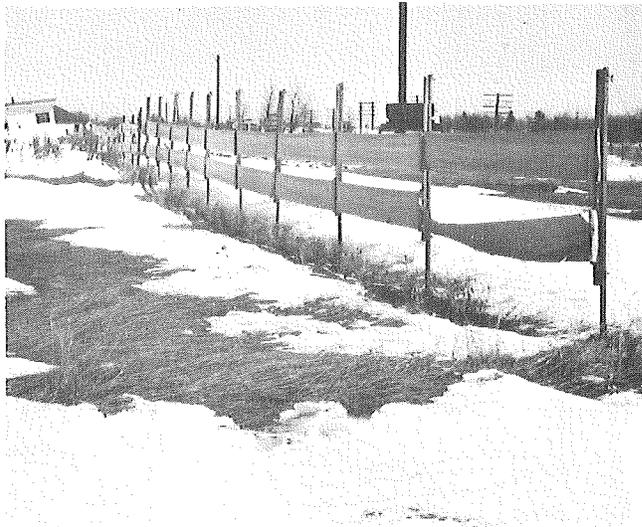
▲ FIGURE 9. DAMAGE OF LOWER STRIP CAUSED BY RECEDING SNOW DRIFT

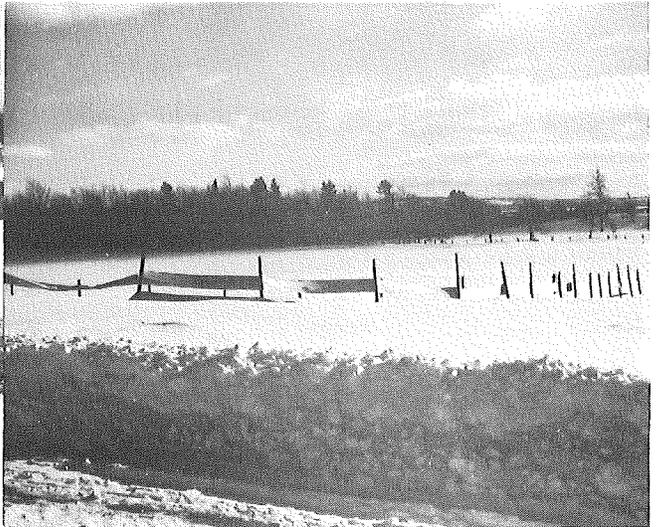
▲ FIGURE 10. CONDITION OF FENCE WHEN IMPROPERLY INSTALLED. IN THIS CASE FENCE POSTS WERE SET TOO FAR APART - 8 FEET WOULD BE THE MAXIMUM SPACING

From experience it has been found that the fence posts must be spaced evenly at distances not greater than eight feet. They must also be firmly placed, and end posts must be anchored to prevent movement.

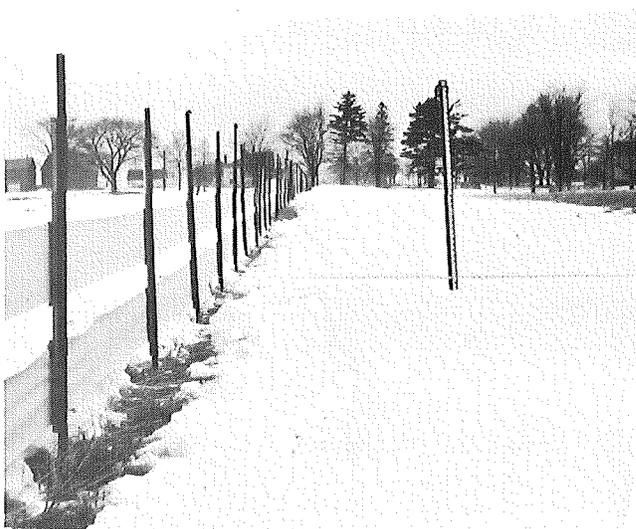
1. Section with two 12-inch strips.
2. Section with three 12-inch strips.
3. Section with one 16-inch strip.
4. Section with two 16-inch strips.
5. Section with one 16-inch strip at bottom and one 12-inch strip at top.

▲ FIGURE 11. TWO 12-INCH STRIPS

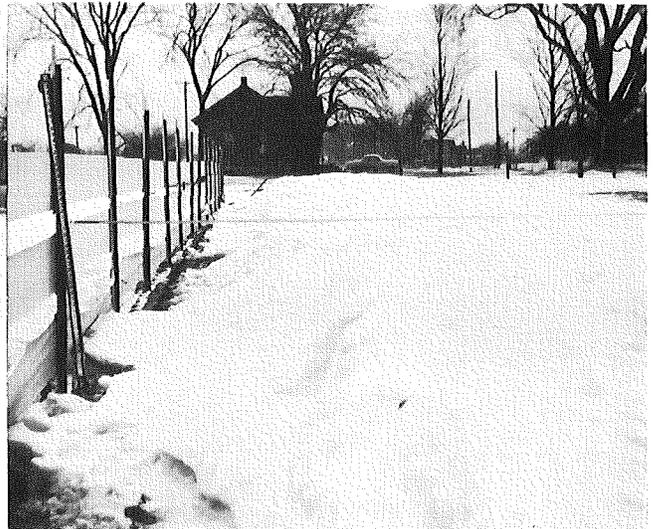
▲ FIGURE 12. THREE 12-INCH STRIPS

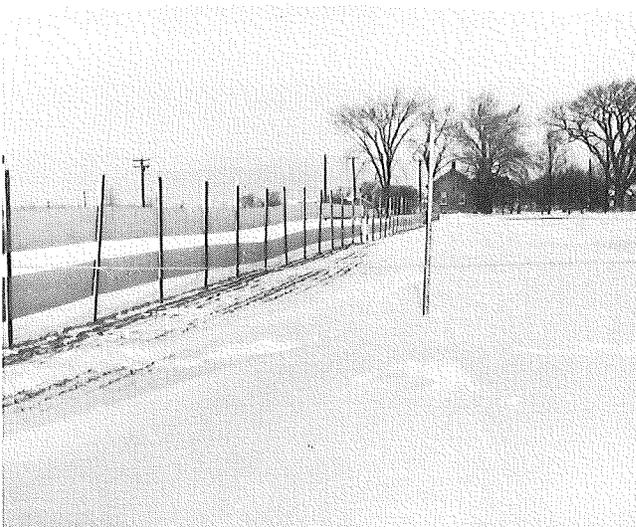
▲ FIGURE 13. TWO 16-INCH STRIPS

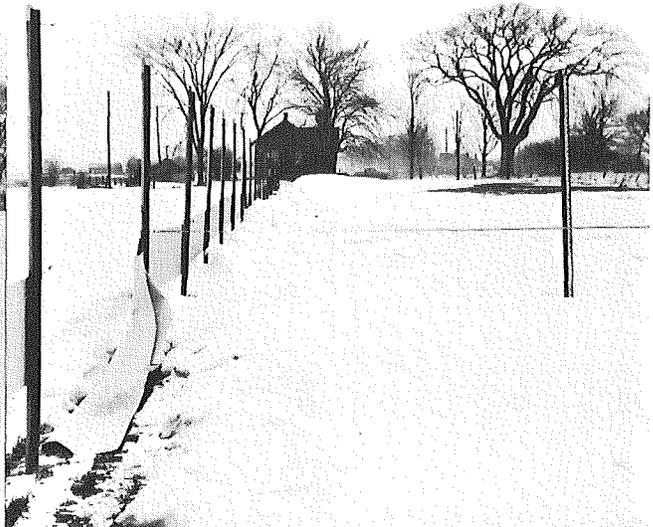
All of these test sections functioned satisfactorily through the winter, with the exception of the one 16-inch strip section, which was covered in one storm. However, the snow melted away right after this storm, and from then on this section continued to function for the balance of the winter. The only damage that occurred to the various sections was caused by school children playing and breaking one panel out of a section, but this damage was easily repaired by stapling a section of paper between posts.

▲ FIGURE 14. ONE 16-INCH STRIP - DAMAGE BY SCHOOL CHILDREN

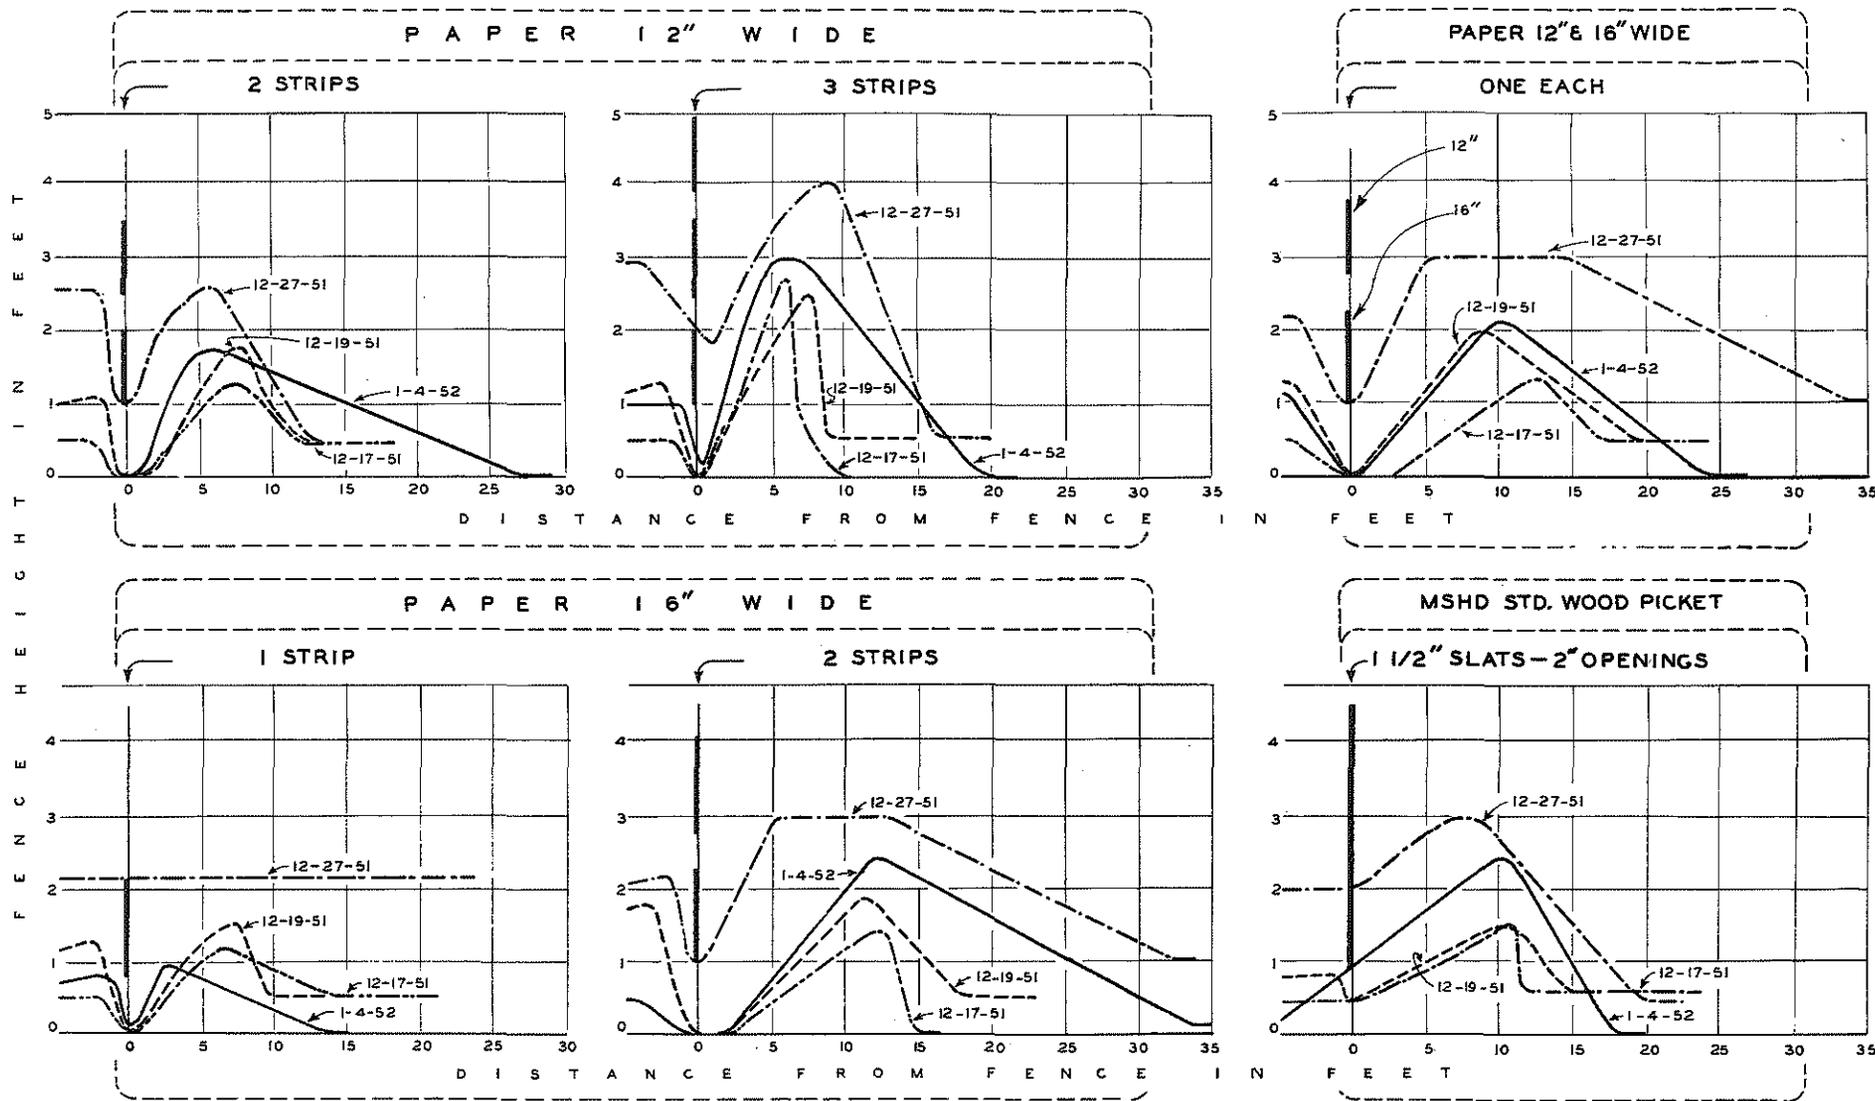
FIGURE 15

The effectiveness of the various paper snow fence sections has been presented graphically in Figure 15. Their performance may be compared with that of a regular vertical slat wooden snow fence erected in the same installation.

CURVES SHOWING DRIFTING CHARACTERISTICS OF PAPER AND WOOD SNOW FENCE INSTALLATIONS  
EXPERIMENTAL SECTION-M 100

CURVES REPRESENTING CHARACTERISTICS OF SNOW DEPOSITION ON DATE SHOWN

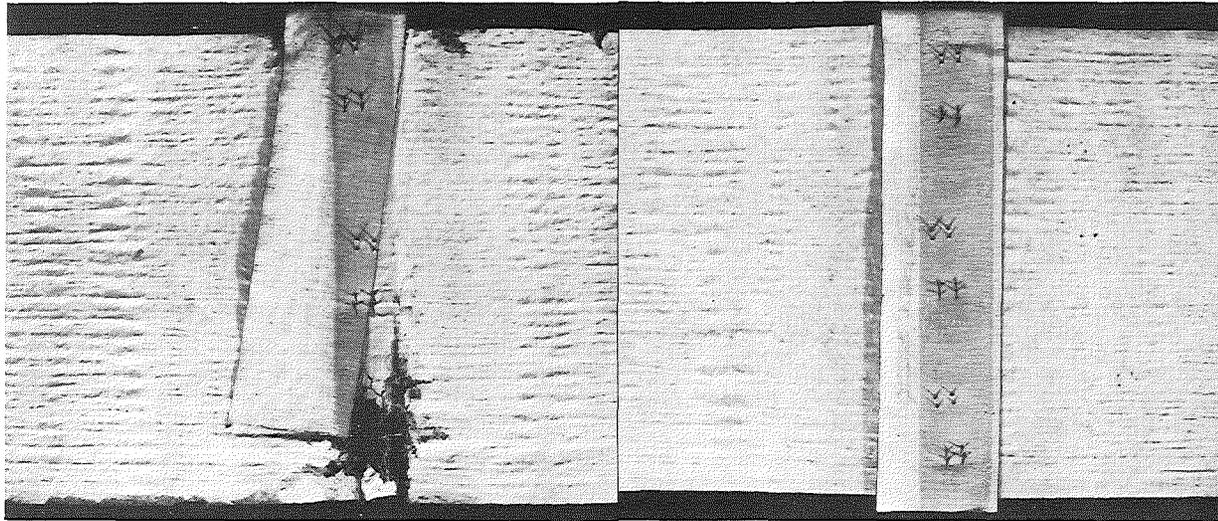
▲ FIGURE 16. POOR INSTALLATION OF CUSHION STRIP—NOTE TEARING OF PAPER STRIP

Paper cushion strips are necessary to make the fence perform satisfactorily. They must be of the proper length and width and installed properly. See Figures 16 and 17.

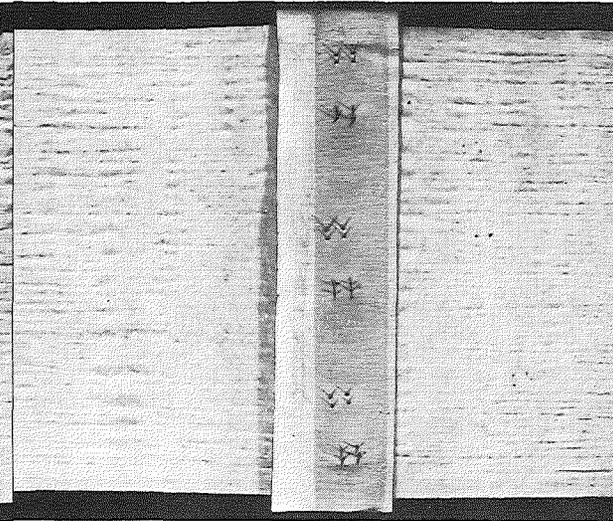
▲ FIGURE 17. PROPER INSTALLATION OF CUSHION STRIP

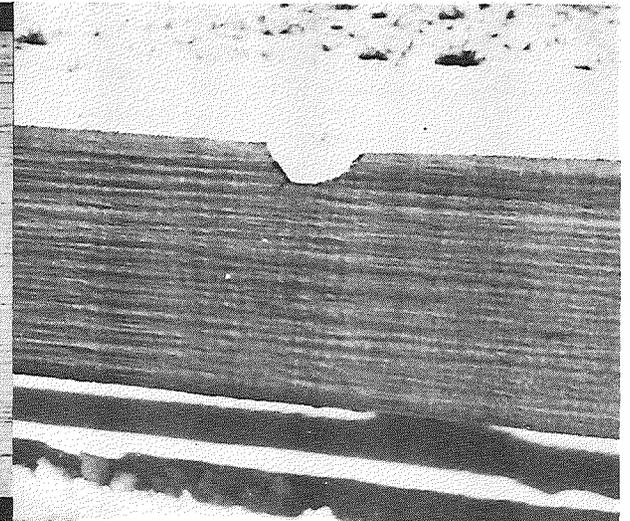
▲ FIGURE 18. SHOWING METHOD OF CONTROLLING TEAR IN PAPER STRIP

Breaks in the paper panels may be easily repaired by simply stapling another strip of paper in place. Small tears in the paper may be controlled by taking a knife and cutting around the tear, as shown in Figure 18.

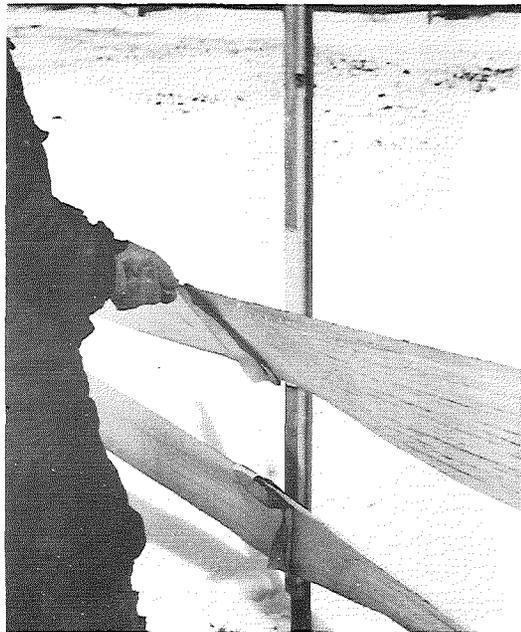
◀ FIGURE 19. METHOD OF STRIPPING PAPER FROM POSTS

If the fence has been properly installed, it will be possible to take it down and salvage a large part of the paper for future use. In this case the cushion material should extend slightly beyond the paper strip, so that it is possible to catch the ends with a large wide-jawed pliers. It is then a simple matter to pull the paper strip off of the post and roll it up with the cushion strip and staples intact. See Figure 19.

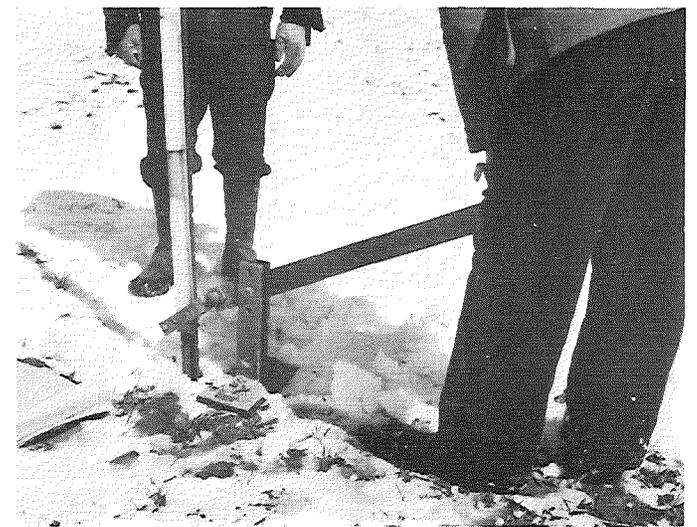
▶ FIGURE 20. METHOD OF PULLING FENCE POSTS WITH WOODEN NAILING STRIPS IN PLACE

It is possible to pull the posts with nailing strips attached, when the strips do not extend to the ground. See Figure 20.
