***COMPARISON OF METHODS USED
TO PRODUCE HOT-DIPPED
GALVANIZED W-BEAM GUARDRAIL***

**Comparison of Methods Used to Produce
Hot-Dipped Galvanized W-Beam Guardrail**

**Research Laboratory Section
Construction and Technology Division
Research Project 97 TI-1831
Research Report No. R-1357**

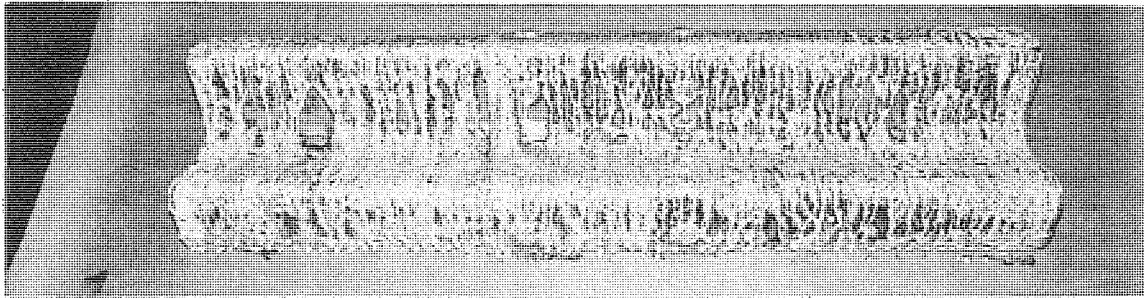
Figure 4 Samples after 1000 hours

A) Sample 3B-4A post-galvanized

B) Sample 1A-2B pre-galvanized

C) Sample 3A-4B post-galvanized

D) Sample 1B-2A pre-galvanized

The samples after 1000 hours are shown in Figure 4. Figure 5 shows the samples at 2000 hours, and Figure 6 shows the samples after 3000 hours. The 4000 hour specimen results are shown in Figure 7 and the 5000 hours results are shown in Figure 8. Figure 9 shows a closeup view of the splice nuts of all four samples after 5000 hours in the salt fog tank. There were no visual differences between the manufacturing methods of the guardrail as shown in Figures 4-9.

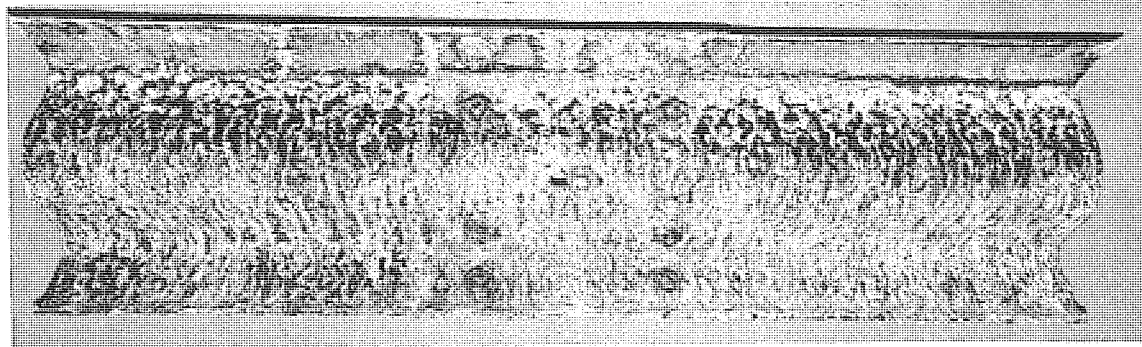
Figure 7 Samples after 4000 hours

A) Sample 3B-4A post-galvanized

B) Sample 1A-2B pre-galvanized

C) Sample 3A-4B post-galvanized

D) Sample 1B-2A pre-galvanized
