R-381R

MICHIGAN
STATE HIGHWAY DEPARTMENT
JOHN C. MACKIE, COMMISSIONER

Subject: Evaluation of Armor Speed Finish and Gun-Tex as Protective Coatings for Concrete Structures. Research Projects R-58 B-45, R-59 NM-10. Report No. R-381 R.

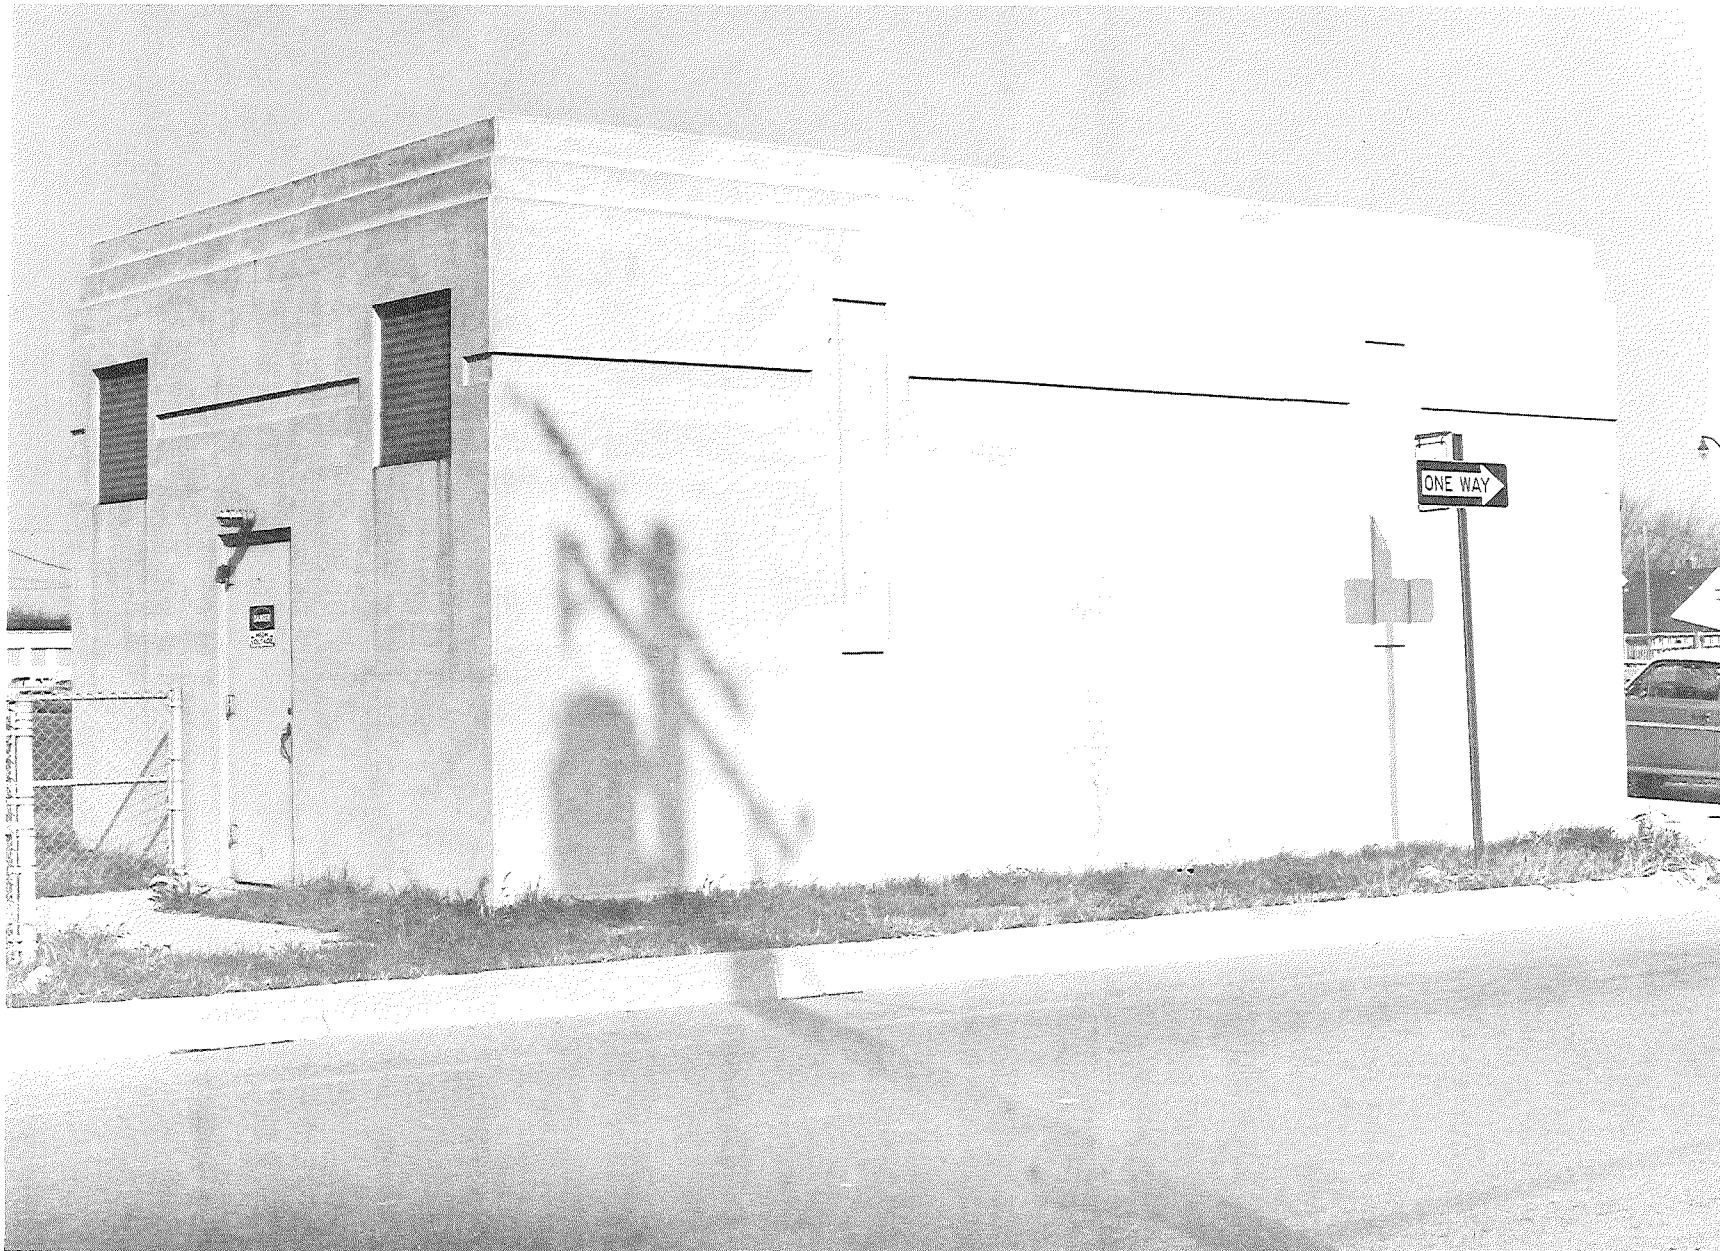
Figure 1. Regulator house with surface finished by hand rubbing, at the Edsel Ford Expressway and Cadieux Ave., Detroit (photo: 11-6-62).

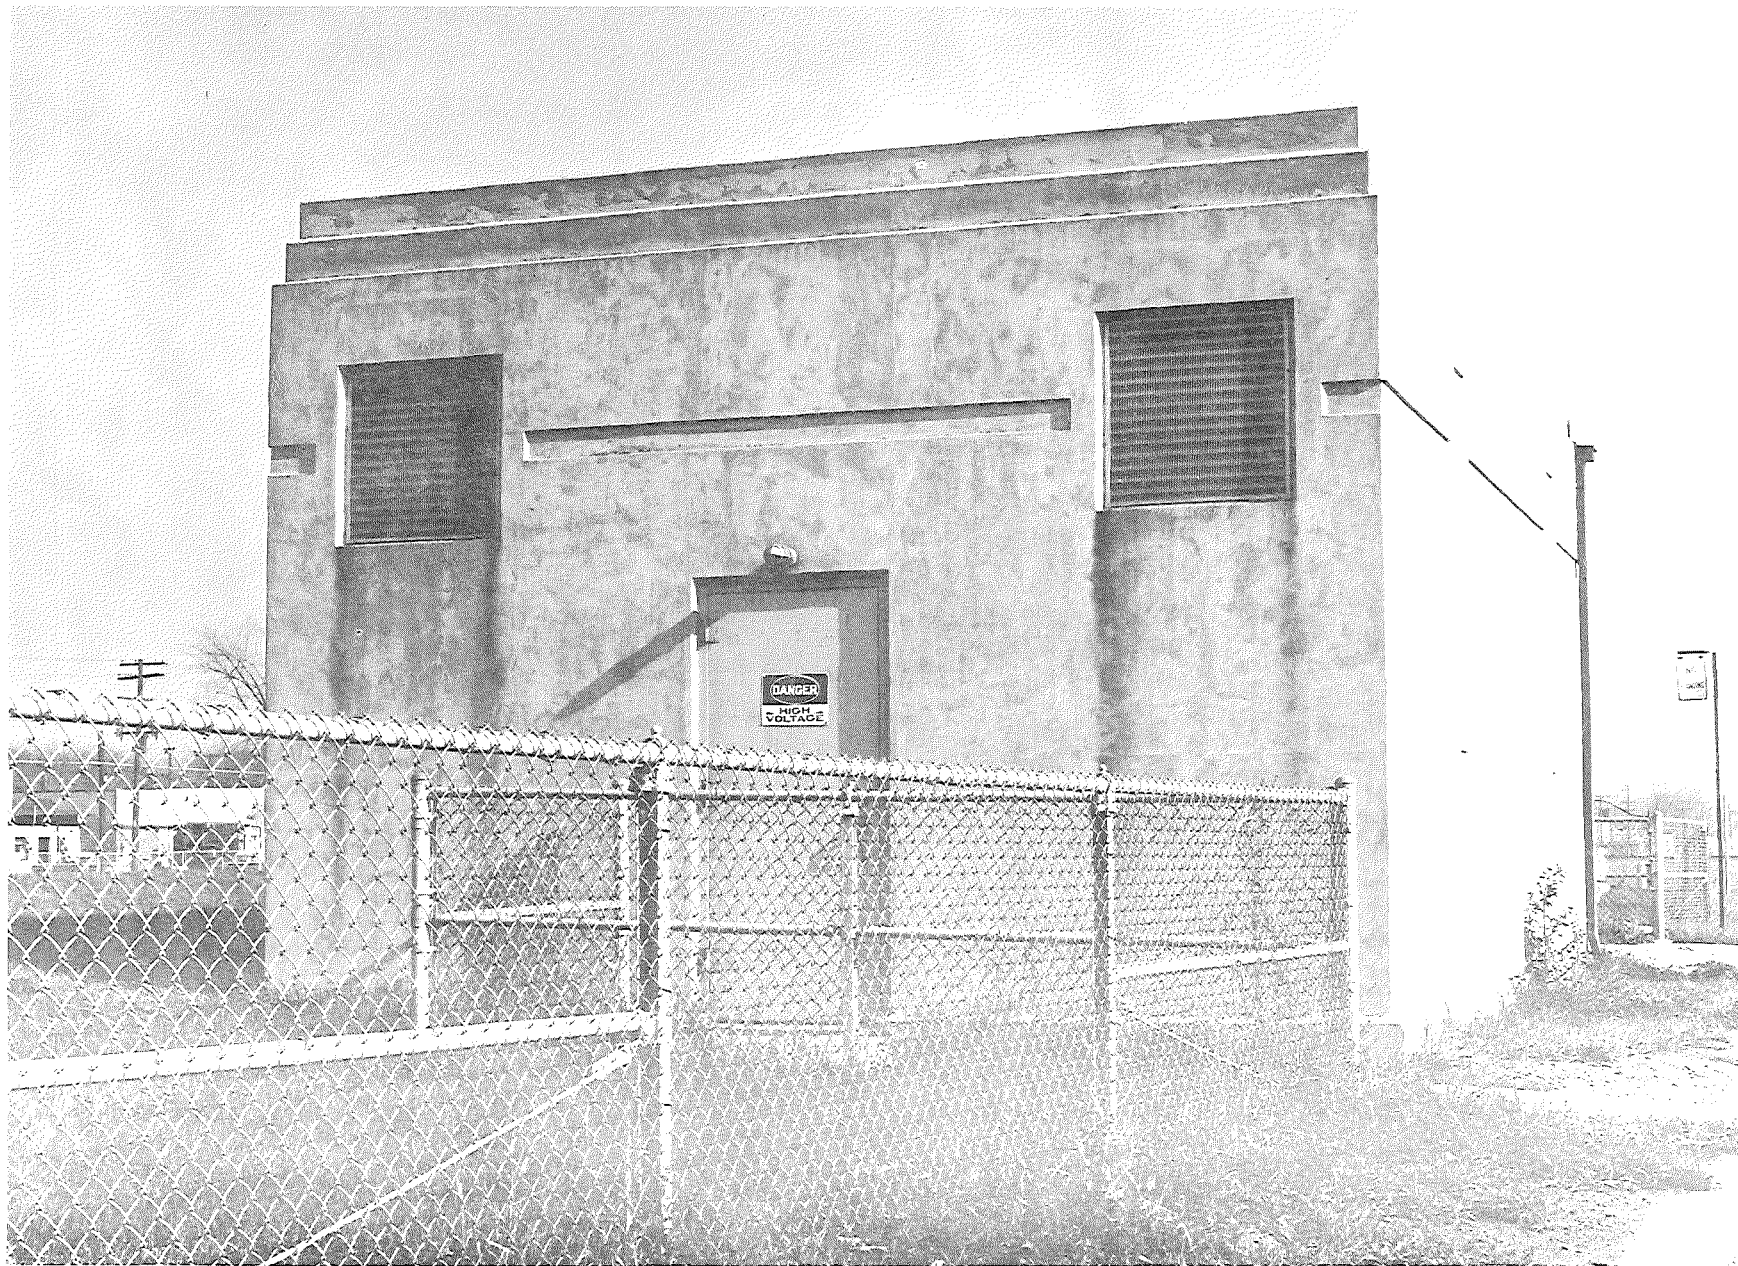
Figure 2. Regulator house finished with Armor Speed Finish, at the Edsel Ford Expressway and Outer Drive, Detroit (photo: 11-6-62).

The regulator house treated with Armor Speed Finish has a mottled and unprepossessing appearance. After three years the durability of the concrete, while satisfactory, appeared no better than that of a similar hand rubbed structure. DeClerk Industries informed the Laboratory on April 4, 1962, that the application had been improper--that the first coat had been allowed to dry out too much before application of the second. Applications on the Belle Isle bridge show no advantage whatever from the treatment.

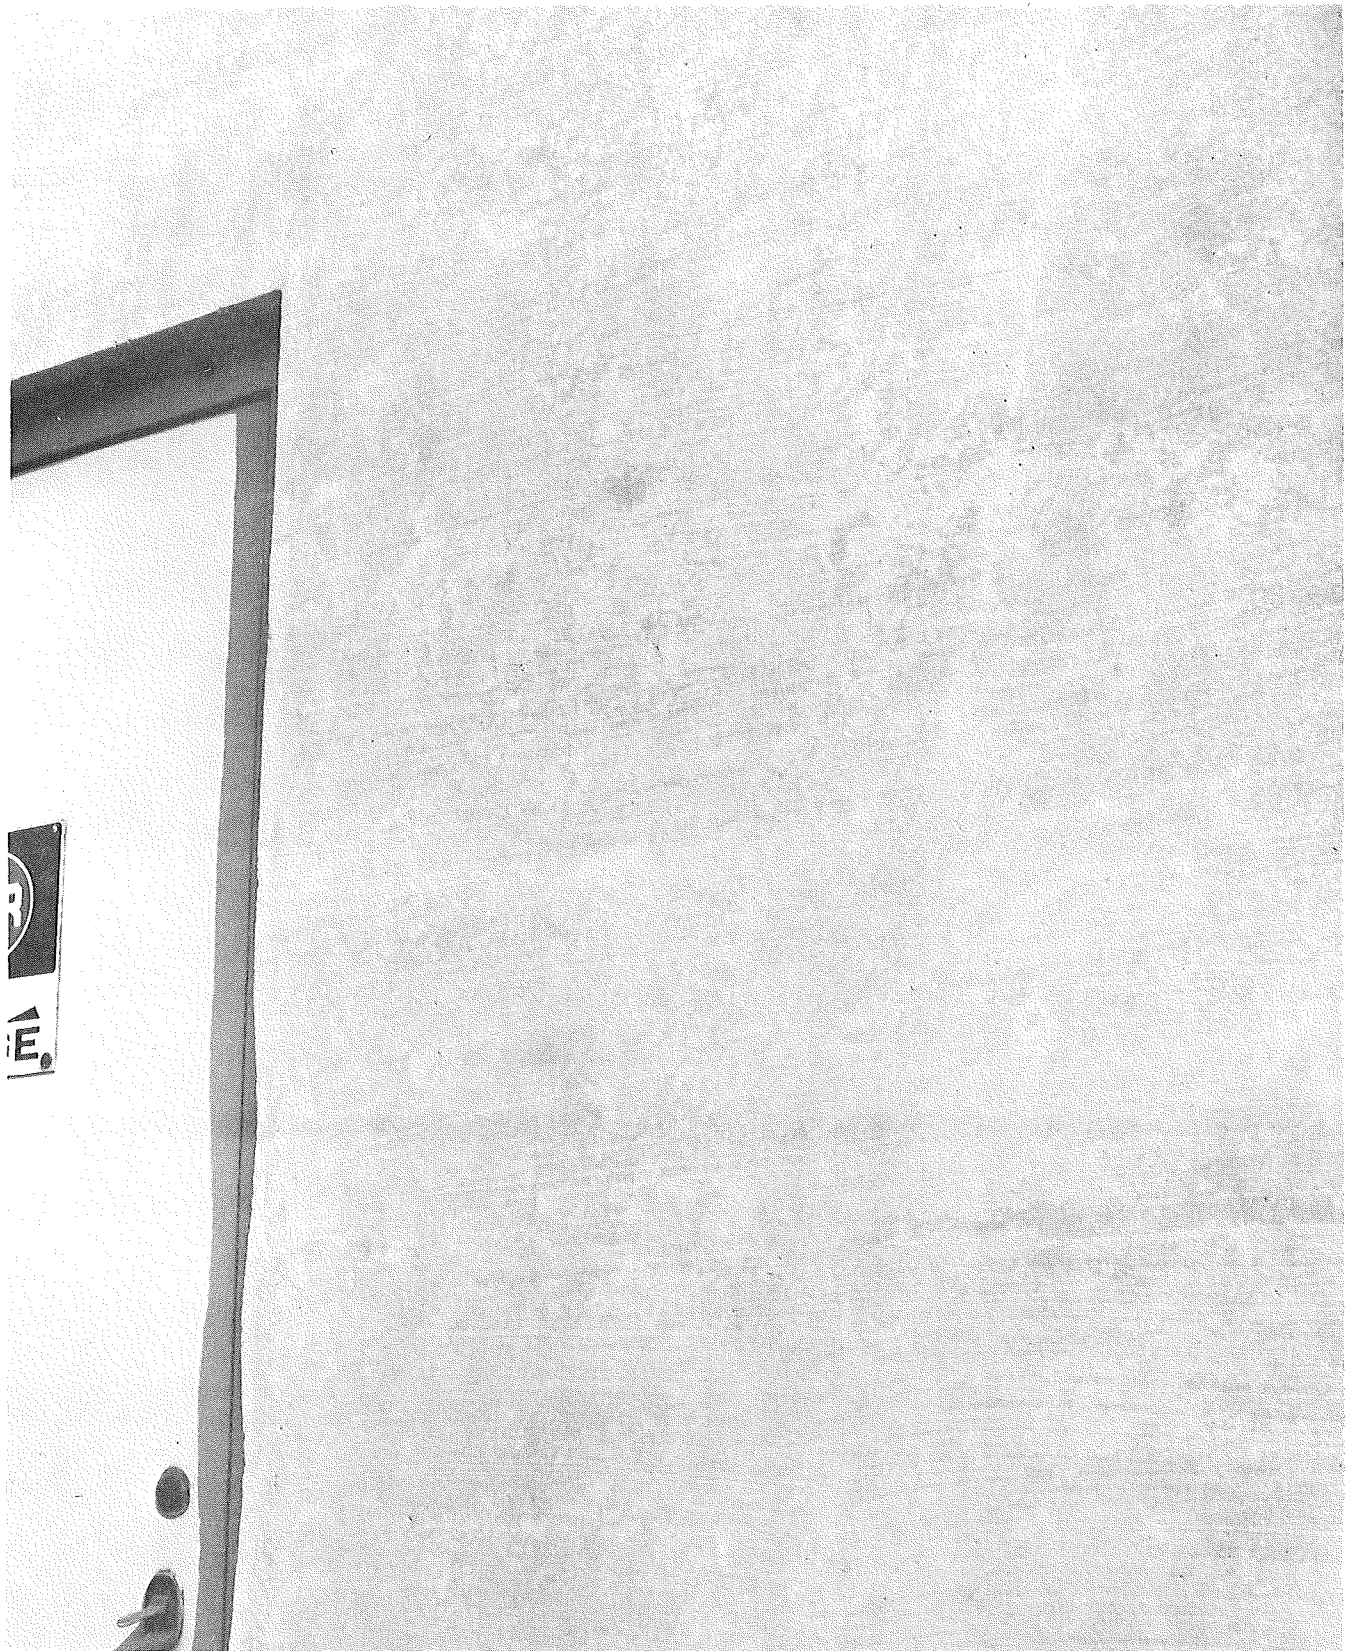
Figure 3. Hand-rubbed finish on Cadieux Ave. regulator house (photo: 11-6-62).

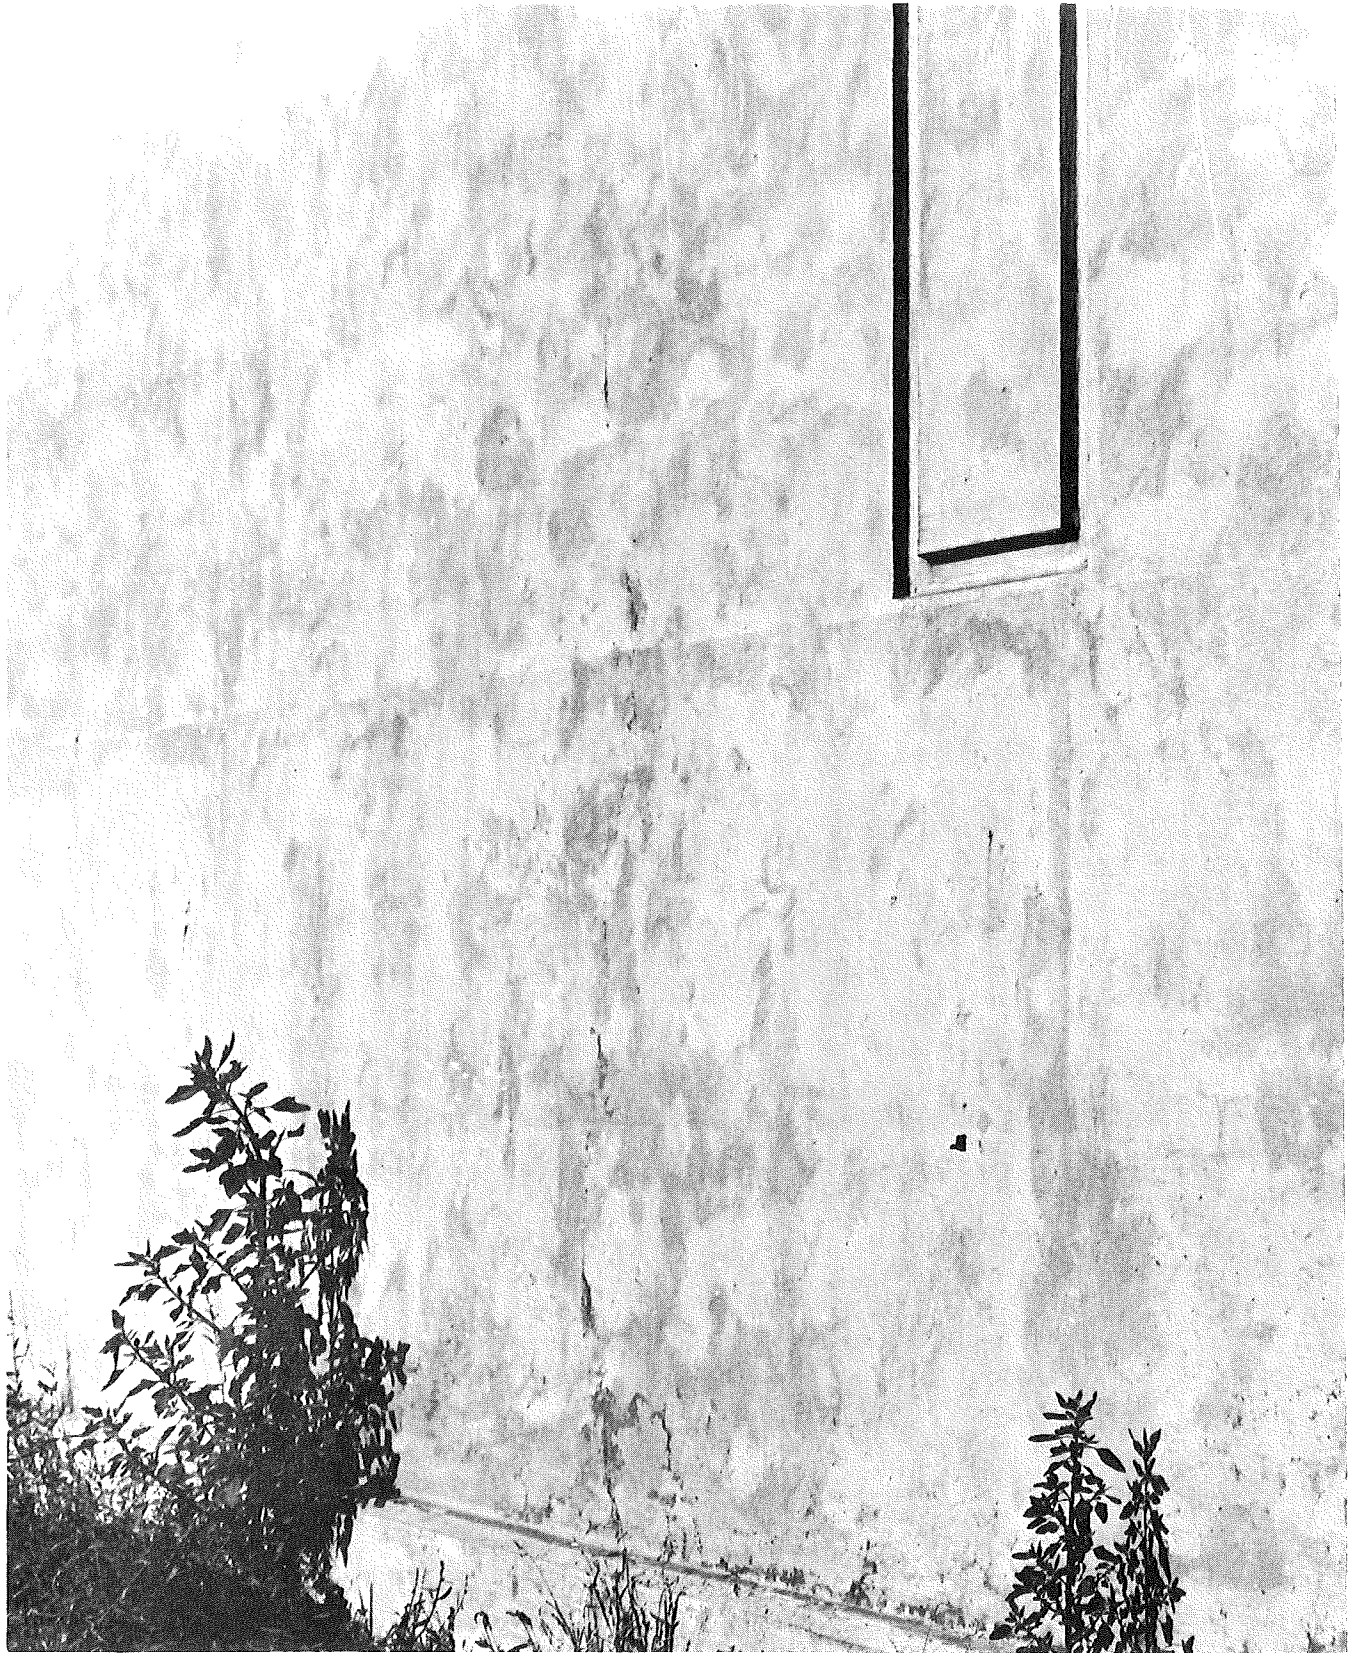
Figure 4. Armor Speed Finish on Outer Drive regulator house (photo: 11-6-62).

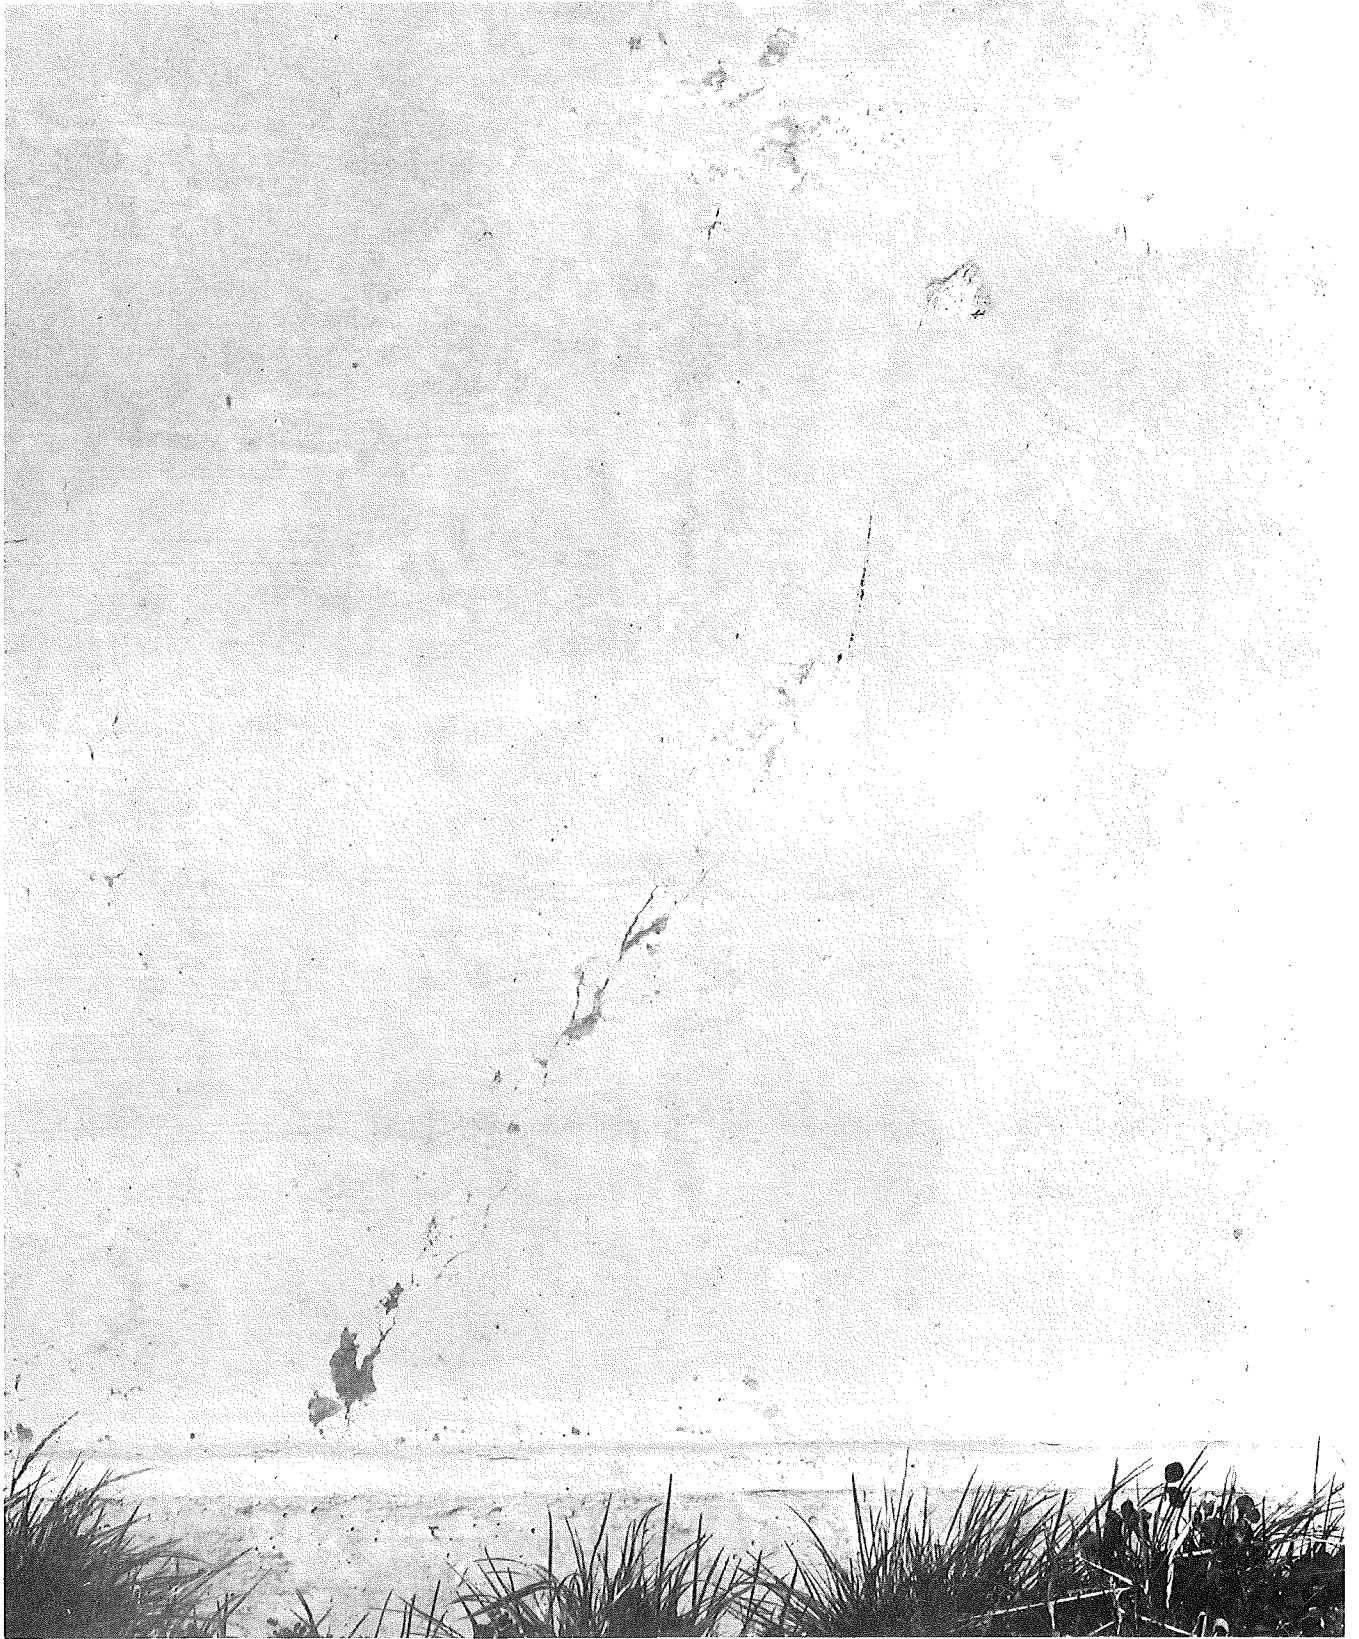
Inspection of the two regulator houses on November 6, 1962, disclosed some crack formation in both structures, as shown in Figs. 1 through 6. Since the cracks occurred in approximately the same places and were quite comparable in the two buildings, their formation undoubtedly bore no relationship to the different surface treatments. However, the marked difference in the appearance of the structures, which is clearly visible in the photographs, is the mottled aspect of the regulator house treated with Armor Speed Finish compared with the one which was hand rubbed. The texture of the rubbed finish seemed more uniform and was better in appearance than the spotty and unprepossessing texture of the test building. At the age of three years the durability of both structural surfaces appeared to be satisfactory.

Figure 5. Hand-rubbed finish with typical crack on Cadieux Ave. regulator house (photo: 11-6-62).

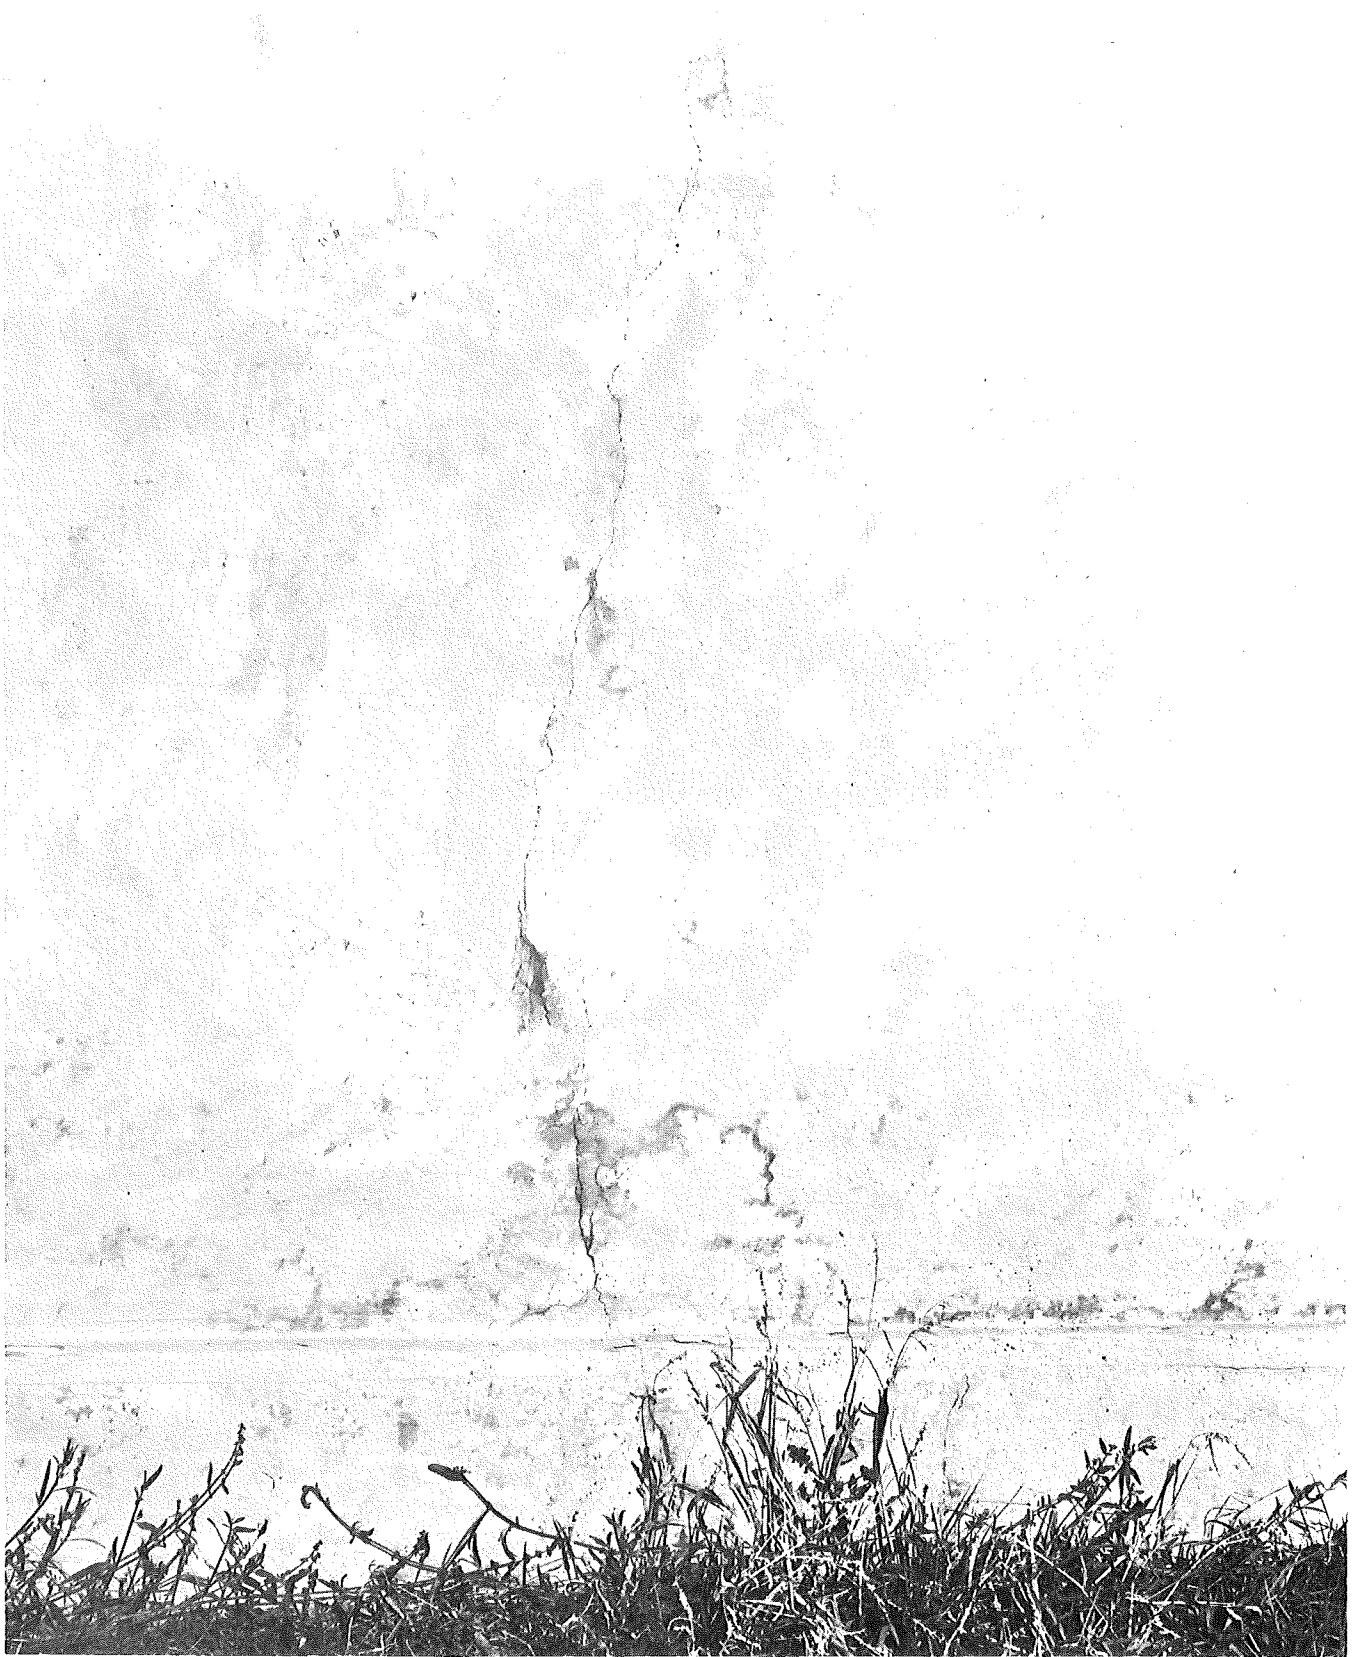
Figure 6. Armor Speed Finish with typical crack on Outer Drive regulator house (photo: 11-6-62).

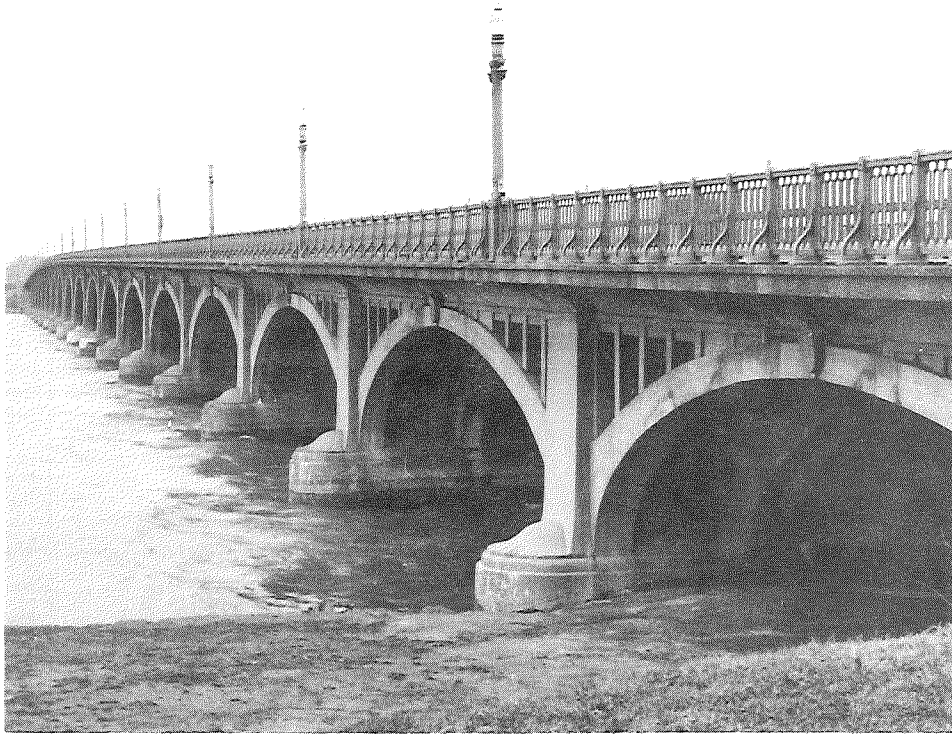
Inspection of the Armor Speed Finish experimental coating on the Belle Isle bridge, on April 9, included two application areas both located in the first bay at the south or island end of the bridge (Fig. 7). One of these (Fig. 8) was a two-coat demonstration area which appeared to have been put on quite recently. The other area (Fig. 9), on an arch in the same bay as the first area, was said by the manufacturer to have been applied in June 1959. Although this arch may have been coated as stated, its appearance was very similar to that of the other arches in this bay. Even those at the bridge sides appeared to be in just as good condition as the arch coated with Armor Speed Finish. Thus, there was no clear evidence that the coating had caused any improvement in the condition of the concrete.

Figure 7. Belle Isle bridge viewed from the island (looking north). Bay on extreme right, which is adjacent to the south abutment, is site of two applications of Armor Speed Finish (photo: 4-9-62).

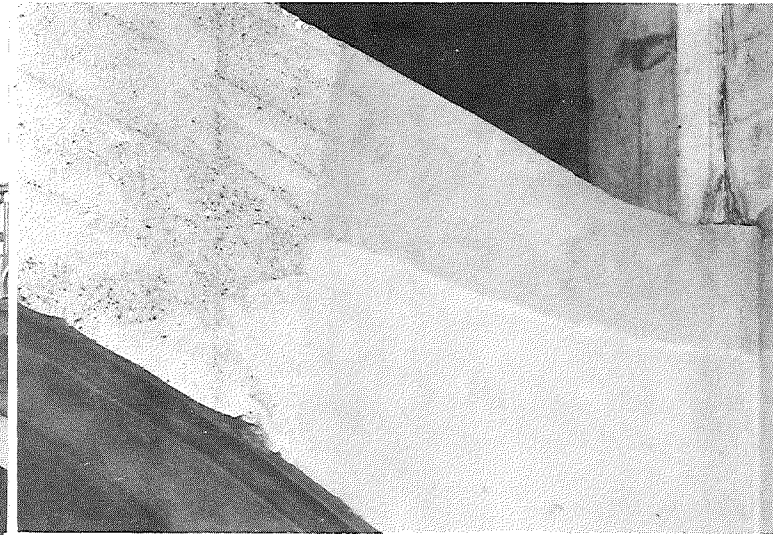
Figure 8. Demonstration application of Armor Speed Finish in two coats (bond coat above, seal coat below) on outer surface of west arch of first bay of Belle Isle bridge, adjacent to south abutment (photo: 4-9-62).

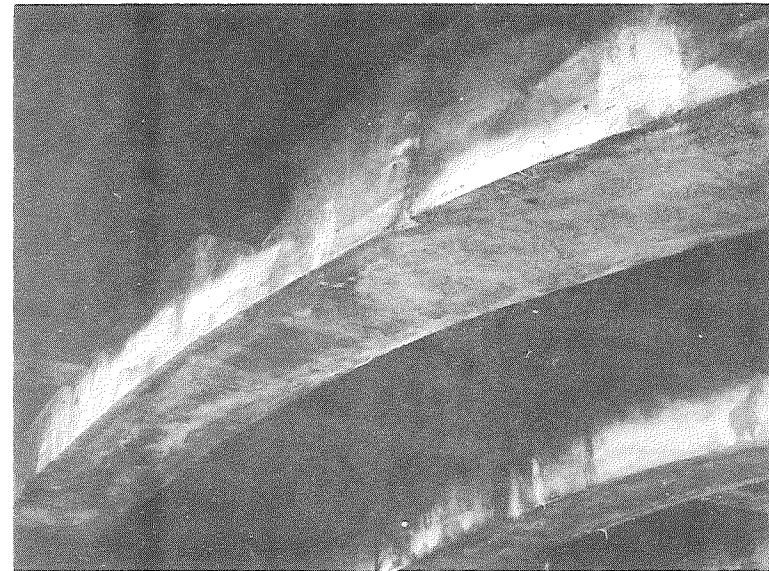
Figure 9. Arch coated with Armor Speed Finish in June 1959, near center of south bay of Belle Isle bridge (photo: 4-9-62).

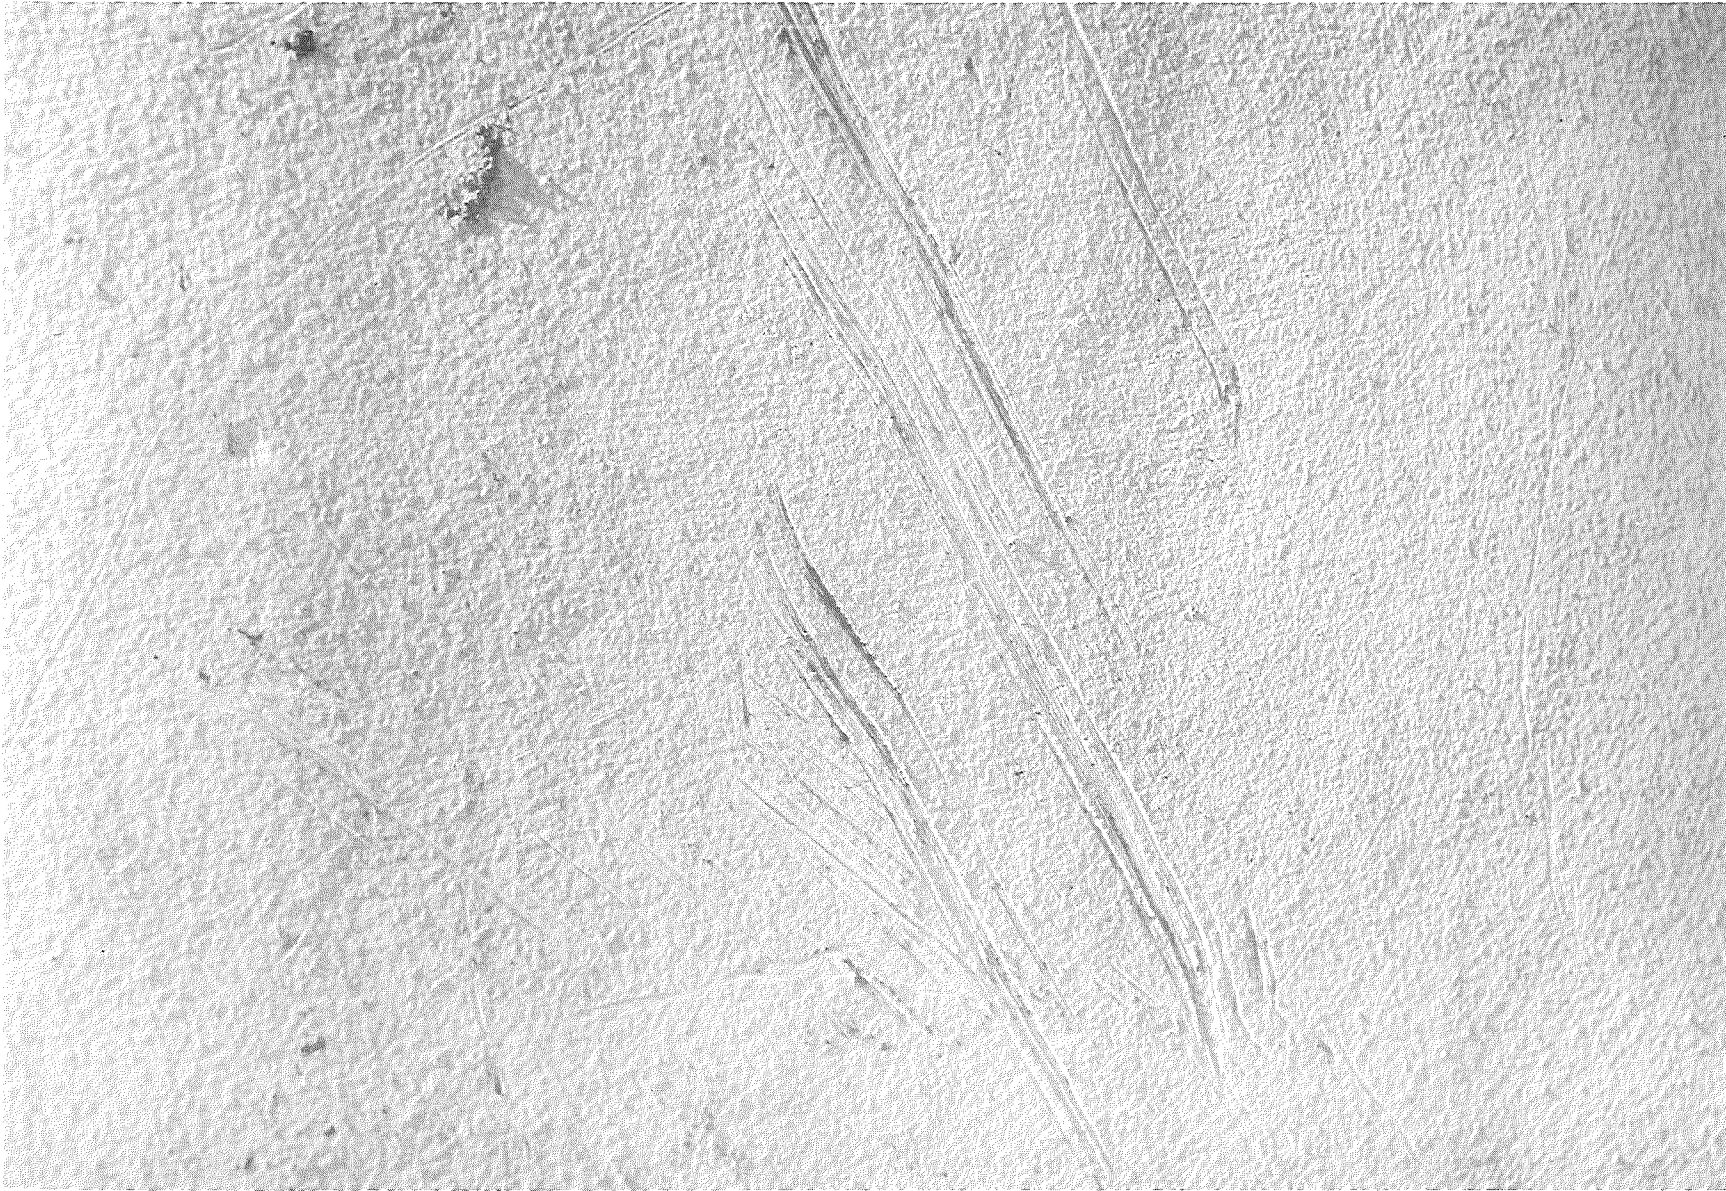
Figure 10. Scuffed area at John K. Orlich funeral home, 17950 Woodward Ave., Detroit. Gun-Tex 000-SMOOTH, white, was applied by spray on June 29, 1960, over badly checked stucco, in one coat at 50 sq ft per gal. Scuffed area shows how material will take this kind of treatment without breaking bond, and indicates depth of coating (photo: 3-1-62).

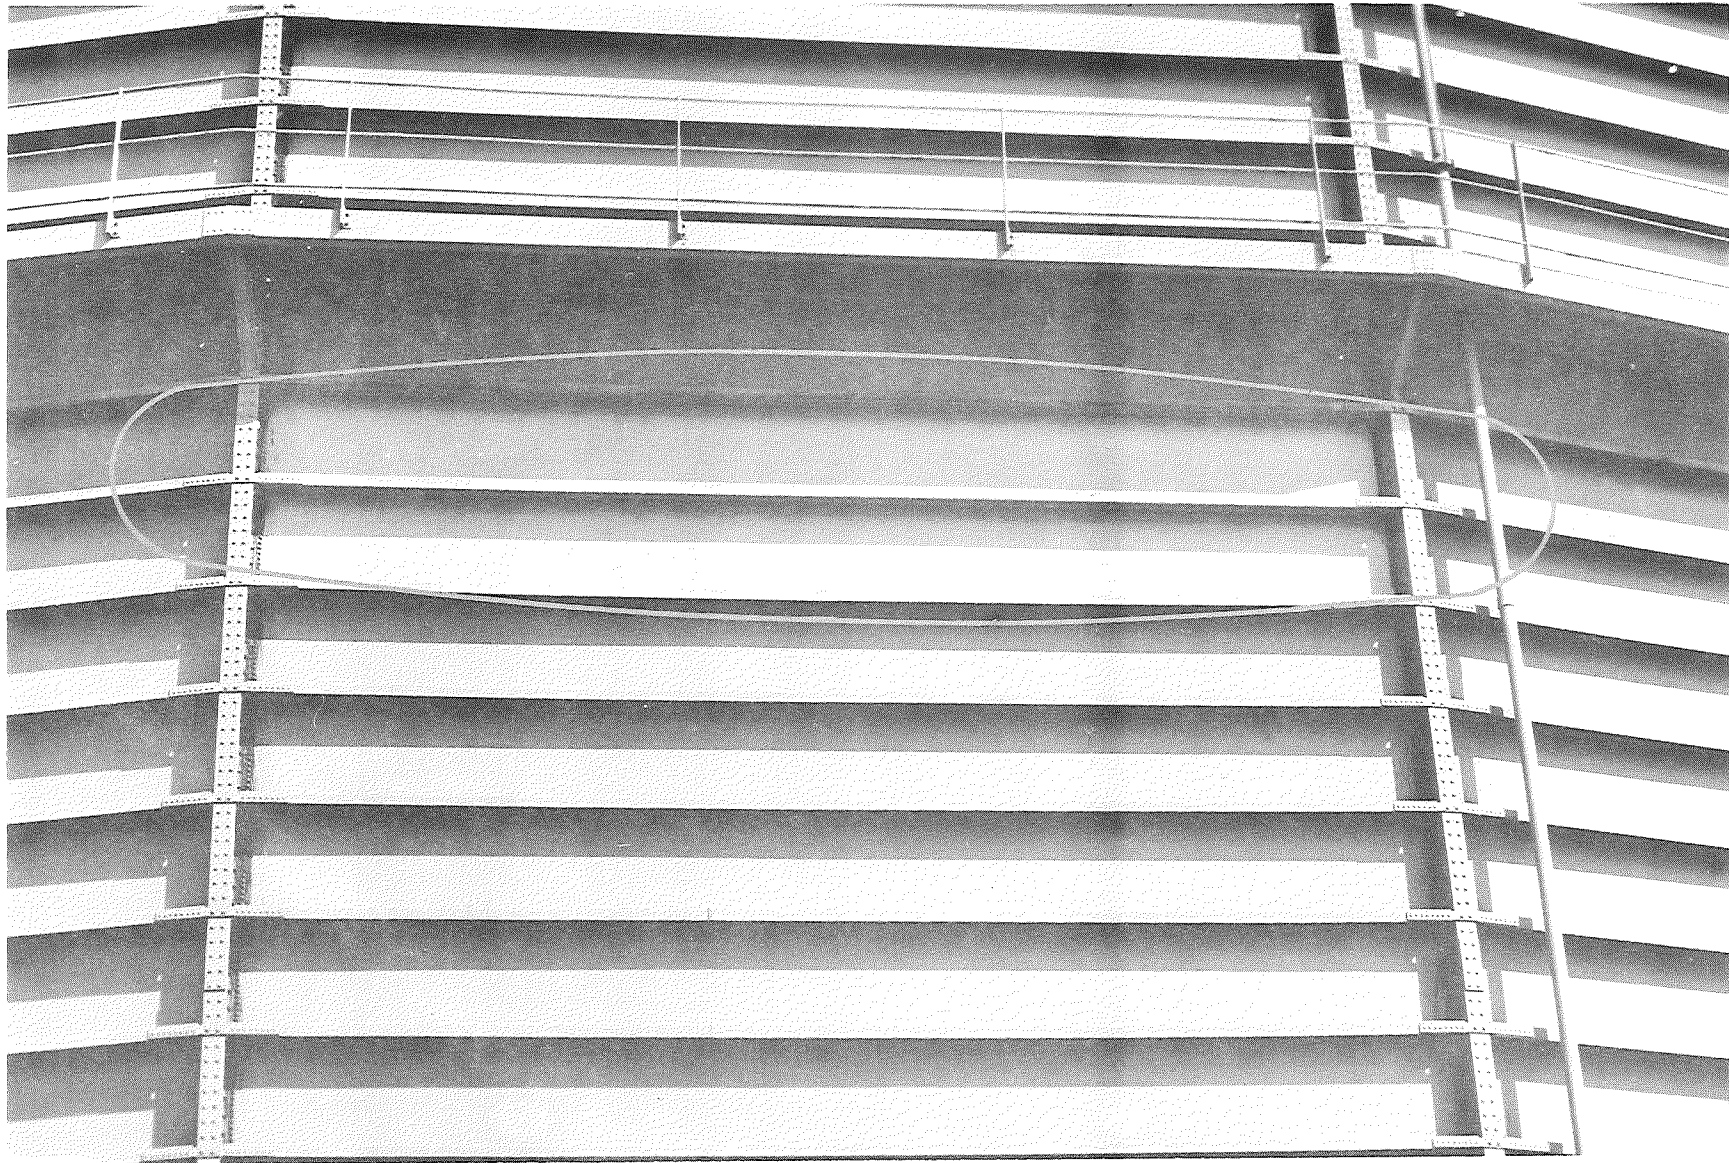
Figure 11. Storage tank of Michigan Consolidated Gas Co. on Lynch Rd. at Detroit City Airport. Two lighter panels (center) were brush coated with Gun-Tex 000-SMOOTH on November 20, 1959, with ambient temperature being below 40 F at time of application. Panels are steel and were sandblasted before coating at 50 sq ft per gal. Coating was in excellent condition at the time of this inspection (photo: 3-1-62).

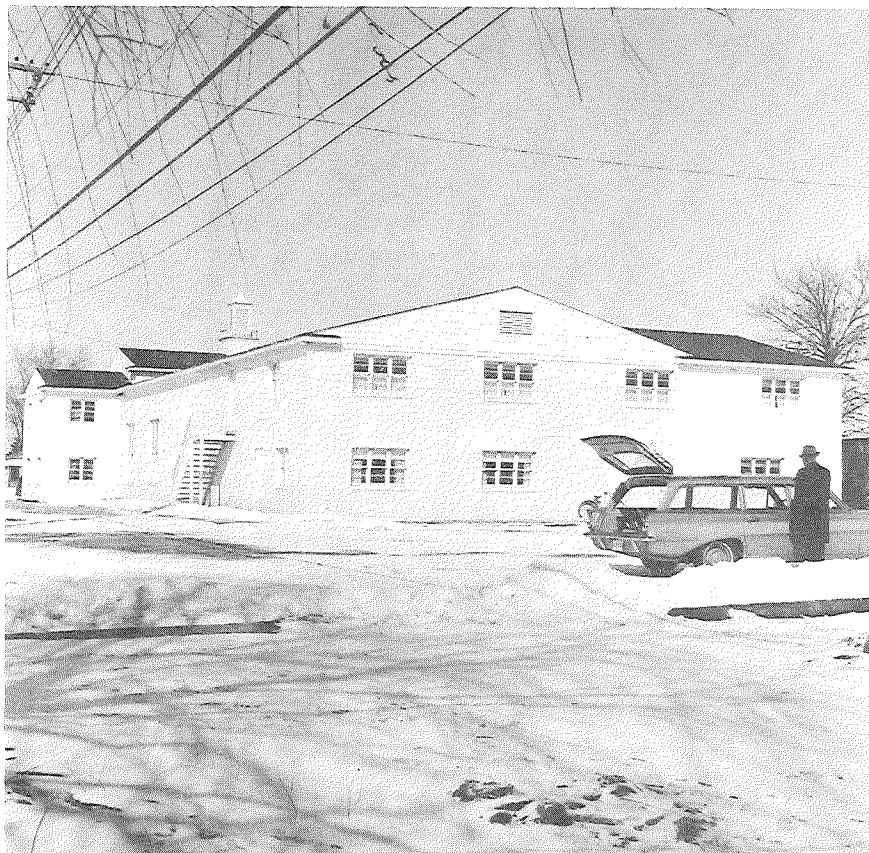
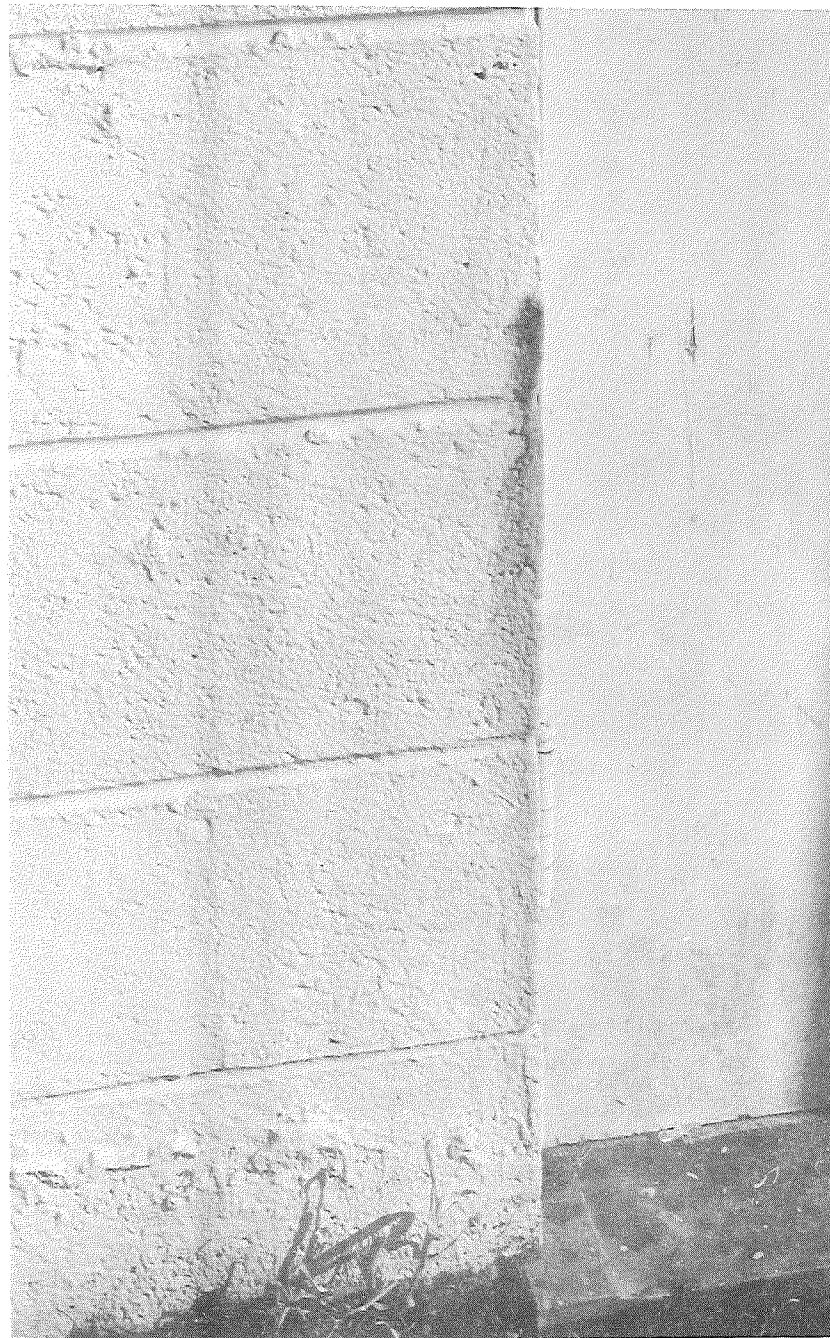
Figure 12. First Baptist Church at 9-1/2 Mile Rd and Coolidge Rd, Oak Park, a cement block structure brush-coated with Gun-Tex 000-SMOOTH in a single coat by members of the congregation in September 1960 at the rate of 50 sq ft per gal. Applicators were unskilled and some were 14-year-old children. General appearance good after two winters. Brown spot bleeding through coating on rear wall was explained by manufacturer's representative as due to insufficient coverage by amateur painters (photos: 3-1-62).
