R-381R

MICHIGAN
STATE HIGHWAY DEPARTMENT
JOHN C. MACKIE, COMMISSIONER

Subject: Evaluation of Armor Speed Finish and Gun-Tex as Protective Coatings for Concrete Structures. Research Projects R-58 B-45, R-59 NM-10. Report No. R-381 R.

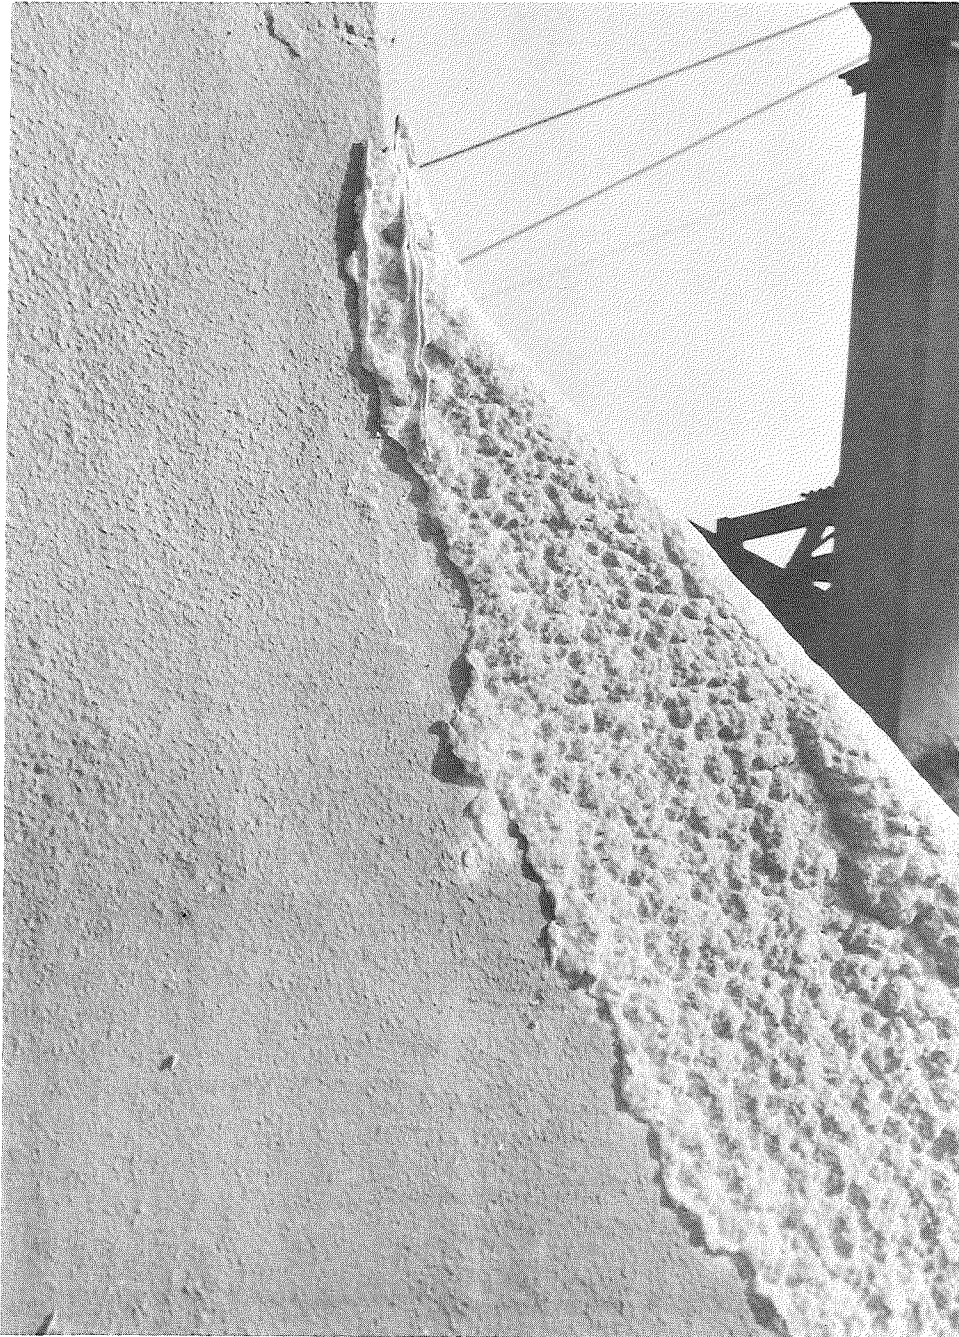
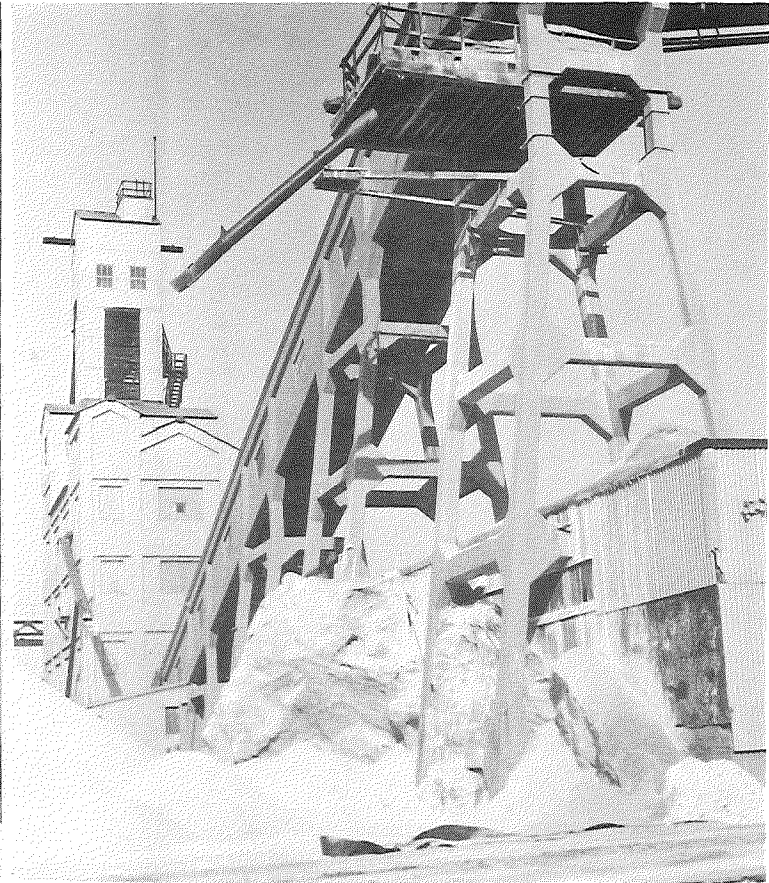
Figure 13. International Salt Co. mine, Detroit. Concrete ramp spray-coated with Gun-Tex 000-SMOOTH in summer of 1961, the old coating having been removed by sandblasting before Gun-Tex application. Concrete pillars supporting ramp have been in contact with salt during entire winter season without apparent effect (photos: 3-1-62).

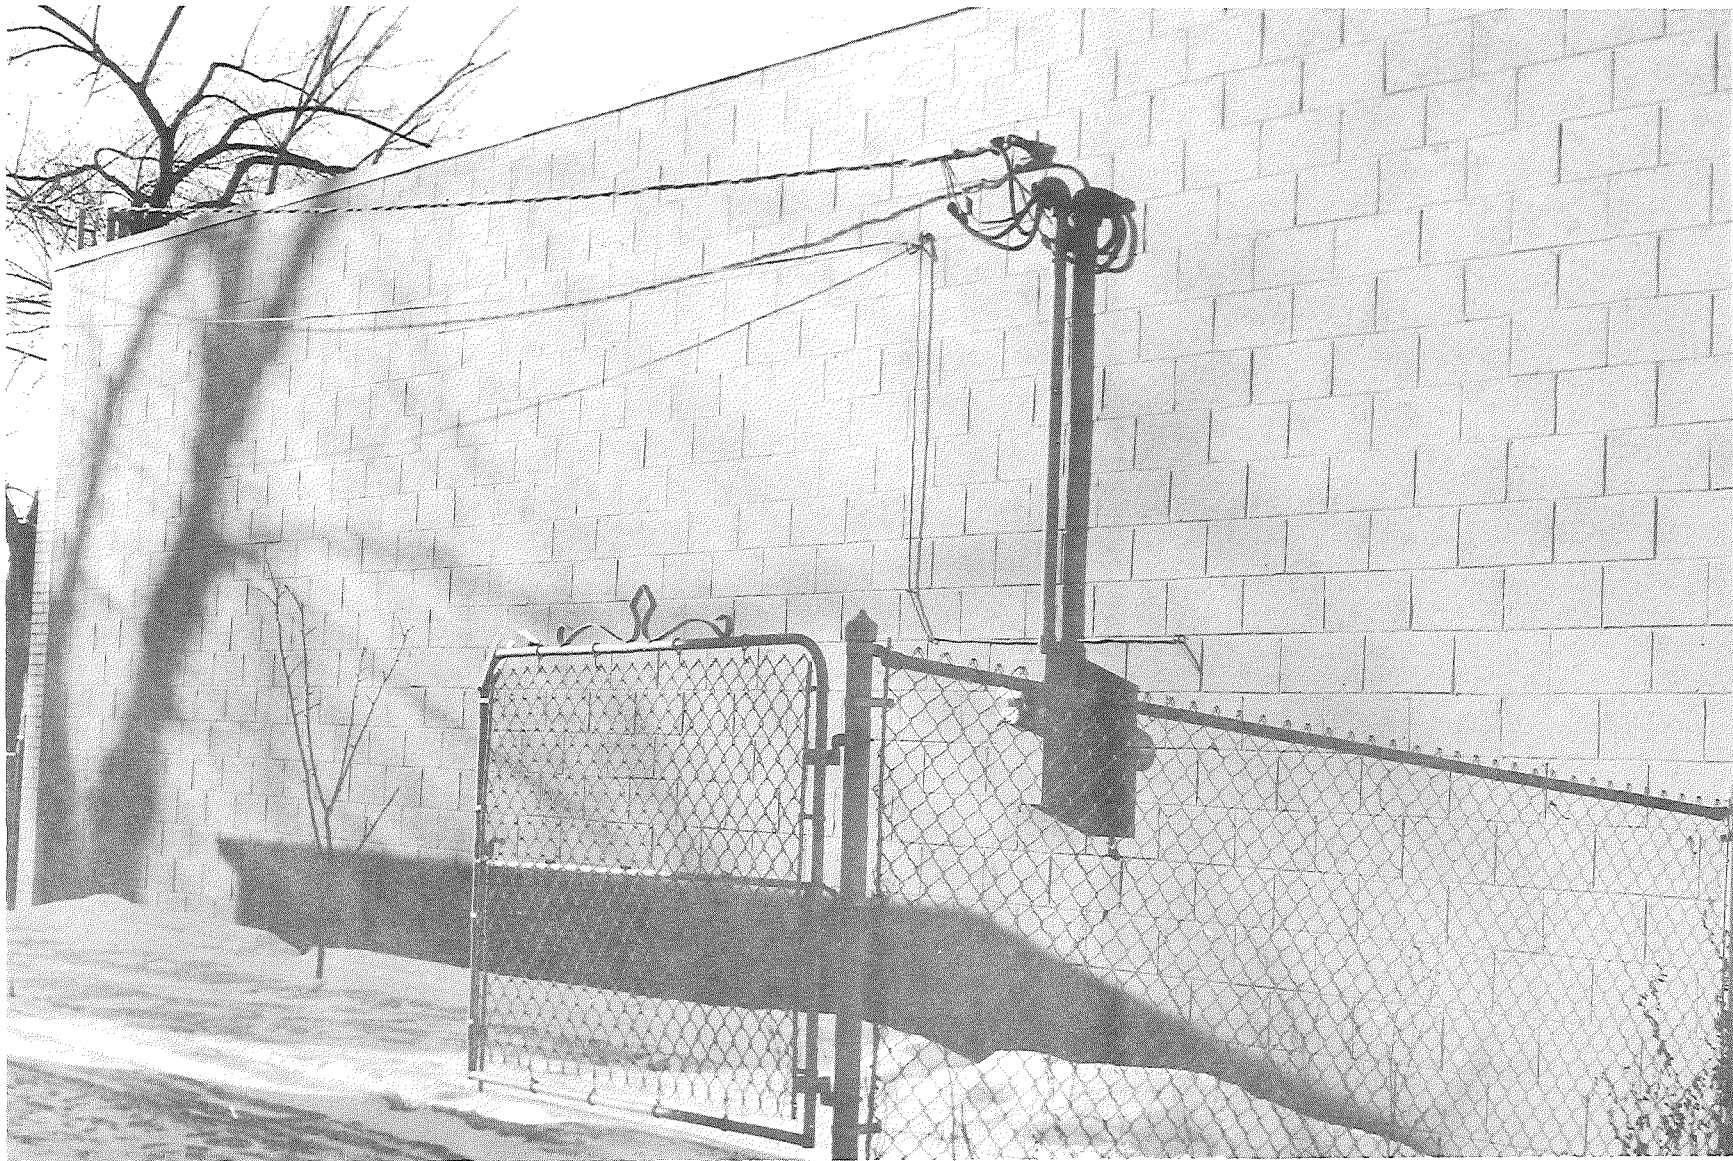
Figure 14. Speedway Corp. service station at Esper and Wyoming, Detroit. Rear wall of new cement block was coated with Gun-Tex 000-SMOOTH in August 1958. One coat of Dri-Cone #1260 was applied at 300 sq ft per gal on mortar joints to arrest lime burning; then Gun-Tex was brushed on immediately in two coats at 60 sq ft per gal total coverage (both coats). In excellent condition at time of inspection (photo: 3-1-62).
