**Cause of Concrete Pier Cap Deterioration
on the I-75 Bridge over River Rouge
(B01 of 82194) in Detroit,
and Effectiveness of Repair Methods**

Final Report

Research and Technology Section
Materials and Technology Division
Research Report No. RC-1346

September 30, 1996

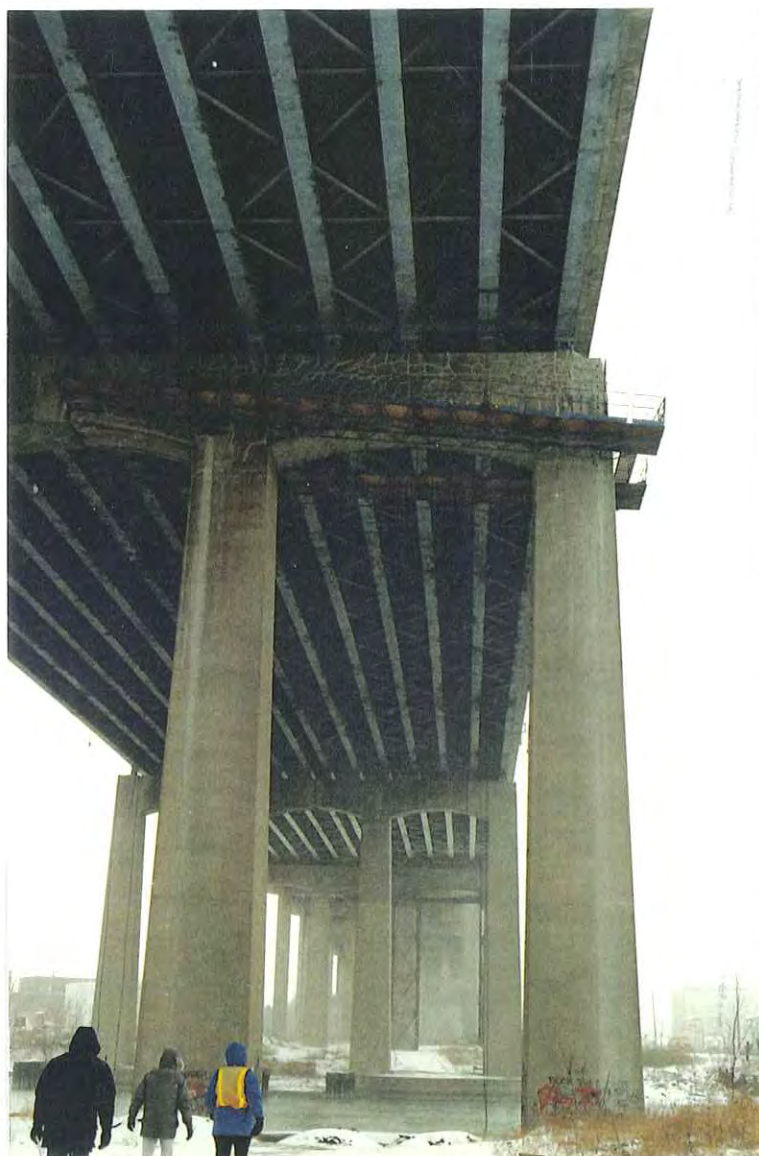
Figure 2. Overview of the main span of the bridge looking south, showing epoxy injected Pier Cap 39 in the foreground, and Piers 38 and 37 in the background.

span of the bridge, showing the piers in question is seen in Figure 2. The team accessed portions of Pier Caps 38 and 39 north-bound from the ground, and from above using a reach-all (Figure 3) provided by the Michigan Department of Transportation (MDOT). Coring of samples from Piers 38 and 39 was conducted by MDOT and under the direction of the project team on December 11-15, 1995.

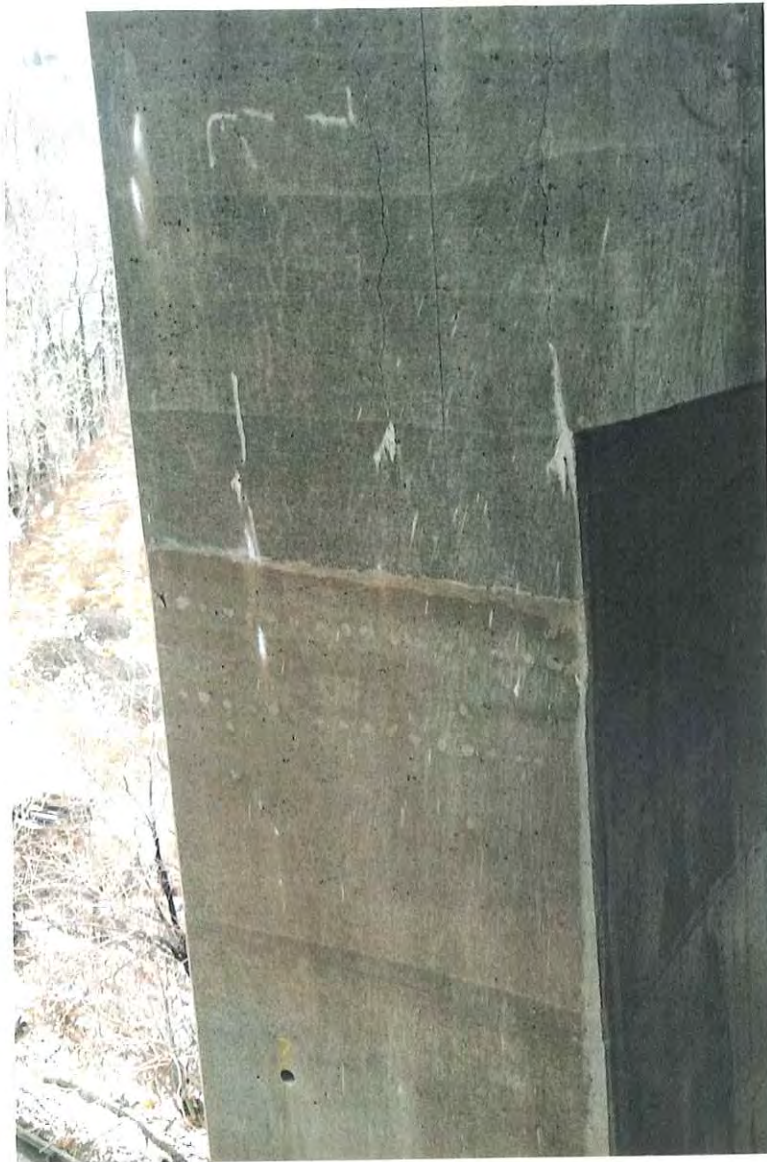
Figure 4. North face of Pier 38 north-bound and outer column. Note the difference in color between the pier cap and column.

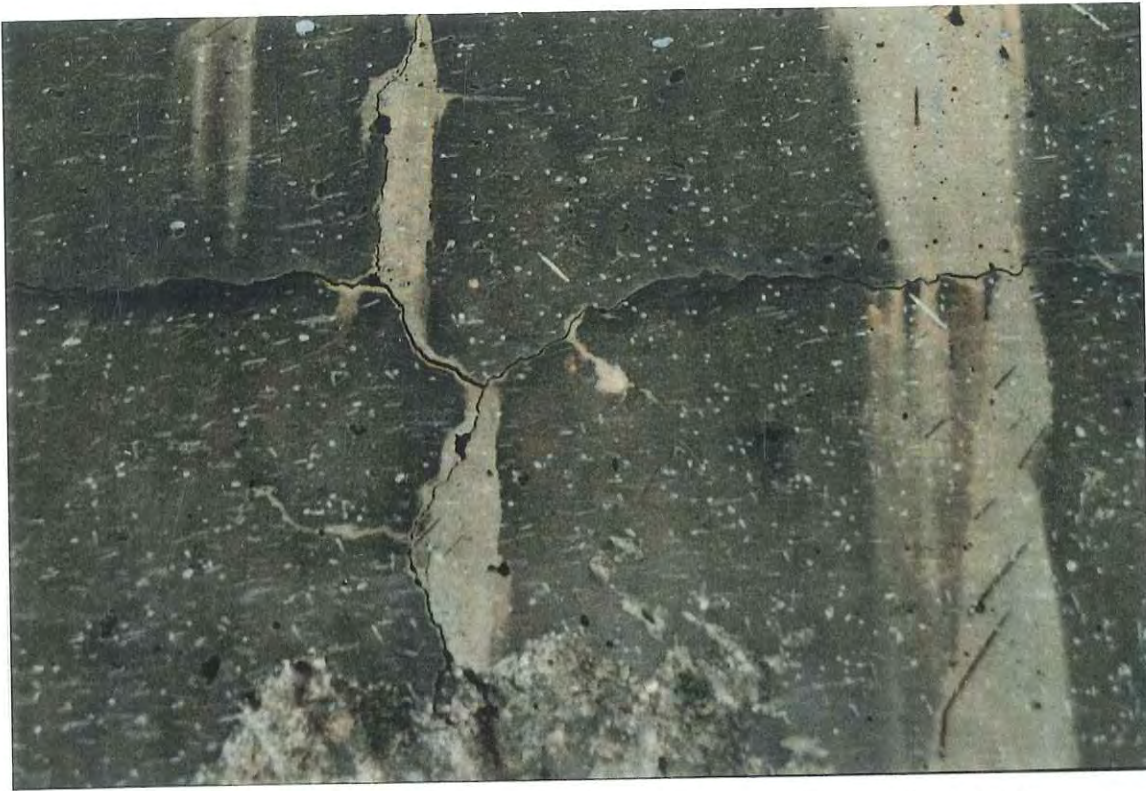
Figure 6. Close-up of south face of Pier 39 north-bound showing the typical pattern cracking seen on the pier caps.

Extensive pattern cracking was observed at all of the pier caps in Piers 37 to 40. Figure 6 shows a close-up of the typical pattern cracking. Some cracks at the north face of Pier 38 north-bound measured wider than 1/8 in. In general, no delamination was detected when surfaces adjacent to cracks were sounded with a hammer. However, surfaces at the exterior (west) face of the pier cap were delaminated.

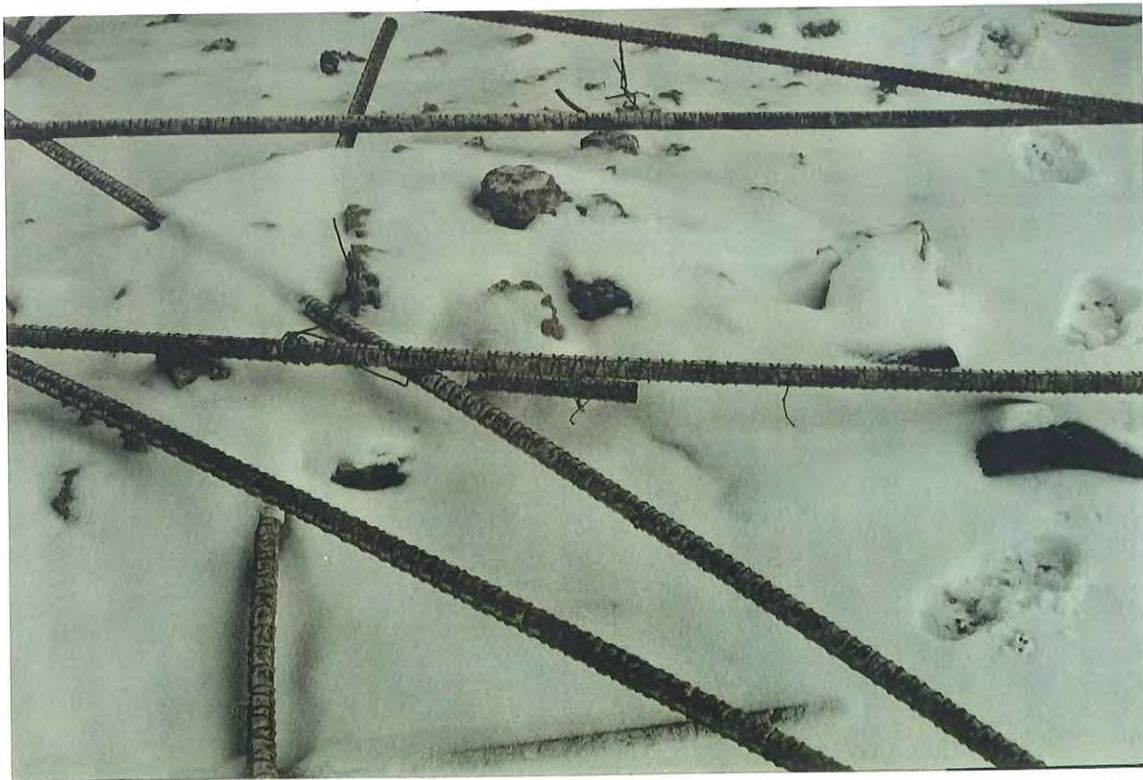
Figure 7. Reinforcing steel presumably taken from Pier 40 during demolition. Note that very little corrosion has taken place; the rust visible on the surface of the bars could have been present at construction or could have occurred after demolition.

The pier cap at Pier 40 south-bound had been demolished in preparation for replacement. Reinforcing steel presumably removed from the pier cap was observed adjacent to the base of the pier, as shown in Figure 7. Corrosion observed on the steel was not considered severe since no substantial pitting or rust pack was observed and reinforcing steel deformations were generally clearly present. Reportedly, concrete was easily demolished at this pier cap.

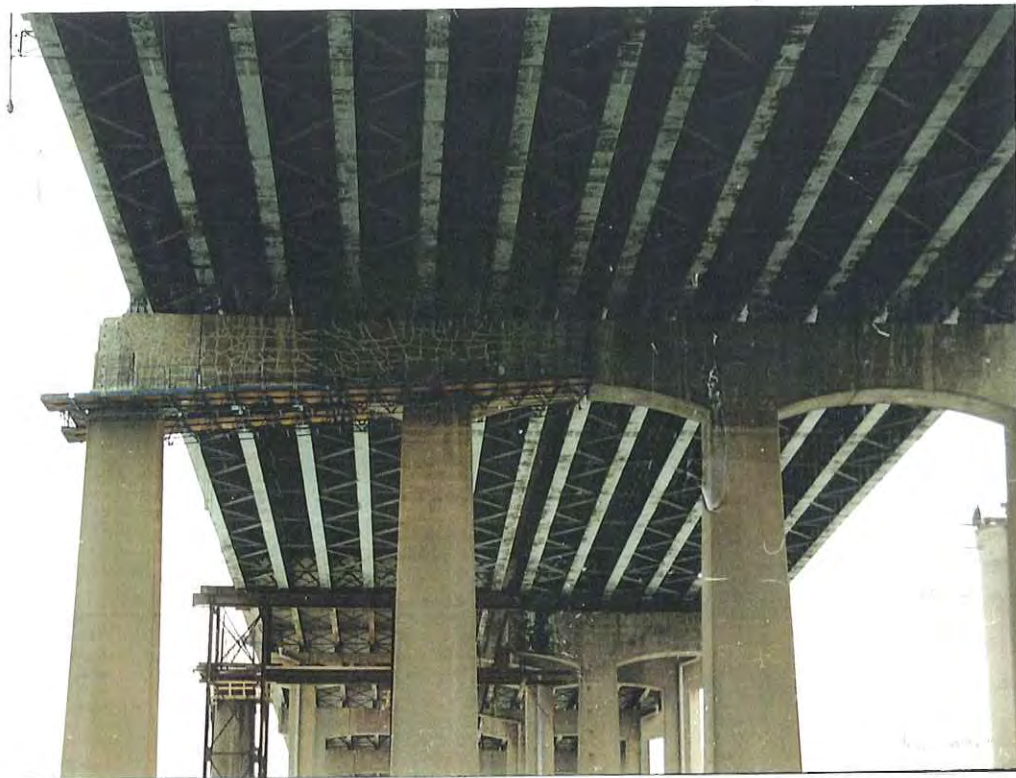
Figure 8. South face of Pier 39 south-bound. The cracks have been injected with epoxy as part of the repair procedure. The left end of the pier cap has been prepared for post-tensioning.

Cracks in the pier cap at Pier 39 south-bound had been epoxy injected as part of repairs in progress, as shown in Figures 8 and 9. Figures 9 and 10 show the locations of the cores taken in the north face of the pier cap for this project.

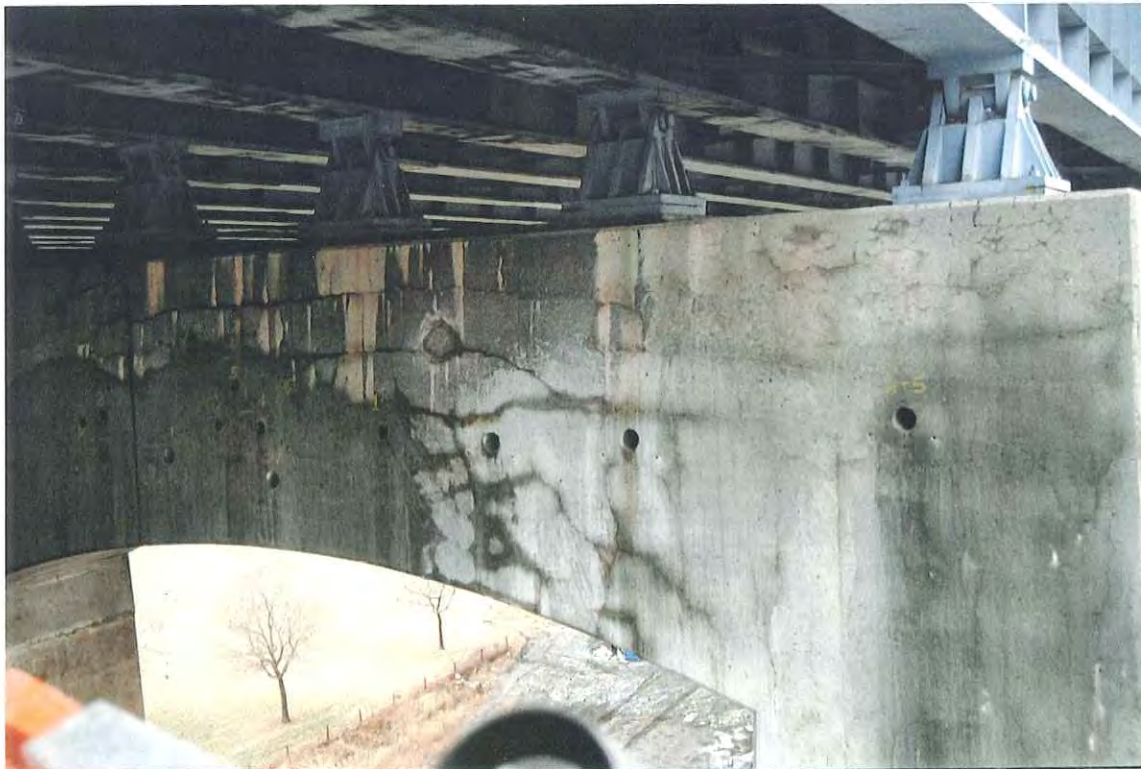
Figure 11. South face of Pier 39 north-bound showing locations of cores. One additional core was taken in the column at the right side of the photo.

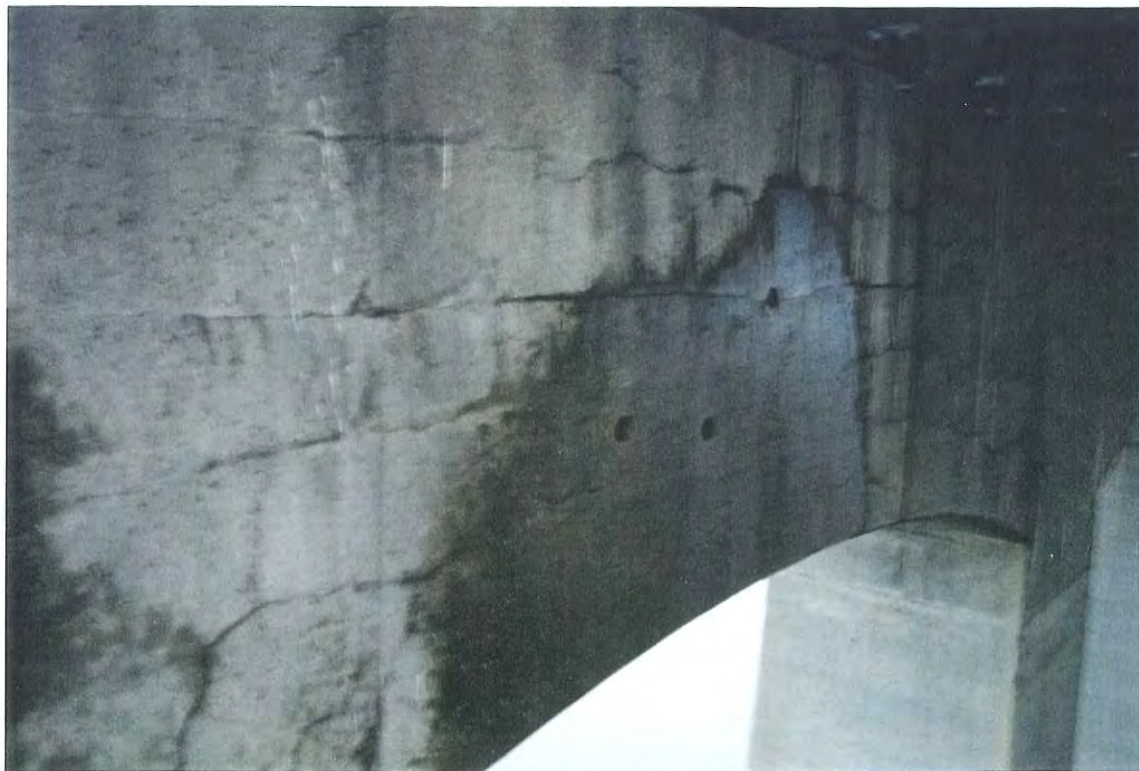
Figure 13. South Face of Pier 38 south-bound, showing all three cores.

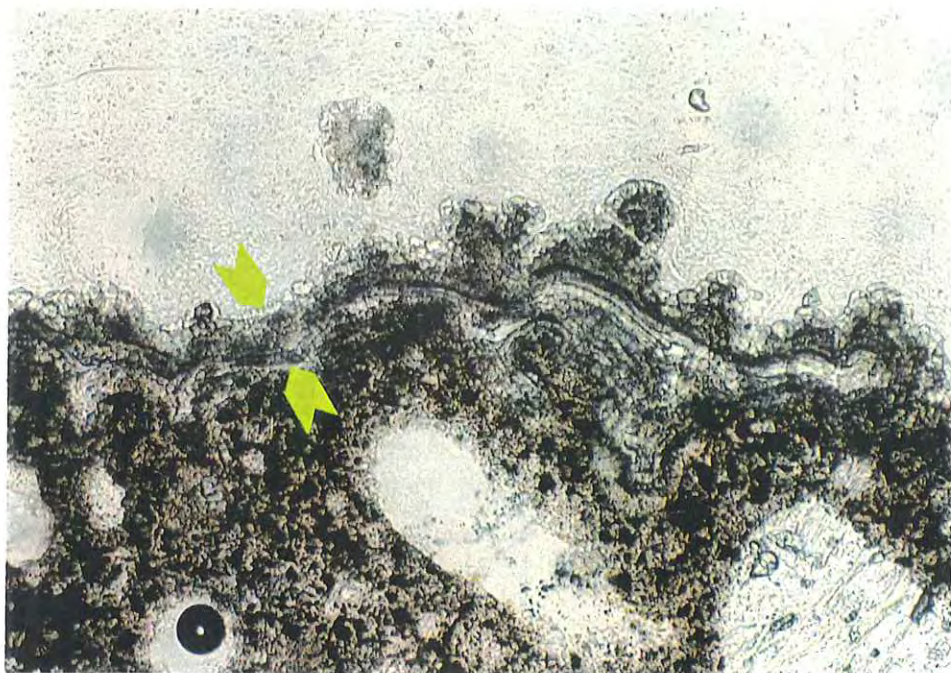
The concrete contains at least two generations of crack evidence. Major cracks are present with a smooth appearance, and do not cut through aggregates. These cracks are interpreted to have developed at early ages. Substantial paste carbonation along the crack walls provides further evidence of considerable crack age. Figure 17 shows the presence of calcium carbonate on the crack surfaces.

Figure 17. Thin section photomicrograph of core #2 from Pier 38 north face, north-bound, showing inter-layered alkali-silica gel and calcium carbonate deposits (between arrows) on crack wall. Plane-polarized light. Width of field is approximately 350 μ m.

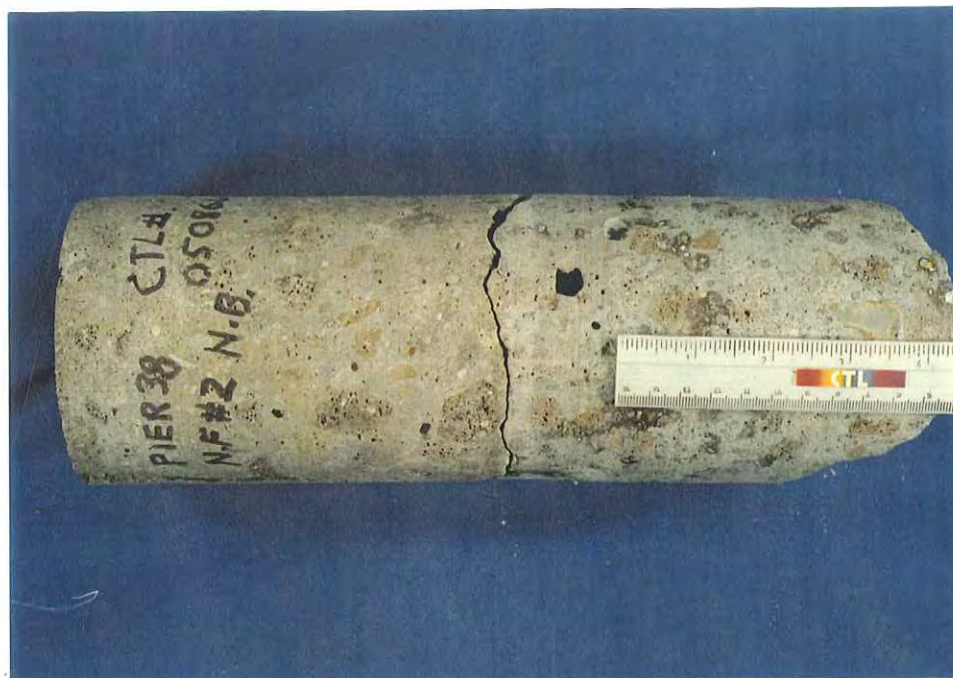
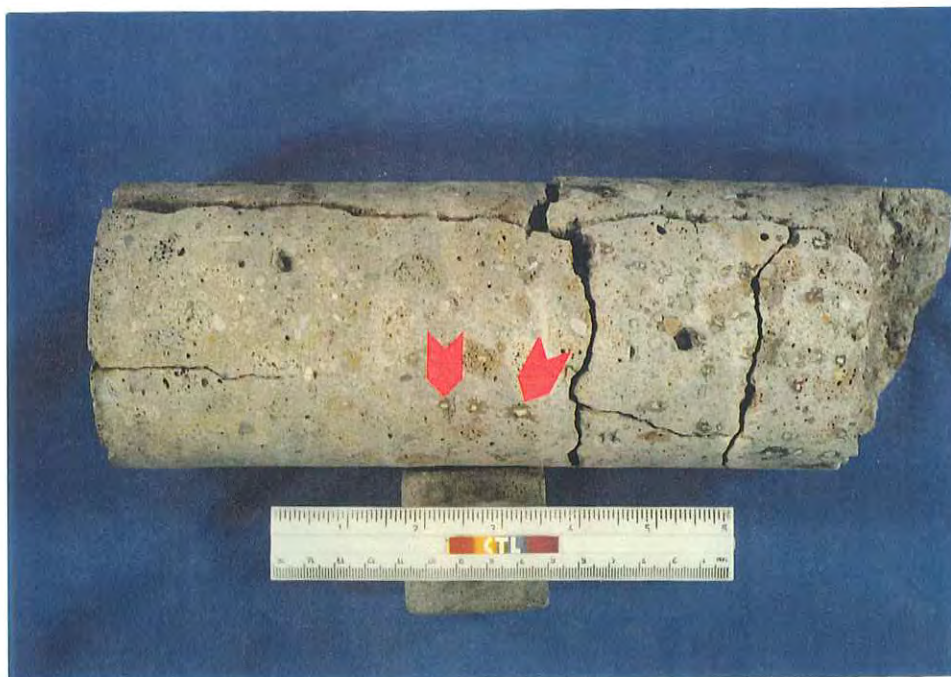
FIG. 3 TWO SIDE VIEWS OF CORE, AS RECEIVED. ARROWS SHOW FRESH ALKALI-SILICA GEL AROUND CHERT AGGREGATES.

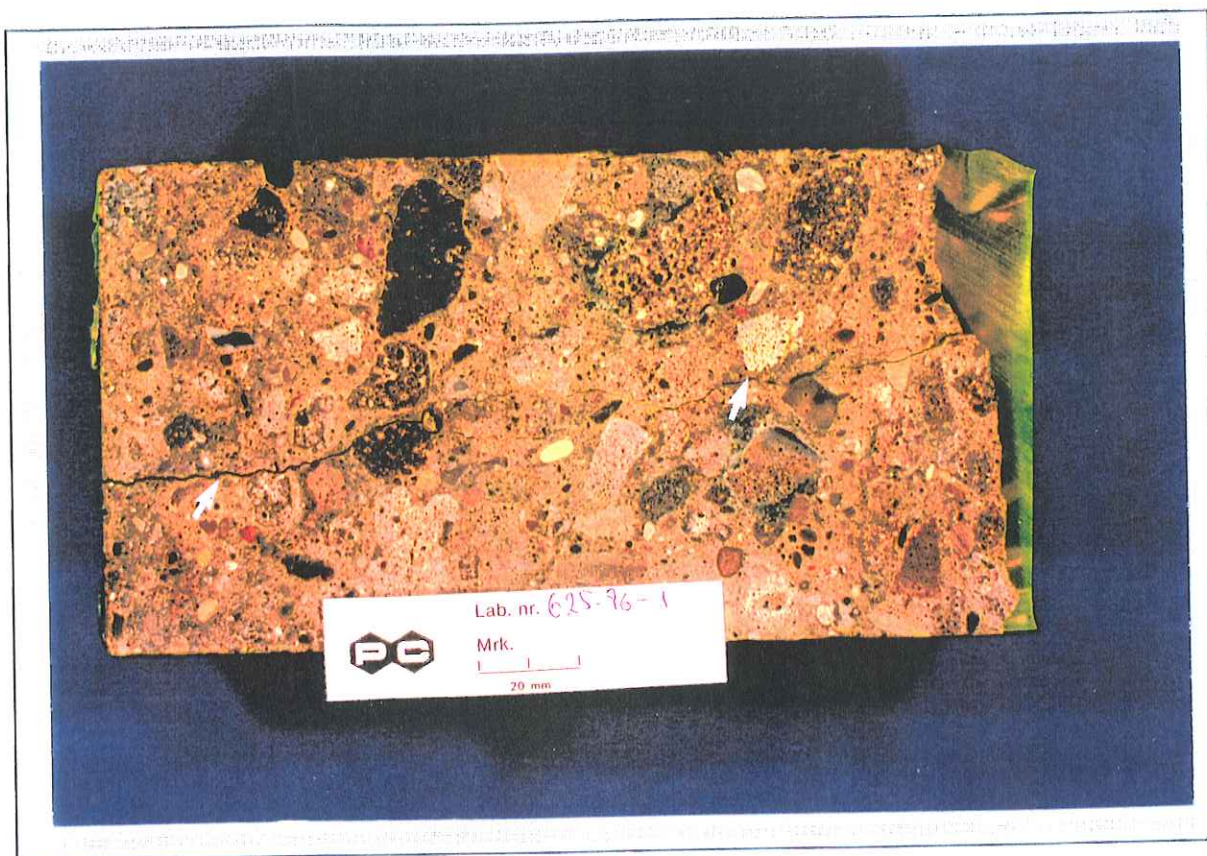
Photo 1. Macrofoto of sample 625-96-1. The concrete contains homogenous distributed slag particles in Portland cement paste. A macro crack penetrates the core perpendicular to surface.

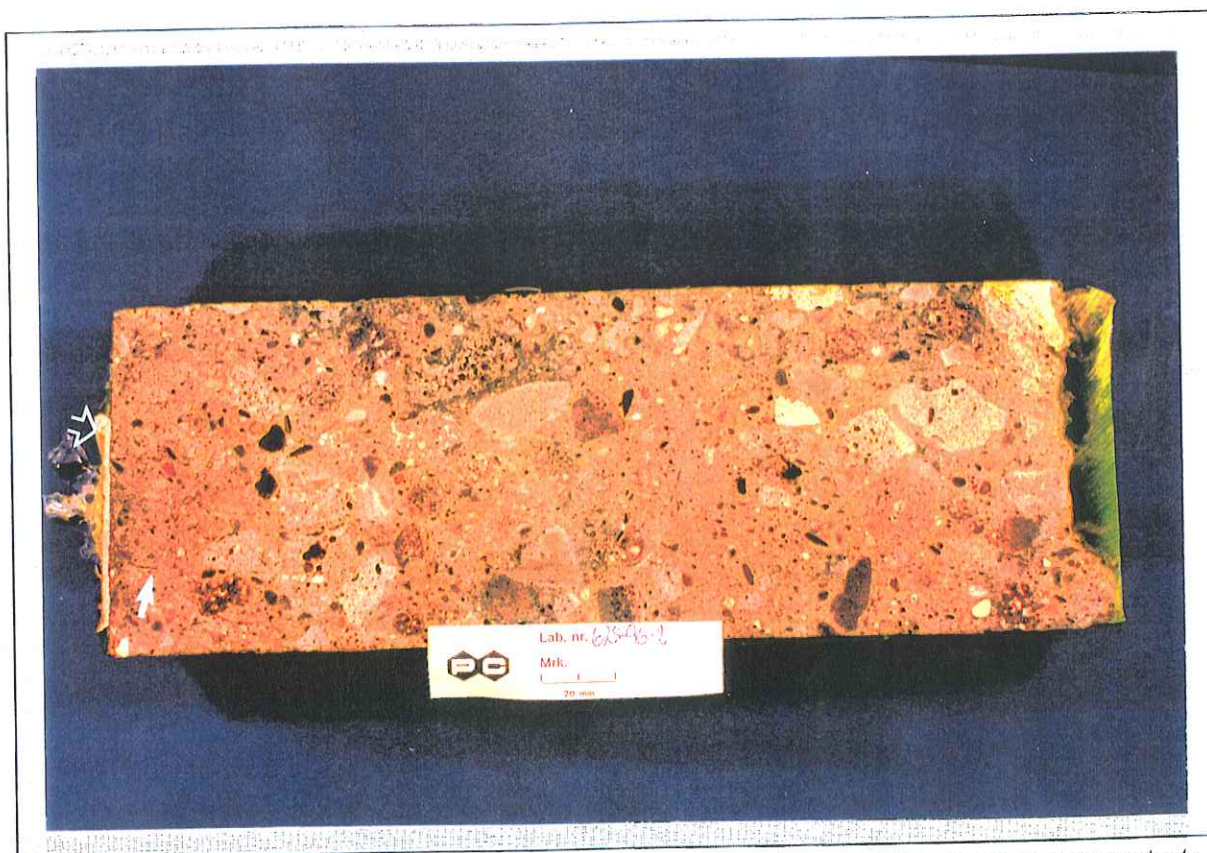
Photo 2. Macrofoto of sample 625-96-2. At surface grey epoxy layer is present. The layer do not penetrate the concrete. Surface crack is present, see arrow.
