FIELD EVALUATION OF STYROFOAM  
AS INSULATION AGAINST FROST EFFECTS  
IN FLEXIBLE PAVEMENT FOUNDATION COMPONENTS

Research Laboratory Division  
Office of Testing and Research  
Research Project 64 E-31  
Research Report No. R-527R

Michigan State Highway Department  
Lansing, October 1965

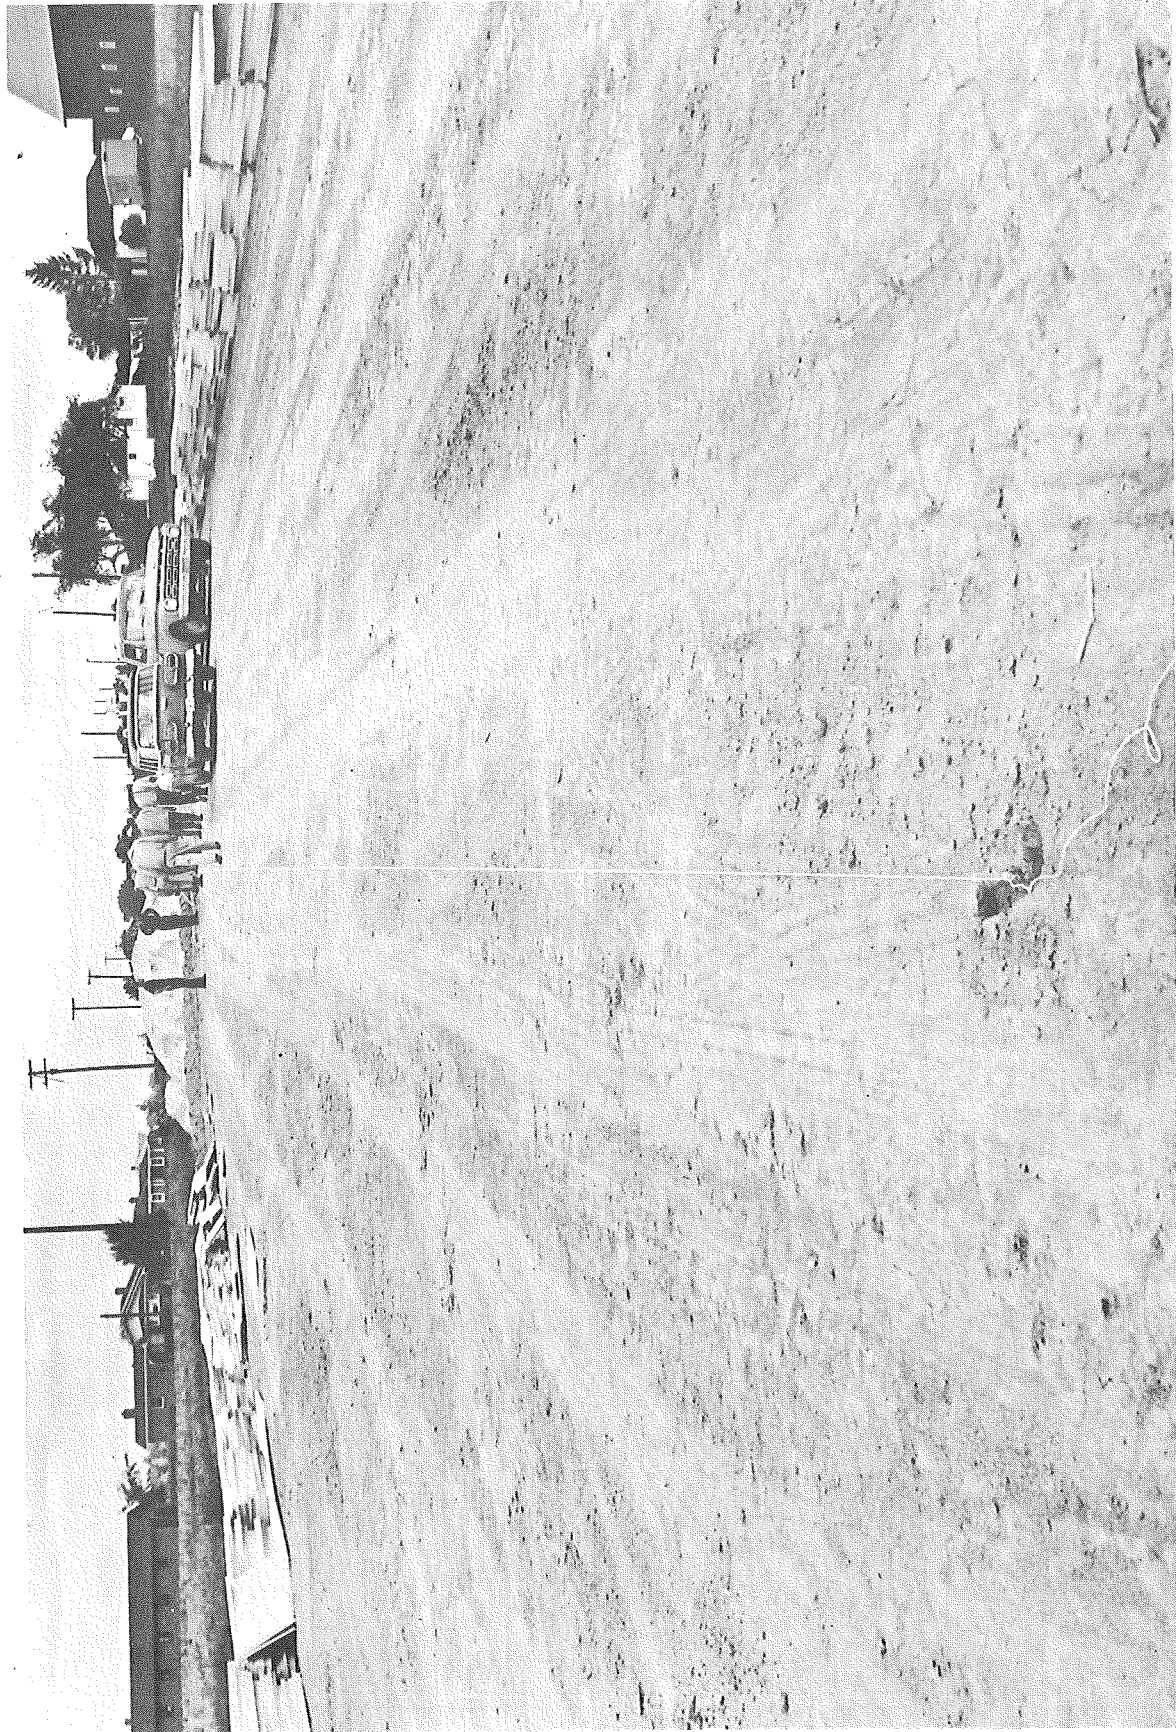
Figure 2. Appearance of prepared subgrade immediately before Styrofoam placement; note stringline used for alignment of Styrofoam sheets.

The clay subgrade was brought to proper elevation and shaped as smooth as possible. Average dry density of this material was 121.1 pcf, as determined by 10 Rainhart tests taken at random locations within the test area. Rainhart values ranged from 111.9 to 133.5 pcf, and were considerably higher than maximum densities determined by the T-99 compaction test (Table 1). Fig. 2 shows this subgrade just before placing the Styrofoam, with a stringline used down the roadway centerline as a reference in aligning the first row of plastic sheets.

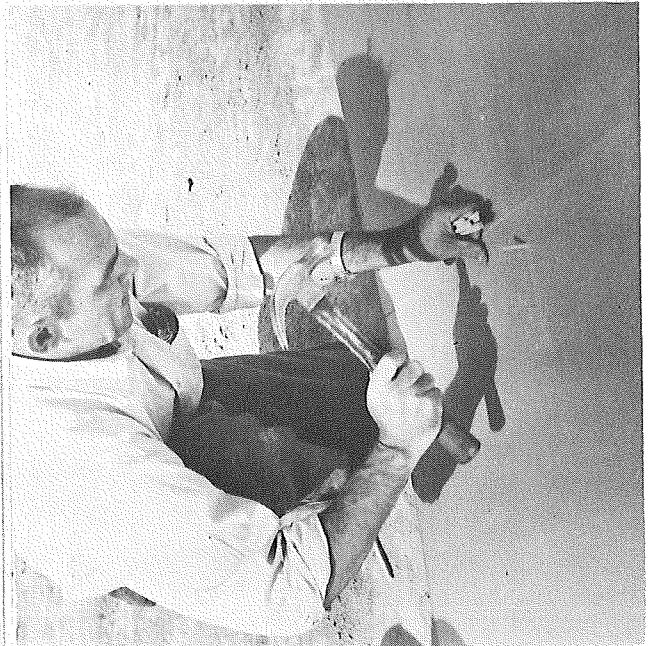
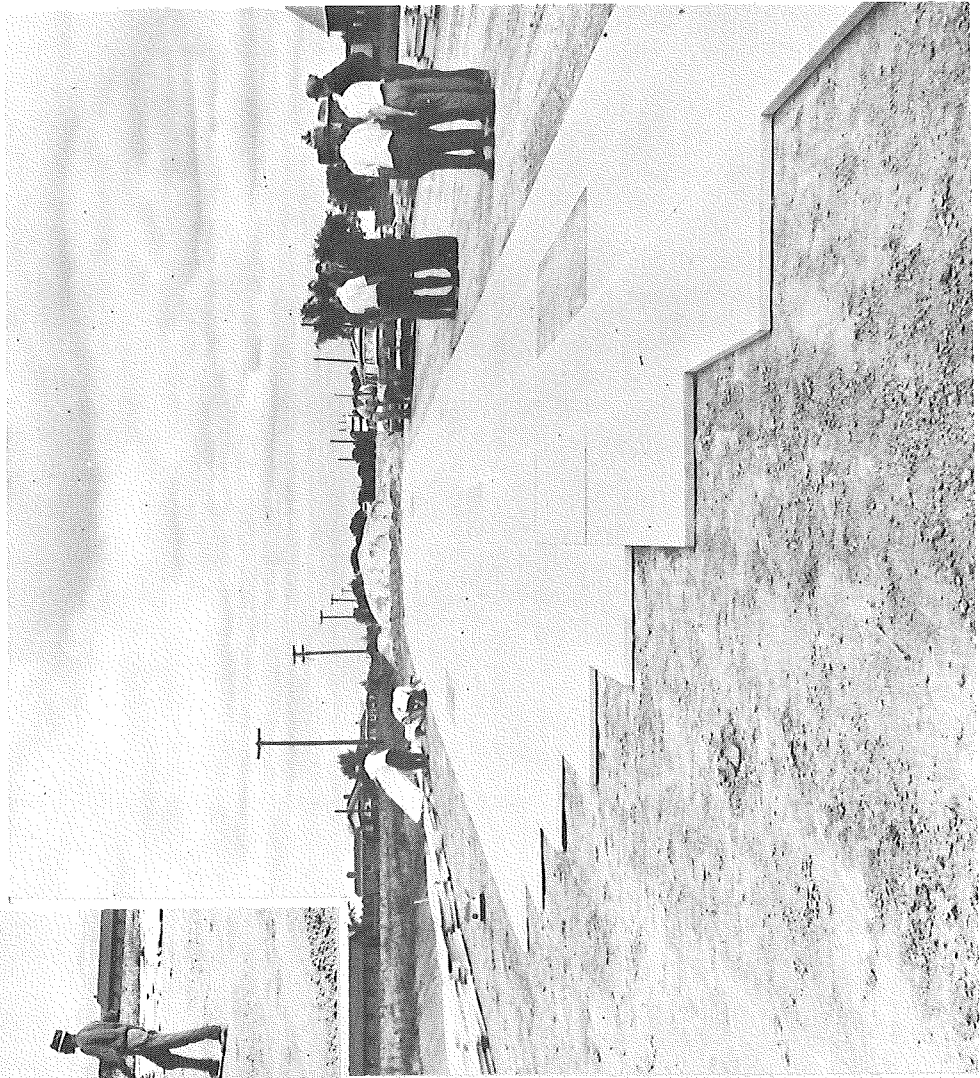
Figure 3. Delivery and placement of Styrofoam.

Consecutive steps in construction of the test section are shown in Figs. 3 and 4. After unloading from vans, the Styrofoam sheets were stored temporarily along the side of the construction site. They were placed directly on the subgrade, and fixed in place by 5-1/2 in. long wooden pegs. The 2 by 8 ft sheets were staggered half their length in alternating rows, each being held in place by at least four pegs. They were butt-jointed as tightly as possible, without use of sealer at the joints. After thorough inspection, the sheets were covered by the sand subbase. This material was pushed ahead of the grader so that it rode on sand, thereby protecting the Styrofoam layer.

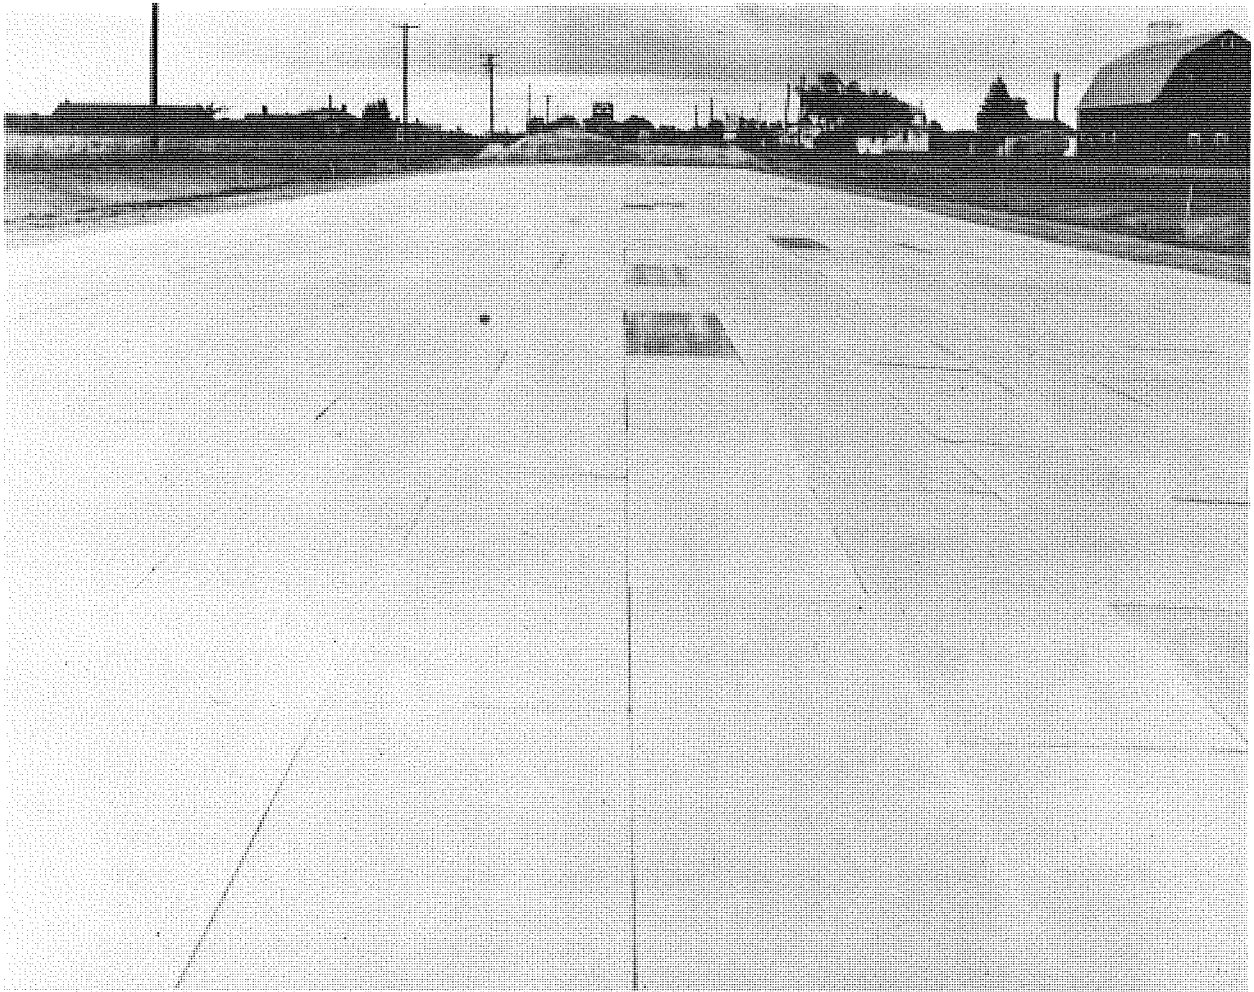
Figure 4. Appearance of Styrofoam in place on subgrade (above), and spreading sand subbase over Styrofoam (below).

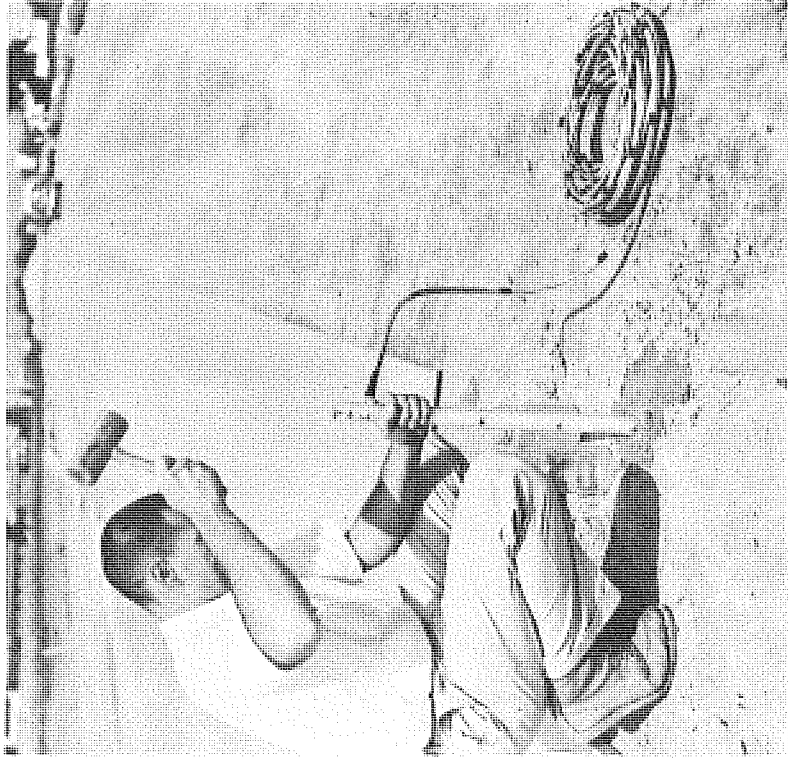
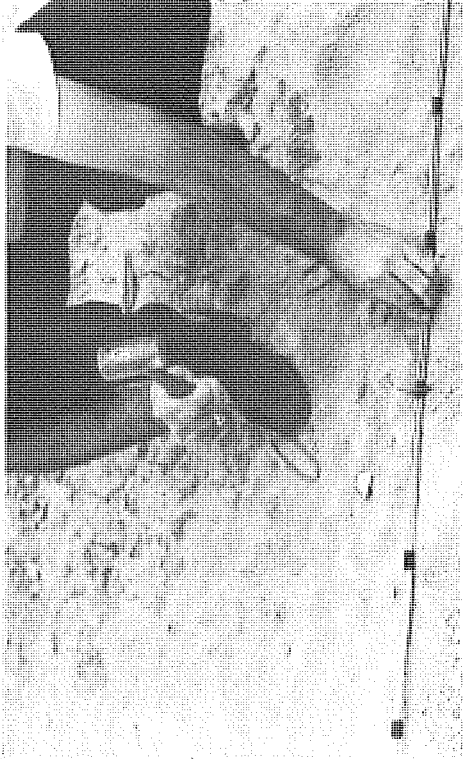
Figure 6. Equipment used in placing thermocouples (upper left), insertion of rod in subgrade (upper right), appearance of installation before covering (lower left), and placement of cables directly on subgrade using U-clips (lower right).

Details of thermocouple installation are shown in Fig. 6. Each polyethylene rod contains four thermocouples, with the four lead cables taped together before insertion into a 1-1/2-in. hole augered in the subgrade. Due to their low coefficient of friction, the polyethylene rods were easily inserted by light tapping into both the subgrade and base

course materials. Thermocouple distances from the top of the rod are fixed so that tamping the top to proper elevation placed the thermocouples in the desired position. Groups of cables were fixed in place on the subgrade by means of U-clips, the cables taken to the edge of the pavement, taped into groups, and led to the recorder shed.

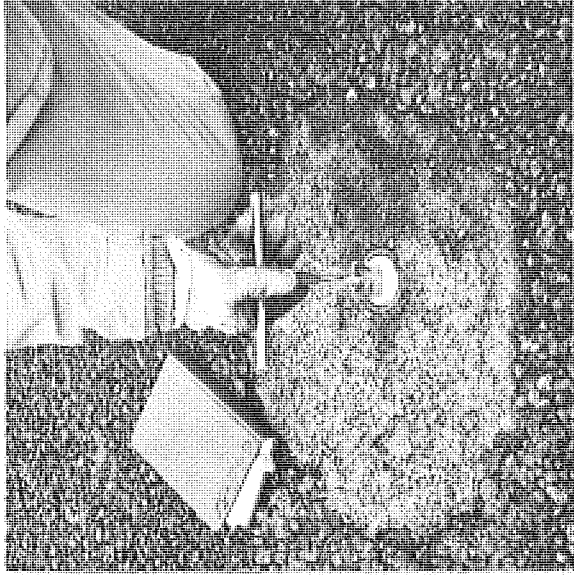
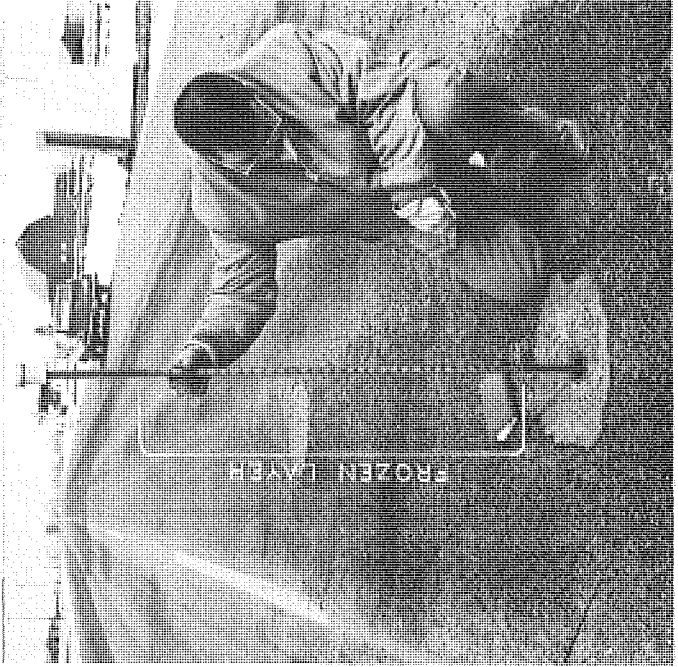
Figure 9. Frost indicator assembly (upper left), indicator head in pavement surface (upper right), reading in insulated section (lower left), and in uninsulated section (lower right).

Fig. 9 shows the principal parts and an assembled view of the indicator, modelled after the Swedish device but made in the Department's Research Laboratory. Basically, the instrument consists of a head, an indicator tube calibrated in inches and containing a dye solution which changes color when frozen, and a plastic liner tube into which the indicator tube can be inserted. The instrument is approximately 6 ft long and 3/4-in. in diameter below the head assembly. The plastic liner tube is about 1-in. ID, which allows free insertion and removal of the indicator tube. It is provided with an anchoring device at the bottom. The indicator dye is a 0.05-percent solution of methylene blue, which at temperatures above freezing is of dark blue color. At lower temperatures, however, the solution freezes into colorless ice and remains in this condition until the temperature rises above 32 F, at which point it reverts to a blue solution.

Two of these frost indicators were placed in the insulated test section and one in each of the control sections at the locations shown in Fig. 5. The top of one of these installations, buried flush with the pavement and sealed in place with cold patching, is shown in Fig. 9. To remove the indicator it is merely necessary to turn the top with the device shown, and lift the head assembly for reading.

One reading in Fig. 9 was taken in the insulated section and shows that the frozen zone (shown by the light portion of the indicator) extends from the surface to the top of the Styrofoam, or about 24 in. A corresponding reading, taken in the uninsulated control section, shows the frozen zone extending to about 44 in. but thawed to a depth of 10 in. from the surface. These tests show how well the Swedish-type indicator can follow the frozen zone in the soil and base course. The device is calibrated in inches of depth below the surface.
