MICHIGAN'S EXPERIMENT
IN
SNOW AND ICE REMOVAL ON HIGHWAYS
BY RADIANT HEAT

Winter Season 1951-1952
Performance and Cost

Highway Research Project 36 G-3(7)
Progress Report No. 5

Research Laboratory
Testing and Research Division
Report No. 190
March 2, 1953

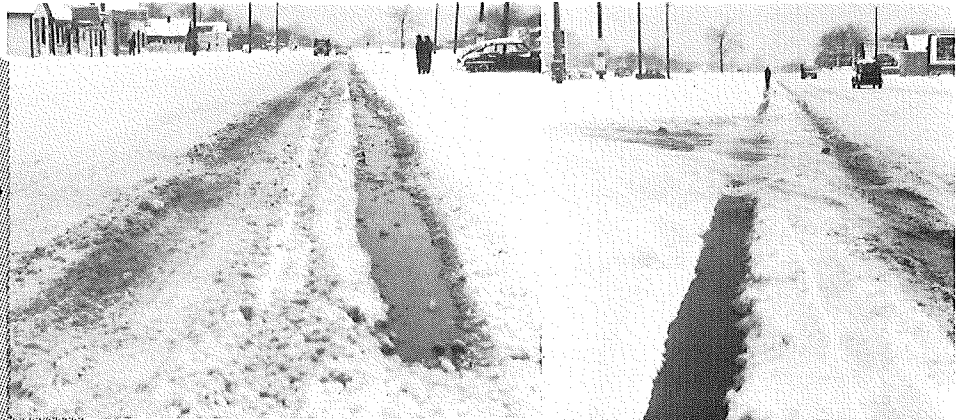
FIGURE 4. BITUMINOUS PAVEMENT 12-18-51 LOOKING EAST. INSIDE TRACK CLEAR, OUTSIDE TRACK COVERED WITH SLUSH.

One of the heaviest snowfalls since the beginning of the experiment occurred during this period. A total of 11.6 inches of snow fell and the average temperature at the site was 17°F. The storm started on the evening of December 17th and the heated areas were observed the following morning after 5 to 6 inches of snow had fallen. The temperature at 8:00 A.M. December 18th was 22°F. The road had not yet been bladed or salted. Snow on the road was so deep that traffic concentrated on the center portion of the 3-lane surfaces. Only half of the heated lanes were being traveled. The untraveled inside tracks of both the concrete and bituminous sections were clear and had apparently handled all the snow falling on them. The outside tracks of both showed only partial melting due to the quantity of loose snow which was continually being pushed on them by traffic from the center lanes. See Figures 3 and 4.

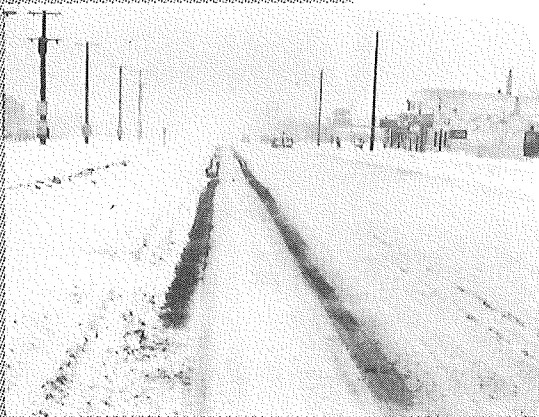
FIGURE 5. CONCRETE PAVEMENT 12-20-51 SHOWING CONDITION OF HEATED SECTIONS.

On December 20th, the heated areas were observed at 10:00 A.M. during a moderate snowfall which began at 6:30 A.M. The temperature was 30°F. The 8-Mile Road in general was covered with 2 inches of loose snow and slush. The less traveled inside tracks on both the concrete and bituminous sections were almost clear except for some splashed slush. The outer tracks of both were being continually

covered by loose snow and slush shoved or thrown over by traffic from the unmelted areas. Ice ridges were forming at the edges and ends, especially on the inside track of the concrete section. This has been a common experience throughout the operation of this project, due to the fact that melted water cannot drain off. See Figures 5 and 6.

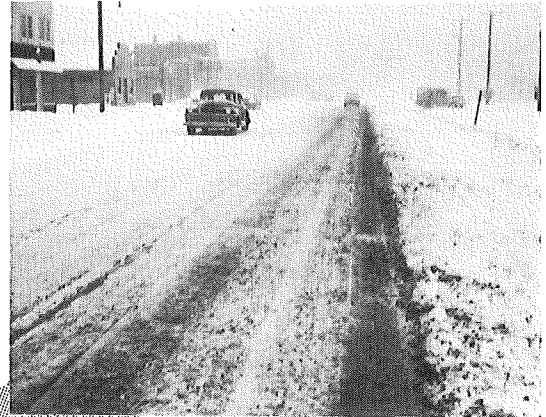
FIGURE 6. BITUMINOUS PAVEMENT 12-20-51 SHOWING CONDITION OF HEATED SECTIONS.

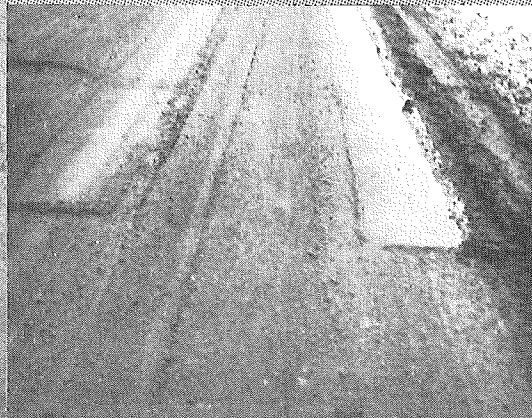
FIGURE 8. BITUMINOUS PAVEMENT 2-20-52 SHOWING CONDITION OF SURFACE.

Snow began falling at 9:00 P.M. on February 19th and by the following morning the fall totaled 1 inch. The snowfall for the entire period totaled 2.5 inches and the average temperature was 28°F. At 8:00 A.M. on the 20th, the snow was turning to rain and sleet. The heated areas were obviously melting all snow and sleet falling on them plus most of the slush being thrown on them by traffic. The bituminous lanes were not as clear as the concrete - probably because of the heavier eastward moving traffic. Thin ice ridges had built up along the sides and ends of the heated areas, forming a neat outline of the grids. The ice ridges on the concrete were somewhat thicker. Also, on the concrete, the ice ridges were much more pronounced on the high side of the crown - phenomenon which must have been caused by the traffic pattern. See Figures 7 and 8.
