EXPERIMENTAL CONCRETE CAPPING
US 127 South of Holt, Project F 33-54, C4
Second Progress Report

Research Laboratory Division
Office of Testing and Research
Research Project 53 F-29
Report No. 353

Michigan State Highway Department
John C. Mackie, Commissioner
Lansing, April 1961

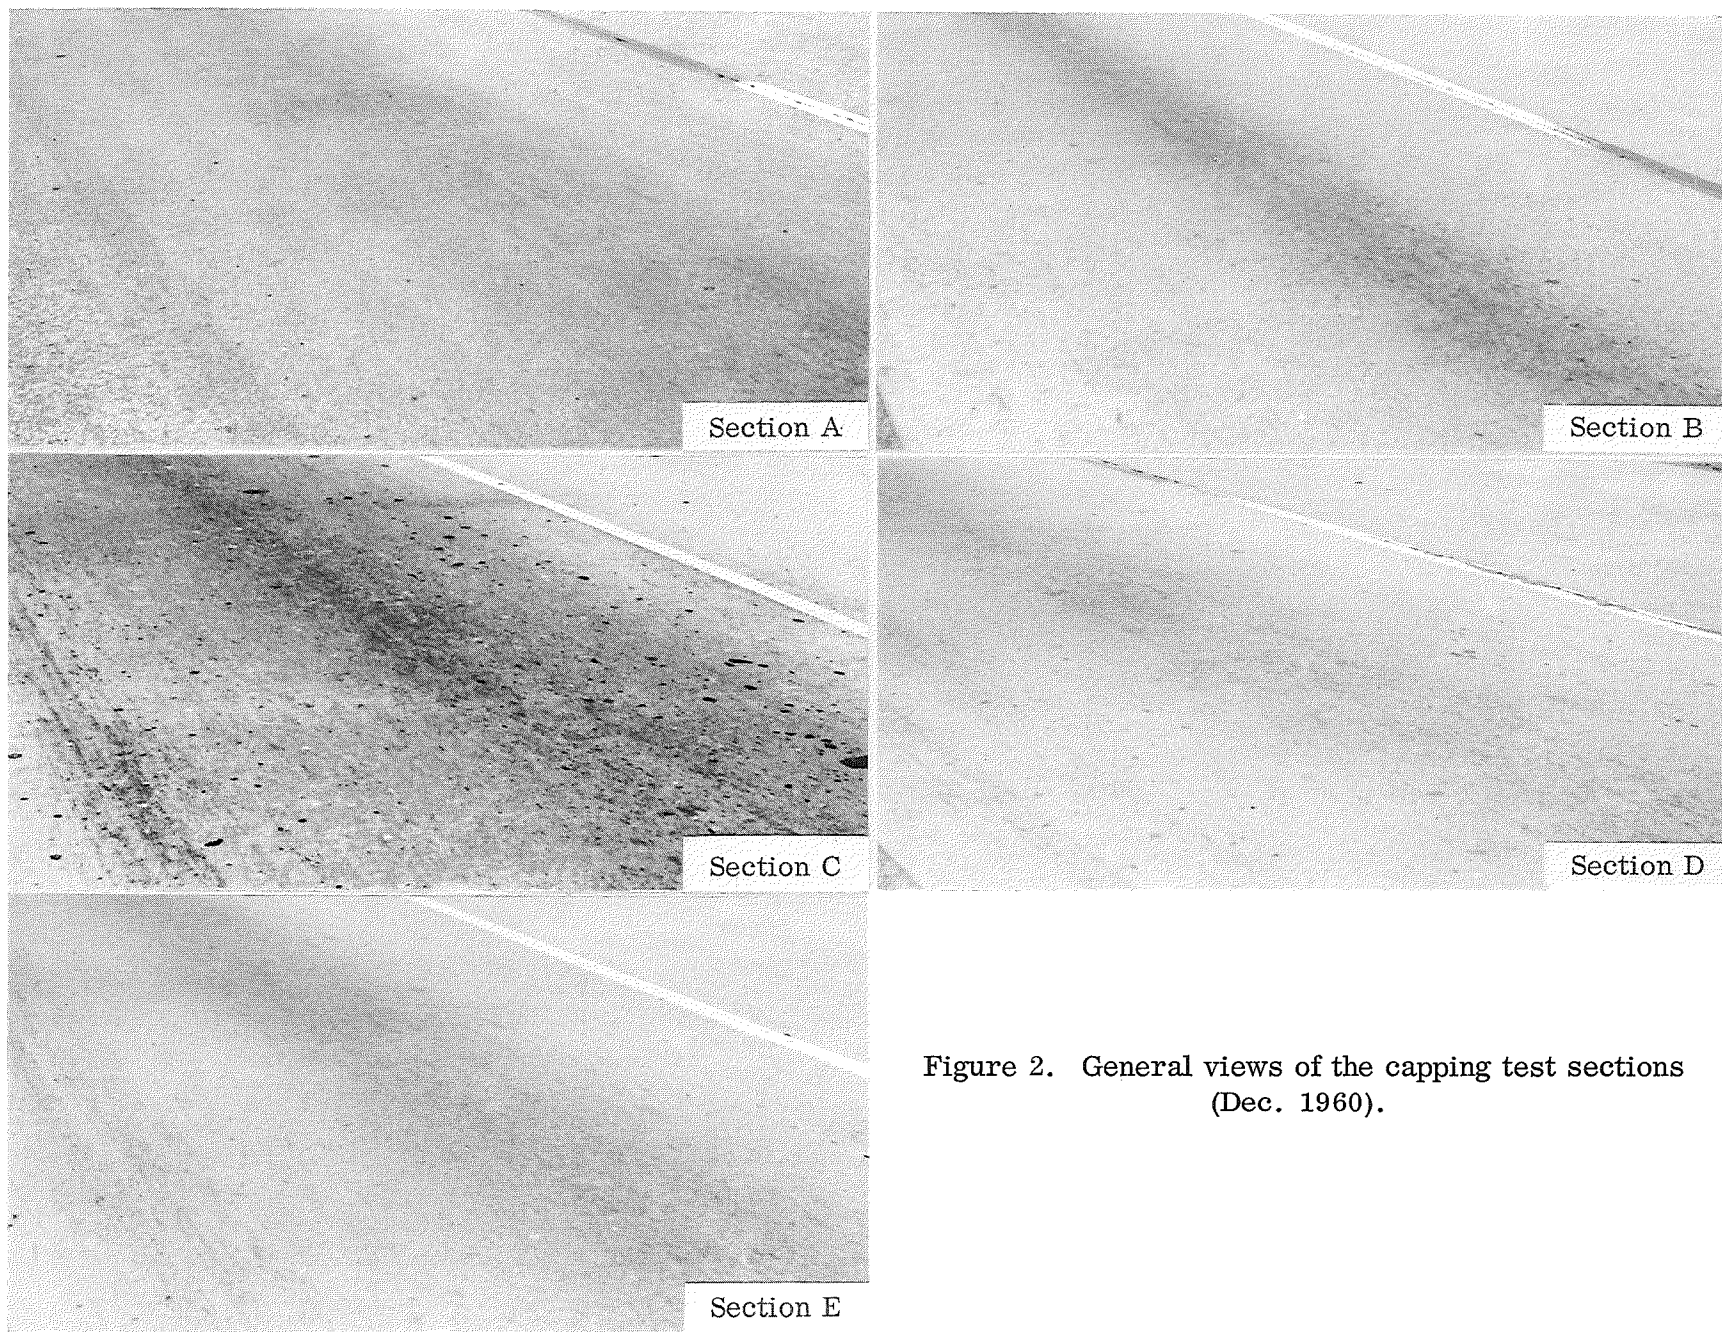
Figure 2. General views of the capping test sections (Dec. 1960).

Typical pavement appearance in each of the five test sections in December 1960 is shown in Fig. 2. Fig. 3 shows the planned cross-section and a photograph taken during joint repair in 1960.
