REST AREA NEEDS STUDY

MAINTENANCE DIVISION
January 1977

Michigan Department of State Highways
and Transportation

Rest Area Needs Study

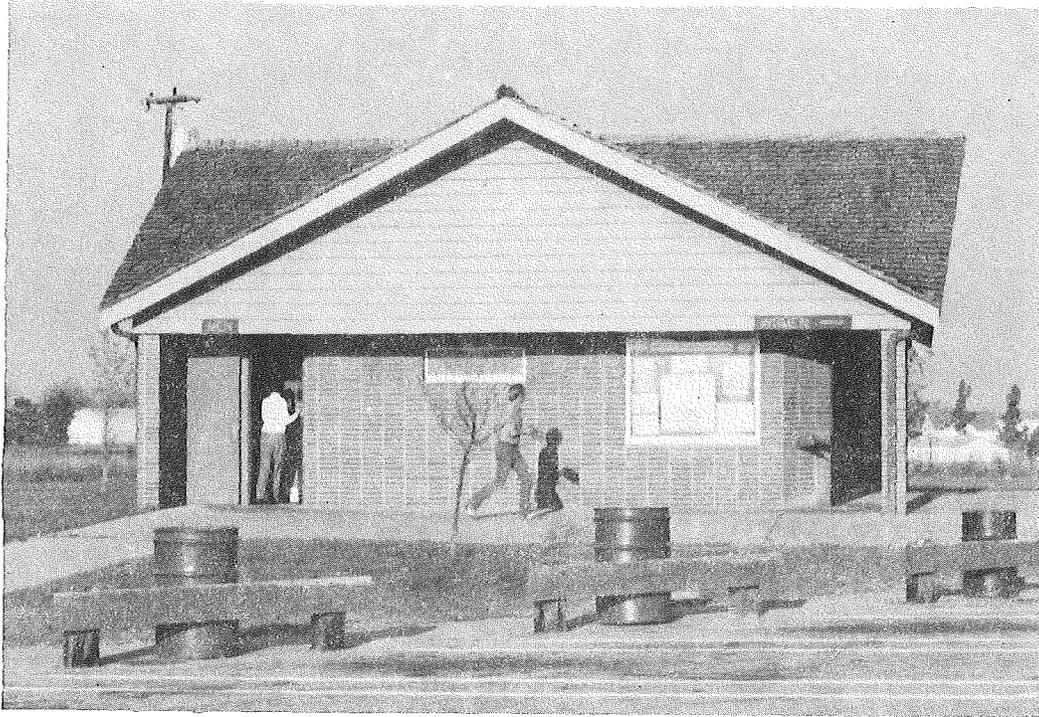
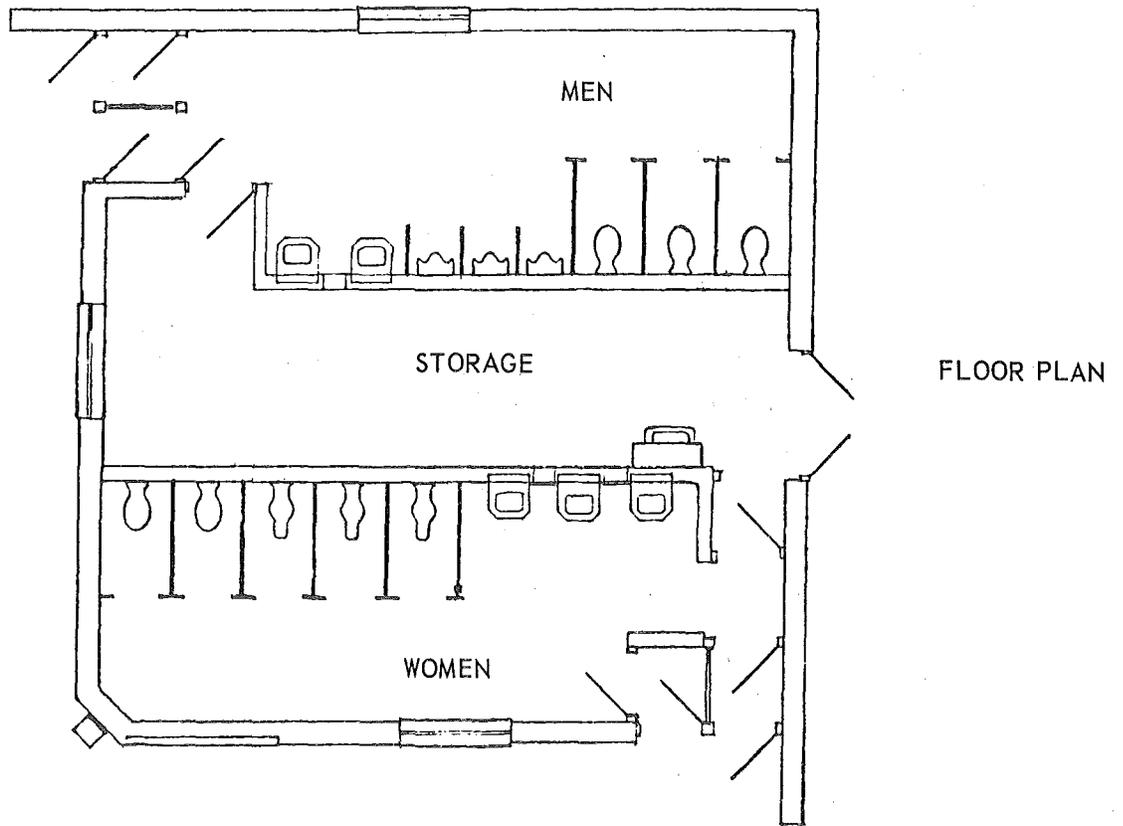
FIGURE 1

Since all of these buildings are about ten years old, most of them are badly in need of major repairs, especially the men's side of the building. Almost without exception, the partitions on the men's side have been repaired repeatedly and in most cases, completely rebuilt. The women's side at most of the facilities is not as bad, but is in need of renovation.

Four Gable Building (Modern-1)

1. Rebuild buildings to accommodate the handicapped, including replacement of exterior doors and changing plumbing so a large toilet compartment can be installed.
2. Rebuild partitions out of concrete blocks.
3. Cover walls and partitions with tile.
4. Replace wall-hung lavatories with built-ins.
5. Replace obsolete electric heating fixtures.
6. Remove remaining towel dispensers and install additional electric dryers where needed.
7. Remove all female urinals and replace with conventional toilets.
8. Install exterior jug filler.

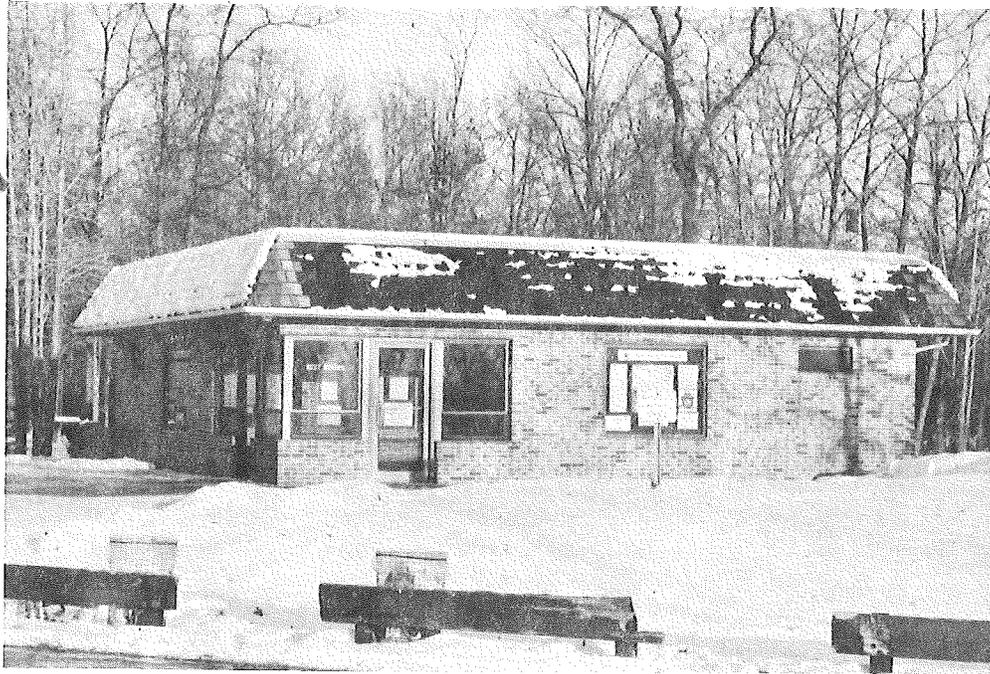
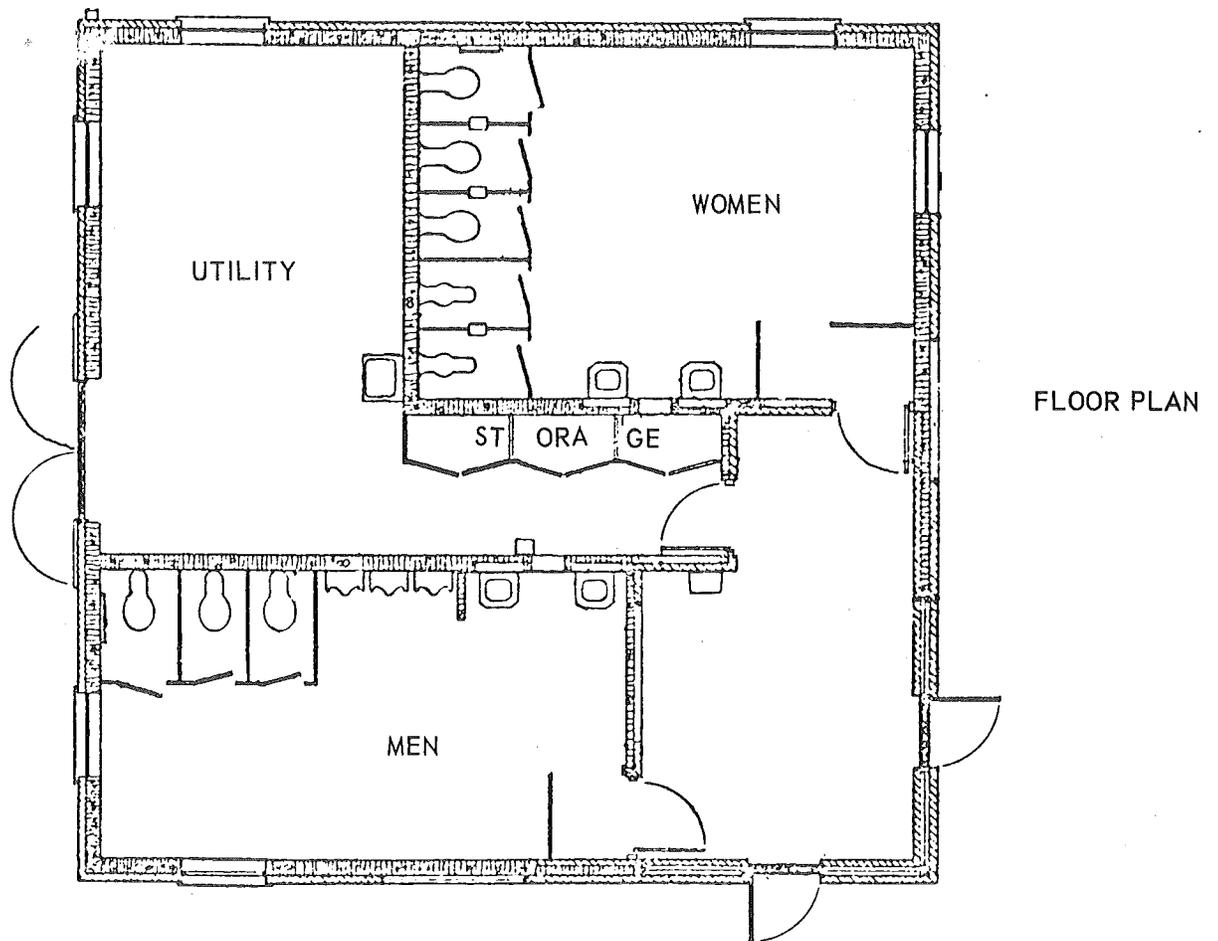
FIGURE 2

Even though these buildings are not as old as the four-gable buildings, many of them need major repairs. In general, with the exception of the handicapped provision, we are making the same recommendations as for the 16 four-gable buildings.

We have also experienced long lines at several of the rest areas equipped with this building. The men's unit at most of these areas seems to adequately handle the traffic, but the women's unit does not have the capacity. Part of the reason for the tie-ups is the reluctance of some women to use the urinals and that fact, plus the fact that small children cannot use them, causes a backup.

Low Mansard Building (Modern-2)

Replacement of the women's urinals with conventional toilets may temporarily solve the problem, but eventually additional toilets will have to be installed.

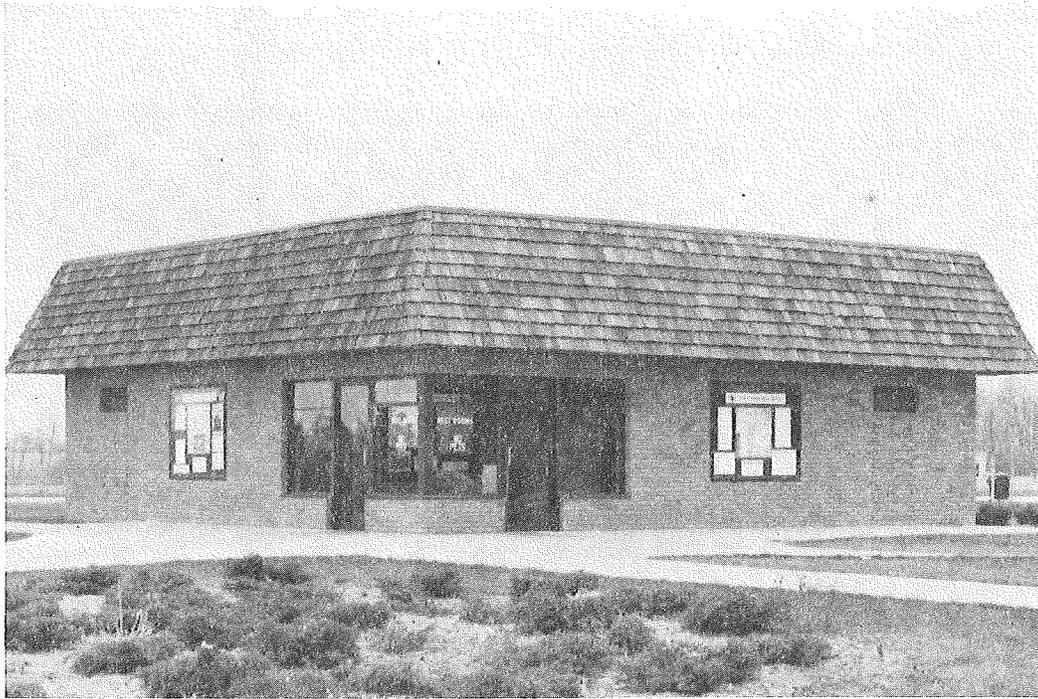
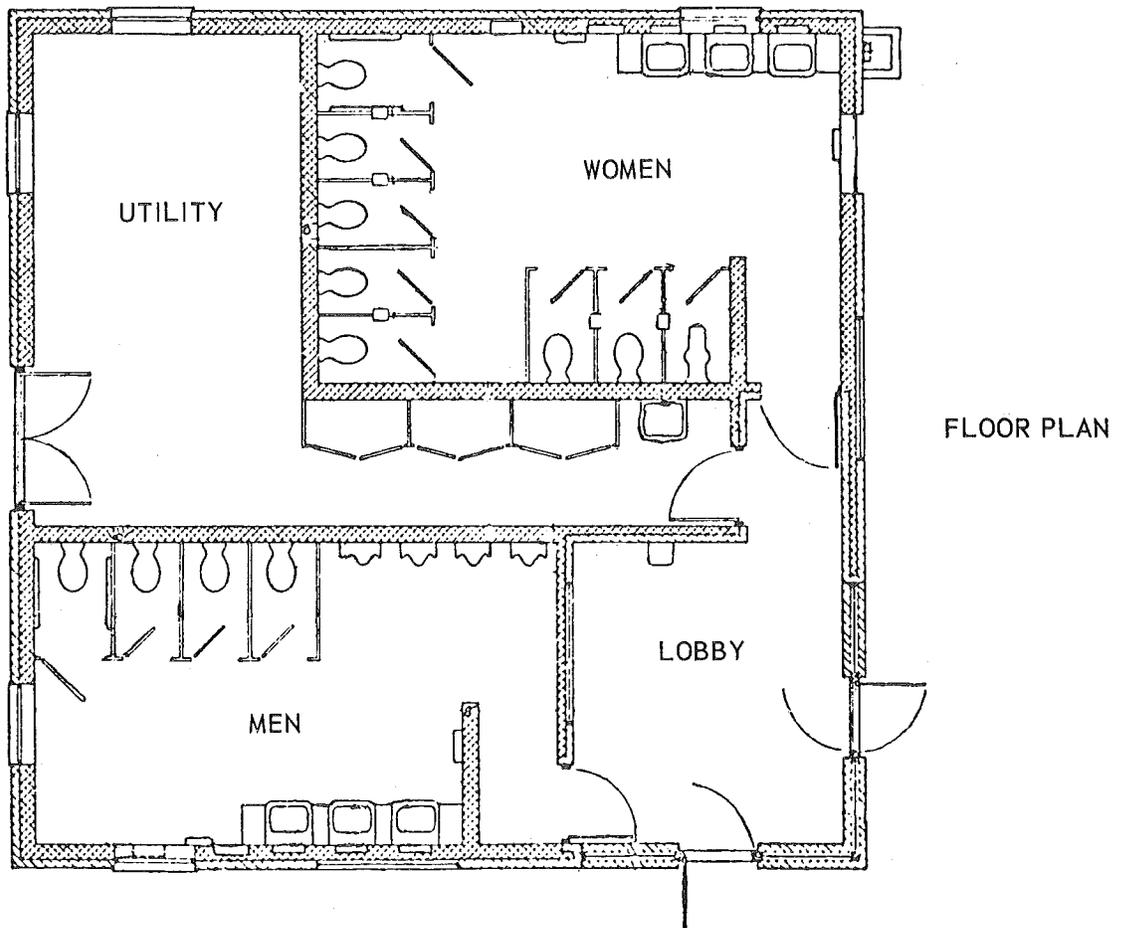
FIGURE 3

High Mansard Building (Modern-3)

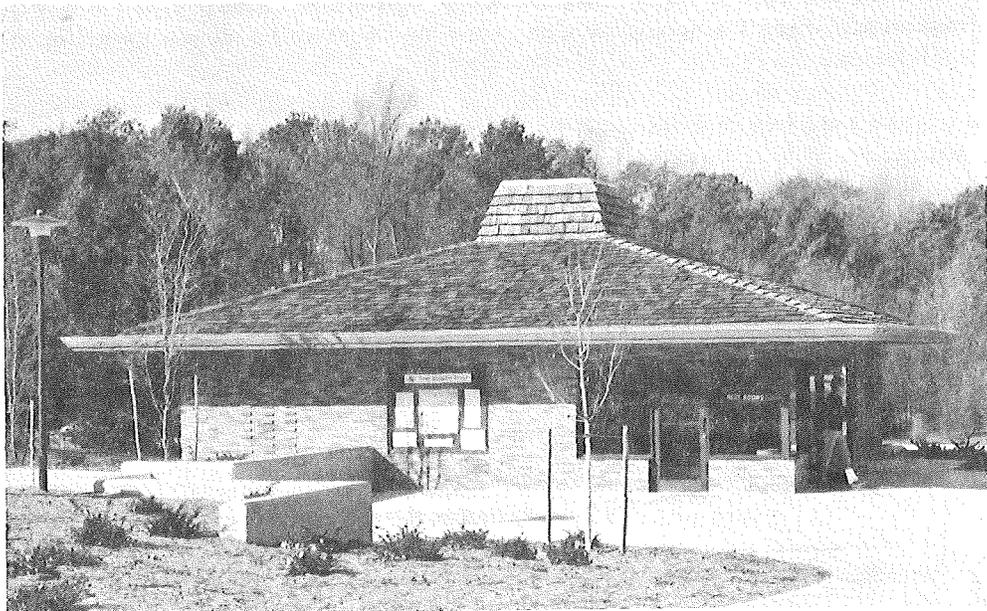
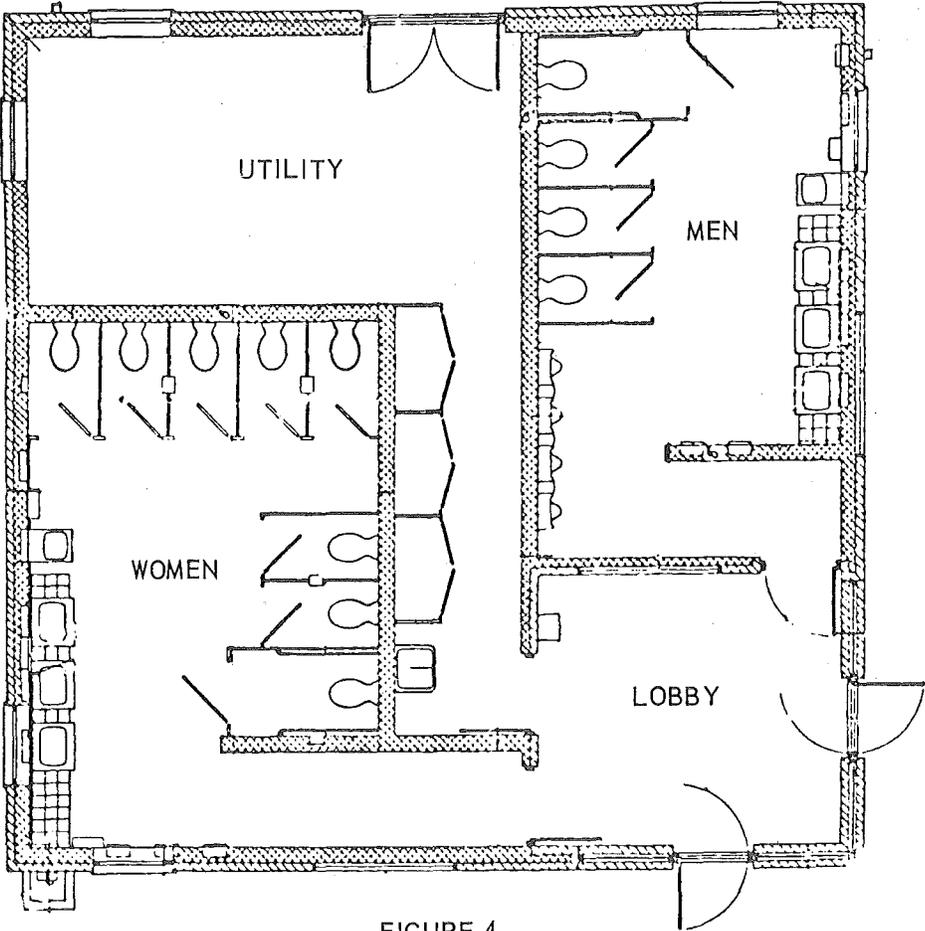
FIGURE 4

Hip-Cupola Building (Modern-4)

FLOOR PLAN

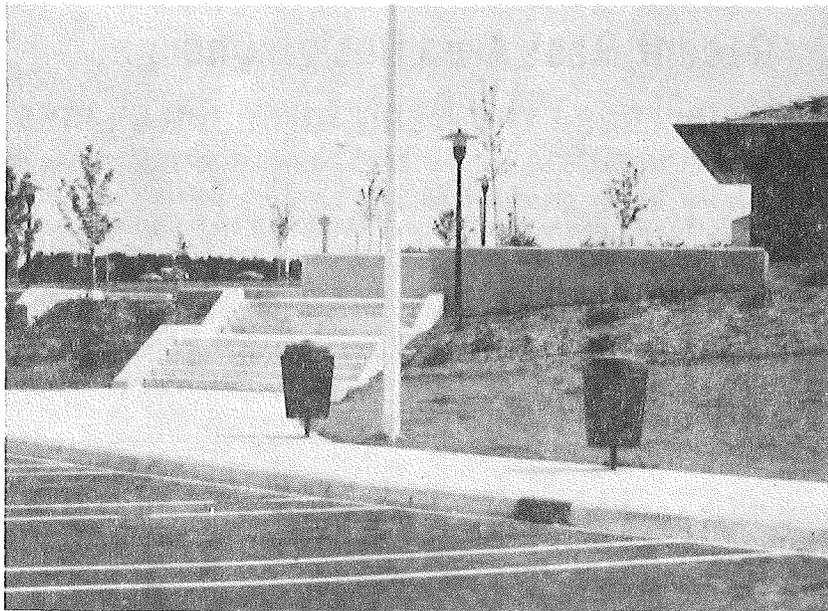
Landscaping at the earlier rest areas was simple and basic and required very little in the way of maintenance to keep it looking presentable. Several of the rest areas recently landscaped have large patio areas with extensive shrub beds, as shown in Figure 5.

The plant species selected for these beds preclude the use of chemicals for weed control so they must be maintained entirely by hand.

FIGURE 5
I-94 Rest Area
at Marshall

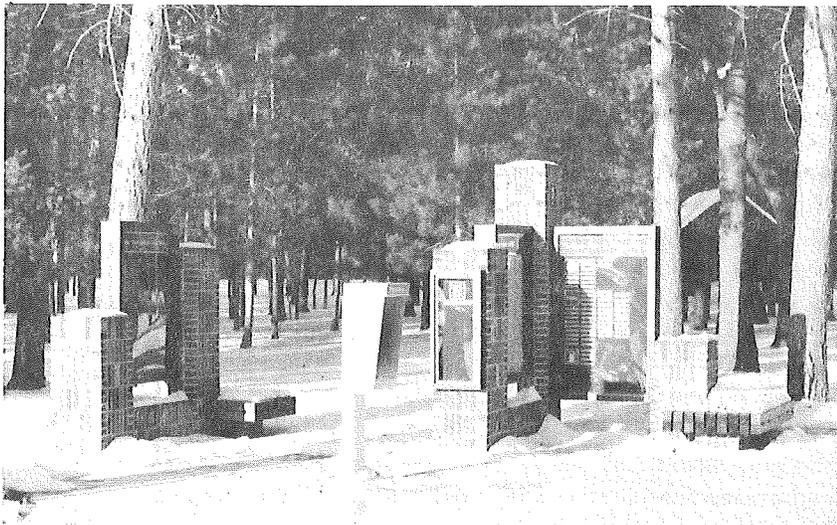
Advertising plazas as shown in Figure 6 are either complete or under construction at ten rest area locations. While the materials in these panels are maintained by another highway agency, the panels themselves and the areas around them are maintained by our division. There is not a lot of maintenance involved, but the snow removal, sweeping and cleaning are additional maintenance responsibilities.

FIGURE 6
Advertising Plaza
US-27 Rest Area Near
Houghton Lake

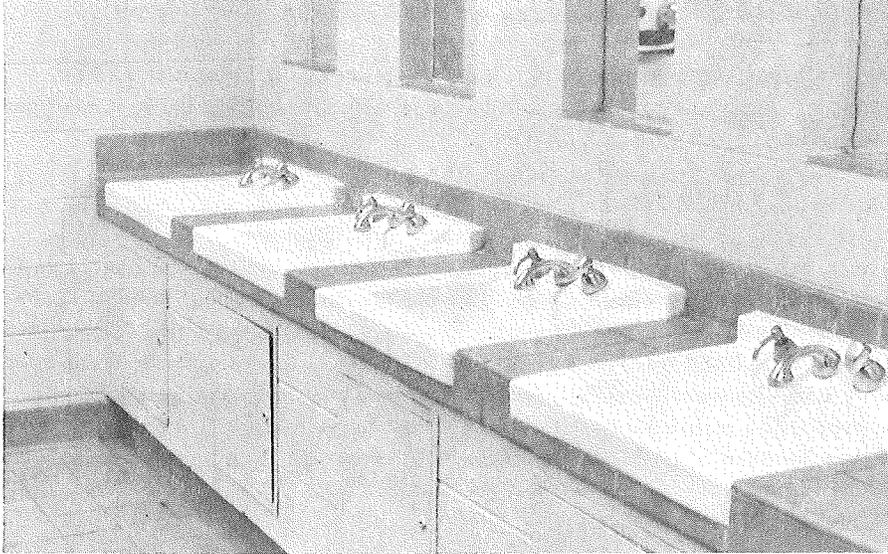
The maintenance inspection doors are often quickly vandalized, locks removed and left to swing. Two of the doors shown in Figure 7 can no longer be locked. We recommend either a more substantial door or a different locking arrangement.

FIGURE 7
Rest Area
Lavatory
Countertop

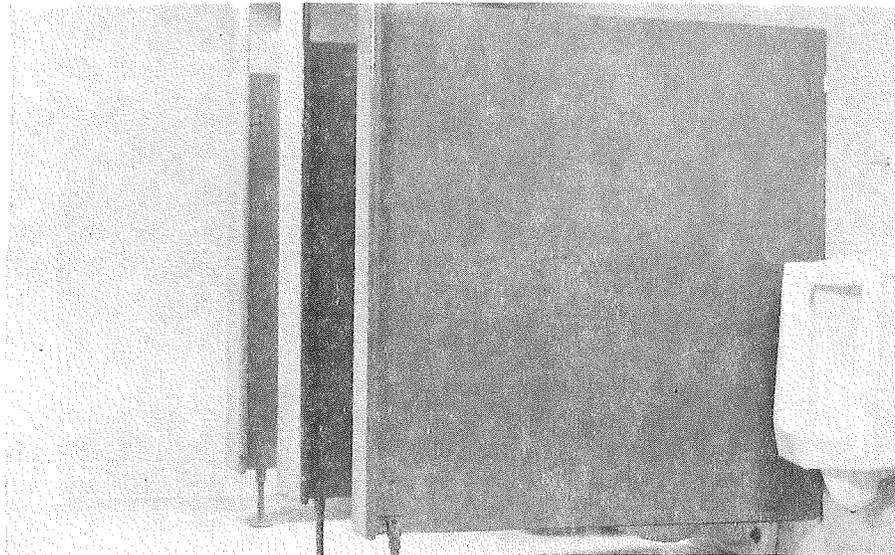
The partitions need replacing on the men's side at about half of our modern rest areas. Figure 8 shows the typical metal partitions used in the M-1 and M-2 buildings. While some of these are badly rusted, most of them have been bent and torn up by vandals. The partitions shown in Figure 8 are not bent but the doors are missing.

FIGURE 8
Metal
Toilet Partitions

It is recommended that a program begin immediately to replace the battered and worn-out partitions and further that they be replaced with partitions constructed of concrete blocks with a tile surface.

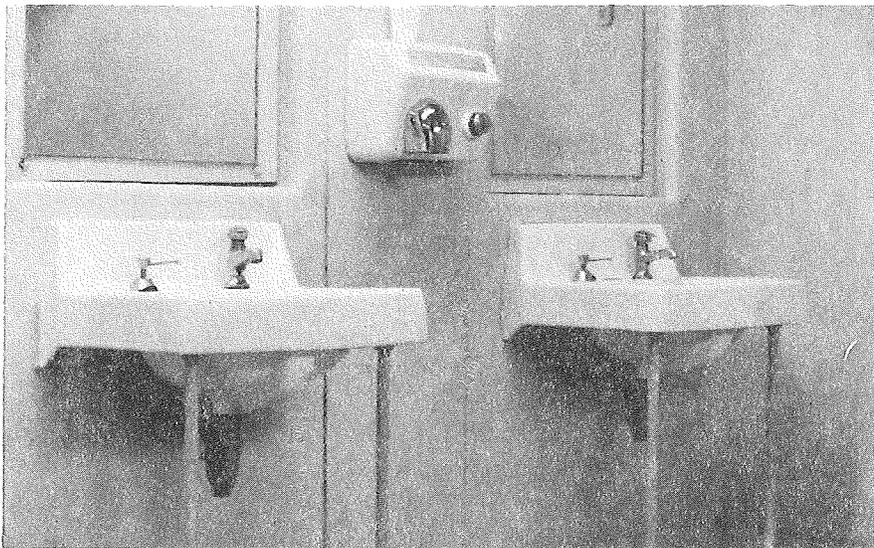
FIGURE 9

A total of 27 of the modern rest area buildings (16 four-gable buildings and 11 low mansard buildings) have wall-hung lavatories as shown in Figure 9.

Wall-Hung Lavatories

If the rest area buildings are going to be renovated, the wall-hung units should be replaced with built-in lavatories on counter tops.

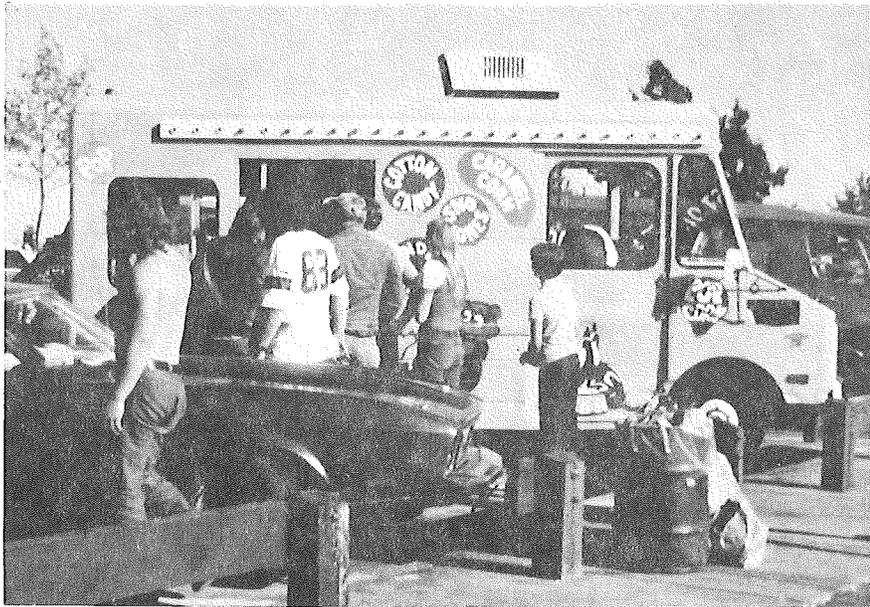
FIGURE 10
Vendor Operating
in a Rest Area.

The vendor shown in Figure 10 was one of two operating in the rest area at the same time. Both had a constant lineup all the time they were observed. The lines at times numbered as many as 18 persons. When the vendors were approached, they refused to leave, demanding identification and authority for asking them to leave.

There are two general problems created by vendors in rest areas. One, of course, is a litter problem. After a vendor has been in a rest area there are ice cream bar wrappers and candy wrappers scattered all around.

Recommended solution: Vending in public places such as rest areas is illegal. Our rest area attendants have a copy of the law, but reporting the vendor does not very often result in any positive action. If the vendors were ticketed and fined the problem would eventually be solved. A letter to the State Police Director requesting cooperation may be necessary.

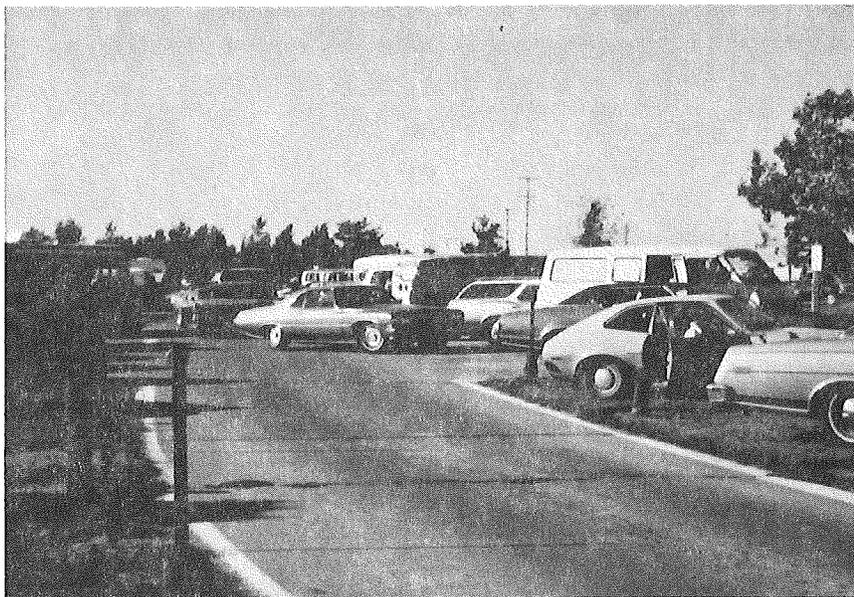
The other problem is a parking problem. Not only do the vending trucks take up parking places, but the average length of stay of the rest area user is increased. For example, if the length of stay is doubled, the available parking spaces per hour are cut in half. Figure 11 shows a rest area where vendors were operating.

FIGURE 11
Parking on Lawn
at Rest Area Where
Vendors Were Operating

At the time the picture in Figure 11 was taken, there were approximately 15 cars parked outside of the parking lot.

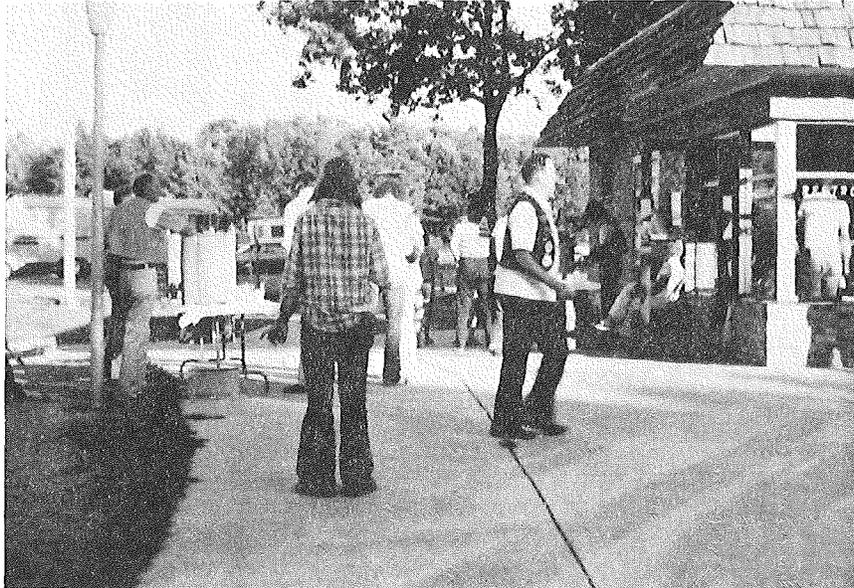
Not all of the clubs are in it for the money, however. Figure 12 shows the operation set up by a Lion's Club at a rest area on I-75. They did not use any of our facilities. The coffee was made in one of the club member's homes and brought to the rest area in large thermos urns. They emphatically refused donations and asked people to pick them up when coins were left on the table.

FIGURE 12
Coffee Serving
at Rest Area

At this location there were problems even though the club ran a good operation in accordance with their permit. The main problem was the extended length of stay by rest area users causing a traffic jam in the rest area.

Recommended Solution: Since rest area parking is at present under-designed for peak loads, we recommend that further coffee-serving requests be denied.

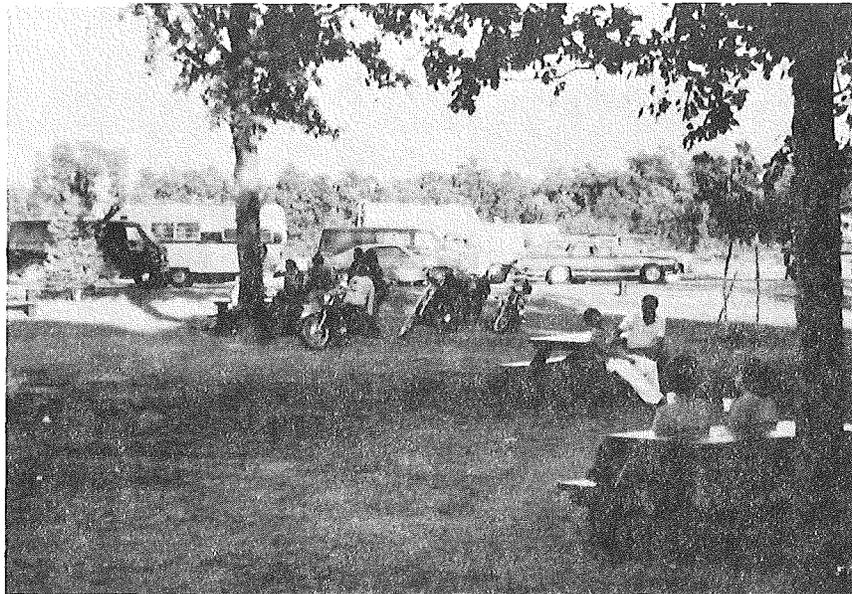
Figure 13 shows motorcycles parking on the lawn.

FIGURE 13
Parking on Lawn

At times there were 20 to 25 cars improperly parked and cars passing through without stopping because of the lack of parking.

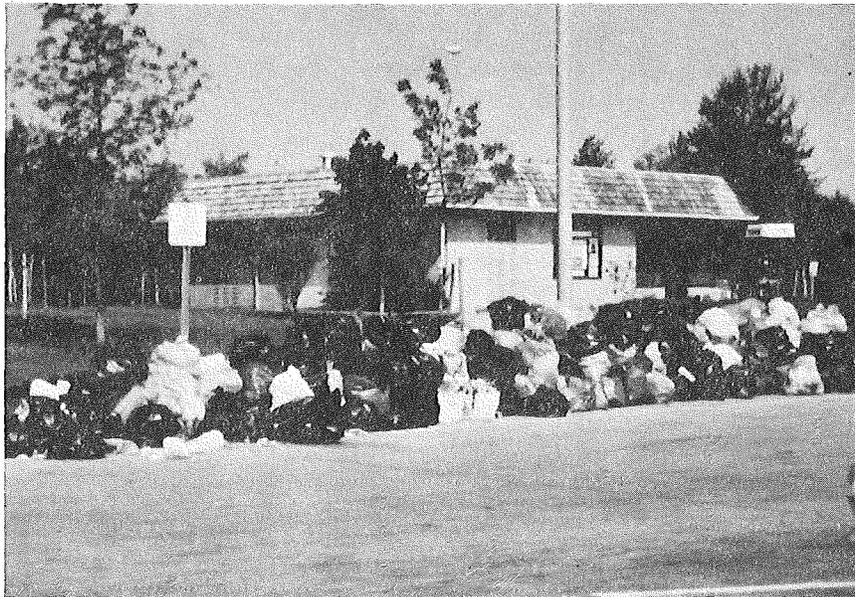
No other agency in the state has felt the adverse effect of the 1965 and 1967 refuse laws to the extent that the MDSH&T has been effected. Dozens of roadside table sites have been discontinued because they were literally buried in garbage. Figure 13a shows one of four piles of garbage which accumulated in the Alger rest area on a typical summer weekend.

FIGURE 13a
Household Garbage
Left at Rest Area

Recommendation: Continued pressure should be exerted on violators so they will eventually find areas to properly dispose of their garbage. Last summer a survey was conducted at the Alger rest area on a Sunday to determine how the rest area was being used. The presence of the Highway vehicle and the personnel making the survey resulted in a fifty percent reduction in the amount of garbage on that particular weekend. This type of deterrent may be used in selected areas in the future.

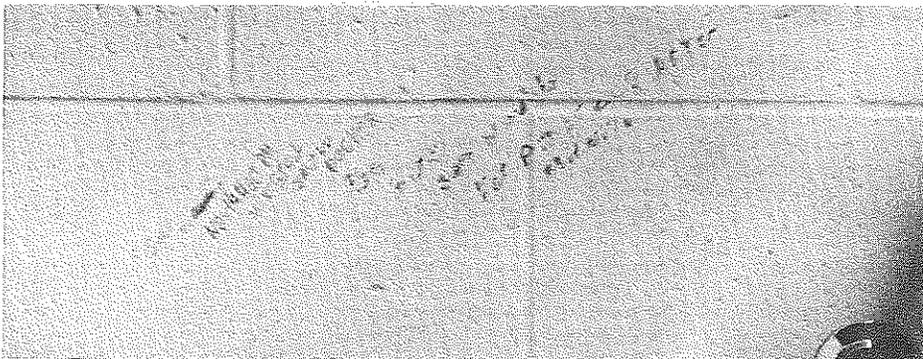
In addition, the walls and partitions are continuously defaced with appointments and obscene writing as shown in Figure 14.

FIGURE 14
Writing on
Restroom Wall

It is a constant challenge for the attendant to try to find soaps or abrasives which will remove the writing done with various types of pens and magic markers. When the writing cannot be removed, the area must be painted over, which usually doesn't blend in with the rest of the wall.

Tile to prevent the writing and concrete to prevent the cutting of peek holes. Tile has been installed at one of the rest areas where we had a problem with writing on the walls and found that, even though there was still some writing, the walls were more easily cleaned.

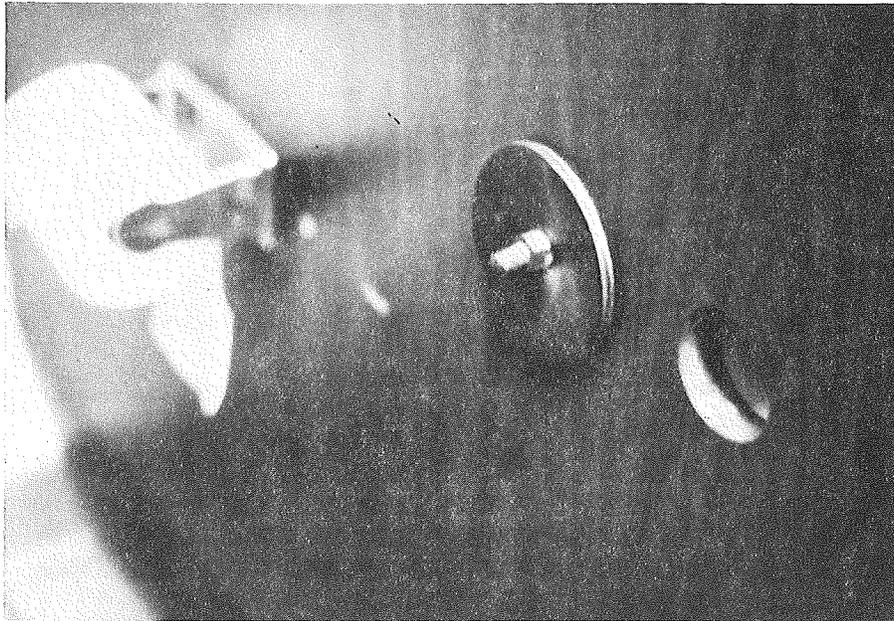
Another problem is the vandalism caused by drilling or cutting holes through the toilet stall partitions. Figure 15 shows where a 2" hole was plugged up with a bolt and two washers, only to have another hole drilled right beside it. Holes are cut in both metal and wood partitions.

FIGURE 15
Holes Drilled
in Partition

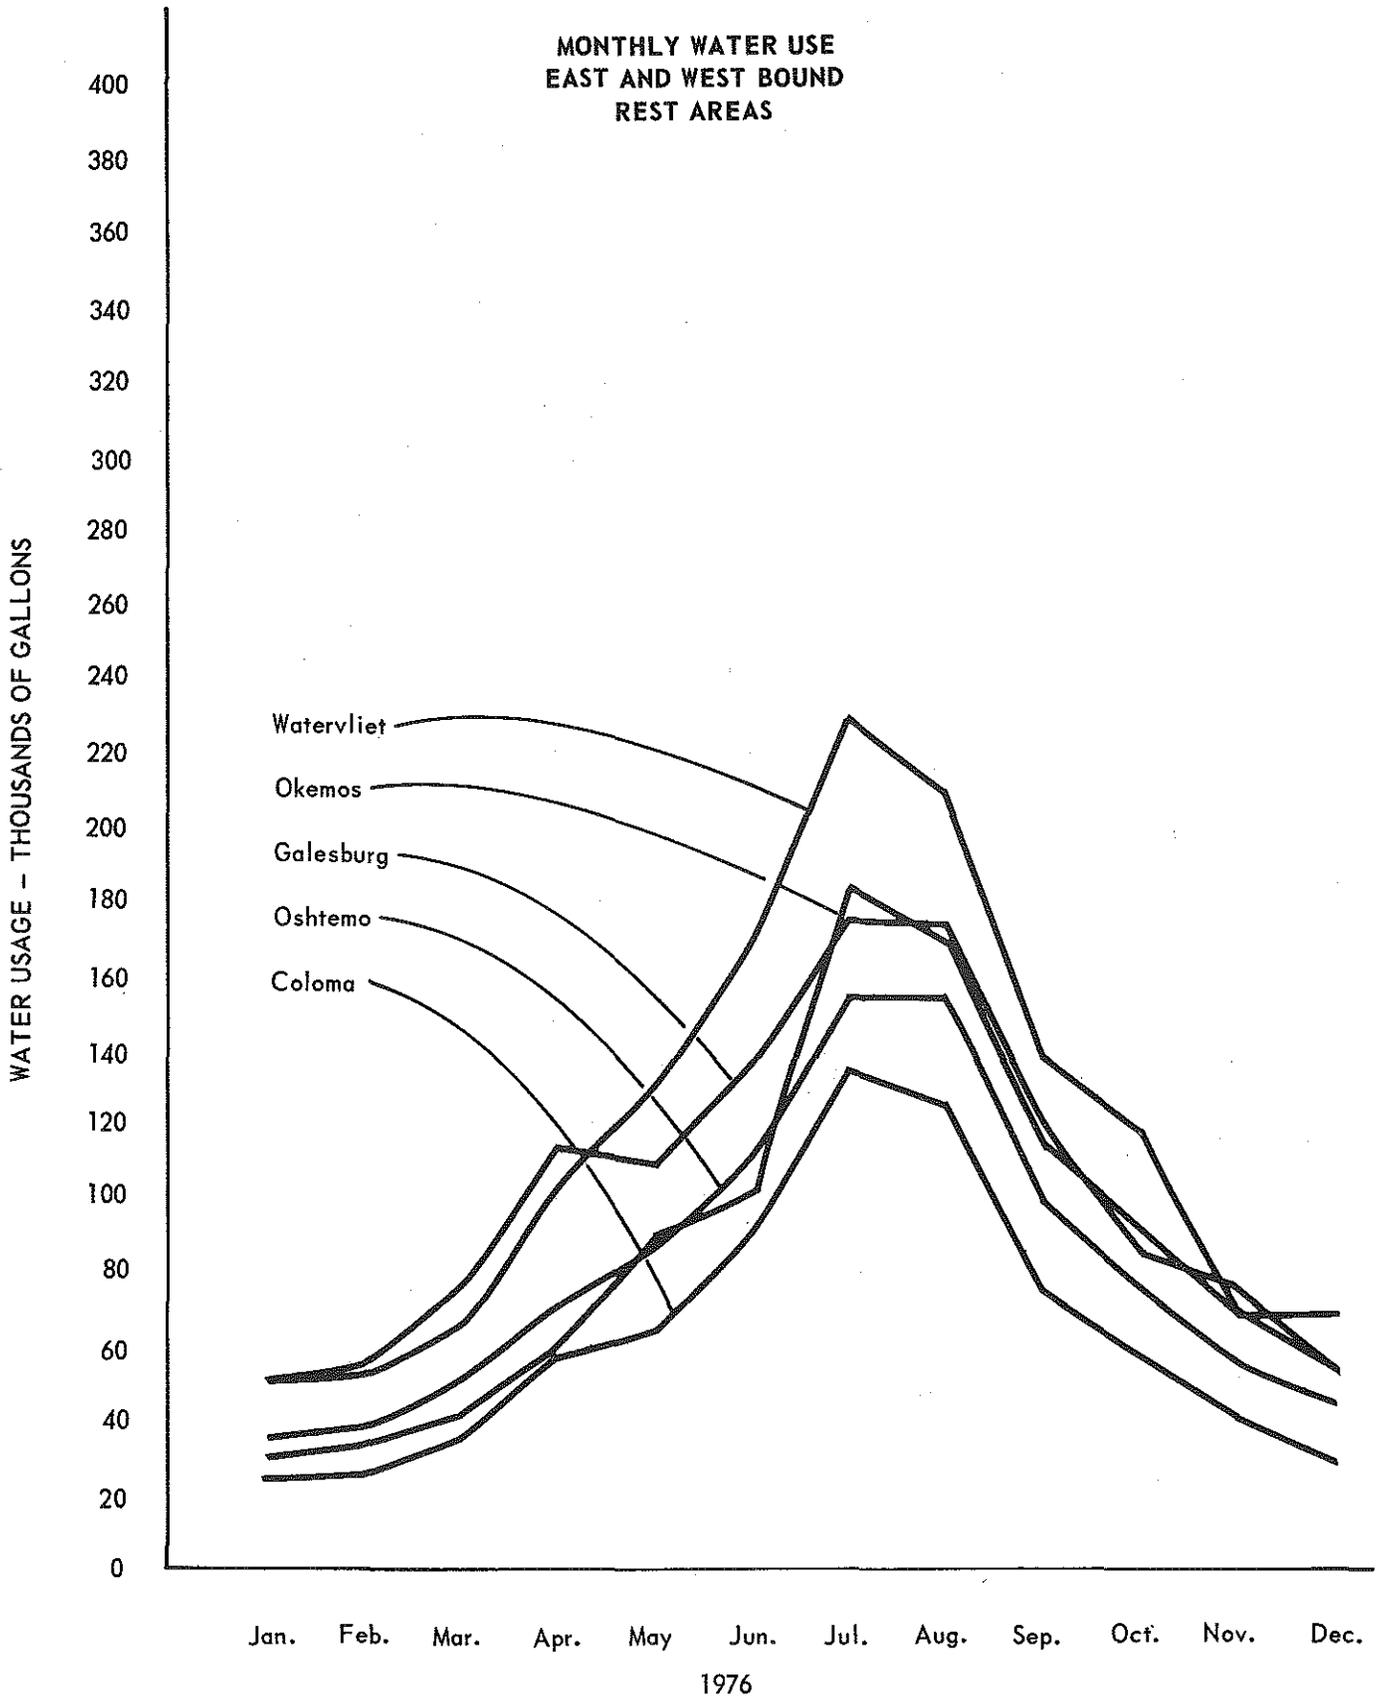
FIGURE 16

MONTHLY WATER USE
EAST AND WEST BOUND
REST AREAS

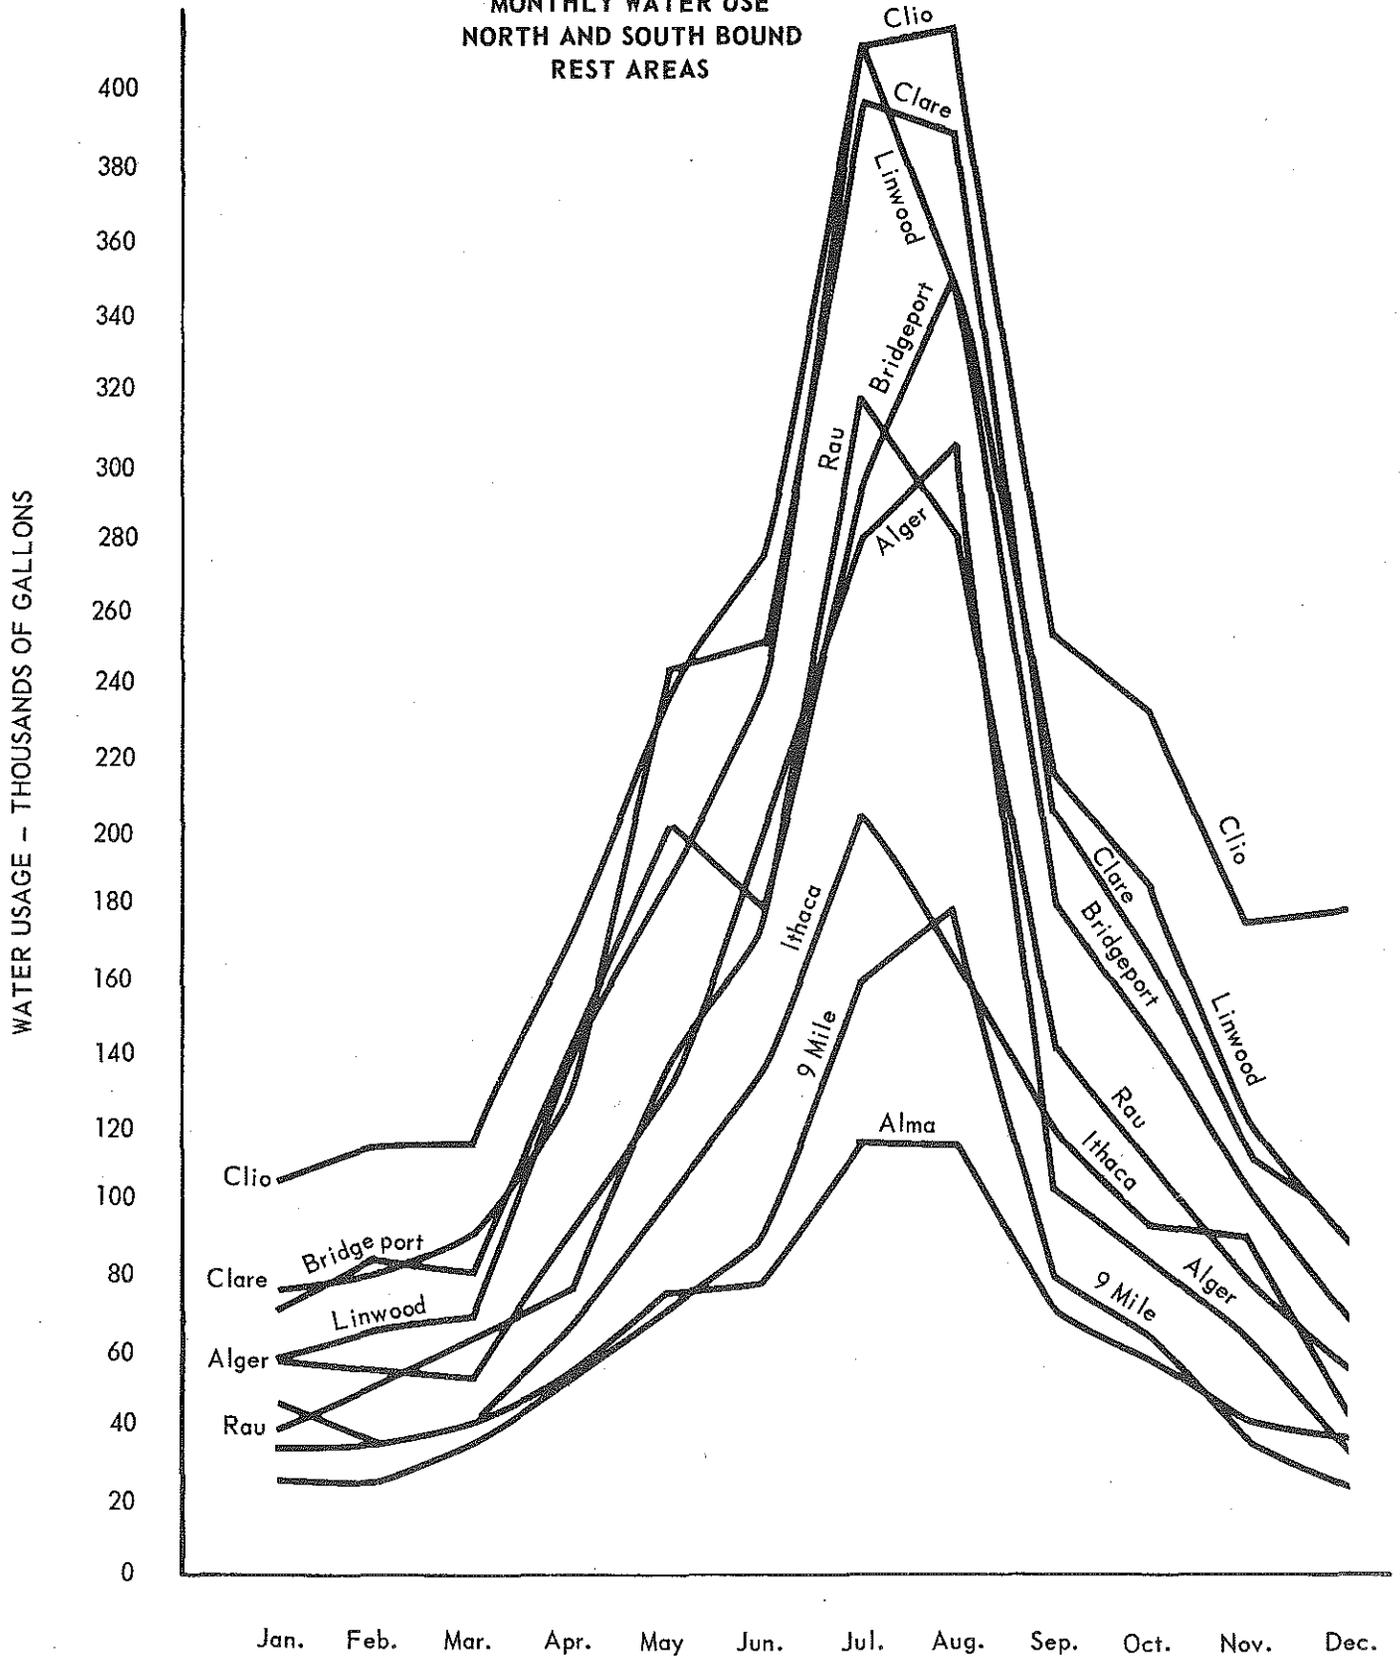
1976
FIGURE 17

MONTHLY WATER USE
NORTH AND SOUTH BOUND
REST AREAS

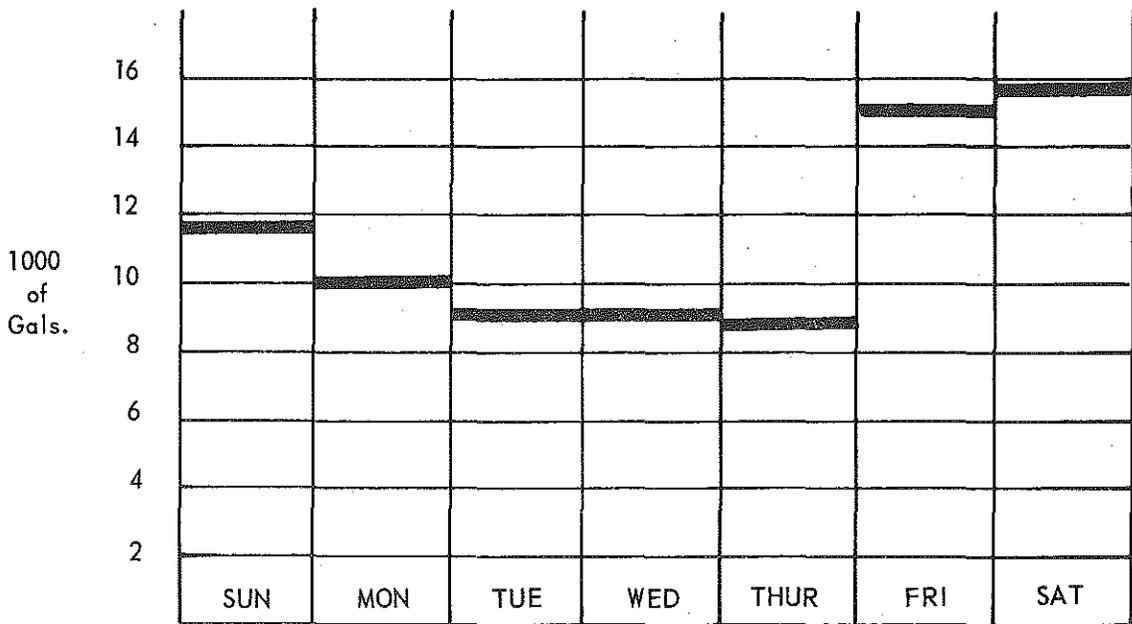
FIGURE 18

**REST AREA WATER USAGE REPORT
BREAKDOWN BY DAY OF WEEK**

(1) NOT USED BECAUSE OF THE INFLUENCE OF THE HOLIDAY WEEKEND
