EVALUATION OF MDOT MAINTENANCE  
DIVISION SEAL COAT PROJECTS  
Final Report

Research Laboratory Section  
Materials and Technology Division  
Research Project 87 TI-1252  
Research Report No. R-1306

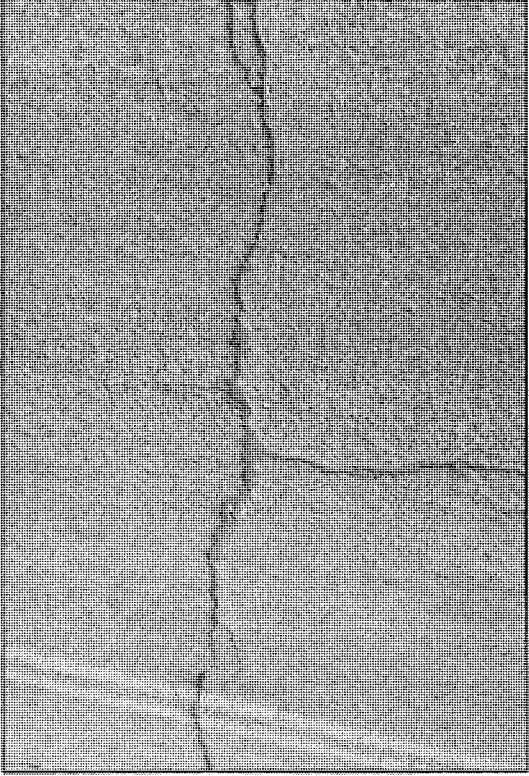
Figure 3. Cracks open before seal coat placement with seal coat intact and seal coat deteriorated.

On seven of the projects (those in Districts 2, 3, 4, and 8) there were open cracks which were filled with seal coat during placement. The 1987 survey found that in 95 percent of these cracks the seal coat had not deteriorated (Fig. 3) and in the 1988 survey in 90 to 93 percent of these cracks, the seal coat was still intact. However, by 1989 cracks with undeteriorated seal coat had reduced to 40 percent for projects in District 8 and to 80 percent for projects in Districts 2, 3, and 4. This difference could possibly be due to: 1) lower traffic counts in Districts 2, 3, and 4 than in District 8 (Table 3); 2) lower numbers of freeze-thaw cycles in Districts 2, 3, and 4 than in District 8.

Crack that was open prior to seal coat placement that was filled with seal coat but seal coat has completely deteriorated in 1987.

Sealing of cracks open 1/2 in. or more prior to placement of the seal coat appears to reduce the amount of reflective cracking showing through the seal coat and also reduces the width of reflective cracks that occur later.

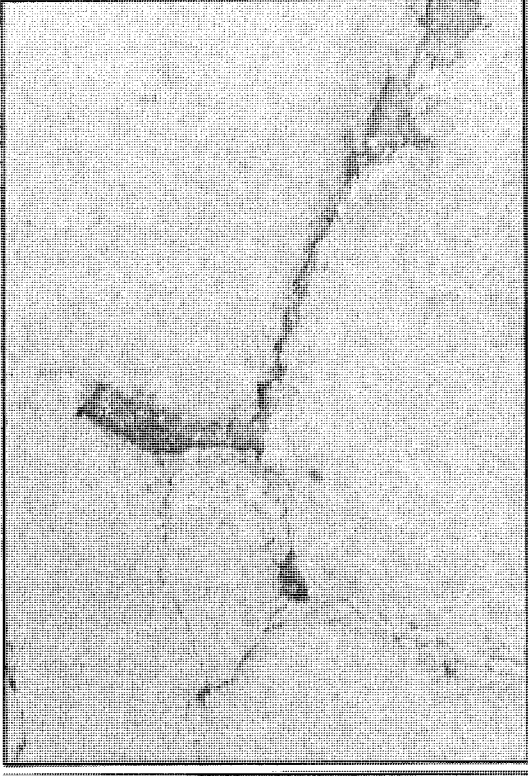
Crack that was open prior to seal coat placement that was filled with seal coat but seal coat has completely deteriorated in 1988.

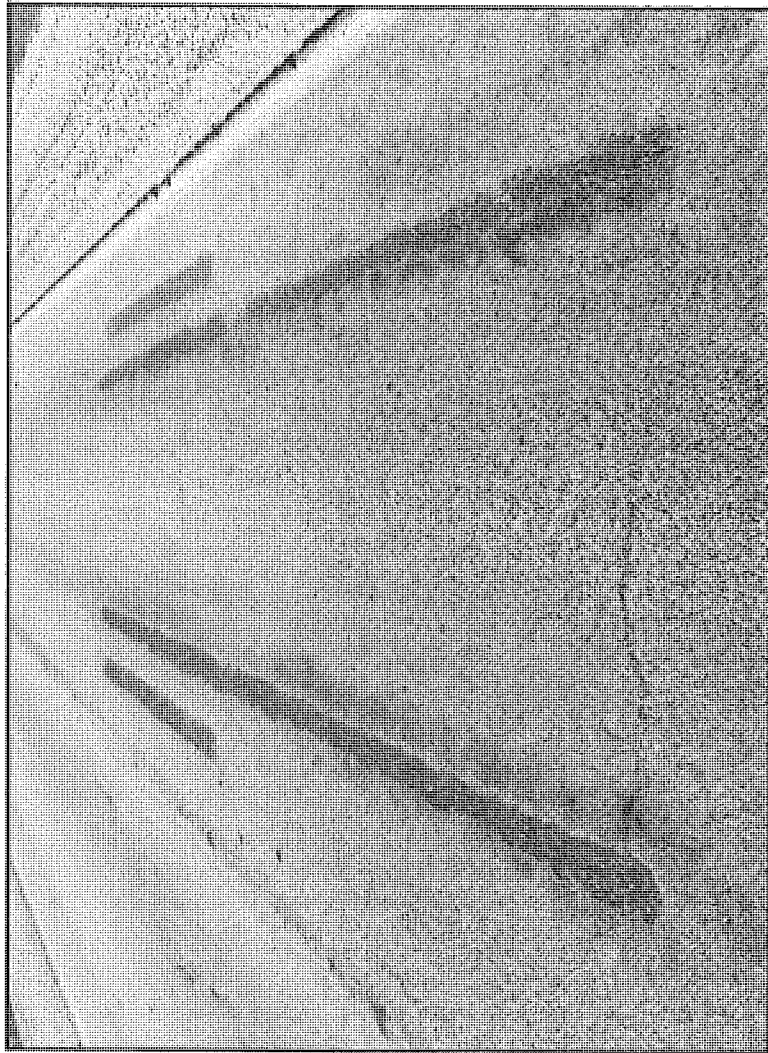
Figure 4

On six of the projects there were isolated spots where the seal coat had been completely removed due to acceleration and/or deceleration of traffic (Fig. 4). In 1987 and 1988 this type of deterioration comprised approximately 5 to 10 percent of the length of each project. By 1989 the deterioration had increased to 7 to 15 percent of the length of each project. These areas generally occurred at intersections, driveways, on curves, or on hills.

Loss of aggregate and emulsion due to acceleration or deceleration on level road.

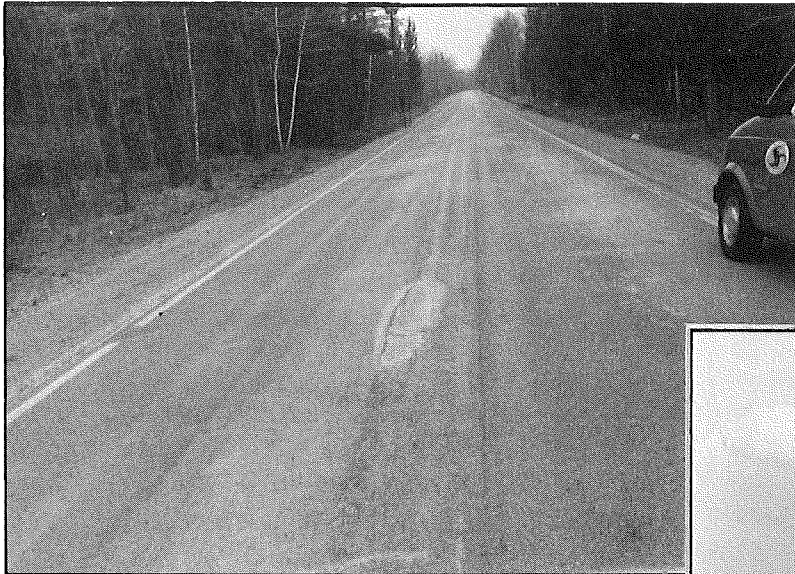
Figure 5.

On four of the projects there were areas where the seal coat had been completely removed by maintenance and/or snow removal equipment (Fig. 5). The amount of removal ranged from just small areas (where a small circle or oval area at the center of the lane or the wheelpath had been removed) to the complete loss of the seal coat over the entire lane for several feet in the direction of traffic. For each project these areas comprised approximately 1 percent in the 1987 survey and increased to 3 to 5 percent by the 1989 survey.

Loss of aggregate and emulsion at center line of road due to dragging of grader blade on high spots.

Most of the damage to the seal coats resulting in the loss of aggregate or the complete loss of the aggregate and asphalt emulsion appears to have been caused by snow removal or road maintenance equipment. However, the damage caused by the snow removal equipment cannot be completely eliminated because of the need to keep the roads clear of snow and ice in the winter.

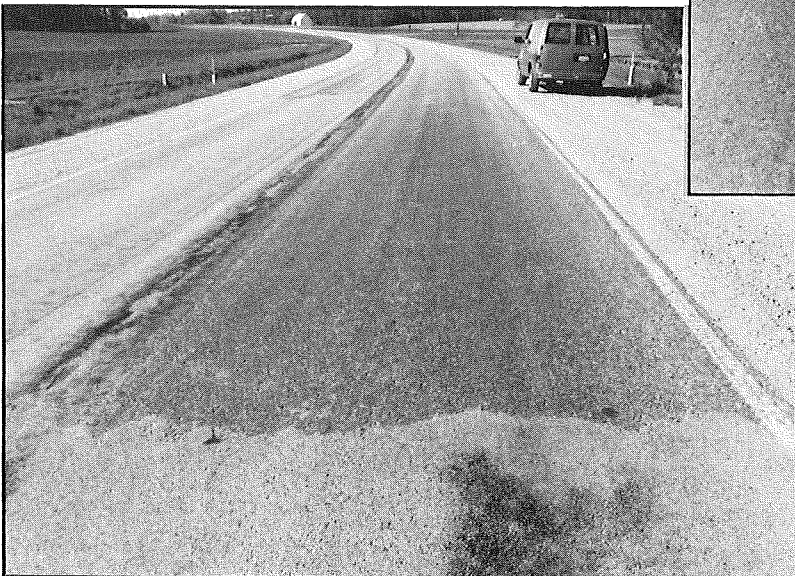
Loss of aggregate and emulsion from turn lane for Stone Road.

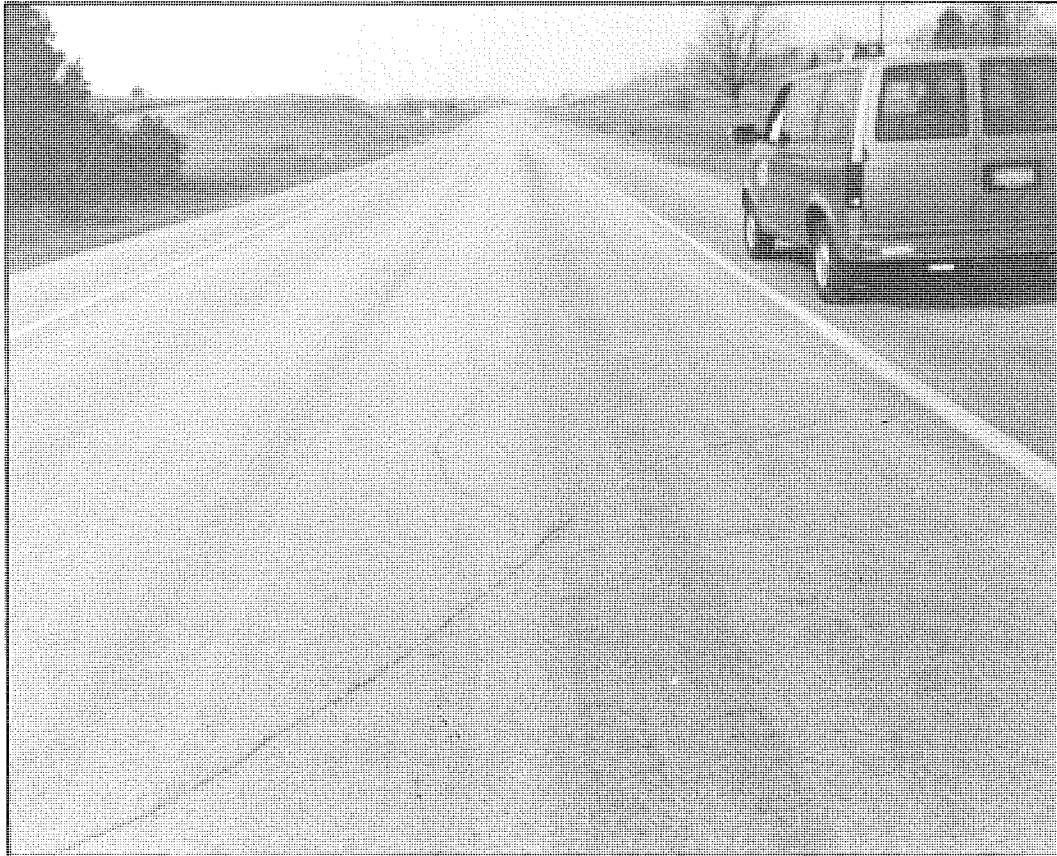
Figure 6. Scraping of center line and center of wheel paths showing loss of aggregate only.

On all but one project (Project No. 4 on M 209) there were indications of scraping along the centerline of the roadway and the center of the lane by snow removal equipment. The severity of this scraping ranged from the loss of some of the aggregate to the complete loss of aggregate and emulsion where there appeared to have been frost heave around open cracks (Figs. 6 and 7).
