ROAD SURFACE FRICTION
FROM THE STANDPOINT OF
AUTOMOTIVE AND HIGHWAY ENGINEERS

For Presentation at the Meeting of the
Association of Paving Technologists
Cleveland, Ohio

February 13 - 15, 1956

P. C. Skeels, Head
Experimental Engineering Department
K. A. Stonex, Head
Technical Data Department
General Motors Proving Ground
and
E. A. Finney, Research Engineer
Michigan State Highway Department

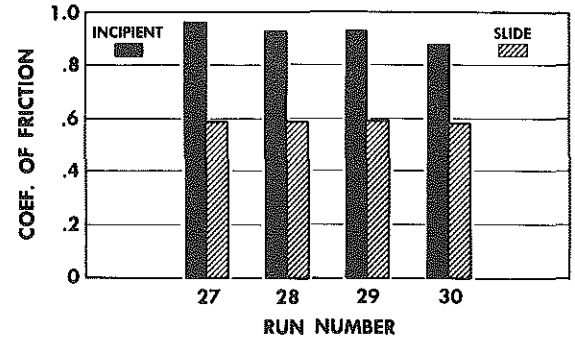
Figure 10—Incipient and sliding coefficients of friction at 40 mph—flooded sheet asphalt surface.

Figure 10 shows the results on a sheet asphalt surface with extremely low traffic volumes and of about six years service.

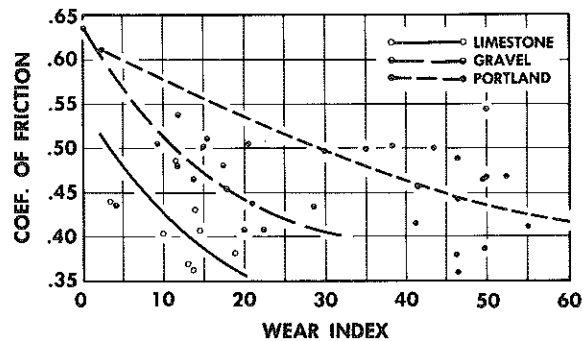
Figure 17—Comparative coefficients of sliding friction as a function of wear index observed on Michigan State Highways at 40 mph, on pavements of bituminous with limestone and gravel aggregate and Portland cement concrete—flooded surfaces.

Figure 16 shows the results with Portland cement surface, and Figure 17 is a composite of the three.

It is conceded that the individual relationships are rather poorly correlated because there are many other variables to be studied including the type of filler, sand, and possibly cementing media, but there is a strong indication of a predominant type of grouping which points out distinctly that the three basic types of surface give distinct wear index behavior patterns.

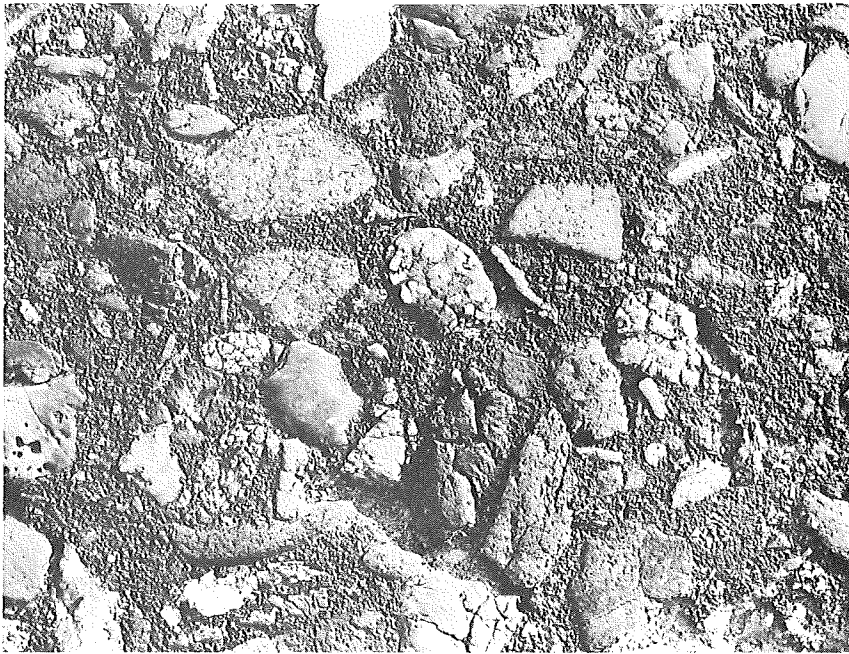
Figure 19—Project 5, Gravel aggregate 26A, Traffic Lane, coef. 0.50. Age 11 years. Average daily traffic, 3920. Wear factor 43.6.

Figures 18 and 19 present photographs of the surface in the traffic lanes of gravel projects 3 and 5, respectively, constructed prior to 1948. In both cases, note the preponderance of coarse aggregate particles which are in various stages of disintegration. This gradual aggregate disintegration process has evidently caused the continual exposure of new projections with sharp edges which have imparted high skid resistance properties to the surface, irrespective of age and traffic load.

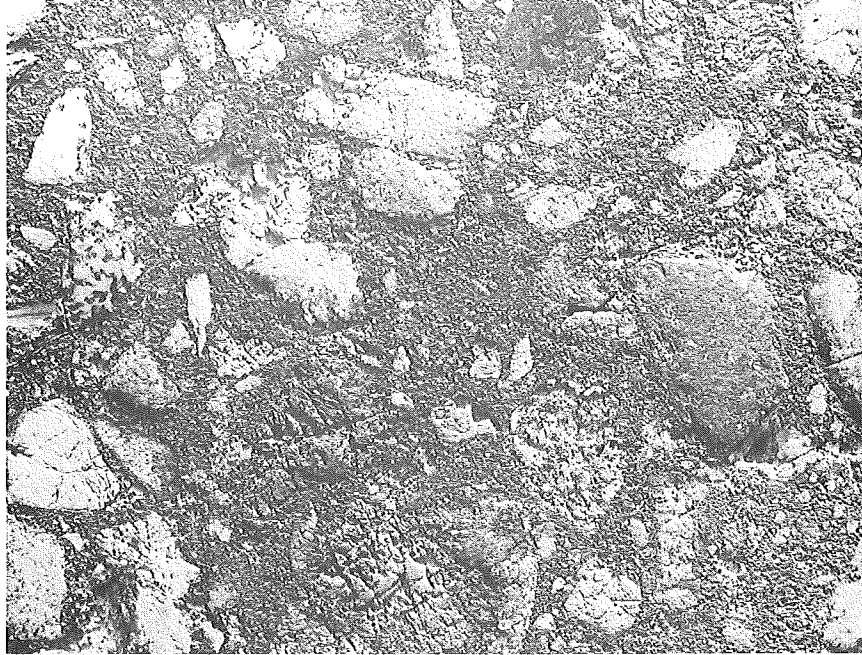
Figure 20—Project 12, Gravel aggregate 25A, Traffic Lane coef. 0.50. Age 3 years. Average daily traffic, 12,000. West end of project. Wear factor 15.5.

Further evidence of the effect of aggregate performance is shown in Figures 20 and 21. The two surfaces illustrated are at different ends of Project 12, which was built since 1948 with 25A specification aggregate under supposedly similar conditions. The coefficient of friction of the two surfaces is decidedly different in that in one case it was 0.48 (Figure 20) and in the other, 0.39 (Figure 21). Here again the surface with the better skid resistance characteristics has a higher proportion of coarse aggregate particles in various stages of disintegration, while in the case of the surface with the lower coefficient of friction (Figure 21), the aggregate particles appear sound and smooth with less evidence of disintegration and displacement.

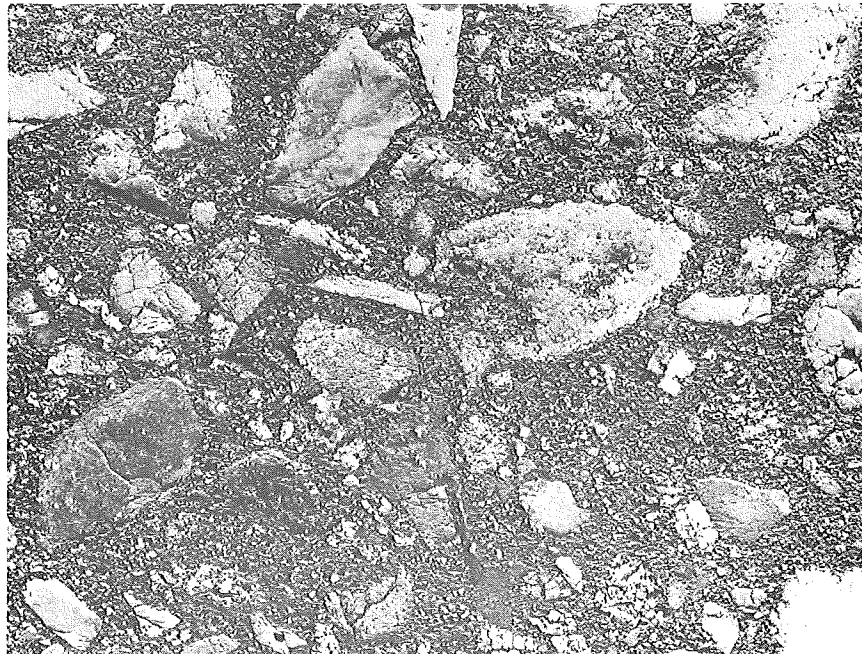
Figure 21—Project 12, Gravel aggregate 25A, Traffic Lane, coef. 0.405. Age 3 years. Average daily traffic, 16,000. East end of project. Wear factor 20.0.

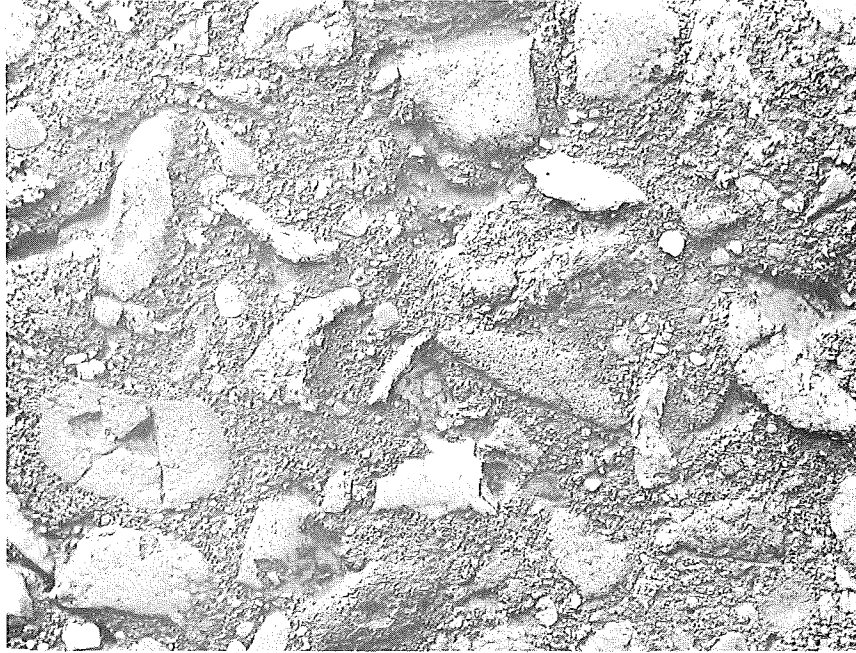
Figure 23—Project 2, Gravel aggregate 25A. Traffic Lane, coef. 0.545. Age 4 years. Average daily traffic, 3120. Wear factor 12.1.

Figures 23, 24, 25, and 26 show typical pavement surfaces in the traffic and passing lanes of two bituminous concrete projects containing different types of coarse aggregate. Photographs taken on many other projects show similar surface conditions in adjacent passing and traffic lanes. It is to be noted that, in the traffic lanes, the coarse aggregates, both gravel and limestone, have become worn and polished to varying degrees and that the bituminous matrix is only slightly depressed around and between the coarse aggregate particles. The coarser sand particles in the matrix are also worn smooth and flat, while in the passing lanes, the coarse aggregate particles and the sand particles in the matrix still retain a high degree of angularity and the difference in elevation of the projections of the coarse aggregates and matrix is much more pronounced. The pictorial evidence clearly demonstrates the effect of heavy traffic on bituminous concrete surfaces and why, in many cases, they become slippery when wet.

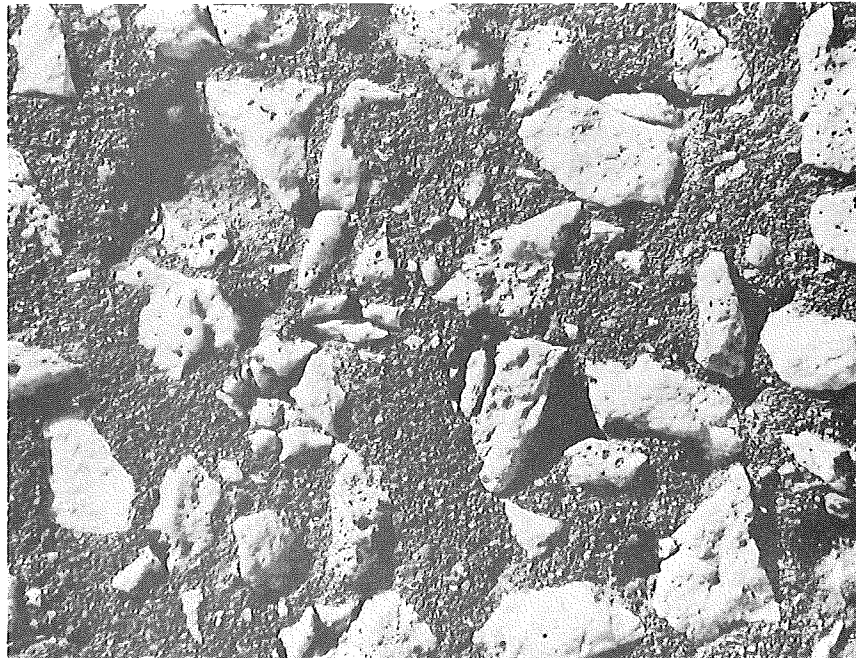
Figure 26—Project 18, Limestone aggregate 25A. Passing Lane, coef. 0.57.

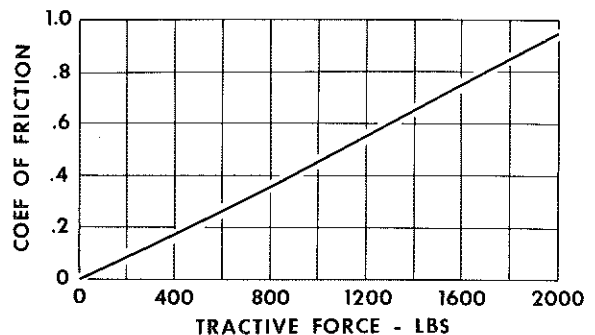
Figure 28—Calibration curve for coefficient of friction from tractive force readings.

With known constant values of F_3 , H_1 , and L_w with this vehicle, the coefficient of friction is calculated for values of tractive force (F_6) indicated by stress observations. Figure 28 shows the coefficient of friction as a function of the tractive force.
