SAFETY BENEFITS OF MEDIAN BARRIER AND ROADSIDE GUARDRAIL

PREPARED UNDER CONTRACT BY AUBURN UNIVERSITY

American Traffic Safety Services Association (ATSSA) Publication
Prepared Under Contract by Auburn University

Dec. 1, 2017

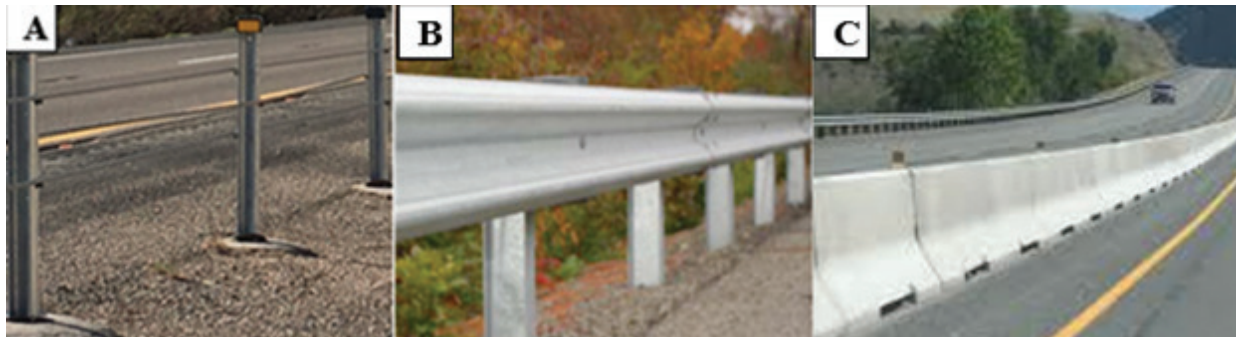
Figure 2.
Types of Median Barriers: a. Flexible; b. Semirigid; c. Rigid

There are three different types of median barriers: flexible, semirigid, and rigid (Figure 2). Each type of barrier is best suited to a specific type of road environment.

- Flexible barriers consist of low-tension and high-tension cable barrier (HTCB) systems. HTCBs have replaced the low-tension cable barriers in most states due to improved performance and maintenance benefits. Cable barriers are best suited for deployment at locations with wide median areas and allow drivers to make a safe stop without re-entering the traffic or entering the travel lane of oncoming traffic (i.e., wrong-way driving). Their larger deflections allow for softer impacts, resulting in fewer injuries, and the open design allows for wind, sand, and snow to pass through the system.

- W-beam guardrails, box-beam and thrie-beam fall into the semirigid barrier category. This guardrail-type median barrier can flex more than 3 feet and allows a driver some control after impact. Guardrail-type barrier is most effective for protecting drivers from drop-offs or colliding with fixed objects on the median or roadside.
- Rigid barriers are made of concrete. Concrete barriers are rigid and are effective for redirecting straying motorists back into their lane. This type of barrier is most effective along roads where traffic in opposing directions is flowing in close proximity due to lack of space.

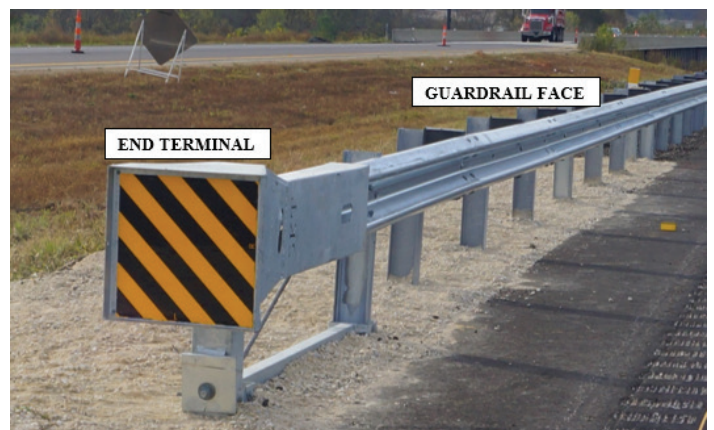
Figure 5.
A Roadside Guardrail

Roadside barriers are placed along the edge of a highway at dangerous sites. Guardrails are the most commonly used roadside barriers. Guardrails function as a system, which includes the guardrail itself, the posts, the soil that the posts are driven into, the connection of the guardrail to the posts, the end terminal, and the anchoring system at the end terminal. All these elements have a bearing in how the guardrail will function upon impact. Guardrails consist of two key functional components: the end terminal and the guardrail face (Figure 5). The guardrail face is the length of the guardrail extending from the end terminal alongside the road. Its function is to redirect the vehicle back onto the roadway. The end terminal is the starting point of the guardrail, also referred to as the end treatment. The exposed end of the guardrail needs to be treated to avoid a significant crash. One common treatment is an energy-absorbing end treatment that is designed to absorb the

energy of an impact by having the impact head slide down the length of the guardrail. These end terminals function in two ways:

1. When hit head-on, the impact head slides down the guardrail, flattening, or extruding, the guardrail and redirecting the guardrail away from the vehicle until the vehicle's impact energy is dissipated and the vehicle has decelerated to a stop. An example of a head-on collision can be seen in the video shown here (courtesy of Ohio Department of Transportation) - <https://www.youtube.com/watch?v=4WnlpNkNFDk>
2. When hit at an angle, the impact head may partially extrude the guardrail and then “gate” out of the way allowing the vehicle to pass behind the guardrail. This means the terminal and guardrail is pushed through, as if opening a gate.

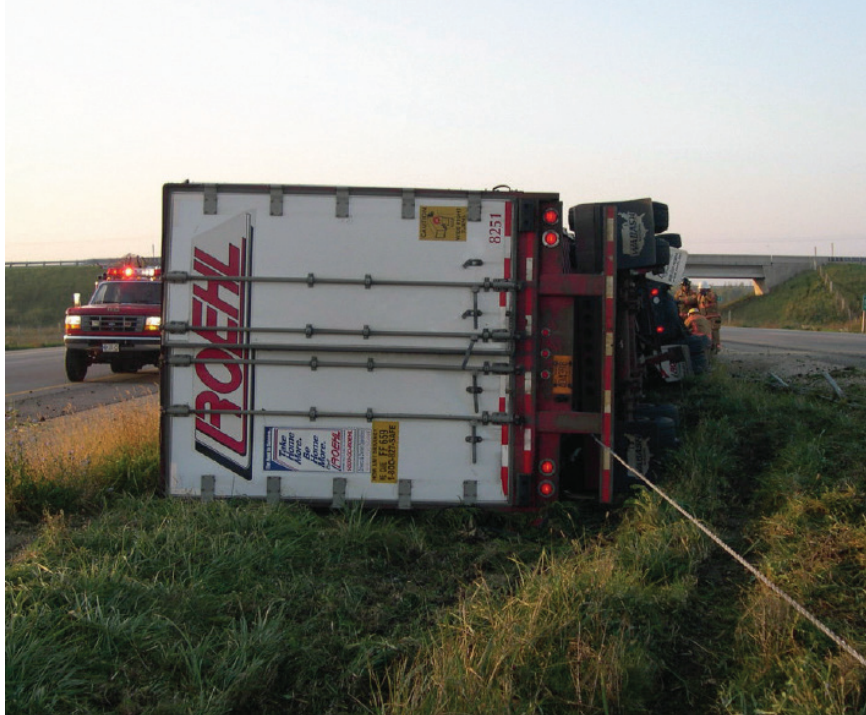
Figure 7.
Mr. Krull's Tractor-Trailer Captured by a Cable Median Barrier on Hwy 41 in Wisconsin

The semitrailer wandered off its lane and was headed through the median toward oncoming traffic. But just before disaster was about to strike, the truck was redirected and tipped over. The newly installed cable median barrier caught the truck and slowed it down before bringing the heavy vehicle to a complete stop. Thus, a major calamity was prevented by the cable barrier.

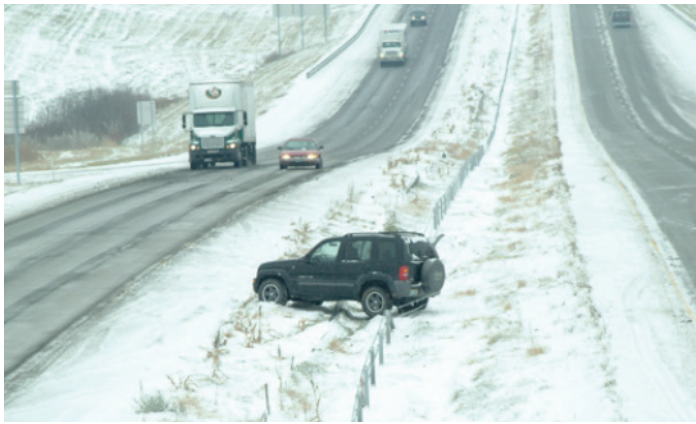
Figure 8.
Ms. Bernskoetter's Vehicle Snagged by a Cable Median Barrier on I-70 in Missouri

As a result of a safety initiative, there was a median cable barrier exactly where Ms. Bernskoetter lost control of her vehicle. The median steel cable barrier snagged Ms. Bernskoetter's vehicle and cushioned the blow. The car was brought to a complete stop by the cable barrier and was prevented from entering the traffic stream coming from the opposite direction. Ms. Bernskoetter left the scene of the accident without any injuries. Since no other vehicles were involved, other potential injuries were averted as well.

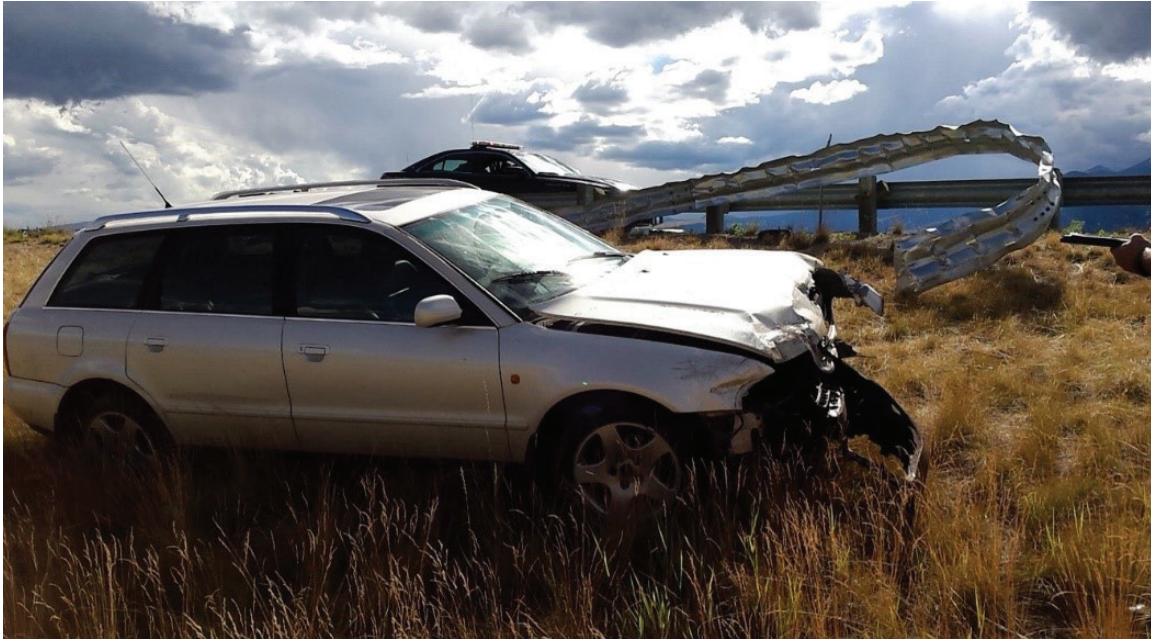
Figure 11.
Mr. Ben Tandberg's Car After Colliding With a Guardrail Terminal in Montana

Right after Mr. Tandberg dozed off, his sedan swerved to the right and collided violently with the guardrail terminal. The guardrail performed exactly as it was designed to. The energy-absorbing guardrail end terminal took in most of the momentum from impact and deflected the guardrail away from the vehicle. By doing this, the vehicle slowed down gradually and came to a complete stop on the roadside. Mr. Tandberg left the scene uninjured even though his car was totaled.

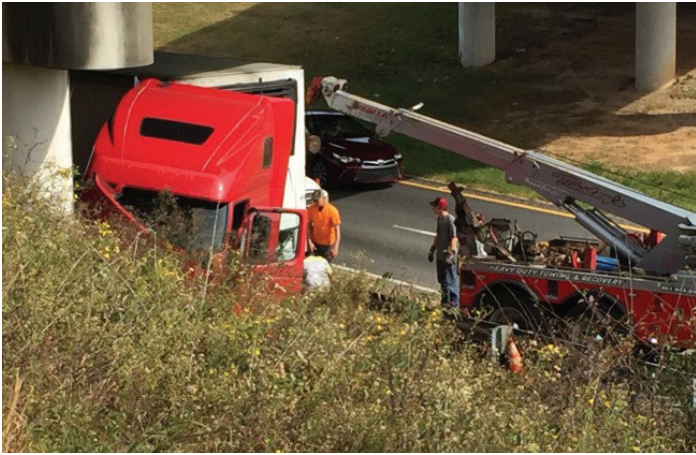
Figure 12.
Tractor-Trailer Crash With a Guardrail on I-85 in Oconee County, S.C. (11)

The truck swerved to the right and headed on a collision course toward the bridge. However, the bridge was shielded by a guardrail. The resulting crash did not cause significant structural damage to the bridge, and the driver of the truck left the scene unscathed. The presence of a guardrail saved a life and protected the bridge.

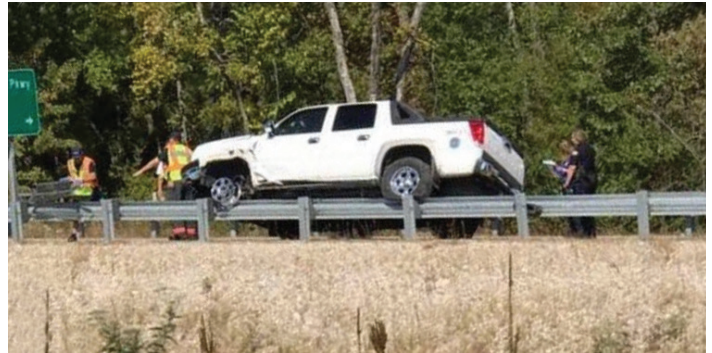
Figure 13.
Mr. Webb's Car Stuck on a Guardrail in Missouri (12)

Mr. Webb lost control of his car and veered to the left. The vehicle ran into the guardrail, which was installed along the ramp to protect vehicles from falling into the ditch beside the ramp. The collision with the guardrail occurred in such a way that Mr. Webb's car ran up onto the guardrail and continued forward on it for a few yards. Finally, the vehicle came to a full stop with its two driver's-side wheels stuck on top of the guardrail and the other two wheels on the ground.
