1. Report No. Research Report R-1465	2. Government Accession No.	3. MDOT Project Manager Michael Eacker
4. Title and Subtitle Unbonded Concrete Overlay Demonstration Project on I-75 in Ogemaw County – Construction Report		5. Report Date June, 2005
7. Author(s) Michael J. Eacker, P.E. Andrew Bennett		6. Performing Organization Code
9. Performing Organization Name and Address Michigan Department of Transportation Construction and Technology Division P.O. Box 30049 Lansing, MI 48909		8. Performing Org Report No. R-1465
12. Sponsoring Agency Name and Address Michigan Department of Transportation Construction and Technology Division P.O. Box 30049 Lansing, MI 48909		10. Work Unit No. (TRAIS)
		11. Contract Number:
		11(a). Authorization Number:
15. Supplementary Notes		13. Type of Report & Period Covered Construction, August to November, 2003
		14. Sponsoring Agency Code

**UNBONDED CONCRETE OVERLAY DEMONSTRATION PROJECT
ON I-75 IN OGEMAW COUNTY - CONSTRUCTION REPORT**

**Testing and Research Section
Construction and Technology Support Area
Work Plan No. 03 WP-147
Research Project G-0333
Research Report R-1465**

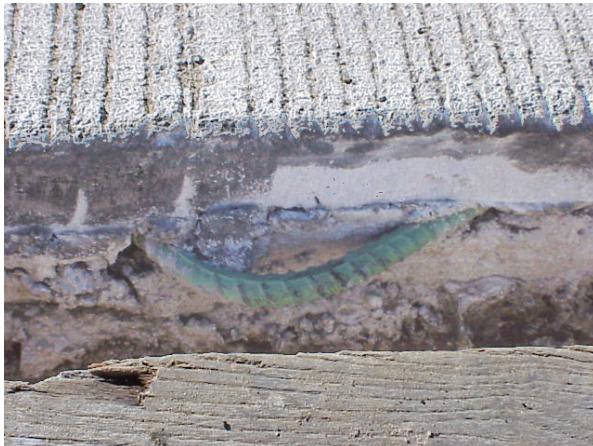
Figure 4. Tie bar embedded in the concrete. This bar can not be straightened and, therefore, is of no use.

Construction for both the unbonded concrete overlay and the rubblize with asphalt overlay went very well. A few concerns were noted in the unbonded concrete overlay: misplaced or embedded lane tie bars, paver track running on the edge of the asphalt separator layer, and plugging of the asphalt separator layer with concrete.

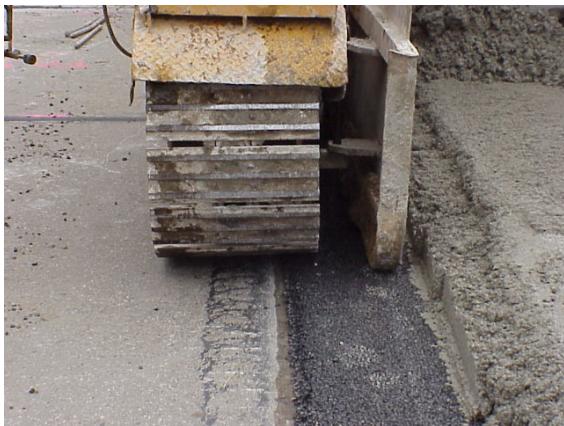
Figure 5. Paver track running on asphalt separator layer.

When the passing lane and inside shoulder was paved, the separator layer was paved a foot wider than the concrete. This caused the paver track to run on the edge of the separator layer as shown in Figure 5. This broke up the edge as seen in Figures 6, 7 and 8, which caused slight headaches when paving the separator layer in the adjacent lane.

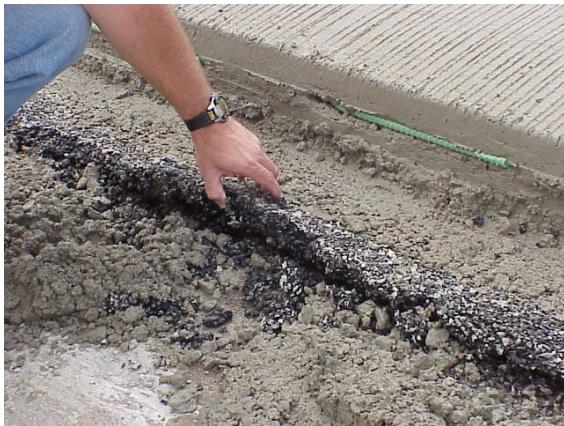
Figure 7. Loose asphalt separator layer. Note embedded lane tie that can not be straightened for the adjacent lane

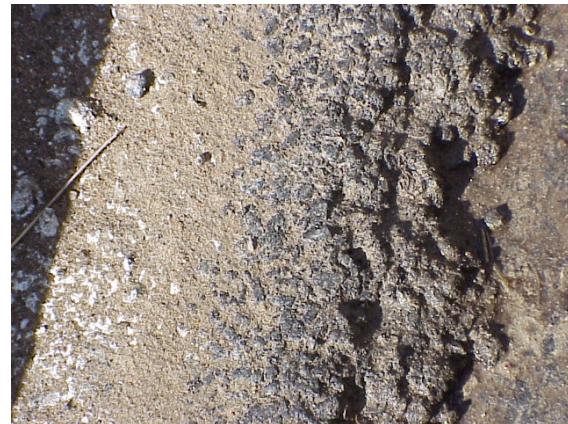
Figure 9. Voids in the separator layer are plugged with construction debris.

Another problem with the extra one foot area was that fines from construction traffic and the concrete placement plugged the voids on the surface of the interlayer (see Figure 9). The idea of the coarse graded separator layer was drain ability of any water that reached it. Drain ability of that section of the separator layer could be a problem especially due to its closeness to the longitudinal joint.

The six inch cores were cut at the asphalt/concrete interface to remove the separator layer for further testing. The separator layer was tested for permeability according to ASTM Provisional Standard PS 129-01. After cutting, it was noted that much of the separator layer void structure near the asphalt/concrete interface was plugged with cement paste. After getting permeability results on each sample, they were cut again to try to eliminate the areas where the voids were plugged. The amount cut off was between 5/16" and 9/16". A second round of testing was then conducted to see if permeabilities went up without the cement paste plugging the voids. Table 4 shows the results before and after cutting.

The mix design selected for the separator layer was an open one to allow for drainability of any water that infiltrated the overlay. The low permeability numbers before the plugged voids were cut off is a concern. However, we do not know the permeability

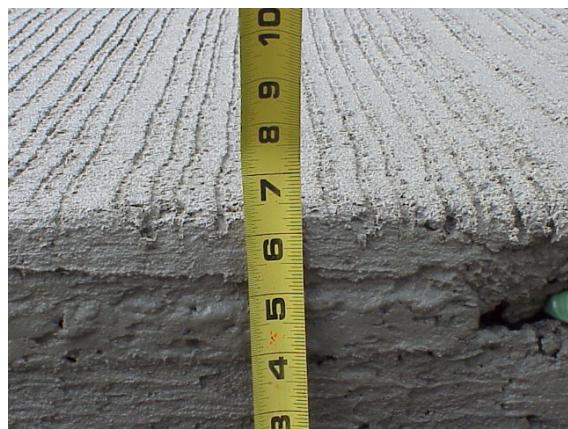
Figure 10. Concrete overlay close to the six inch proposed thickness.

Although not a problem per se, it should be noted that due to grade correction, depth of the overlay varied from about six inches to twelve inches as seen in Figures 10 and 11. The thicker sections were typically in super elevated areas. The majority of the pavement was in the seven inch range.

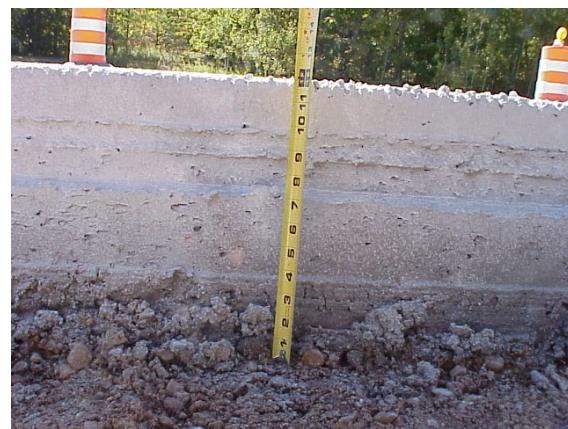
Figure 11. Area where the concrete overlay was twelve inches thick. This was at the outside shoulder joint.
