PERFORMANCE OF HOT-POURED  
AND COLD-APPLIED JOINT SEALERS

Research Laboratory Division  
Office of Testing and Research  
Research Project R-62 G-116  
Research Report No. R-493

Michigan State Highway Department  
Lansing, February 1965

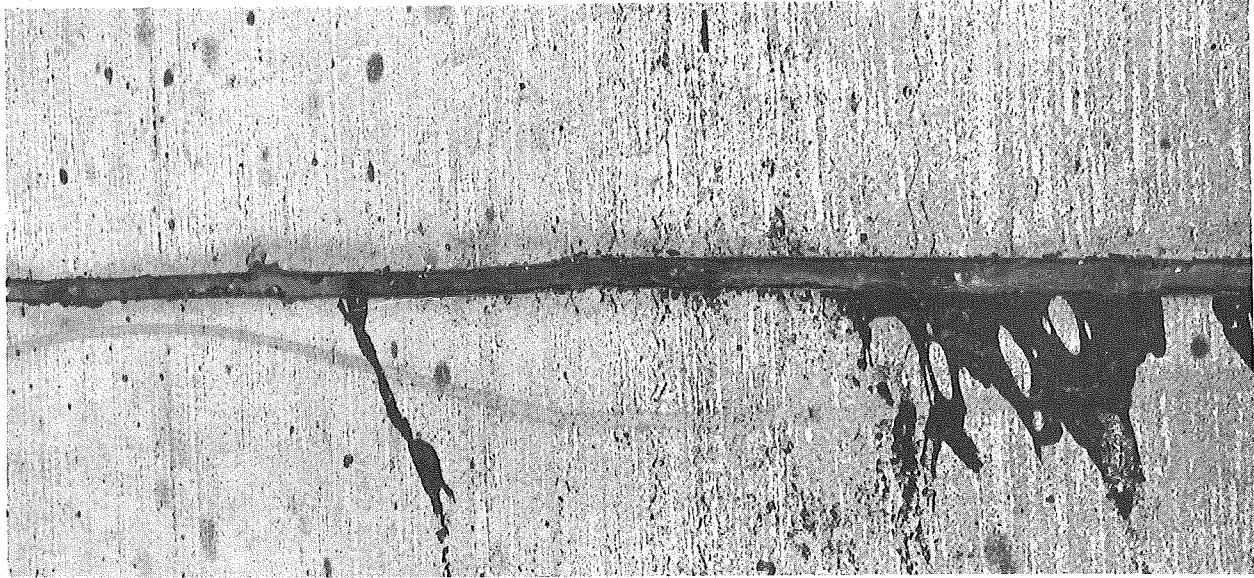
Probably the most universal and extreme failure of hot-poured, rubber-asphalt joint sealers in recent years was found in seven pavement construction projects between Mt. Clemens and Marysville, totaling approximately 30 miles and completed in the summer and fall of 1963. The sealer had failed in most joints before the winter had hardly begun. The projects were surveyed in November 1963, and the results reported by M. G. Brown and D. F. Simmons (Research Report No. R-456) in April 1964. Pictures from that report are reproduced here as Figs. 10 through 15. Since all the sealing was done under varying weather conditions from summer through fall by four different contractors using sealants from three different manufacturers, it proved very difficult to explain why such a high proportion of the sealing was of generally poor quality.

Figure 13. Typical severe adhesion failure with embedded dirt (Project BI 50112A, C1, Sta. 798+02 NB).

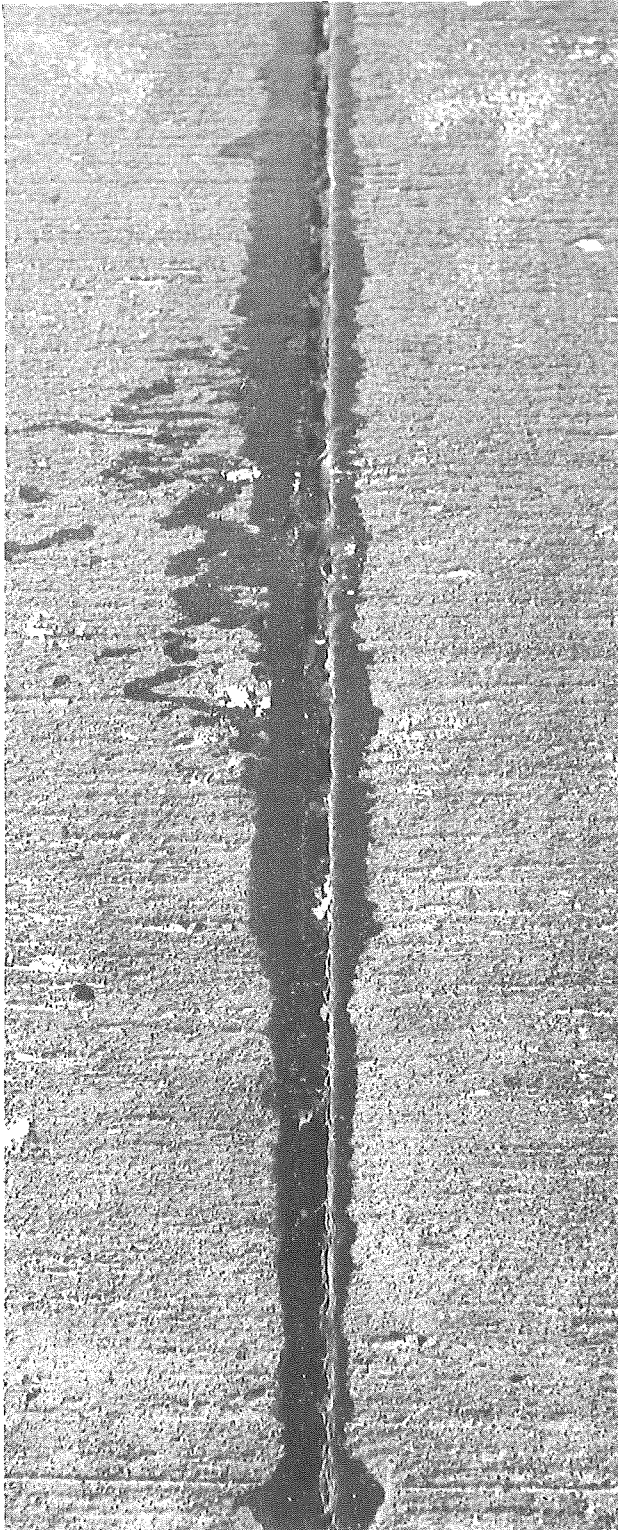
In the same I 96 area, observations were made on the performance of hot-pour sealer. The condition of the seal in two such joints is shown in Figs. 26 and 27. The hot-pour seal under this temperature condition is very rigid and both adhesion and cohesion failure is quite complete for some joints (Fig. 26).

Figure 26. Pronounced adhesion and cohesion failure of hot-pour joint seal (westbound traffic lane, Sta. 649+00, Project EBACI 33083A, C1).

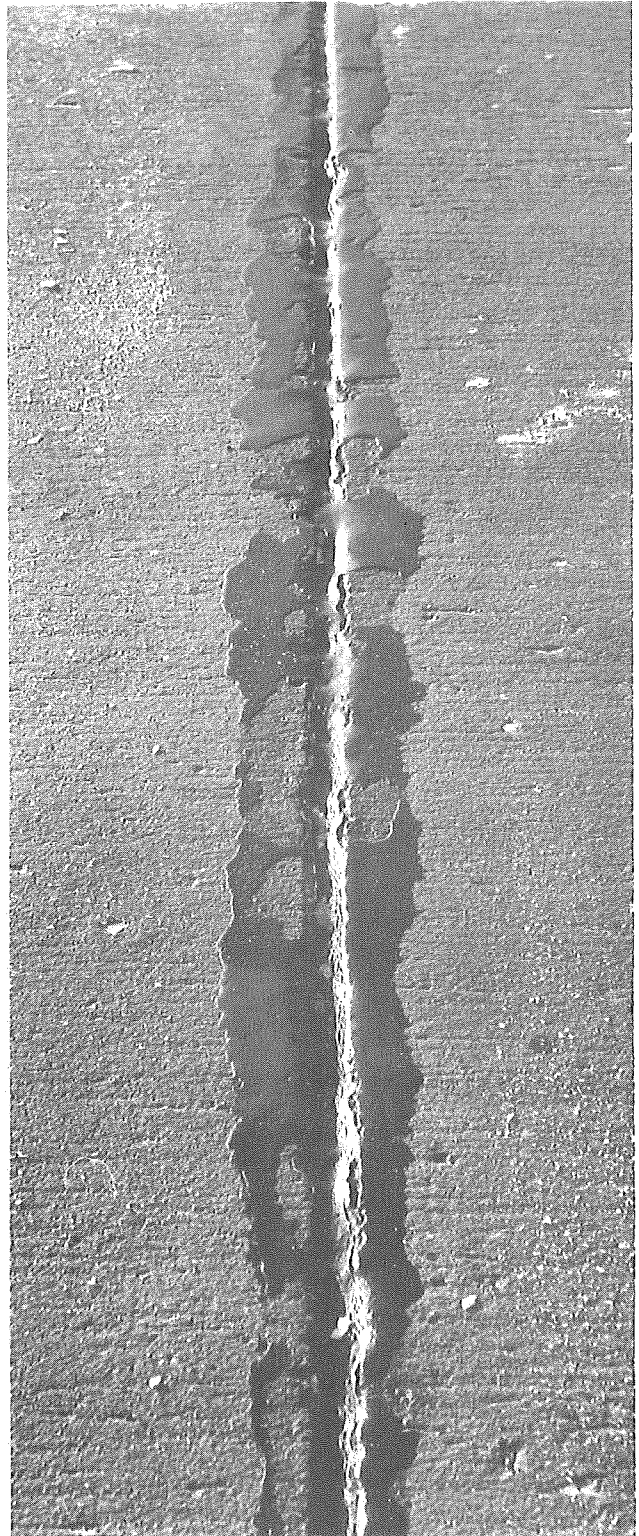
Figure 27. Some cohesion failure of hot-pour joint seal (westbound traffic lane, Sta. 553+08, Project EBACI 23151A, C1).
