LATEX MODIFIED MORTAR in the RESTORATION of BRIDGE STRUCTURES

LATEX MODIFIED MORTAR IN THE RESTORATION OF BRIDGE STRUCTURES

Prepared for Presentation at
The Thirty-Ninth Annual Meeting of the Highway Research Board
Washington, D. C., January 11-15, 1960

Report 321
Research Laboratory Division
Office of Testing and Research
Research Project 57 B-39

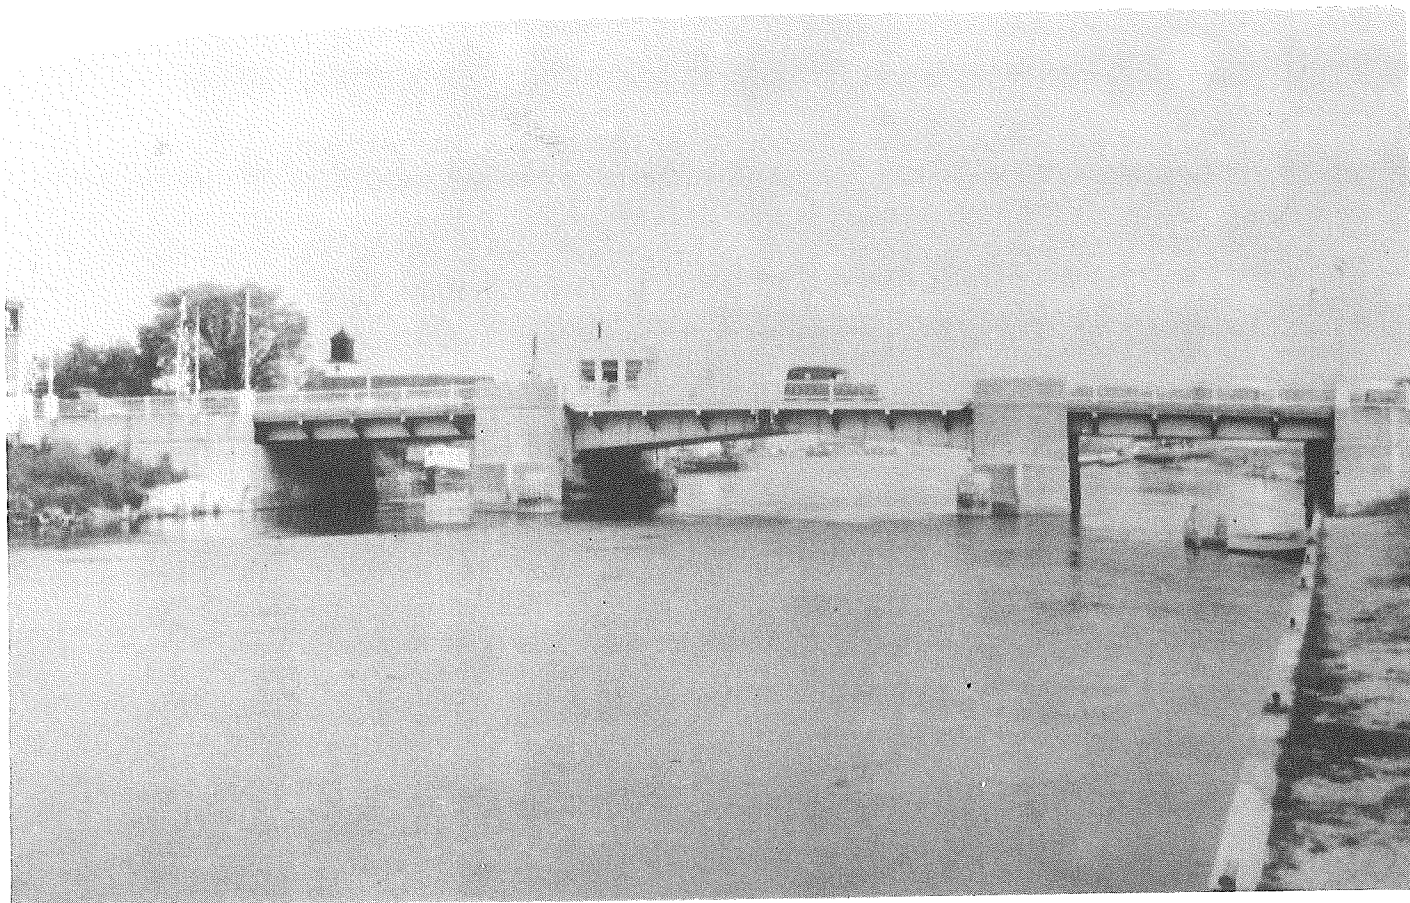
Figure 1. Bascule bridge on US 23, Cheboygan, Michigan.

It was decided that this latex would be tried in patching mixtures on a regular field maintenance project. It was furnished to a bridge maintenance crew and incorporated in patching mixes for restoration of a deteriorated bridge deck. Technical assistance was given by the manufacturer, and measurements and pictures taken by the Research Laboratory Division of the Office of Testing and Research. The structure chosen for this field test was a three-span bascule bridge over the Cheboygan River on US 23 in Cheboygan, Michigan, Project B1 of 16-3-7 (Fig. 1).

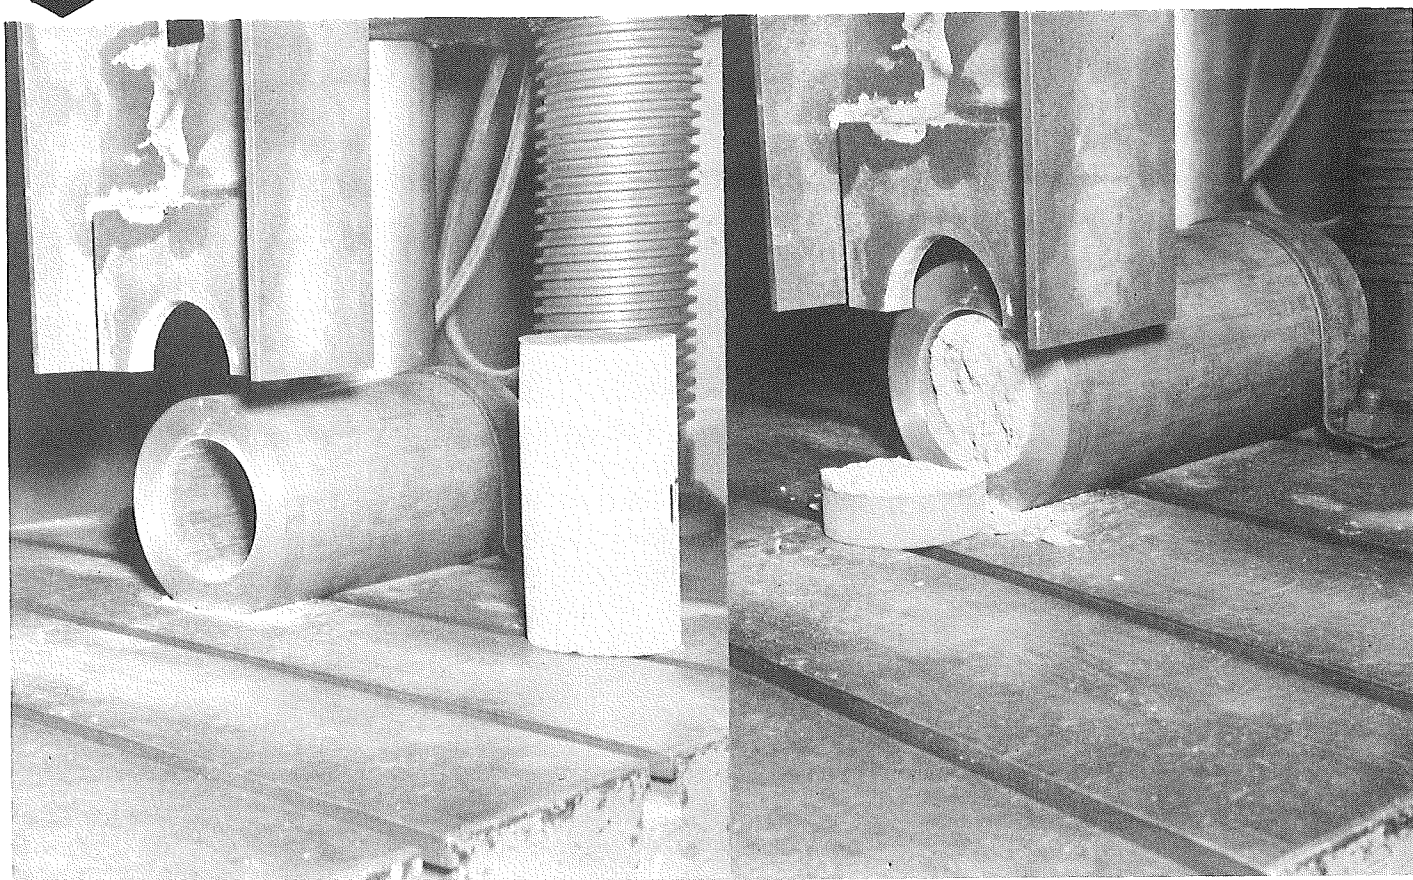
Figure 2. Laboratory equipment for determining shear bond strength of latex-cement mortar patches on concrete cylinders.

A laboratory evaluation compared the physical properties of mortars using these two latex emulsions with those of regular mortar, after two periods of curing (Table 1). Latex X2130.1 had a considerable advantage over Latex 560 or plain mortar, particularly in shear bond strength. The shear bond tests were run on the various mortar coatings applied to 3-3/8- by 6-in. concrete cylinders, cured 14 days prior to capping, and tested as shown in Fig. 2.

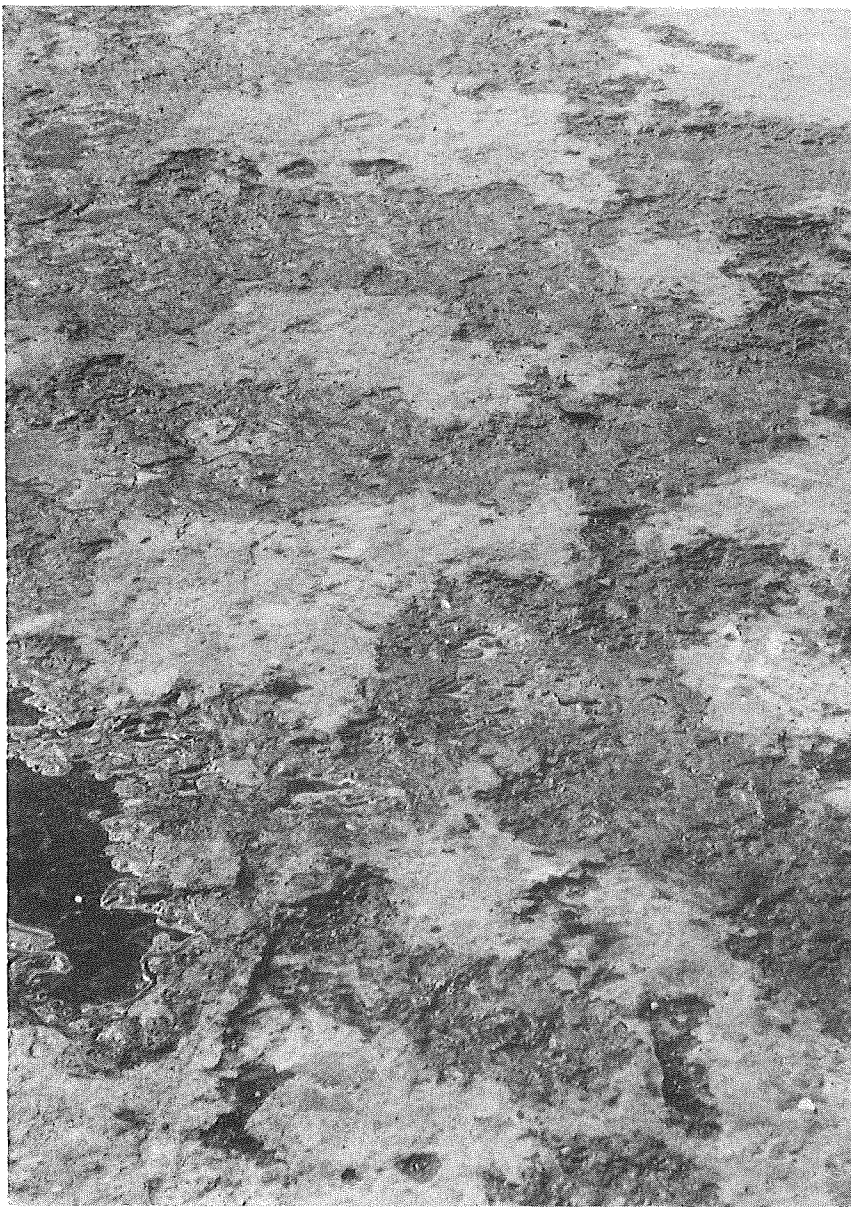
Figure 5. North sidewalk patches chipped to squared edges.

was removed with a cutting machine (Fig. 4), so that a latex-portland cement mortar layer of 1/2-in. minimum thickness could be applied. Some areas of the filled-grid walk sections were chipped out to squared edges (Fig. 5). Small air chisels and sandblasting equipment were also used to prepare the deck for thin patching. Narrow steel strike-off bars were greased and set with anchor bolts along the edge of each lane, so that the proper depth of patch and crown of the deck surface would be maintained during screeding and finishing operations. These bars were removed after the latex-cement mortar had cured.

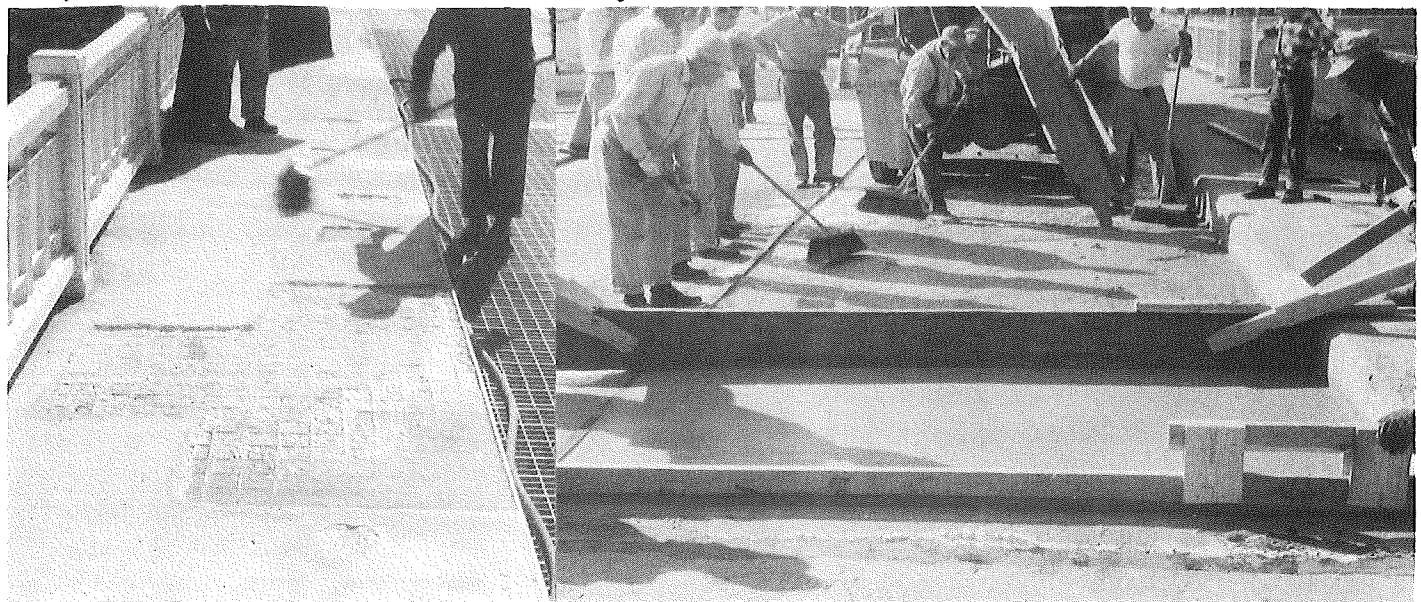
Figure 6. Typical placement and finishing procedure for latex-cement mortar.

The latex-cement mixes were made in a standard transit mix truck with moist sand (2NS) weighed and loaded first. The necessary bagged Type I cement was added as the drum continued to rotate. After mixing the sand and cement for 10 to 15 min, the Latex 560 was added from 55-gal drums, using a hoist truck. Mixing continued while the transit mix truck was traveling the few blocks from plant to bridge site. Very little water was added, since about 6 percent water was contained in the sand. Typical placement and finishing are shown in Fig. 6.

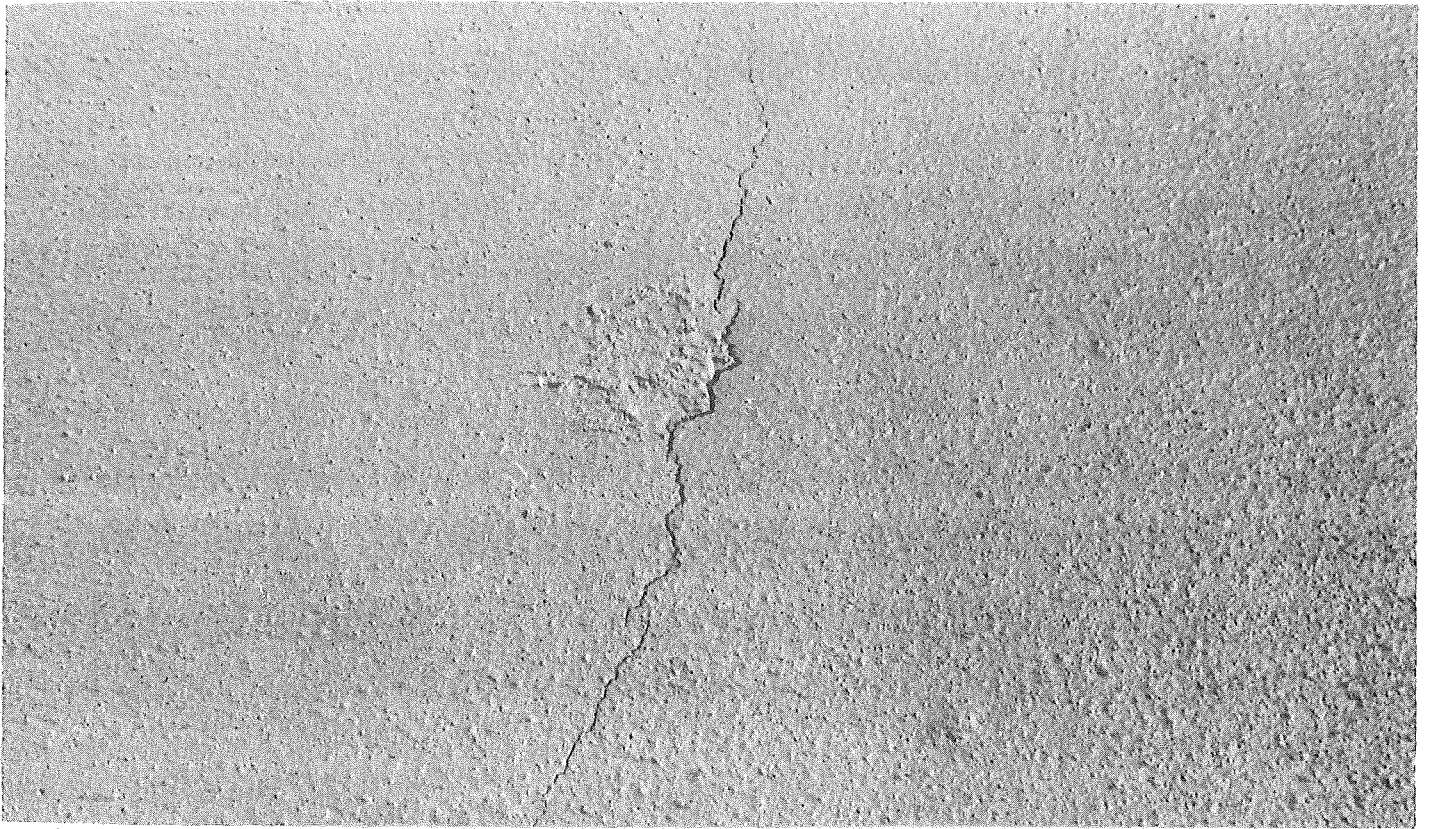
A nominal sand-cement ratio of 3:1 and a latex solids content of 20 percent, based on the cement weight, were used for all batches. During mixing, trouble was encountered with the moist sand balling up with the cement. Most of the large sand and cement lumps were screened out as the mortar was placed, but some smaller ones were finished into the thin surfacing. Shrinkage cracks appeared through a few of these lumps soon after finishing (Fig. 8).

Figure 8. Shrinkage crack adjacent to sand-cement lump.

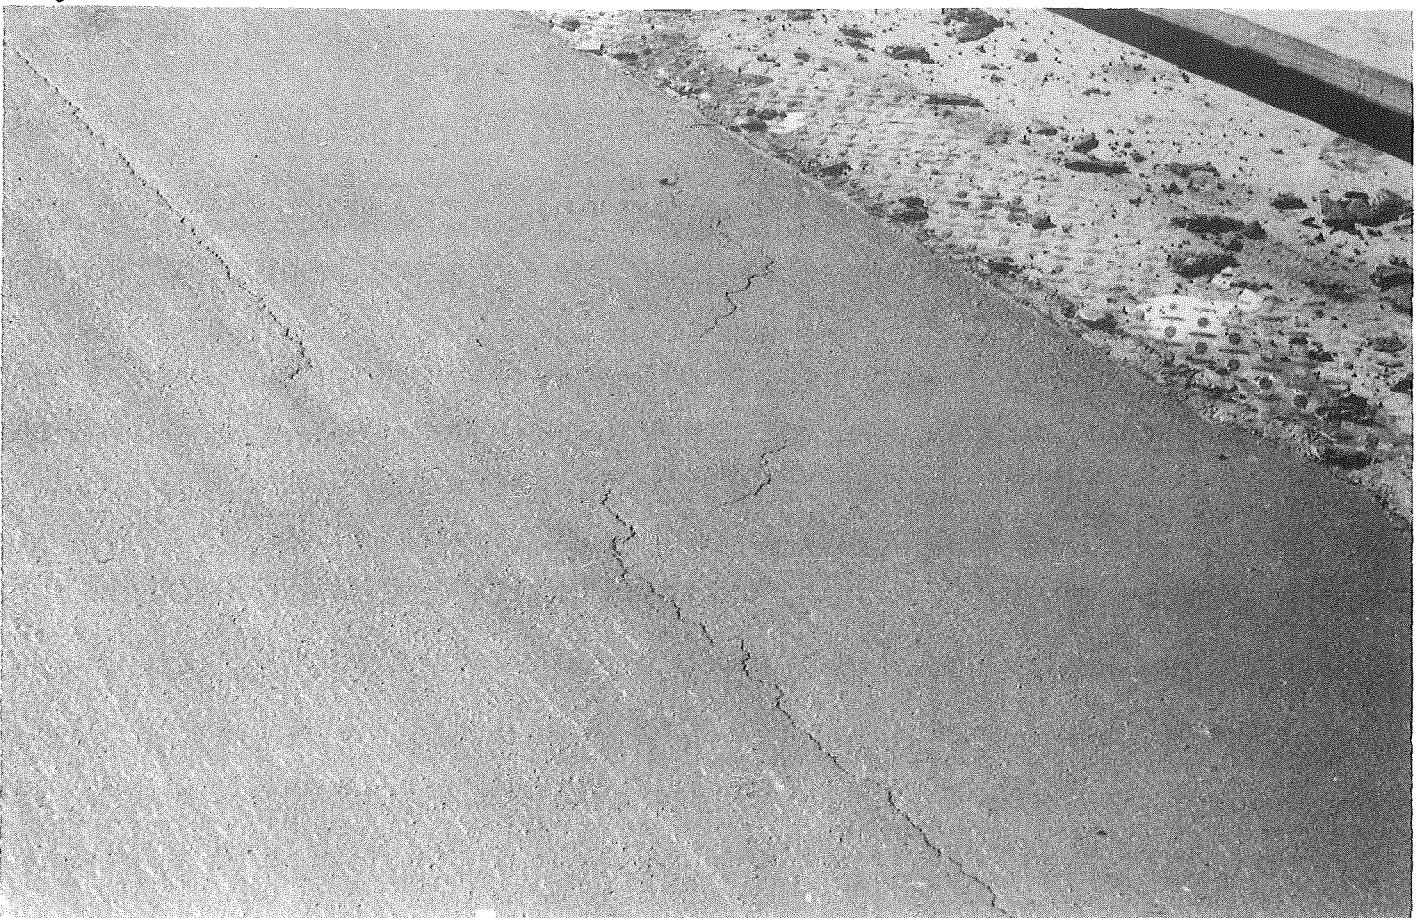
The latex-cement mortar tended to form a surface skin which produced shrinkage cracks (Fig. 9), if not immediately covered with wet burlap. This was especially true when the weather was sunny and windy.

Figure 9. Shrinkage cracks in latex mortar surface on west end of Lane D when not quickly covered with wet burlap.

The new mortar differed from that placed a year earlier in that a nominal sand-cement ratio of 2:1 was used, with a latex solids to cement fraction of 15 percent. About 5 percent diethylene glycol was added to the mortar to increase the finishing time and reduce the tendency of the latex mortar to skin over and produce shrinkage cracks. The glycol reduced but did not entirely eliminate this tendency.

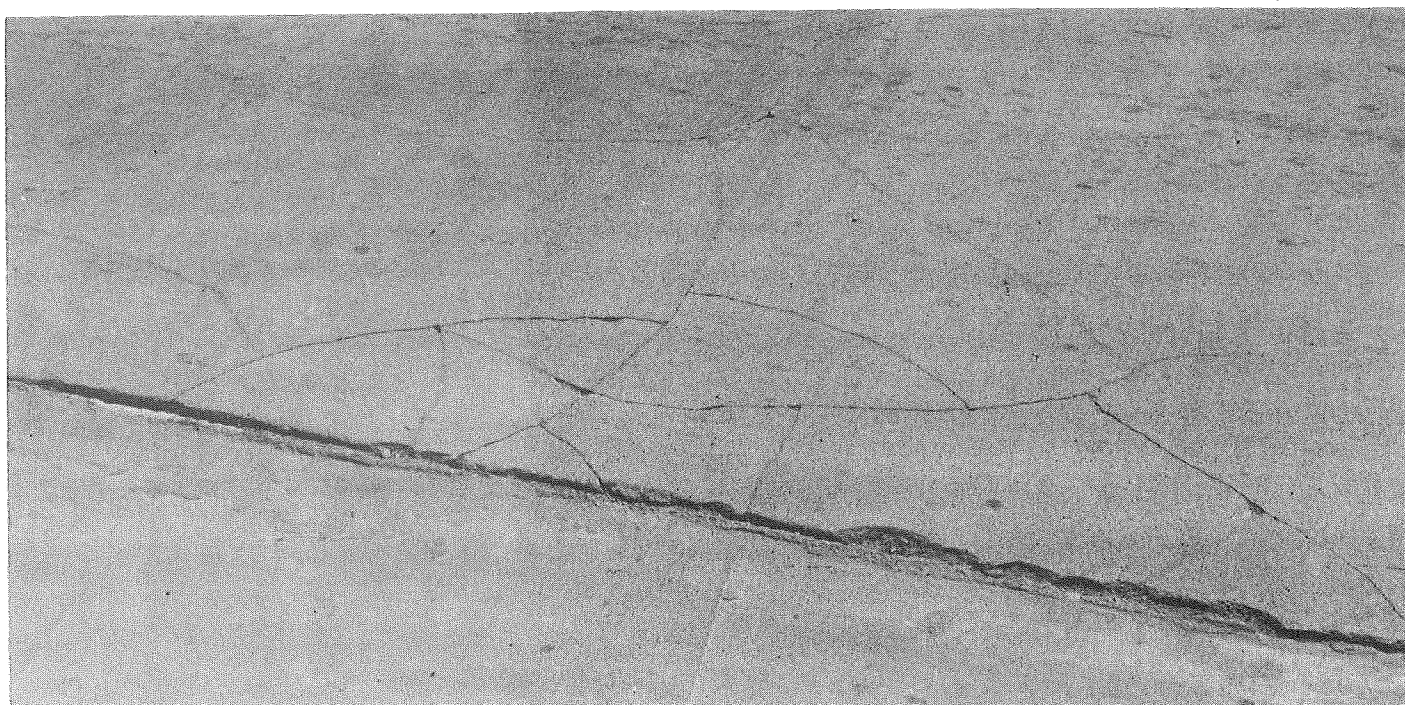
Figure 10. Extensive cracking and loose latex mortar on east end of Lane F after one winter. April 1958.

On April 15, 1958, the latex-cement mortar thin surfacing on the Cheboygan bridge was appraised after exposure to its first winter. Two quite extensive areas were badly cracked and loosened from the substrate. Fig. 10 is a closeup of the east end of Lane F, containing cracked and loosened latex-cement mortar which had been applied over a dry substrate. A similar failure of the latex-cement mortar was found at the west end of Lane D, where the prepared base had been broomed with a straight solution of Latex 560 emulsion (Fig. 11). Only these two test areas appeared to be losing bond in April 1958.

All these loosened areas were removed and cleaned with pneumatic chisels and sandblasting. It was decided that these areas should be repaired using a latex-cement mortar containing the newer X2130.1 experimental latex emulsion. The tests reported in Table 1 had shown that this latex emulsion was superior to Latex 560 in some properties; in particular, the shear bond strength was about double.

On September 27 and October 6, 1958, the Latex X2130.1-cement mortar was used to replace all the loosened areas. The materials were handled and mixed essentially the same way as in September 1957. Mix data for the three mortar batches involved are presented in Table 4 and the deck placement in Fig. 12. The deck areas to be replaced were cleared of loose patch material and then washed and soaked with water just before resurfacing.

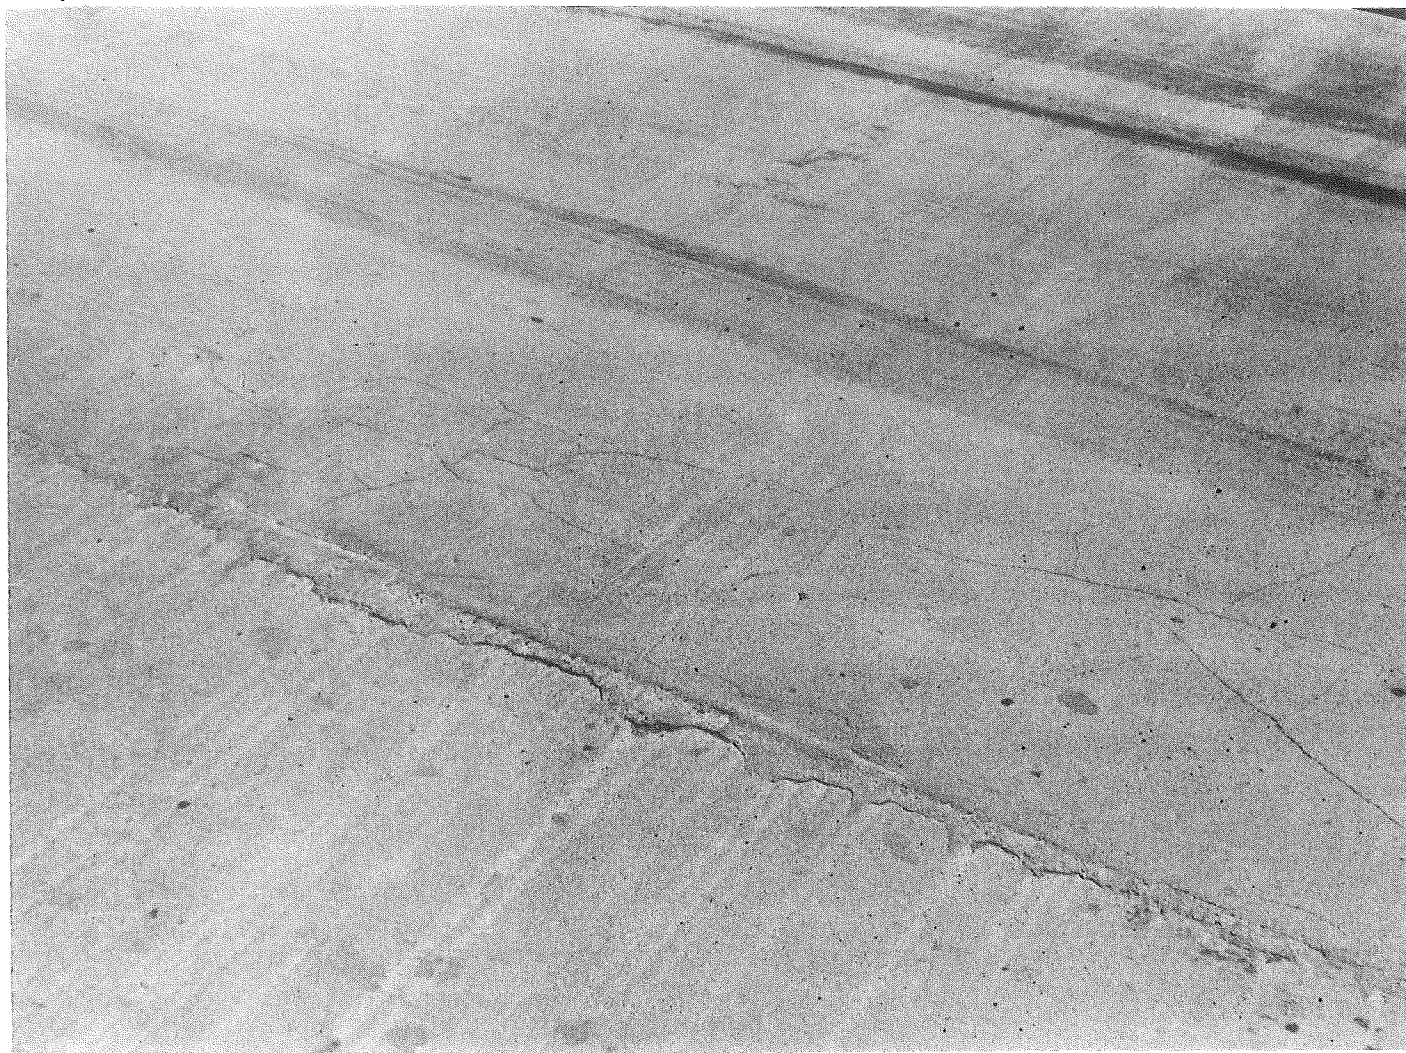
Figure 11. Cracking and loose mortar in west end of Lane D after one winter. April 1958.

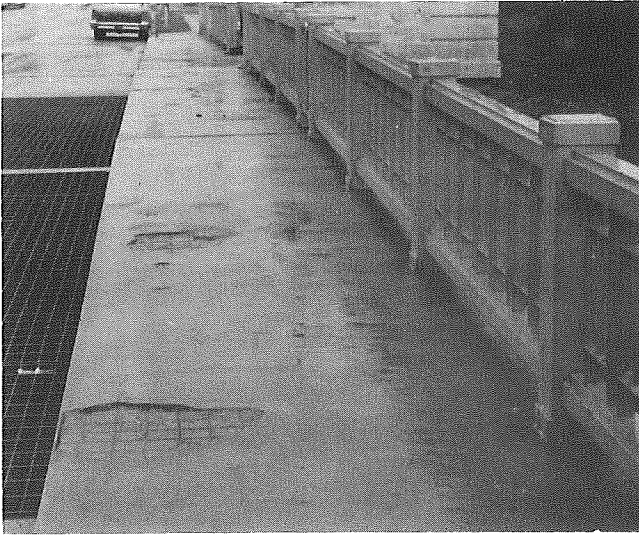
On April 14, 1959, another inspection trip was made to the bridge site. The remaining 1957 sections and those reapplied in 1958 were still bonded to the old bridge deck. A few newly spalled areas were found in the old concrete surface of sidewalk areas J and K, bordering some of the 1957 latex-mortar patches (Fig. 13). However, all the latex mortar areas appeared sound.

Figure 13. Newly spalled areas in north sidewalk, some adjacent to patches.

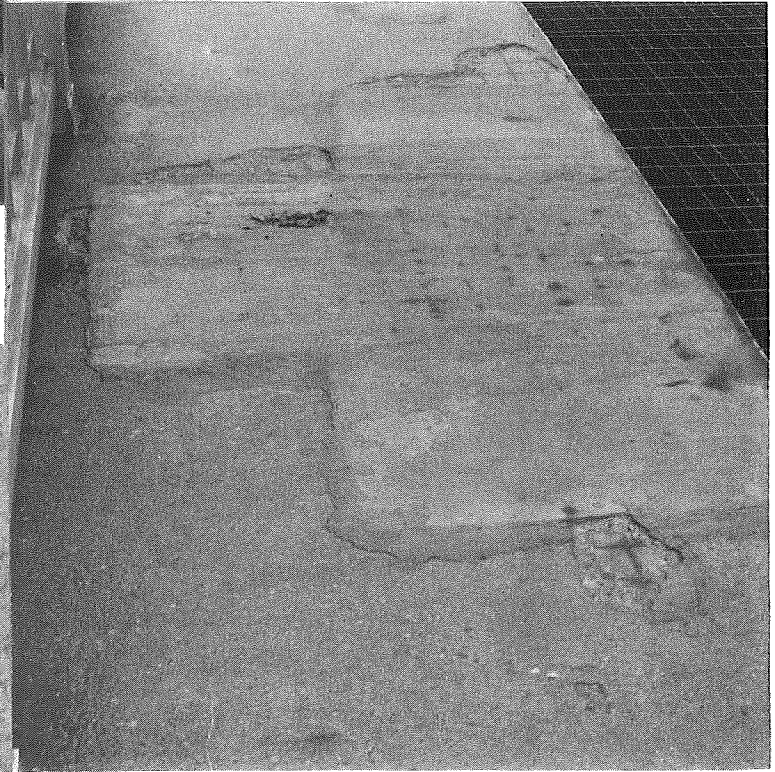
The bridge was examined again on August 7, 1959. The sidewalk spalling in the original concrete around the latex mortar patches observed in April was spreading even farther (Fig. 14). This breakdown of old concrete over the filled grid sidewalk may gradually loosen the adjacent latex-mortar patches. Surface dampness because of rain during this inspection made the fine crack network in the September 1958 repair work especially clear (Fig. 15), but patches seemed to be bonded to the concrete. General views of the sound latex mortar resurfaced lanes after two years of exposure are presented in Fig. 16.

Figure 14. Further failure around large latex mortar patch in north sidewalk.

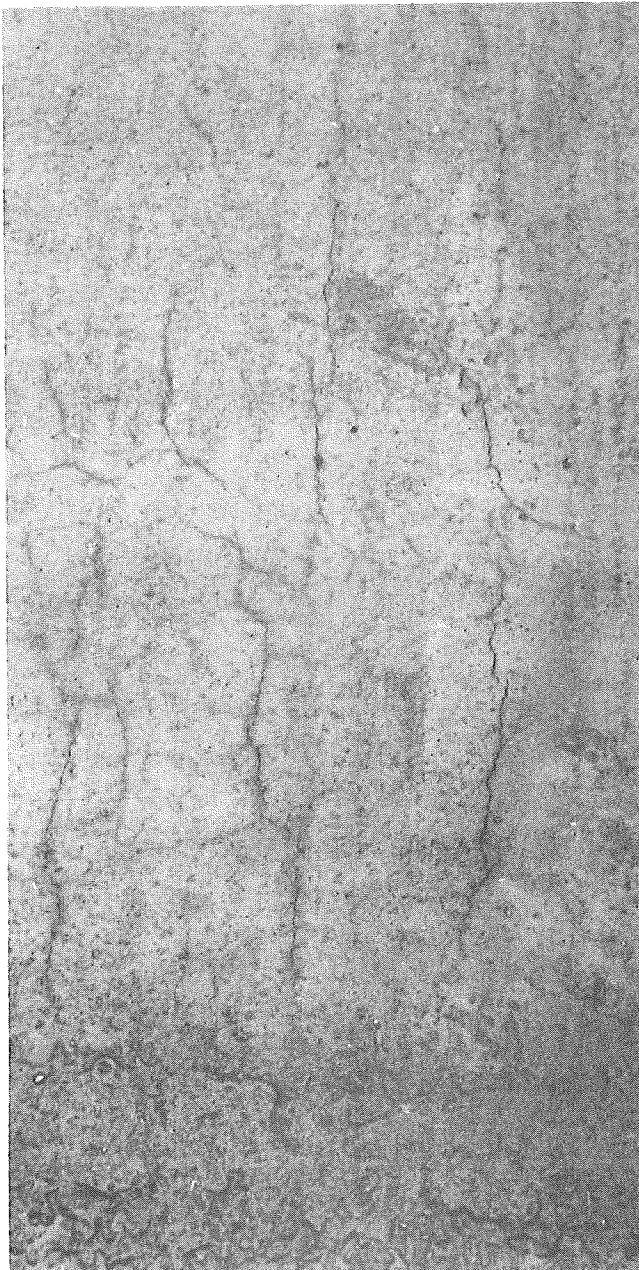
Figure 15. Network of shrinkage cracks in latex mortar resurfacing on southeast lane, after one winter.

The patching mixes of Fall 1958 may have been too rich in cement, having a sand-cement ratio of 1.8:1 as compared to the ratio of 2.8:1 used in September 1957. Excessive refinishing necessitated by considerable rain during placement may have promoted the extensive crack formation which occurred in the areas patched September 27, 1958. Similar Latex X2130.1 mixes placed under more normal conditions one week later showed no cracks after a year of exposure.

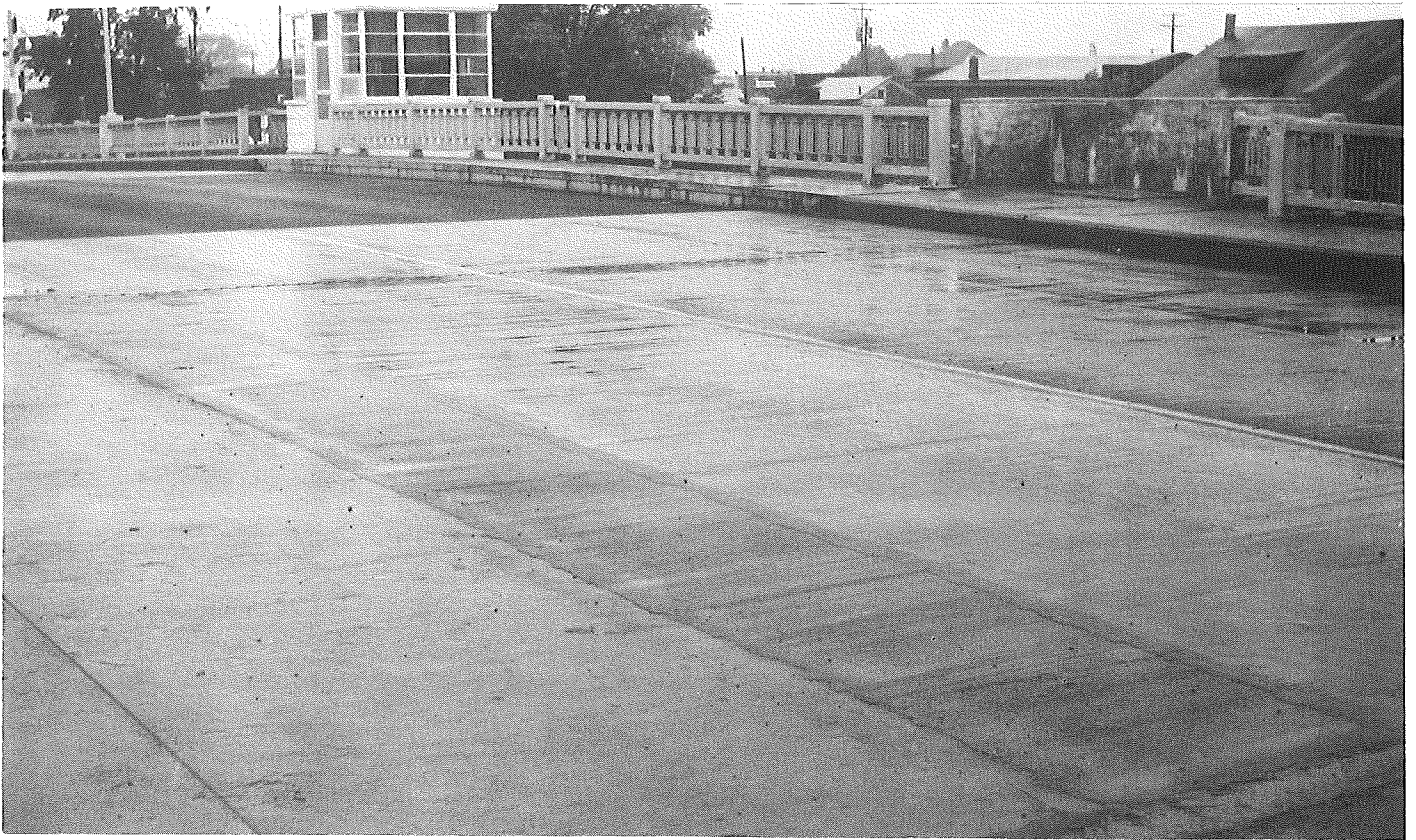
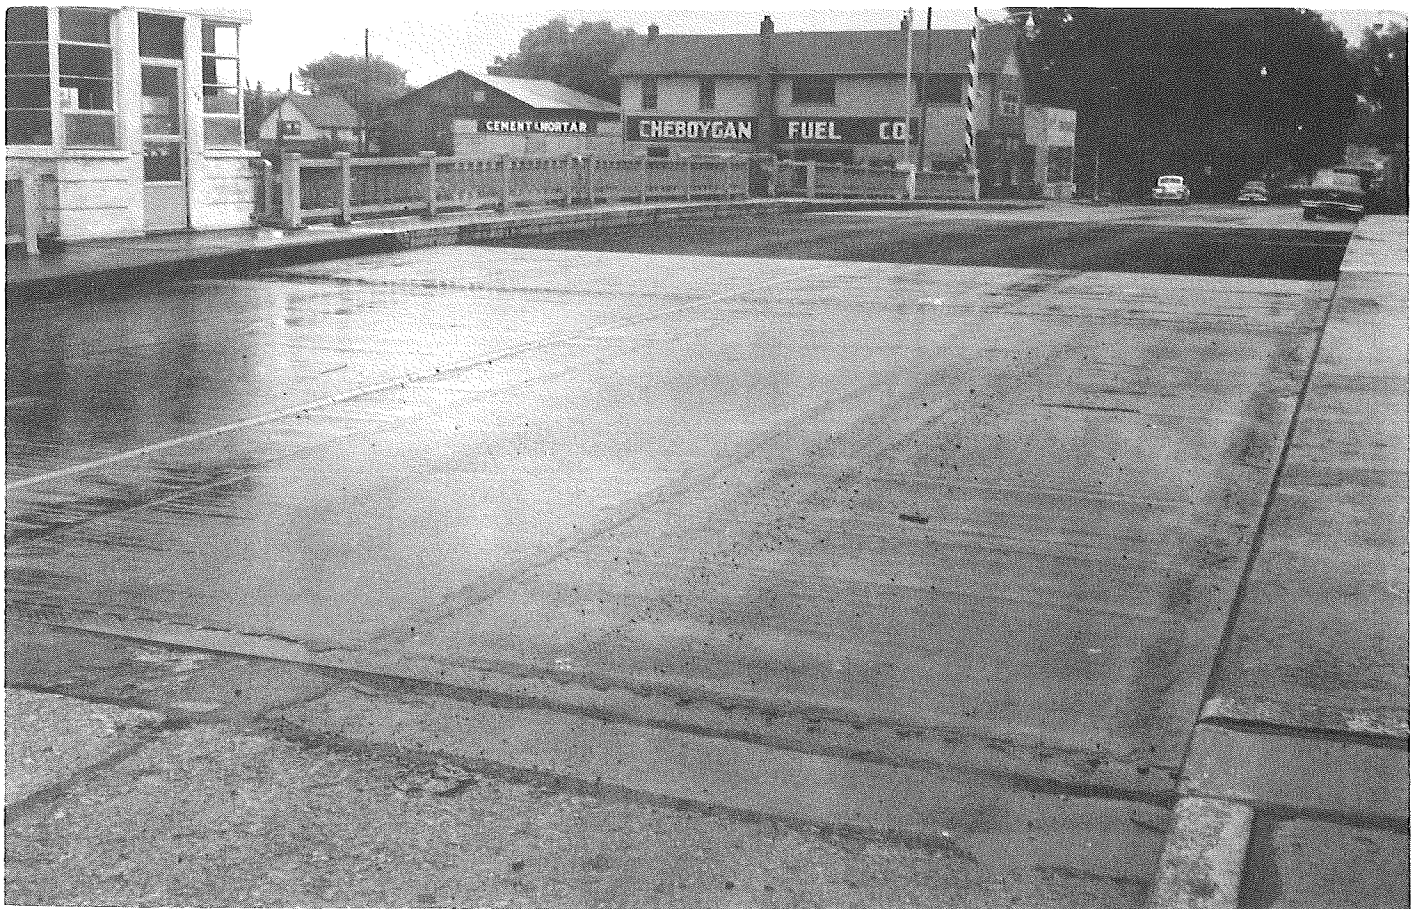
Figure 16. General views of the bridge deck showing overall sound condition of latex mortar lanes in August 1959, after two winters; east end (top) and west end (bottom).

The two lanes of Latex 560 mortar placed over a wet substrate are intact after two years, and the Latex X2130.1 mortar areas are sound after one year. These lanes will be examined and evaluated after additional winters of exposure. Further field exposures using latex modified mortar would be valuable, preferably using the Saran type emulsion and employing higher sand-cement ratios or leaner mixes with several latex-cement ratios.
