1959 PERFORMANCE TESTS
ON WHITE AND YELLOW TRAFFIC PAINTS

Research Laboratory Division
Office of Testing and Research
Report No. 348
Research Project 47 G-36(12)

Michigan State Highway Department
John C. Mackie, Commissioner
Lansing, October 1960

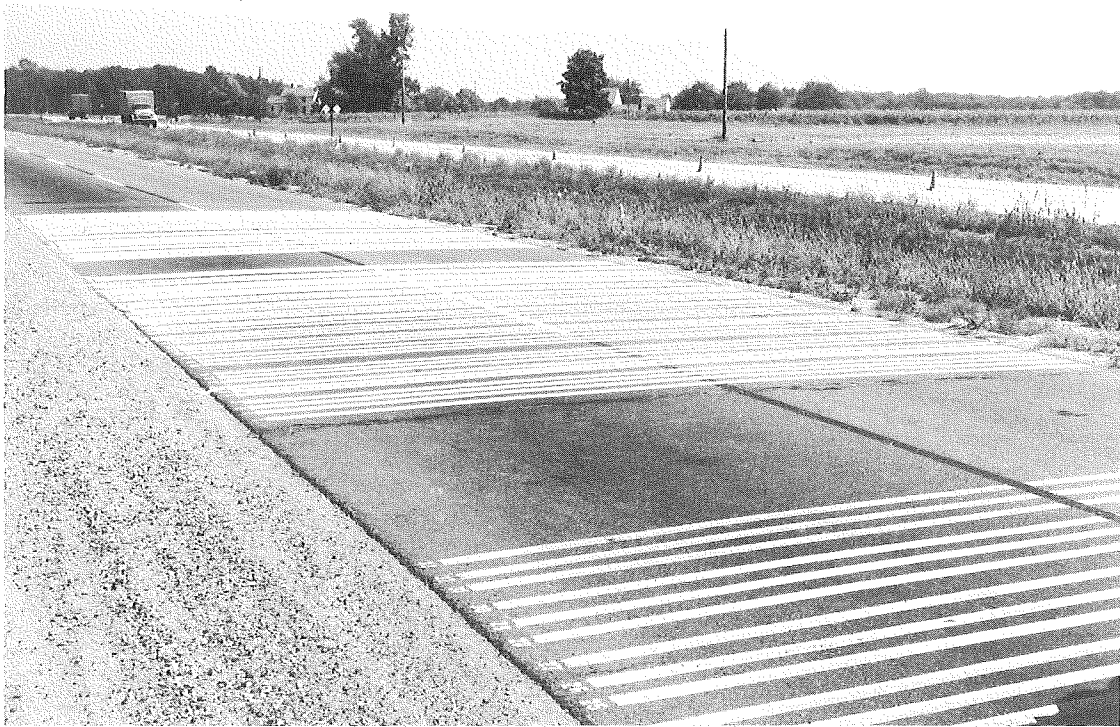
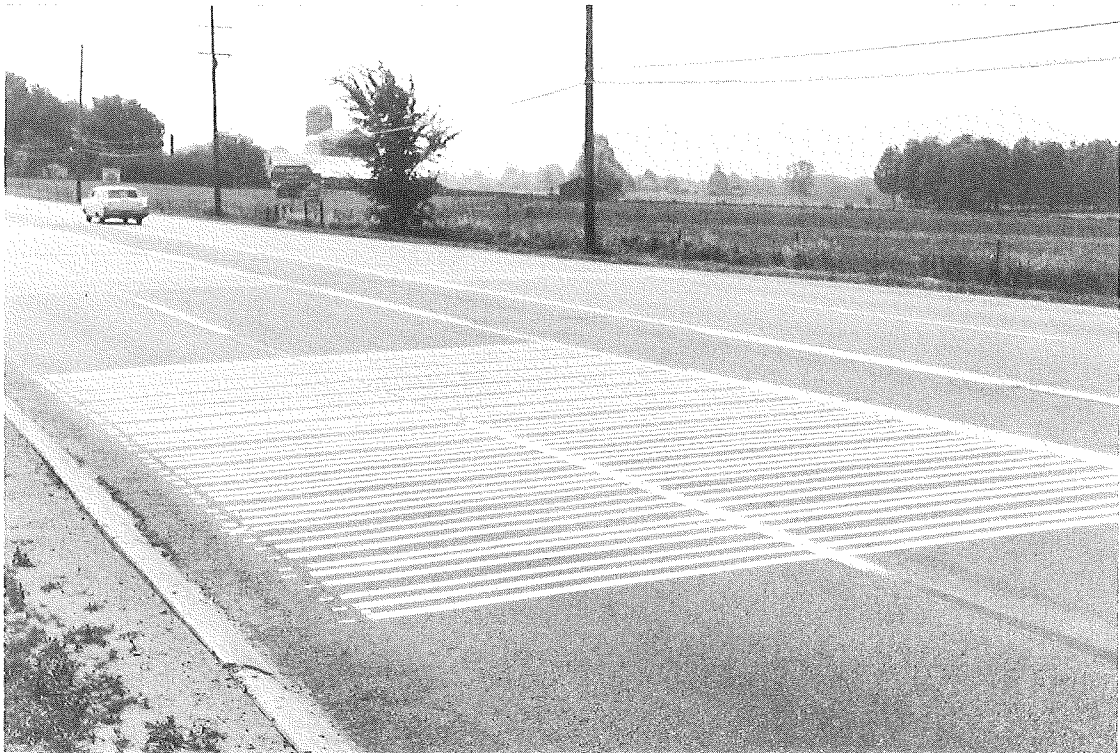
Figure 2. 1959 performance areas shortly after deposition of striping: Area 2, bituminous, in top photo, white and yellow stripes in background adjoining 1958 whites in foreground. Area 4, bituminous, in lower photo with yellow stripes in foreground, and 1958 or older striping in background.

No difficulty was experienced in depositing any of the standard paints, though the rubber-based experimental white had poor sprayability in the application equipment used in performance areas, two of which are shown in Fig. 2.

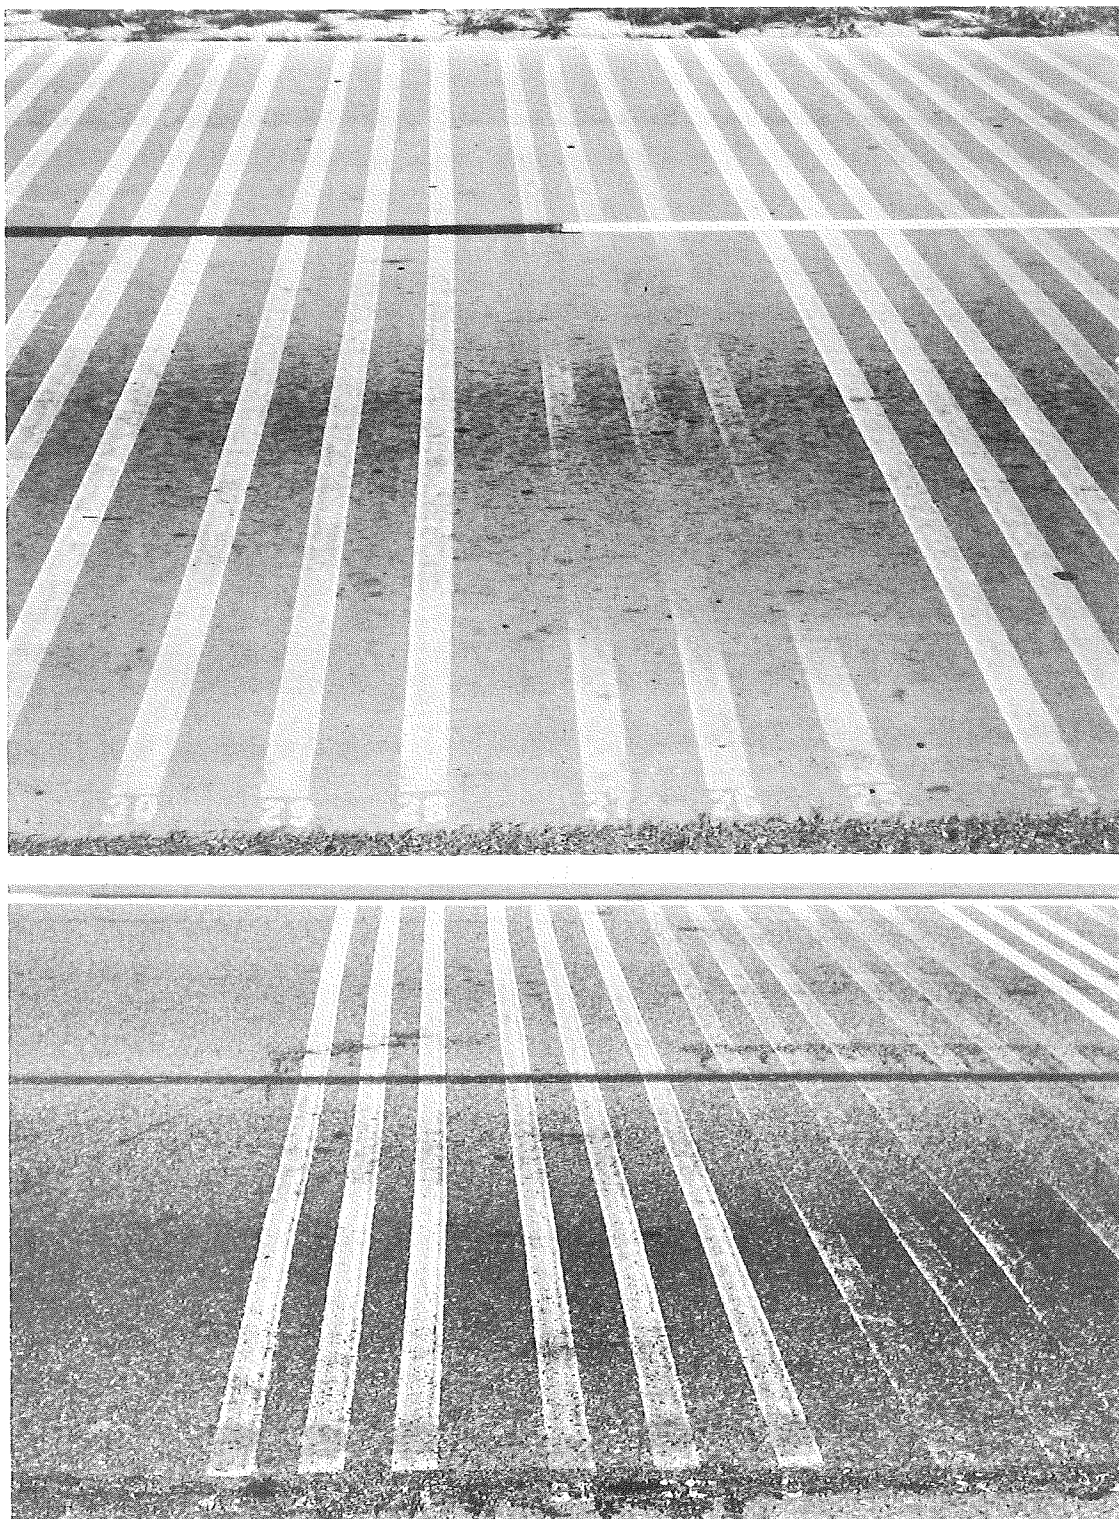
Figure 3. Some 1959 stripes after one year's exposure in test areas. Upper photo shows condition of yellow stripes 22 to 23 on concrete of M 78; stripes 22-24 are yellow paint purchased for highway striping in 1959. Lower photo shows yellow stripes 36 to 42 on black-top of US 127; stripes 39-42 represent Laboratory experimental paints.

As in previous years there was considerable difference in the quality ratings of the evaluated paints in the four test sections. As previously, test paints deteriorated considerably faster in test areas of US 127 than in the two other sections, this year located on M 78, which had about half the traffic density of the former, with the majority of the paints showing fastest deterioration in the concrete test area on US 127. The terminal condition of some test stripes is shown in Fig. 3.
