R-455

MICHIGAN
STATE HIGHWAY DEPARTMENT

Subject: Installation and First Inspection of Experimental Joint Sealants on I 496
(Construction Projects I 33045D, C1, S12, and S14 of 33045D) I 496-7(4) 146.
Research Projects R-51 G-56, R-62 NM-62, R-62 NM-66, and R-63 NM-85.
Research Report No. R-455.

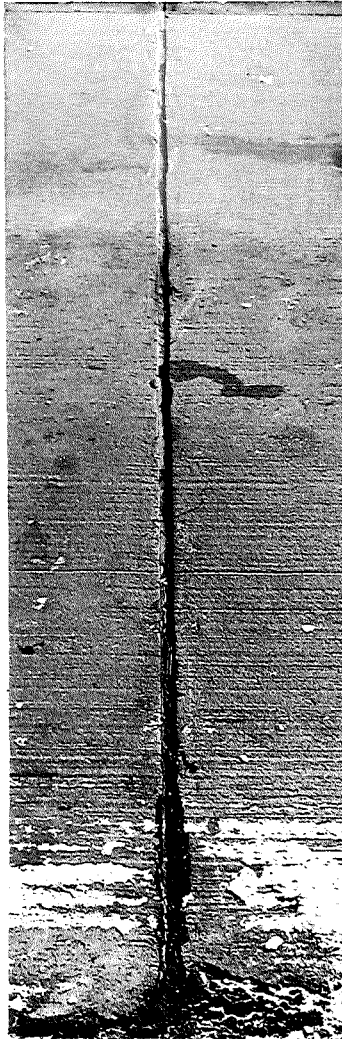
Presstite two-component cold-applied polysulfide type sealant 54/404 appeared in good condition in regular contraction and expansion joints (Fig. 2). On the roadway joints an adhesion loss of about 5 percent was estimated. In the steel expansion dam in the southbound structure over Cavanaugh Road complete adhesion loss was evident on the leading edge (Fig. 3). The supplier of material believed this to be caused by improper priming of joints. This sealer was softer and more resilient than standard rubber-asphalt sealer, at the 15 F inspection temperature.

Figure 2. Polysulfide two-component sealer (Presstite) gave satisfactory performance after three month's service; Sta 670+95 (SB).

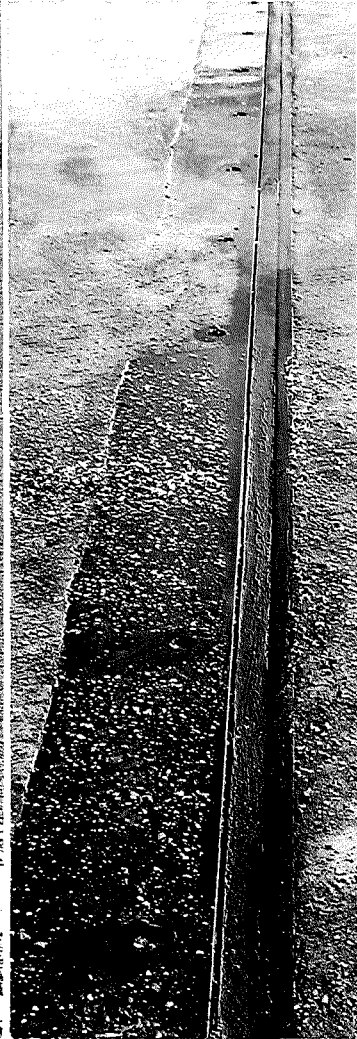
failures had developed along 5 to 20 percent of the sealer length. Of these two, the former is giving good field performance in the bridge steel expansion dam where it was placed, showing only two small spots of adhesion failure, while the latter exhibits complete adhesion failure along the joint leading edge on the parallel bridge structure.

Figure 3. Polysulfide sealer shows adhesion loss on leading edge of bridge expansion dam after three months of winter service.
