US-23 Aggregate Test Road Long-Term Performance Evaluation

Final Report

1. Report No. SPR-1652	2. Government Accession No. N/A	3. Recipient's Catalog No.	
4. Title and Subtitle Concrete Pavement Performance Center of Excellence (CPP-COE) – Supplemental Services		5. Report Date March 24, 2017

16. Abstract The US-23 Aggregate Test Road was constructed in 1992 with the main purpose to determine the influence of coarse aggregate of varying frost susceptibility on long-term concrete durability. The pavement structure for the entire Test Road consists of a 10.5 inch, 27 ft. jointed reinforced concrete pavement (JRCP) constructed on a 4 in. asphalt-treated permeable base (ATPB) layer on top of a 3 in. gravel separator layer. Half of each test section was built on the original poorly-draining subbase with the other half constructed on a “select” well-draining permeable sand subbase. The report findings are based on latest field investigation in 2016 and previous year’s field tests, aggregate properties, concrete mix proportions, periodic distress surveys, and IRI data collected by MDOT personnel. The main findings are: No joint durability distress was found. This is attributed to excell

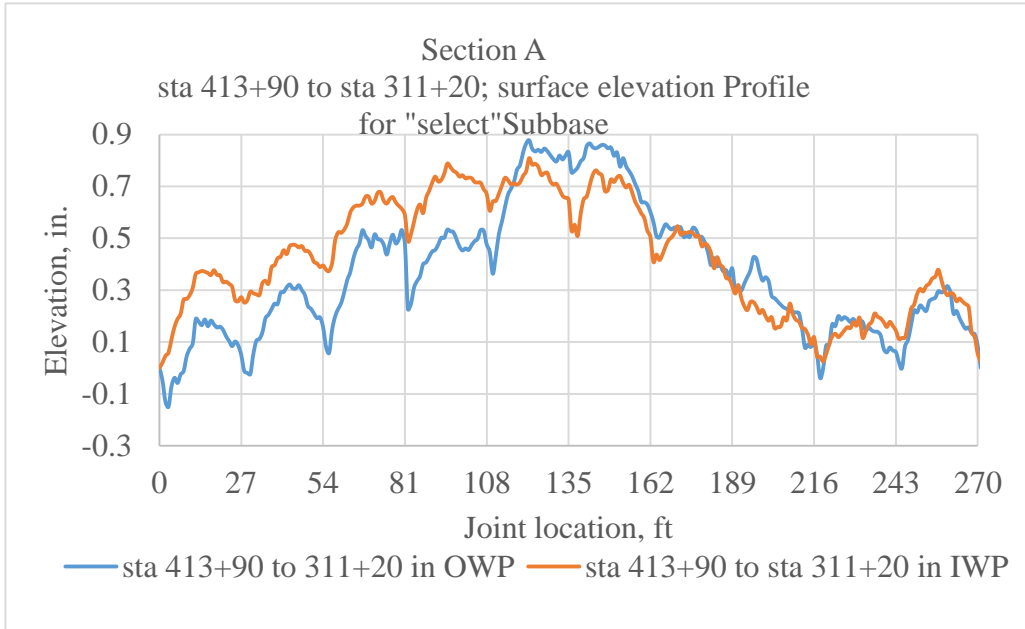
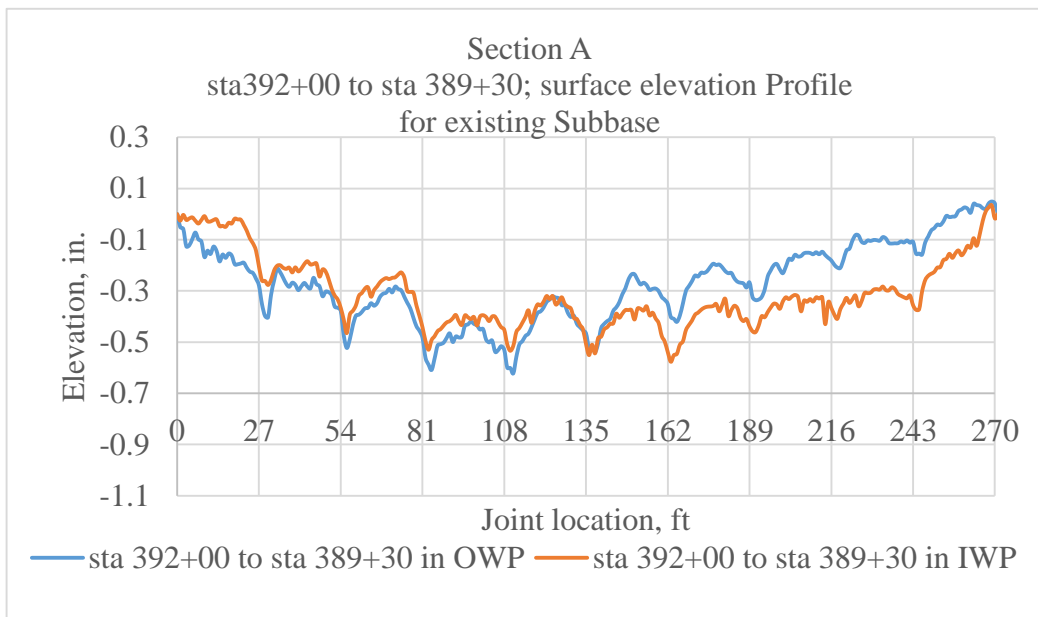
Figure 2.7. Permanent joint settlement is similar for “select” (a) and existing subbase (b) typical for all sections.

Surface elevation results based on the Dipstick Road Profiler show that the transverse joints for sections A through E have settled by about 0.10-0.20 inch. Typical slab results are shown for Section A in Figure 2.7. The joint settlement has developed as a result of loss of joint load transfer at the contraction joints. Typical surface elevation profiles based on Dipstick measurements are shown in Figure 2.7 for profile results in the outer wheel-path (OWP) and inner wheel-path (IWP). Subbase type had no influence on joint settlement. The downward-curved slab shape creates maximum top tensile bending stress in the mid-panel region, which combined with early morning loss of support increase total slab bending stresses from joint loading. This condition promotes top-down mid-slab cracking consistent with observations from cores in 2006 (Figure 2.8).

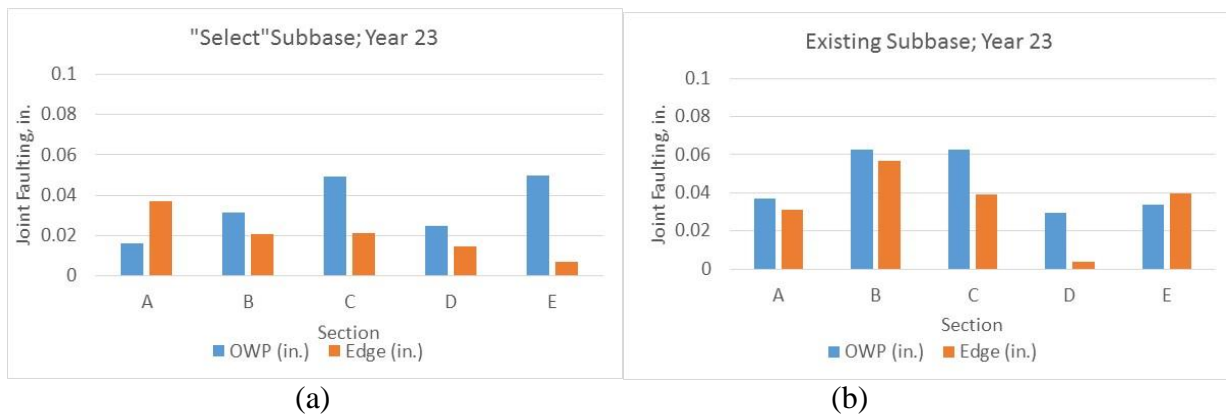
Figure 2.9. Average joint faulting for new (a) and old (b) subbase types

Pumping erosion leading to joint faulting has not developed in any of the five sections of the Aggregate Test Road after 23 years in service as the joint faulting is low ($< 1\text{mm}$), irrespective of subbase type (Figure 2.9).

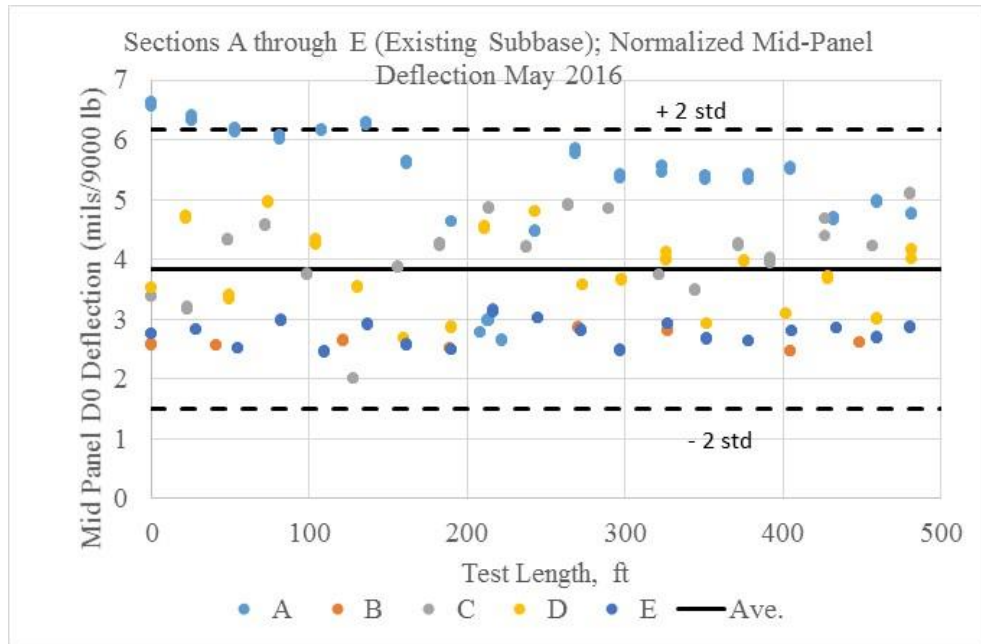
Figure 2.10. (a) Mid-panel deflection on existing subbase and (b) “select” subbase

Mid-panel deflections are lower in all section containing the “select” subbase compared to the existing poorly draining subbase, (Fig.2.10) and deflections are more uniform in the sections containing the “select” subbase. Mid-panel based back-calculation (Huang) for effective layer stiffness k (pci) using four FWD sensors D0, D4, D6 and D7 at distances (0, 12, 24 and 36 inches) from the D0 based on average D0 values result in static k -value of about 50 pci and 100 pci

respectively for the existing and “select” subbase sections. These differences in average k-values do not have a significant effect on joint deflections. However, the large spread in deflections for the existing subbase is a concern. Backcalculation of k and E suggest that the effective slab thickness for the case of a 10.5 in. slab on a 4 in. bonded ATPB is slightly increased (approx. 11.5 inches) (Figure 2.11a). At the joint outer edge some erosion of the base is evident (Figure 2.11b).

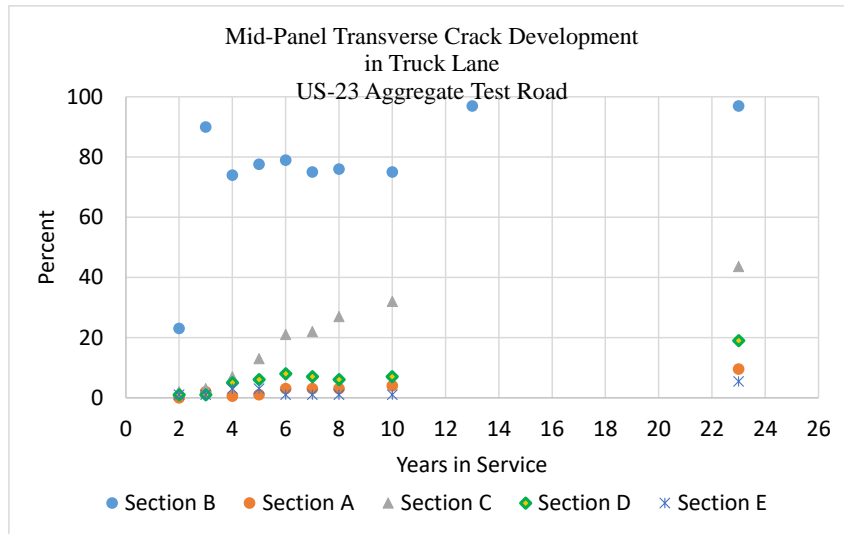
Figure 2.12. Mid-panel transverse crack development.

Test section B has developed premature mid-panel cracking early in its service life. Surface spalling developed which eventually required full-depth repairs in 29% of all slabs in the truck-lane after 19 years. Spalling is an indicator that aggregate interlock has been lost due to excessive crack opening. Premature mid-panel transverse cracking has developed rapidly (with first 5 years). Initially these cracks were tight, but quickly developed into working cracks, which then promoted spalling, while cracks in the other sections remained tight without spalling. Rapid development of mid-panel cracking is shown in Figure 2.12. Figure 2.13 shows a typical spalled mid-panel crack in section B from 2006. Figure 14 illustrates the large difference in full-depth repairs between Section B and the other sections.
