INVESTIGATION OF SNOW FENCE POST BREAKAGE

Research Laboratory Division  
Office of Testing and Research  
Research Project R-63 G-132  
Research Report No. R-462

Michigan State Highway Department  
John C. Mackie, Commissioner  
Lansing, June 1964

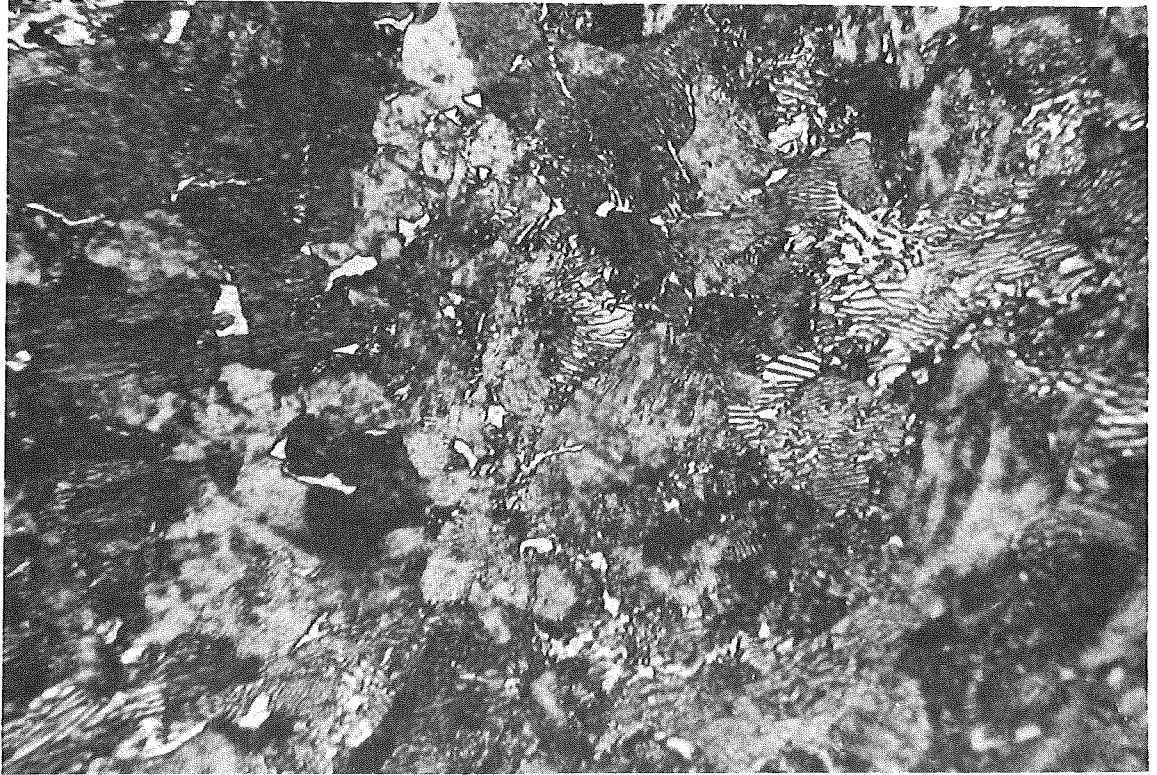
Examination of the grain size and microstructure revealed no visible difference between the galvanized and ungalvanized posts. Photomicrographs of galvanized and ungalvanized samples are shown in Figs. 3 and 4.

Figure 3. Microstructure of galvanized post 600X.

There appears to be no reason to believe that the galvanizing process has caused the brittleness of the snow fence posts. Steels of this strength, carbon content, hardness, and grain size range should not be recommended for use as fence posts. Instead, it is advisable that posts of larger cross-section and lower-strength material be used.

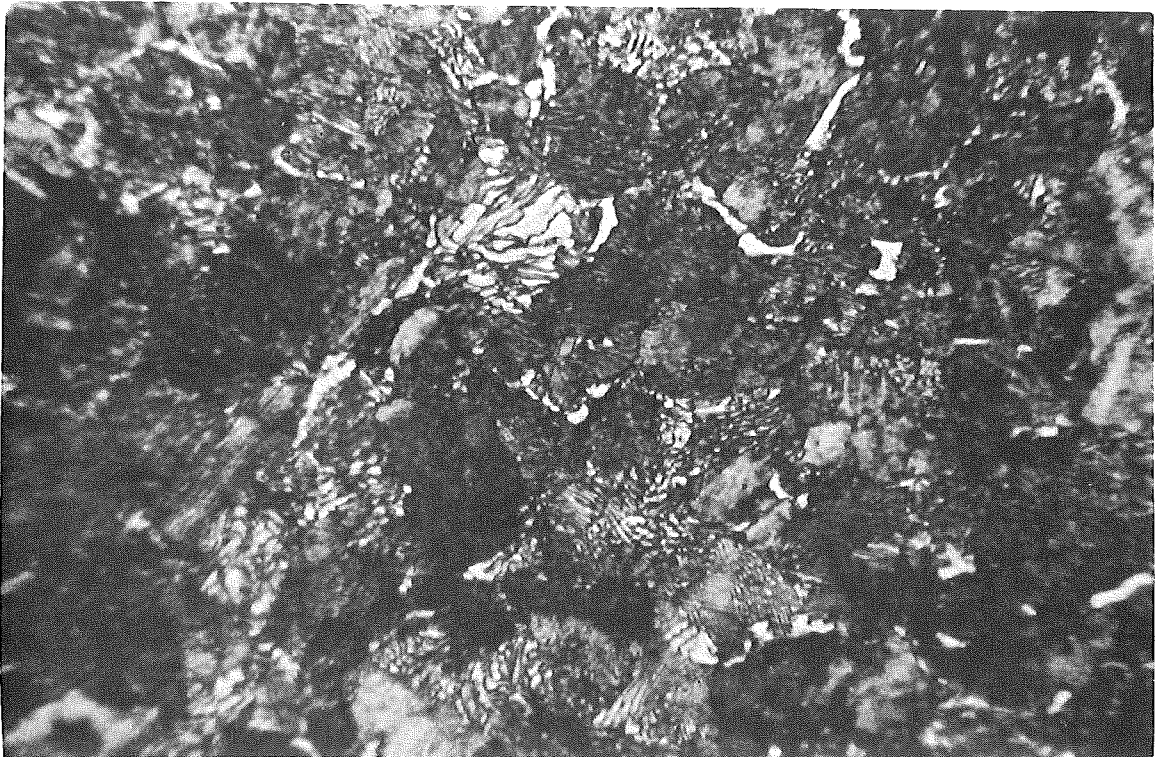
Figure 4. Microstructure of ungalvanized post 600X.
