**HIGH DENSITY CONCRETE DECK  
OVERLAY WITH SUPERPLASTICIZER**

**Research Laboratory Section  
Materials and Technology Division  
Research Project 82 TI-801  
Research Report No. R-1227**

SUBJECT: High Density Concrete Deck Overlay with Superplasticizer  
Research Project 82 TI-801

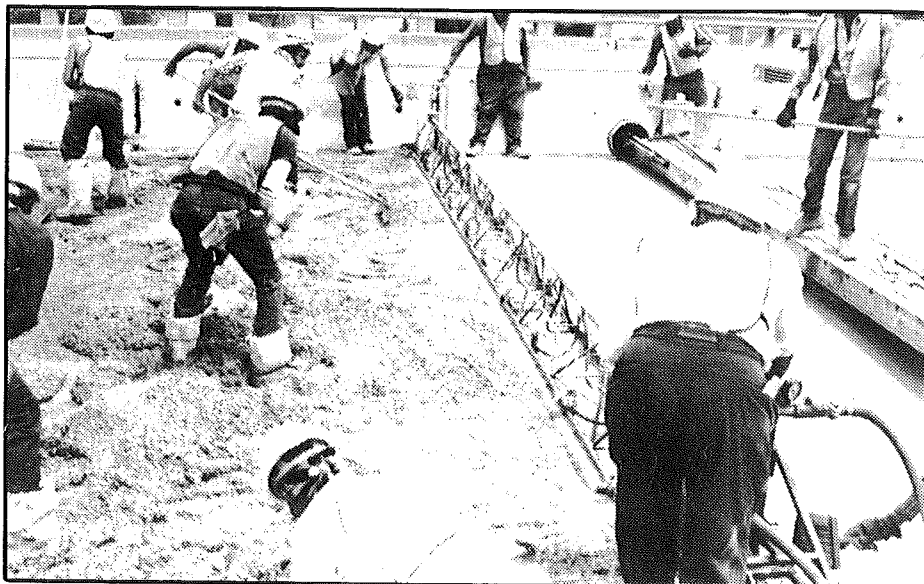
This particular screeding machine, an Allen Razorback screed, features a triangular cross-sectioned truss fabricated from steel angles, with air operated vibrators mounted on the leading edge (Fig. 1). It was drawn along the top surface of pipe rails by light steel cables anchored to the bridge deck surface and winched onto a screed-mounted cable spool at each end of the screed. This type of screed was called for since the Illinois

Figure 1. Placement of high density mix with superplasticizer using Allen Razorback screed on northbound I 75 (S21 of 82252).

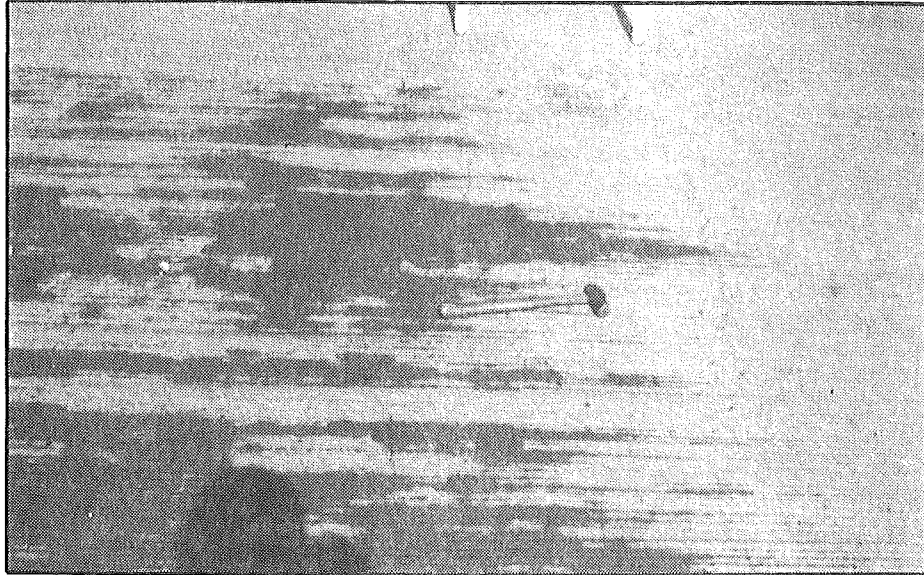
These overlays were placed in June and early July of 1982. An inspection in April 1983 revealed a fine crack pattern in the wetted surface which was randomly spaced and mainly longitudinal (Fig. 3, Report R-1227). Now, two years later, the cracks are easily detected without wetting the surface. The longitudinal cracks in some areas extend nearly the full span length and some of them, based on their surface width, are judged to extend through the overlay.

Briefly, we found numerous fine shrinkage cracks, largely short longitudinal ones, in the inside northbound lane on I 75 of S21, X08, and S22 of 82252 done last year (Fig. 3). The same type of fine cracks were found last July in the 1981 overlay (Fig. 4). The April 20 inspection of this latter deck did not appear to indicate much change from last year in the crack severity.

Figure 3. Inspection of northbound median lane on S21 of 82252. Area was wet with water to delineate fine crack pattern which was randomly spaced and mainly longitudinal (April 1983).

Based on the recent inspection of the deck overlays, it is recommended that the moratorium on using LSHD-HRWR overlays be continued until a better assessment of their performance can be made.

Therefore, we would strongly recommend that no more LSHD-HRWR overlays be placed this year and until an assessment can be made in the spring of 1984 of these type overlays placed in 1981, '82, and '83. We will also have a much better concept of the chloride penetration and long-term drying shrinkage—both of which at this time appear to be a very serious problem. Moreover, other physical properties from laboratory tests well underway as well as specimens made from the Port Huron deck pour can be assessed.

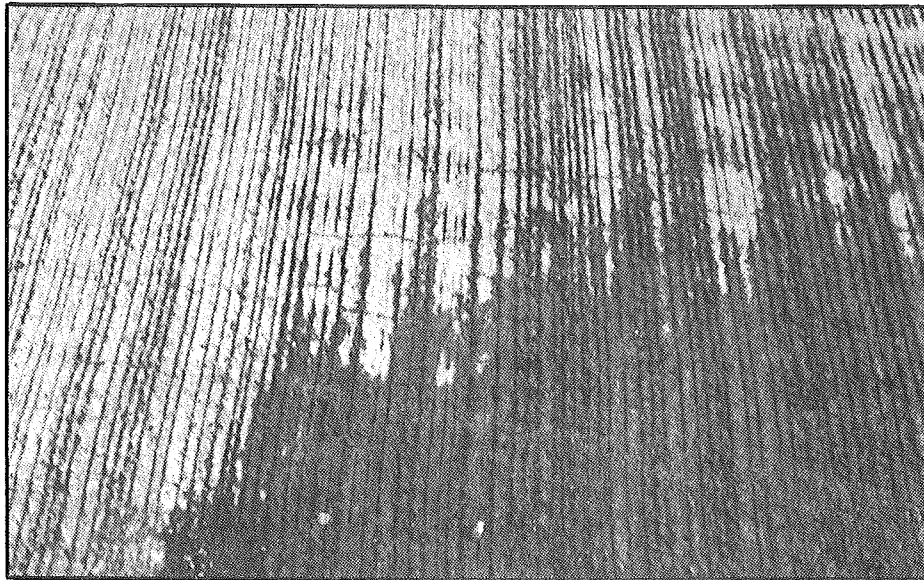
This overlay was placed in the summer of 1981 and an inspection in April of 1983 revealed a fine map cracking pattern in the wetted overlay surface (Fig. 4, Report R-1227). This type of cracking has now advanced to the stage where it is easily visible when the deck is dry. Although the cracks are quite noticeable they are still very tight and apparently do not as yet extend through the overlay.

Figure 4. Fine crack pattern in northwest quadrant of Span 3, S25 of 82252, in LSHD and HRWR pour of August 1981 (photo July 1982).

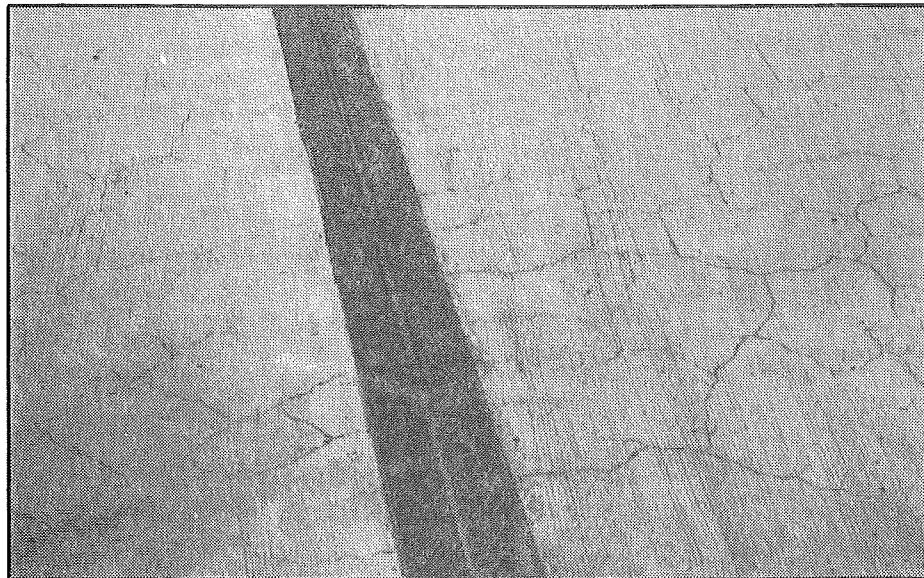
Figure 6. Crack pattern in southbound I 94 near Pier 2 of B03 of 50111. LSHD overlay of 1977 after five years.

We have been concerned about this fine cracking because it may develop into the more pronounced and severe type of random cracking we have found, to some degree, on all LSHD overlay jobs done in 1975, '77, and '78. These decks total 27 of which eight of them were new two-course decks on I 475. The LSHD mix design is the same as the superplasticizer type used in 1981 and '82 except for the addition of a high range water reducer just before placement. The long-term shrinkage should be essentially the same. Typical examples of the cracking problem which has been developing on these older LSHD overlays are shown in Figures 5, 6, and 7.

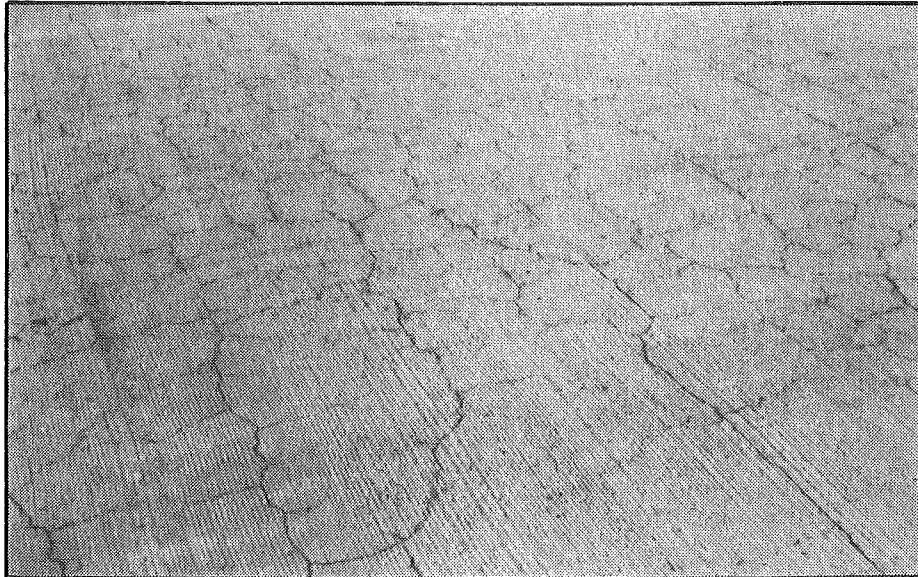
Figure 7. Random crack pattern in eastbound I 96 inside lane of LSHD pour of 1975 on S10 of 47065 after seven years.
