Research Record

Issue Number 87

Bituminous Pavement Resurfacing at Snowmobile Crossings

MDOT Studies Asphalt Pavement Coatings

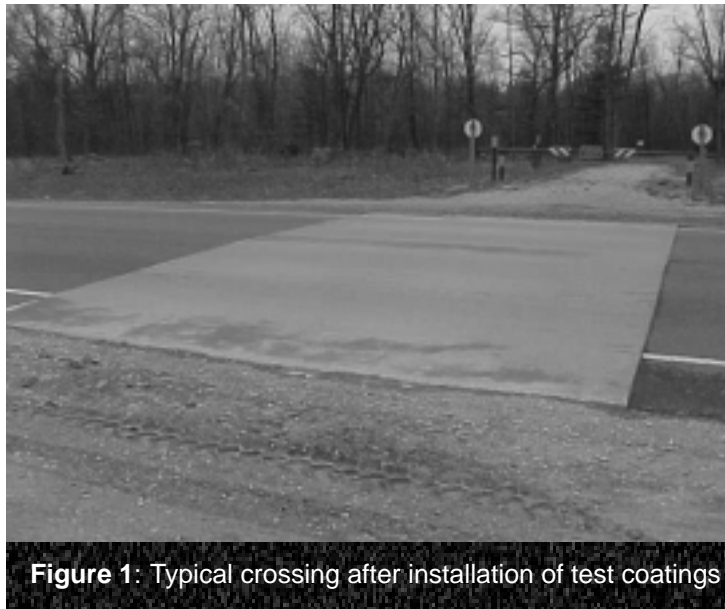
Figure 1: Typical crossing after installation of test coatings

Methods used during the installation of the coating materials varied from spray-on to broom and seed to trowel applied. In addition, several different aggregate types were used as part of the coating systems. These ranged from silica sand to aluminum oxide to chipped flint, depending on the manufacturer's recommendations. The sprayed-on materials were applied in as many coats as the manufacturer's representative felt necessary. The most common method of application involved applying two coats of material.

After a 24 hour curing period, the first six coating products began to crack around the perimeter. This cracking is most likely due to either stresses resulting from thermal incompatibilities between the coating and the bituminous concrete, or to tensile stresses from shrinkage of the coating materials during curing. The problem was alleviated by sawing 25 mm deep by 3 mm wide channels around the perimeter of the coated sections. These saw cuts were blown out and sealed with silicone sealant to prevent the possible infiltration of incompressibles.

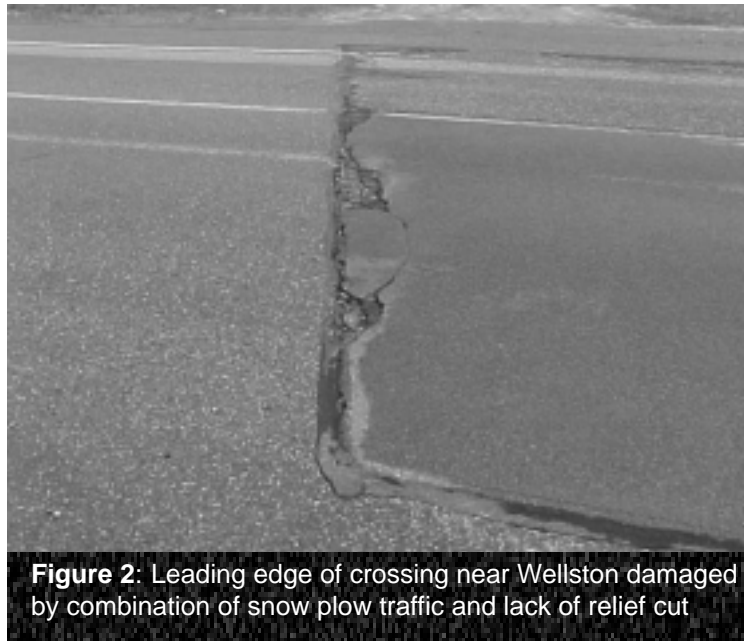
Figure 2: Leading edge of crossing near Wellston damaged by combination of snow plow traffic and lack of relief cut

During the installation of the test materials, a number of important observations were made that will help ensure a better performing coating system in the future. As mentioned earlier, it is vital that relief cuts are sawed at the leading and trailing edges of the coating, and that these cuts must be cleaned and sealed with a silicone sealant to prevent intrusion of incompressible materials (please refer to Figure 2). Furthermore, the liquid binder must be allowed to run off of the edge of the pavement onto the gravel surface to protect the exposed edge of the pavement.

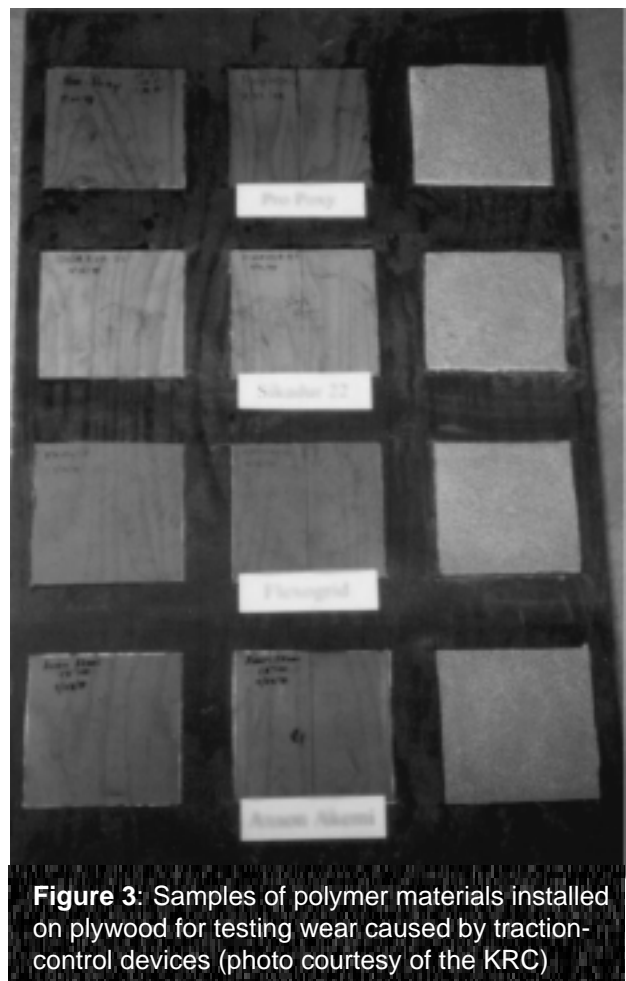
Figure 3: Samples of polymer materials installed on plywood for testing wear caused by traction-control devices (photo courtesy of the KRC)

The KRC also performed another test using a 4 ft. x 8 ft. sheet of plywood. In this test, the four different coatings were applied in four rows consisting of three square test sections (please refer to Figure 3). The thickness of the epoxy was approximately 3.2 mm. The test snowmobile was run over these test sections and the wear to each was monitored. The four samples along the right-hand side of the plywood in Figure 3 were coated with aggregate, while the samples along the center and left-hand sides consisted of the epoxy coating only. The samples on the right and left edges lined up with the carbide runners on the skis, while the samples along the center aligned with the snowmobile track which contained the carbide studs. This configuration allowed the KRC to directly compare the performance of the four samples with and without aggregate. The four samples that contained aggregate performed the best, showing minute scratches after passage, but for all practical purposes, showing no wear.
